# Independent Builders Report

Total Home Inspection Services Porirua City Ltd

Thu 16 Jul 2026

**22 Pinewood Gr, Paraparaumu Beach, Paraparaumu,  
5032, New Zealand**

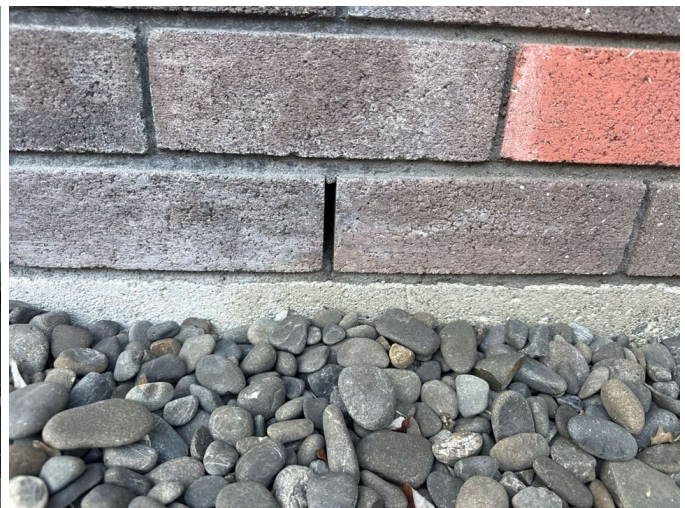
The brick facade has a cavity and weep hole detail which allows ventilation and drainage to and from the cavity behind the bricks. Weep holes and ventilation gaps must be kept clear for this to be effective.

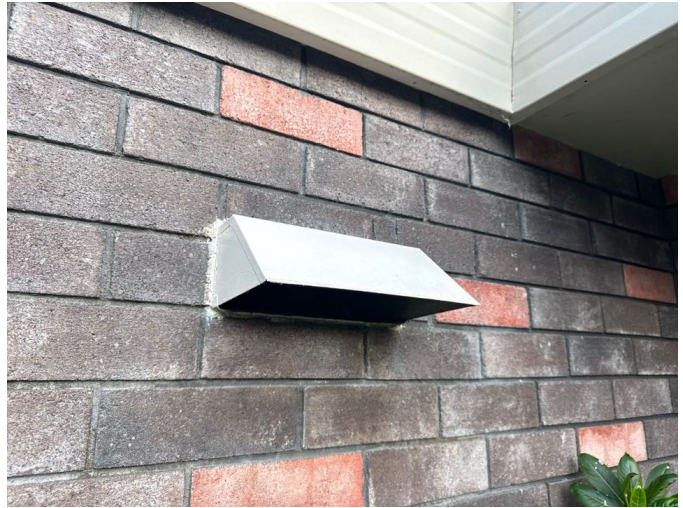
Extraction vents exit through the wall and soffits

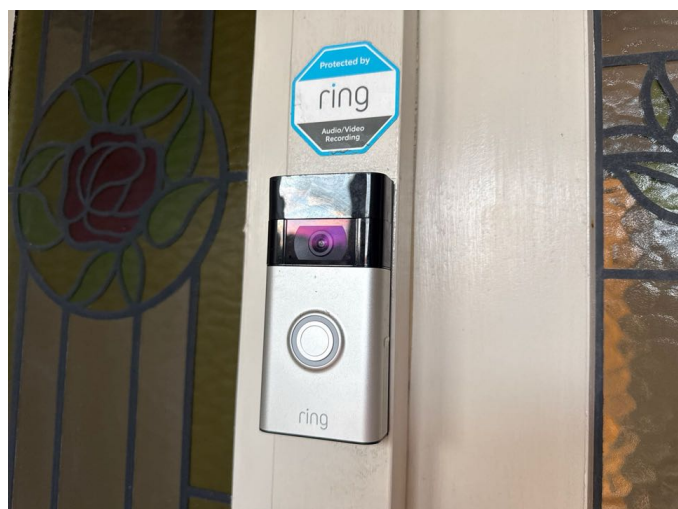
Security camera/door bell installed at the front entrance - untested

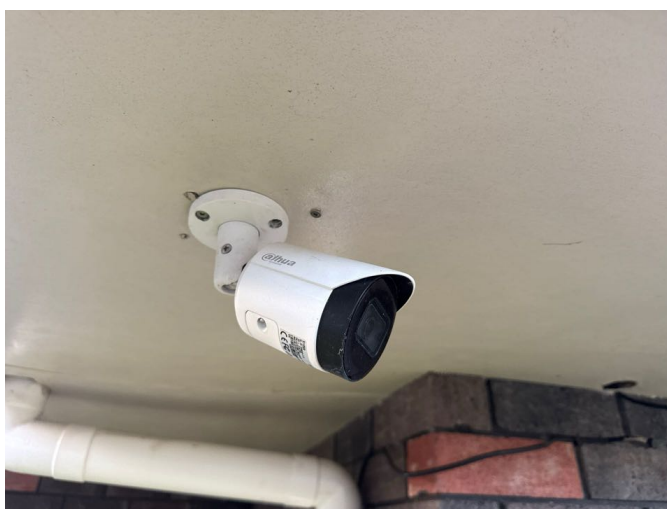
Security camera system installed. Untested.

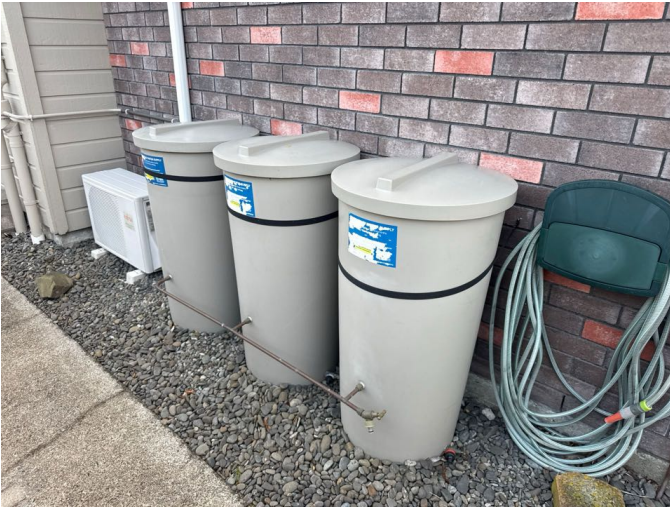
Water storage tank installed on the southwest side

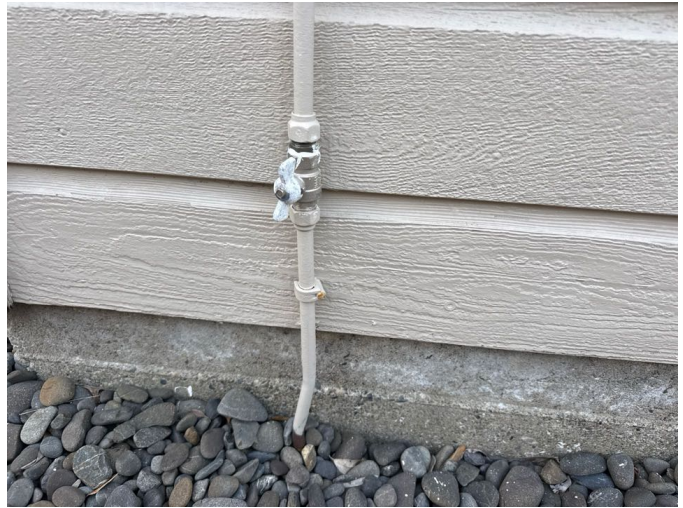
Water isolation valve to the southwest side

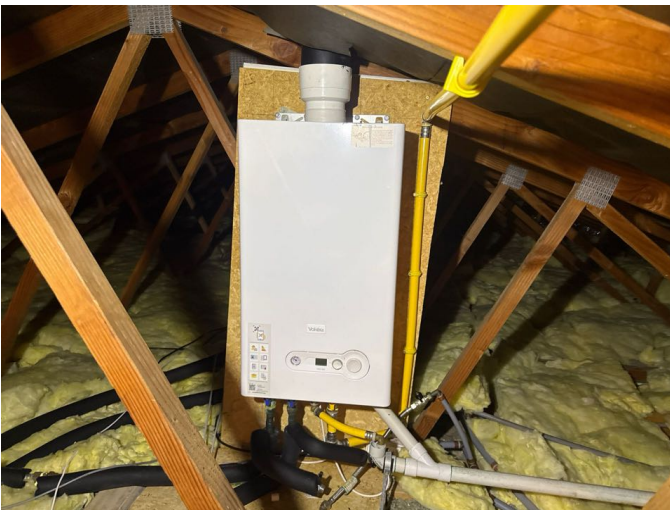
The boiler for the radiator heating system is located in the ceiling cavity.

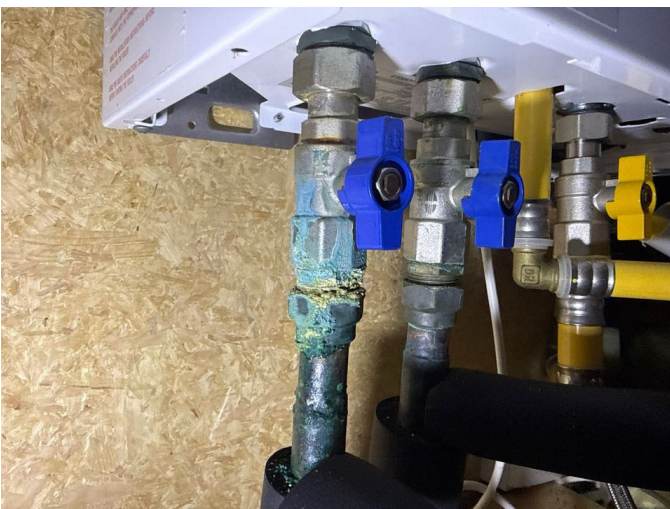
Another example of oxidation beneath the boiler

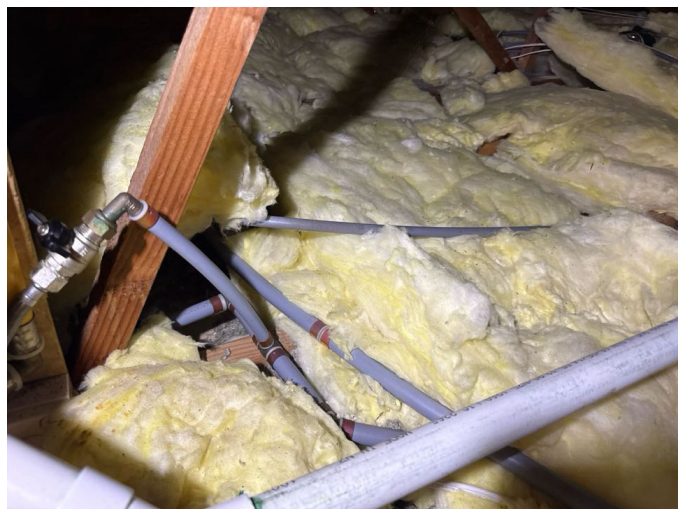
There was no evidence of plumbing failure found at the time of the inspection

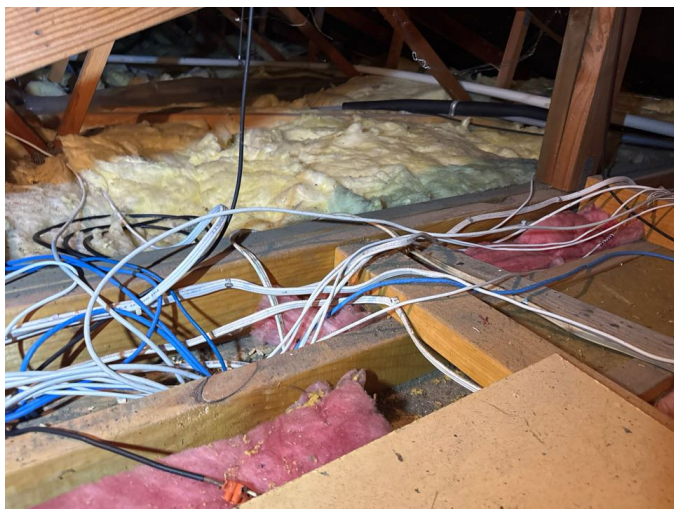
The insulation is a combination of loose fill and batts

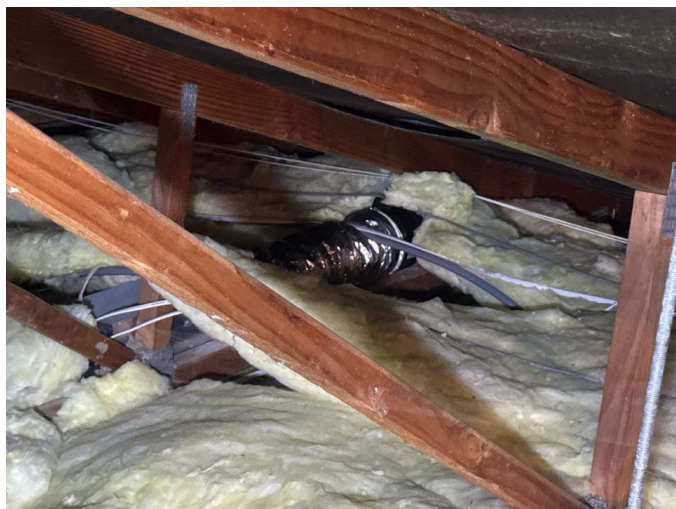
Extraction units vent to the exterior

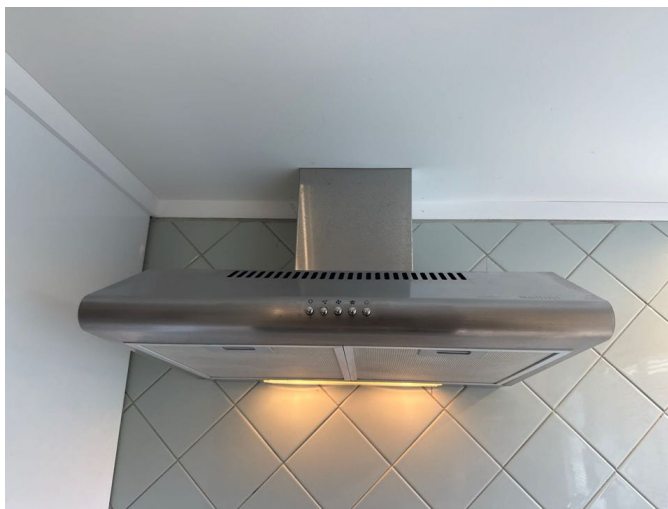
The range hood extraction unit is functioning

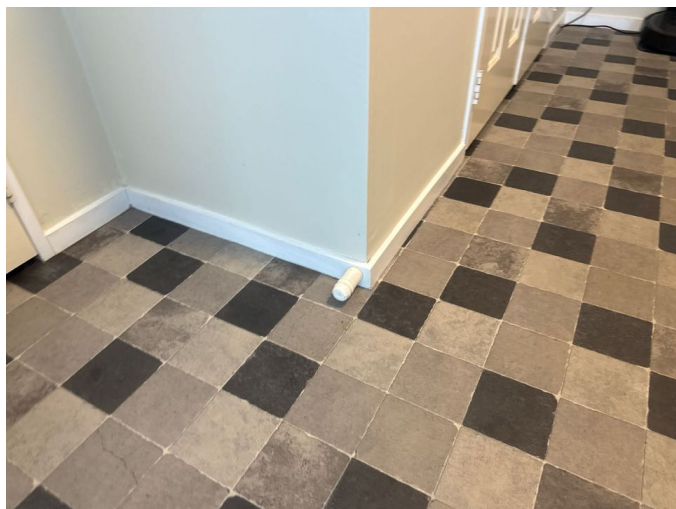
The wall linings and vinyl flooring are tidy

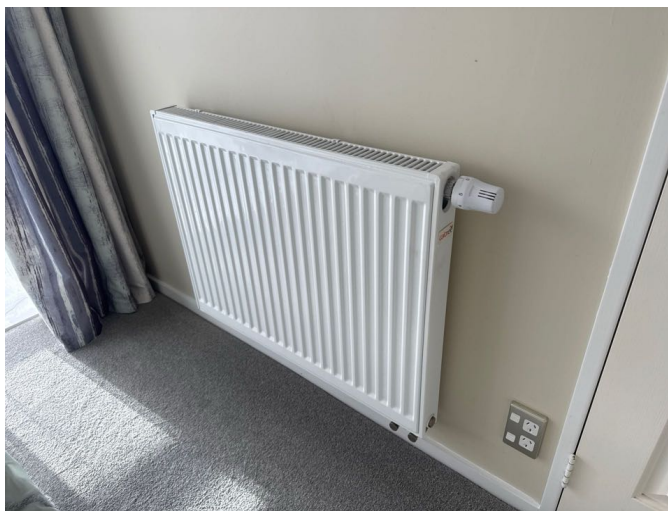
Radiator heating to the bedrooms

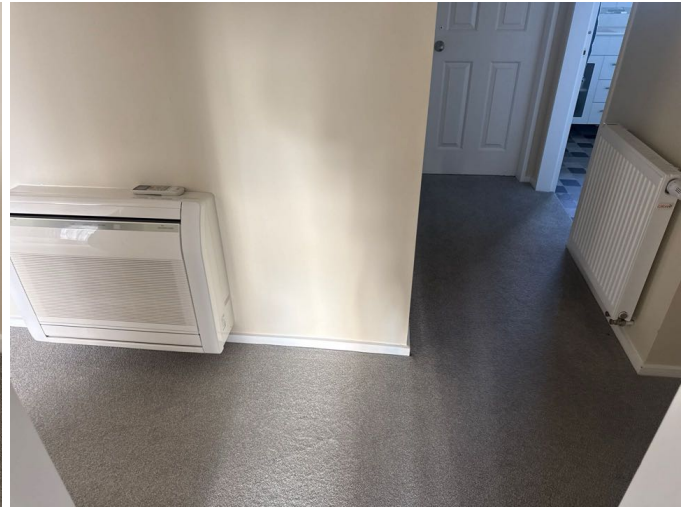
The wall and ceiling linings and carpet are in good condition
