# EARTHQUAKE RECOVERY (EQR) DOCUMENTATION

# EQR Property Overview Report

**MULTI-UNIT STRUCTURAL ASSESSMENT REPORT (DRAFT)**

**54 Devon Street, Sydenham**

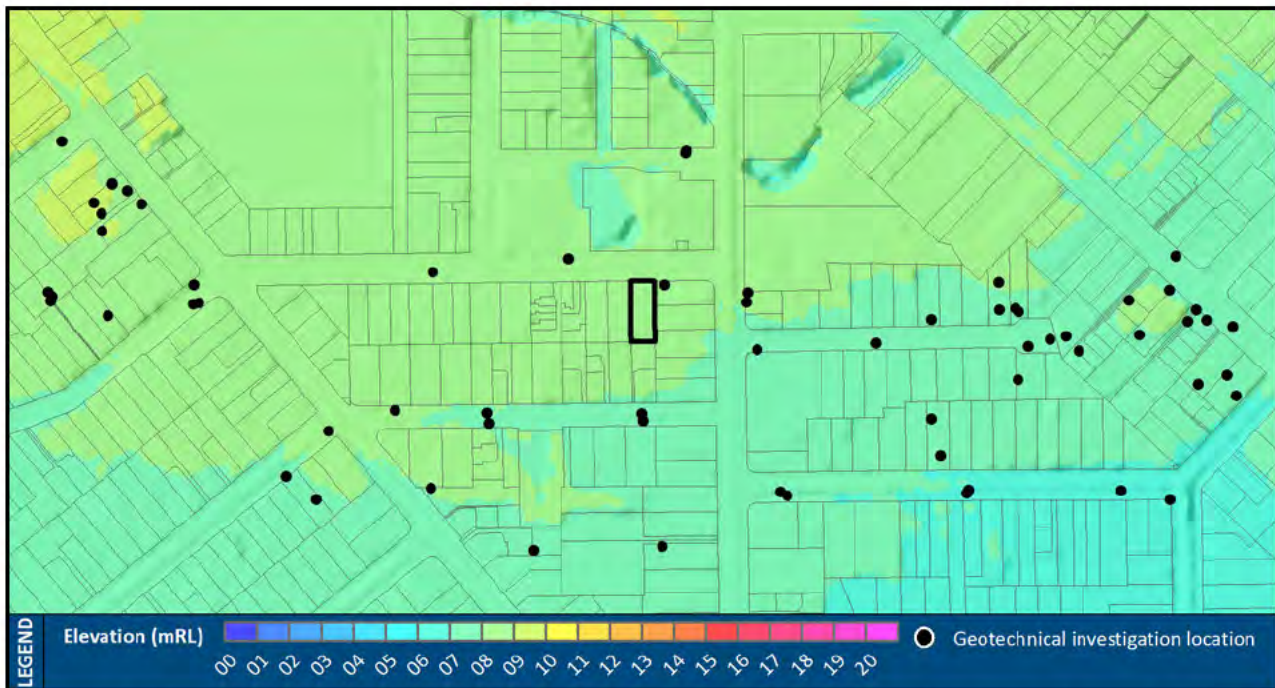
**Map 1: Post Canterbury earthquake sequence ground surface elevation and geotechnical investigation locations**

This map shows the ground surface elevation (i.e. the height of the land) following the Canterbury earthquake sequence. The elevation shown is the height above mean sea level.

The black dots show the locations of geotechnical investigations. These comprise a combination of Cone Penetration Tests (CPTs), boreholes and laboratory tests.

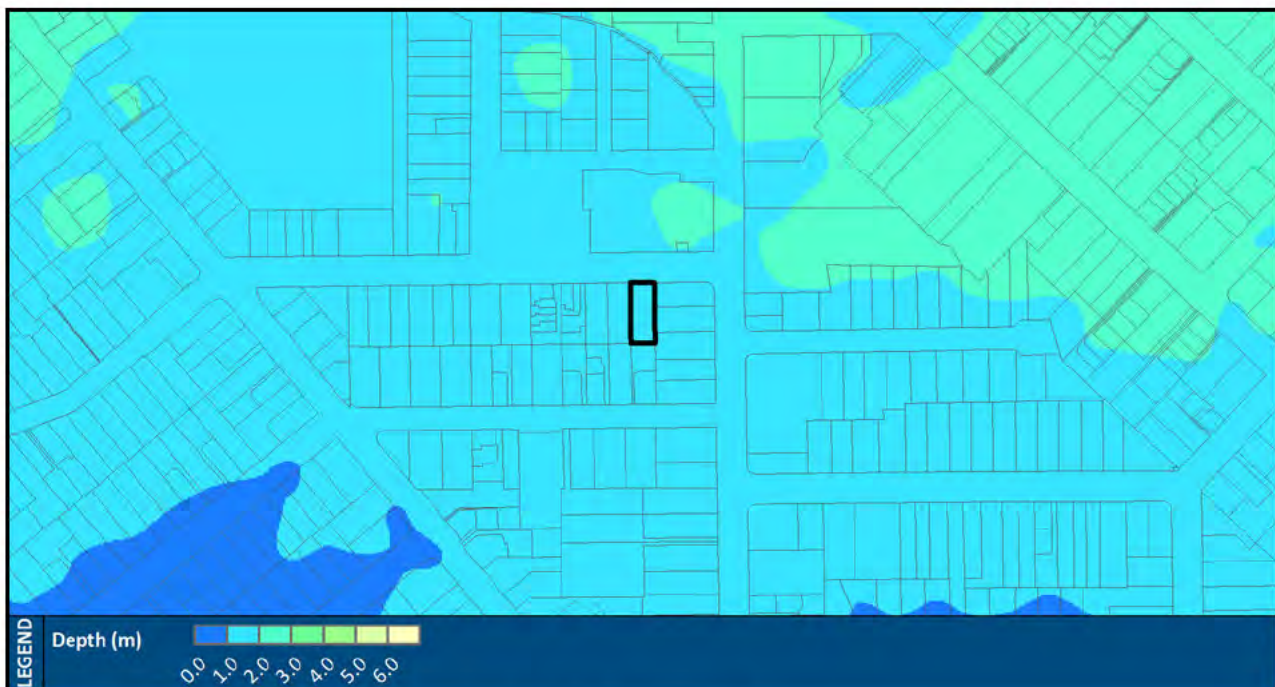
**Map 2: Post Canterbury earthquake sequence depth to groundwater**

This map shows the median depth to groundwater below the ground surface after the Canterbury earthquake sequence.

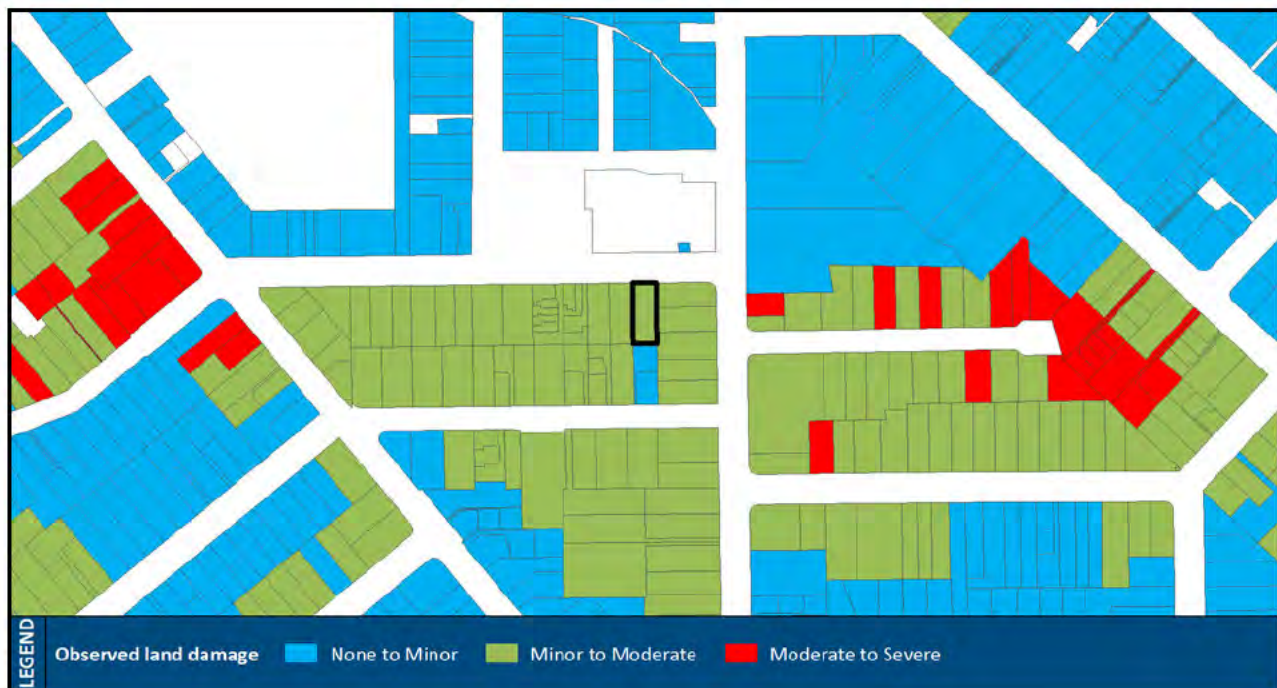
**Map 3: Worst observed land damage due to the Canterbury earthquake sequence**

This map shows the worst observed land damage recorded for the four main earthquakes during the Canterbury earthquake sequence. Descriptions of the observed land damage categories are: **None to Minor** – no observed liquefaction related land damage through to minor observed ground cracking but with no observed ejected liquefied material at the ground surface; **Minor to Moderate** – observed ground surface undulation and minor-to-moderate quantities of observed ejected liquefied material at the ground surface but with no observed lateral spreading; and **Moderate to Severe** – large quantities of observed ejected liquefied material at the ground surface and severe ground surface undulation and/or moderate-to-severe lateral spreading.

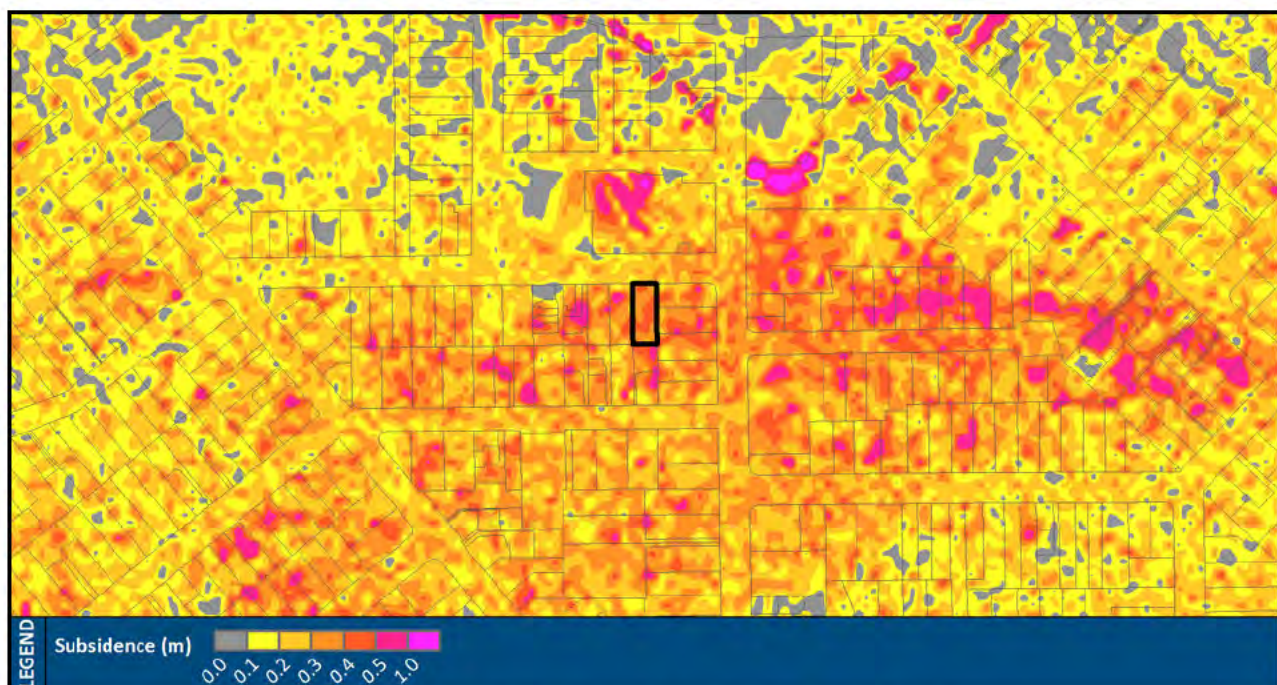
**Map 4: Total ground surface subsidence due to the Canterbury earthquake sequence**

This map shows the estimated total amount of ground subsidence as a result of the Canterbury earthquake sequence. Ground surface subsidence is estimated by comparing ground surface levels after each of the four main earthquakes. Adjustments have been made to the map to remove subsidence or uplift that is not as a result of the Canterbury earthquake sequence (e.g. man-made activities such as earthworks).
