## 2.4 Site Description

The western slopes are grass or scrub covered with some trees with the dominant landform comprising two arcuate features, separated by a minor spur (annotated on Figure No. 822-S2-004 in Appendix A). The northern and southern arcuate features are located to the north and south of Titiro Street. These areas are referred to herein as Northern Stage 2 and Southern Stage 2, respectively.

## 4. Site Walkover Observations

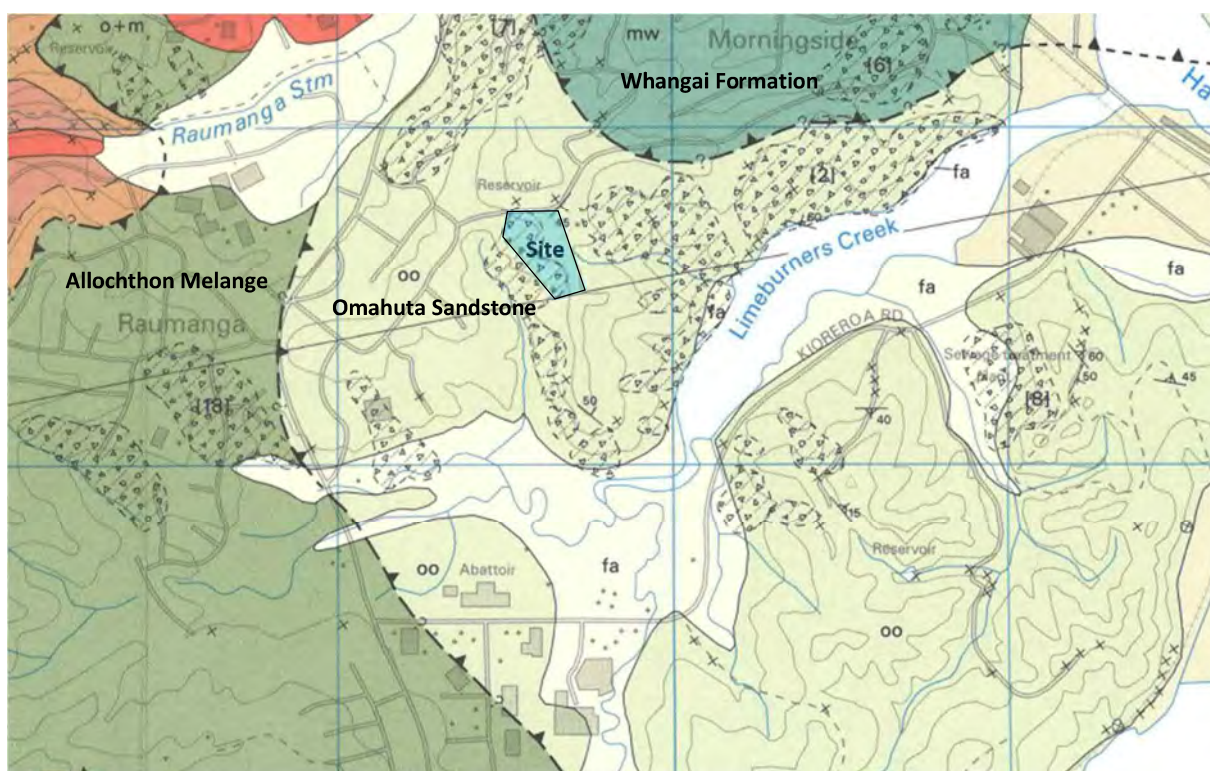
Figure 3-2: White & Perrin 2003 1:25,000 Whangarei Urban Area Geological Map

In addition to the available aerial photography, White and Perrin (2003) mapped instability around the site on the 1:25,000 Whangarei Urban Area map (see **Error! Reference source not found.** above, hatched areas indicate mapped instability). White and Perrin have mapped instability within the arcuate features on the western slopes, consistent with our review of the historic aerial review above, and more extensive areas on the eastern side of the ridgeline.

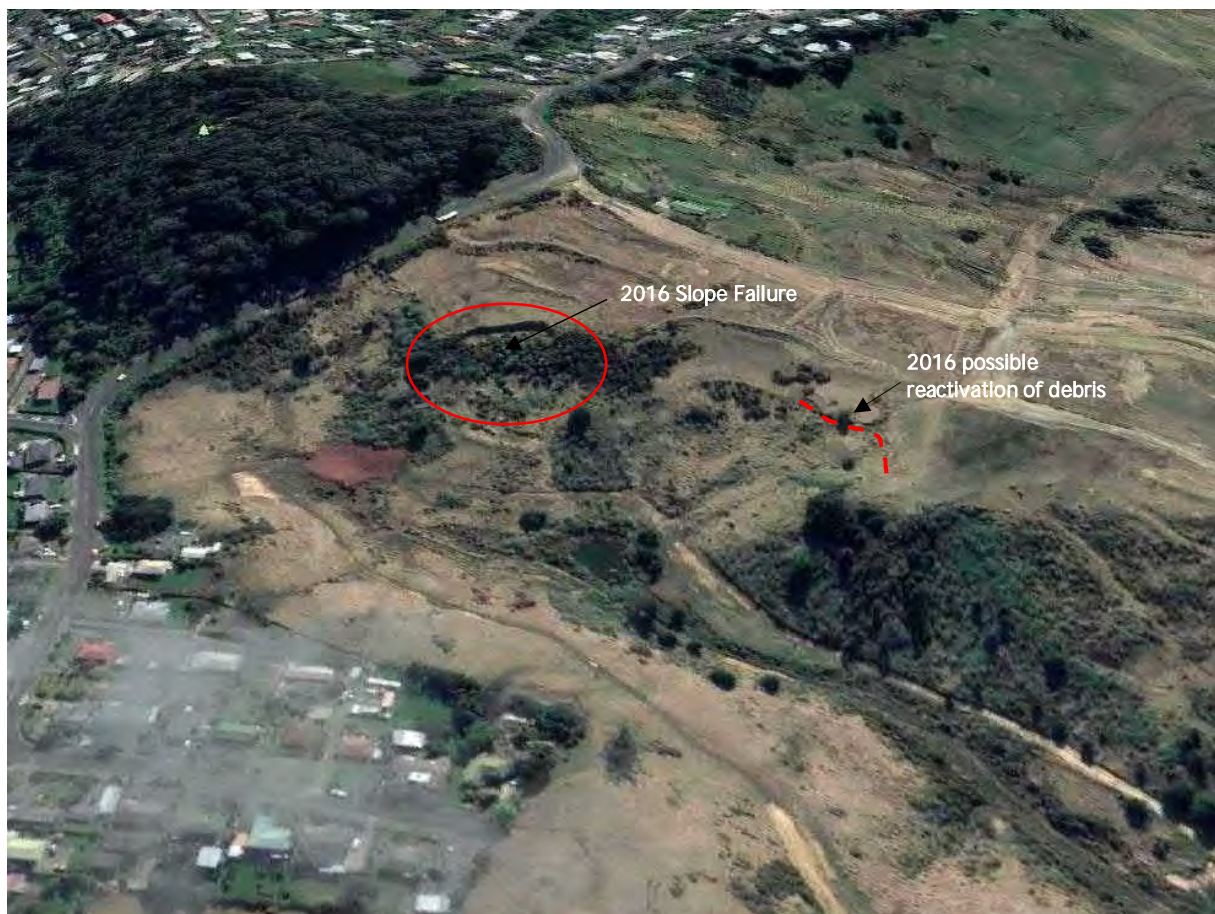
- The 1982, 1999 and 2004 aerial photographs provide a guide to the pre-development geomorphology, with the wider area clearly the subject of significant historical slope instability (Drawing 822-S2-004, Appendix A).
- The two arcuate features on the western slopes show evidence of shallow instability with notably "hummocky" ground apparent.
- Eastern slopes within Stage 2 exhibit well-defined terracettes, interpreted to be the result of shallow instability.
- The September 2016 Google Earth satellite imagery (Figure 5-1) shows a failure within the northern most arcuate feature (to the southwest of Lots 12 to 16). The failure is discussed in Section 2.5 above. During this time, there also appears to be a re-activation of instability within the southern arcuate feature.

Figure 5-1: September 2016 Google Earth Image (Maxar Technologies)

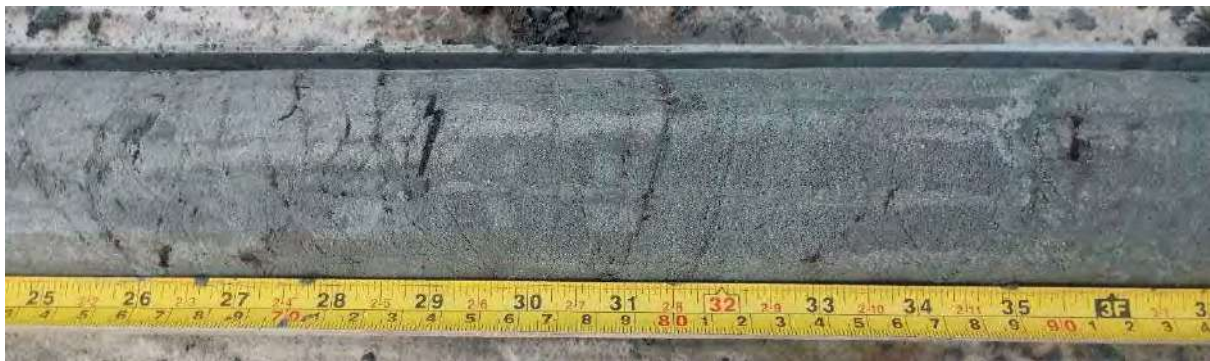
The unit has occasional defects, which are typically steeply dipping and rough, occasionally with a polished veneer. Additionally, re-healed defects were commonly present throughout the sandstone. No instances of significant shear zones or planar smooth low angle defects were identified in this sandstone unit of the type that would be considered indicative of potentially persistent defect-controlled failure surfaces.

Figure 7-1: Typical glauconitic sandstone core (MBH20 - approx. 22.5 mBGL, note minor lignite)

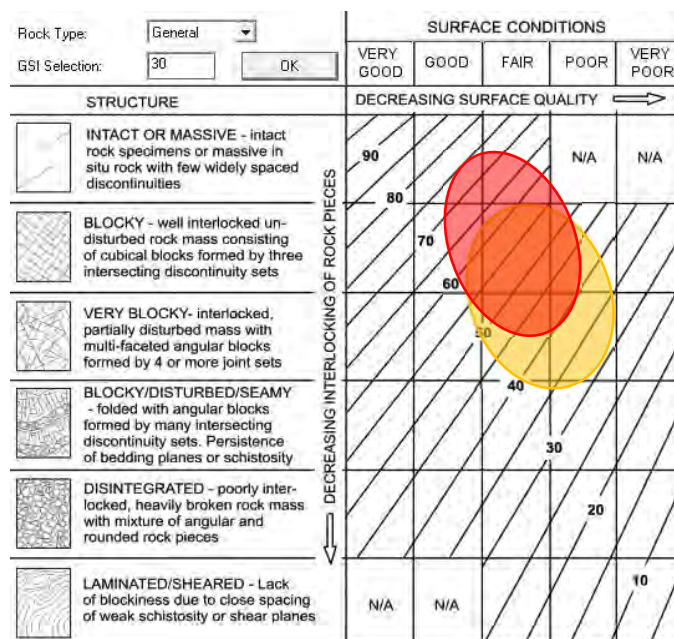
Figure 8-1: Assessed GSI for Allochthonous Ruatangata Sandstone (Red is Sandstone, Orange is intercalated Sandstone / Siltstone)
