# RESIDENTIAL PROPERTY INSPECTION

**Inspection Address:** 47 cam rd. Kaiapoi

**Inspection Date:** Tuesday, 28 July 2026

**BuildQual NZ Ltd**

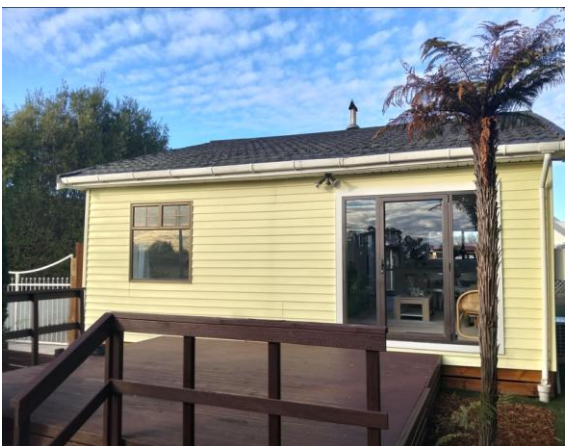
Fences

- Cracking of the asphalt noted at the curb. Cracking noted on the concrete driveway, paths and parking areas, uneven slab joins
- The fence on the eastern boundary has a lean

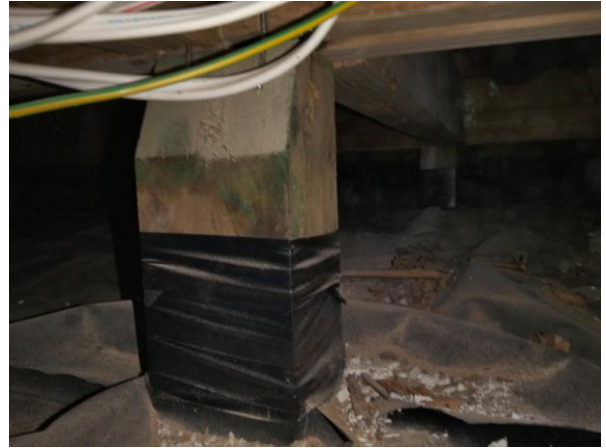
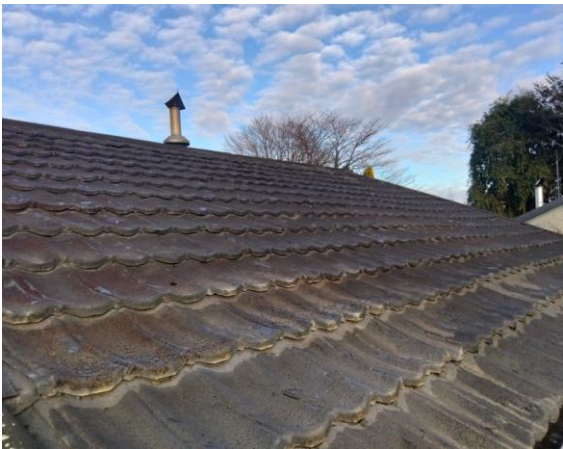
Roof – general view

- Some denting and loss of coating noted on the roof tiles
- Trims are missing around the manhole opening

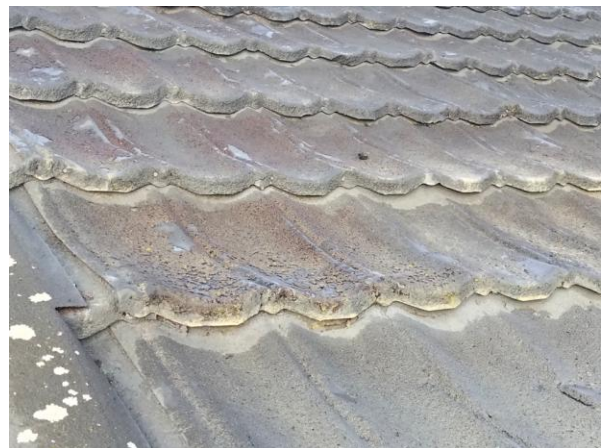
Dented tiles

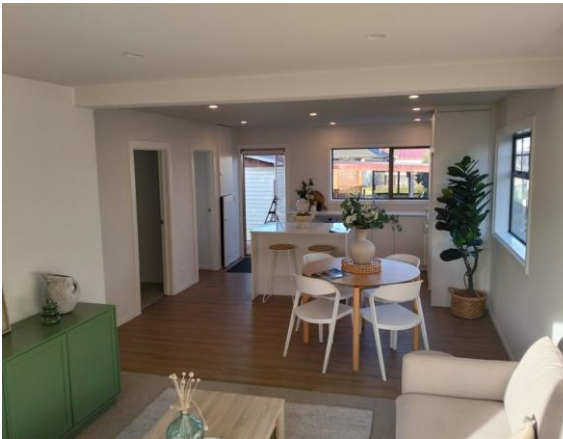
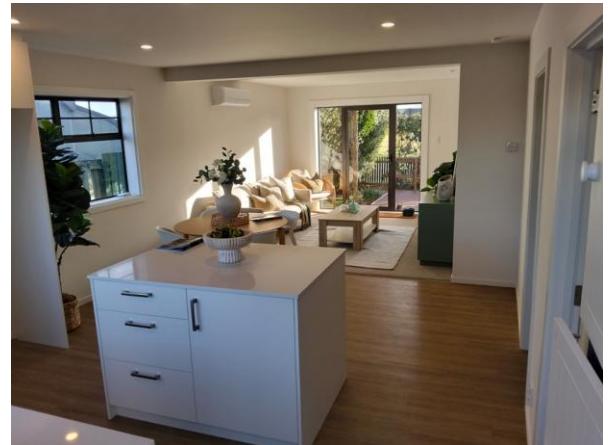
Walls and ceilings – general view

- Minor blemishes to the walls and ceilings
- Only minor interior imperfections noted to the doors, frames and skirtings
- Wet moisture readings on the bathroom windowsill.

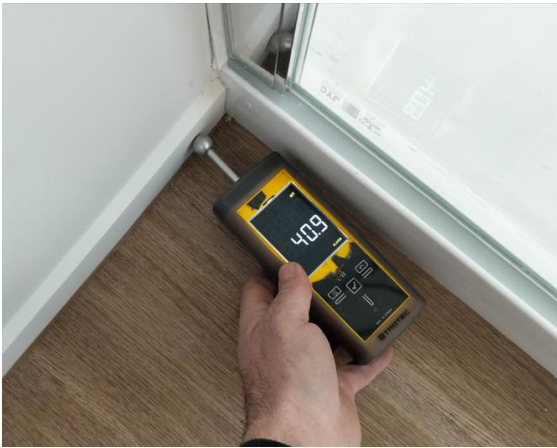
Moisture readings – dry range

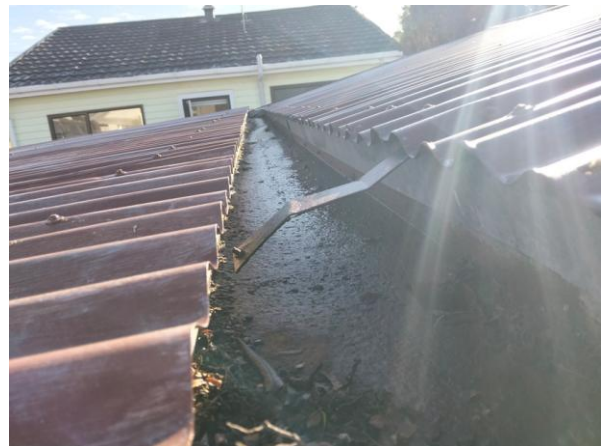
- Garage and carport roofs have some rust noted on the inside of the garage roof, roof underlay is deteriorated in the garage and carport
- The gutter and down pipe on the garage roof is rusted
- Water staining on the garage roof purlins. Garage door opening/locking mechanism is damaged.

Garage spouting
