## Presale Building Report.

300 Rosetta Road, Raumati Beach, Paraparaumu 5032

Date: 28/07/26

Building Inspector: Simon Murray

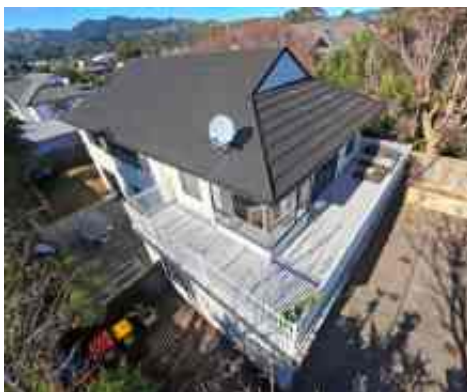
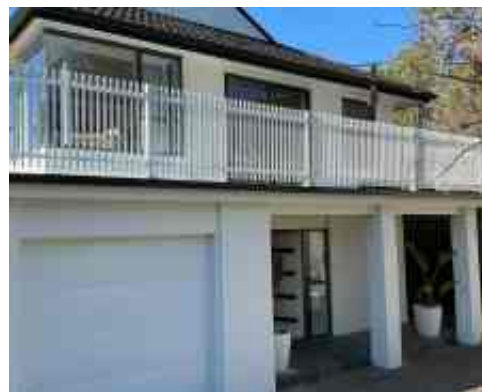
The property is a two-level timber frame dwelling, constructed on concrete perimeter foundations and concrete slab, built in 1991, and consists of 4 bedrooms, 2 bathrooms and single internal access garage. The property is built to the methods at the time of construction, with no visual sign of any structural issues sighted.

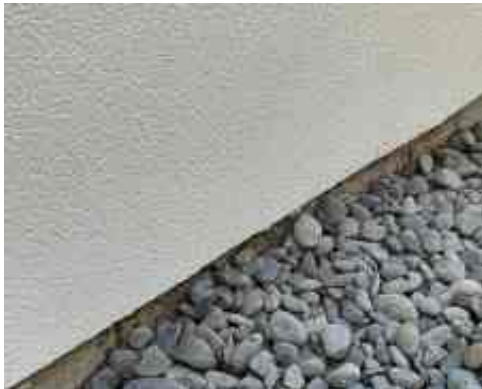
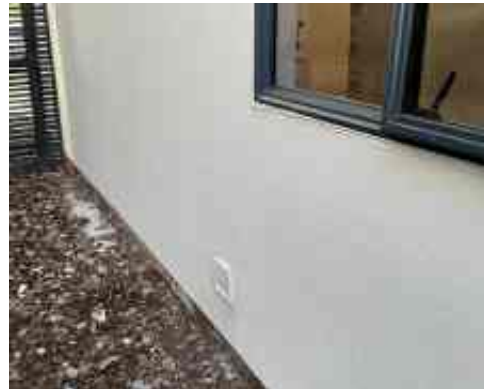
The concrete perimeter foundations and concrete slab are in good condition with no visual sign of any structural issues.

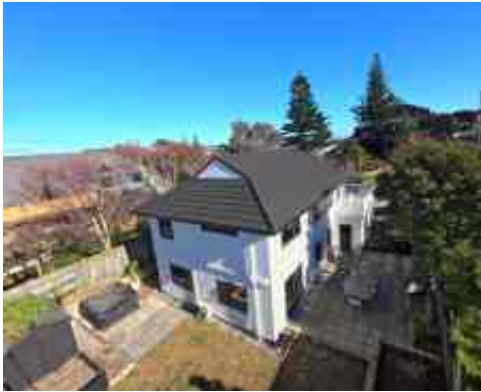
This property has a single internal access garage, due to stored items we were unable to access all areas, the trafiguard membrane deck is in good condition, whilst the top fixed balustrade posts are class as a high risk detail we found no issues as a result, the spa if containing water must have a lockable cover to comply with pool regulations, the rear patio and garden are tidy and well maintained.

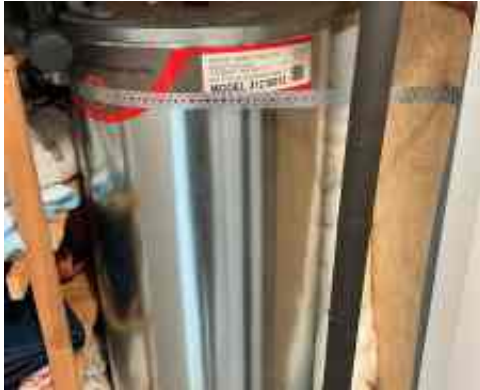
Plumbing systems have been inspected, however this is not a detailed assessment with pressure testing carried out, but rather a visual inspection of pipework clips and fixings, and running fittings if possible. Just the exterior pipes need clips as reported.

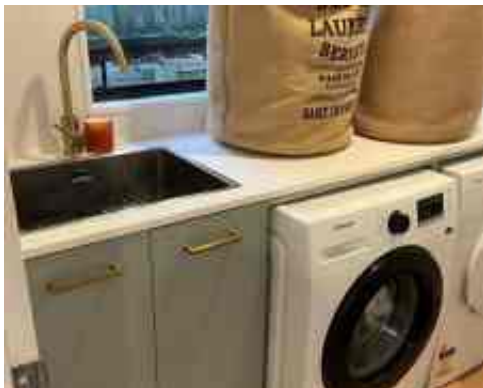
We have tested the plumbing. All is in good working order.

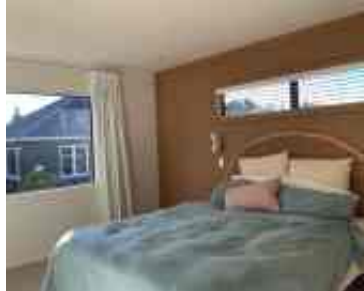
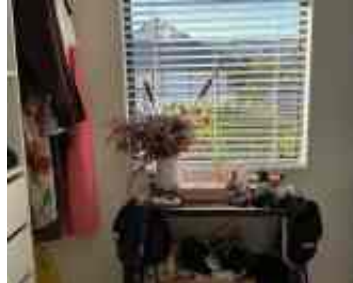
The bedrooms are tidy and well presented. We recommend that you check the new smoke alarm regulations for smoke alarm positioning.
