# Your Building Inspection Report

CONFIDENTIAL REPORT FOR  
Russell Black  
ID 172753  
Wednesday, August 19, 2026

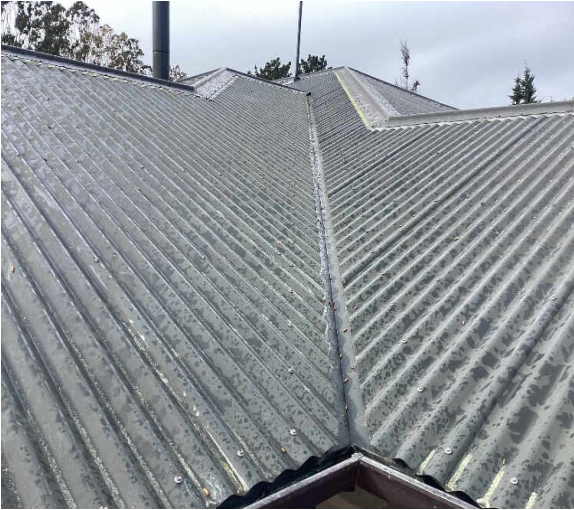
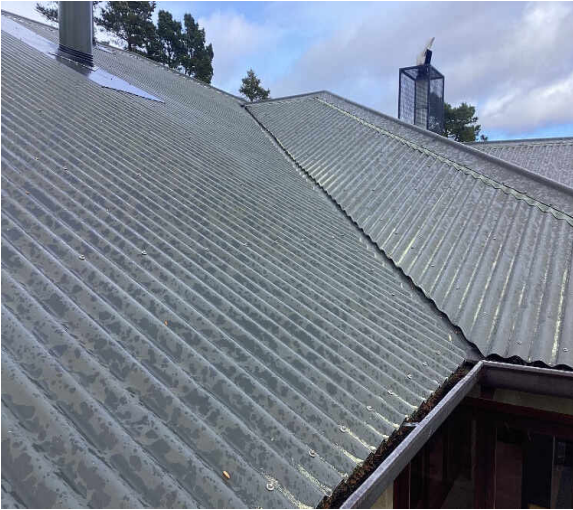
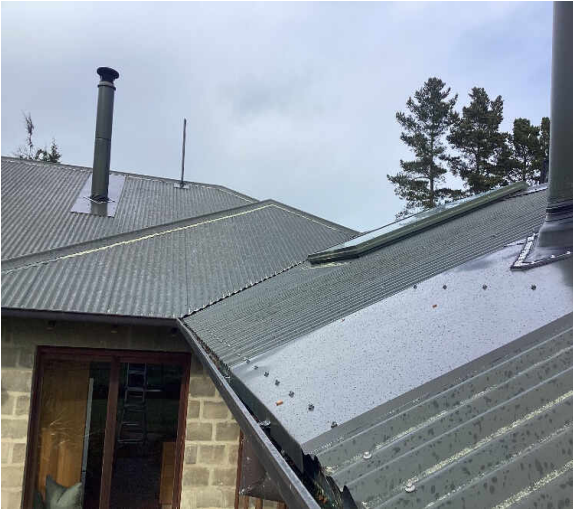
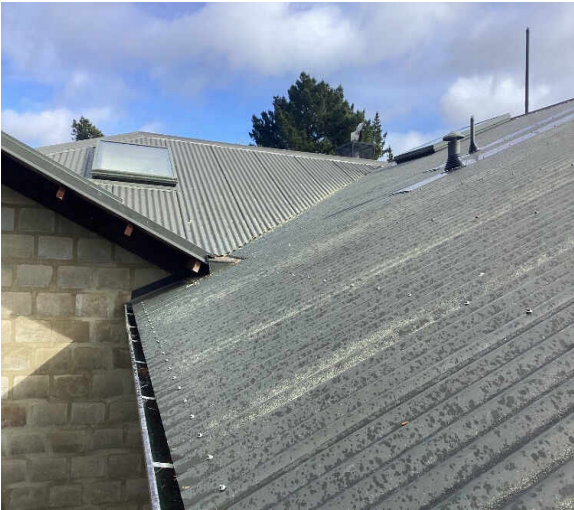
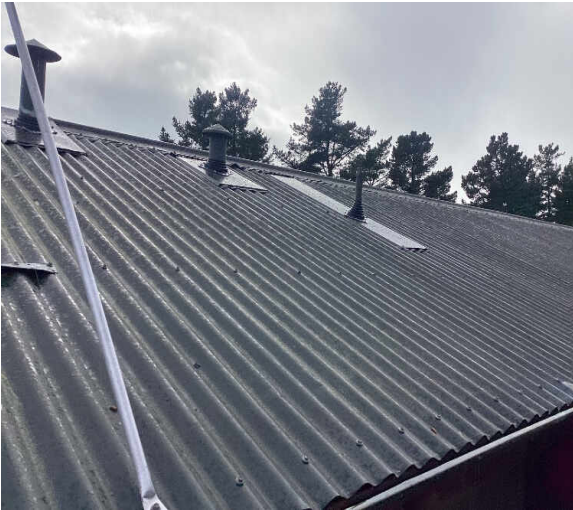
No visible issues noted during the inspection. Allow to constantly monitor and maintain as required.

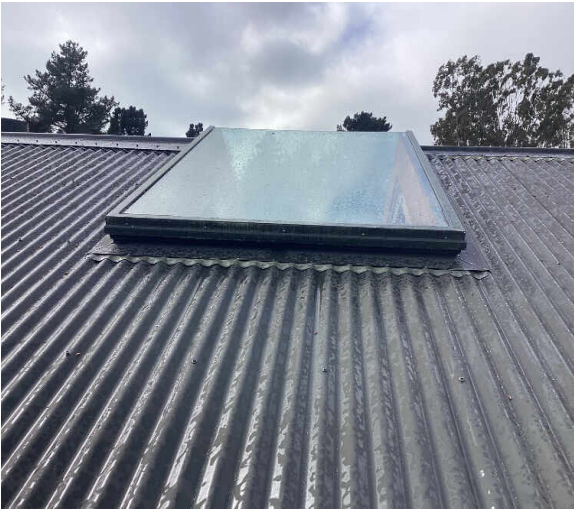
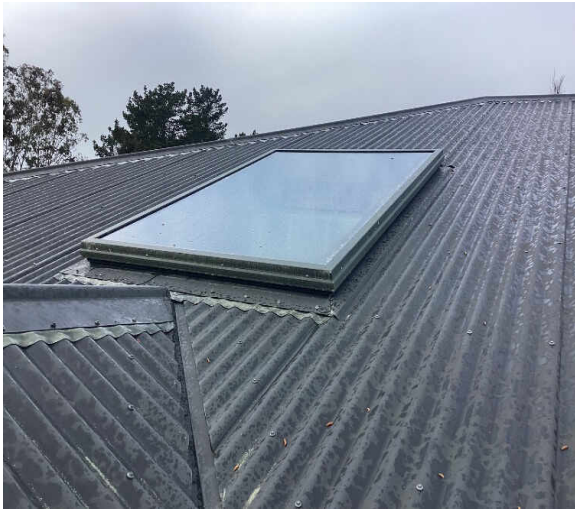
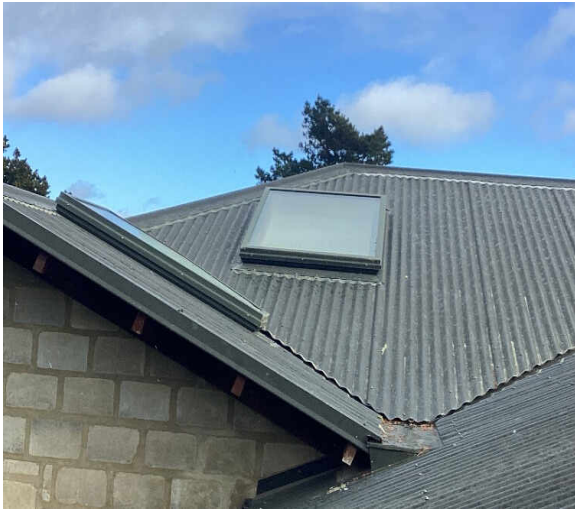
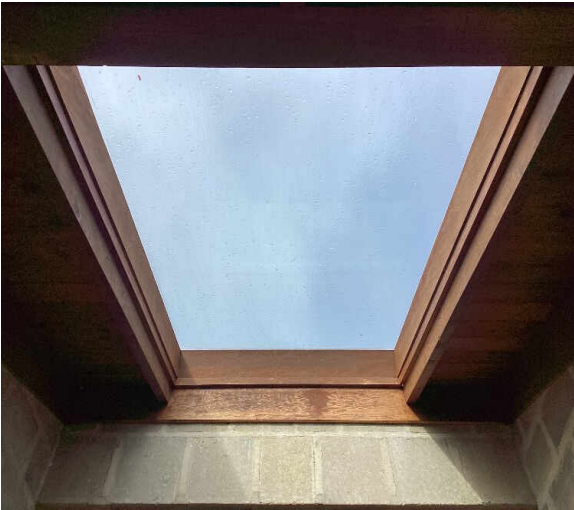
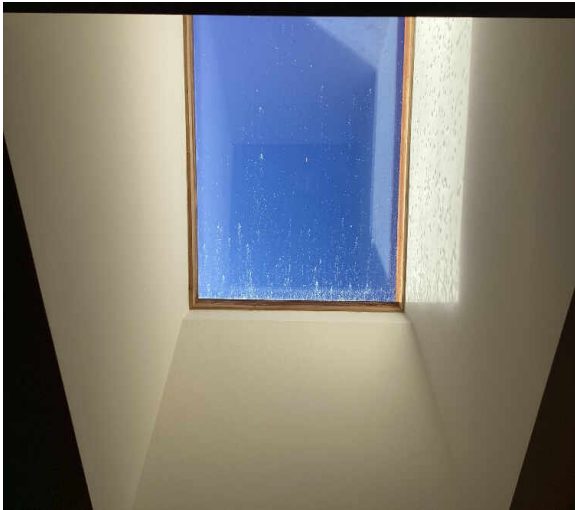
Skylight flashings are high risk flashings that are prone to leaking and should be inspected annually. No visible issues were noted during the inspection. Allow to constantly monitor and maintain as required.

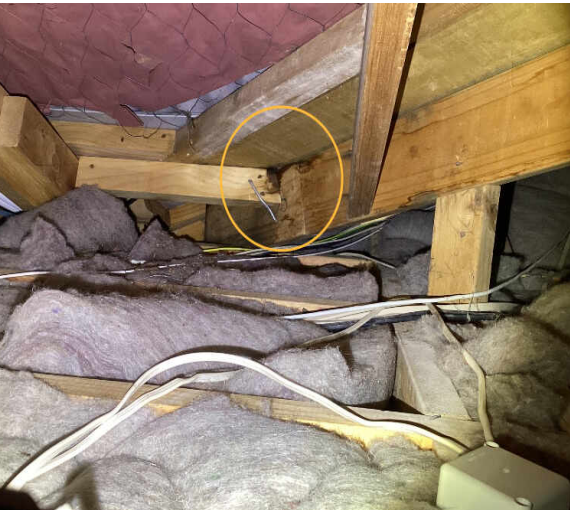
water staining was noted on the roof framing. This would indicate water ingress. We recommend this is further investigated by a registered roofer.

Approximate location above where stains were noted.

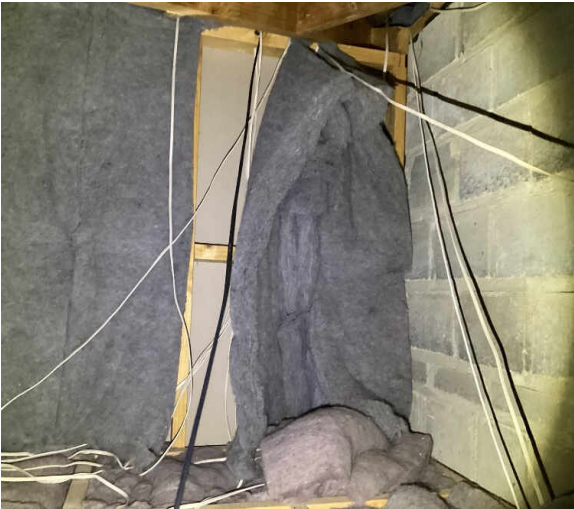
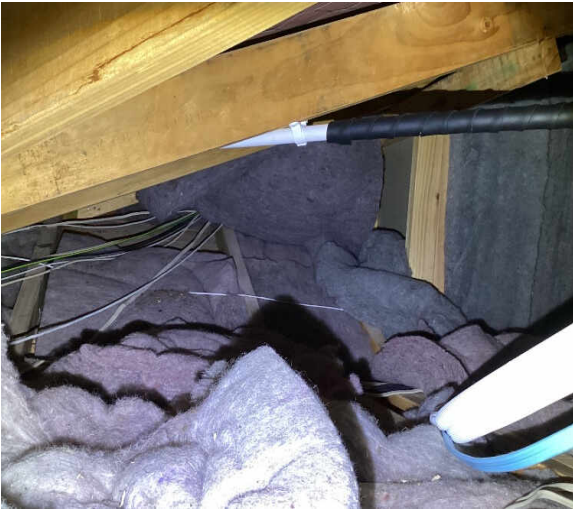
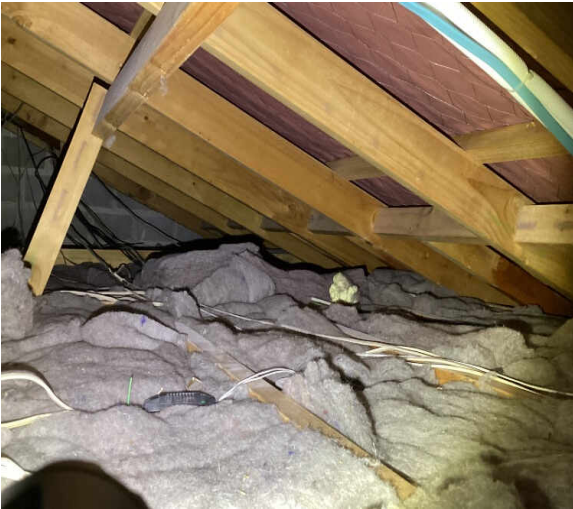
The ceiling insulation has been poorly laid in areas and or has come loose. We recommend the insulation is tidied up.

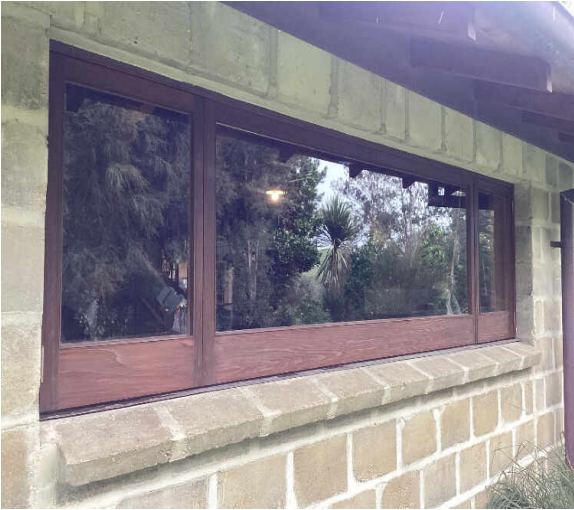
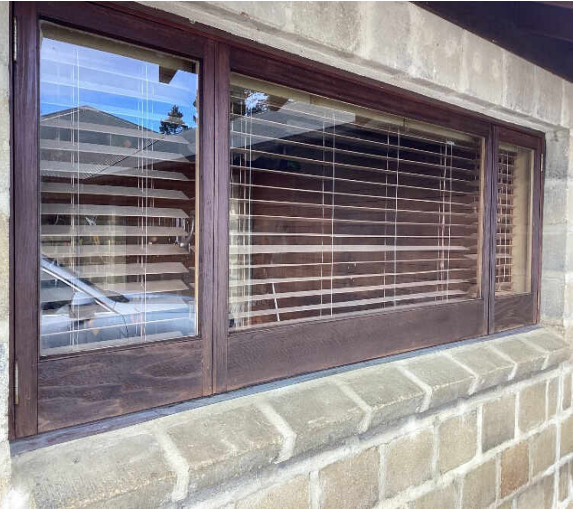
No visible issues were noted during the inspection. Allow to constantly monitor and maintain as required.

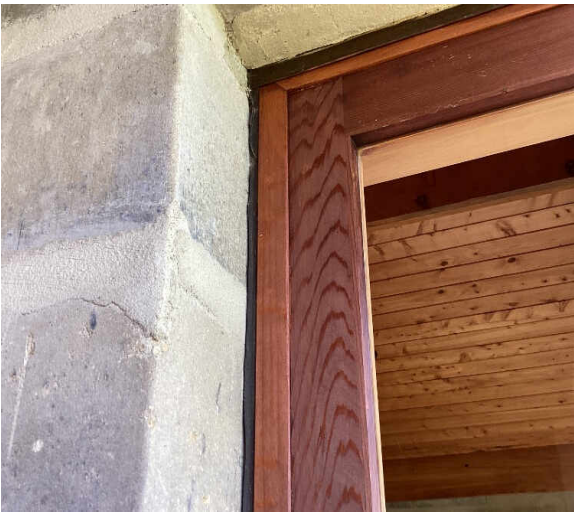
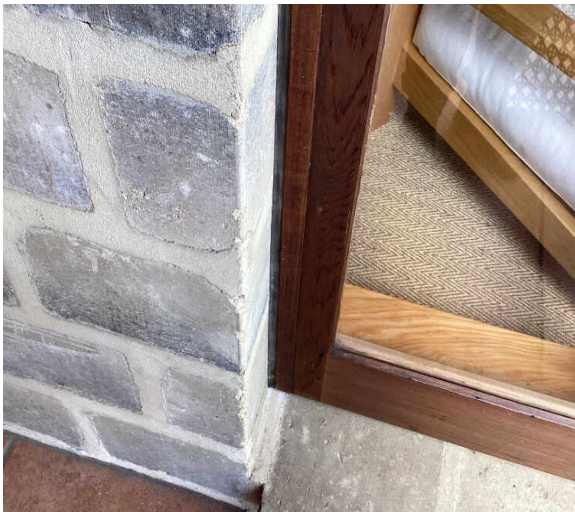
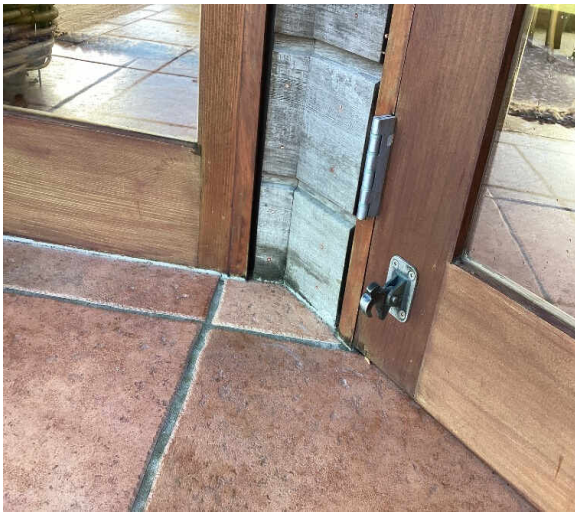
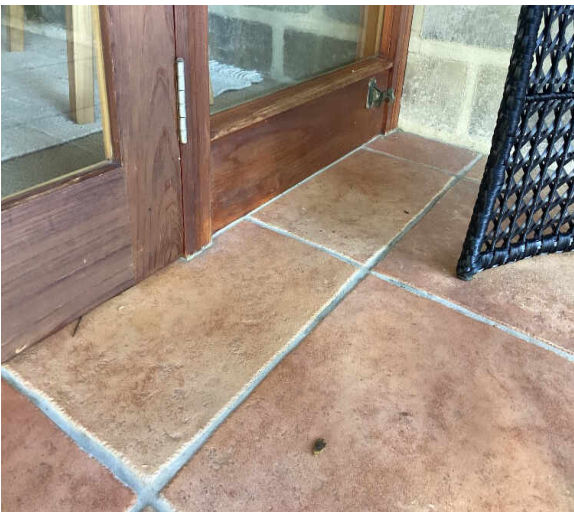
Sealant has been applied between the timber to masonry junctions. This will need to be monitored as the sealant will breakdown over time.

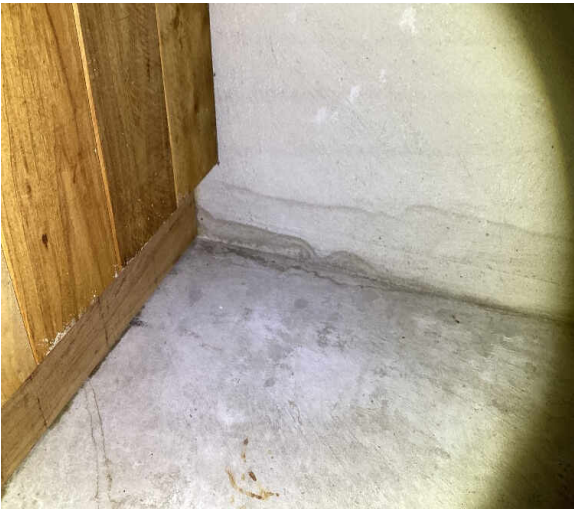
Some minor staining was noted in the basement floor to wall junction. This would appear to be efflorescence. We recommend this is monitored. Any further staining should be further investigated by a suitably qualified professional.

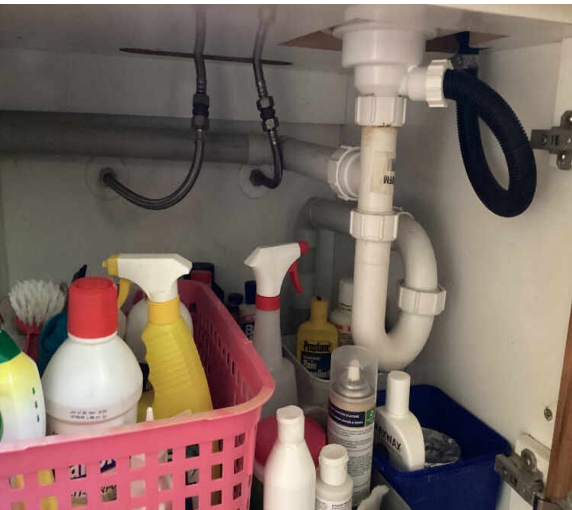
No visible issues noted during the inspection. Allow to constantly monitor and maintain as required.

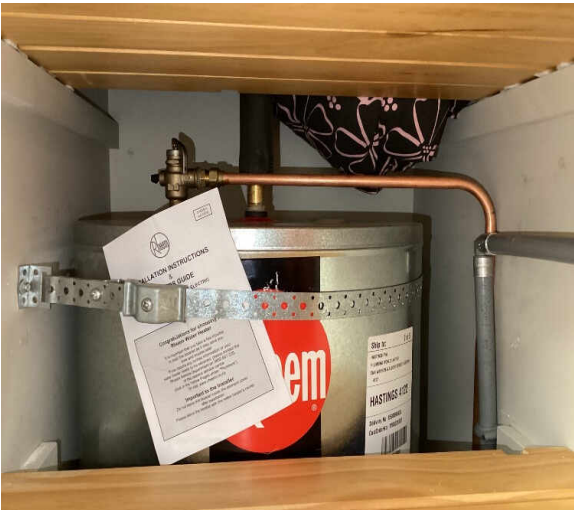
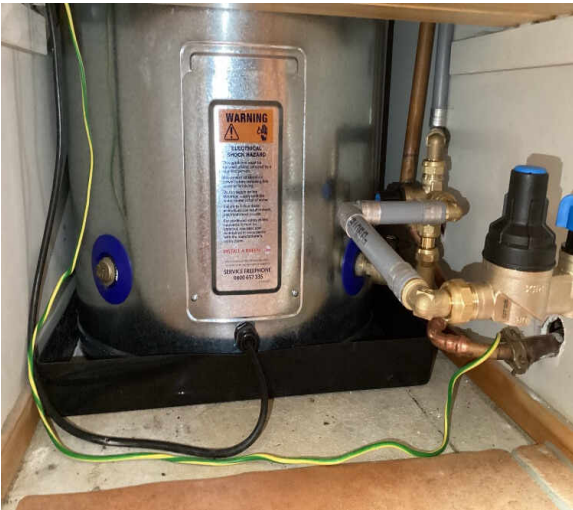
No visible issues noted during the inspection. Allow to constantly monitor and maintain as required.

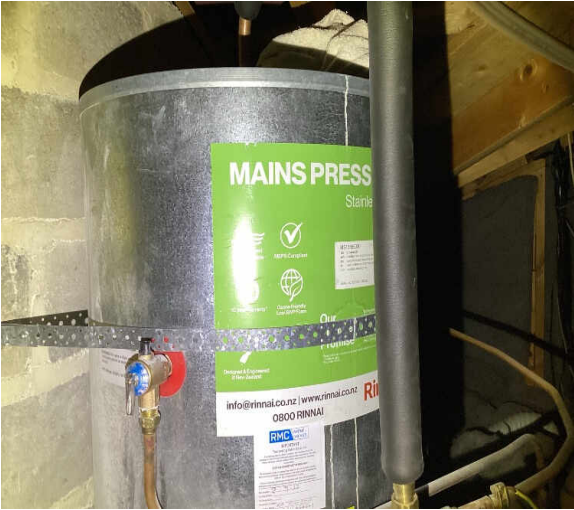
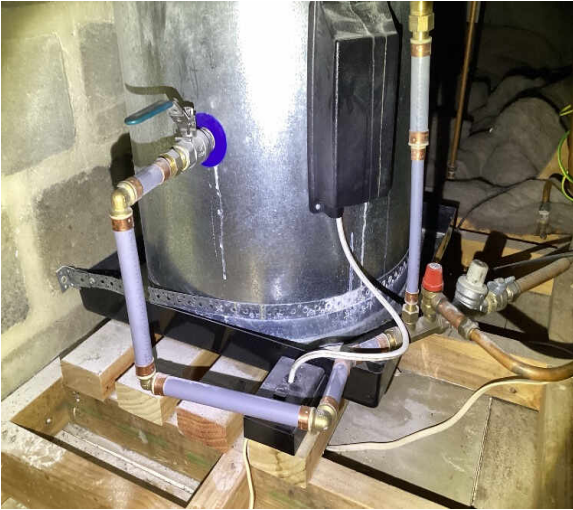
No visible issues noted during the inspection. Allow to constantly monitor and maintain as required.

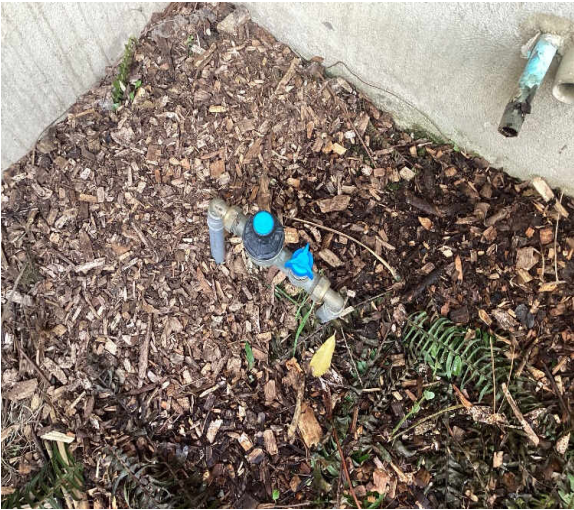
The function or integrity of the water toby (valve) was not assessed.

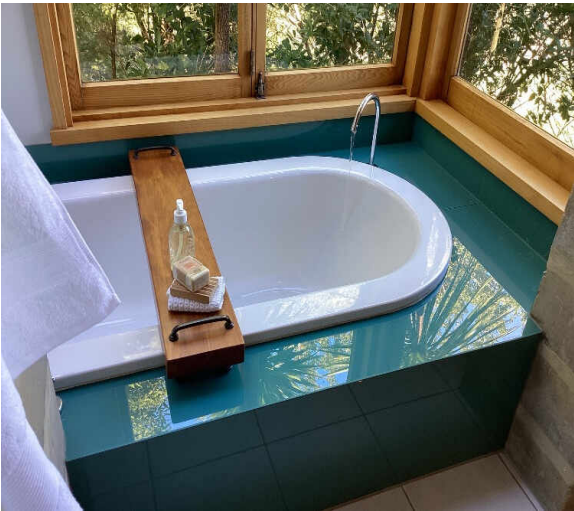
Inbuilt baths can be prone to maintenance issues, failing and leaking. Depending on the quality of the bath, the installation workmanship and how the bath has been maintained depends on how water tight it remains and how much future maintenance it will require. Moisture testing cannot be undertaken around the base or internal bath linings due to inconsistencies in the readings. Typical failure points are where the bath meets the wall and around the tap units. It is recommended you constantly monitor these junctions to ensure damage is not occurring to the adjacent walls. The bath was tested. There was no visible indications of water penetration to surrounding areas. IMPORTANT NOTE: The test may not reveal water leaks until the system has been tested under normal or constant use.

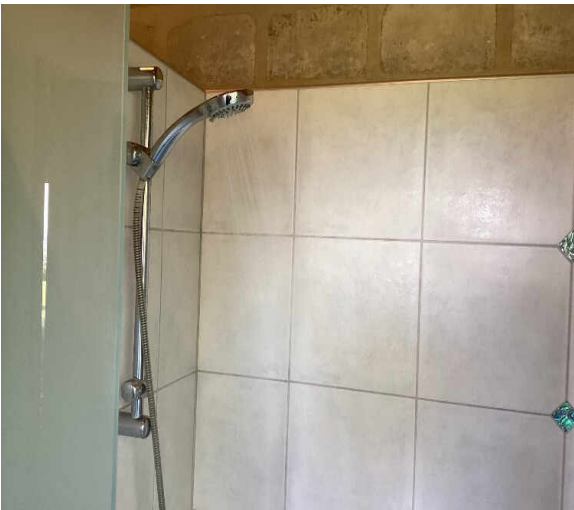
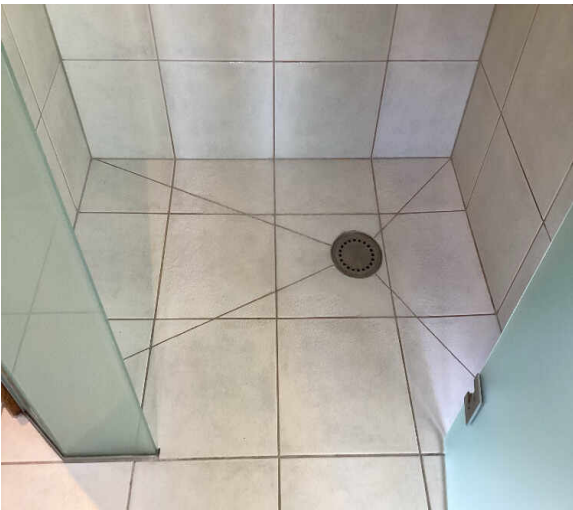
Wet floor showers are high maintenance showers and are prone to leaking, with their water tightness relying on the floor covering and a waterproof membrane under the floor covering. We are not able to comment on the condition or function of this membrane during our visual inspection. Moisture testing cannot be undertaken around the base or internal shower linings due to inconsistencies in the readings. We recommend inspection annually and all areas kept sealed. The shower was tested. There was no visible indications of water penetration to surrounding areas. IMPORTANT NOTE: The test may not reveal water leaks until the system has been tested under normal or constant use.

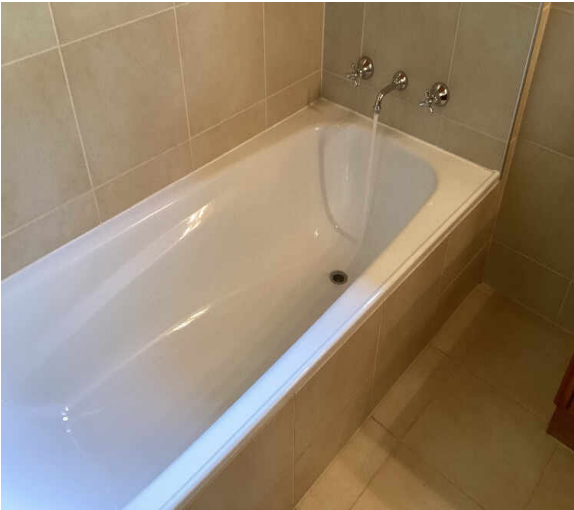
Inbuilt baths can be prone to maintenance issues, failing and leaking. Depending on the quality of the bath, the installation workmanship and how the bath has been maintained depends on how water tight it remains and how much future maintenance it will require. Moisture testing cannot be undertaken around the base or internal bath linings due to inconsistencies in the readings. Typical failure points are where the bath meets the wall and around the tap units. It is recommended you constantly monitor these junctions to ensure damage is not occurring to the adjacent walls. The bath was tested. There was no visible indications of water penetration to surrounding areas. IMPORTANT NOTE: The test may not reveal water leaks until the system has been tested under normal or constant use.

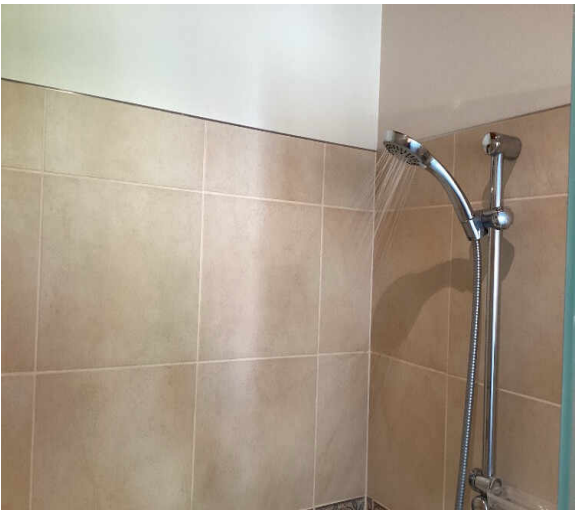
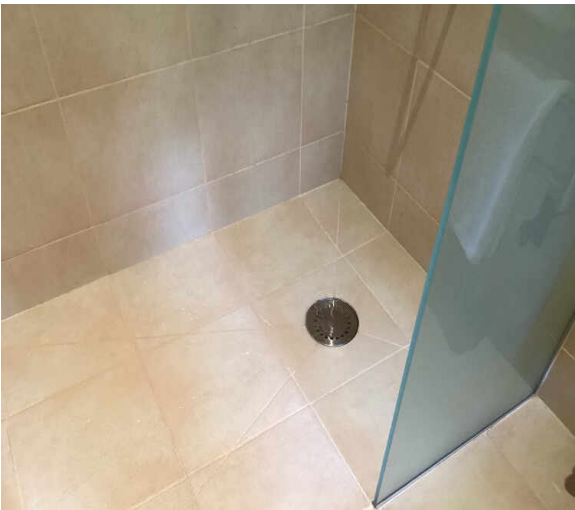
Wet floor showers are high maintenance showers and are prone to leaking, with their water tightness relying on the floor covering and a waterproof membrane under the floor covering. We are not able to comment on the condition or function of this membrane during our visual inspection. Moisture testing cannot be undertaken around the base or internal shower linings due to inconsistencies in the readings. We recommend inspection annually and all areas kept sealed. The shower was tested. There was no visible indications of water penetration to surrounding areas. IMPORTANT NOTE: The test may not reveal water leaks until the system has been tested under normal or constant use.

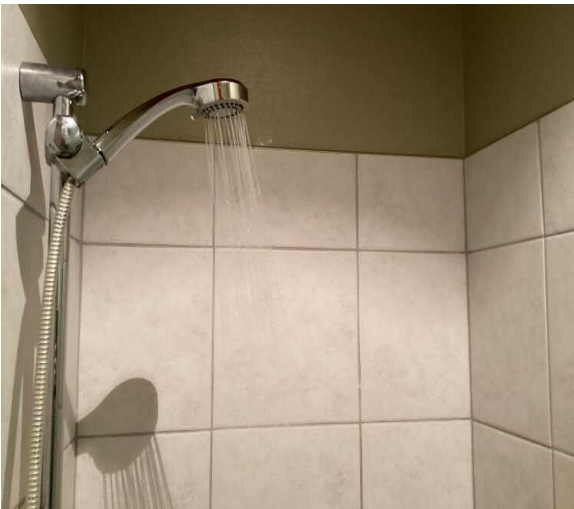
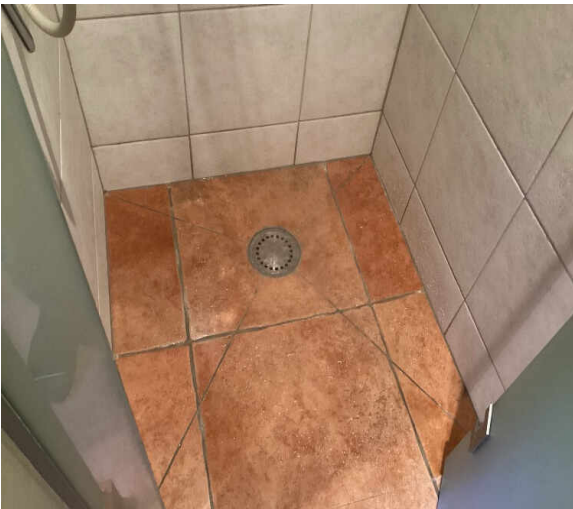
Wet floor showers are high maintenance showers and are prone to leaking, with their water tightness relying on the floor covering and a waterproof membrane under the floor covering. We are not able to comment on the condition or function of this membrane during our visual inspection. Moisture testing cannot be undertaken around the base or internal shower linings due to inconsistencies in the readings. We recommend inspection annually and all areas kept sealed. The shower was tested. There was no visible indications of water penetration to surrounding areas. IMPORTANT NOTE: The test may not reveal water leaks until the system has been tested under normal or constant use.

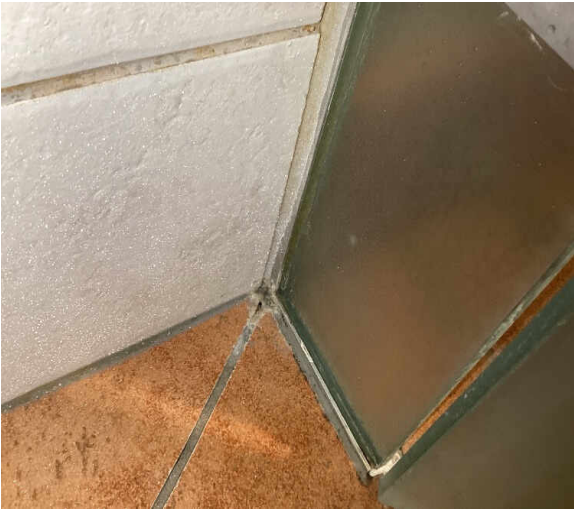
The grout and sealant has begun to deteriorate around the shower junctions. This may affect the water tightness of the shower. We recommend this is further investigated by a registered tiler.

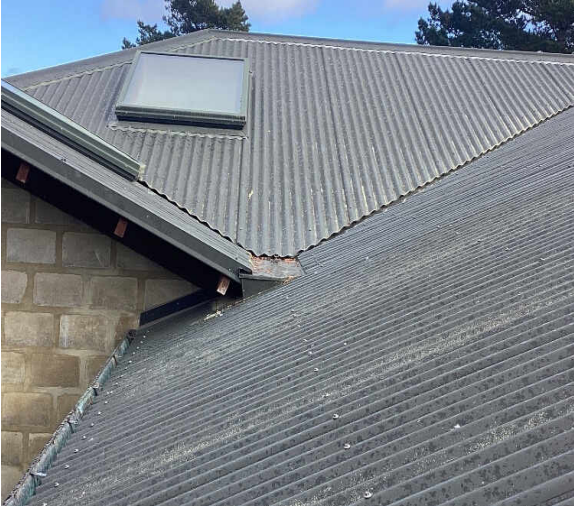
There is an internal gutter installed. The profiled metal gutters such as on this dwelling have the potential to allow water entry through poor application and installation, lack of maintenance, poor detailing and complex junctions. This tends to occur particularly on buildings built between 1990 and 2006. We suggest that a thorough examination is completed bi-annually (ideally at the end of winter and end of summer), and any sealant break down, water pooling, "popping" of rivets or any signs of deterioration of the metal should be investigated by a roofing specialist.

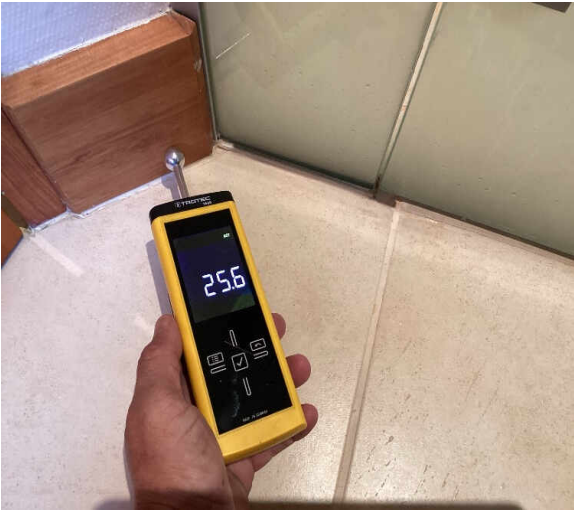
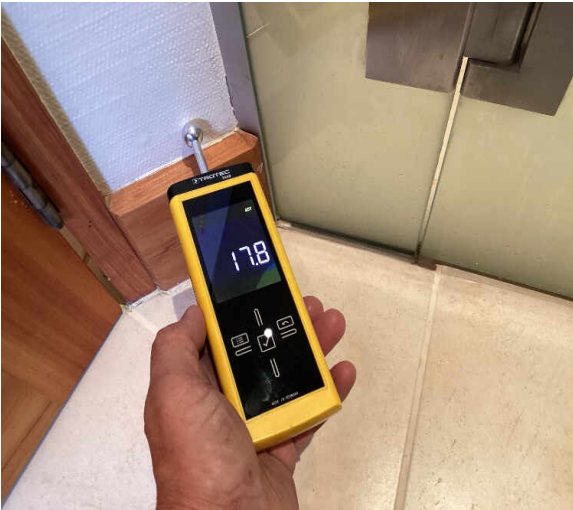
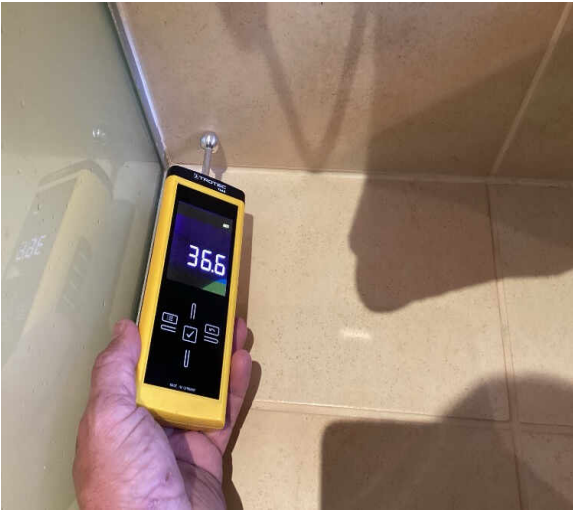
MOISTURE READING AROUND SHOWER OR BATH

No visible issues noted during the inspection. Allow to constantly monitor and maintain as required.

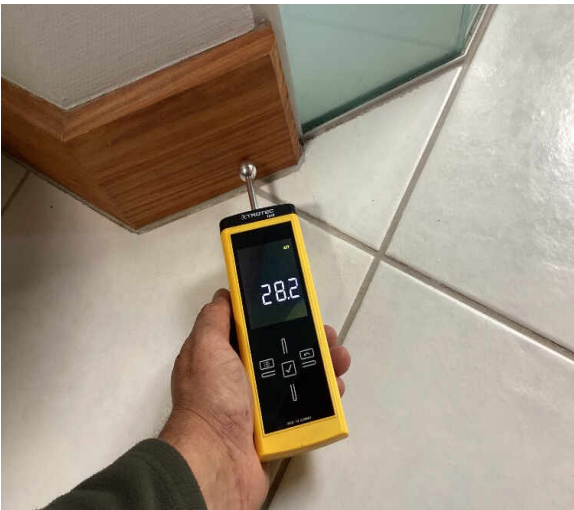
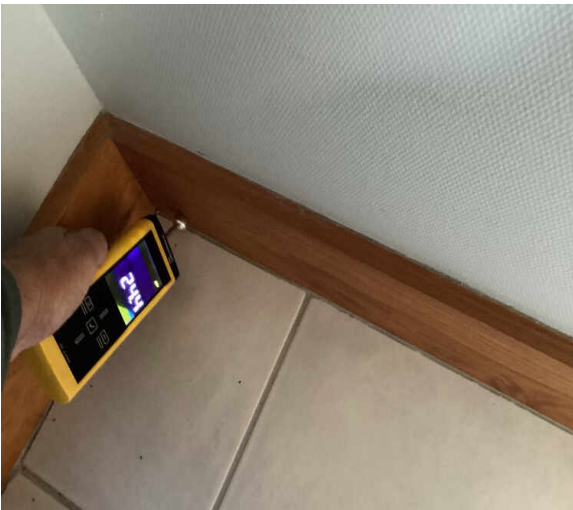
MOISTURE READING AROUND SHOWER OR BATH

No visible issues noted during the inspection. Allow to constantly monitor and maintain as required.

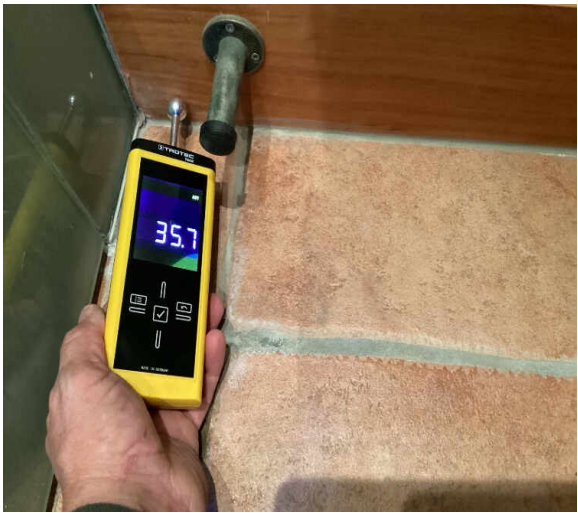
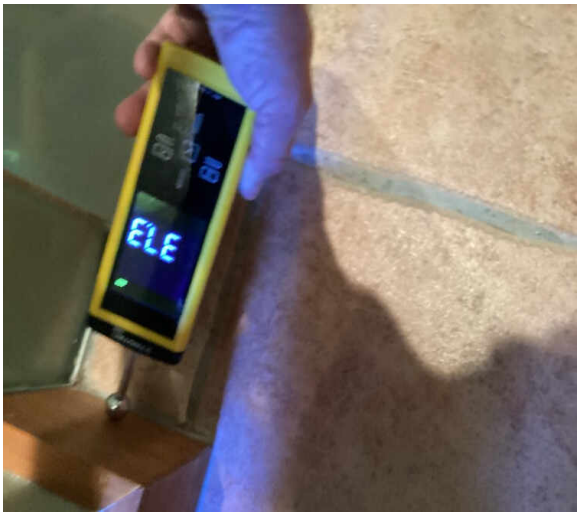
MOISTURE READING AROUND SHOWER OR BATH

No visible issues noted during the inspection. Allow to constantly monitor and maintain as required.

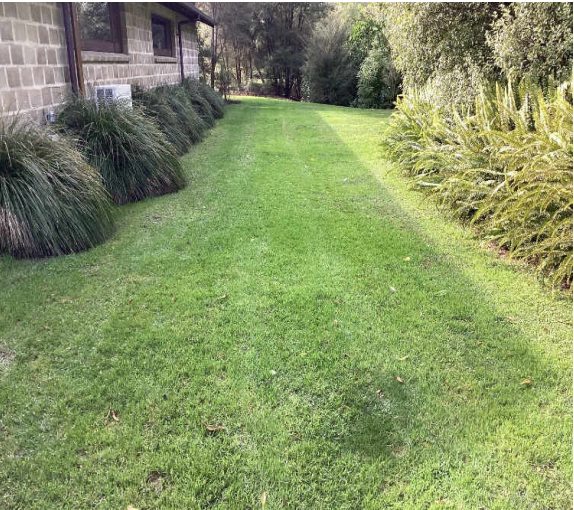
We are unable to comment on the stability of the land. Likewise, we cannot determine what areas are filled or what material is underneath. We recommend further investigation of the council files to ensure any documented evidence is discovered. If limited information is available, investigation of the land by a geotechnical engineer is advised if you have concerns following a council file check.

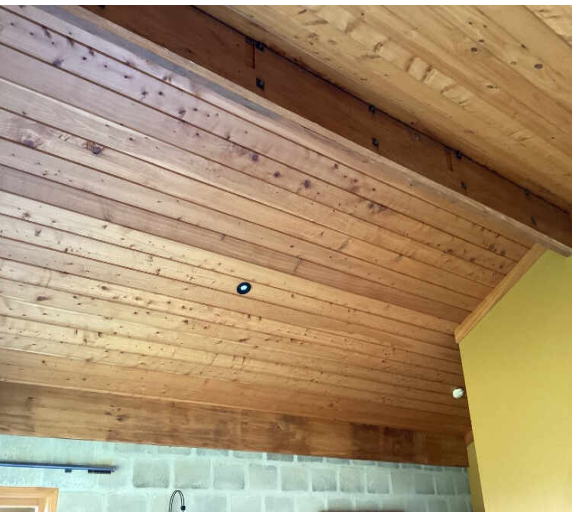
## SIGNIFICANT INTERIOR CEILING DAMAGE OR DEFECTS

No visible issues noted during the inspection. Allow to constantly monitor and maintain as required.

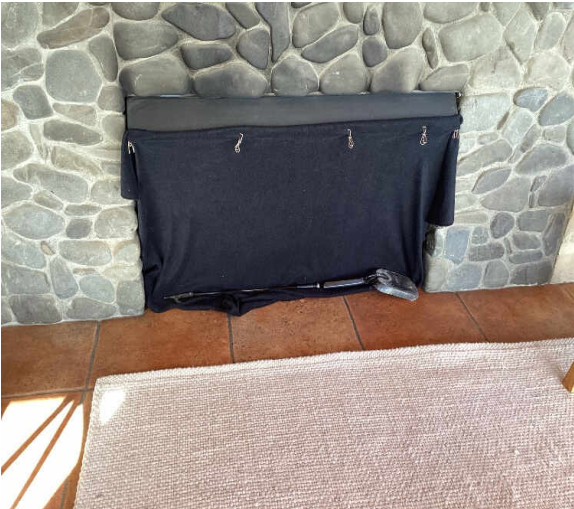
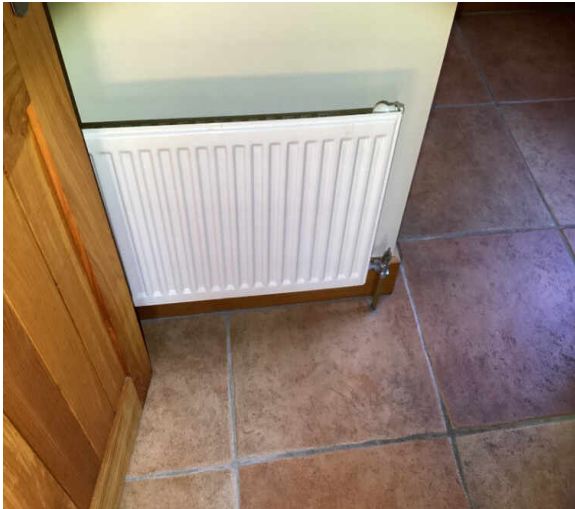
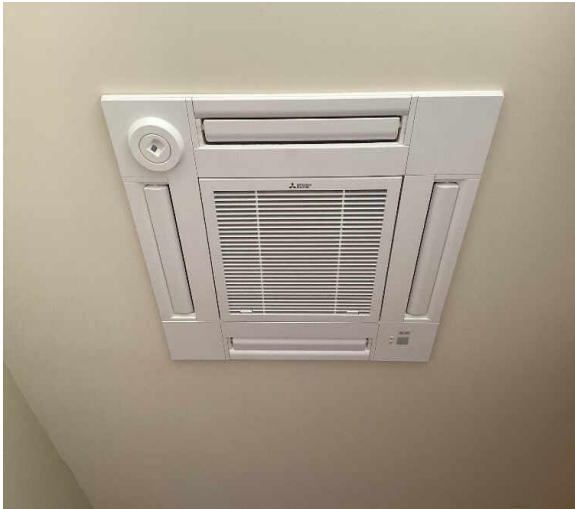
The operation, efficiency and integrity of any heat source was not tested. This was not tested as it is beyond our scope and expertise. It is recommended that all heating and ventilation systems are tested by the purchaser, or a suitably qualified professional or confirmation that they are all functional before the unconditional date is received.

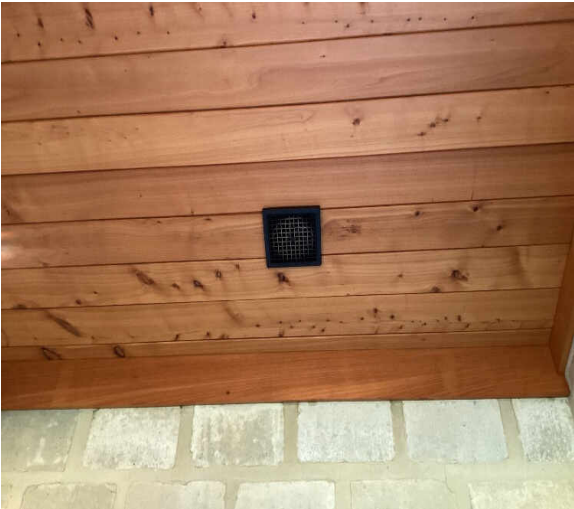
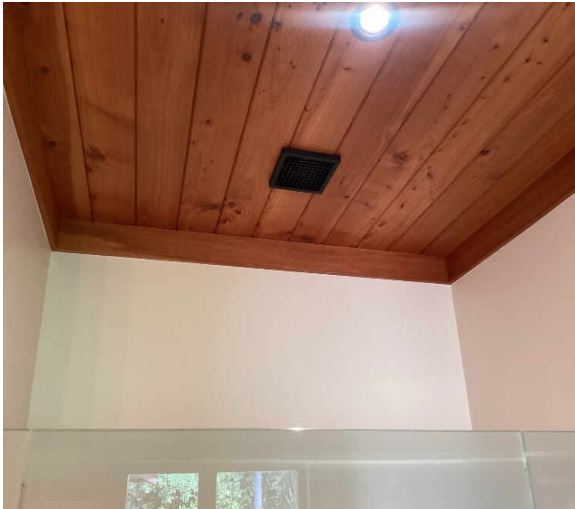
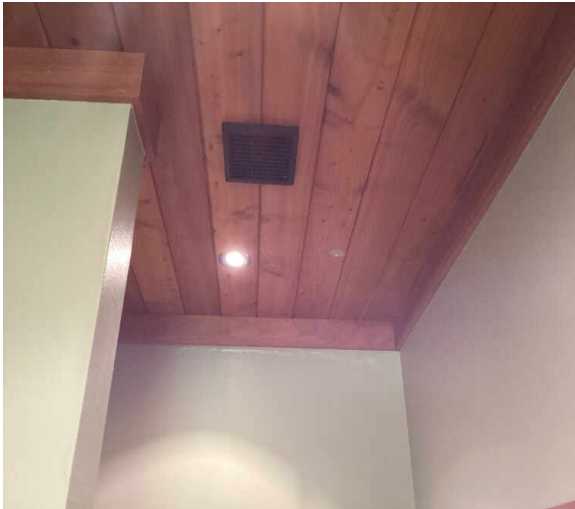
BATHROOM VENTILATION

The fan is operational.

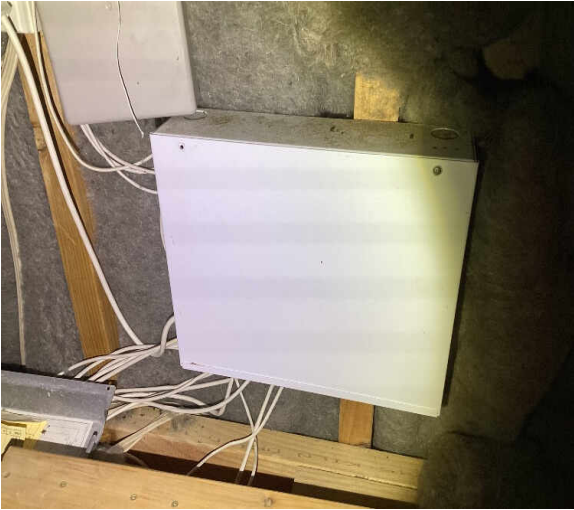
No visible issues noted during the inspection. Allow to constantly monitor and maintain as required.

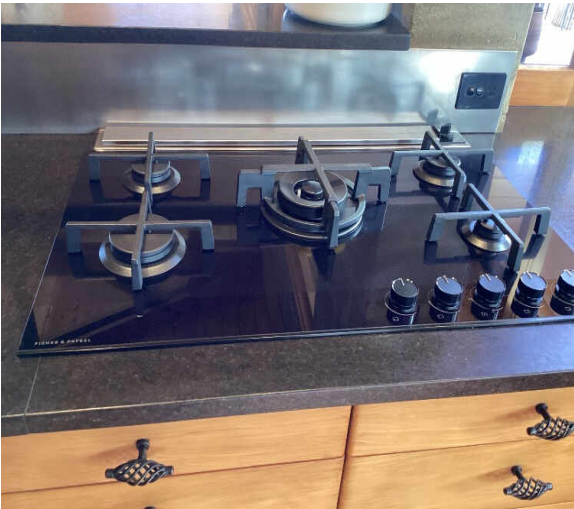
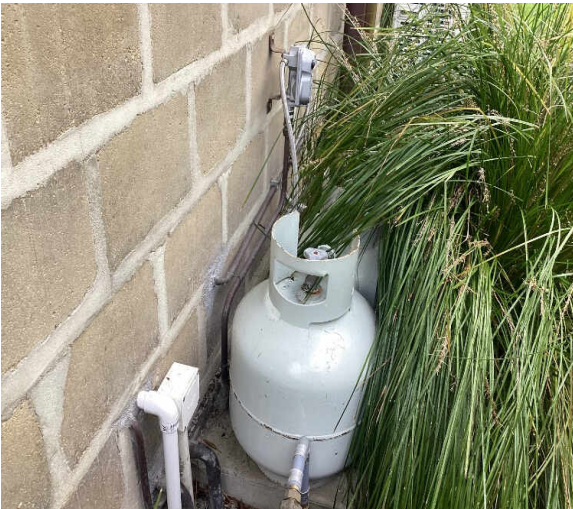
There is no chain restraining the gas bottles back in the event of sudden movement or earthquake. It is recommended that a chain or seismic restraint is installed around the bottles.

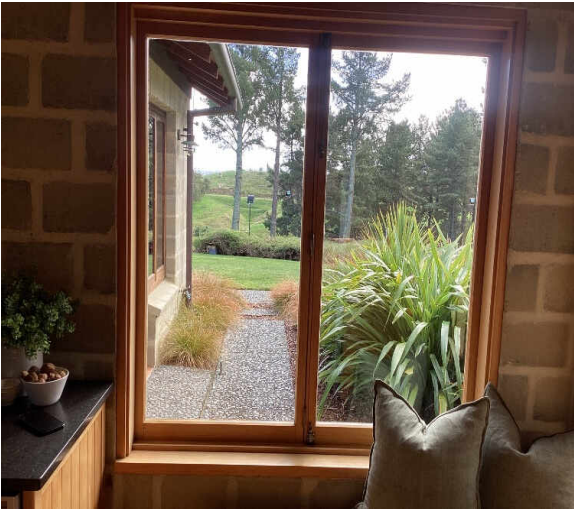
The kitchen window is binding and requires easing to improve functionality. There is moisture staining on some frames. We recommend these are monitored. If staining continues to spread we recommend they are further in by a suitably qualified professional.
