## Pre-Sale Inspection

**14 Kauika Road, Whangarei**

**Inspection Date: 17 August 2026**

**Award Building Services**

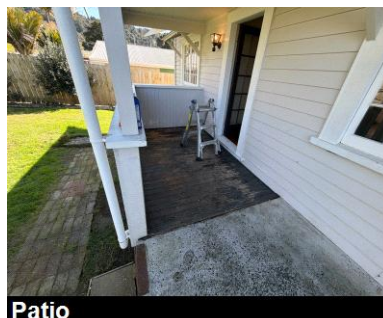
Patio

We note undulation and slumping of the timber patio decking. This may be due to foundation movement or material shrinkage. You may wish to have this assessed and repaired to avoid trip hazards.

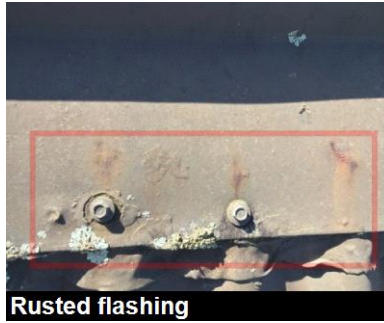
| Material: | Metal. Surface rust to some roof flashings which may be able to be cleaned back, primed and painted alternatively, you may wish to have the rusted flashings replaced. |

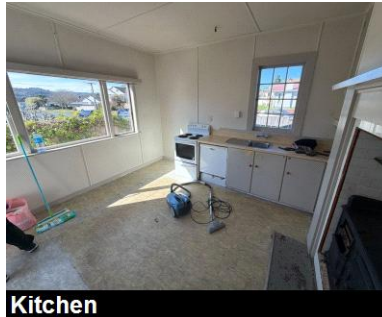
Vinyl. Vinyl floor coverings are damaged and may be the type that contain asbestos, however confirming the presence of asbestos would require a sample to be laboratory tested. Should you have concerns we recommend a sample is taken and tested for the presence of asbestos.

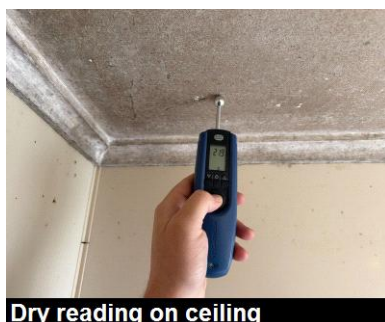
Mould staining visible. The moisture meter indicated what is regarded as "within normal tolerances" at the time of inspection. As mould is a potential health concern you may also wish to consider removal and correction.

**Dry reading on ceiling**

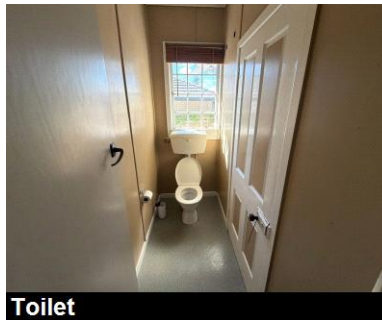
Floor: Vinyl. Some flooring vinyl is delaminating. You may wish to consider further assessment and repairs by a qualified vinyl specialist.
