# CASH SETTLED CLAIM(S)

## Statement of Claim Checklist / Repair Strategy

CLM/2010/158807

C SC Carvell  
 C 44 PENNINGTON STREET  
 S LEESTON  
 H: [REDACTED]  
 W: [REDACTED]  
 M: [REDACTED]

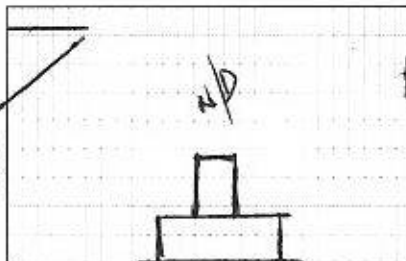
| <p>Bathroom 3530</p> | <p>Toilet 1 950</p> | <p>Toilet 2</p> |

| Room | Earthquake<br>Damage | Walls | Ceiling | Floor | |
|---|---|---|---|---|---|
| 3.53x2.88<br>Bathroom<br>T96 | Y | - | ✓ | - | Crack in ceiling. Rake out, stop, paint |

| DESCRIPTION: | Units | Length | Breadth | Depth | Qty | Rate | Cost |
|---|---|---|---|---|---|---|---|
| Bathroom: Crack to ceiling, Rake out, stop, paint. | | | | | | | |

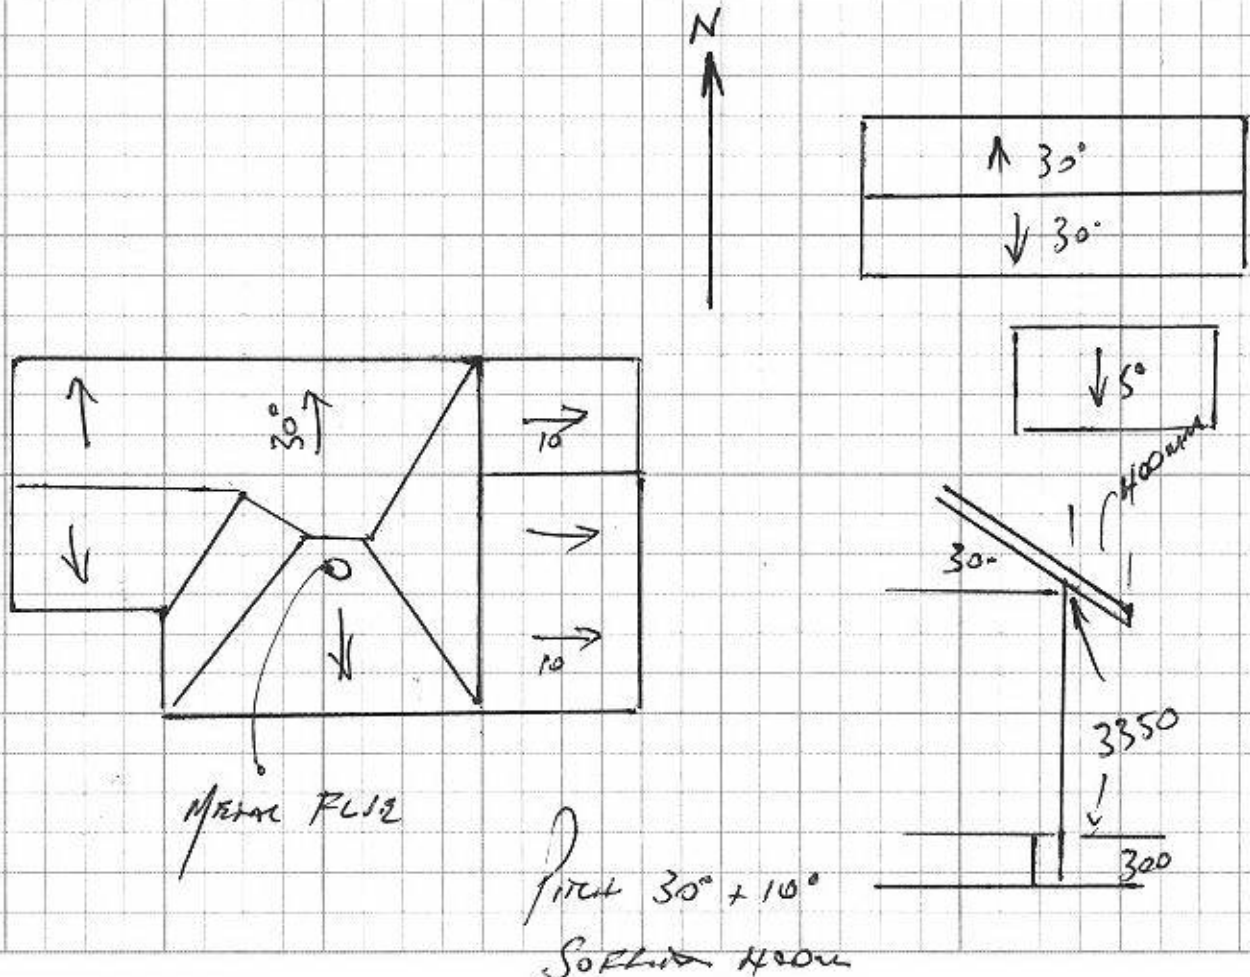
PLAN SKETCH OF PROPERTY (identify each room, indicate damage). Attach photo if available

φ = EXISTING CRACKS TO Ring FOUNDATION.
