# **Trout, Uninterrupted:**

## **Assessment and Monitoring of the Mills Creek Dam Removal**

LAEP 227 Univ Calif Berkeley  
Dec 2000

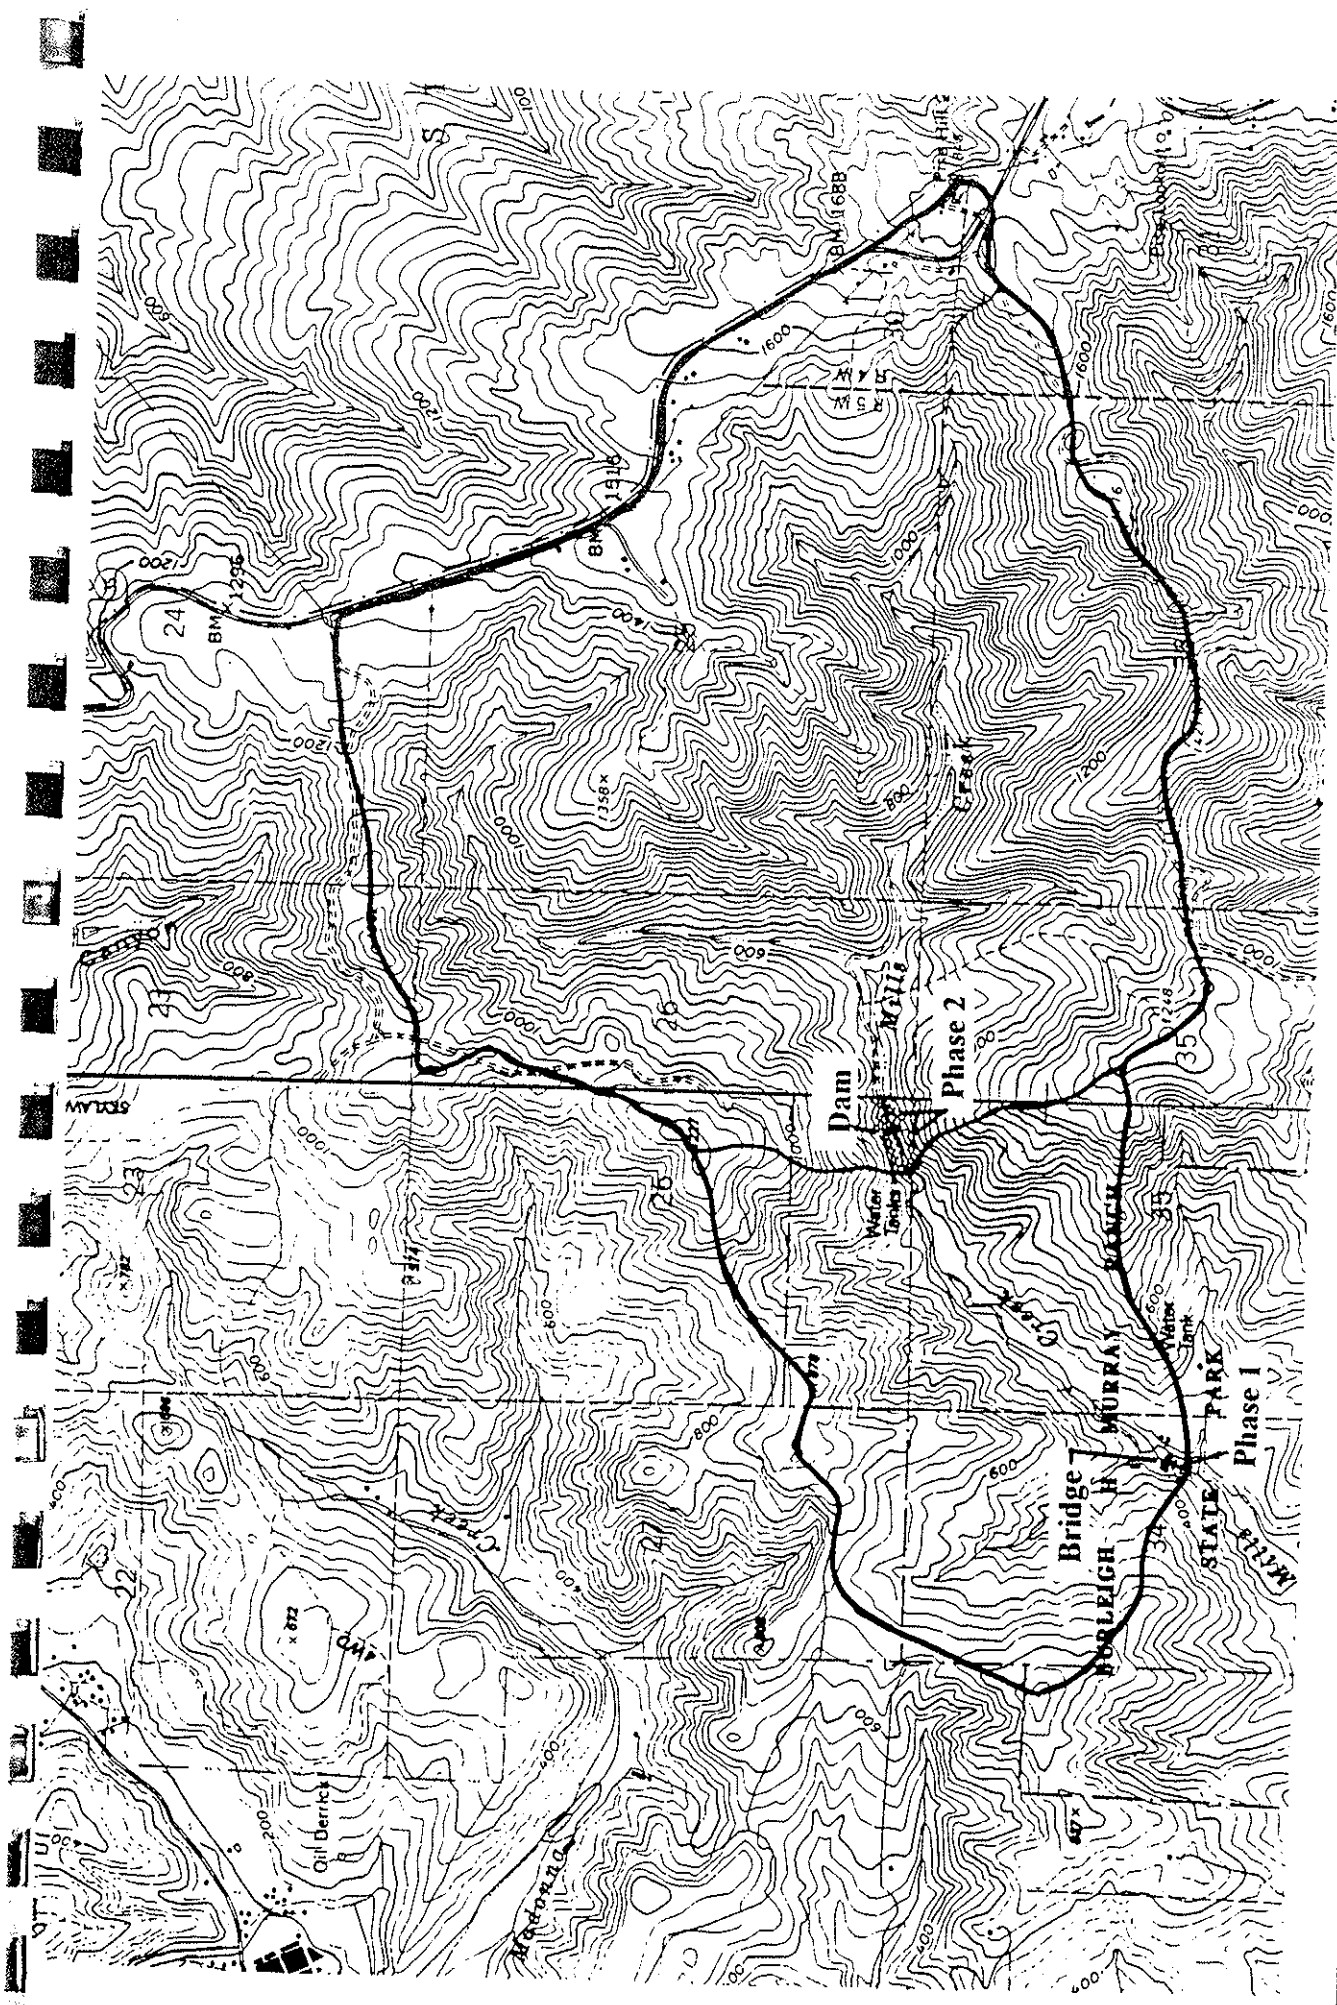
| <p><b>FIGURE</b></p> | <p><b>2</b></p> |

| <p><b>CLEARWATER<br/>HYDROLOGY</b></p> | <p><b>MILLS CREEK WATERSHED MAP</b></p> |
