Implementing a long-term monitoring system on the restored Conococheague Creek  
following removal of Birch Run Dam

A Thesis submitted to the  
Geography-Earth Science Department  
and the Graduate Council  
in partial fulfillment of the requirements for the degree of  
Master of Science

Shippensburg University  
Shippensburg, Pennsylvania  
December 2009

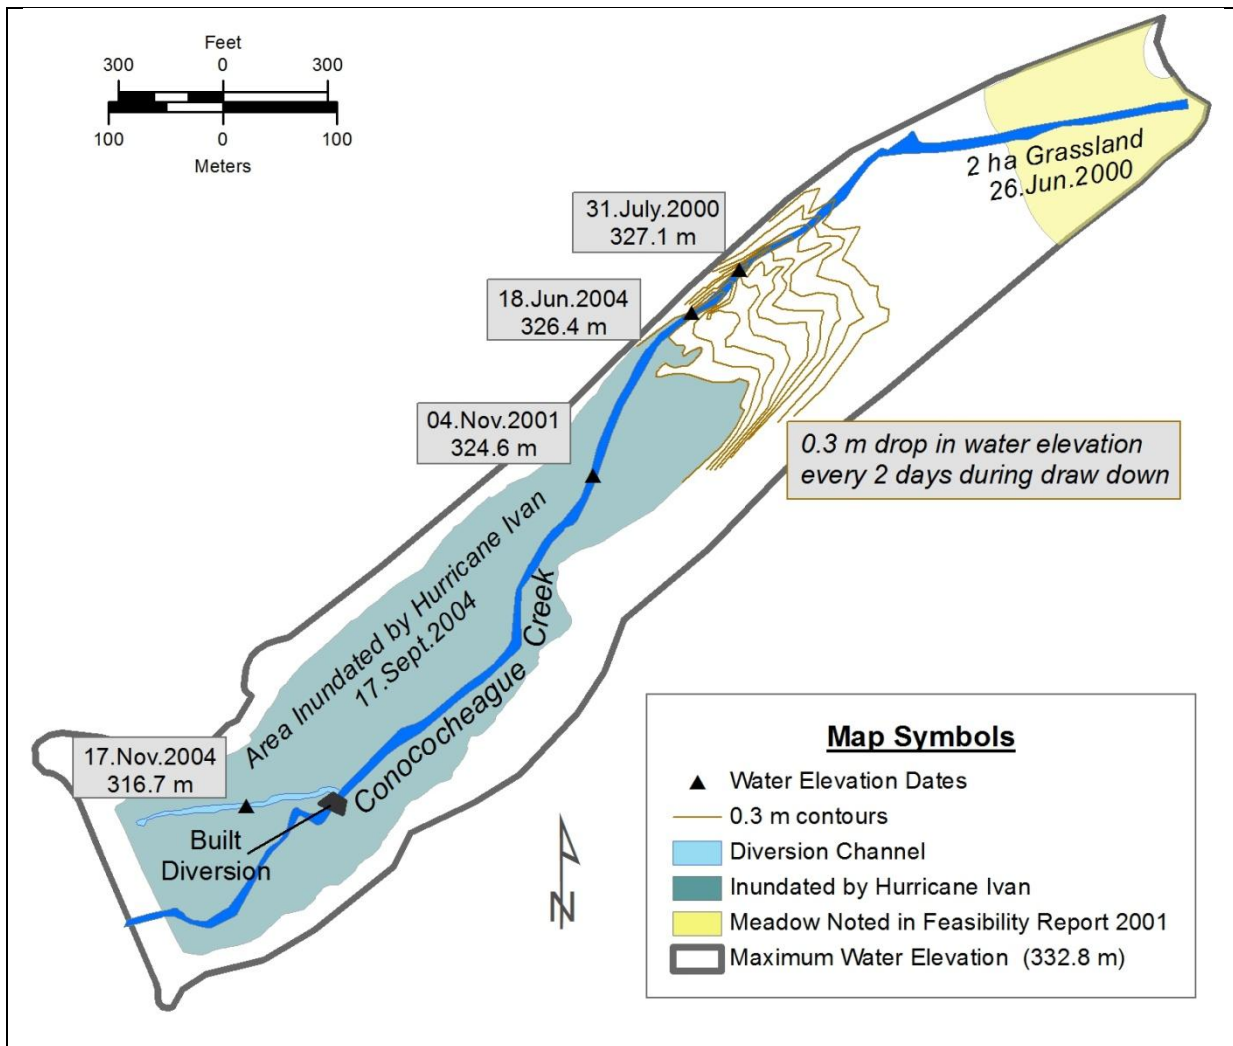
Figure 2. A graphic illustration of the different events that altered the deposition and erosion of the Conococheague channel. The uppermost reach of the stream, in the area of deltaic deposits, was observed as a sandy grassland during a DEP inspection (dated, 26.June.2000). The incremental exposure of the valley and stream channel during the draw down is illustrated with contours representing the changing waterline every two days. Individual measurements of the reservoir depth (DEP inspections, as dated) describe the varying lengths of the channel exposed over the lifespan of the Chambersburg Reservoir. The length of stream channel upstream of the diversion was exposed to a ten-year storm (Hurricane Ivan) and partially inundated.

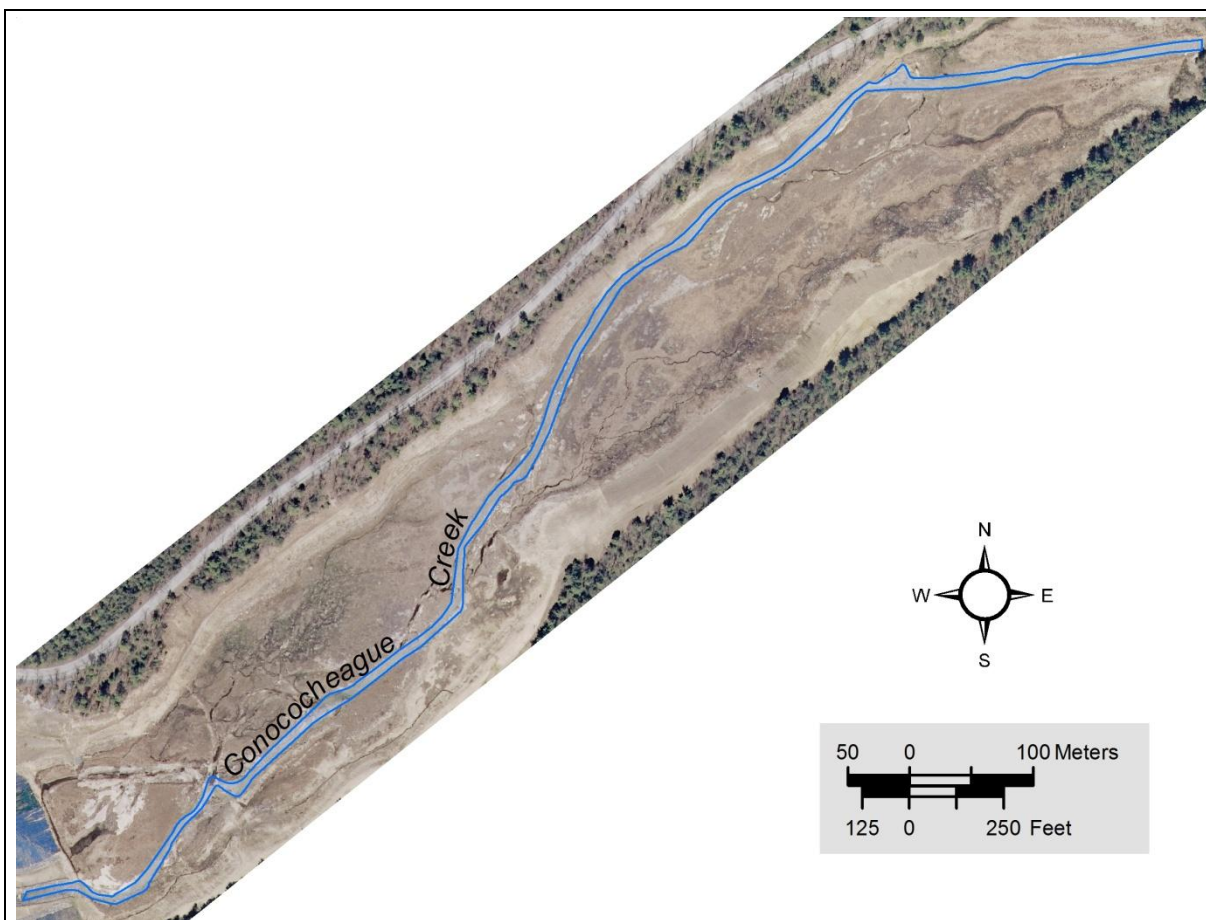
A sinuosity value of 1.0 describes a straight channel, thus suggesting that the Conococheague Creek has a relatively straight channel with no significant meanders. The stream path did not appear to have shifted course appreciably (Figure 8) when the mapped stream boundaries were compared with recent aerial images from 2005 and 2006 (USDA 2005; PA DCNR 2008).

Figure 8. Stream planform of the Conococheague Creek through the former impoundment behind Birch Run Dam. Channel boundaries were mapped in the fall of 2008. There is no change to the channel planform compared to an aerial image taken in 2005 (PA DCNR 2008).

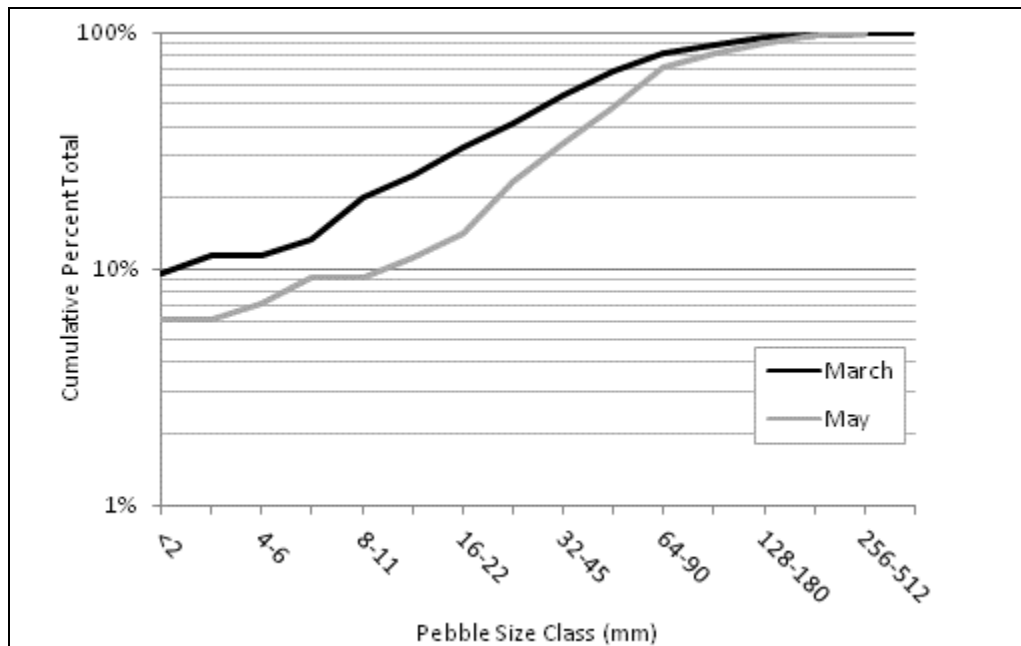
Figure 11. The results of two pebble counts on the channel bed of the Conococheague Creek (*Alpha* reach) are graphed in a logarithmic format. The bed material of the *Alpha* reach was quantified based on a pebble count (Wolman 1954).

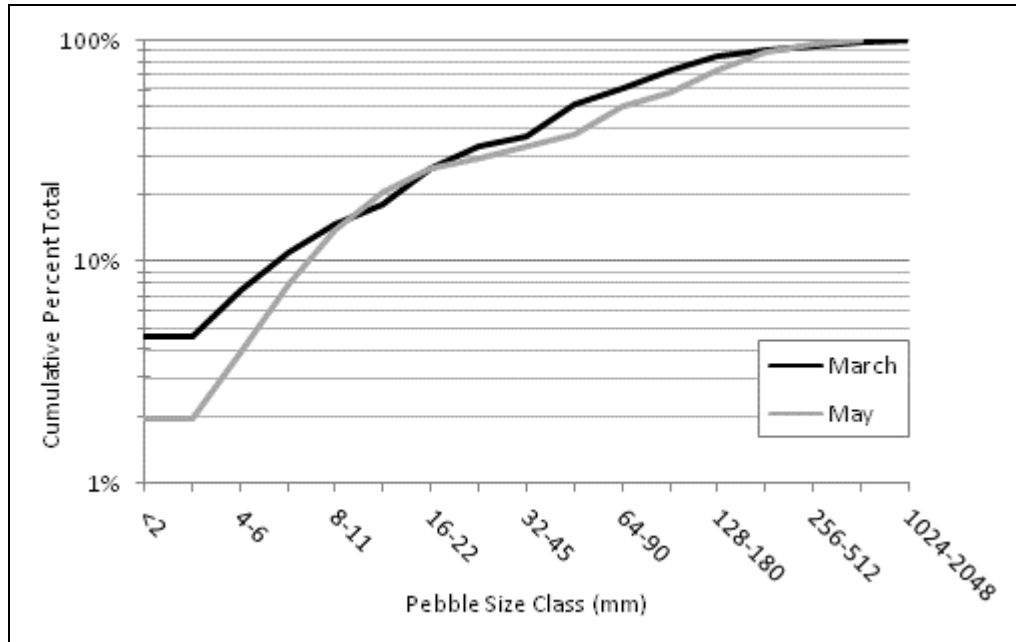
Based on the Wolman (1954) pebble count methodology, the bed material along the *Bravo* reach was dominated by coarse gravels and small cobbles (Table 7). The D16 pebble class, 8-11 mm, did not change over the two field visits. The D50 pebble class increased from the 45-64 mm to the 64-90 mm class. The D84 pebble class size increased from 128-180 mm to the 180-256 mm pebble class size. The overall character of the bed material appears to have changed little over the period of observation (Figure 15).

Figure 15. The results of two pebble counts on the channel bed of the Conococheague Creek (*Bravo* reach) are graphed in a logarithmic format. The bed material of the *Bravo* reach was quantified based on a pebble count (Wolman 1954).

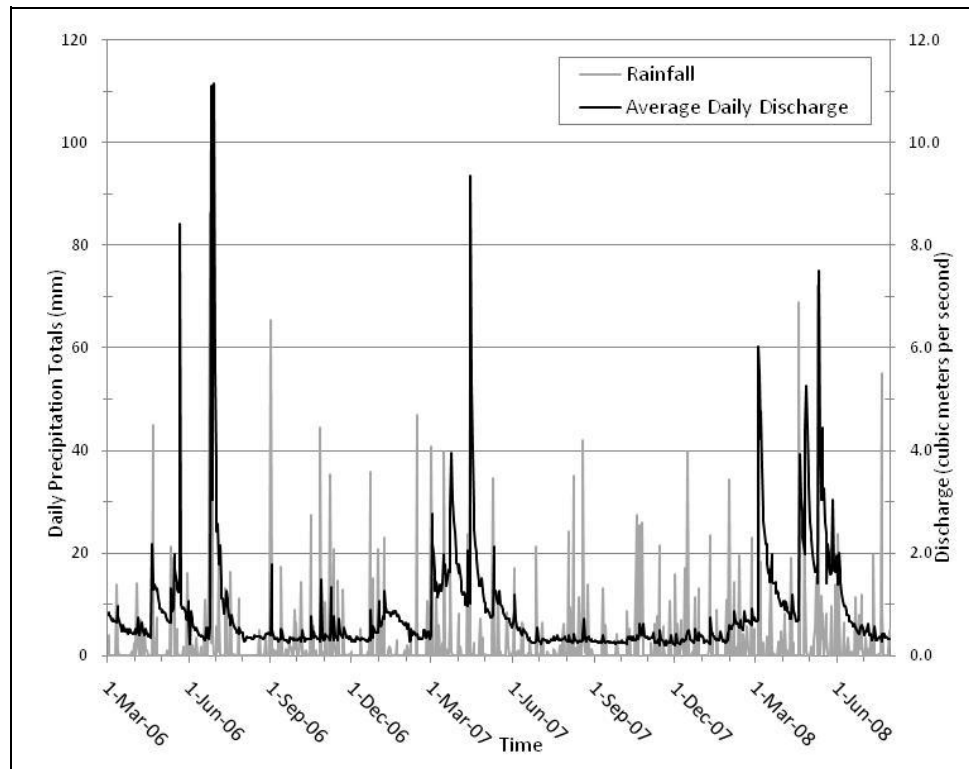
Figure 20. A comparison of the discharge of Conococheague Creek and precipitation between March 2006 and July 2008. Only during spring rains when the Long Pine Reservoir is most likely to be at capacity does the discharge of directly reflect precipitation events (discharge data from the Chambersburg Water Authority; precipitation data from Pennsylvania State Climatologist 2009).
