Attachment E

Dive Report

Iron Gate Dam, Copco 1 Dam, and JC Boyle Dam are three facilities owned and operated by Pacific Corp, a subsidiary of MidAmerican Energy Holdings Company, that were examined by the Bureau of Reclamation Pacific Northwest Underwater Inspection Team members from April 12 through 16, 2010.

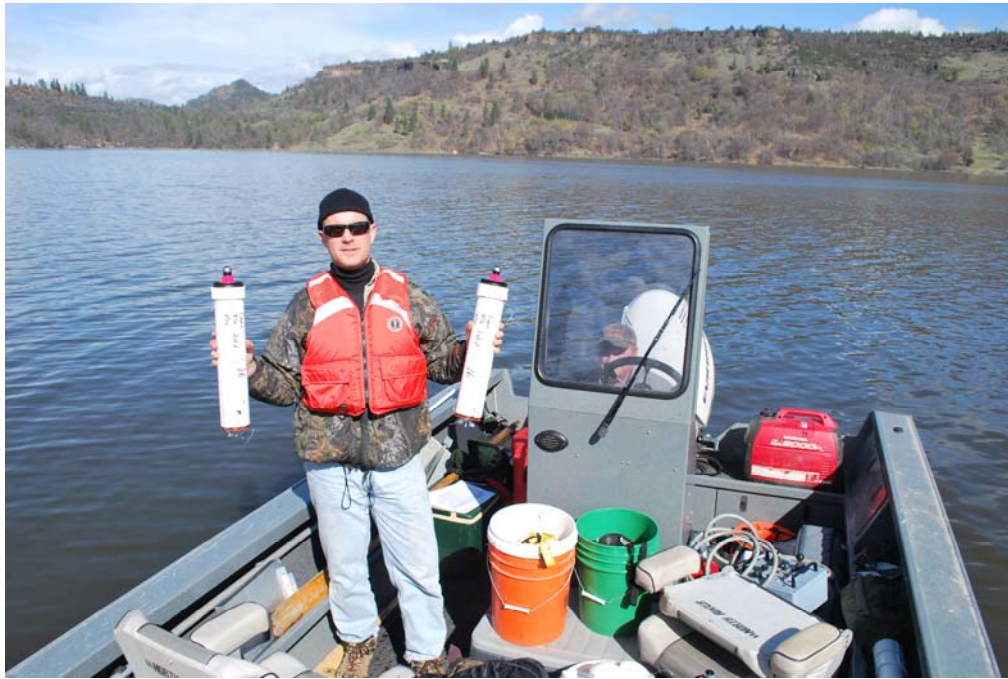
**Photograph No. 1** Paul Zedonis (USFWS) showing arrangement and orientation required for proper delivery of sediment sampling tubes to the surface. Bureau of Reclamation - Pacific Northwest Underwater Inspection Team. JC Boyle, Copco 1 and Iron Gate Dam, Klamath Hydroelectric Project, Oregon-California – April 12-16, 2010.

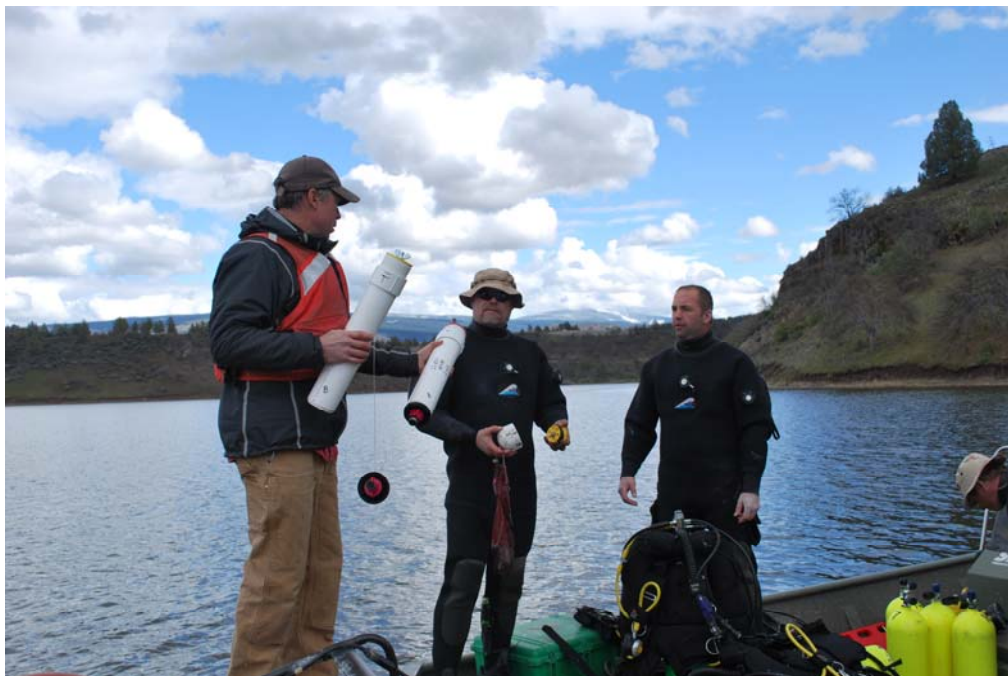
**Photograph No. 2** Chauncey Anderson (USGS) providing divers with pre-dive briefing to go over requirements for adequate sampling of river bottom. Bureau of Reclamation - Pacific Northwest Underwater Inspection Team. JC Boyle, Copco 1 and Iron Gate Dam, Klamath Hydroelectric Project, Oregon-California – April 12-16, 2010.

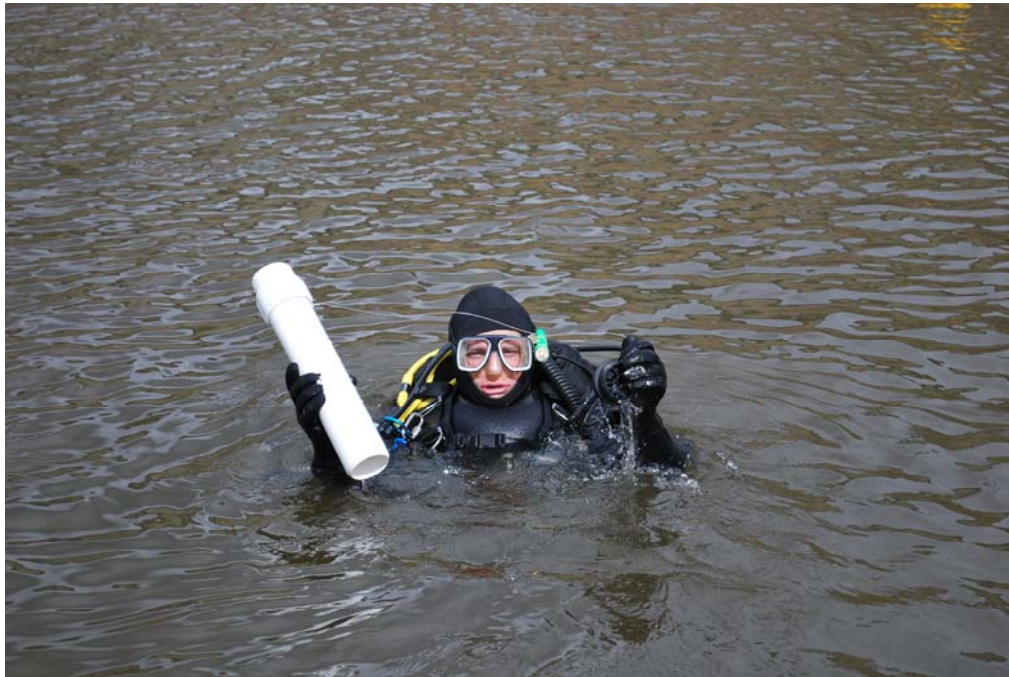
**Photograph No. 3** Diver with sediment sampling tube in hand preparing to descend for sediment retrieval. Bureau of Reclamation - Pacific Northwest Underwater Inspection Team. JC Boyle, Copco 1 and Iron Gate Dam, Klamath Hydroelectric Project, Oregon-California – April 12-16, 2010.

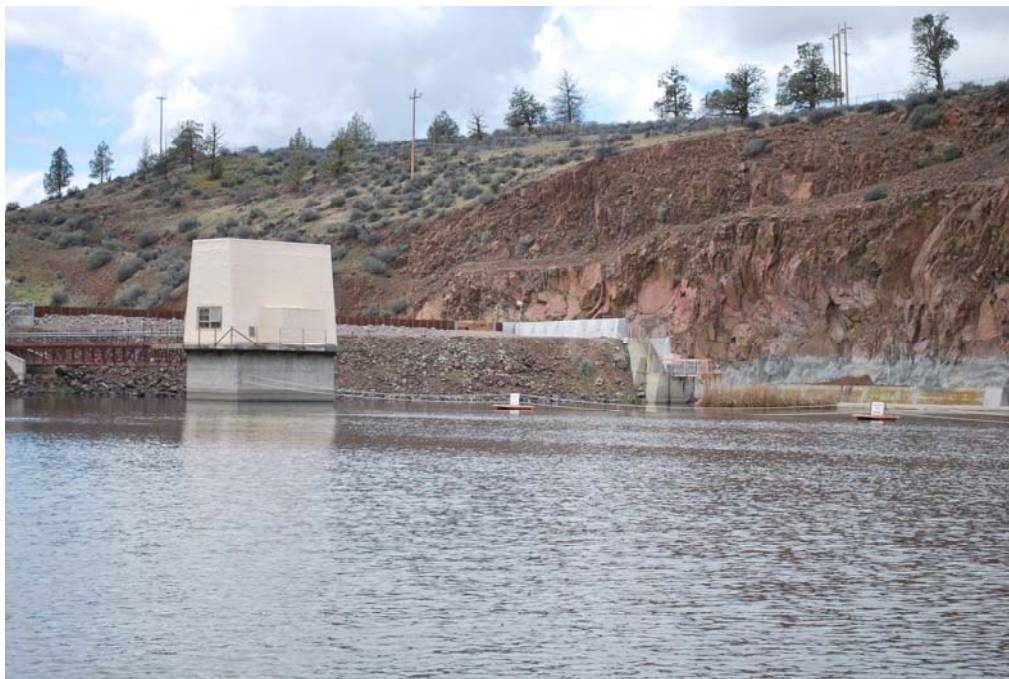
The team then moved downstream to conduct the intake structure inspection. The dive team located the intake structure by boat using bottom scanning sonar in conjunction with “fishing” for the metallic trash racks with a large magnet (Photo 4); see Figure 4 for reference drawing. Once located, the intake structure coordinates were recorded to be 122° 26.1219’ N, 41° 56.1462’ W. The trashracks protecting the intake structure were inspected with a Remotely Operated Vehicle (ROV) (Photos 5 through 8) due to depth limitations of divers on scuba equipment. The trashracks are all covered with ¼ inch of organic matter (Photo 9). Approximately 15 feet of the upper portion of the intake structure is free of sediment and debris. The lower section is silted in with fine organics and sediments. A very small amount of woody debris, up to 3 inches was observed. The trashracks had minor rust nodules covering 5 to 10 percent of their surface. Some nodules looked to be 2 to 3 inch in diameter and up to 1 inch in height (Photo 10). The concrete appeared to be in very good condition with no spalling or scaling. The top of the intake structure had approximately 3 to 4 inches of fine sediment and debris. Photo 11 shows the “fishing” magnet secured to the side of the intake structure.

**Photograph No. 4** Right abutment of Iron Gate dam at approximate location for deployment of ROV used to survey intake structure. Bureau of Reclamation - Pacific Northwest Underwater Inspection Team. JC Boyle, Copco 1 and Iron Gate Dam, Klamath Hydroelectric Project, Oregon-California – April 12-16, 2010.

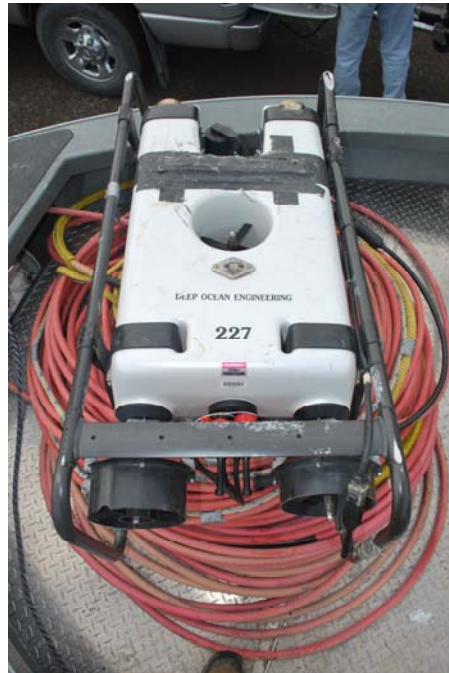
**Photograph No. 5** PN Dive team Deep Ocean Engineering ROV. Bureau of Reclamation - Pacific Northwest Underwater Inspection Team. JC Boyle, Copco 1 and Iron Gate Dam, Klamath Hydroelectric Project, Oregon-California – April 12-16, 2010.

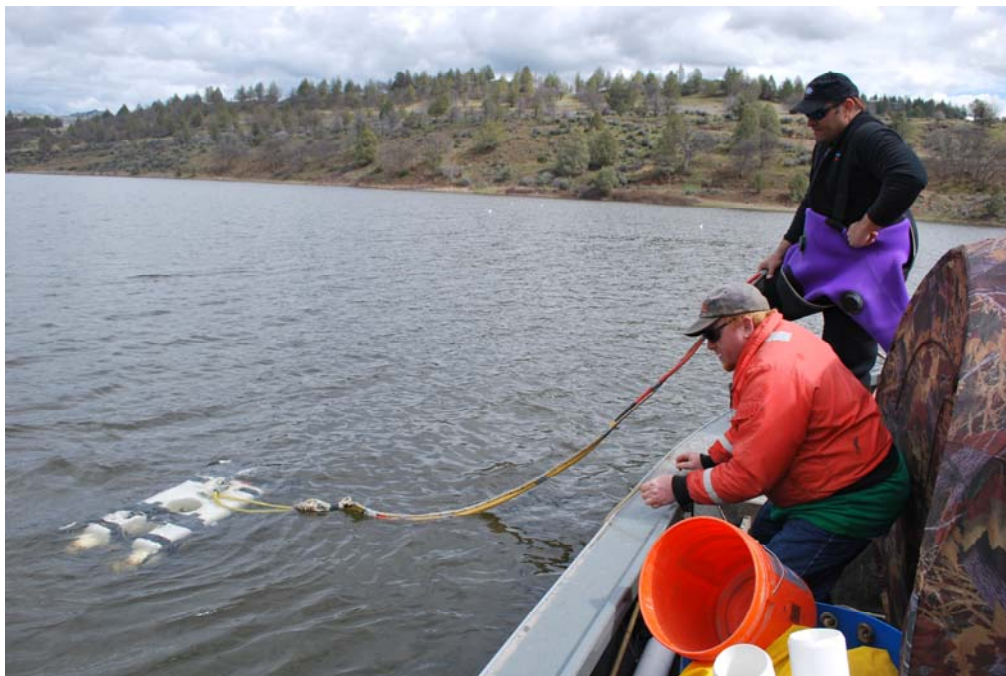
**Photograph No. 6** ROV on surface with surface support personnel tending descent and ascent of vehicle. Bureau of Reclamation - Pacific Northwest Underwater Inspection Team. JC Boyle, Copco 1 and Iron Gate Dam, Klamath Hydroelectric Project, Oregon-California – April 12-16, 2010.

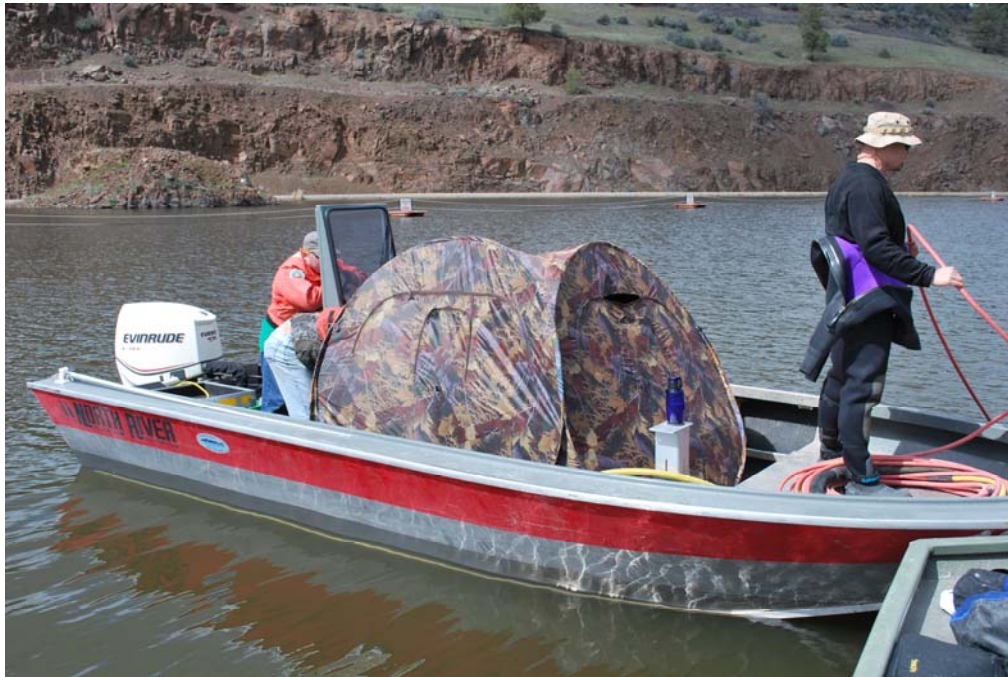
**Photograph No. 7** Hunting blind used for viewing ROV video monitor. Bureau of Reclamation - Pacific Northwest Underwater Inspection Team. JC Boyle, Copco 1 and Iron Gate Dam, Klamath Hydroelectric Project, Oregon-California – April 12-16, 2010.

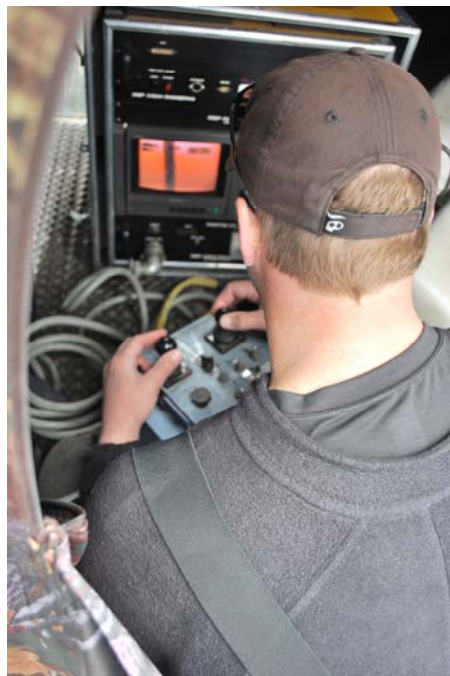
**Photograph No. 8** View of ROV controls and video display unit. Bureau of Reclamation - Pacific Northwest Underwater Inspection Team. JC Boyle, Copco 1 and Iron Gate Dam, Klamath Hydroelectric Project, Oregon-California – April 12-16, 2010.

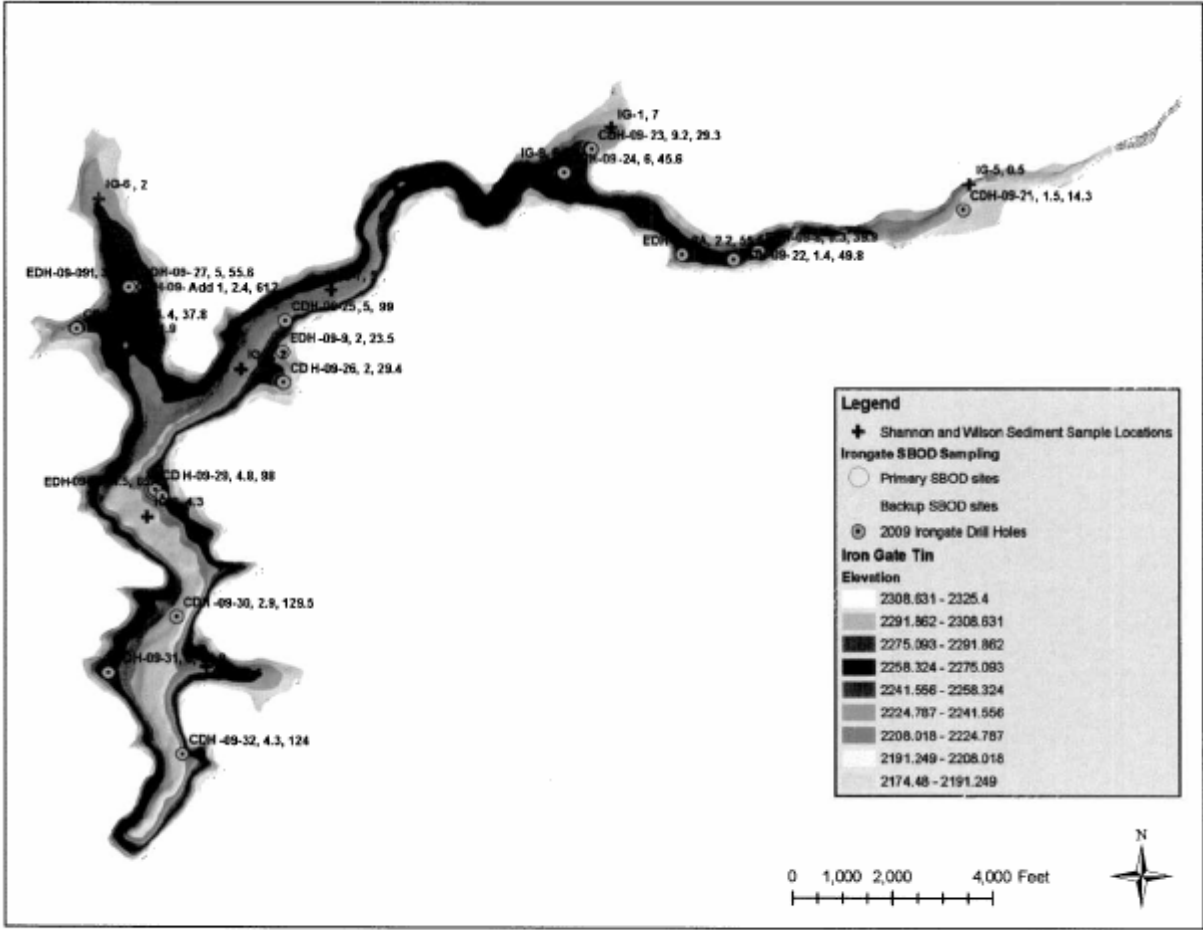
FIGURE 1

Iron Gate Reservoir map showing approximate locations of sampling sites.

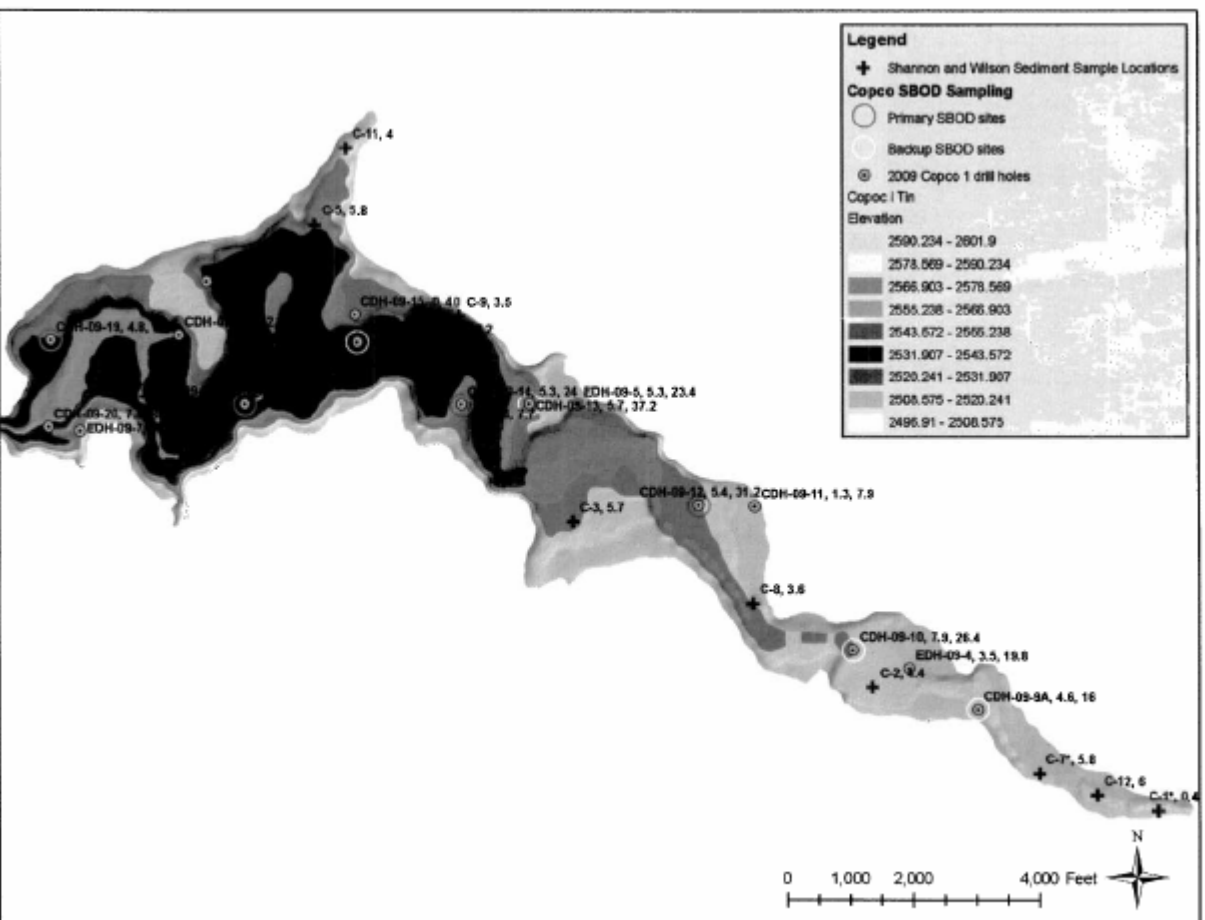
FIGURE 2

Copco Reservoir map showing approximate locations of sampling sites.
