Technical Report No. SRH-2011-19

## **Reservoir Area Management Plan for the Secretary's Determination on Klamath River Dam Removal and Basin Restoration**

**Klamath River, Oregon and California  
Mid-Pacific Region**

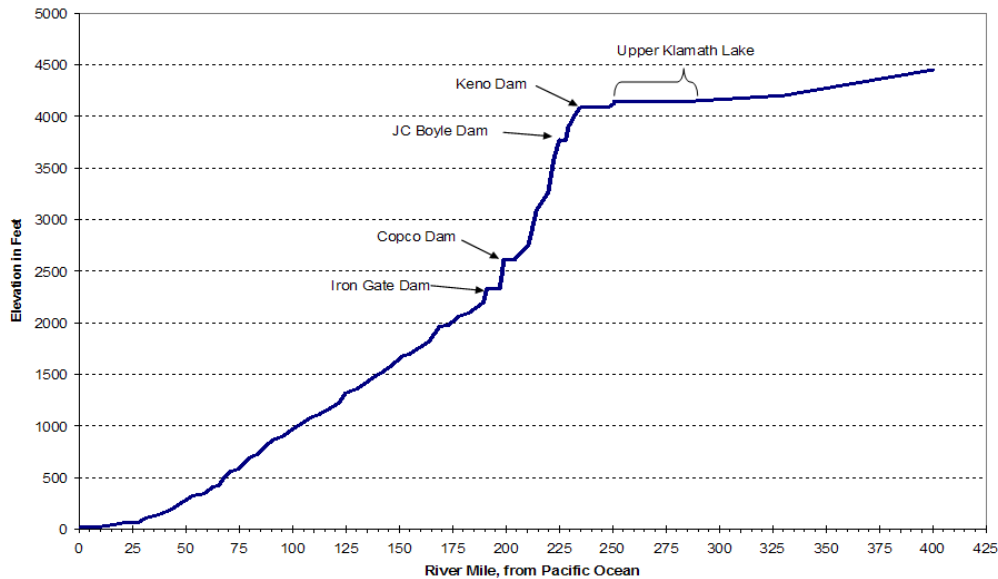
Figure 2-2. Slope of the Klamath River from Upper Klamath Lake to the Pacific Ocean. Note the gentle slope upstream from the reservoirs compared to the slope downstream. This is opposite of most watershed settings and is important context for the production of deposits stored in the reservoirs, as well as the transport of deposits by the river if released upon dam removal.

The reservoirs are located in a mid-basin setting between the Basin Range and High Cascades geologic provinces, in various volcanic rock formations. An overview of the Klamath Basin is shown in Figure 2-1. The reservoirs are located downstream of Upper Klamath Lake (UKL) and the most downstream reservoir are located 190 miles upstream from the Pacific Ocean. The slope of the Klamath River upstream from the reservoirs is smaller than the slope downstream from the reservoirs (Figure 2-2). This river profile is generally the opposite in most watersheds, where the headwaters are steeper and the channel flattens downstream.

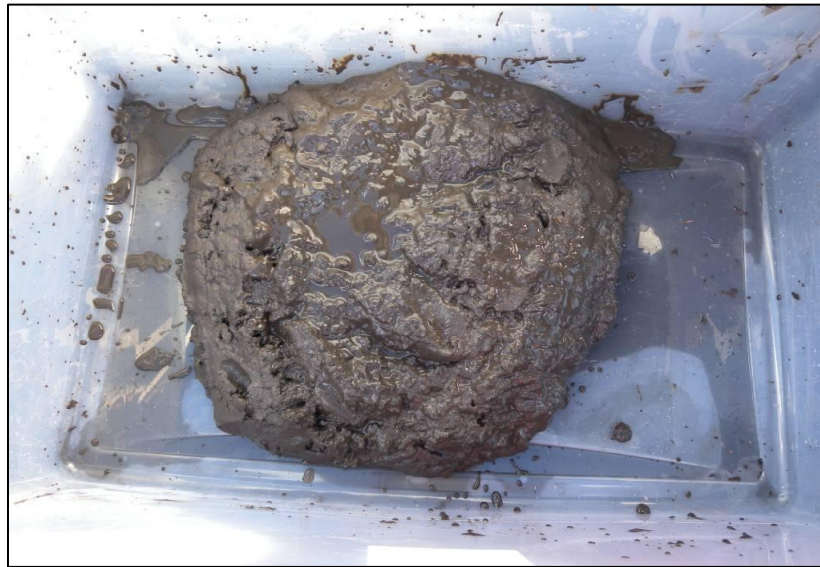
Figure 2-12. Reservoir sample just after release from clamshell sampling device.

Approximately twelve 5-gallon samples were collected in each reservoir by a 9 inch clam-shell (Ponar) sampler, repacked in the lab, and tested using a jet test device described in Simons et al. (2010). One such sample collected from the Ponar sampler is shown in Figure 2-12. Samples were tested under wet and dry conditions. The effects of drying on erosion resistance and erodibility ( $\tau_c$  and  $k_d$ ) were significant, with reservoir-average values of  $\tau_c$  increasing by at least an order of magnitude. Associated decreases in  $k_d$  also occurred with sample drying, but not to the extent of the increases in critical shear stress. The median value of the erodibility coefficient decreased by about 80%. The average erodibility of the moist reservoir deposit was similar to that of sand, while the average erodibility of the dried deposit was similar to that of gravel or cobbles.

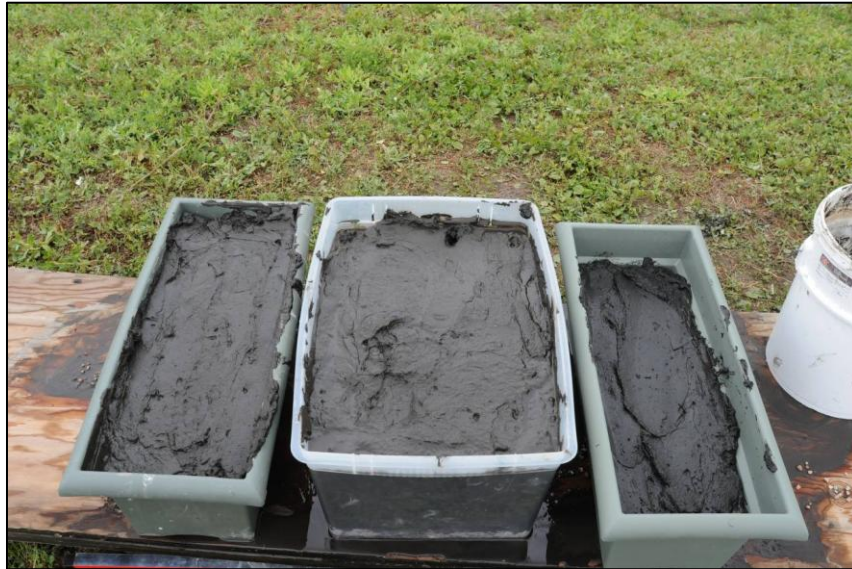
Figure 2-13. Picture of deposit from J.C. Boyle Reservoir immediately after placement

The sample was allowed to dry outside. The initial and final sample thicknesses are given in Table 2.4. The desiccated thickness of the sample was about 60% of the initial. In addition, deep cracks developed in the soil and the sample pulled away from the container edges (Figure 2.13). It was estimated that the volume of the sample decreased by approximately 66%. The porosity changed from 0.82 to approximately 0.46. The dry bulk density increased from  $29.5 \text{ lb/ft}^3$  to approximately  $87 \text{ lb/ft}^3$ . The sample tested was taken from the upper portion of J.C. Boyle Reservoir and has a slightly higher bulk density than the deposit in the lower portions of the three reservoirs. The dry bulk density of the finer material located in the lower parts of the three reservoirs is expected to increase from its existing value of  $16 - 20 \text{ lb/ft}^3$  to between 47 to  $58 \text{ lb/ft}^3$ .

3. Drying, consolidation, cracking and hardening of reservoir deposit. After the initial slumping and draining of excess water, the deposit will begin to dry as the result of evaporation. Figure 2-13 and Figure 2-14 shows the effect of drying the reservoir deposit. The remaining reservoir will reduce in volume by approximately 2/3 and the thickness of the deposit will decrease by about 1/3. Cracks will appear and the deposit will harden

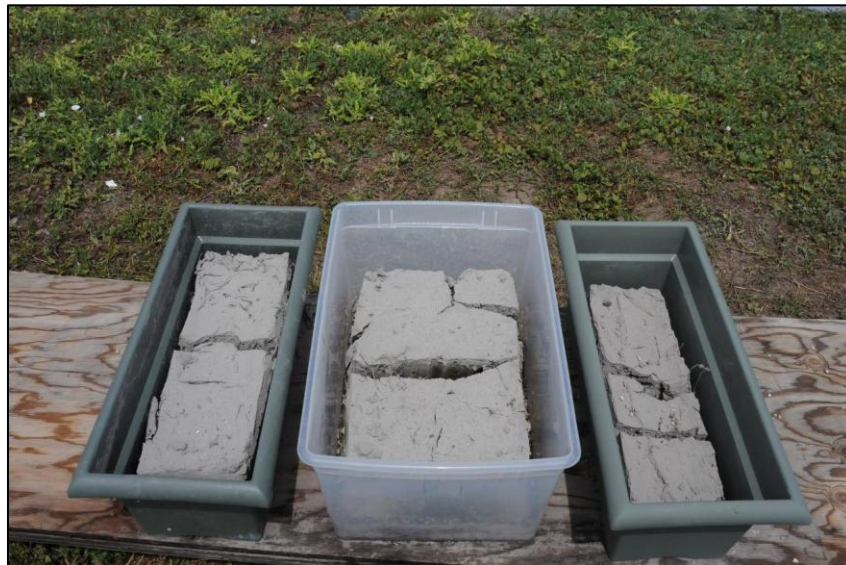
Figure 2-14. Picture of sample from J.C. Boyle after 15 days of air drying.

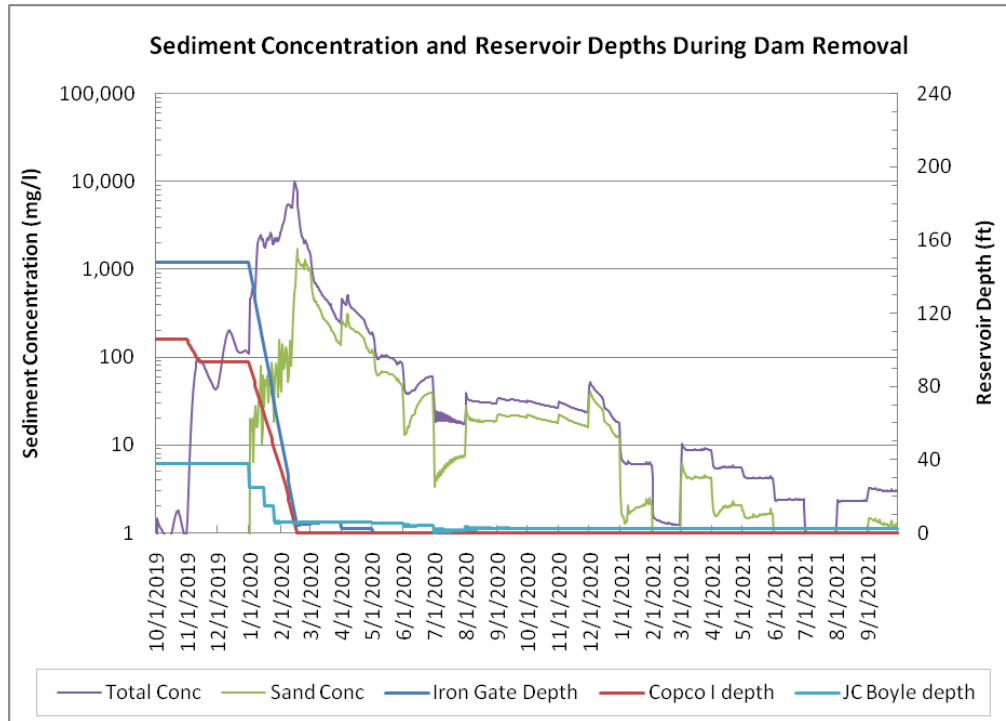
Figure 3-1. Sediment Concentrations predicted Downstream of Iron Gate Reservoir for median year for Scenario 8 (Reclamation 2011).

The model was used to assess the volume of material eroded during drawdown and in the subsequent year after dam removal. It also predicted the sediment concentrations downstream of the dams. Several drawdown scenarios were analyzed assuming different maximum drawdown rates, different notching scenarios at Copco 1, and different start times. Details of the deconstruction plan can be found in Reclamation (2011a). The sediment concentration predicted during drawdown and in the subsequent year after drawdown for Scenario 8 (Reclamation, 2011b) is shown in Figure 3-1. Scenario 8 corresponds to the major drawdown of the reservoirs beginning January 1, 2020. It also includes a preliminary drawdown of Copco Reservoir to the spillway elevation beginning November 1, 2019. The results are shown for the approximately median water year (WY) of 1976. Concentrations remain over 1,000 mg/l until early March. By May, the concentrations are approximately 100 mg/l. The volume of erosion is shown in Figure 3-2. For a median water year under Scenario 8, slightly more than 7 million yd<sup>3</sup> of material is expected to be eroded during the first drawdown period. This equates to slightly more than 1/2 of the total deposit deposited behind the dams. There will be less erosion during a dry year and more erosion during a wet year with the amount of erosion from the reservoirs varying from 1/3 to 2/3 of the deposit.

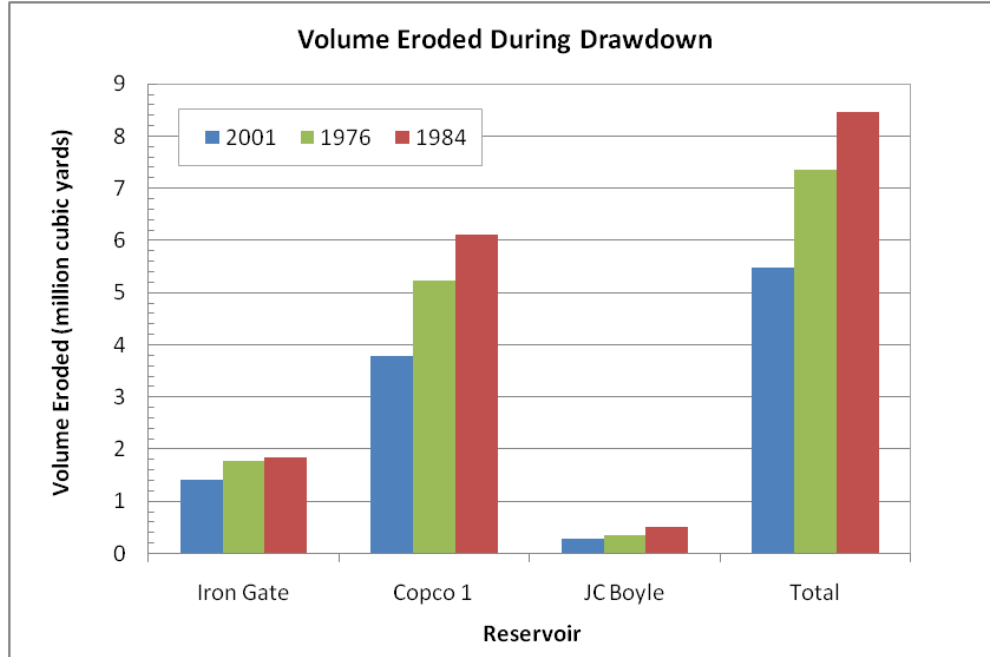
Figure 3-2. Erosion Volumes predicted at JC Boyle, Copco and Iron Gate Reservoirs for Scenario 8 of Reclamation (2011), for Dry (2001), Median (1976) and Wet (1984) water years.

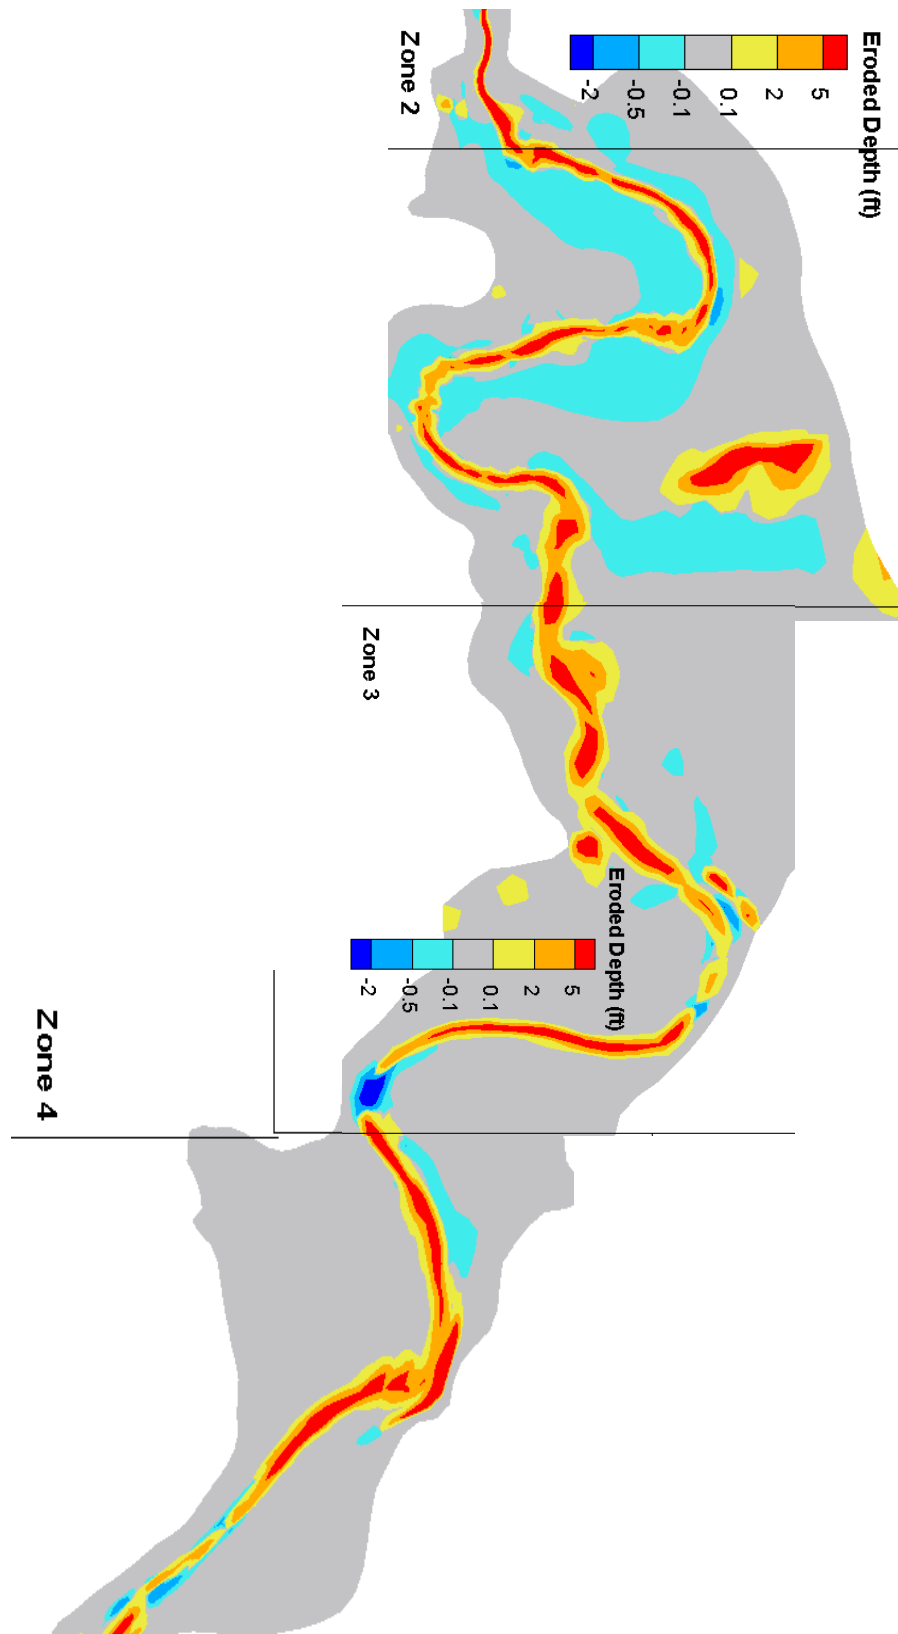
Figure 3-3. SRH-2D predicted erosion/deposition pattern after the drawdown of Copco 1 reservoir under an average water year.

Figure 3-3 shows the areas of erosion and deposition within the reservoir. The erosion is focused primarily in the historical stream channel and the pre-dam elevations are attained during dam removal because the reservoir deposits are extremely erodible. There are minor amounts of deposition along the channel banks, generally less than 0.5 ft. The deposition in the model occurs during high flows that inundate the floodplains and deposit small amounts. The 2D model would generally underestimate the erosion along the bankline because it does not include a mechanism to simulate bank erosion or bank collapse. Therefore, in reality, the areas of deposition shown in the figure are expected to be slightly erosional.

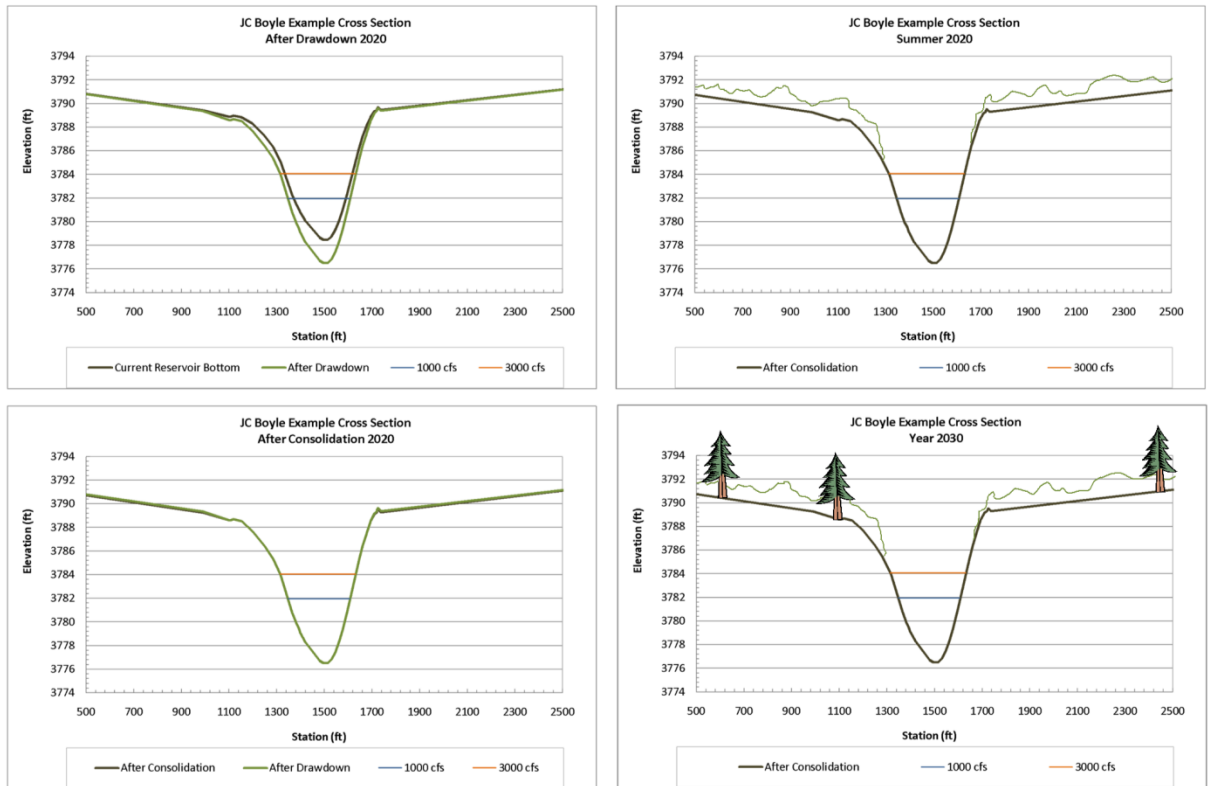
Figure 3-4. Example cross section at JC Boyle Reservoir.

An example cross section at JC Boyle is shown in Figure 3-4. The cross section is located upstream of the state highway bridge. The cross section is shown before and after drawdown showing that the erosion is focused in the main channel. After drawdown, there will be minor amounts of consolidation of the floodplain deposit. There is little consolidation of deposit on the floodplain because there are only small amounts of reservoir deposit on these surfaces. Most flow will be confined to the main channel and the upper floodplain terrace will rarely become inundated. The predicted water surface at 1000 cfs and 3000 cfs is shown on the cross section. Herbaceous species will be planted in the spring following drawdown. Conifer species will reestablish on the river terraces as they propagate from the outer edges of the reservoir.

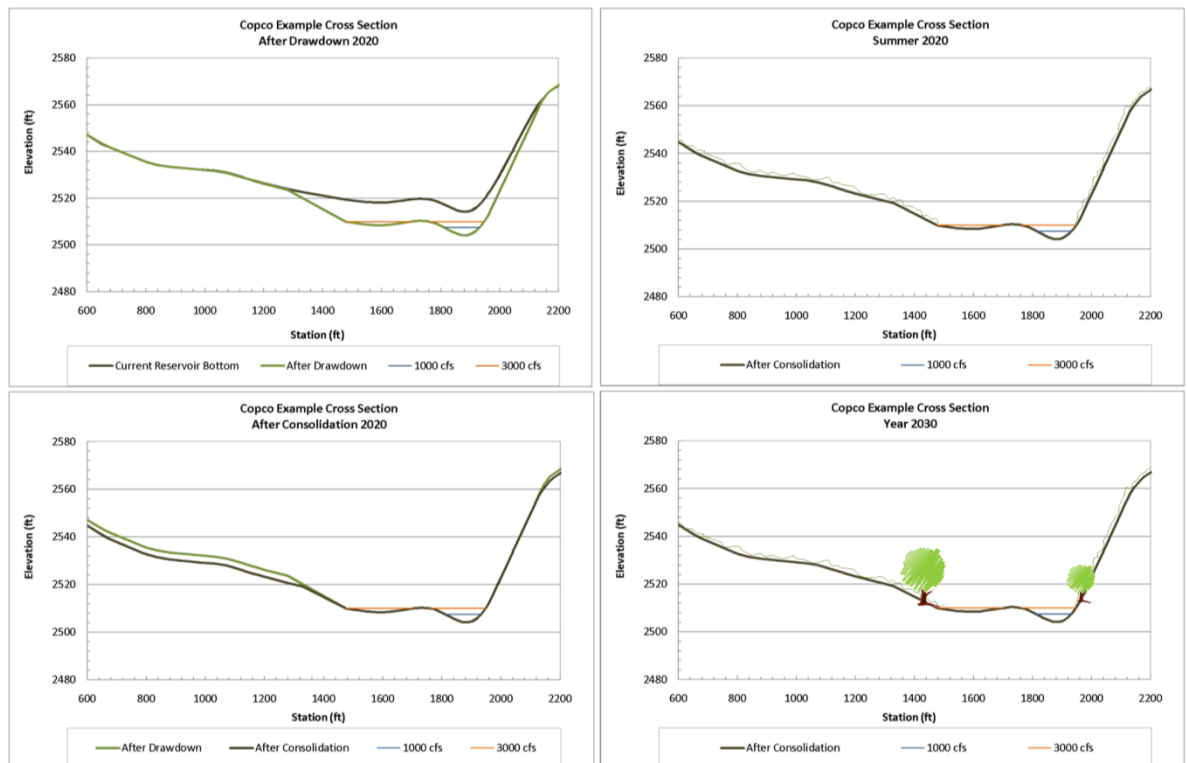
Figure 3-5. Example cross section at Copco Reservoir.

An example cross section at Copco is shown in Figure 3-5. The cross section is located in the wide middle section of the reservoir. River flows erode to the pre-dam surface during the first drawdown. The width of the eroded channel will depend upon the stream flows during drawdown. The figure shows the expected width if the flows during drawdown are relatively high. After drawdown, the remaining deposits will begin to consolidate and decrease in thickness. At Copco, this will be a relatively major process and the thickness of the deposit will decrease up to a few feet. Cracks will appear perhaps to the full thickness of the deposit as it dries. Seeded herbaceous species are expected to germinate after spring revegetation. Woody species will be planted along the river banks and establish over a period of years.

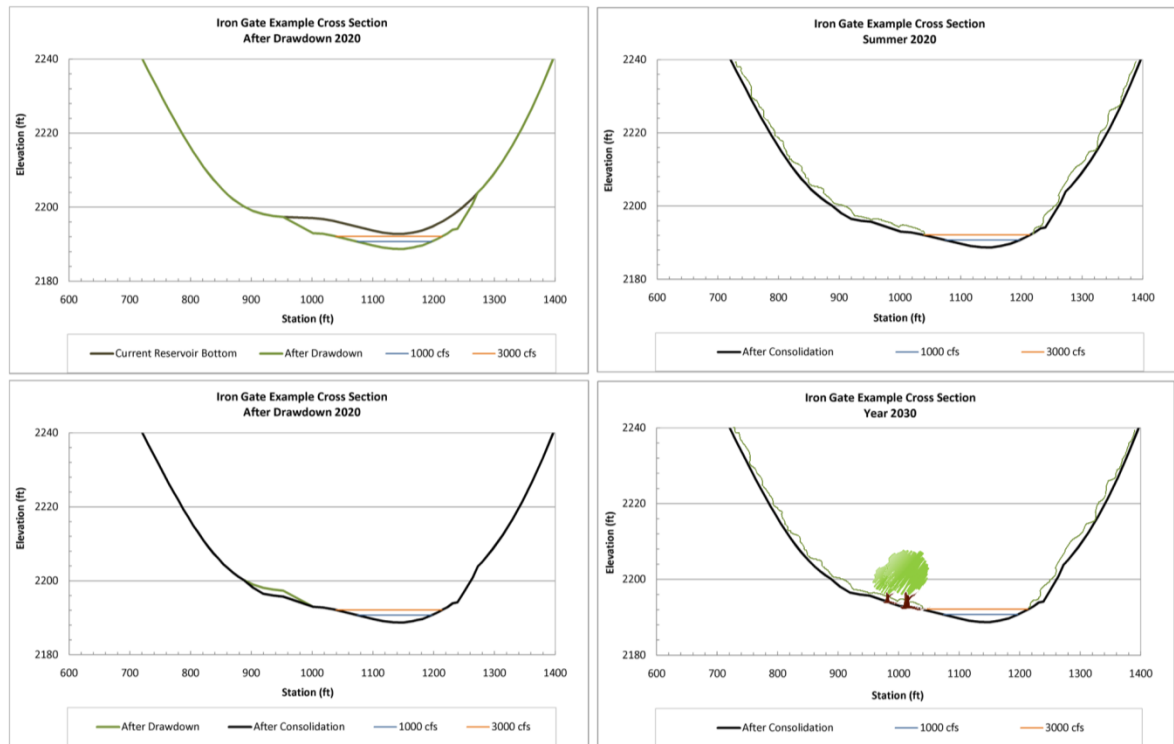
Figure 3-6. Example cross section at Iron Gate Reservoir.

An example cross section showing the erosion, consolidation, and vegetation growth at Iron Gate is shown in Figure 3-6. Because the deposit is generally less than four feet thick and much of the deposit will be eroded at Iron Gate, the consolidation process will be relatively less important.

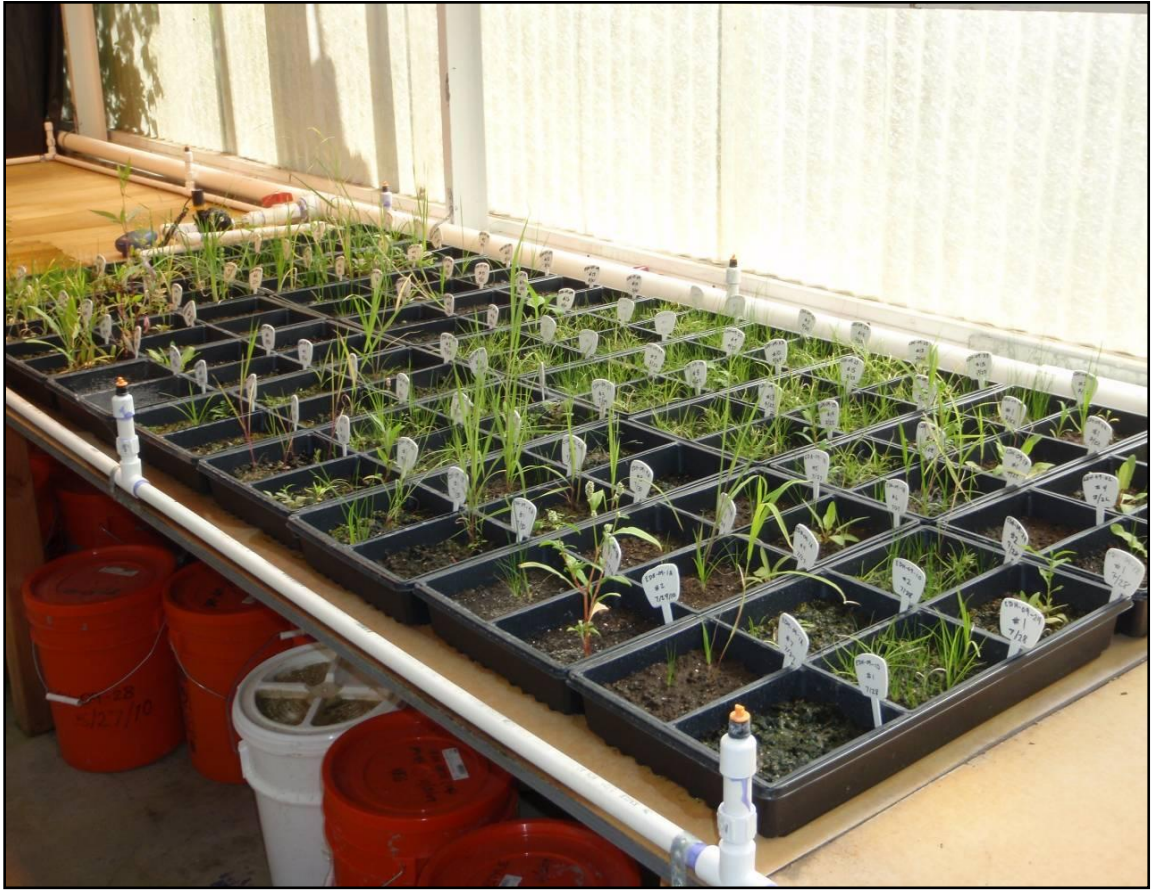
Figure 3-7. Soil seedbank germination study flats, 6 weeks after planting.

Flats were monitored daily and photographed weekly. Identification and quantification was conducted at 6 weeks after planting, although plants were not yet at a growth stage where they could be keyed out to the species level.

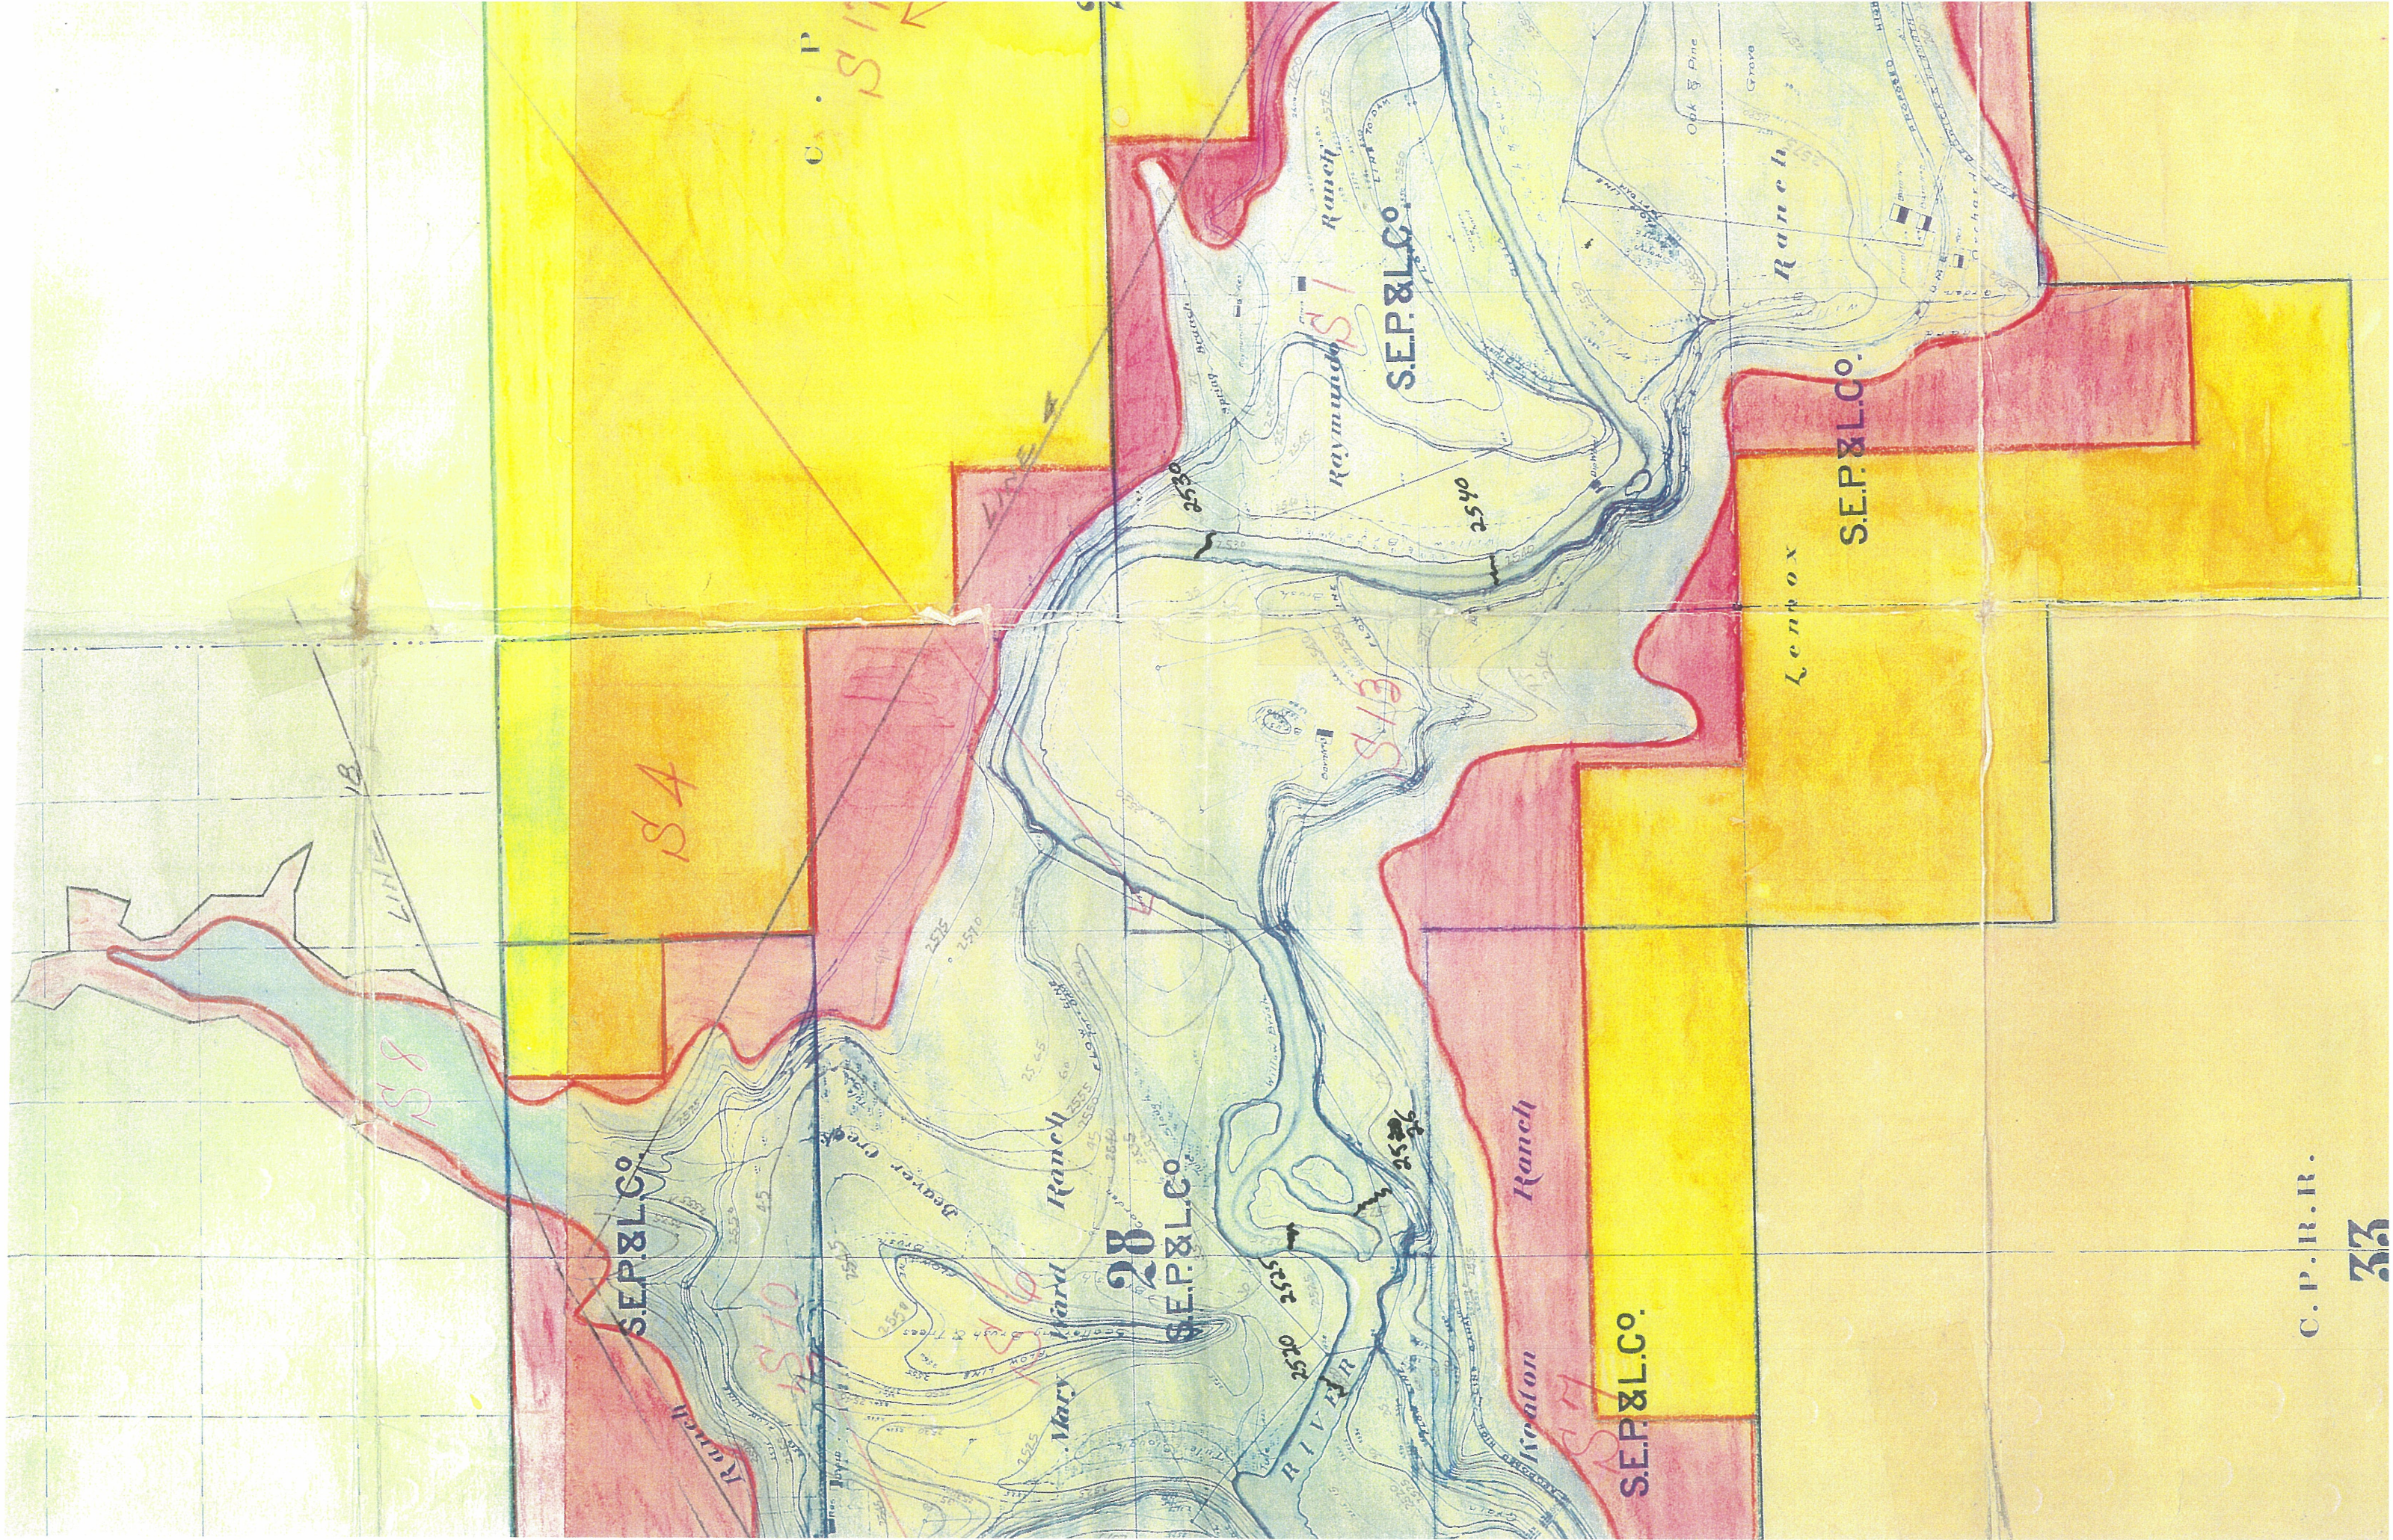
Figure 6-1. Maps of the pre-dam topography and floodplain features of Copco Reservoir. The maps were from PacifiCorp and the scanned digital maps were provided by Larry Dunsmoor, Senior Aquatics Biologist, The Klamath Tribes, Chiloquin, Oregon.

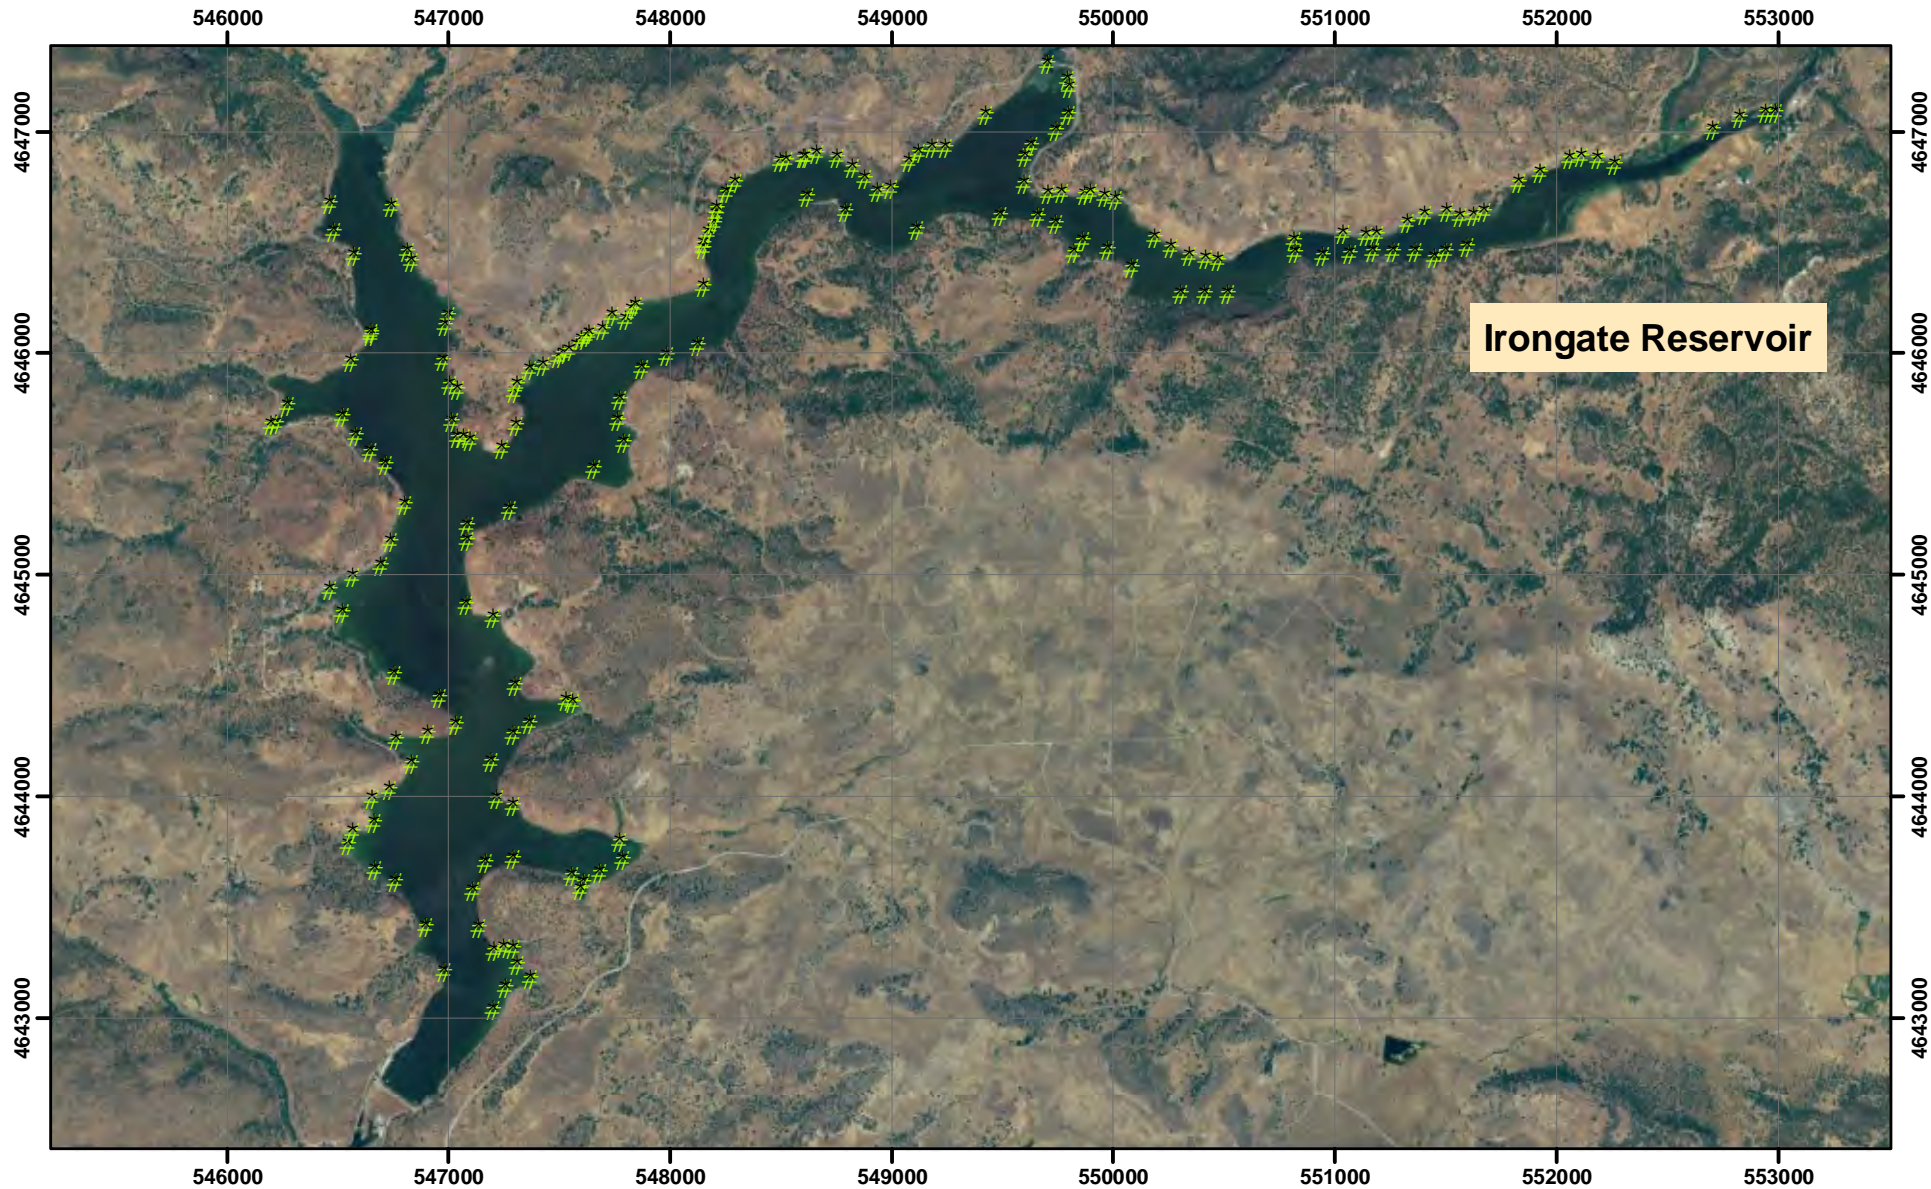
Locations of assorted native grasses

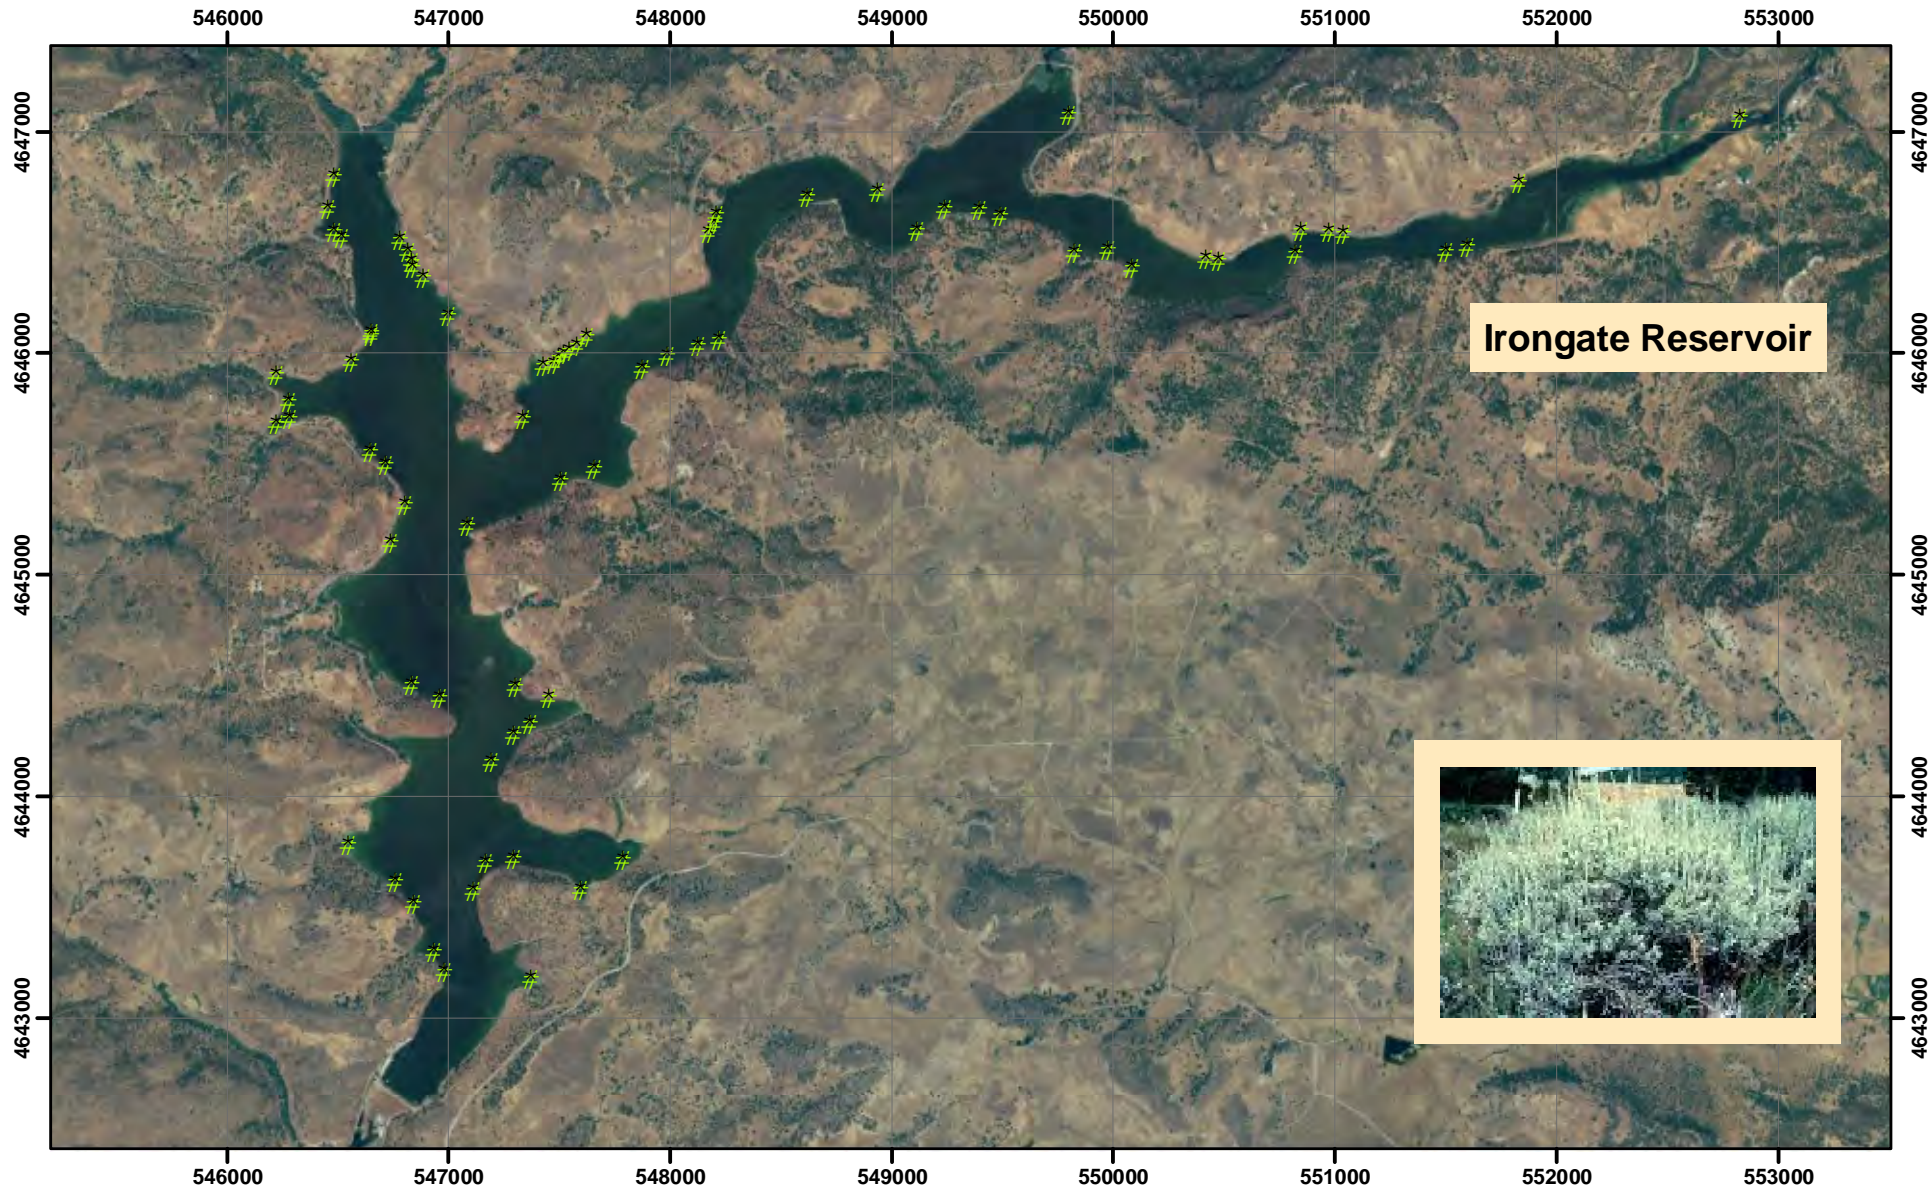
Locations of assorted native shrubs

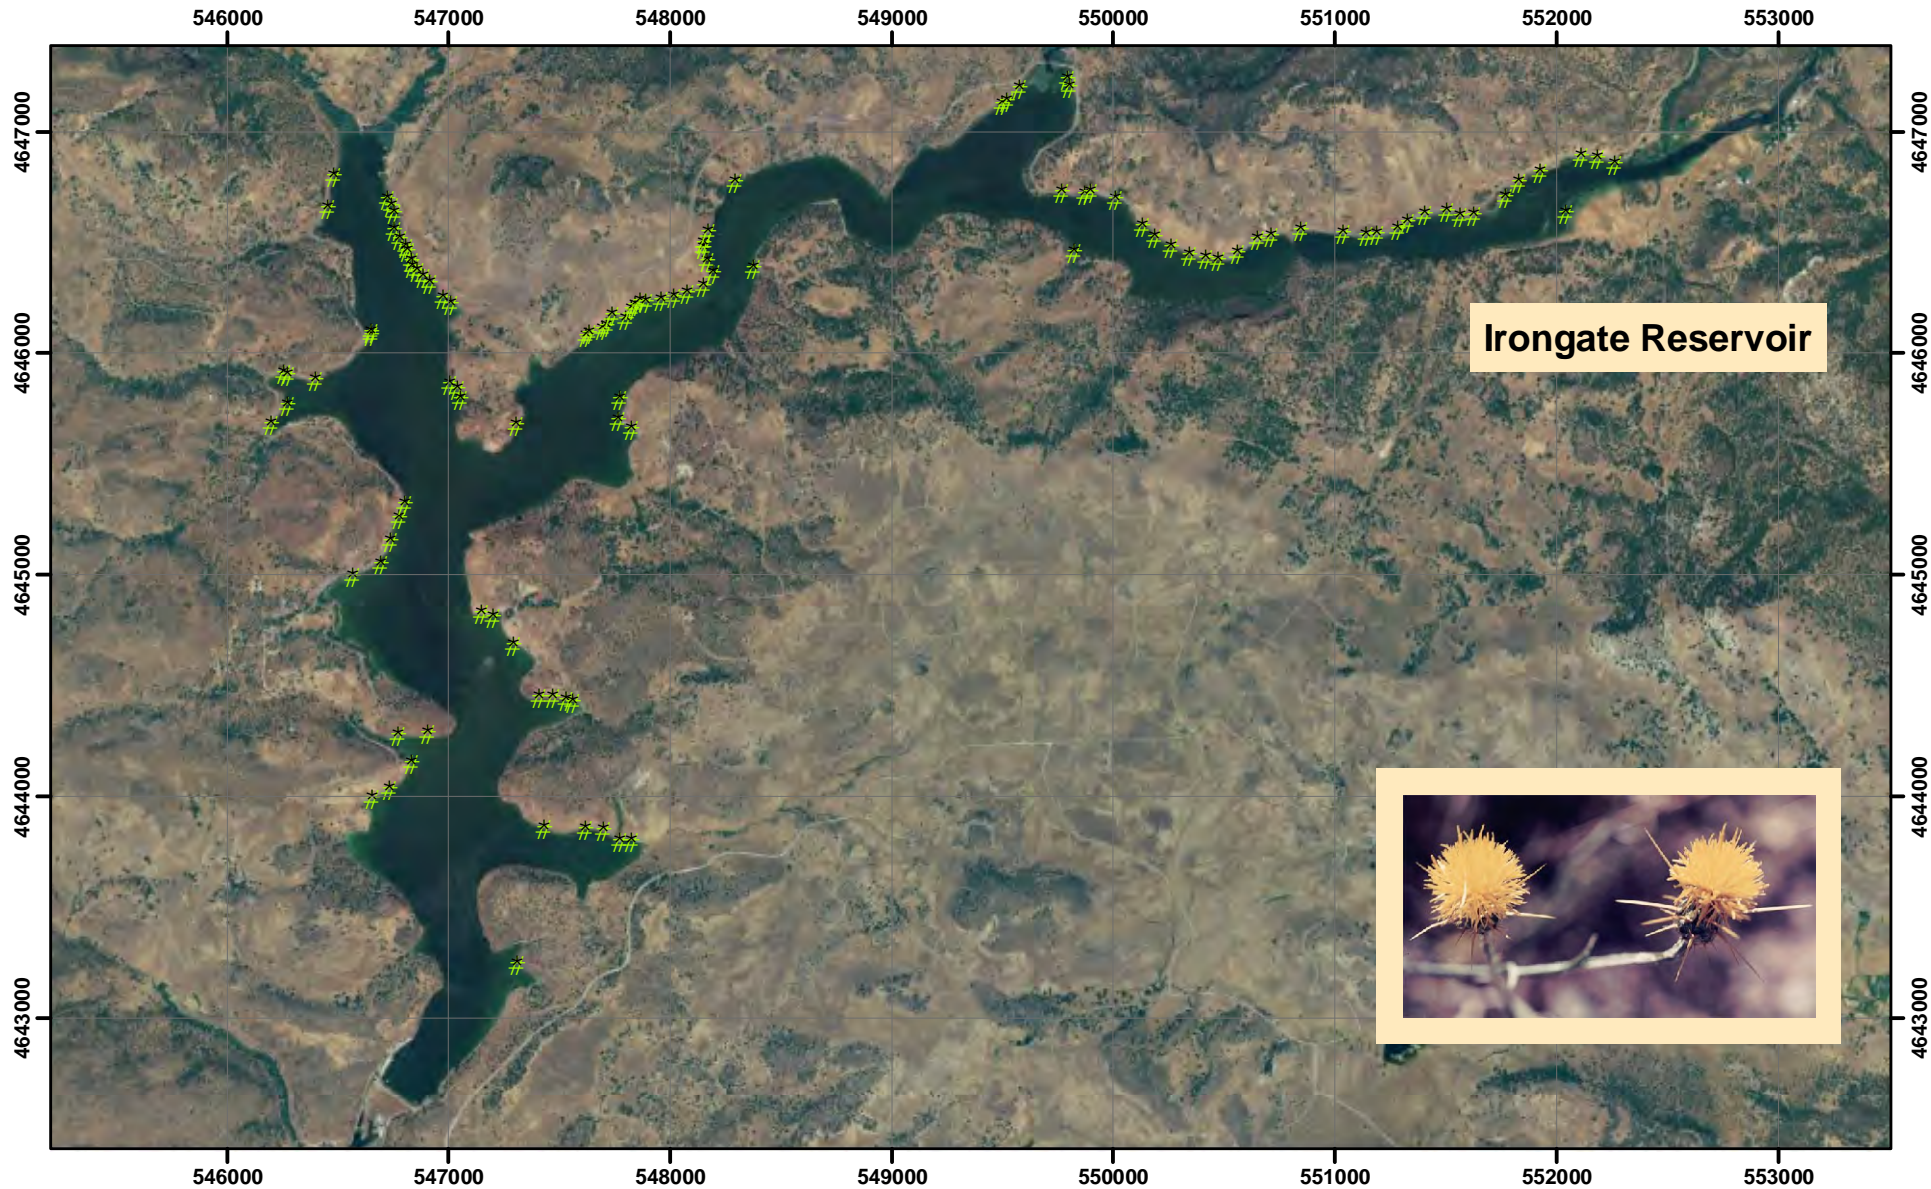
\* Locations of Sagebrush (*Artemisia* spp.)
