Technical Report No. SRH-2011-19

## **Reservoir Area Management Plan for the Secretary's Determination on Klamath River Dam Removal and Basin Restoration**

**Klamath River, Oregon and California  
Mid-Pacific Region**

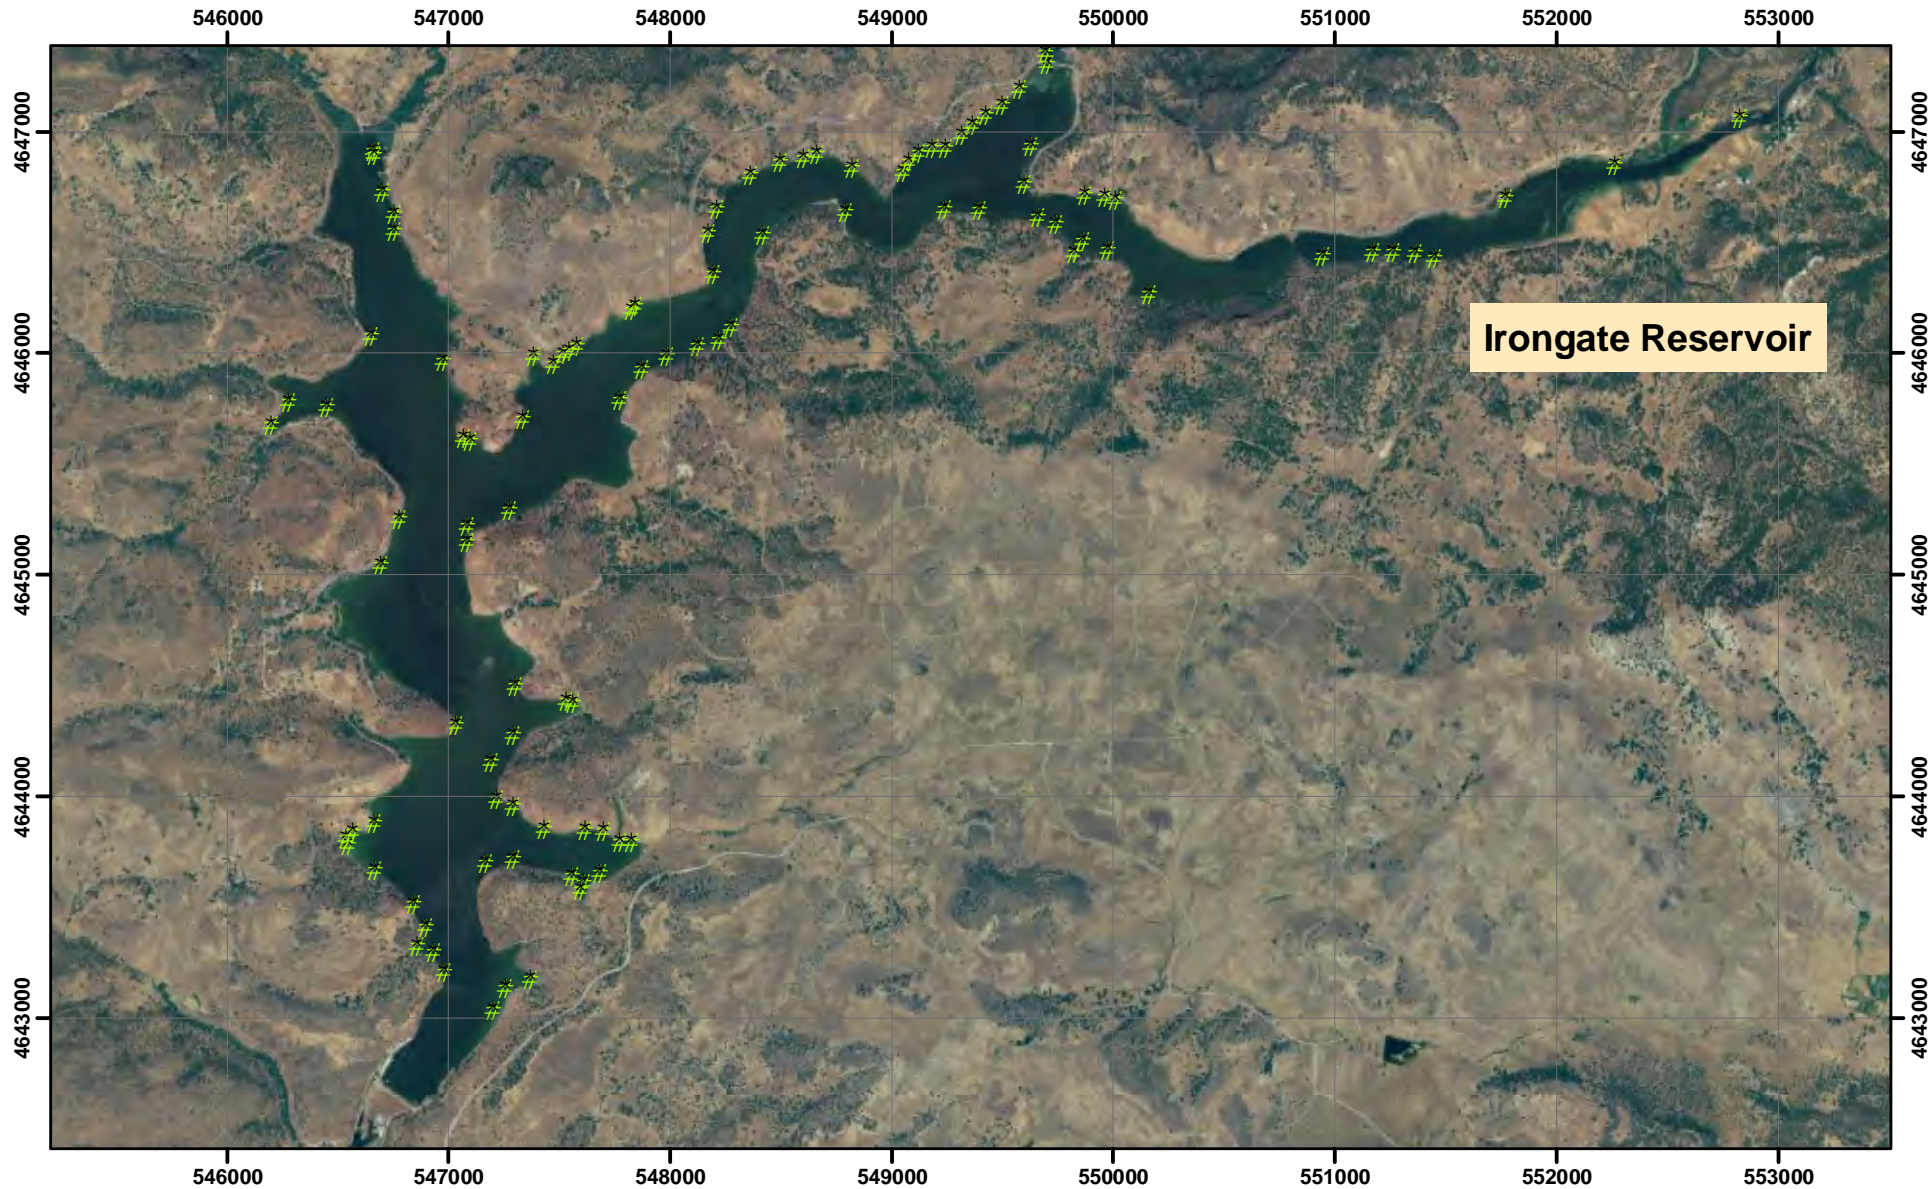
Locations of yellow star-thistle (*Centaurea solstitialis* L.)

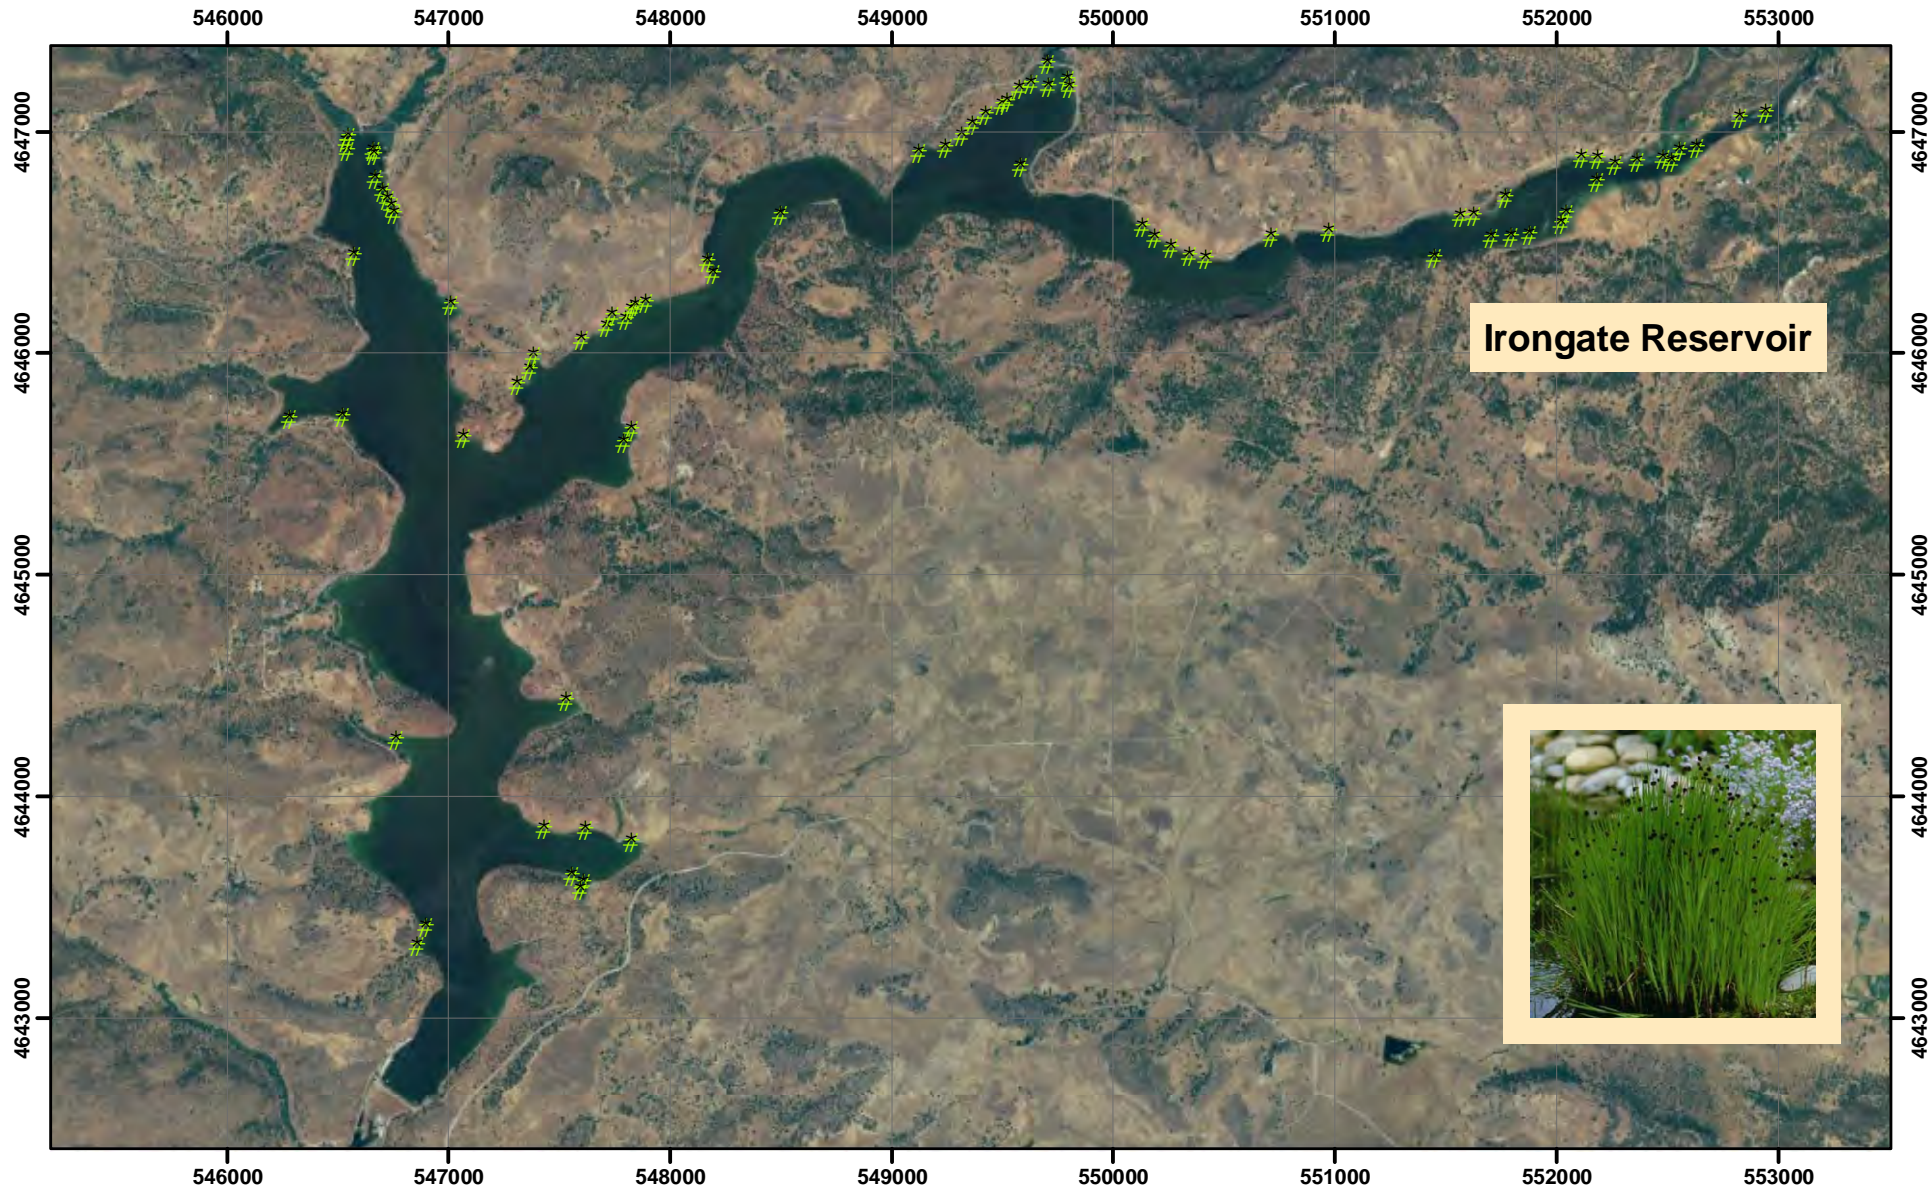
Locations of conifers

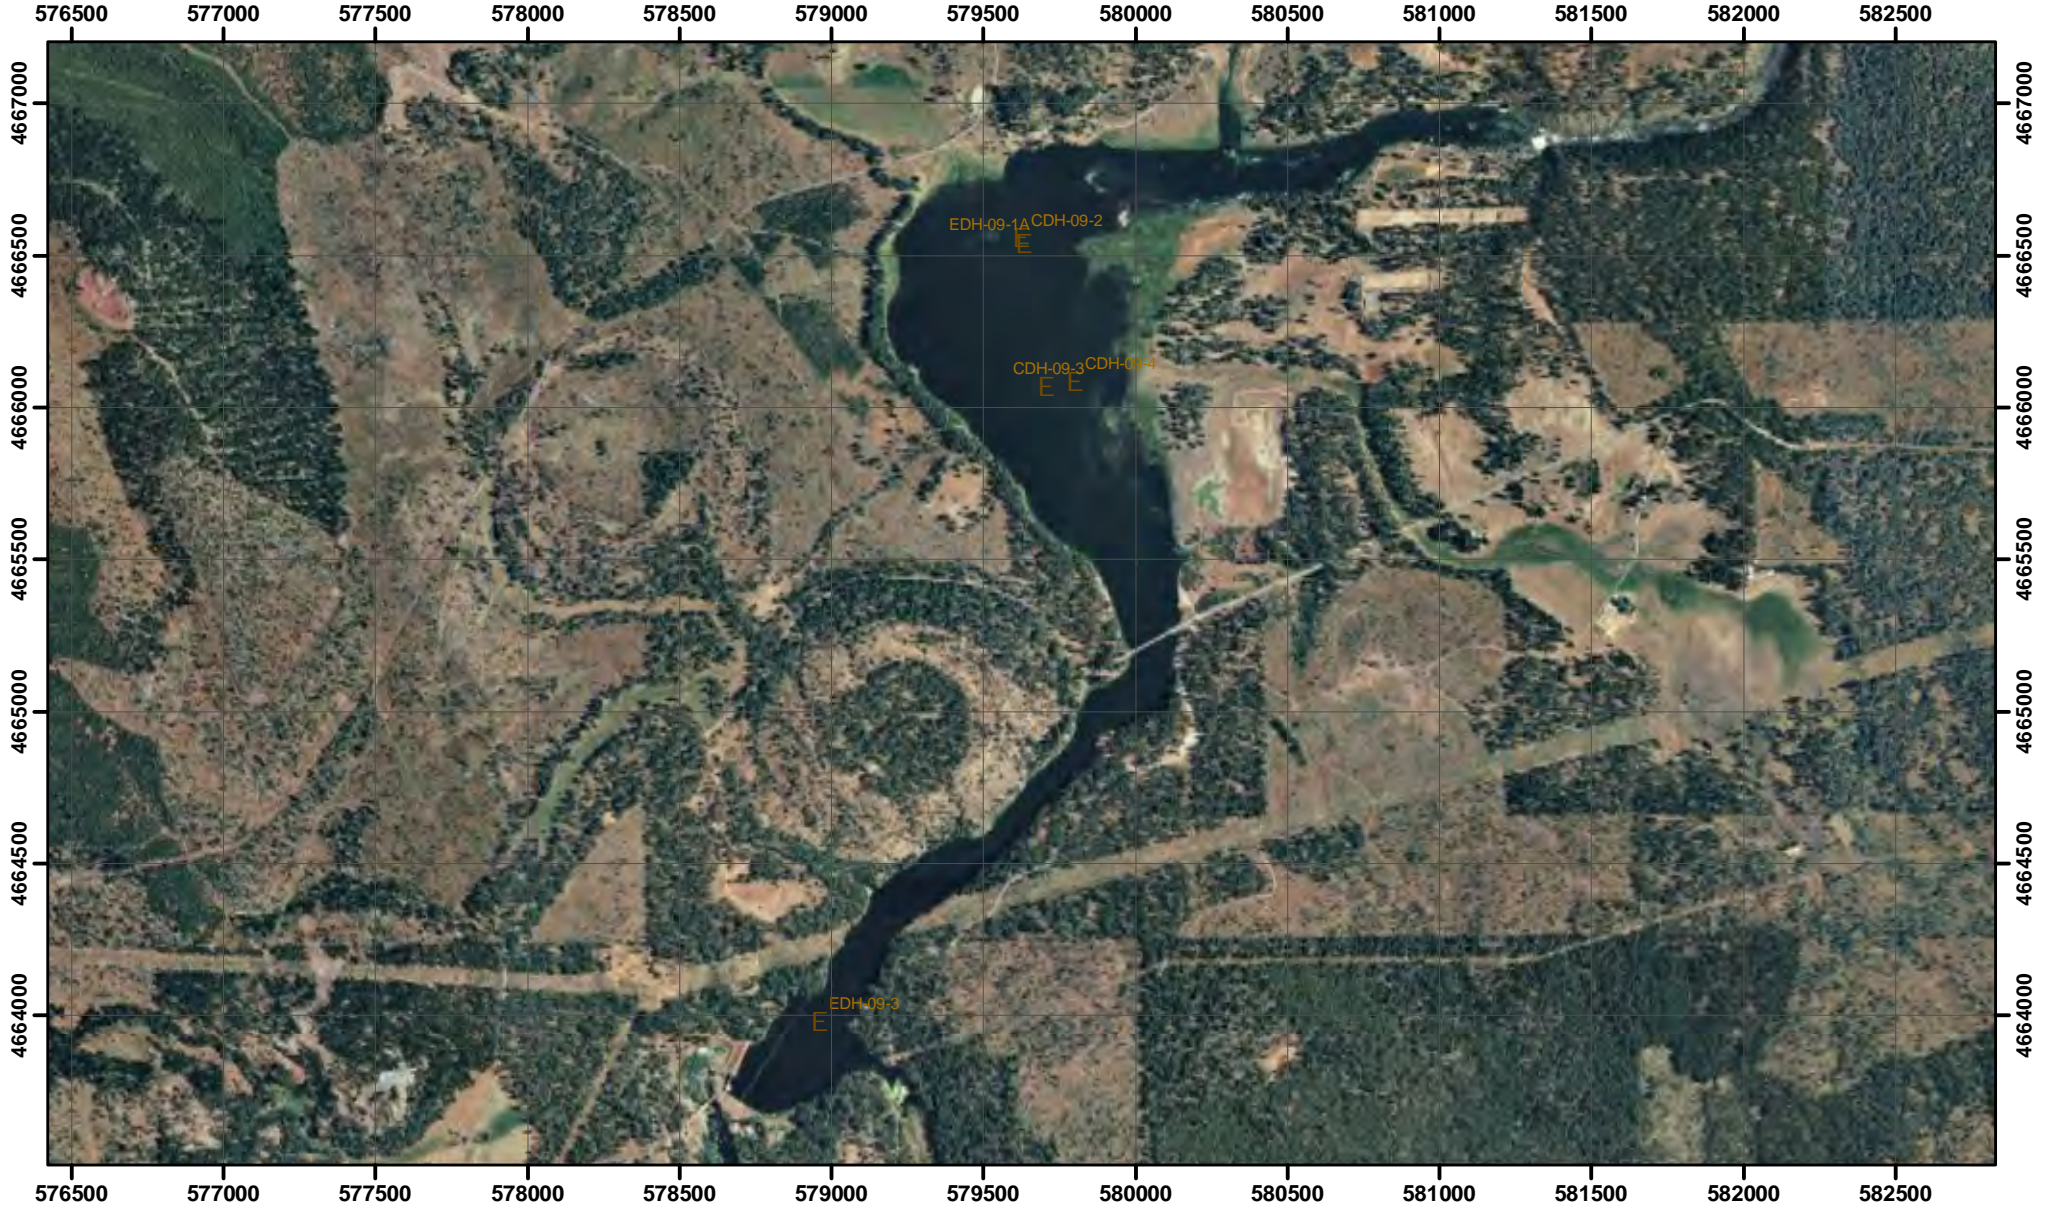
E Seedbank Germination Sample Sites

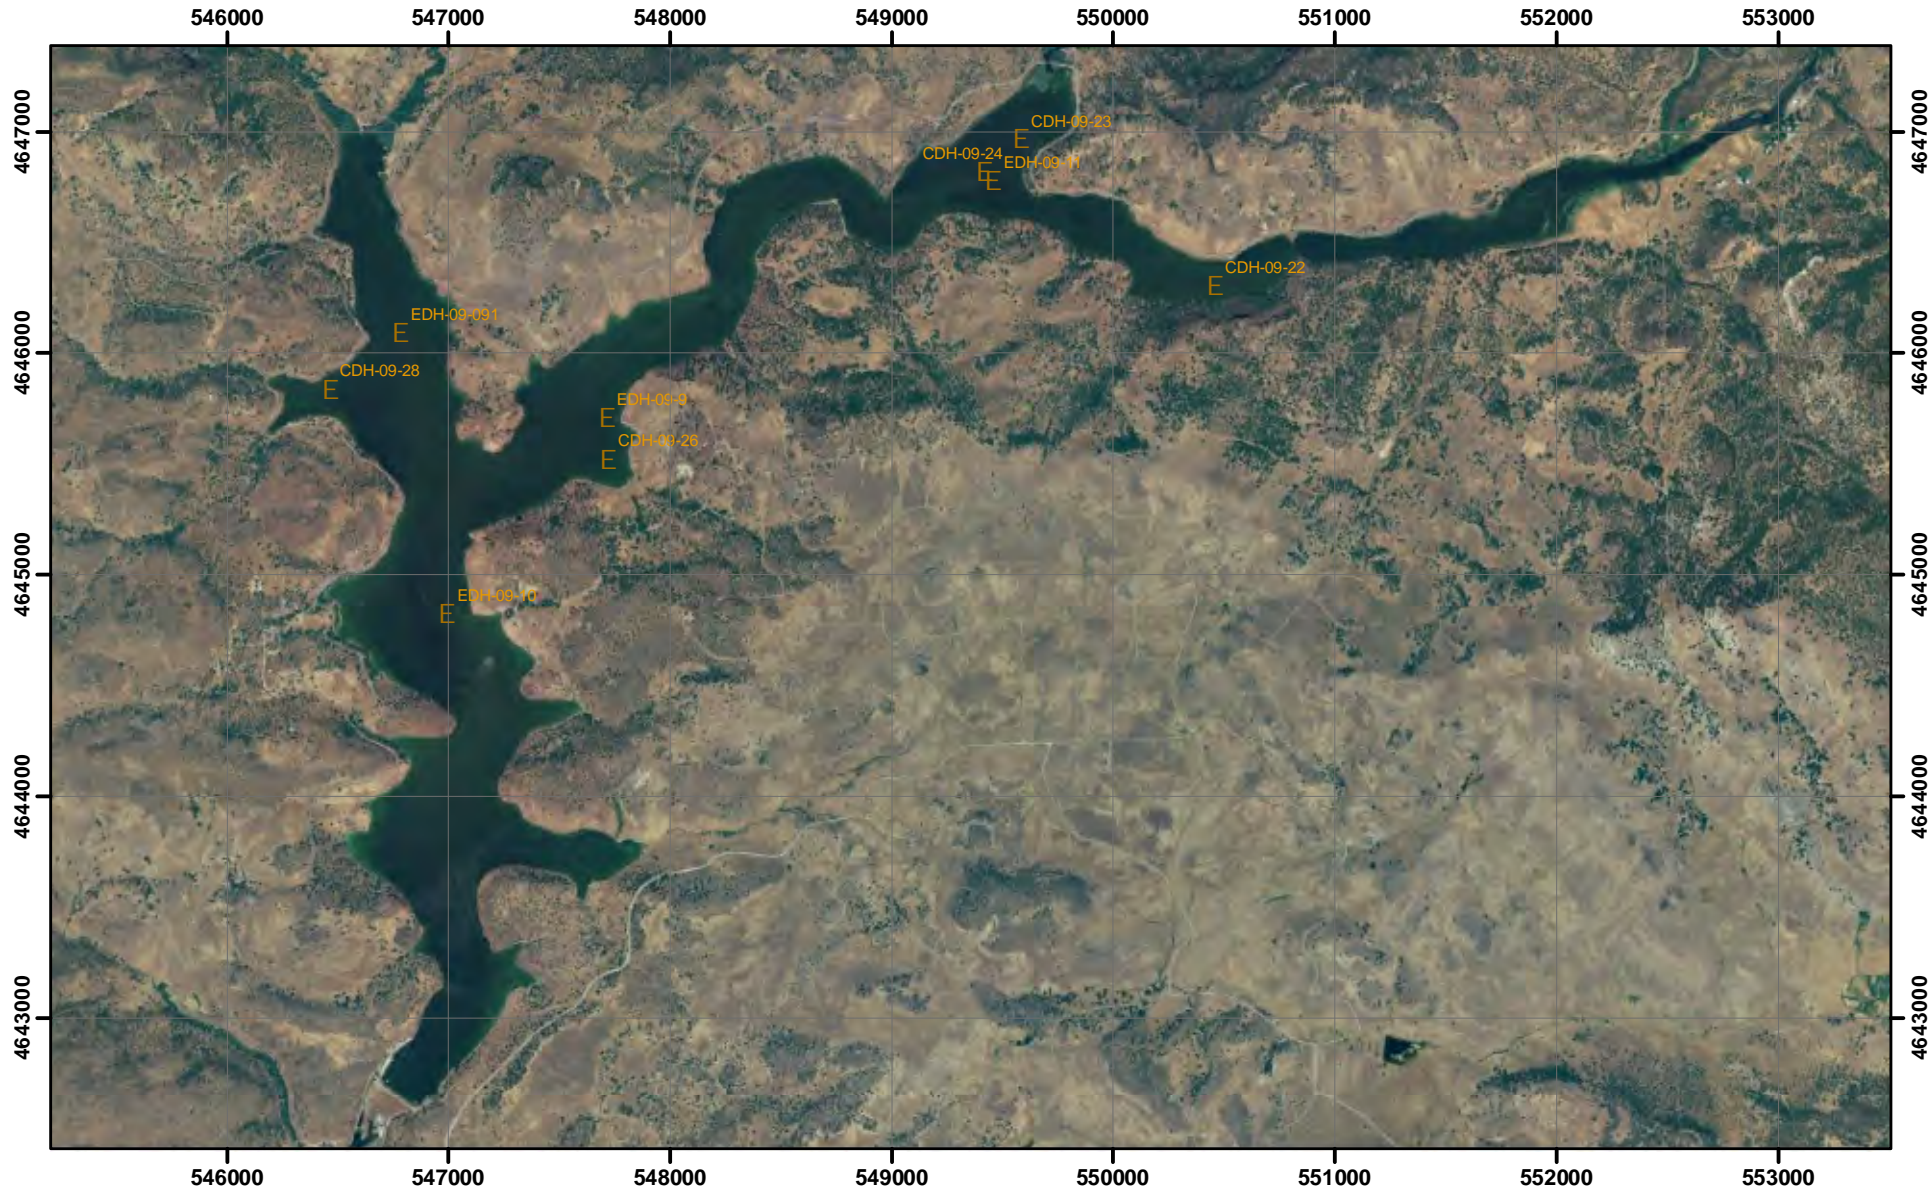
E Seedbank Germination Sample Sites
