Builders Report

21 Croftwood Lane, Harewood Christchurch

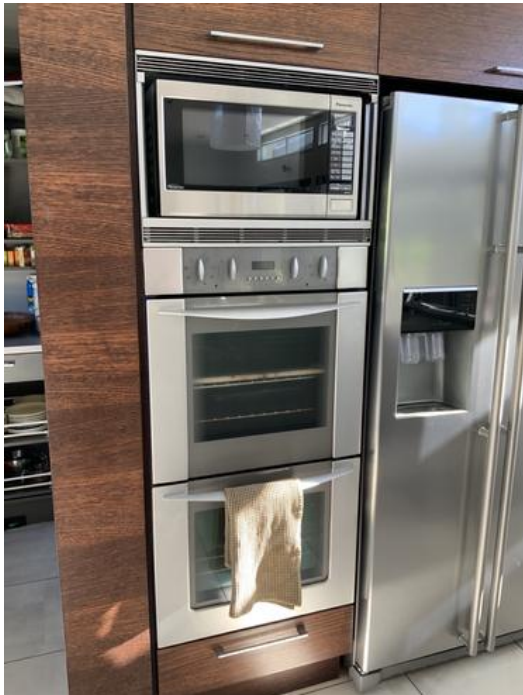
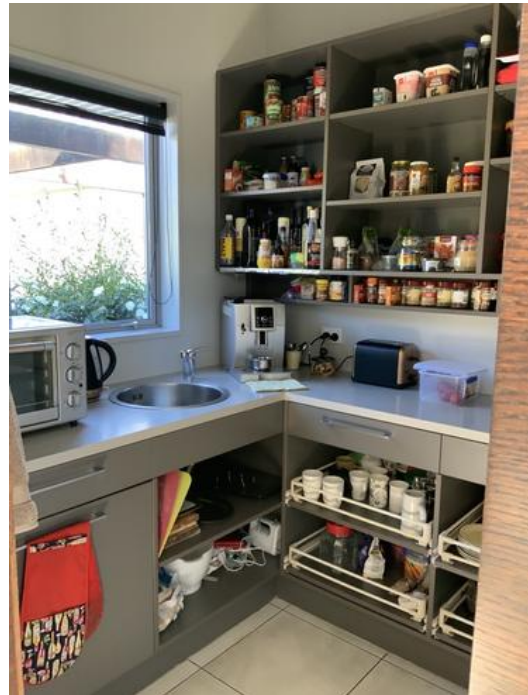
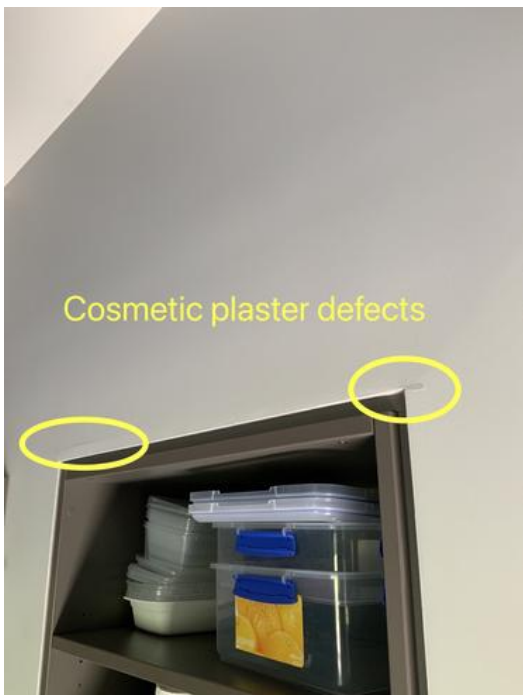
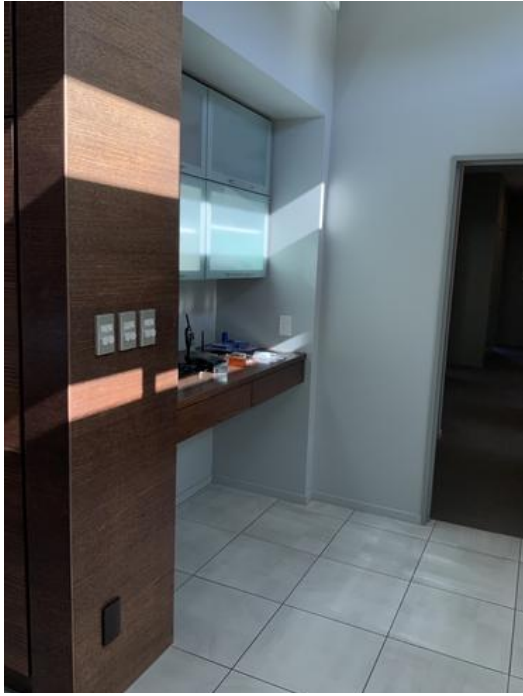
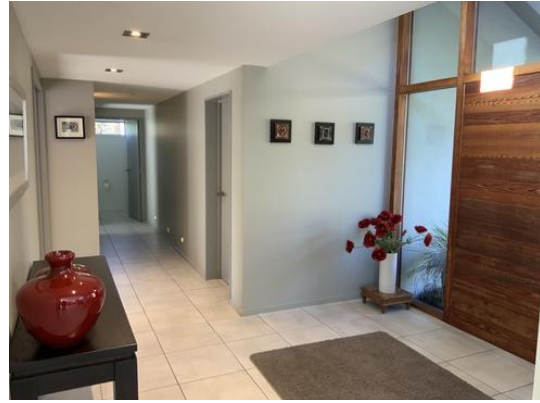
-Cosmetic plaster defects to wall in scullery

Ceiling Condition	Good with general wear
Flooring type	Tiles
Flooring Condition	Fair for age

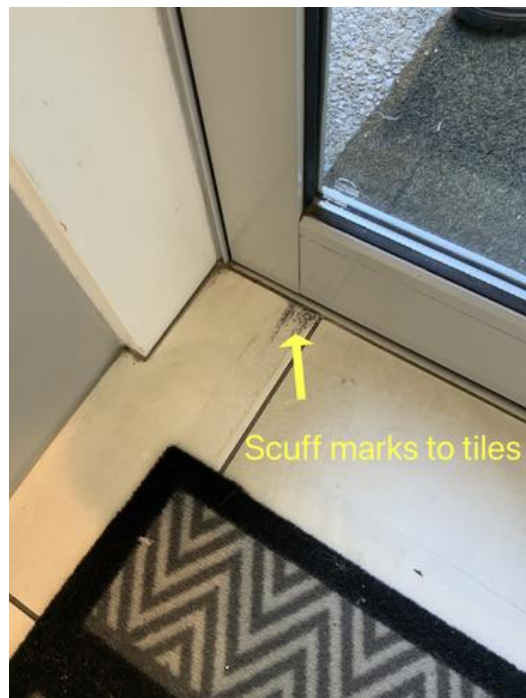
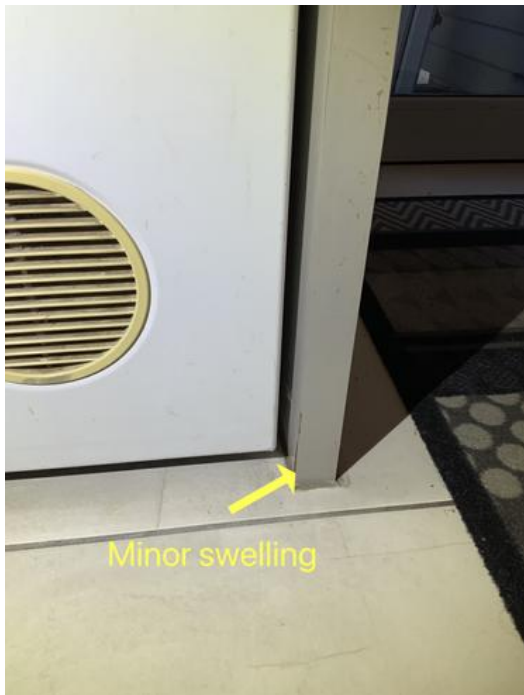
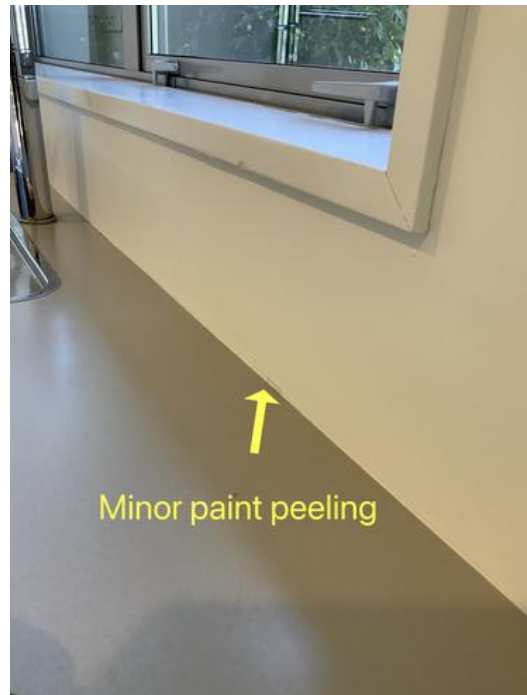
Condition of windows, doors and hardware	Good with general wear
Cabinetry Condition	Good for age with general wear
	Minor cosmetic defects

Minor swelling noted to base of joinery

Condition of plumbing items	Good with general wear
-----------------------------	------------------------

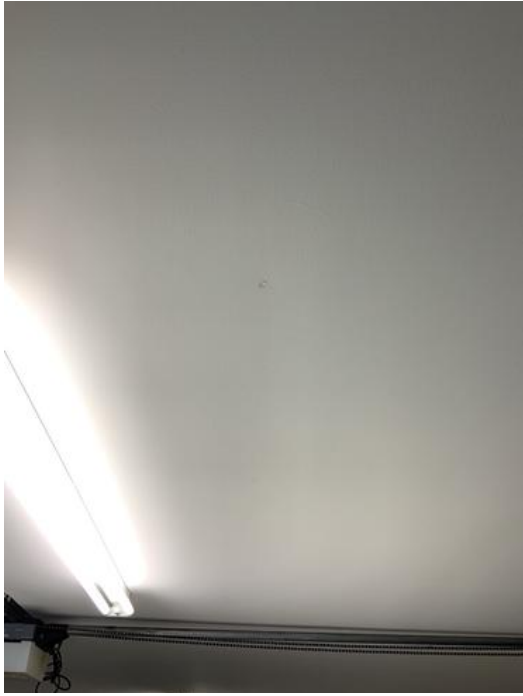
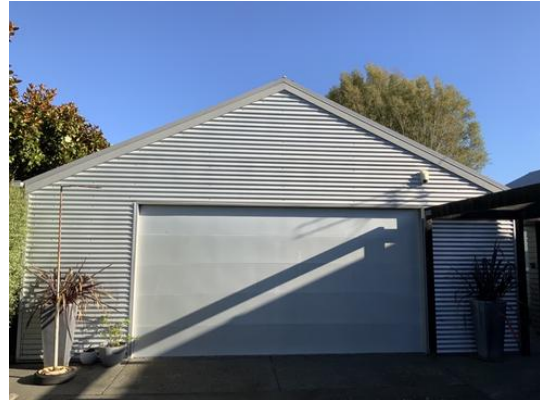
Wall Condition	Good with general wear
Ceiling Condition	Good with general wear
	Minor cosmetic defects

Minor cosmetic paint sealer cracking to perimeter of ceiling

Flooring type	Painted concrete
Flooring Condition	Good for age with general wear
	Minor cosmetic defects

General wear / peeling to paint

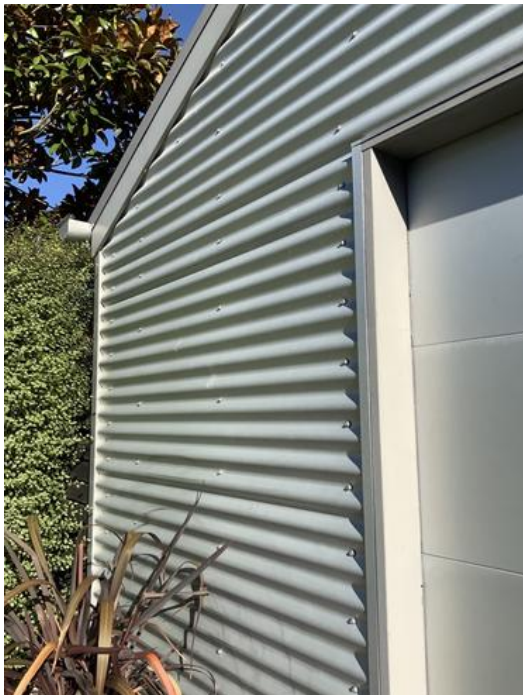
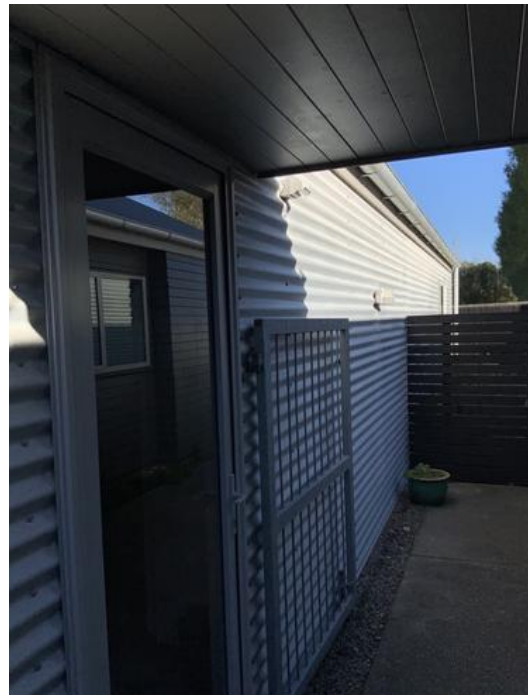
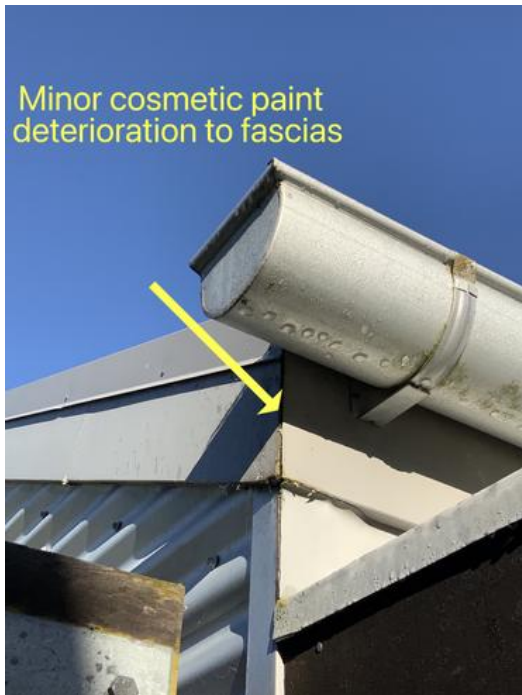
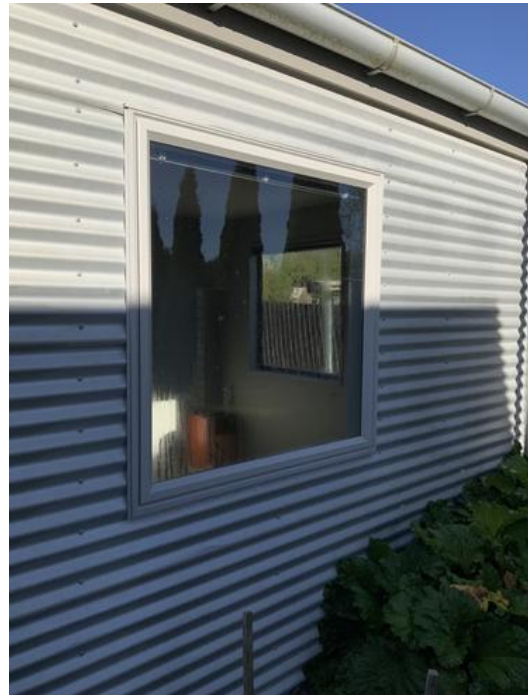
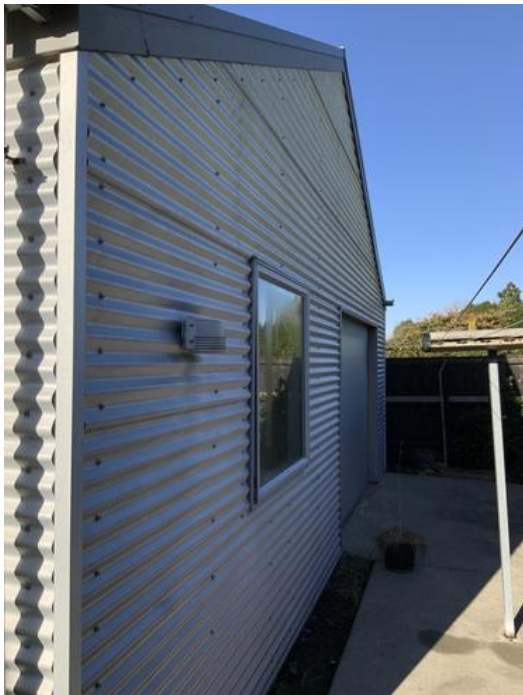
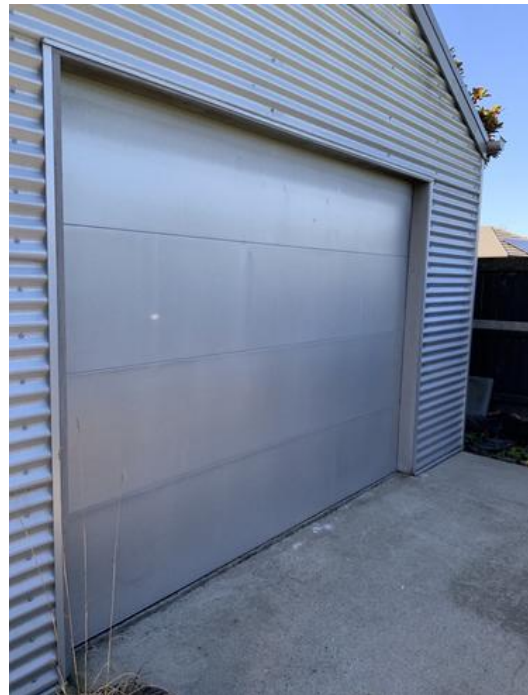
Cladding Condition

Good for age with general wear

Minor cosmetic defects

- Corrosion noted to steel cladding base trims
- Cosmetic paint deterioration to external painted trims including fascias and door reveals
