Land Information Memorandum

1/126 Halswell Junction Road

REPORT

GEOTECHNICAL ASSESSMENT REPORT - HALSWELL GROUP OF HOUSES

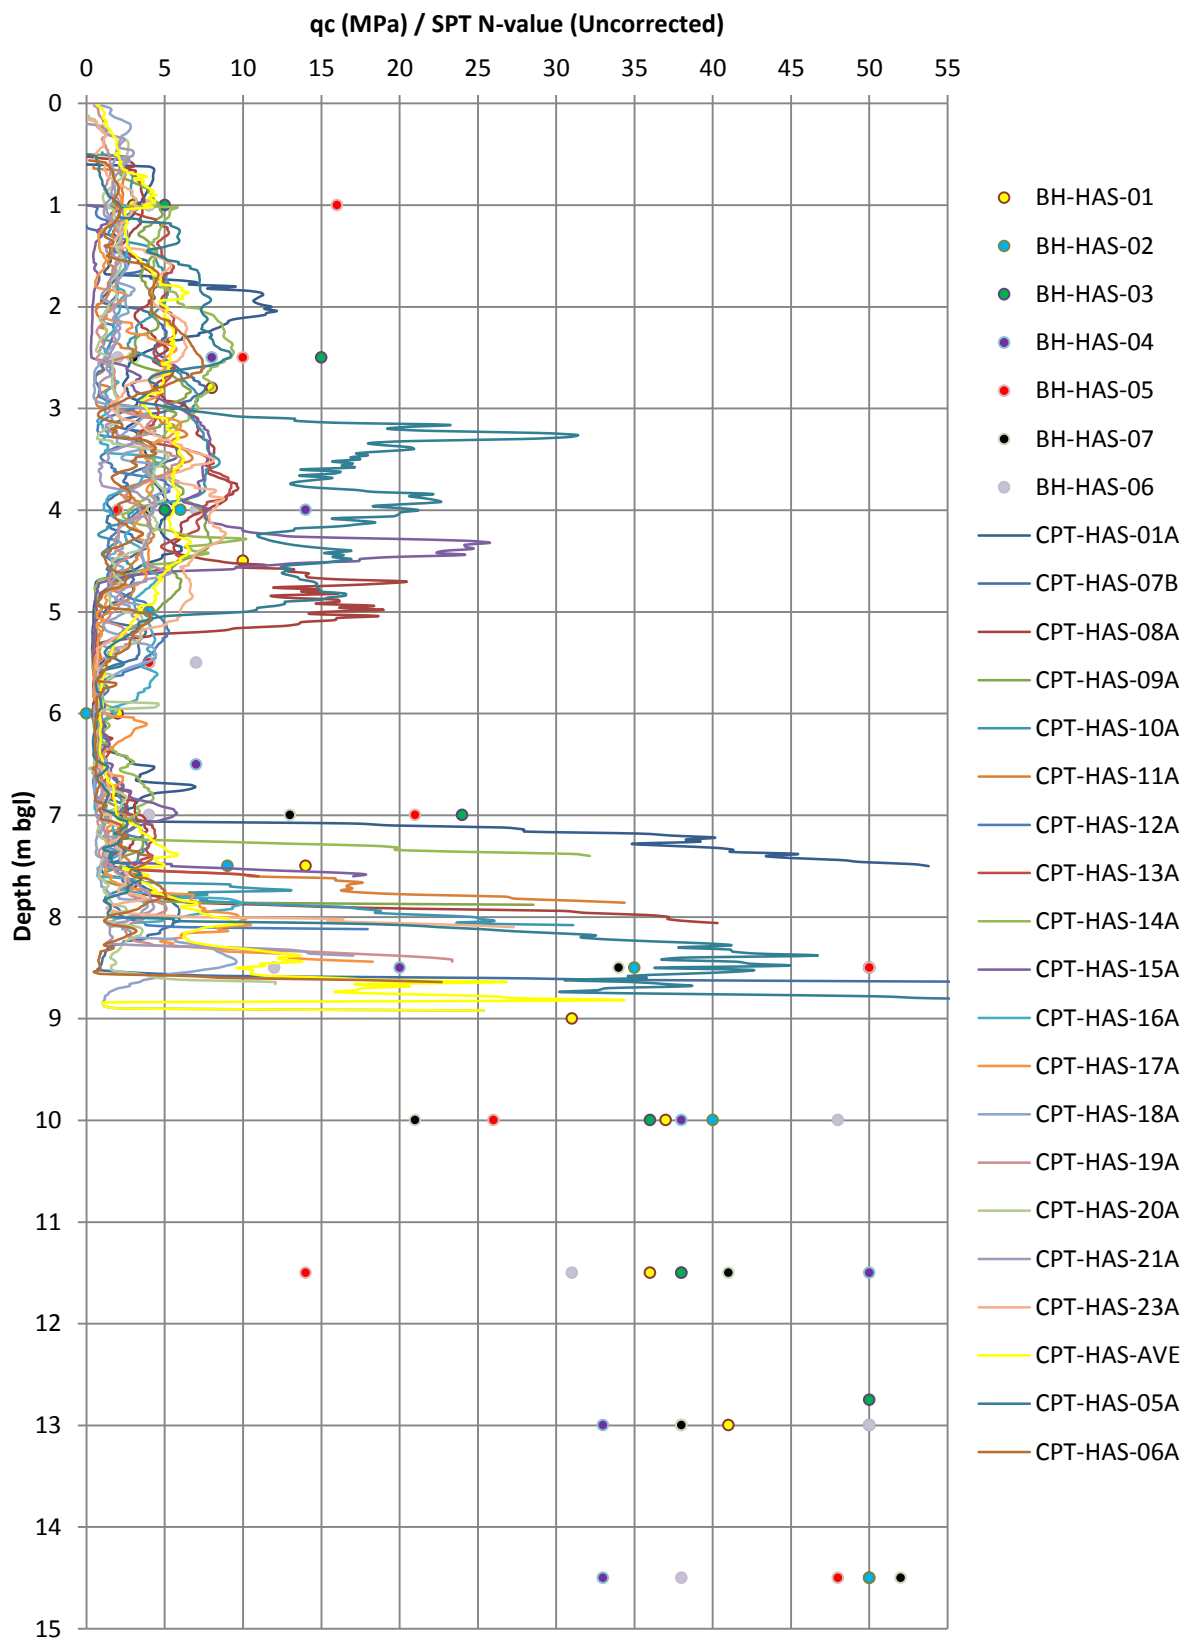
Figure 1: CPT/SPT depth profiles.

The general trends of the CPTs and SPT results are presented in Figure 1 below.

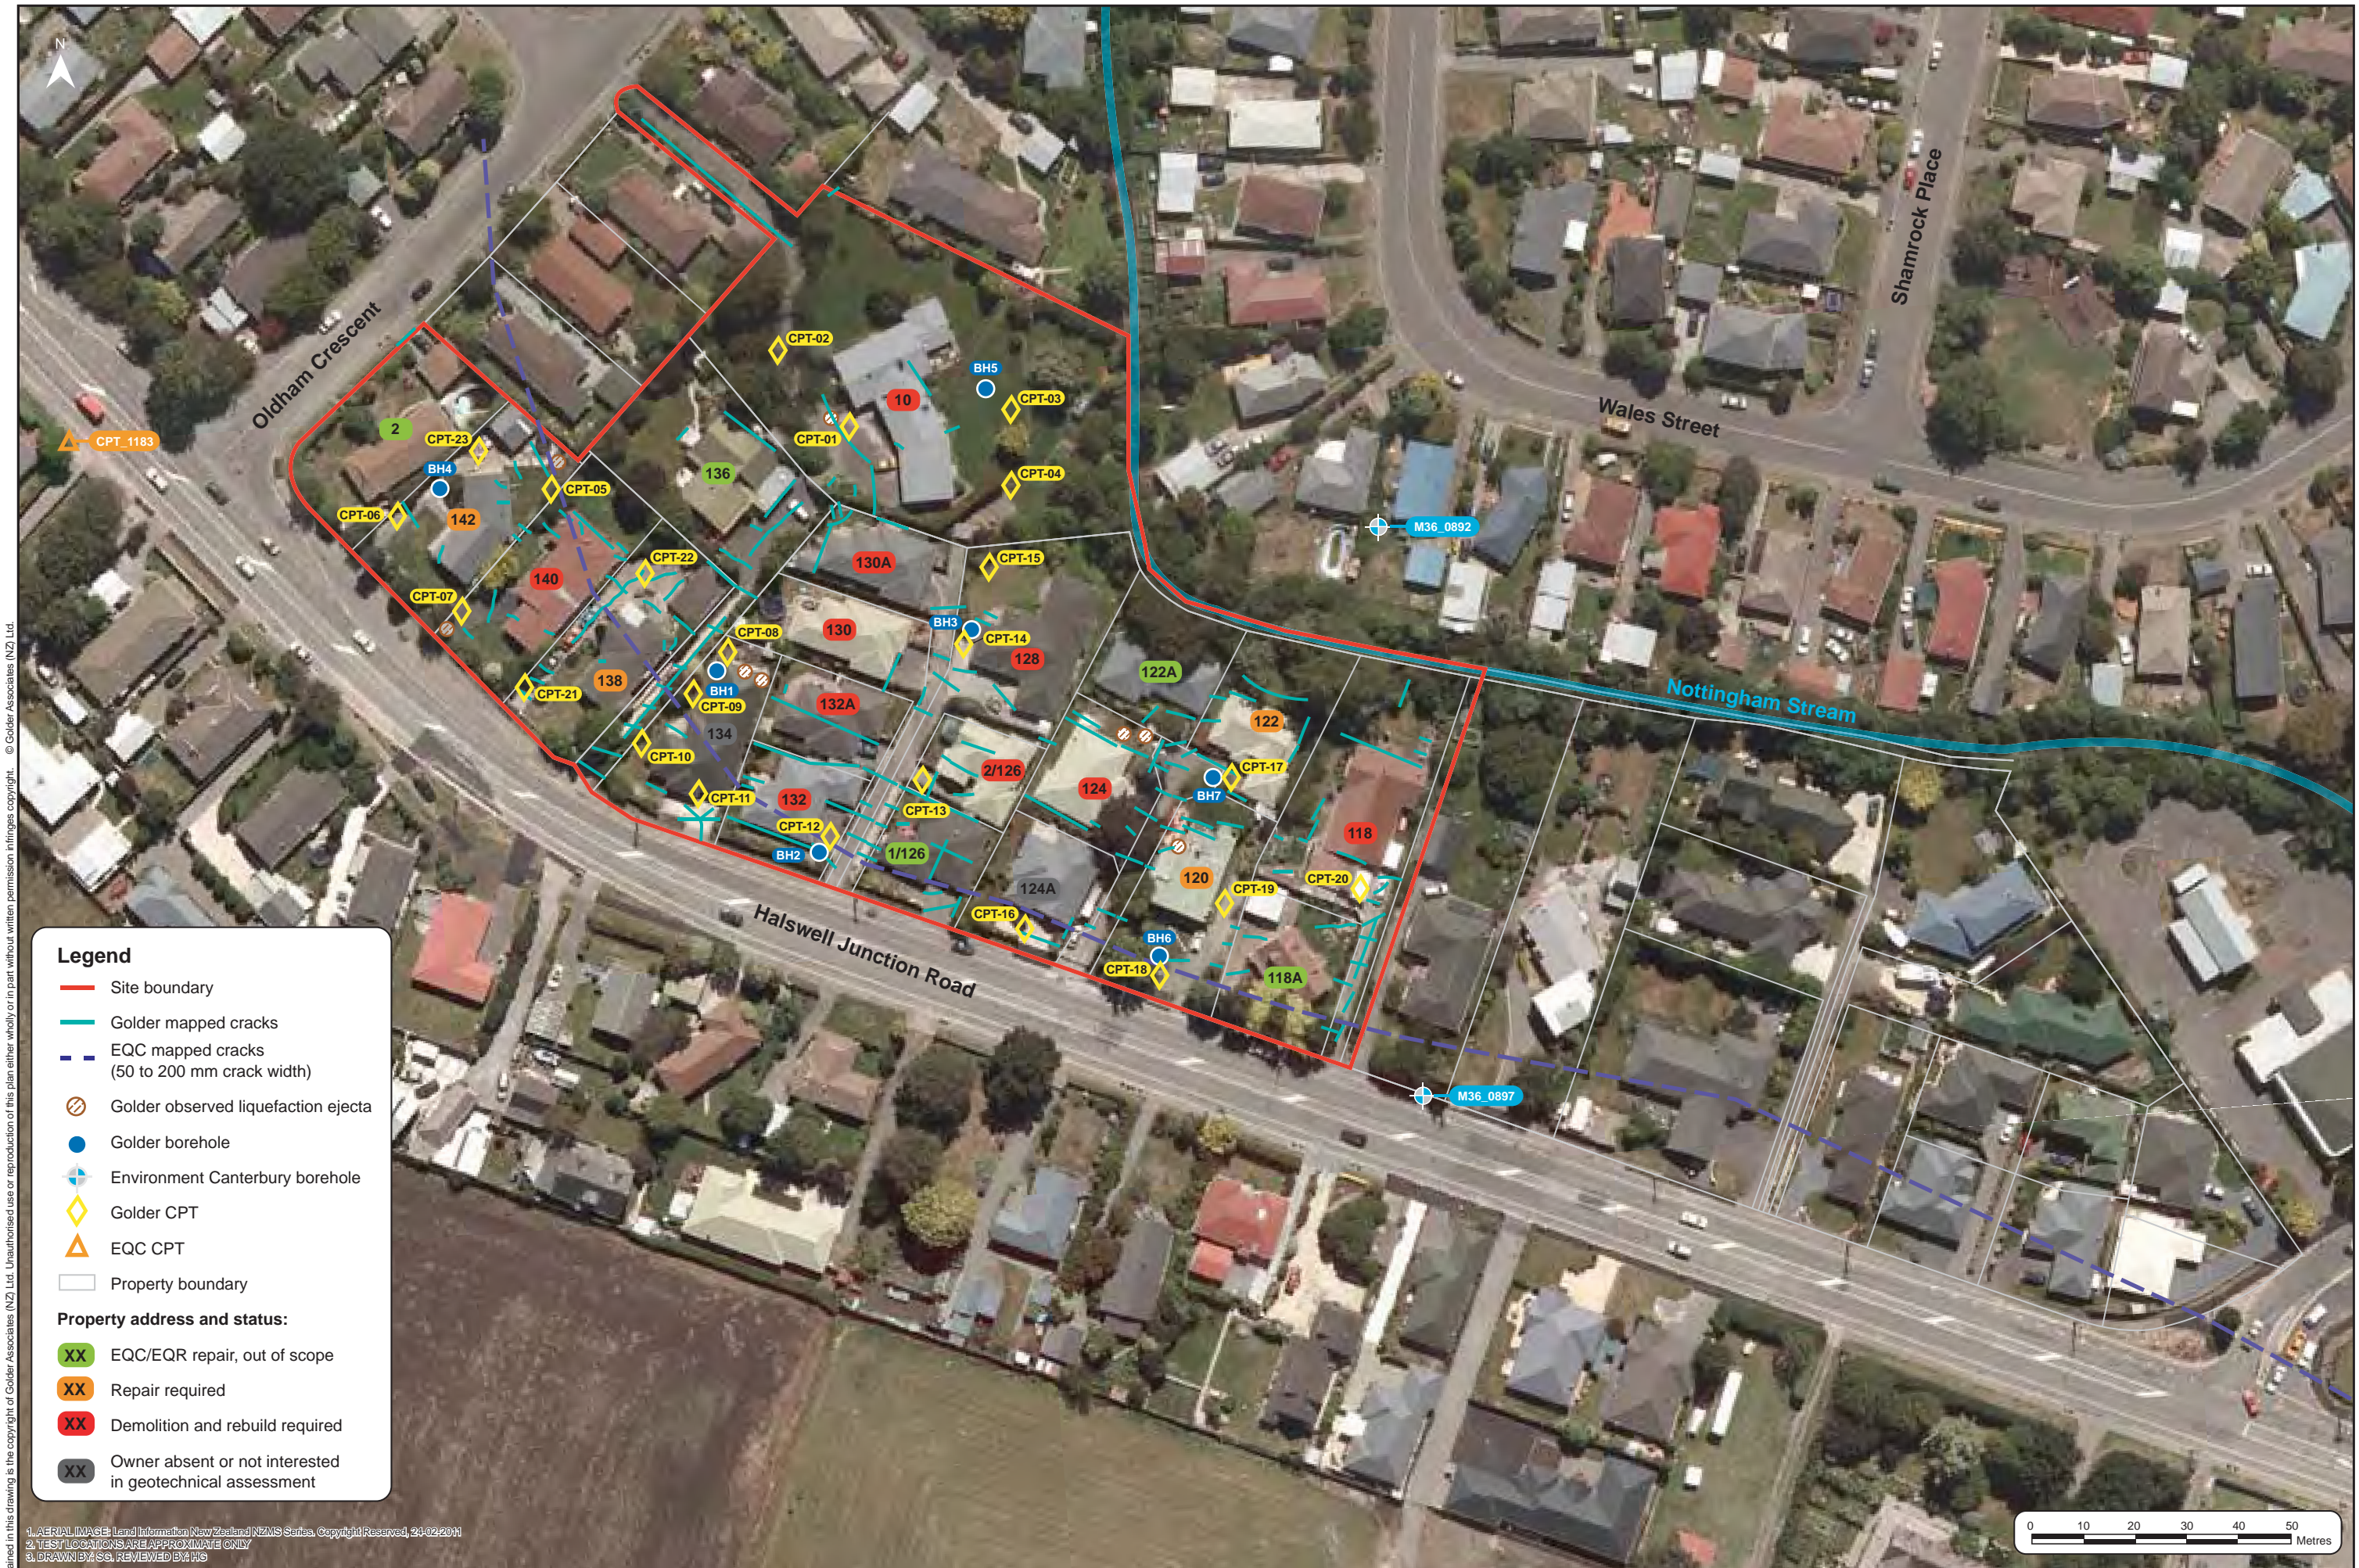
Site Plans and Inferred Stratigraphic Sections

Observations of one ground crack, running parallel to Nottingham Stream and approximately 50 to 200 mm wide, have been mapped through the site by the EQC. Other minor unclassified cracks have been shown to trend from a southeast through to northwest direction and are shown on the site plan, Figure B1 in Appendix B.

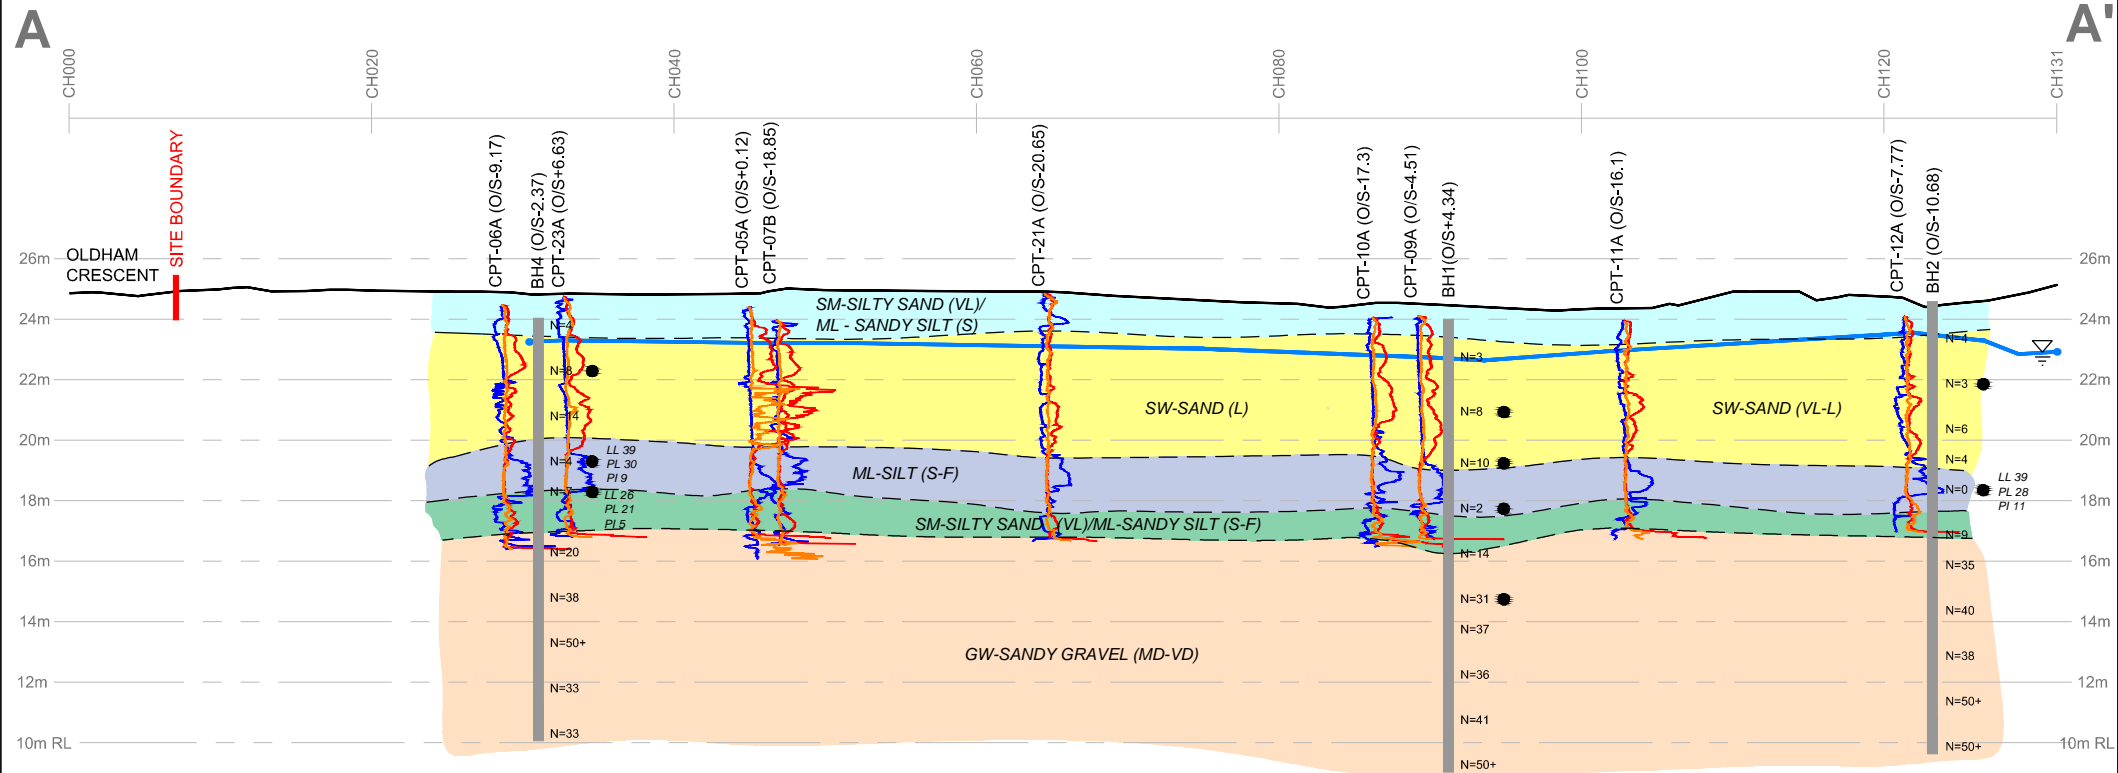
www.golder.com GOLDER ASSOCIATES (NZ) LTD.	CLIENT ARROW INTERNATIONAL		PROJECT HALSWELL GROUP OF HOUSES					
	DRAWN BY CC	DATE 18.10.12	DRAWING TITLE INFERRED STRATIGRAPHIC SECTION A-A'					
	CHECKED BY MCH	DATE 25.10.12						
	SCALE H: 1:500 V: 1:250	SHEET SIZE A4	PROJECT No 1078102455	DOC No 001	DOC TYPE R	FIGURE No B5	REVISION 0	TASK 1660

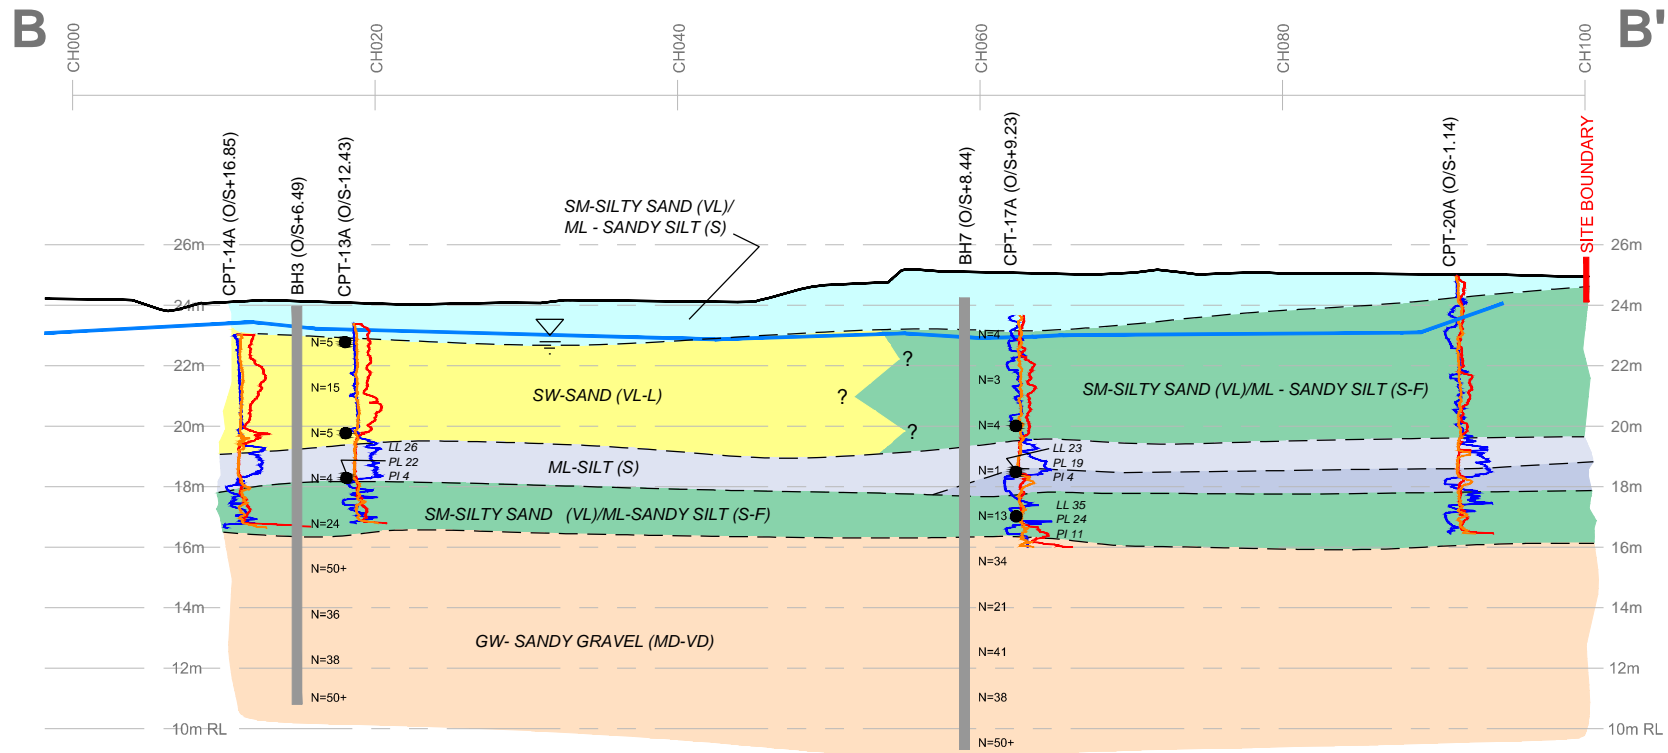
www.golder.com GOLDER ASSOCIATES (NZ) LTD.	CLIENT ARROW INTERNATIONAL		PROJECT HALSWELL GROUP OF HOUSES					
	DRAWN BY CC	DATE 19.10.12	DRAWING TITLE A INFERRED STRATIGRAPHIC SECTION B-B'					
	CHECKED BY MCH	DATE 25.10.12						
	SCALE H: 1:500 V: 1:250	SHEET SIZE A4	PROJECT No 1078102455	DOC No 001	DOC TYPE R	FIGURE No B6	REVISION 0	TASK 1660

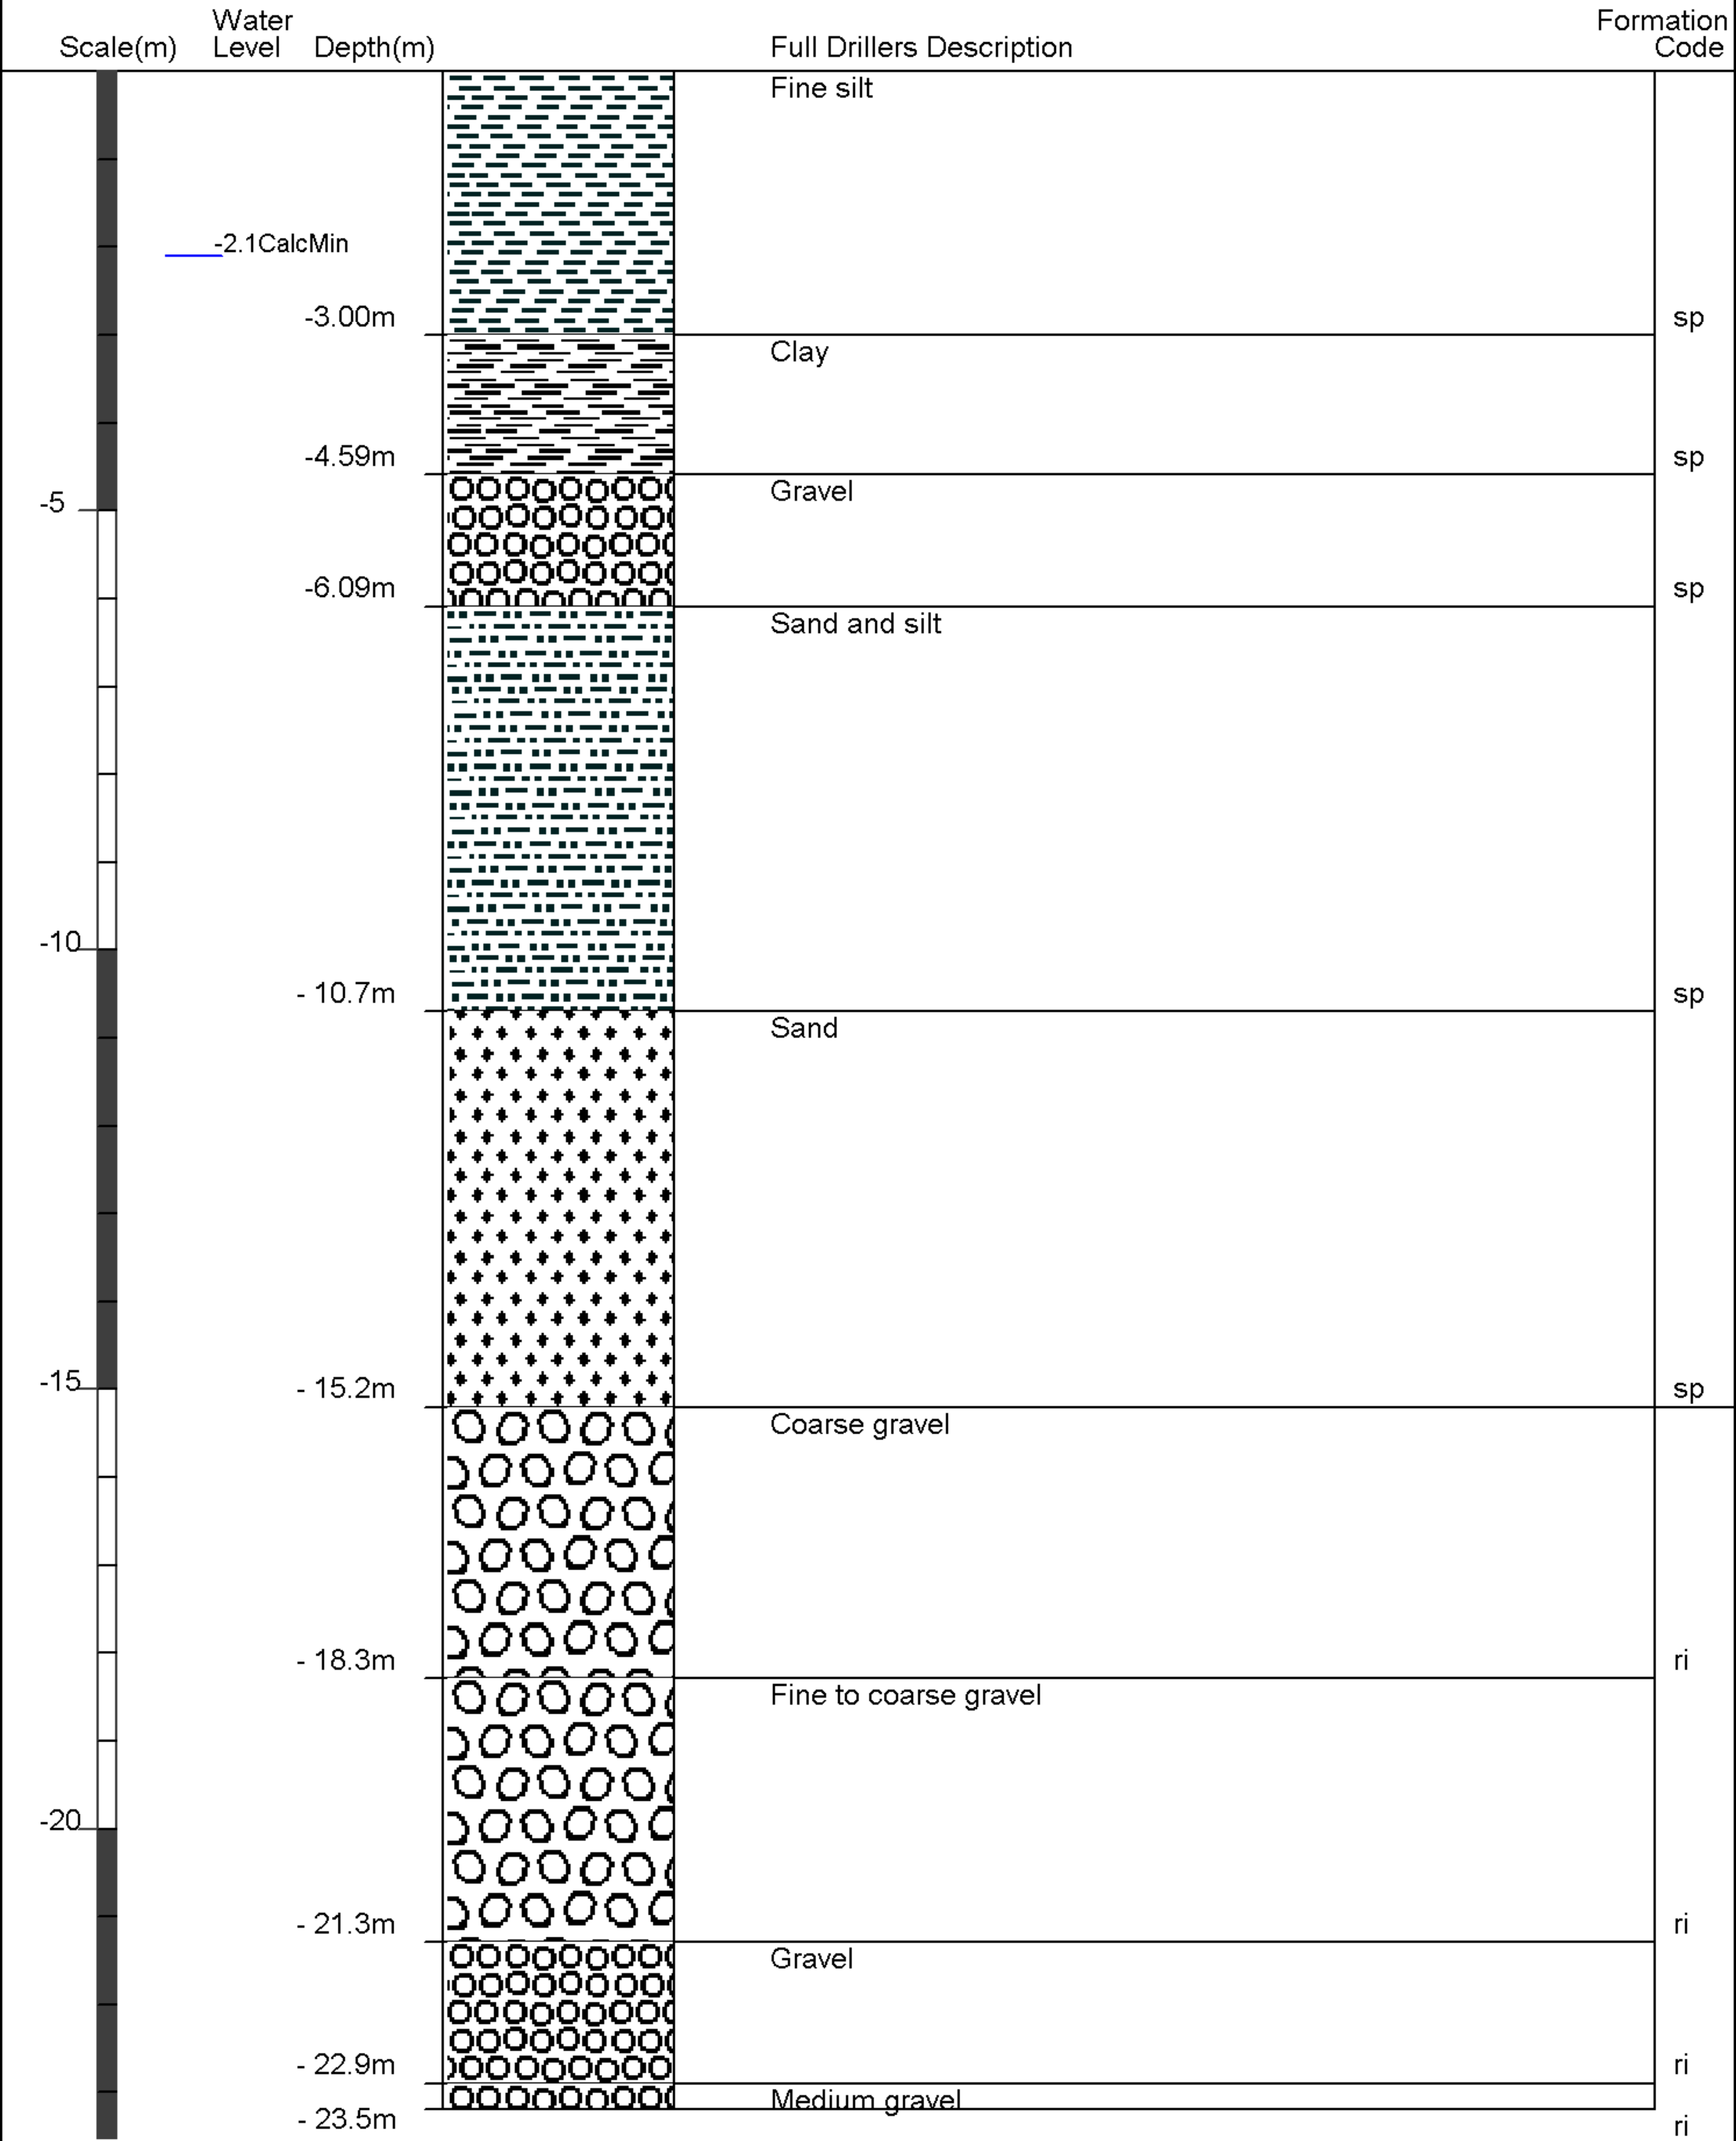
Borelog for well M36/0897

Gridref: M36:744-362 Accuracy : 4 (1=high, 5=low)

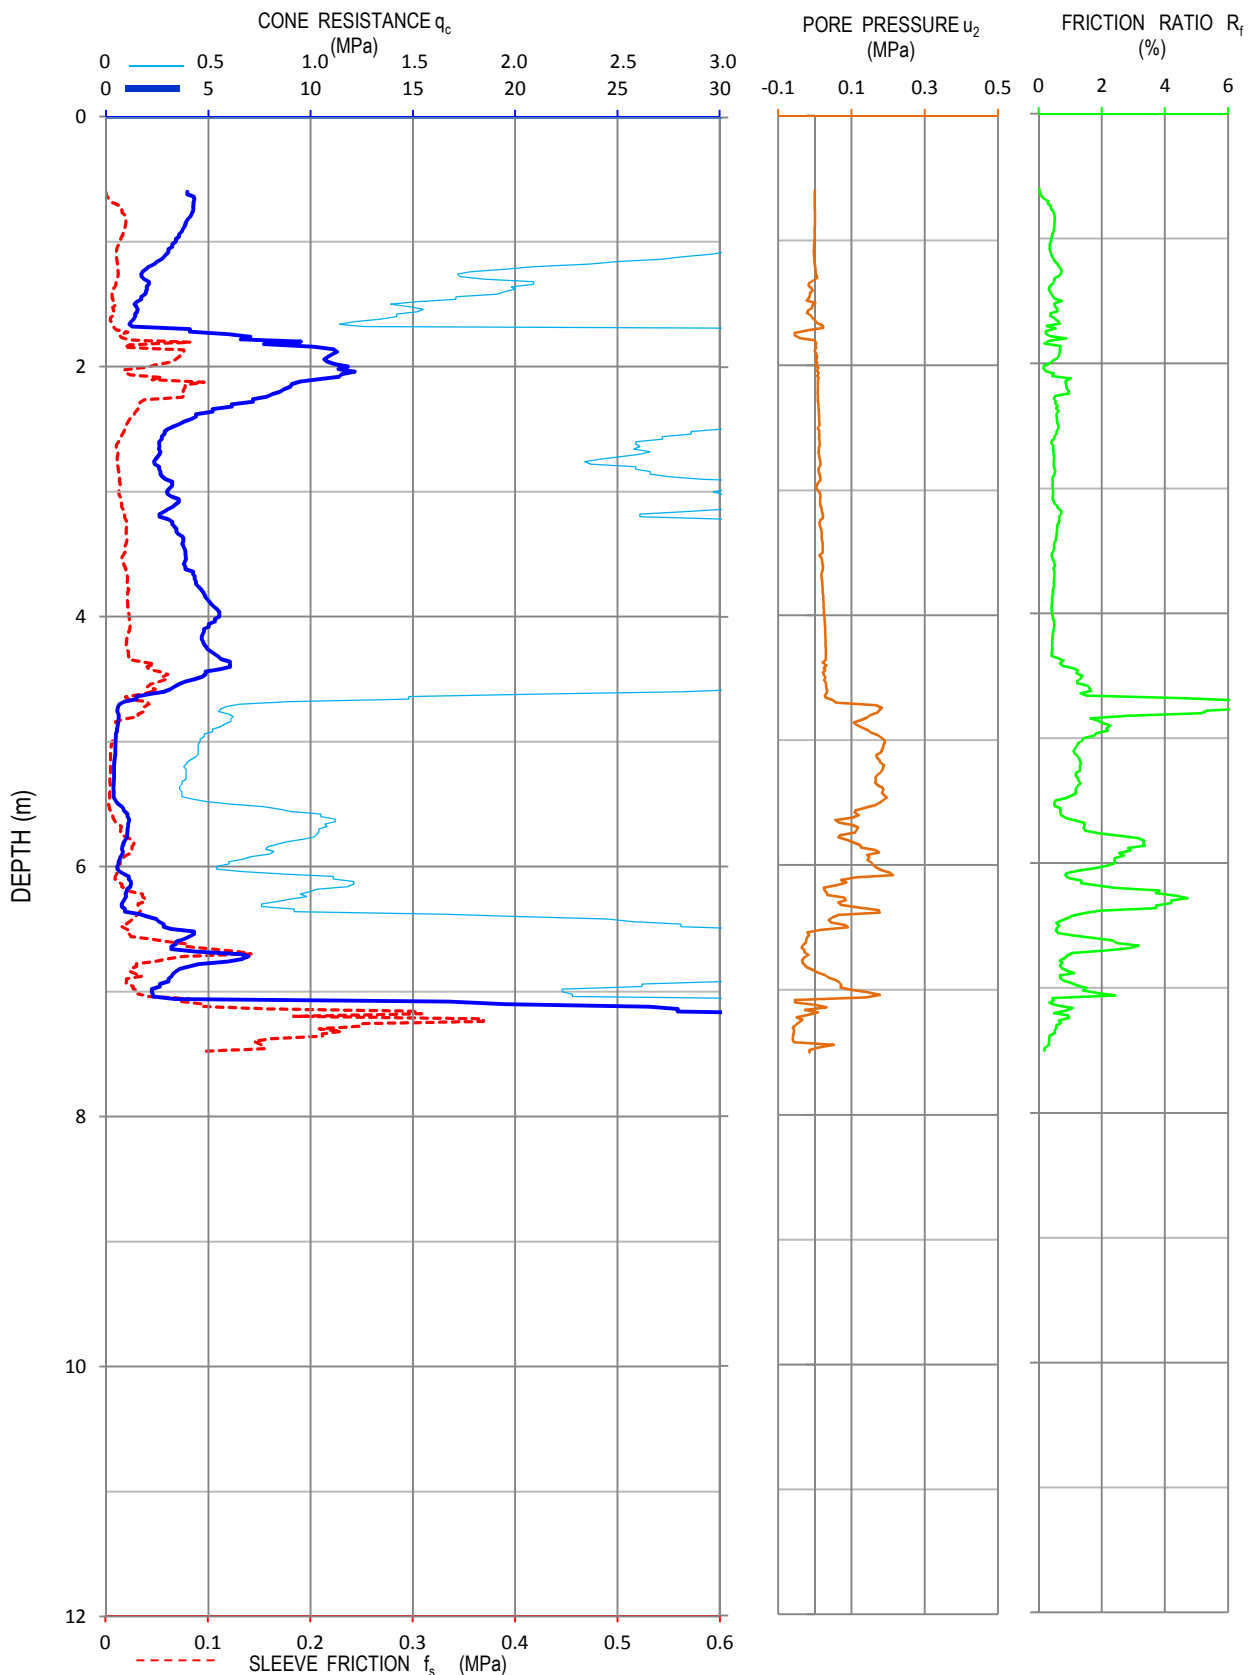
CLIENT:	Arrow International Limited	COORDS:	1564311 m E	5174717 m N	NZTM Z59
PROJECT:	Earthquake Reconstruction Project	SURFACE RL:	24.2 m	DATUM:	CDD
LOCATION:	Halswell Group of Houses	INCLINATION:	-90°	DATE TESTED:	30/07/2012
JOB NUMBER:	1078102455_1660	HOLE DEPTH:	7.5 m	CONTRACTOR:	Golder
				CONE ID:	4469
				CHECKED BY:	KRB

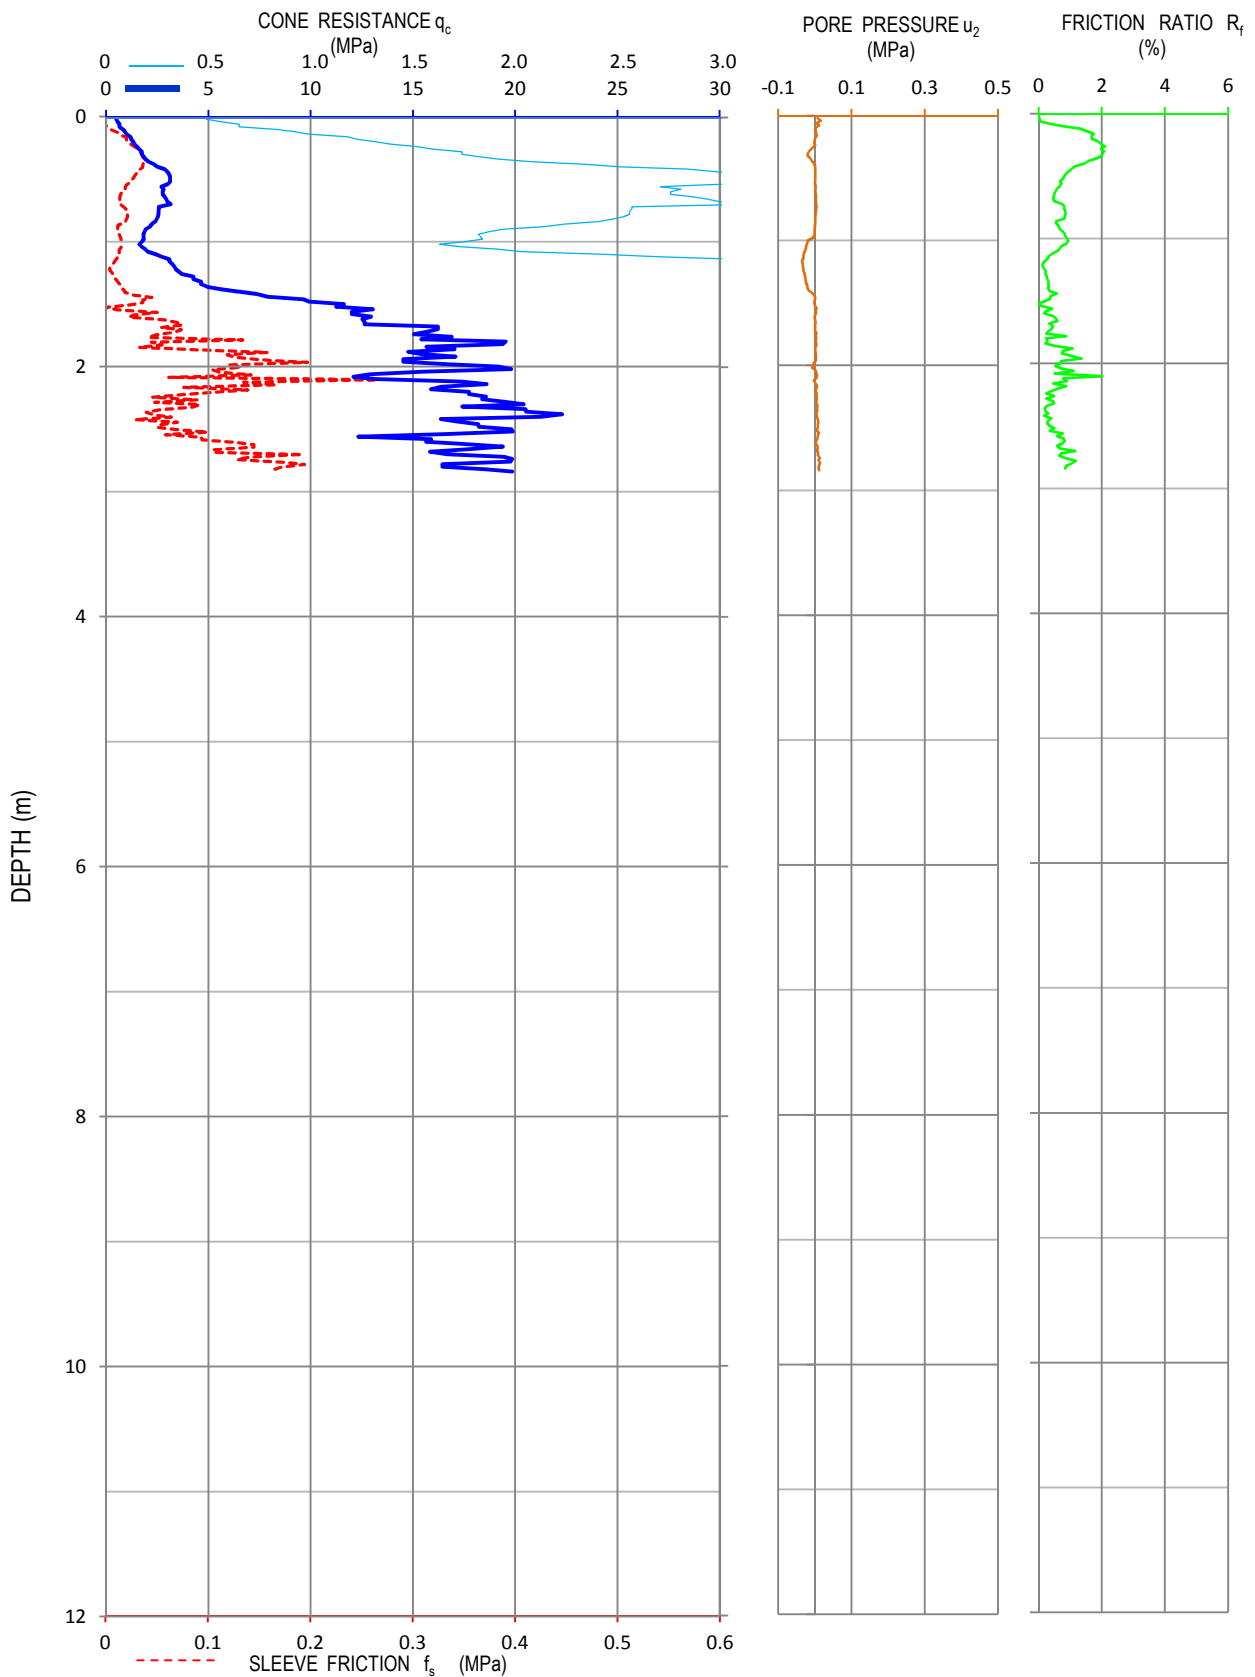
CLIENT:	Arrow International Limited	COORDS:	1564301 m E	5174733 m N	NZTM Z59
PROJECT:	Earthquake Reconstruction Project	SURFACE RL:	24.3 m	DATUM:	CDD
LOCATION:	Halswell Group of Houses	INCLINATION:	-90°	DATE TESTED:	30/07/2012
JOB NUMBER:	1078102455_1660	HOLE DEPTH:	2.8 m	CONTRACTOR:	Golder
				CONE ID:	4469
				CHECKED BY:	KRB

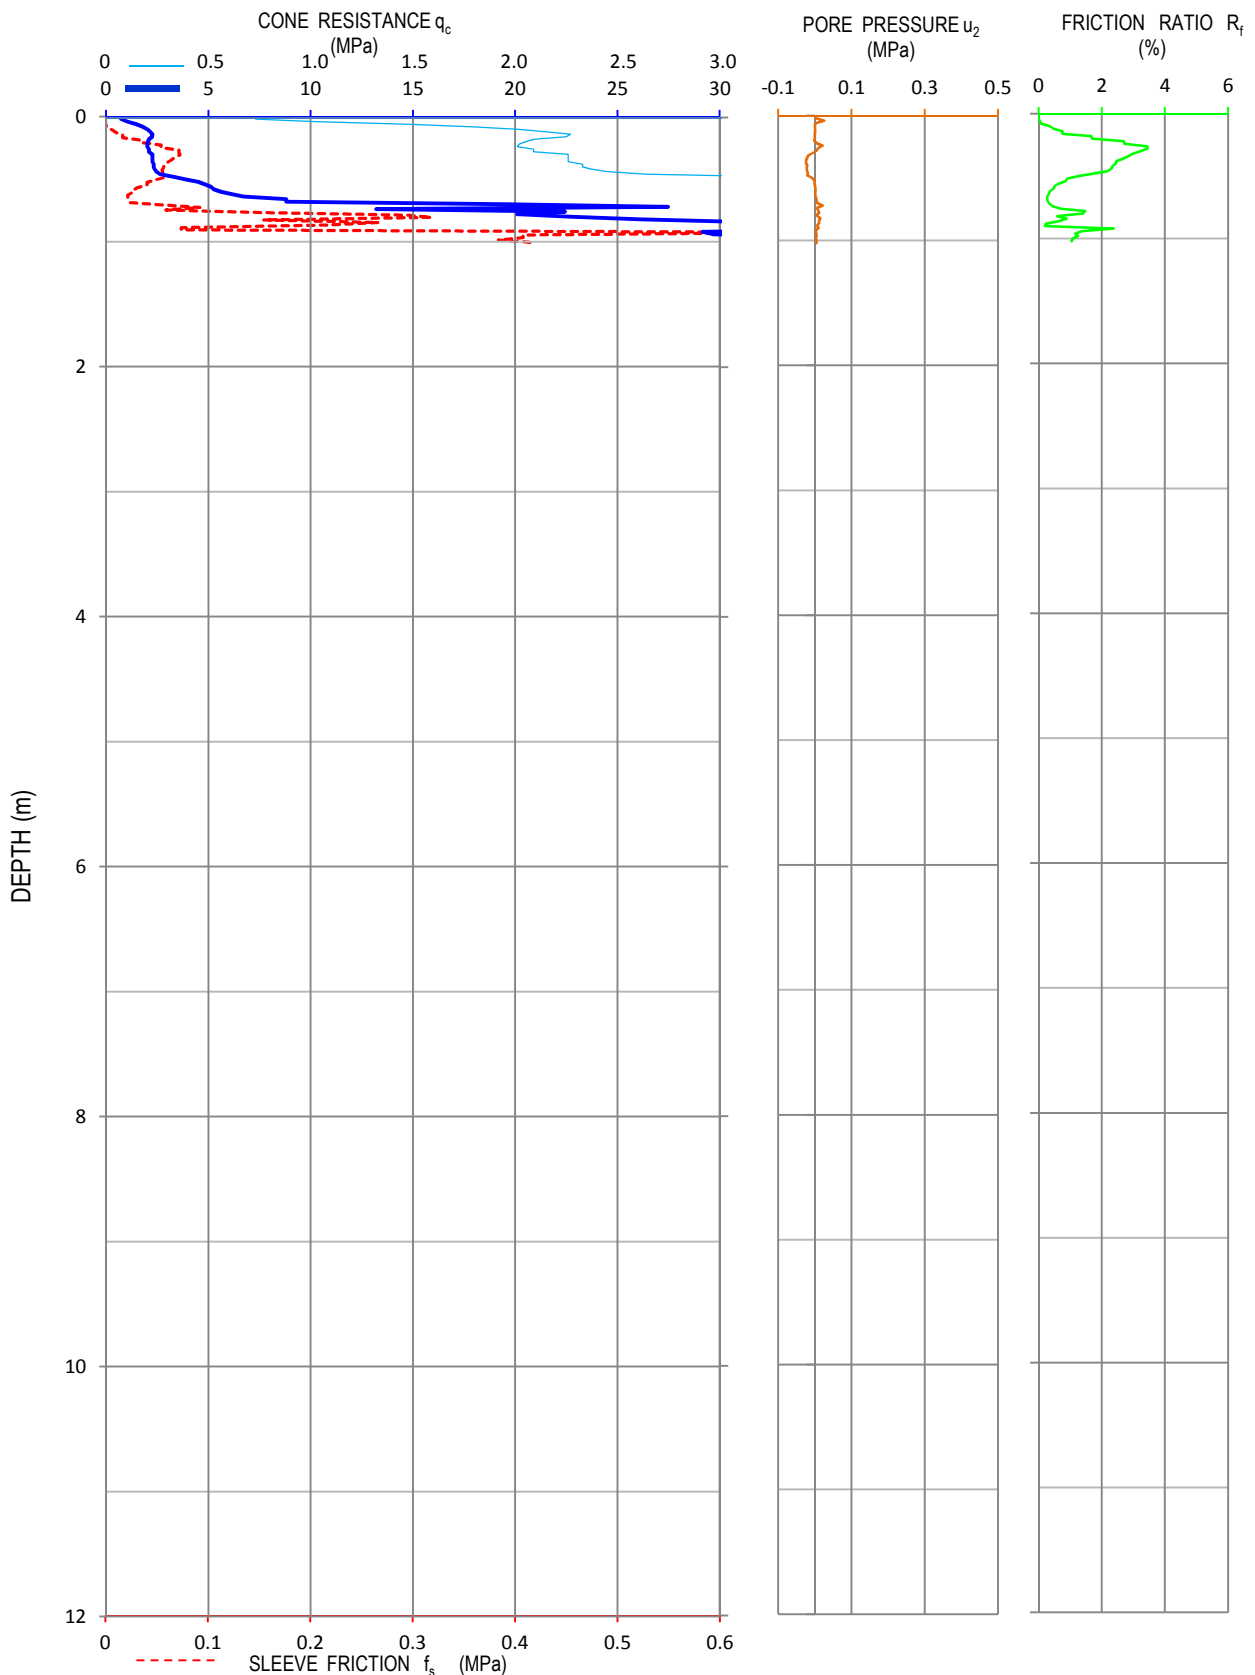
CLIENT:	Arrow International Limited	COORDS:	1564339 m E	5174717 m N	NZTM Z59
PROJECT:	Earthquake Reconstruction Project	SURFACE RL:	24.2 m	DATUM:	CDD
LOCATION:	Halswell Group of Houses	INCLINATION:	-90°	DATE TESTED:	30/07/2012
JOB NUMBER:	1078102455_1660	HOLE DEPTH:	1.0 m	CONTRACTOR:	Golder
				CONE ID:	4469
				CHECKED BY:	KRB

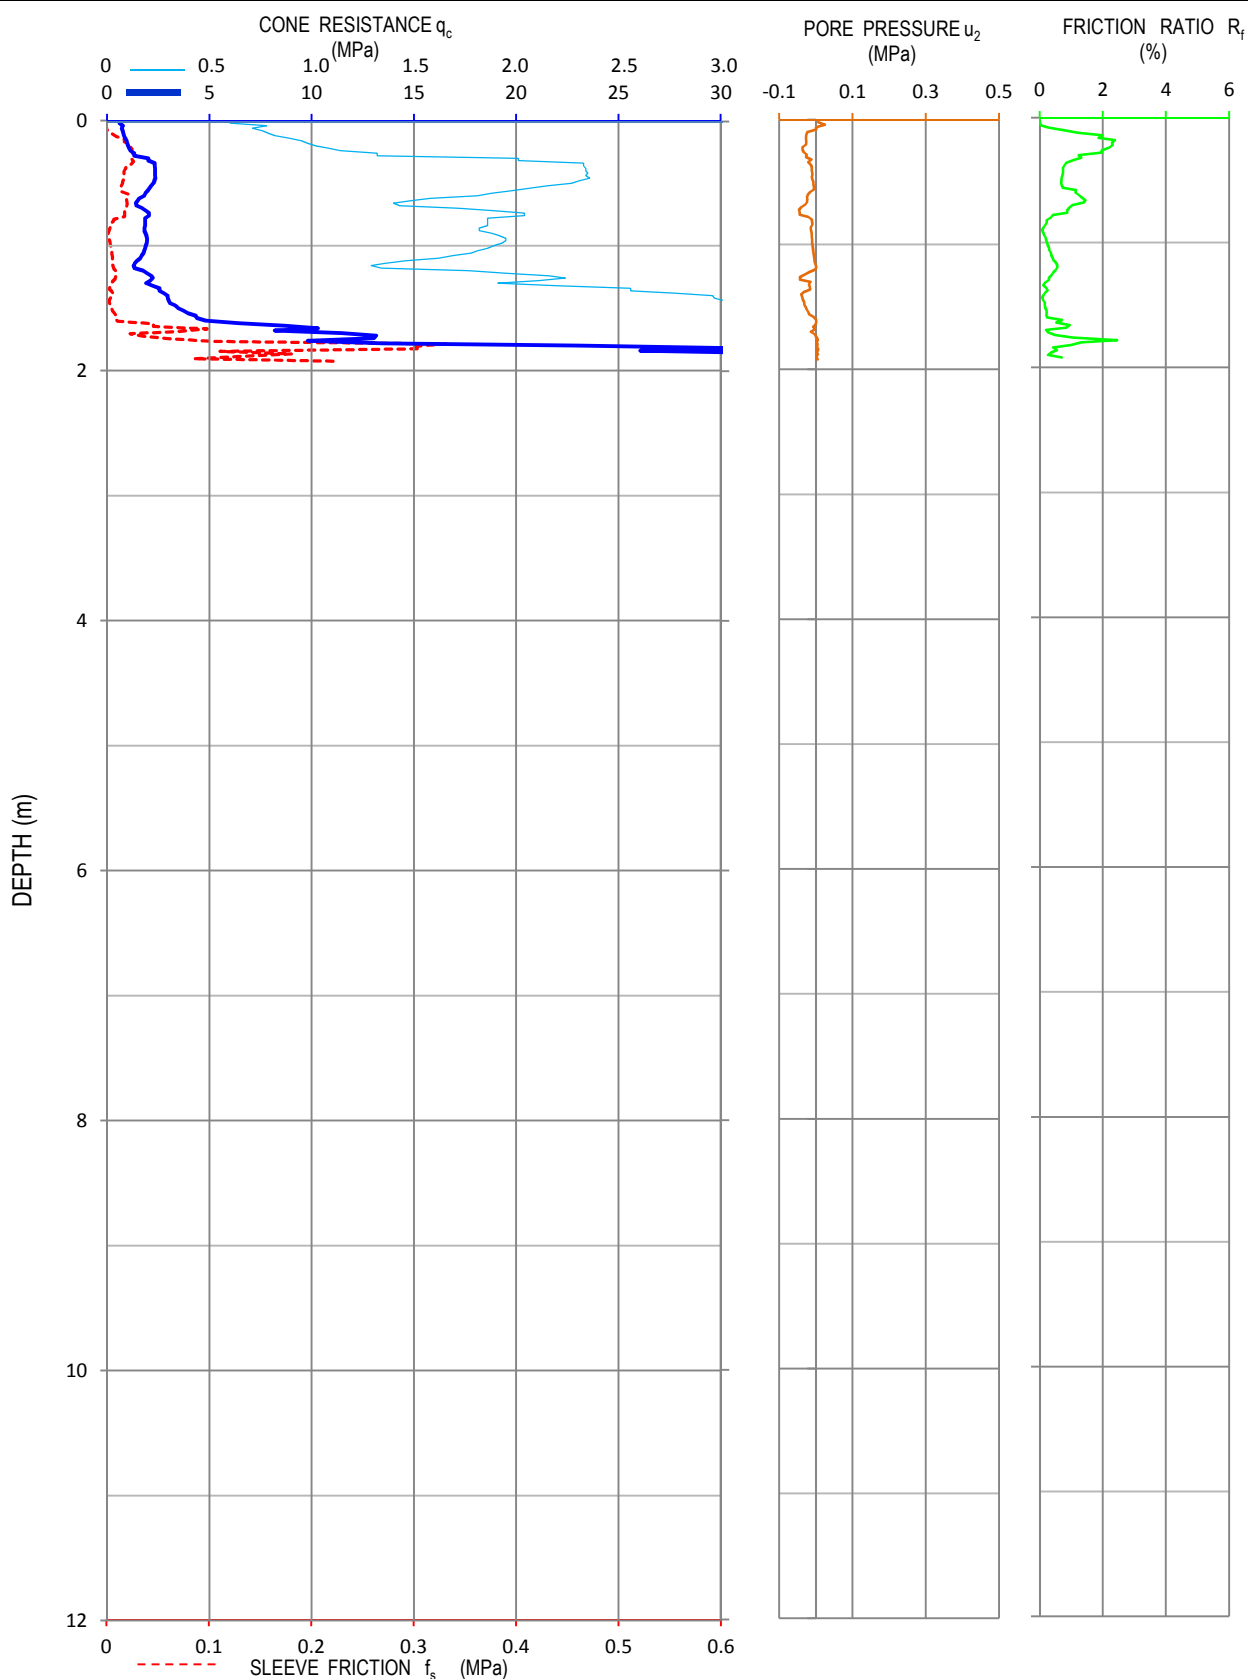
CLIENT:	Arrow International Limited	COORDS:	1564341 m E	5174707 m N	NZTM Z59
PROJECT:	Earthquake Reconstruction Project	SURFACE RL:	24.0 m	DATUM:	CDD
LOCATION:	Halswell Group of Houses	INCLINATION:	-90°	DATE TESTED:	30/07/2012
JOB NUMBER:	1078102455_1660	HOLE DEPTH:	1.9 m	CONTRACTOR:	Golder
				CONE ID:	4469
				CHECKED BY:	KRB
