Land Information Memorandum

1/126 Halswell Junction Road

REPORT

GEOTECHNICAL ASSESSMENT REPORT - HALSWELL GROUP OF HOUSES

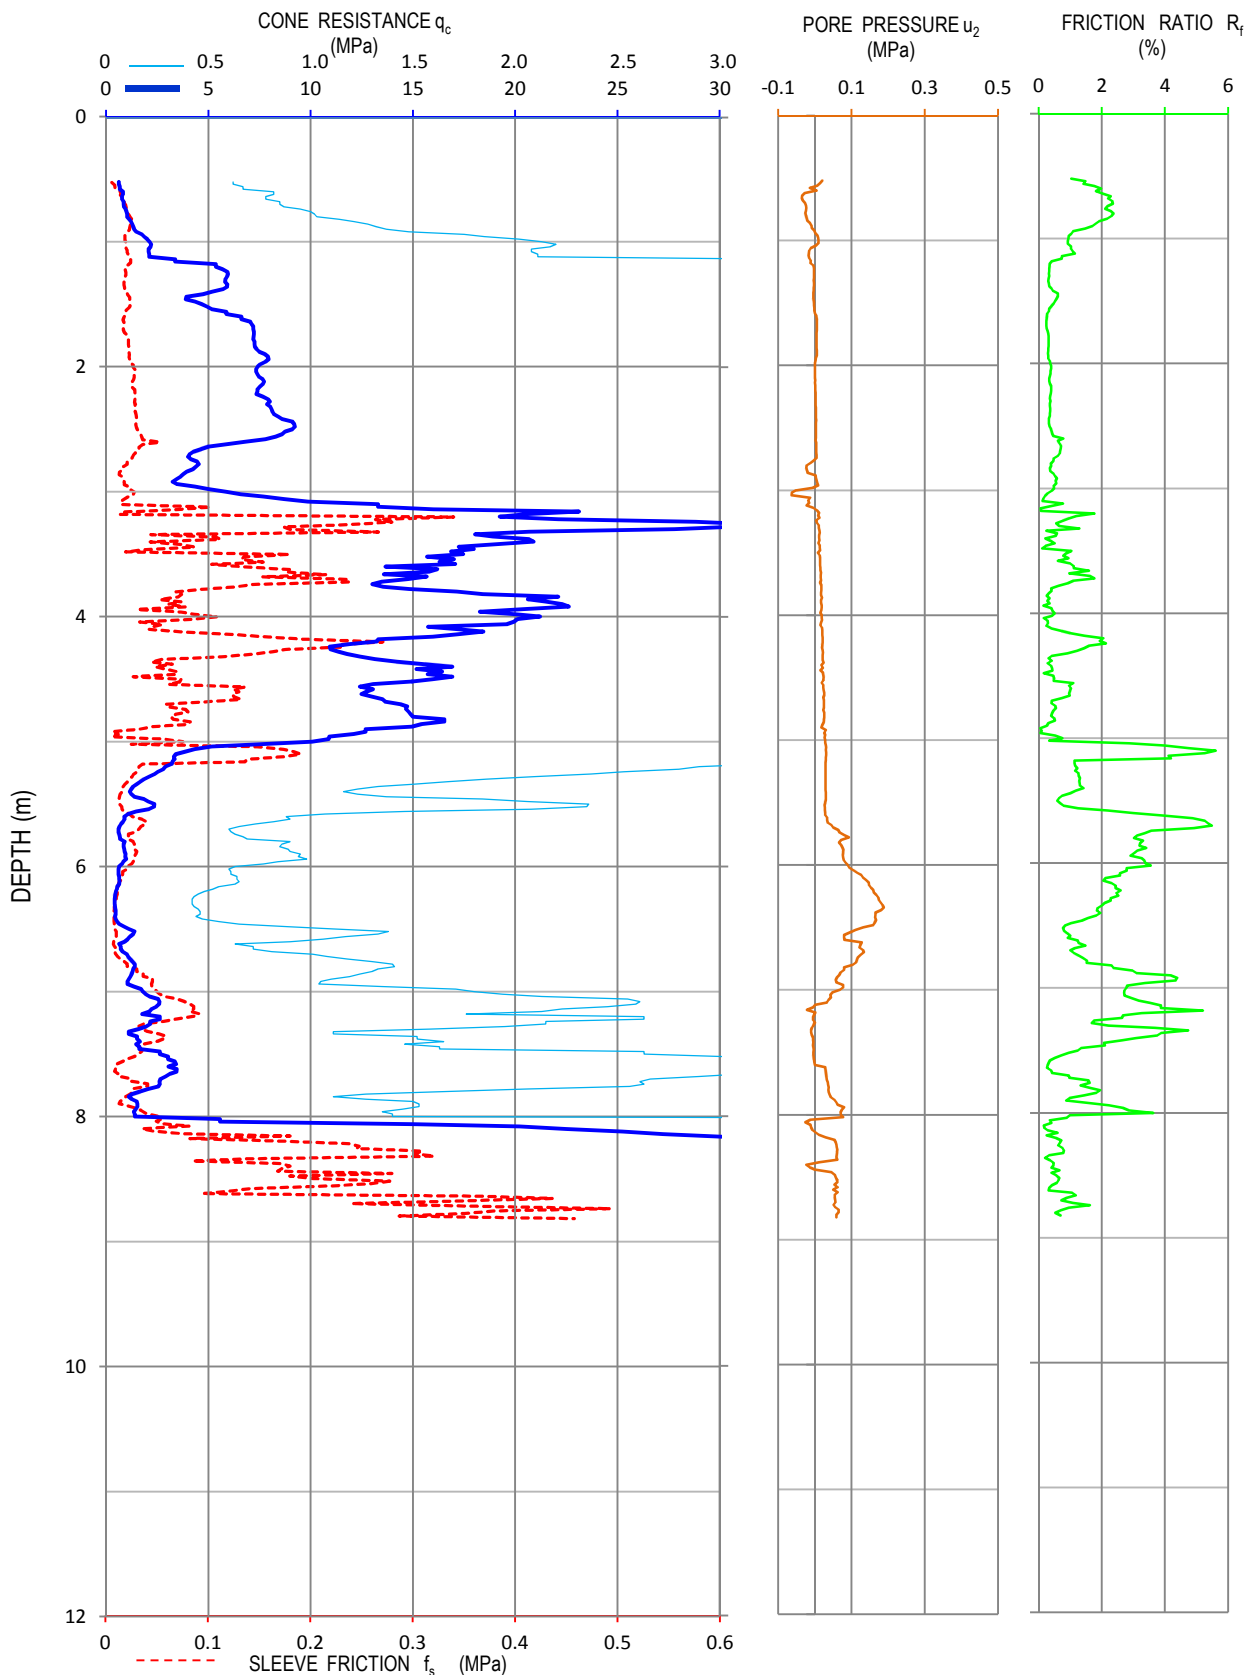
CLIENT:	Arrow International Limited	COORDS:	1564258 m E	5174710 m N	NZTM Z59
PROJECT:	Earthquake Reconstruction Project	SURFACE RL:	24.9 m	DATUM:	CDD
LOCATION:	Halswell Group of Houses	INCLINATION:	-90°	DATE TESTED:	31/07/2012
JOB NUMBER:	1078102455_1660	HOLE DEPTH:	8.8 m	CONTRACTOR:	Golder
				CONE ID:	4469
				CHECKED BY:	KRB

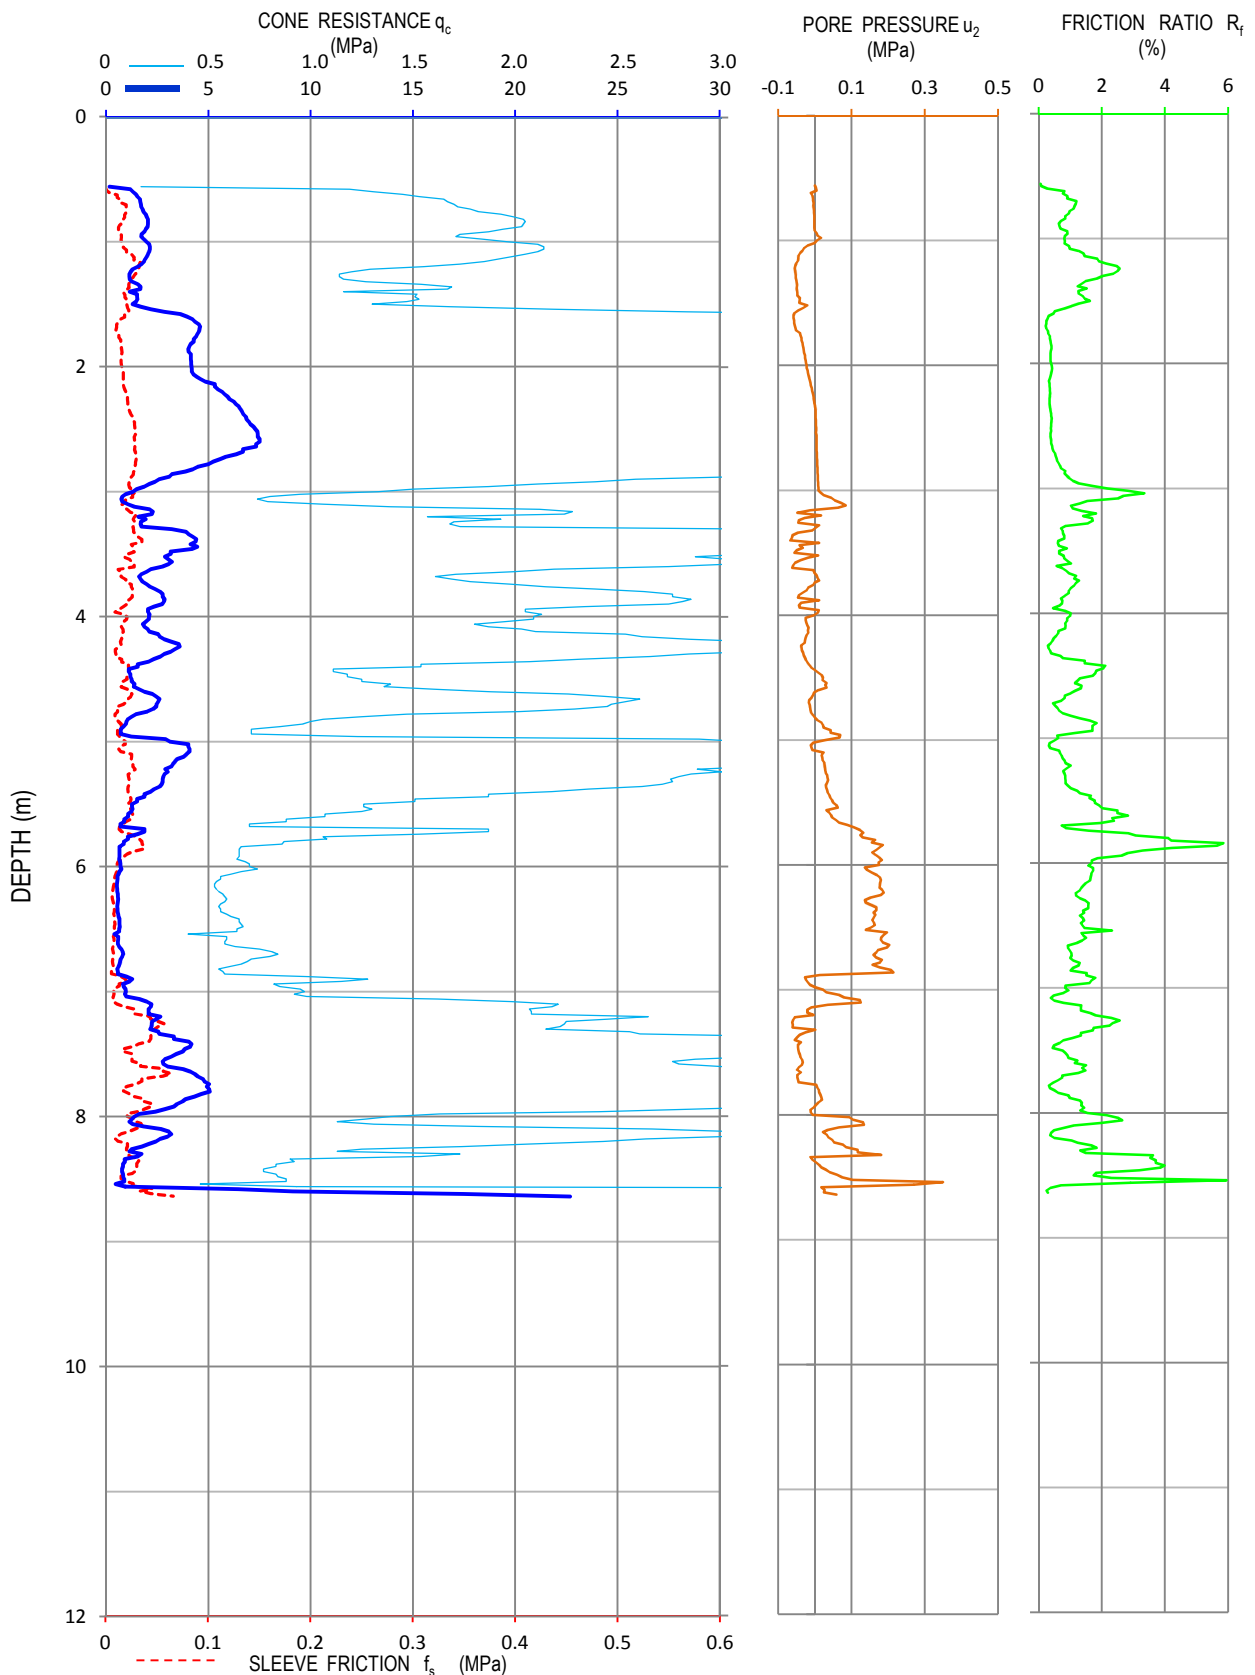
CLIENT:	Arrow International Limited	COORDS:	1564233 m E	5174707 m N	NZTM Z59
PROJECT:	Earthquake Reconstruction Project	SURFACE RL:	25 m	DATUM:	CDD
LOCATION:	Halswell Group of Houses	INCLINATION:	-90°	DATE TESTED:	31/07/2012
JOB NUMBER:	1078102455_1660	HOLE DEPTH:	8.6 m	CONTRACTOR:	Golder
				CONE ID:	4469
				CHECKED BY:	KRB

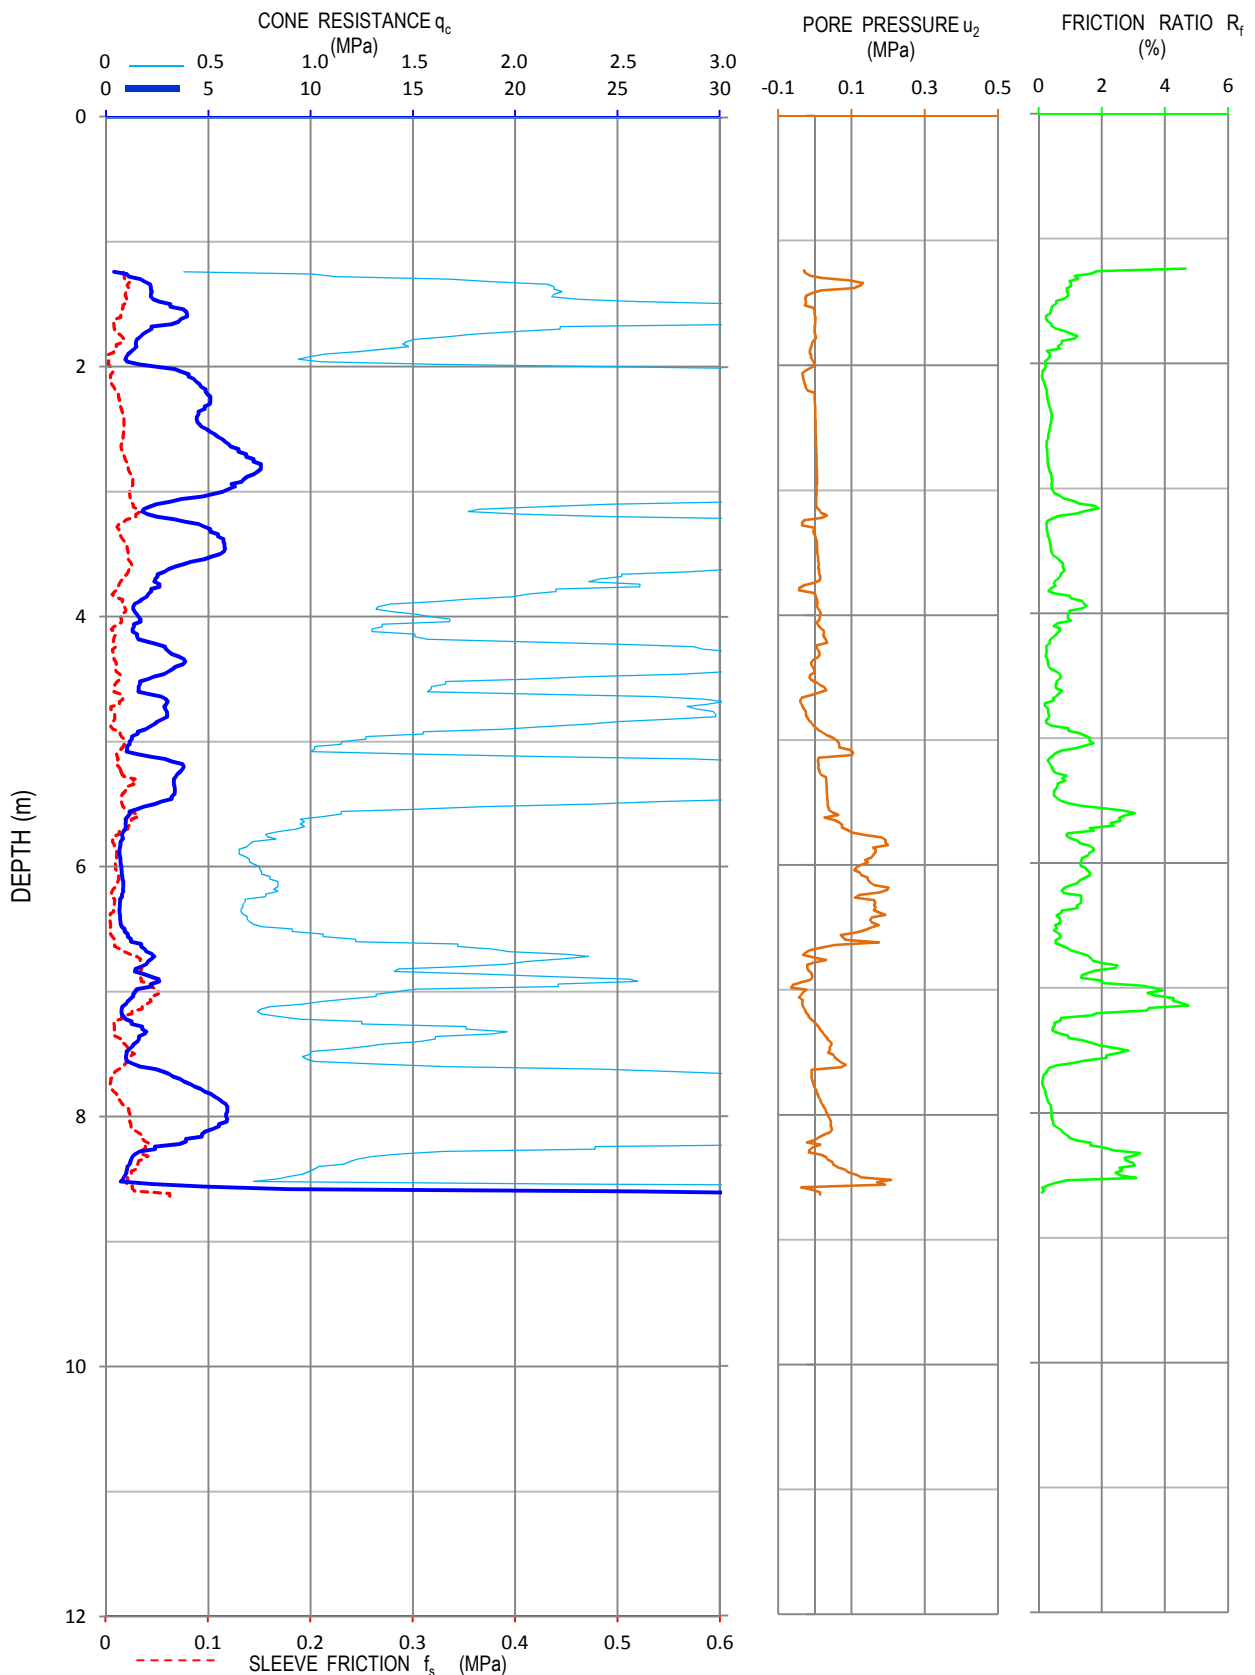
CLIENT:	Arrow International Limited	COORDS:	1564240 m E	5174688 m N	NZTM Z59
PROJECT:	Earthquake Reconstruction Project	SURFACE RL:	24.2 m	DATUM:	CDD
LOCATION:	Halswell Group of Houses	INCLINATION:	-90°	DATE TESTED:	31/07/2012
JOB NUMBER:	1078102455_1660	HOLE DEPTH:	8.6 m	CONTRACTOR:	Golder
				CONE ID:	4469
				CHECKED BY:	KRB

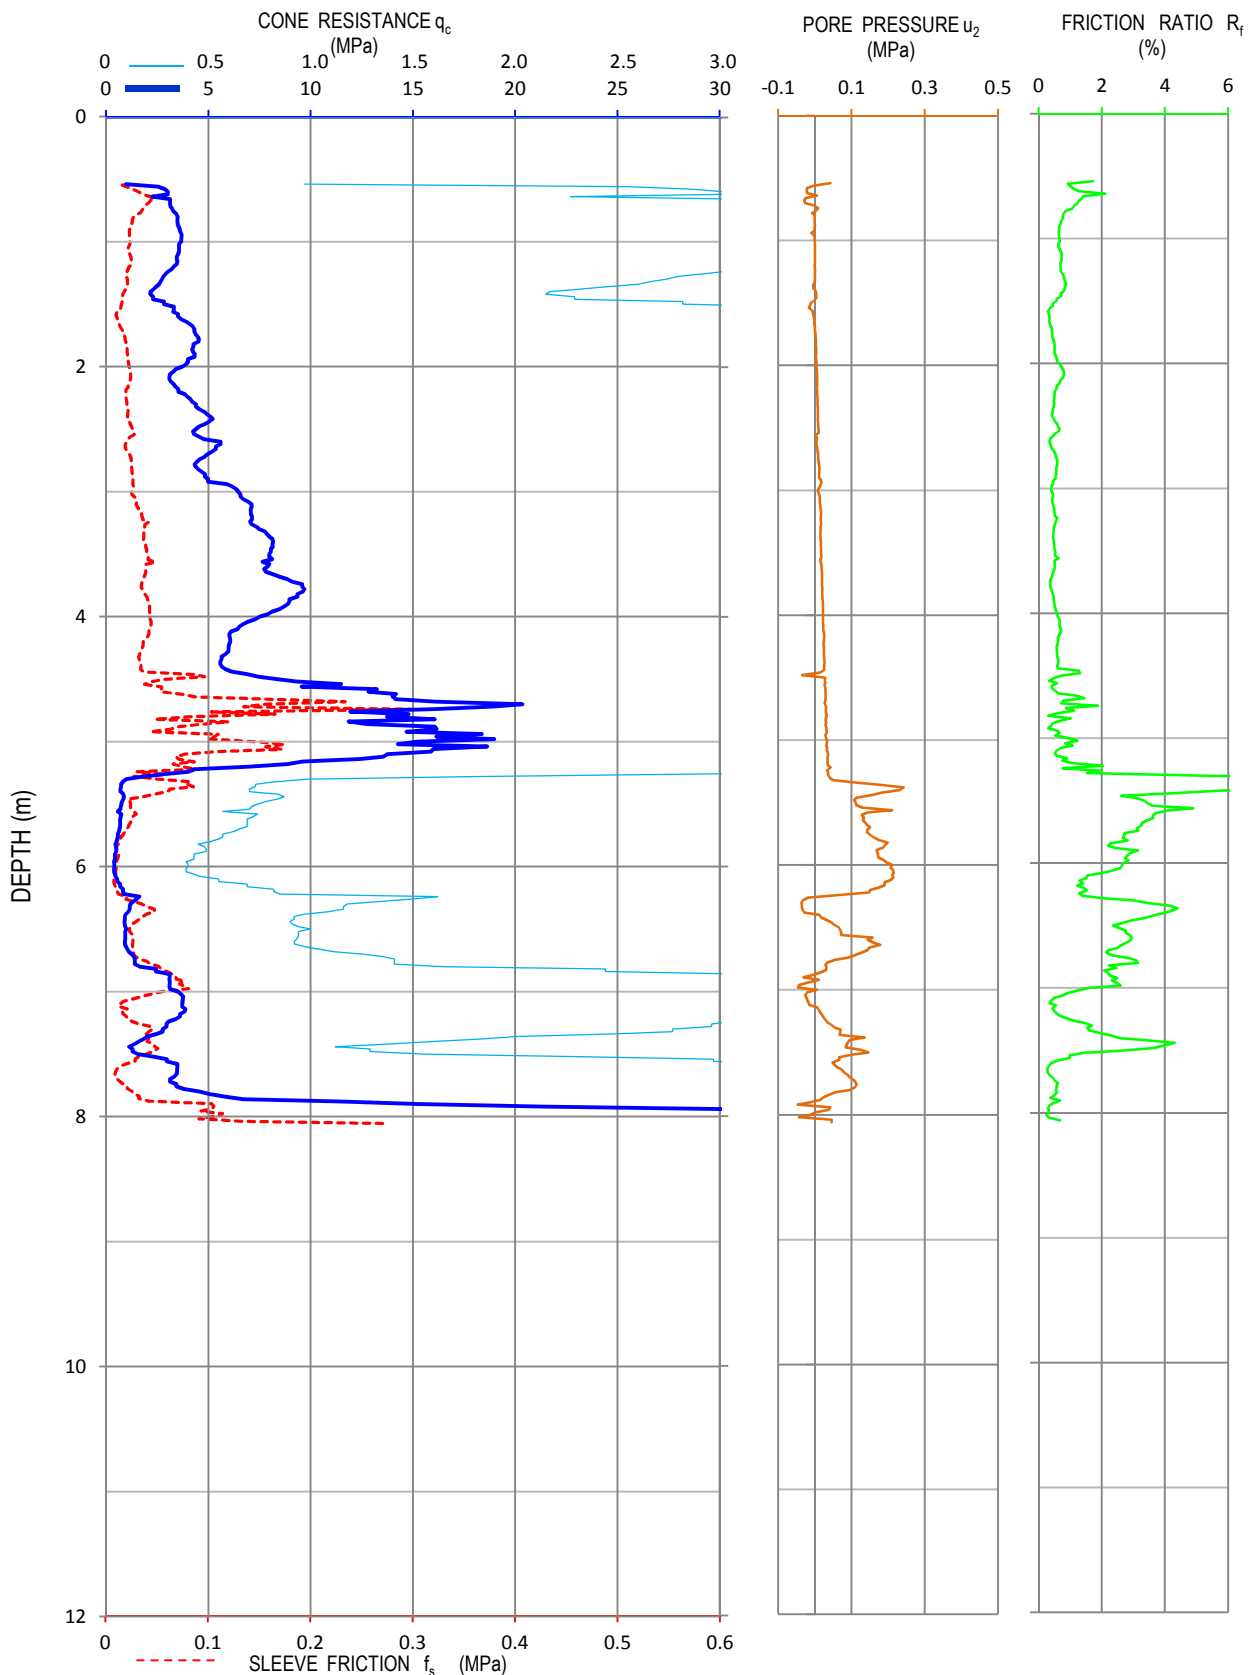
CLIENT:	Arrow International Limited	COORDS:	1564292 m E	5174681 m N	NZTM Z59
PROJECT:	Earthquake Reconstruction Project	SURFACE RL:	24.6 m	DATUM:	CDD
LOCATION:	Halswell Group of Houses	INCLINATION:	-90°	DATE TESTED:	1/08/2012
JOB NUMBER:	1078102455_1660	HOLE DEPTH:	8.1 m	CONTRACTOR:	Golder
				CONE ID:	4469
				CHECKED BY:	KRB

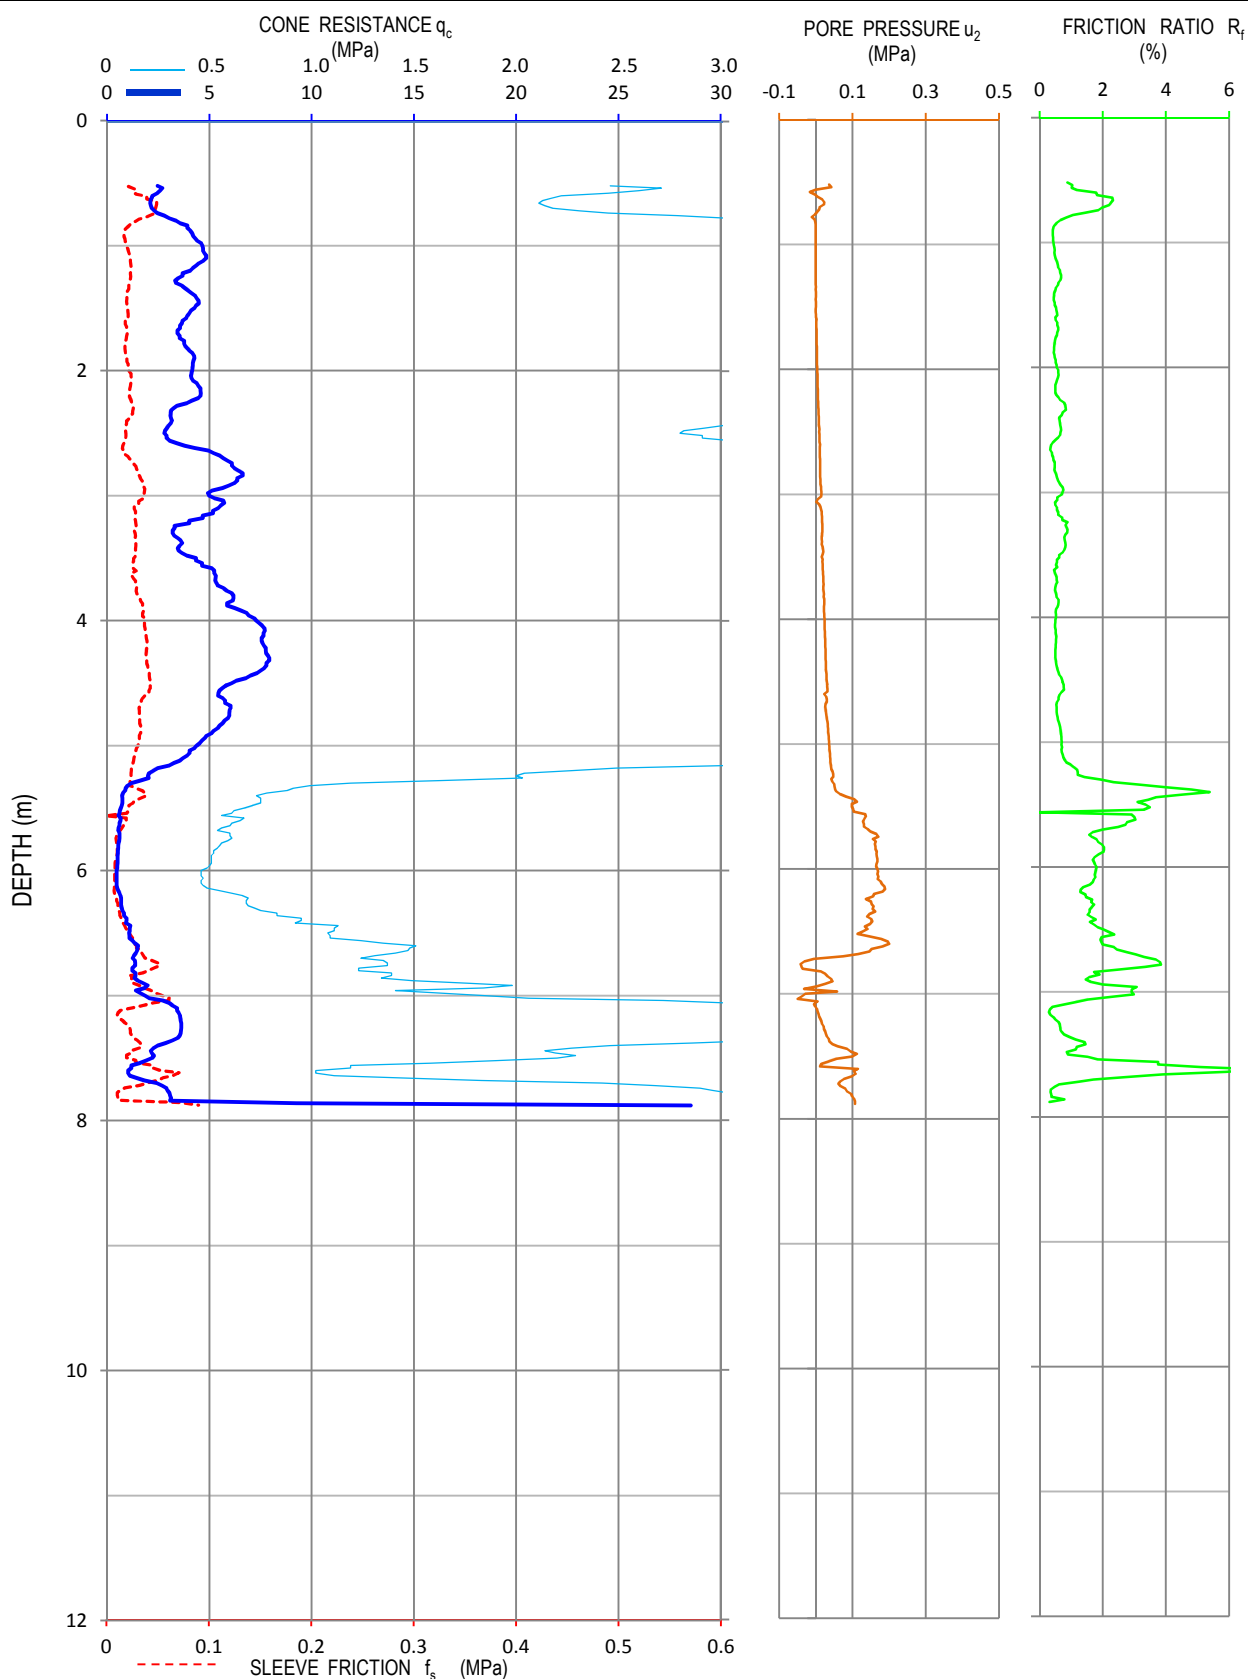
CLIENT:	Arrow International Limited	COORDS:	1564281 m E	5174670 m N	NZTM Z59
PROJECT:	Earthquake Reconstruction Project	SURFACE RL:	24.6 m	DATUM:	CDD
LOCATION:	Halswell Group of Houses	INCLINATION:	-90°	DATE TESTED:	1/08/2012
JOB NUMBER:	1078102455_1660	HOLE DEPTH:	7.9 m	CONTRACTOR:	Golder
				CONE ID:	4469
				CHECKED BY:	KRB

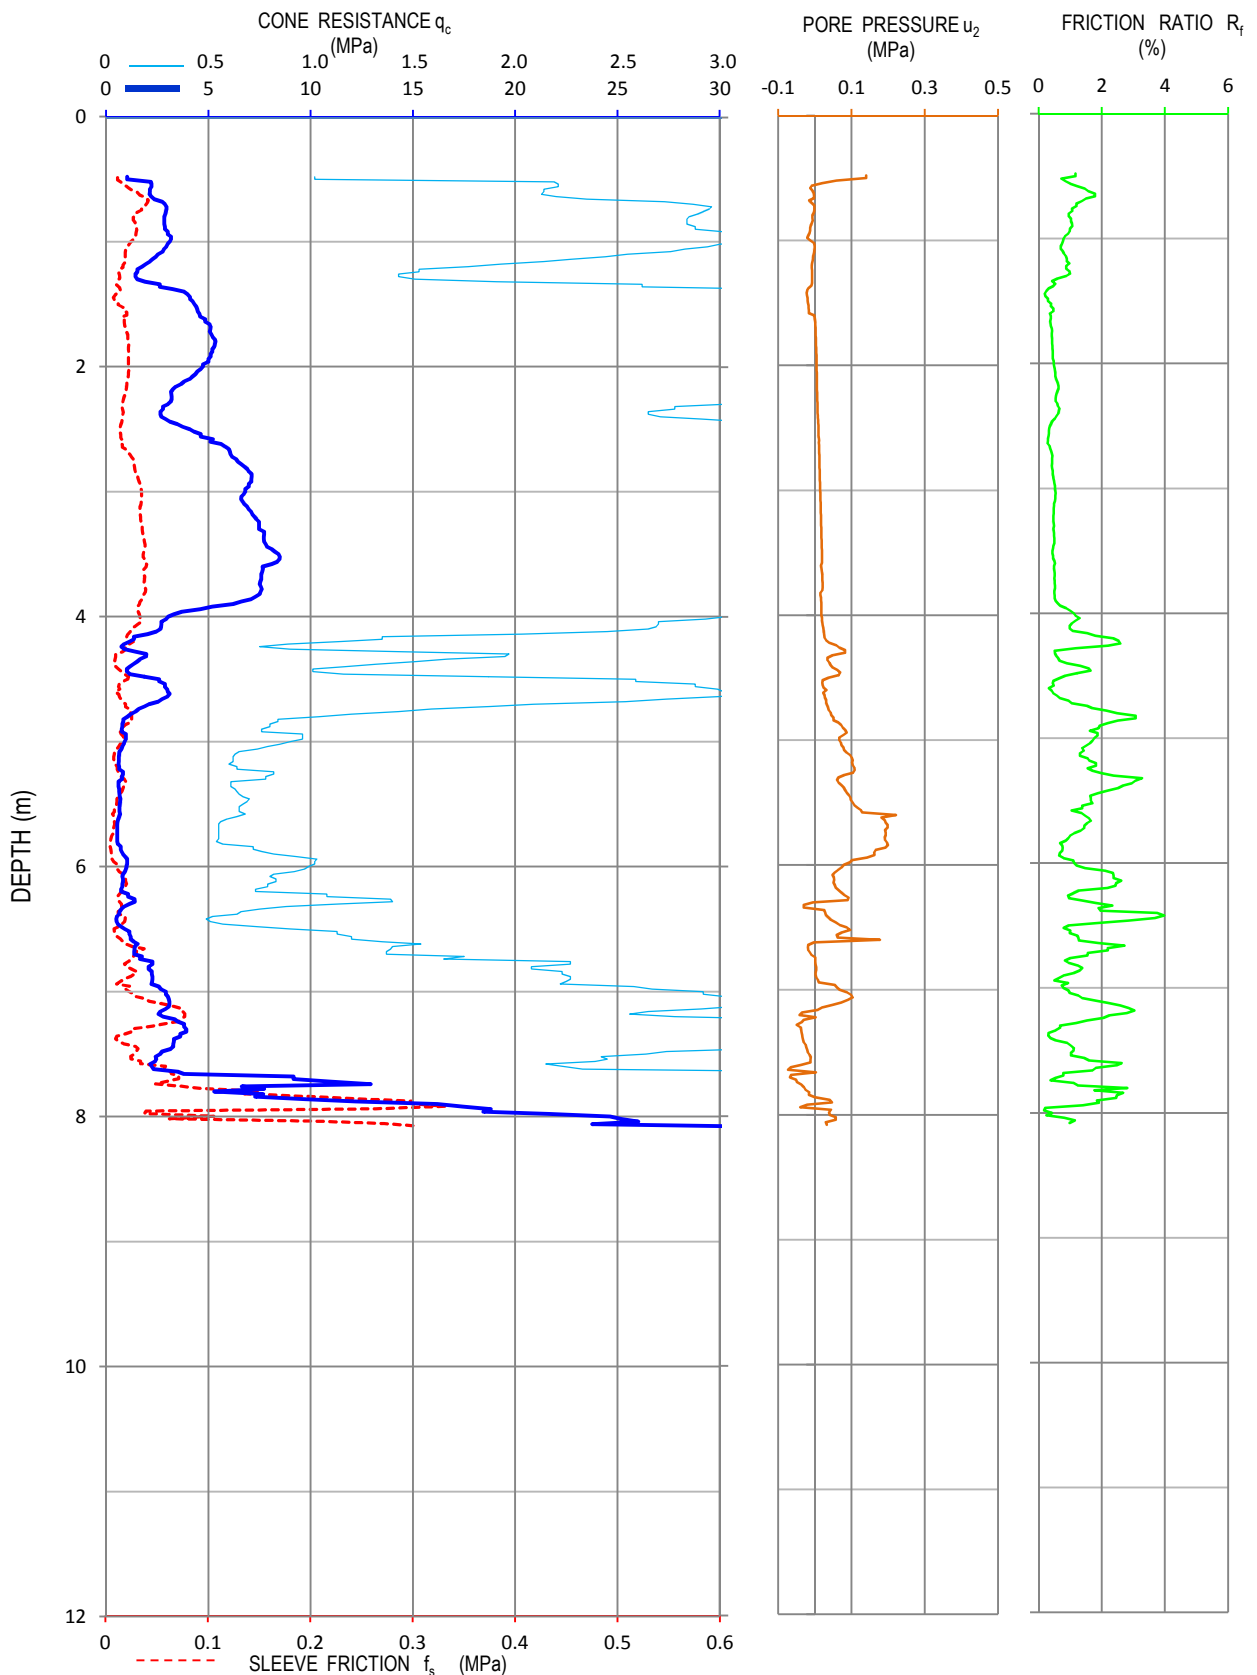
CLIENT:	Arrow International Limited	COORDS:	1564270 m E	5174662 m N	NZTM Z59
PROJECT:	Earthquake Reconstruction Project	SURFACE RL:	24.6 m	DATUM:	CDD
LOCATION:	Halswell Group of Houses	INCLINATION:	-90°	DATE TESTED:	1/08/2012
JOB NUMBER:	1078102455_1660	HOLE DEPTH:	8.1 m	CONTRACTOR:	Golder
				CONE ID:	4469
				CHECKED BY:	KRB

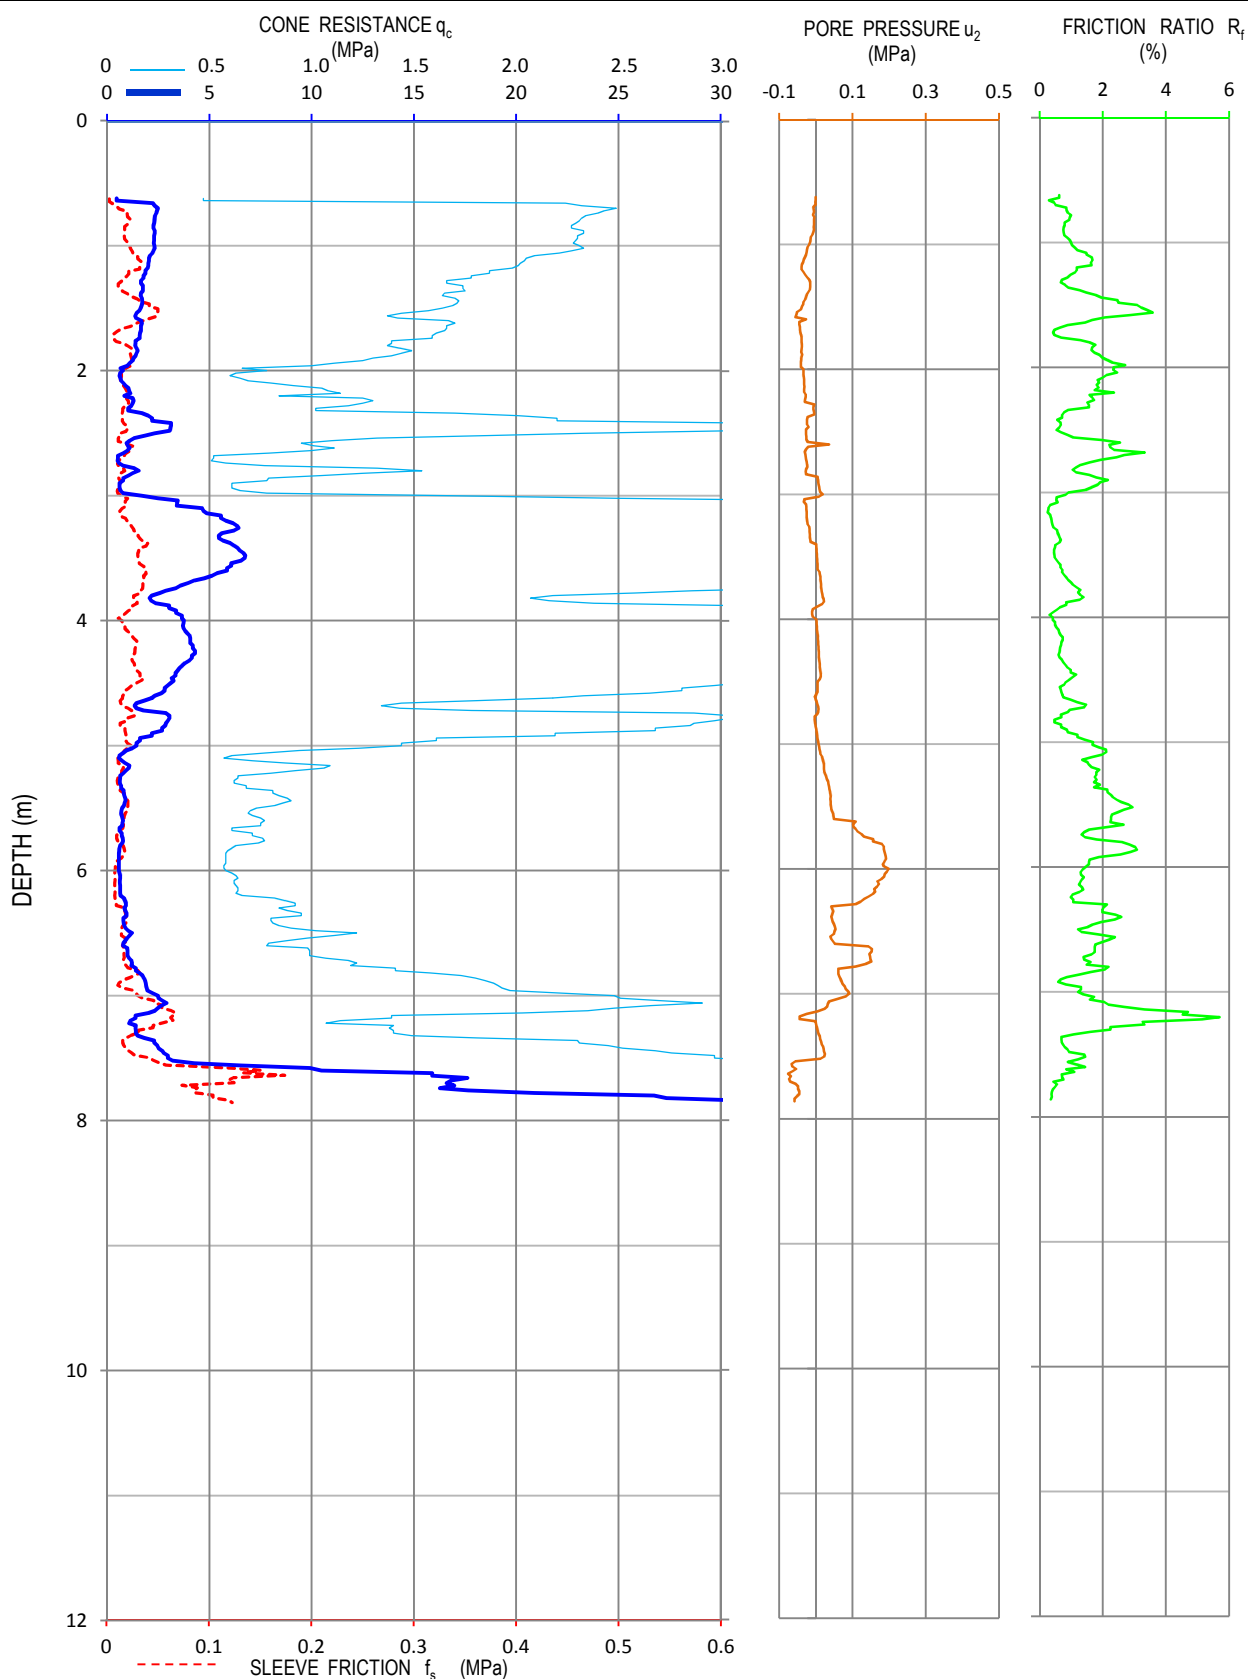
CLIENT:	Arrow International Limited	COORDS:	1564283 m E	5174652 m N	NZTM Z59
PROJECT:	Earthquake Reconstruction Project	SURFACE RL:	24.4 m	DATUM:	CDD
LOCATION:	Halswell Group of Houses	INCLINATION:	-90°	DATE TESTED:	1/08/2012
JOB NUMBER:	1078102455_1660	HOLE DEPTH:	7.9 m	CONTRACTOR:	Golder
				CONE ID:	4469
				CHECKED BY:	KRB

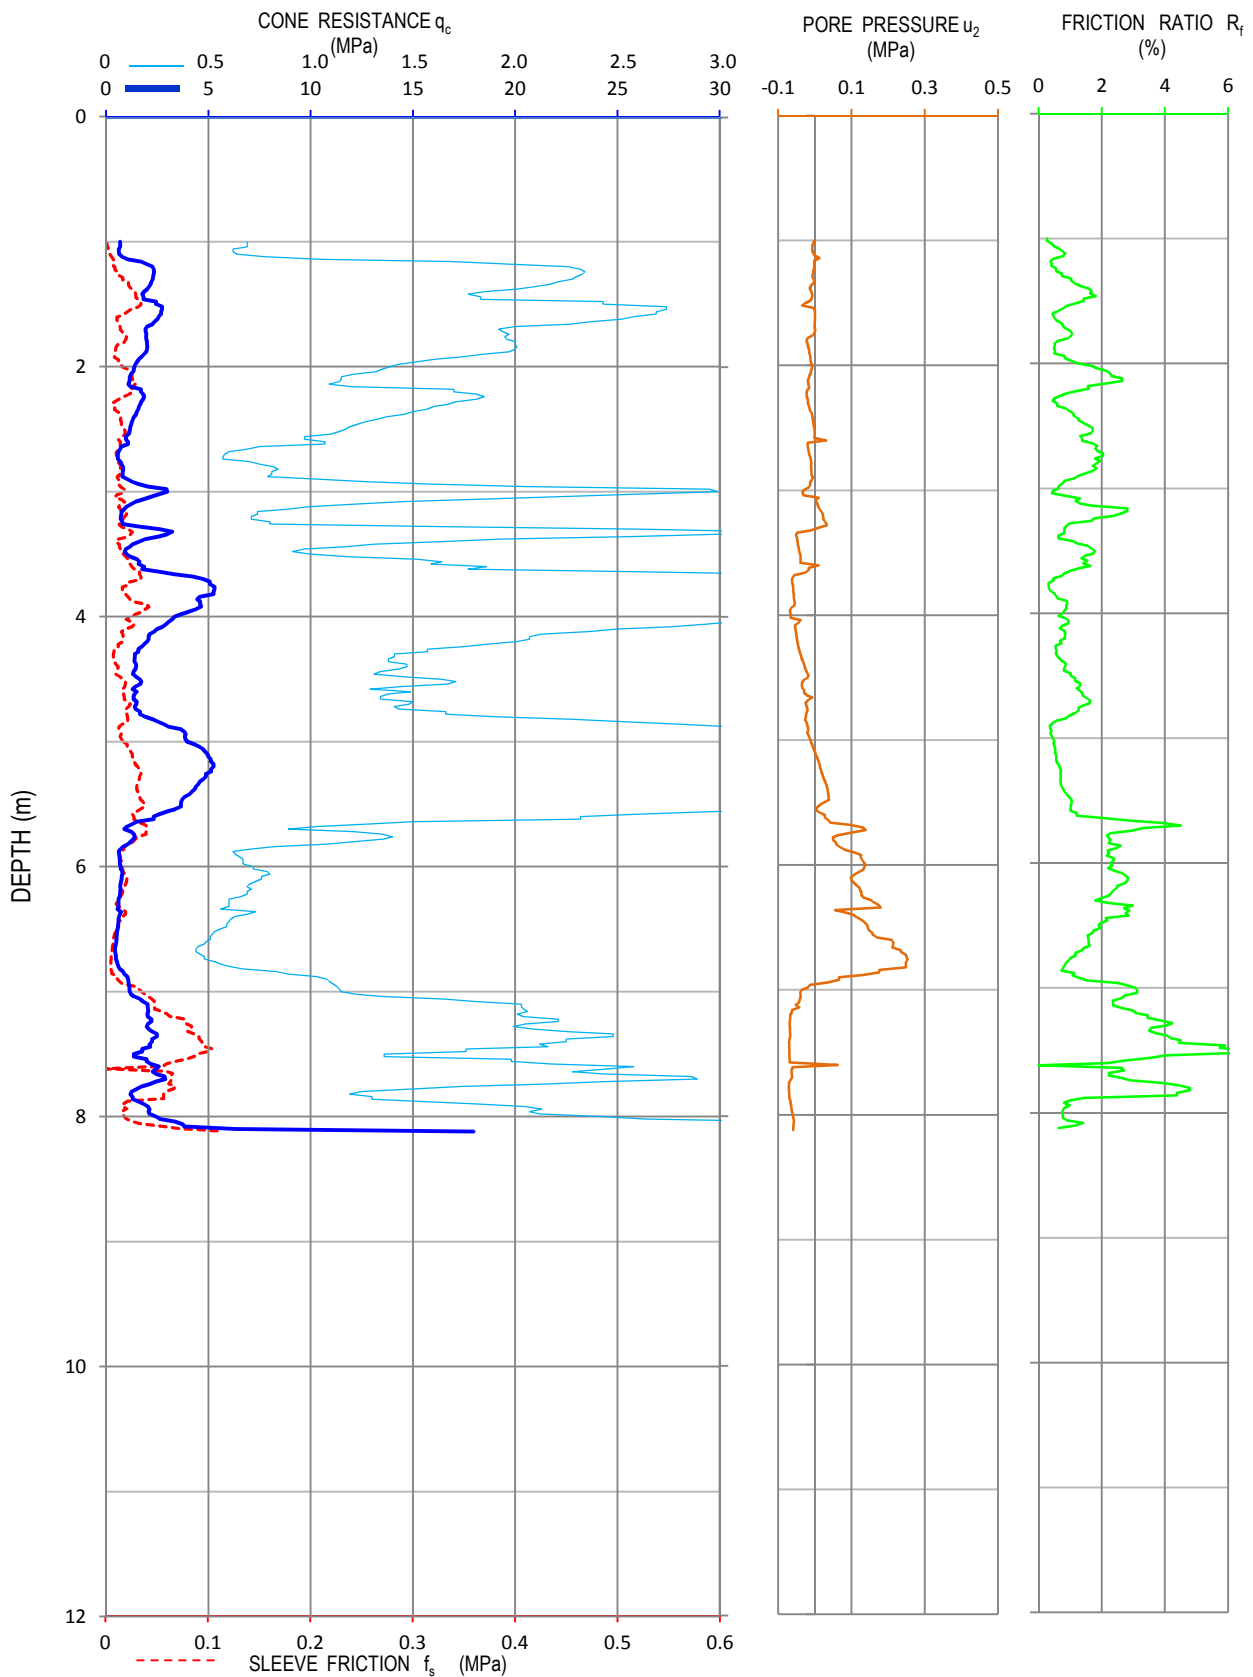
CLIENT:	Arrow International Limited	COORDS:	1564302 m E	5174645 m N	NZTM Z59
PROJECT:	Earthquake Reconstruction Project	SURFACE RL:	25.1 m	DATUM:	CDD
LOCATION:	Halswell Group of Houses	INCLINATION:	-90°	DATE TESTED:	6/08/2012
JOB NUMBER:	1078102455_1660	HOLE DEPTH:	8.1 m	CONTRACTOR:	Golder
				CONE ID:	4469
				CHECKED BY:	KRB

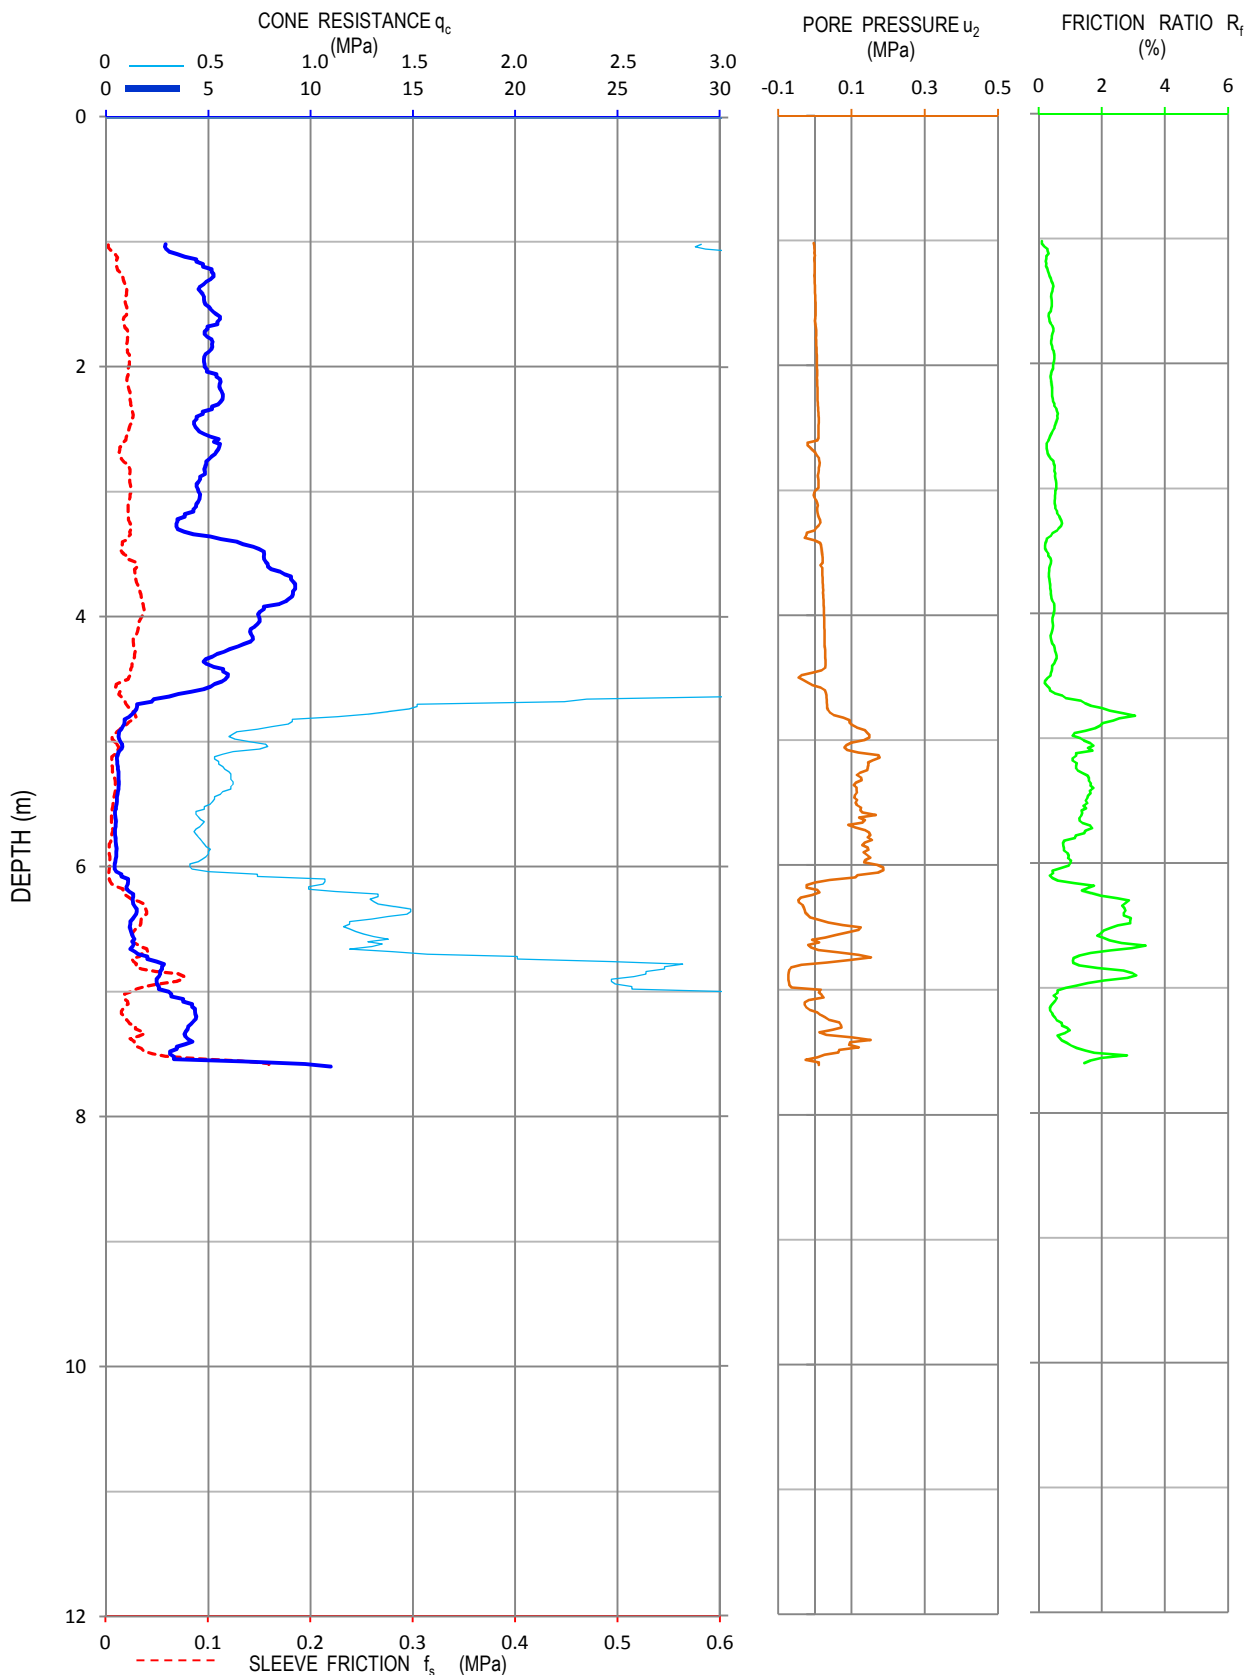
CLIENT:	Arrow International Limited	COORDS:	1564324 m E	5174650 m N	NZTM Z59
PROJECT:	Earthquake Reconstruction Project	SURFACE RL:	24.4 m	DATUM:	CDD
LOCATION:	Halswell Group of Houses	INCLINATION:	-90°	DATE TESTED:	6/08/2012
JOB NUMBER:	1078102455_1660	HOLE DEPTH:	7.6 m	CONTRACTOR:	Golder
				CONE ID:	4469
				CHECKED BY:	KRB

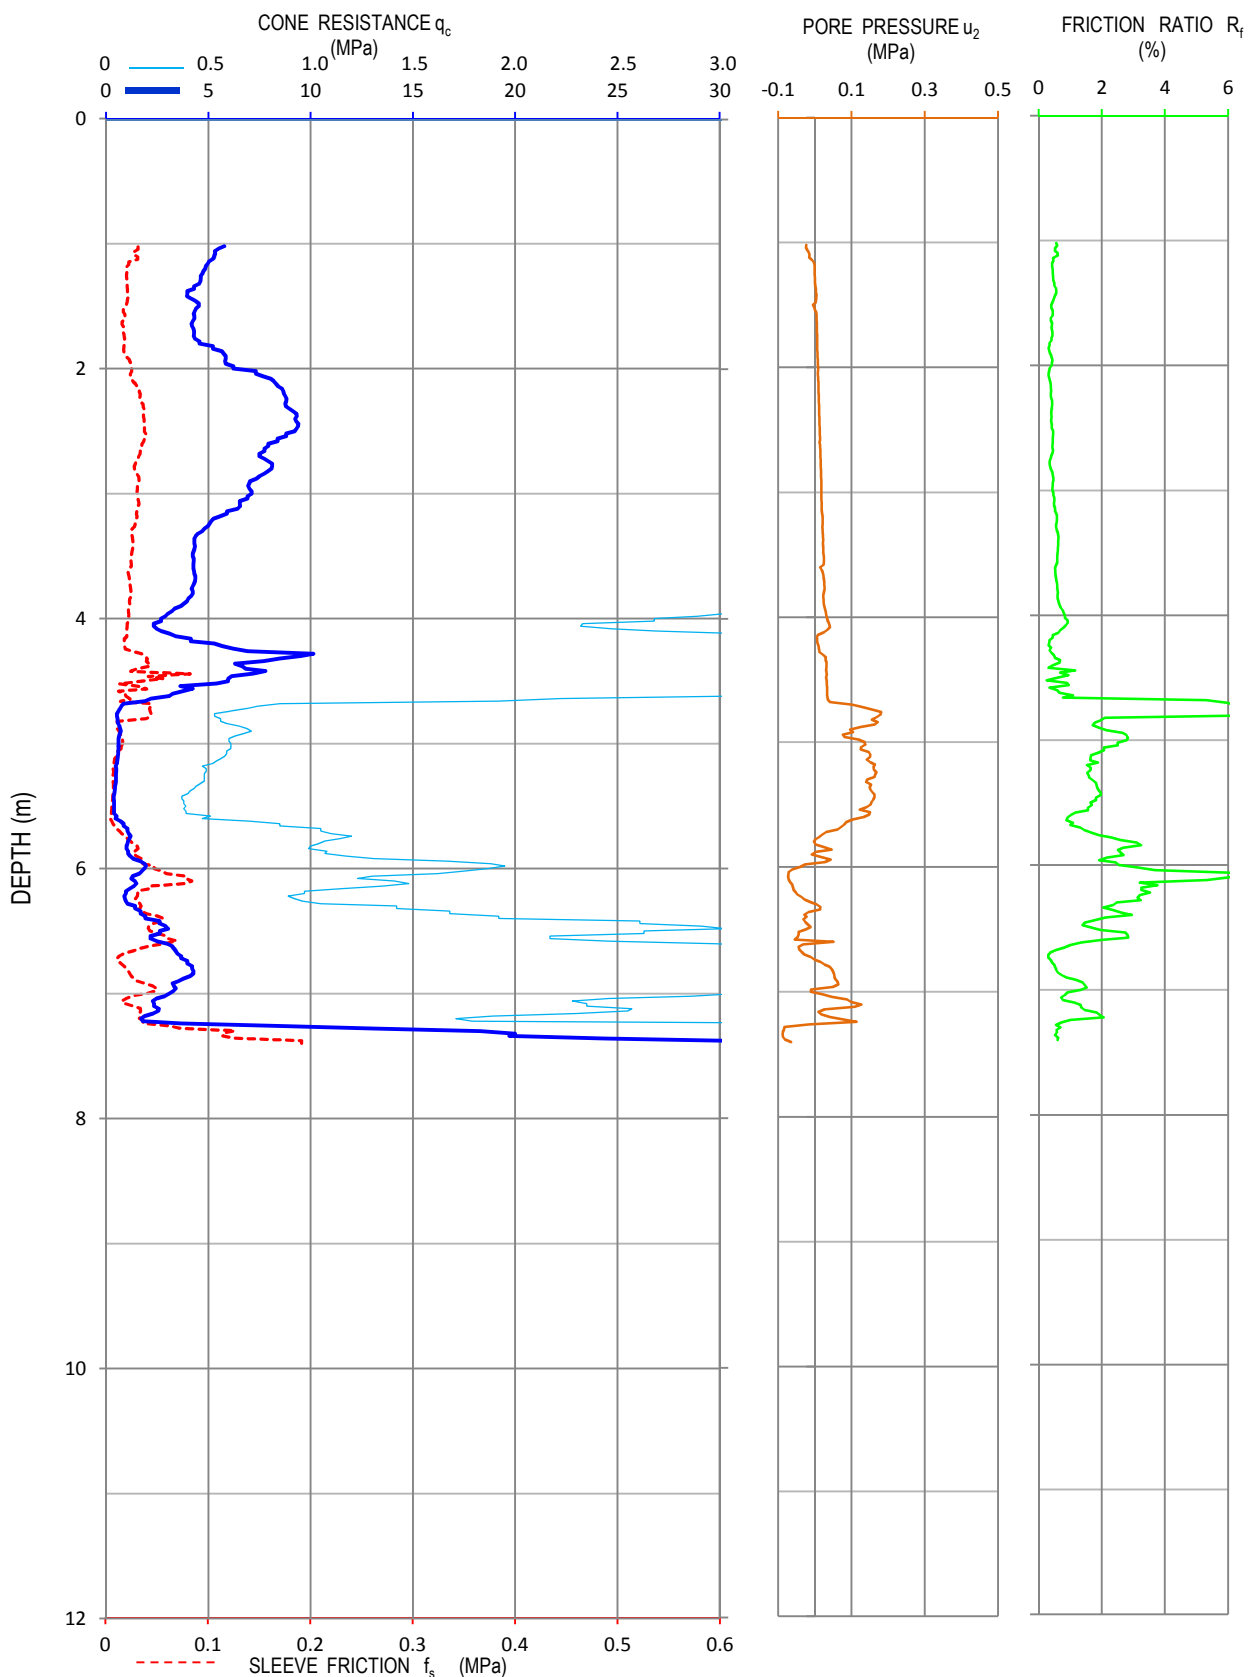
CLIENT:	Arrow International Limited	COORDS:	1564330 m E	5174679 m N	NZTM Z59
PROJECT:	Earthquake Reconstruction Project	SURFACE RL:	24.0 m	DATUM:	CDD
LOCATION:	Halswell Group of Houses	INCLINATION:	-90°	DATE TESTED:	6/08/2012
JOB NUMBER:	1078102455_1660	HOLE DEPTH:	7.4 m	CONTRACTOR:	Golder
				CONE ID:	4469
				CHECKED BY:	KRB
