Land Information Memorandum

1/126 Halswell Junction Road

REPORT

GEOTECHNICAL ASSESSMENT REPORT - HALSWELL GROUP OF HOUSES

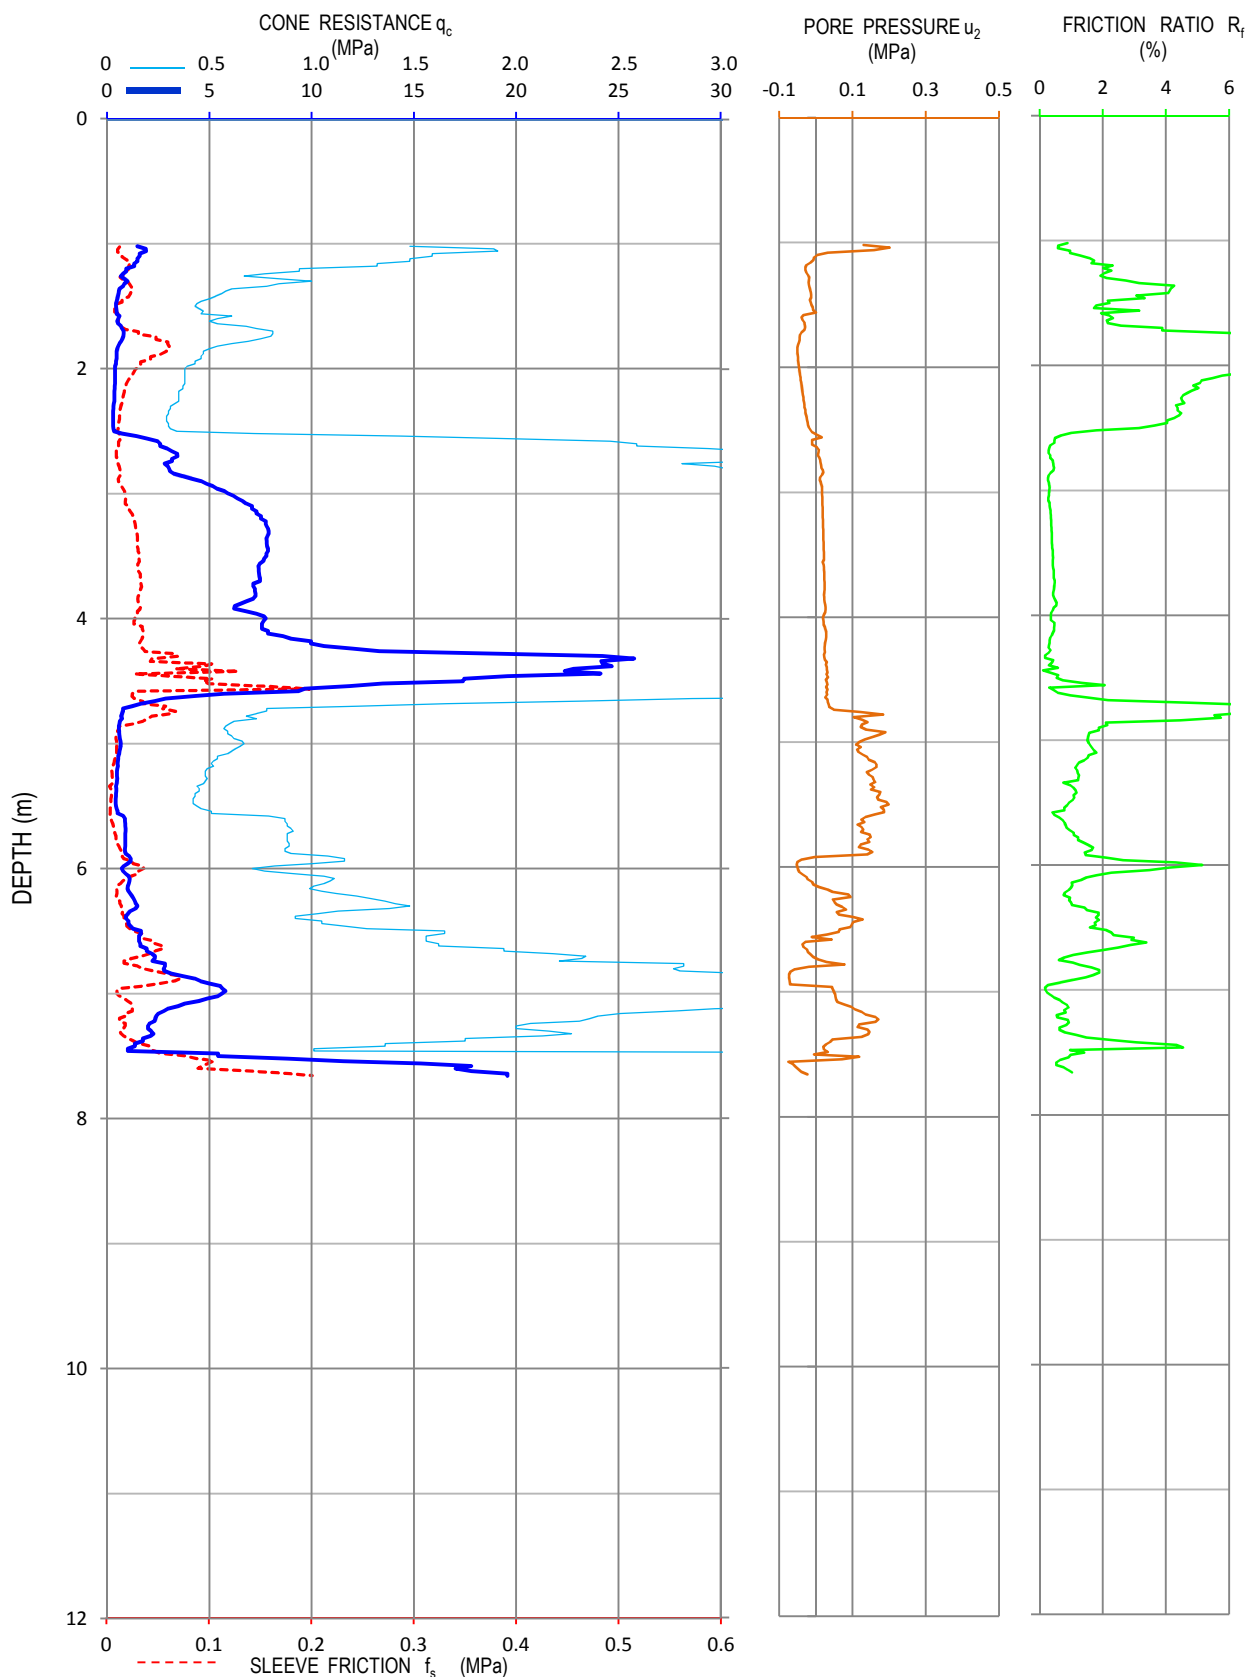
CLIENT:	Arrow International Limited	COORDS:	1564334 m E	5174688 m N	NZTM Z59
PROJECT:	Earthquake Reconstruction Project	SURFACE RL:	24.2 m	DATUM:	CDD
LOCATION:	Halswell Group of Houses	INCLINATION:	-90°	DATE TESTED:	6/08/2012
JOB NUMBER:	1078102455_1660	HOLE DEPTH:	7.7 m	CONTRACTOR:	Golder
				CONE ID:	4469
				CHECKED BY:	KRB

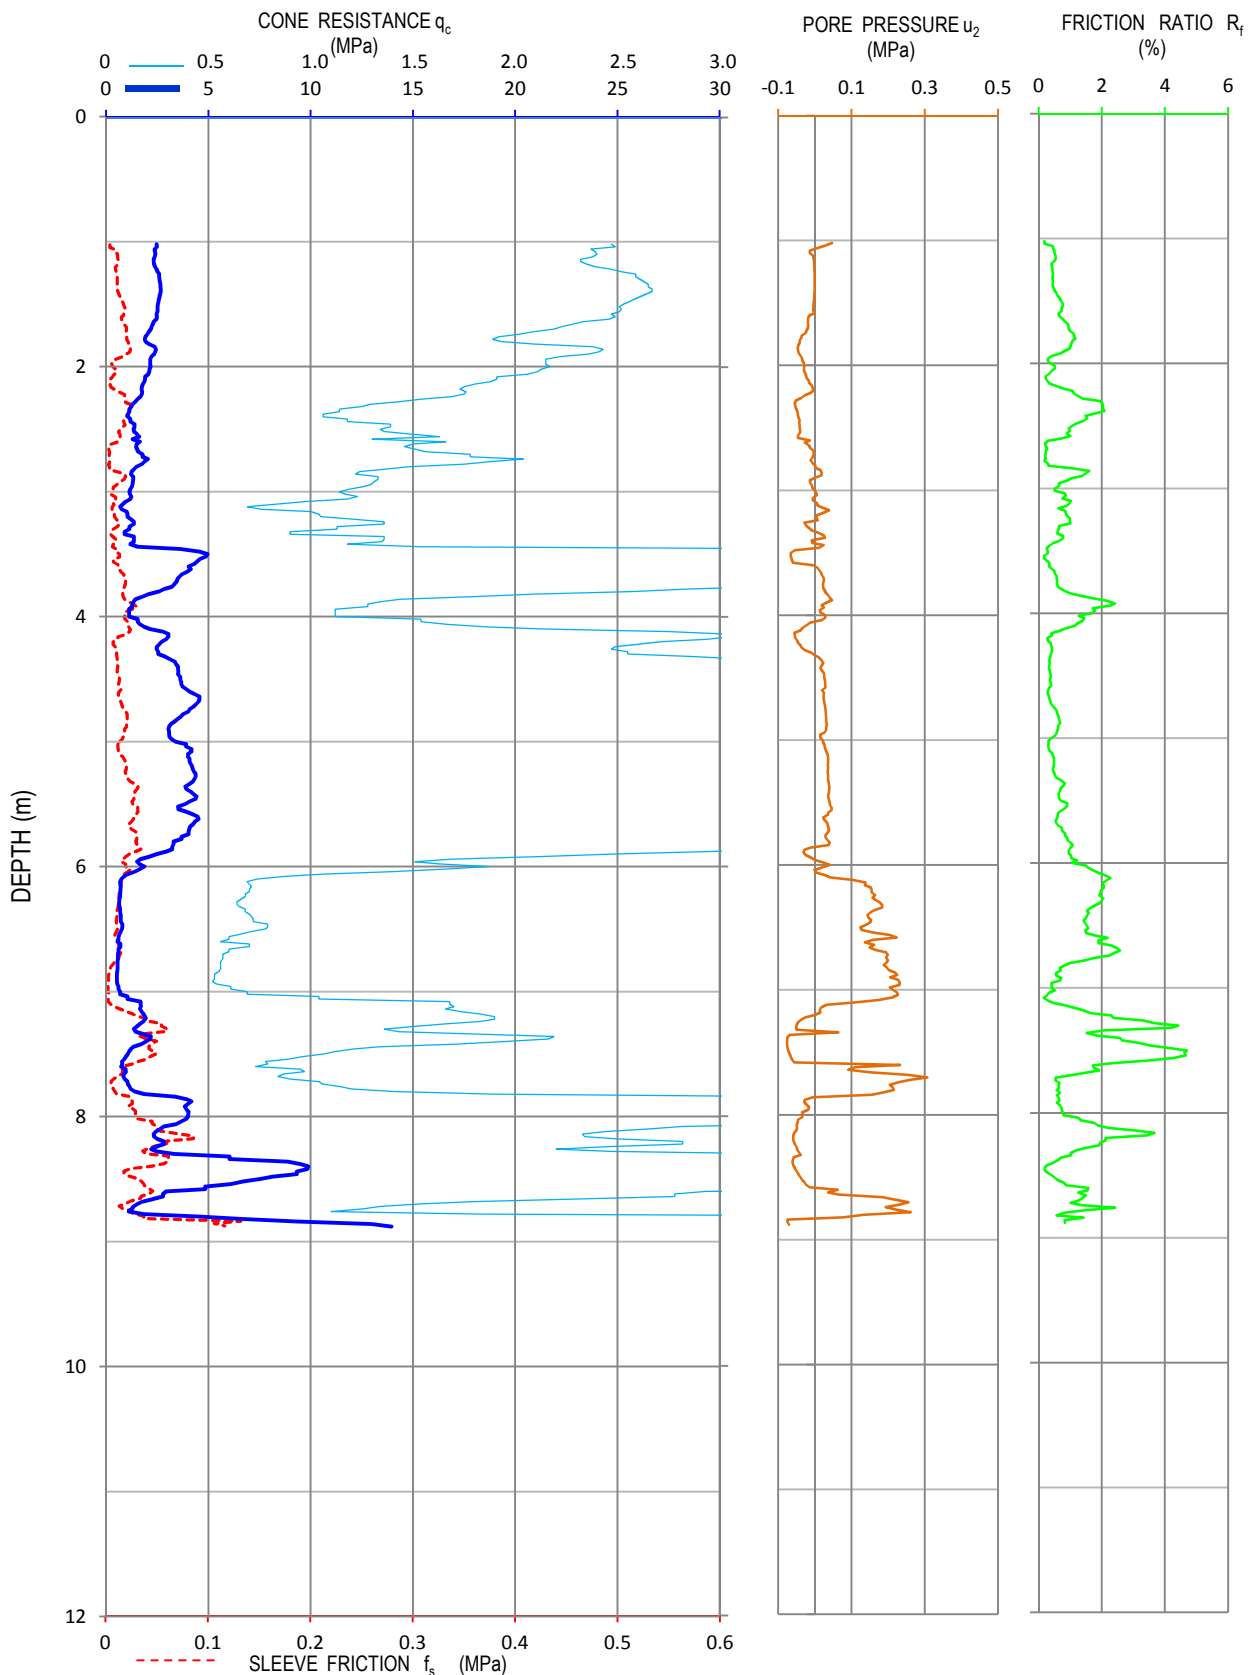
CLIENT:	Arrow International Limited	COORDS:	1564338 m E	5174624 m N	NZTM Z59
PROJECT:	Earthquake Reconstruction Project	SURFACE RL:	25.3 m	DATUM:	CDD
LOCATION:	Halswell Group of Houses	INCLINATION:	-90°	DATE TESTED:	7/08/2012
JOB NUMBER:	1078102455_1660	HOLE DEPTH:	8.9 m	CONTRACTOR:	Golder
				CONE ID:	4469
				CHECKED BY:	KRB

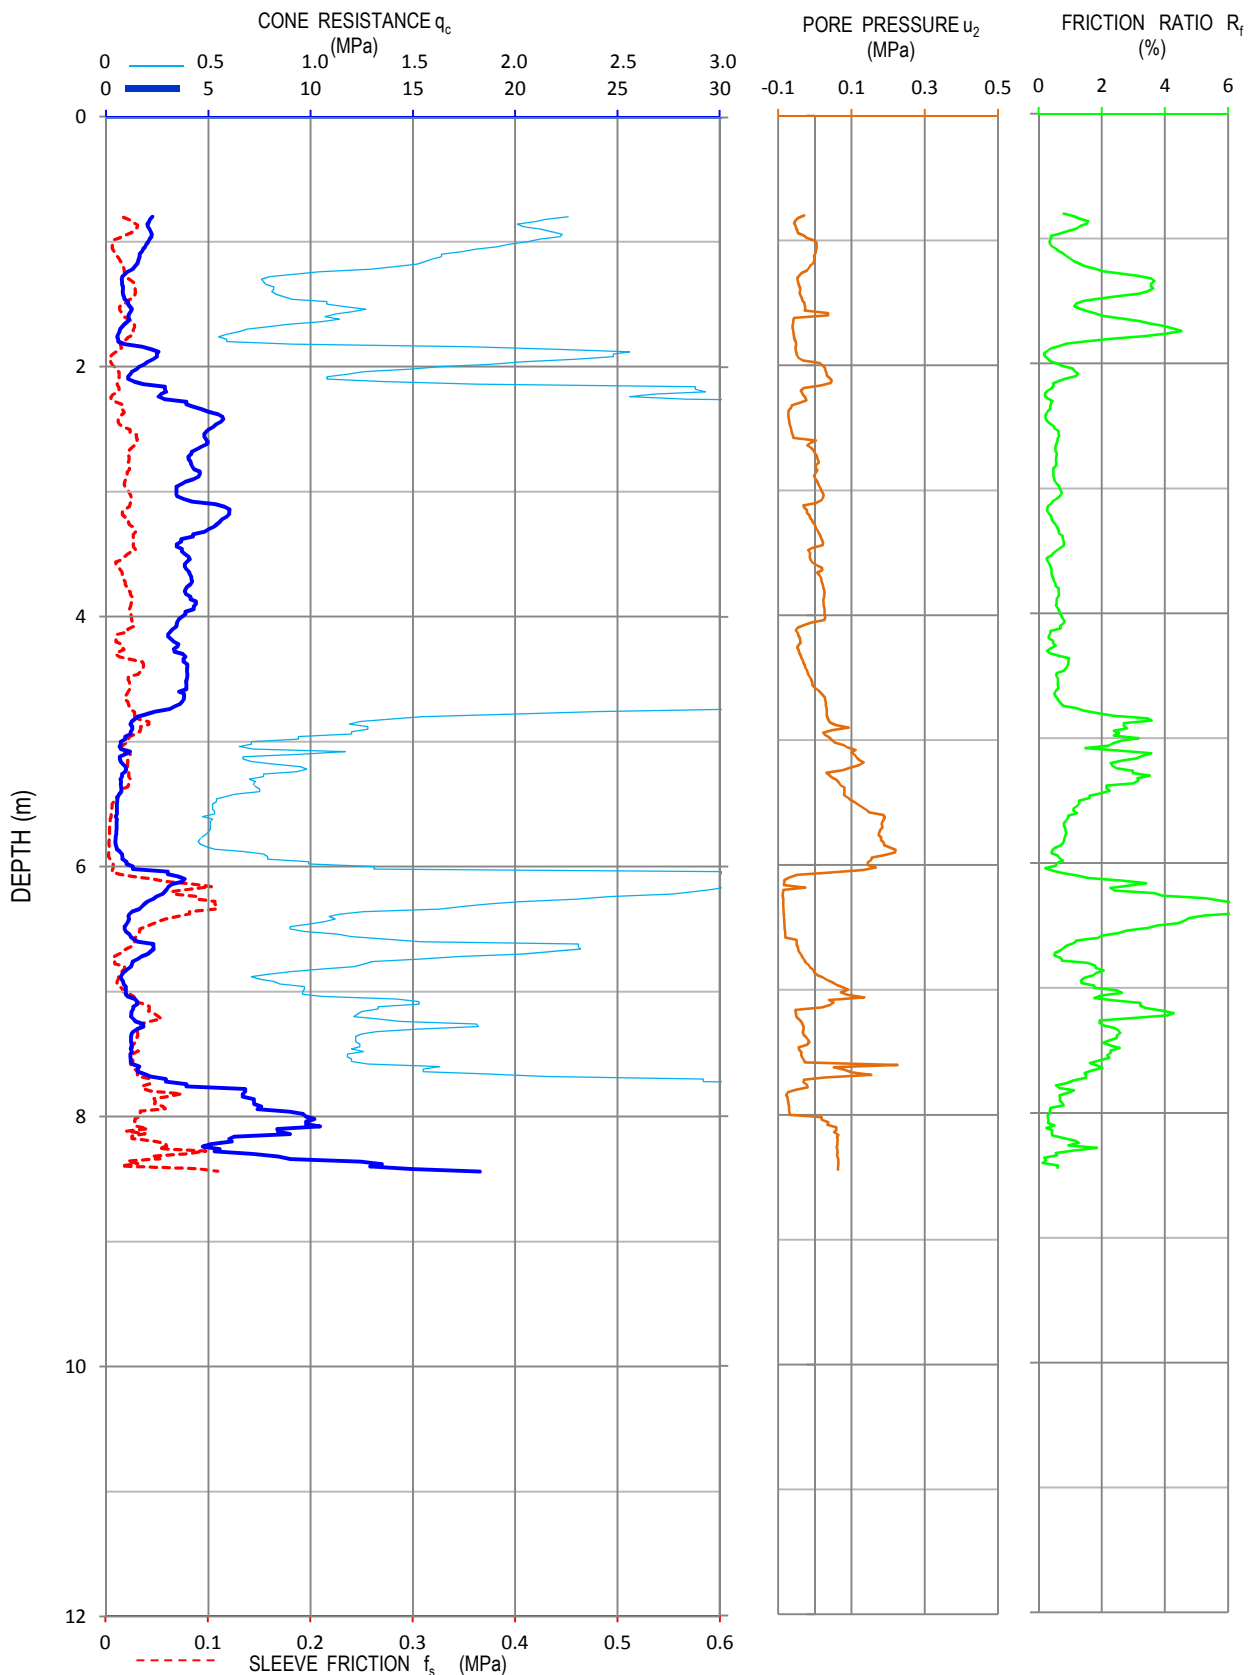
CLIENT:	Arrow International Limited	COORDS:	1564373 m E	5174650 m N	NZTM Z59
PROJECT:	Earthquake Reconstruction Project	SURFACE RL:	24.5 m	DATUM:	CDD
LOCATION:	Halswell Group of Houses	INCLINATION:	-90°	DATE TESTED:	7/08/2012
JOB NUMBER:	1078102455_1660	HOLE DEPTH:	8.4 m	CONTRACTOR:	Golder
				CONE ID:	4469
				CHECKED BY:	KRB

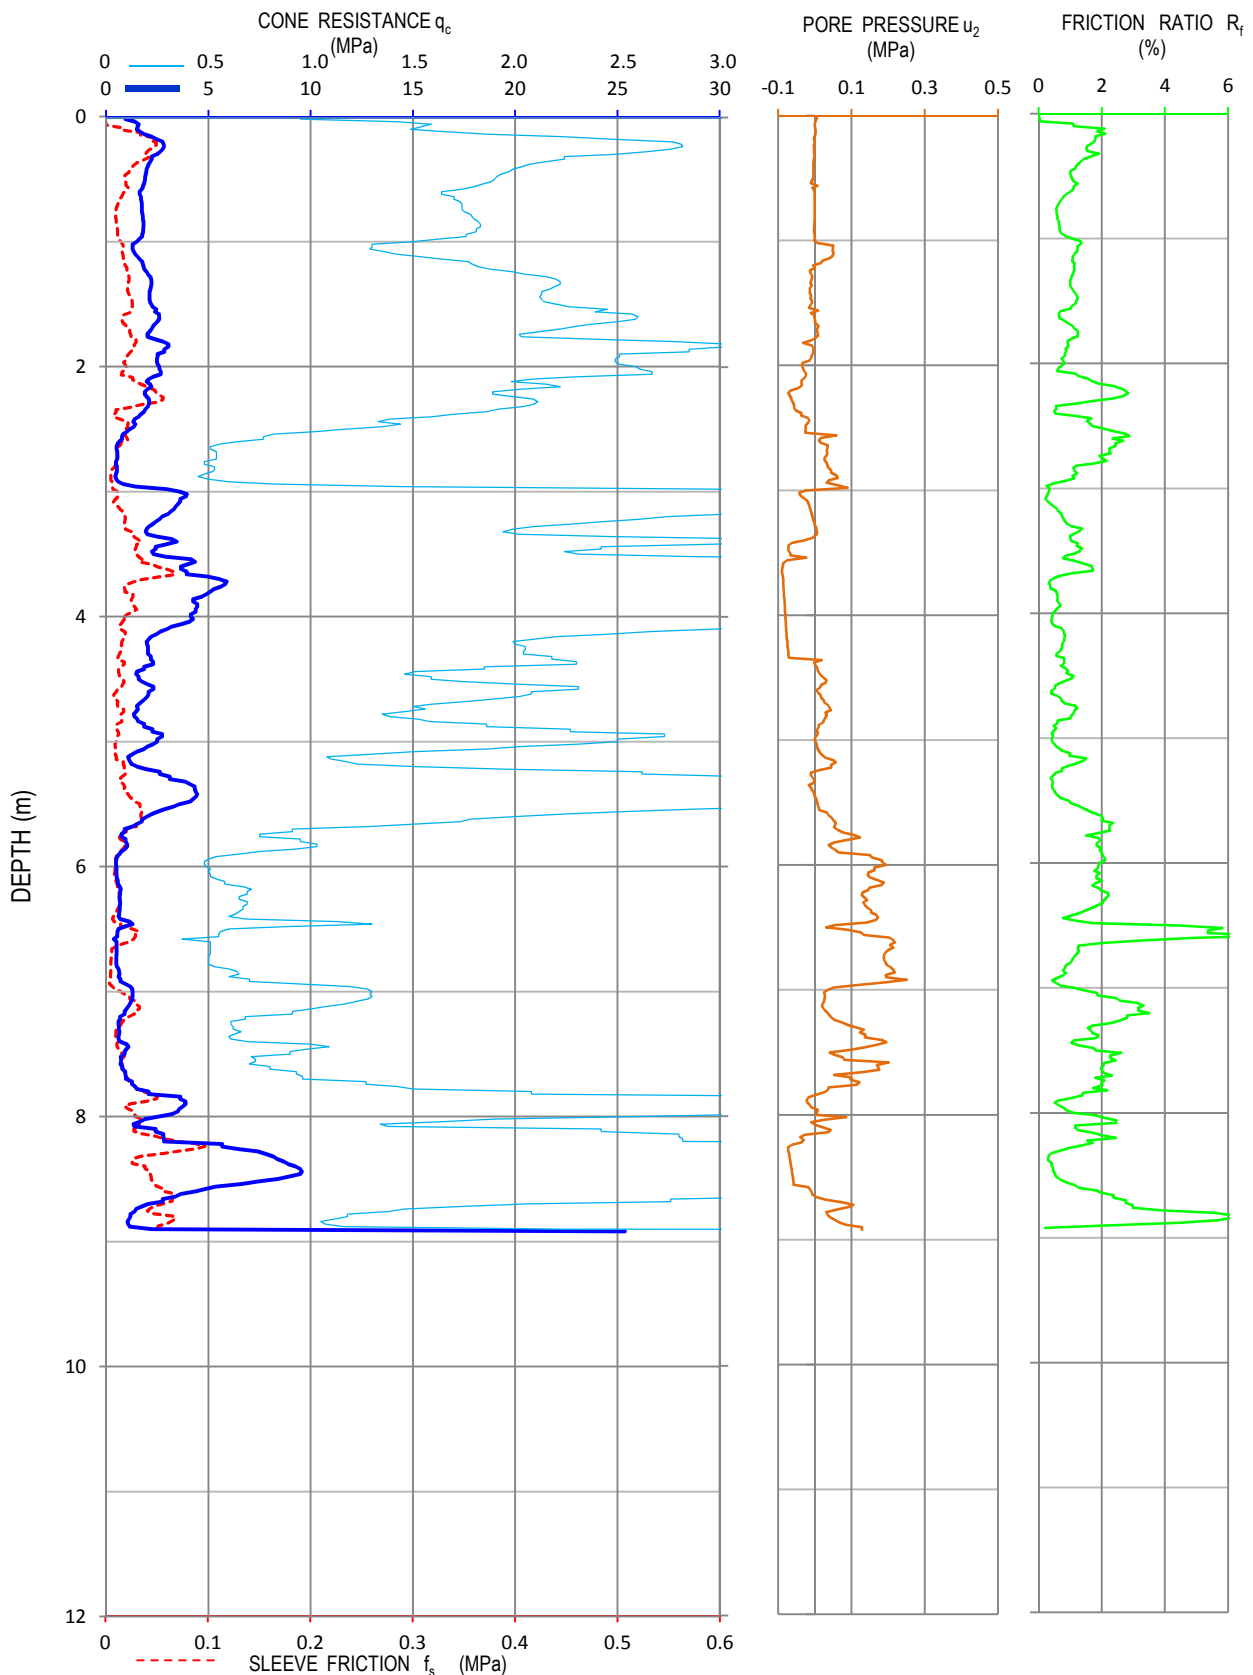
CLIENT:	Arrow International Limited	COORDS:	1564359 m E	5174618 m N	NZTM Z59
PROJECT:	Earthquake Reconstruction Project	SURFACE RL:	25.3 m	DATUM:	CDD
LOCATION:	Halswell Group of Houses	INCLINATION:	-90°	DATE TESTED:	7/08/2012
JOB NUMBER:	1078102455_1660	HOLE DEPTH:	8.9 m	CONTRACTOR:	Golder
				CONE ID:	4469
				CHECKED BY:	KRB

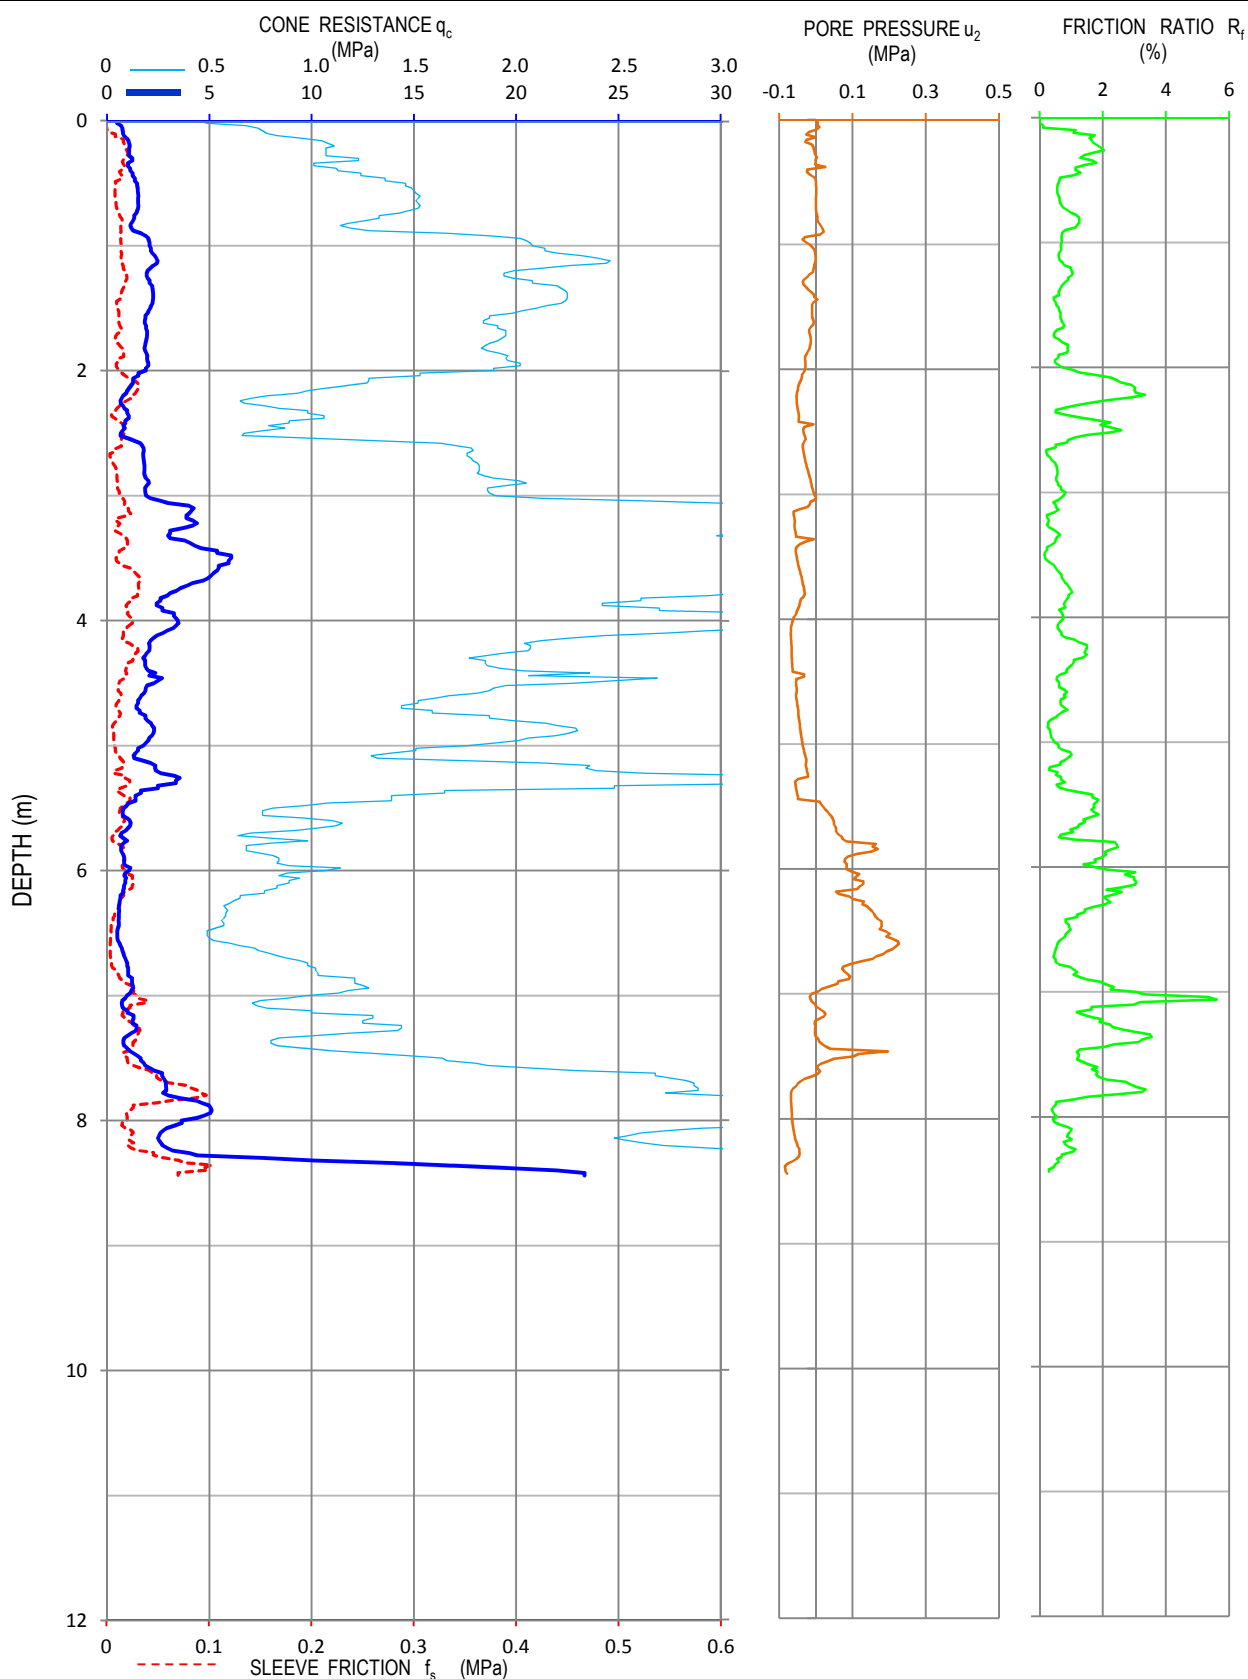
CLIENT:	Arrow International Limited	COORDS:	1564371 m E	5174626 m N	NZTM Z59
PROJECT:	Earthquake Reconstruction Project	SURFACE RL:	25.1 m	DATUM:	CDD
LOCATION:	Halswell Group of Houses	INCLINATION:	-90°	DATE TESTED:	7/08/2012
JOB NUMBER:	1078102455_1660	HOLE DEPTH:	8.4 m	CONTRACTOR:	Golder
				CONE ID:	4469
				CHECKED BY:	KRB

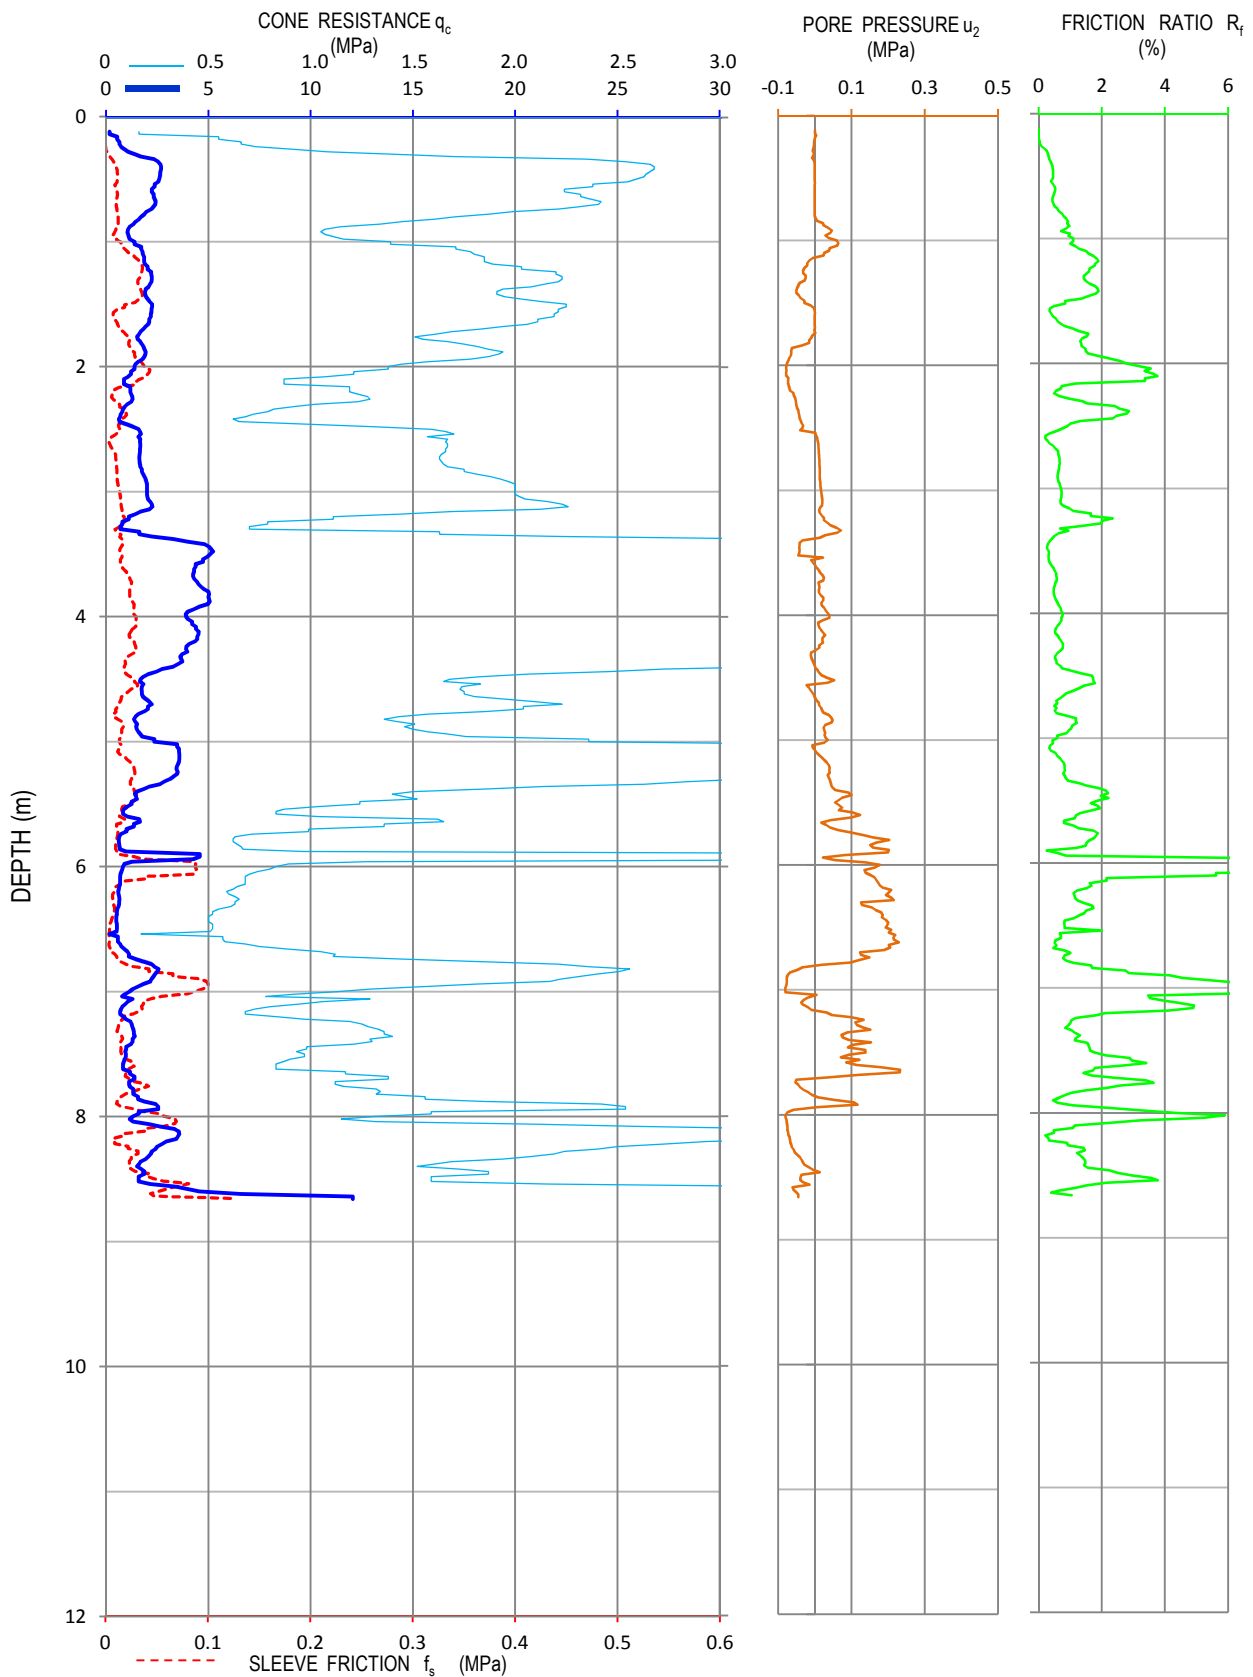
CLIENT:	Arrow International Limited	COORDS:	1564395 m E	5174628 m N	NZTM Z59
PROJECT:	Earthquake Reconstruction Project	SURFACE RL:	25.1 m	DATUM:	CDD
LOCATION:	Halswell Group of Houses	INCLINATION:	-90°	DATE TESTED:	8/08/2012
JOB NUMBER:	1078102455_1660	HOLE DEPTH:	8.7 m	CONTRACTOR:	Golder
				CONE ID:	4469
				CHECKED BY:	KRB

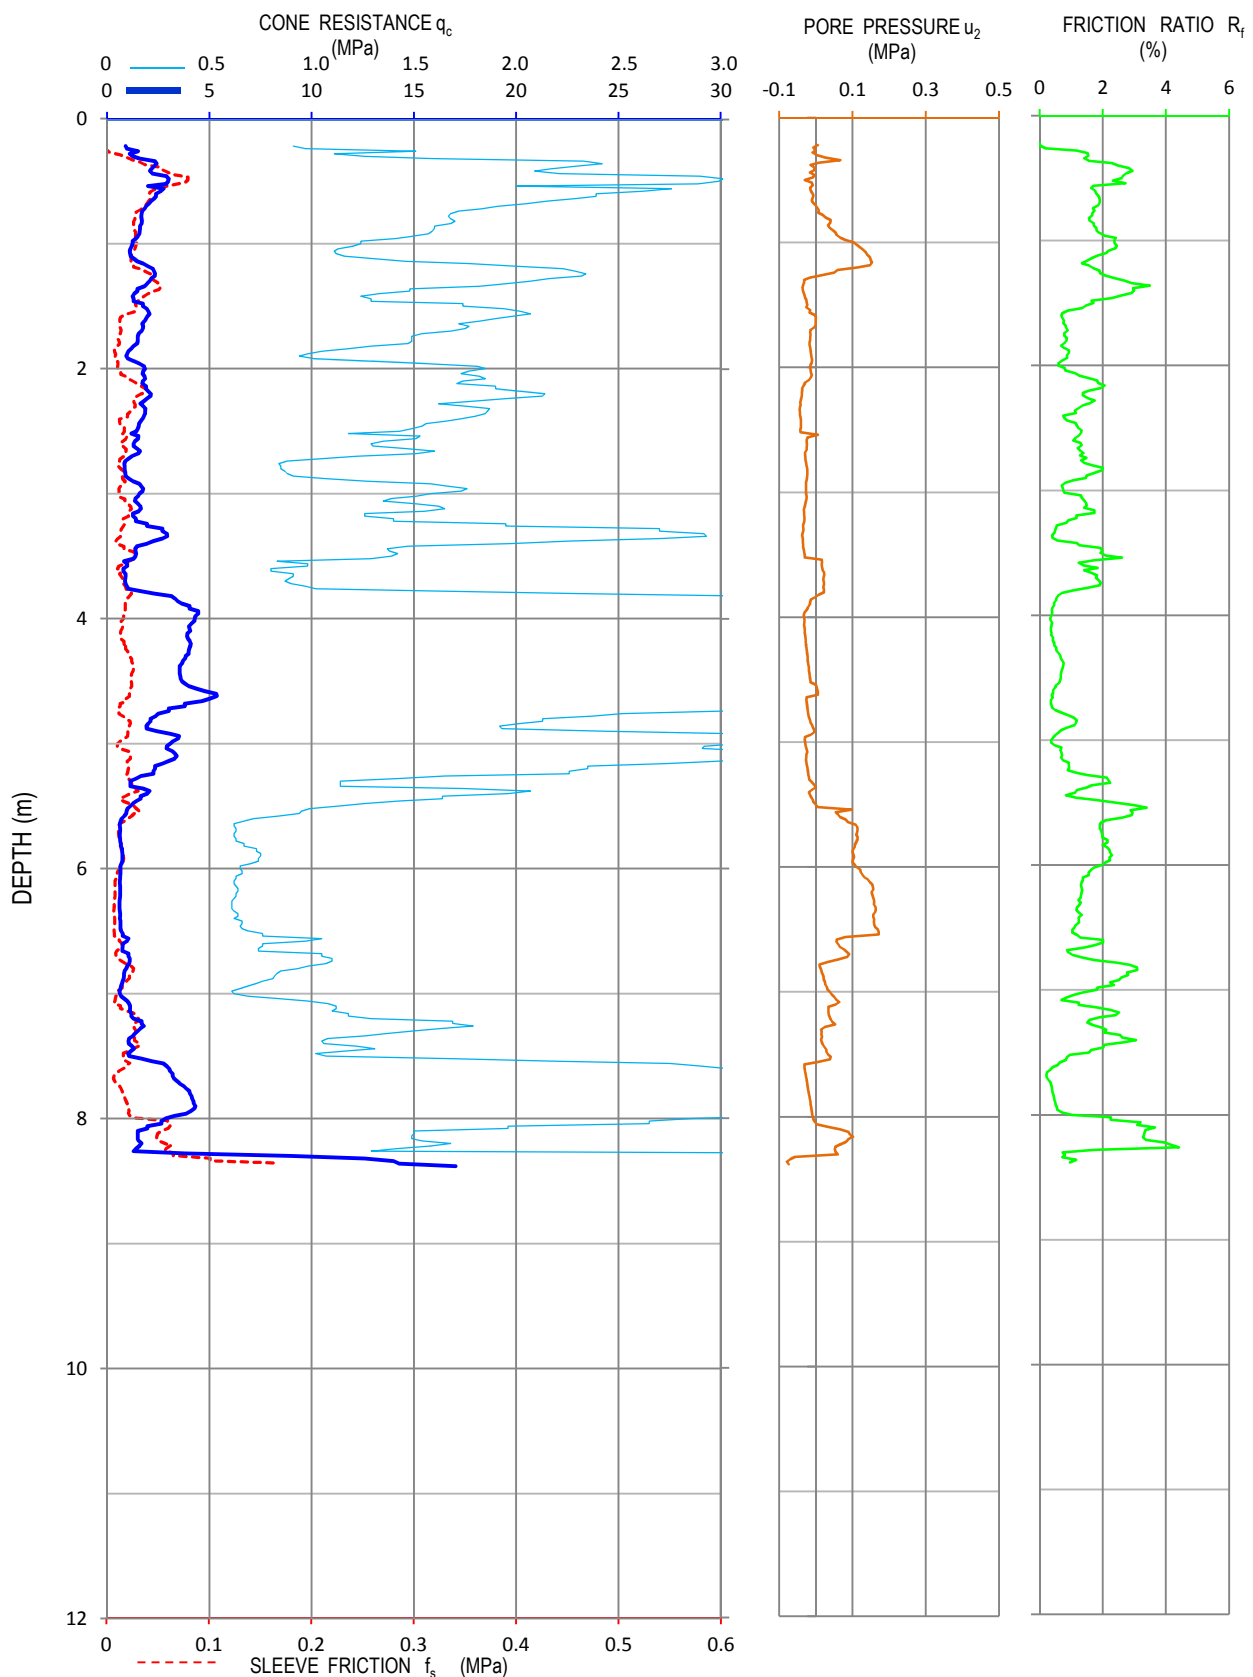
CLIENT:	Arrow International Limited	COORDS:	1564252 m E	5174674 m N	NZTM Z59
PROJECT:	Earthquake Reconstruction Project	SURFACE RL:	25.0 m	DATUM:	CDD
LOCATION:	Halswell Group of Houses	INCLINATION:	-90°	DATE TESTED:	8/08/2012
JOB NUMBER:	1078102455_1660	HOLE DEPTH:	8.4 m	CONTRACTOR:	Golder
				CONE ID:	4469
				CHECKED BY:	KRB

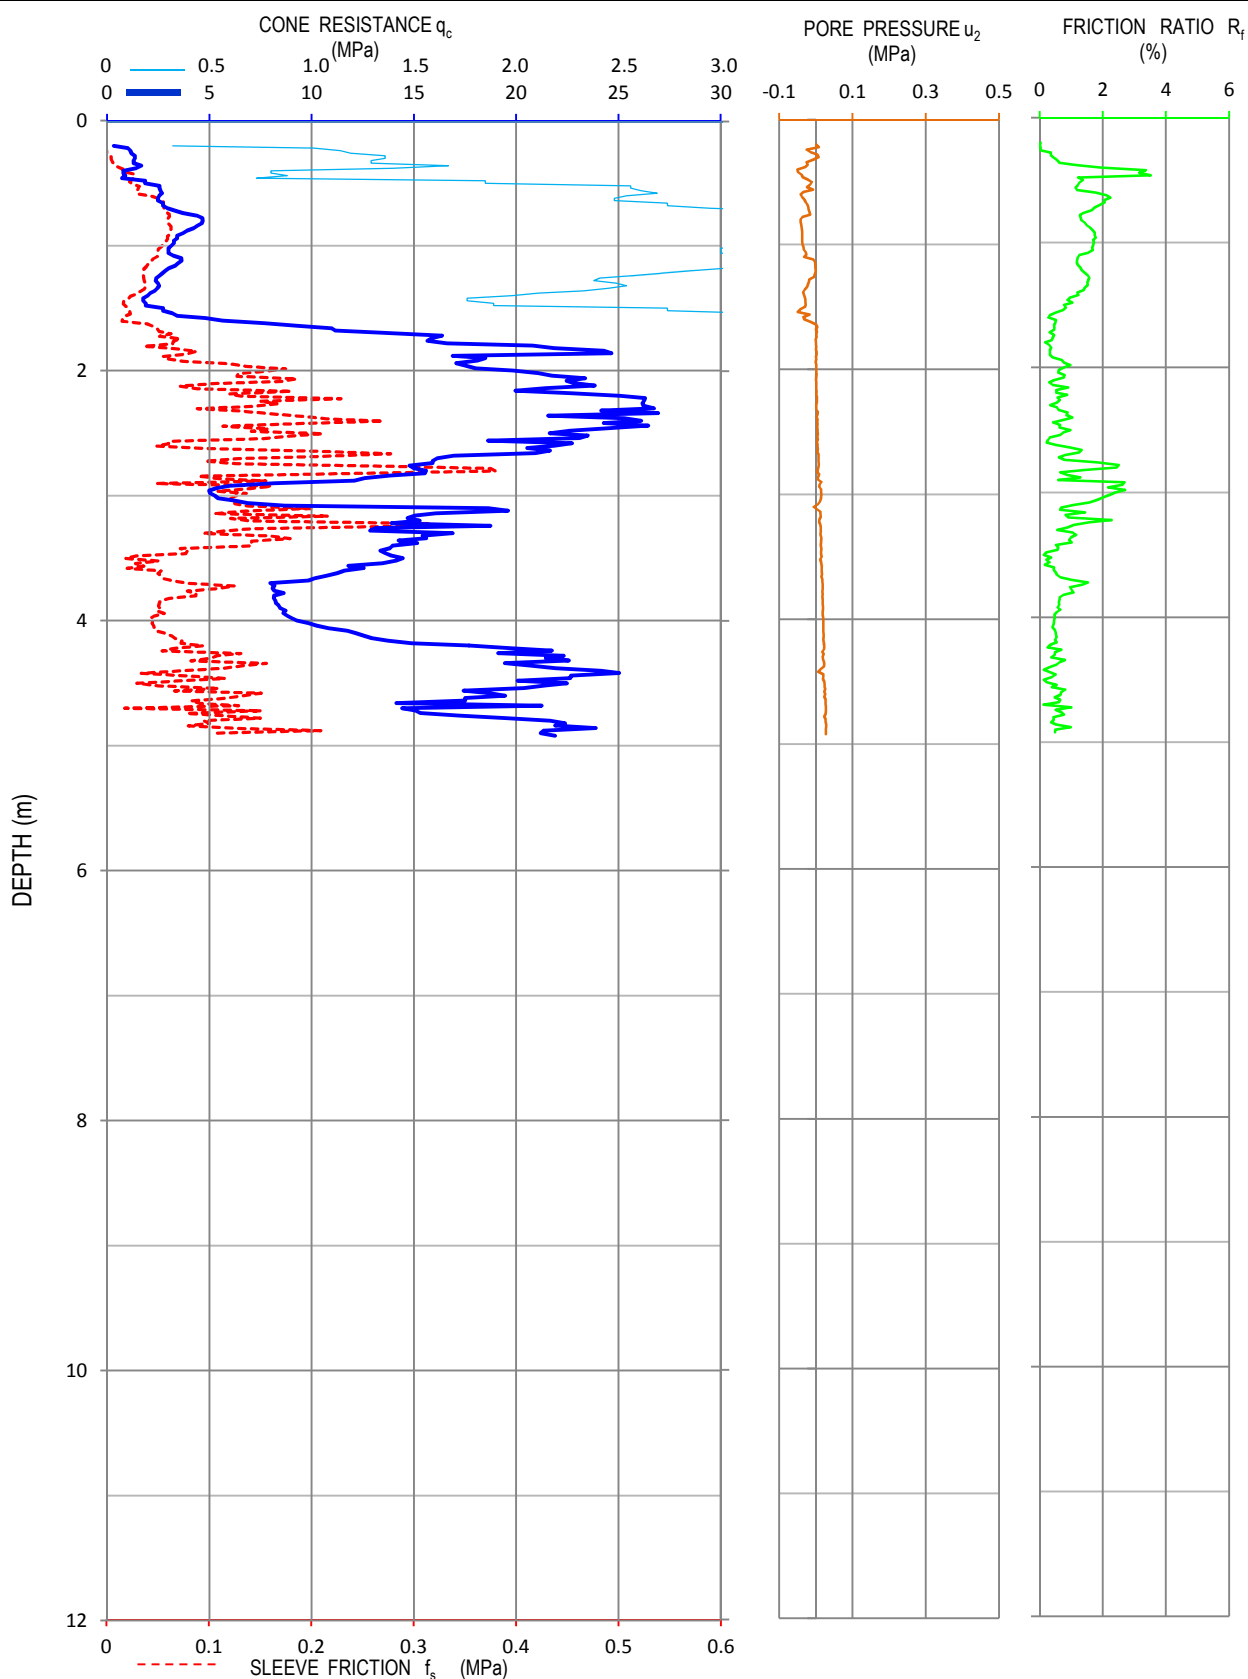
CLIENT:	Arrow International Limited	COORDS:	1564274 m E	5174693 m N	NZTM Z59
PROJECT:	Earthquake Reconstruction Project	SURFACE RL:	24.9 m	DATUM:	CDD
LOCATION:	Halswell Group of Houses	INCLINATION:	-90°	DATE TESTED:	8/08/2012
JOB NUMBER:	1078102455_1660	HOLE DEPTH:	4.9 m	CONTRACTOR:	Golder
				CONE ID:	4469
				CHECKED BY:	KRB

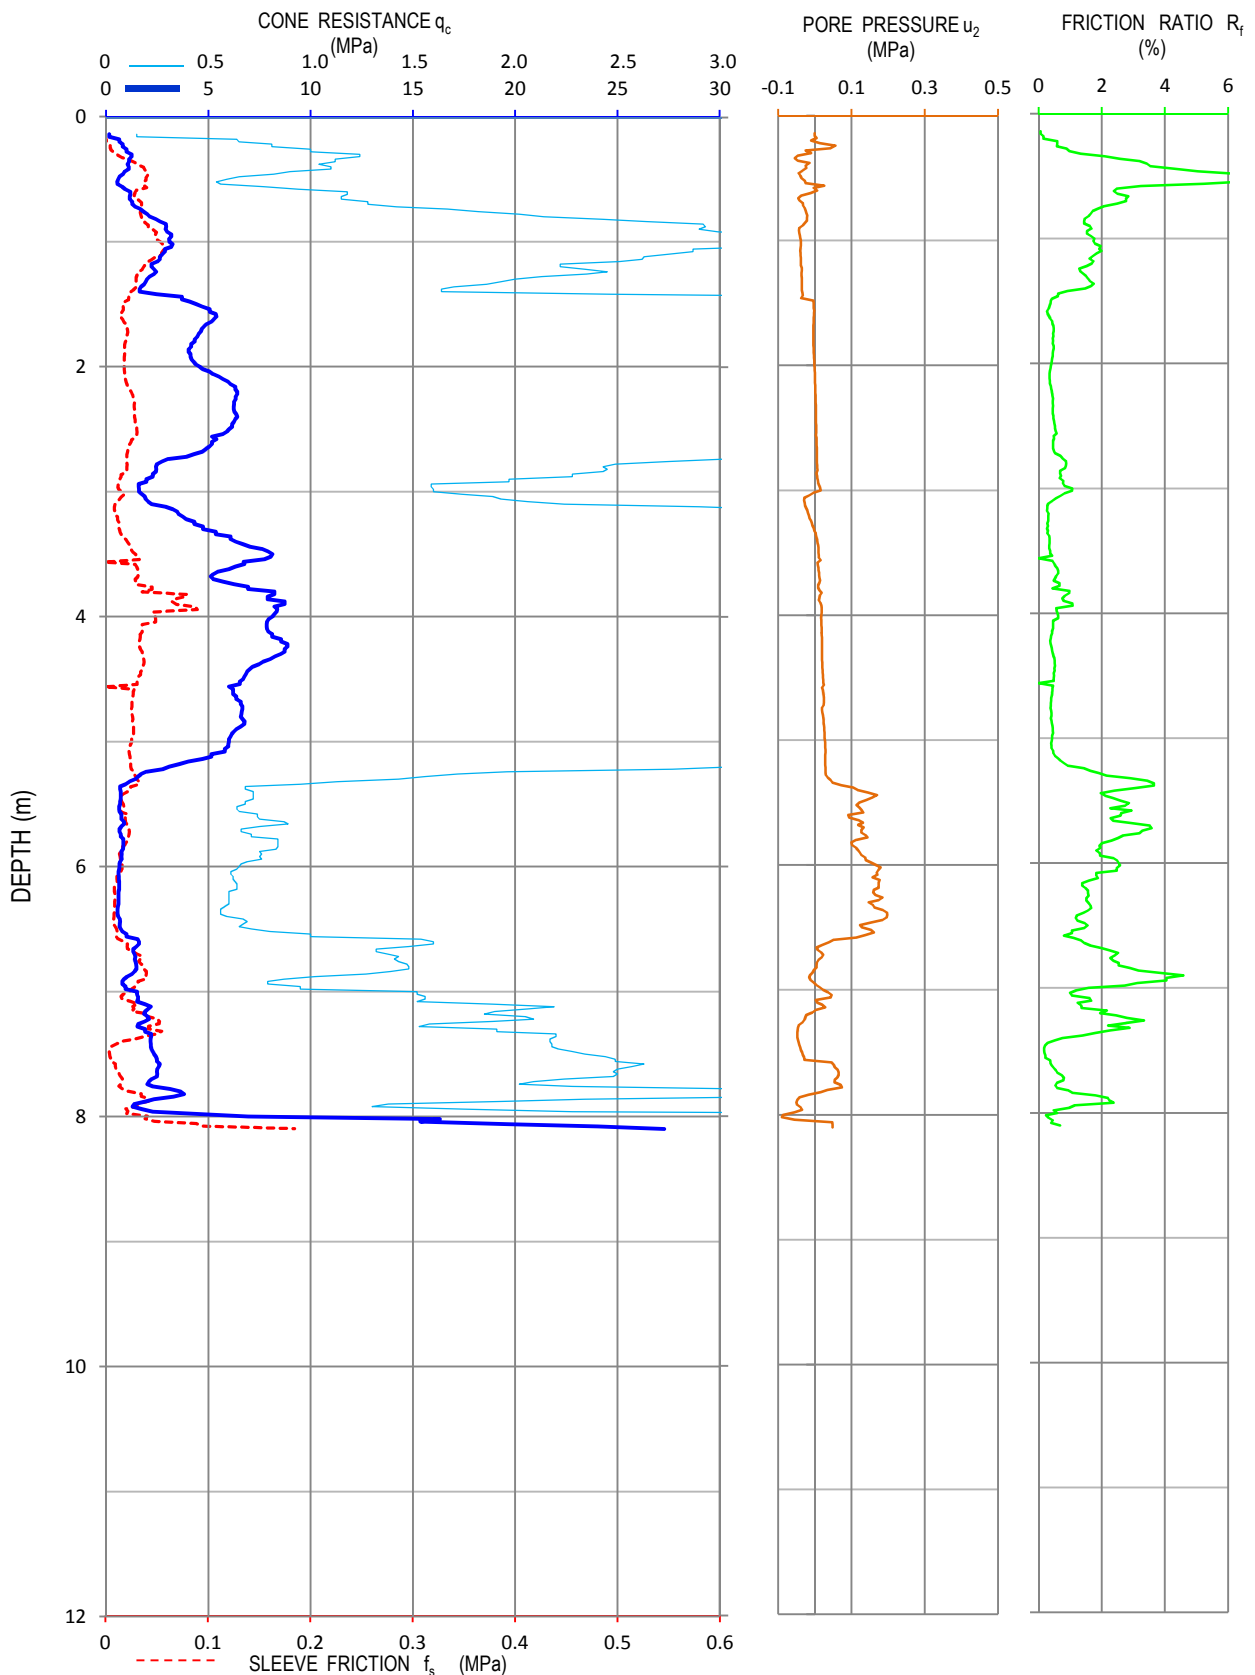
CLIENT:	Arrow International Limited	COORDS:	1564246 m E	5174716 m N	NZTM Z59
PROJECT:	Earthquake Reconstruction Project	SURFACE RL:	24.9 m	DATUM:	CDD
LOCATION:	Halswell Group of Houses	INCLINATION:	-90°	DATE TESTED:	8/08/2012
JOB NUMBER:	1078102455_1660	HOLE DEPTH:	8.1 m	CONTRACTOR:	Golder
				CONE ID:	4469
				CHECKED BY:	KRB

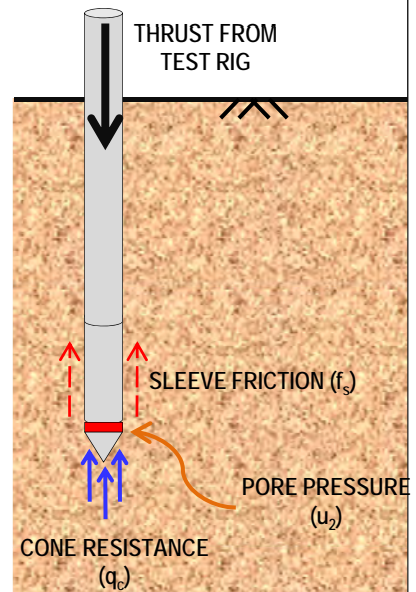
The Friction-Cone Penetration Test (CPT) uses a cone with a following friction sleeve that is fitted with electronic strain and pressure transducers and which is pushed into soil at a constant rate of 1 to 2 cm/s (in accordance with AS1289.6.5.1-1999). The readout from the cone and friction sleeve load cells provide a continuous trace of cone resistance (q_c), and sleeve friction (f_s). If a filter element is incorporated with the cone to measure the pore pressure response (u) as the cone is pushed into the soil, this is referred to as a Piezo-Cone Penetration Test (CPTu). The data obtained from the cone, friction sleeve load cells and pore pressure transducer is transmitted to a computer for data processing and presentation. Traditionally the data is transferred to the surface via a cable that is run inside hollow stem push rods typically 35.7 mm in outside diameter. However data can also be transmitted to the surface via an acoustic signal along the metal rod string and negating the need for a cable connection. This device is referred to as an acoustic cone or acoustic piezo-cone.

The measured values of q_c , f_s and u can be interpreted to assess soil stratigraphy, strength and deformation characteristics. These characteristics may be interpreted using published methods such as outlined in *Cone Penetration Testing in Geotechnical Practice* (Lunne et al 1997).

Dissipation tests can be undertaken during a CPTu by halting the push at a selected depth and measuring the rate of decay in the pore pressure generated. As the cone is stationary, the pore pressure will dissipate to the *in situ* hydrostatic pore pressure. By recording and plotting this rate of dissipation, a measure of the horizontal permeability and consolidation characteristics of the soil can then be inferred.

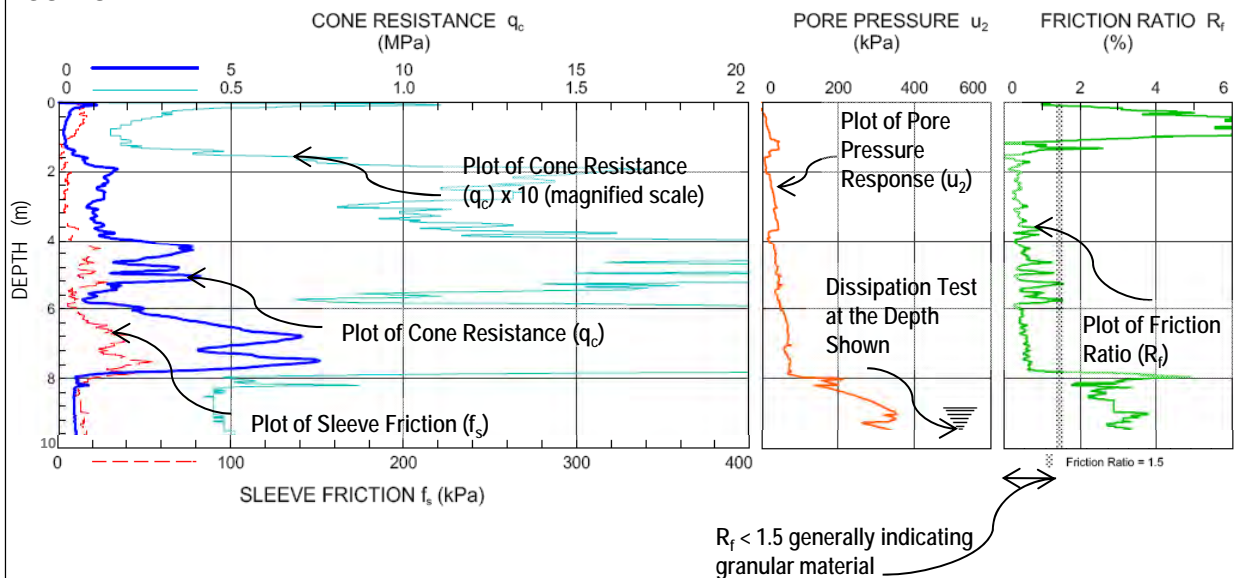
OUTPUT EXAMPLE

q_c — Measured Cone Resistance
 f_s — Sleeve Friction
 u_2 — Pore Pressure
 R_f — Friction Ratio = $\frac{\text{Sleeve Friction} \times 100}{\text{Cone Resistance}}$
 $= \frac{f_s \times 100}{q_c}$

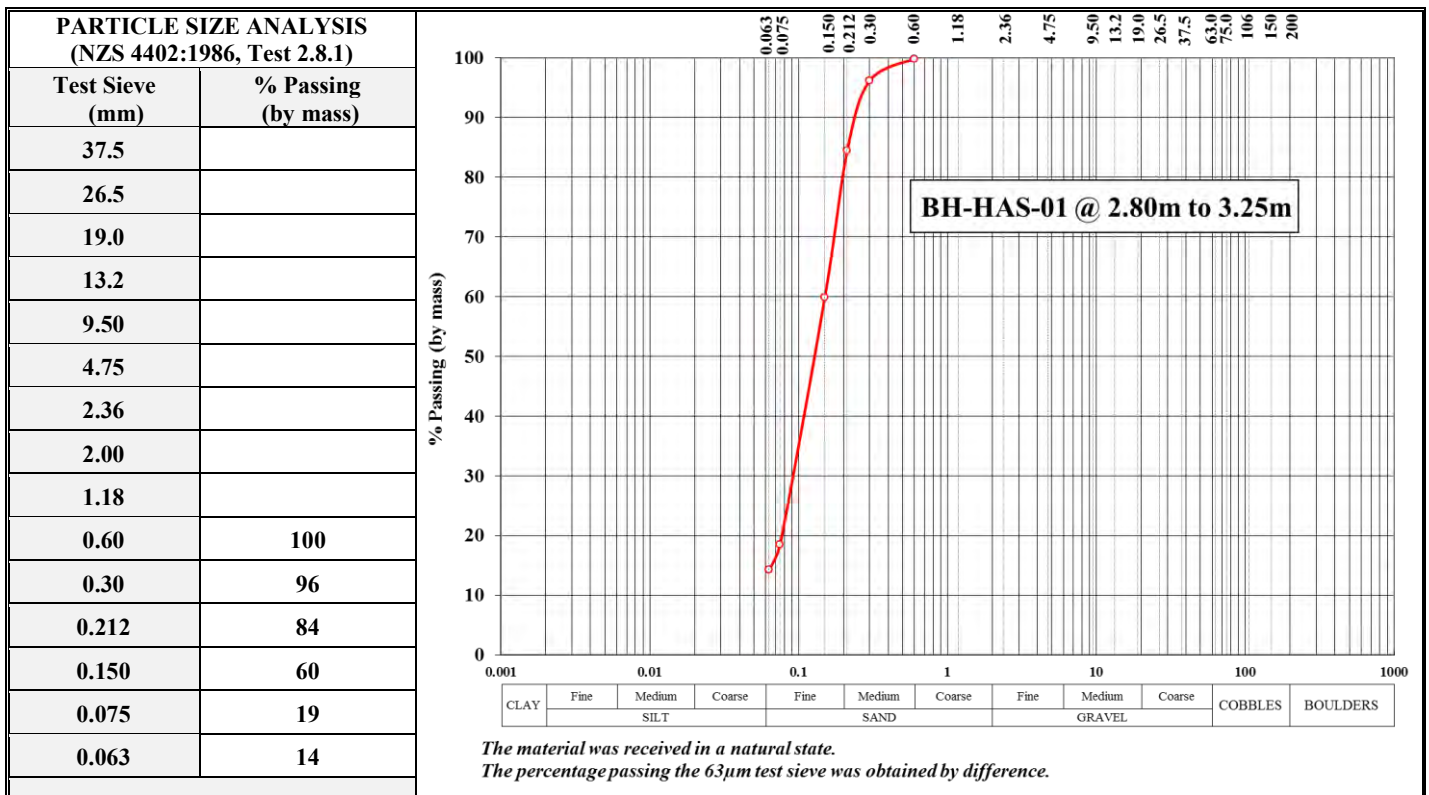
Client Details:	Golder Associates (NZ) Ltd, P.O. Box 2281, Christchurch	Attention:	M. Furniss
Job Description:	Halswell Rd / Halswell Junction Rd – J/N 1078102455-1660	Sample Source:	BH-HAS-01 @ 2.80m to 3.25m
Sample Description:	SAND with some silt	Sampled By:	M. Furniss
Date & Time Sampled:	22-Aug-12 (Trial 134)	Sample Method:	Borehole

WATER CONTENT RESULT - NZS 4402:1986, Test 2.1
