Land Information Memorandum

1/126 Halswell Junction Road

REPORT

GEOTECHNICAL ASSESSMENT REPORT - HALSWELL GROUP OF HOUSES

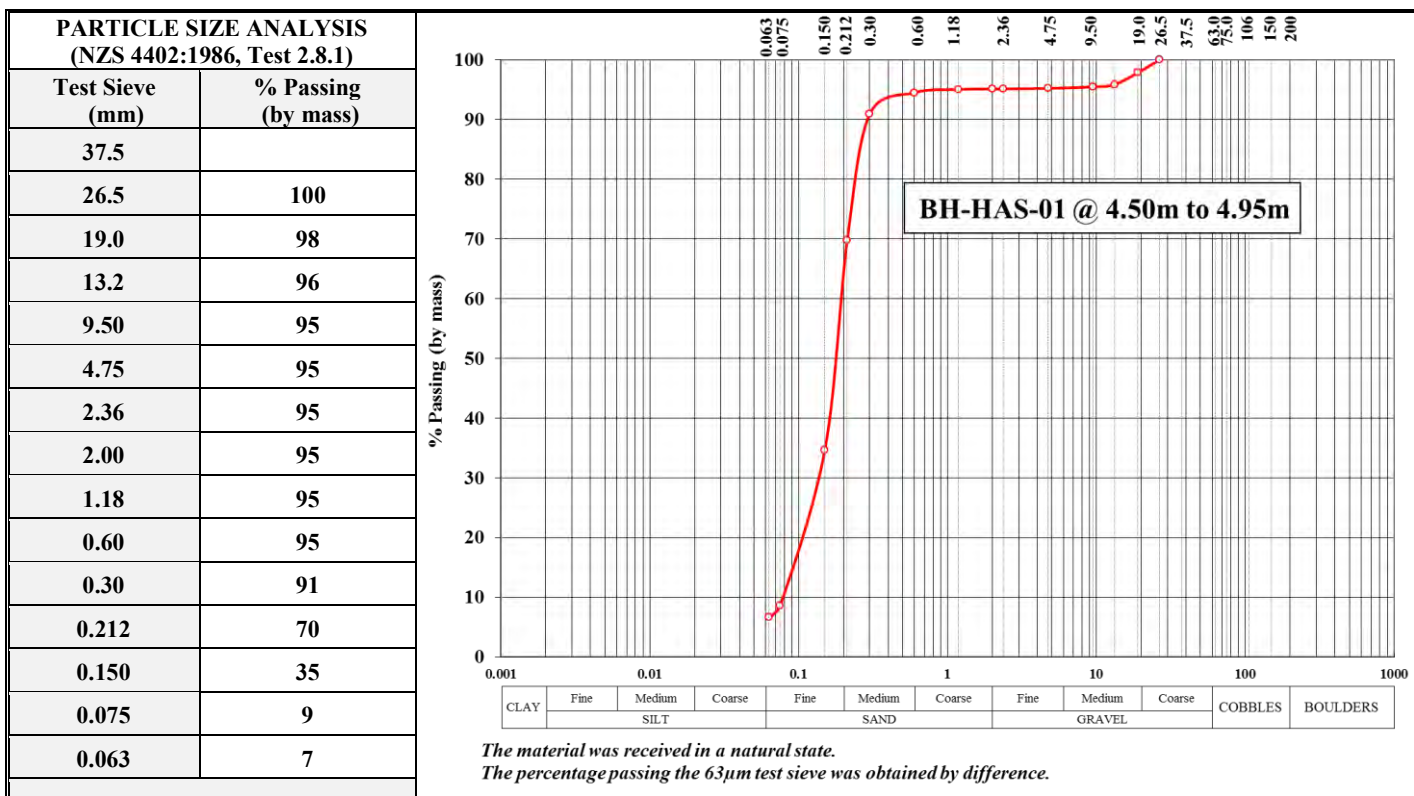
Client Details:	Golder Associates (NZ) Ltd, P.O. Box 2281, Christchurch	Attention:	M. Furniss
Job Description:	Halswell Rd / Halswell Junction Rd – J/N 1078102455-1660	Sample Source:	BH-HAS-01 @ 4.50m to 4.95m
Sample Description:	SAND with minor silt and trace of / minor gravel	Sampled By:	M. Furniss
Date & Time Sampled:	22-Aug-12 (Trial 134)	Sample Method:	Borehole

WATER CONTENT RESULT - NZS 4402:1986, Test 2.1	
Water Content: (As Received)	25.0 %
Note: The sample received was in a natural state.

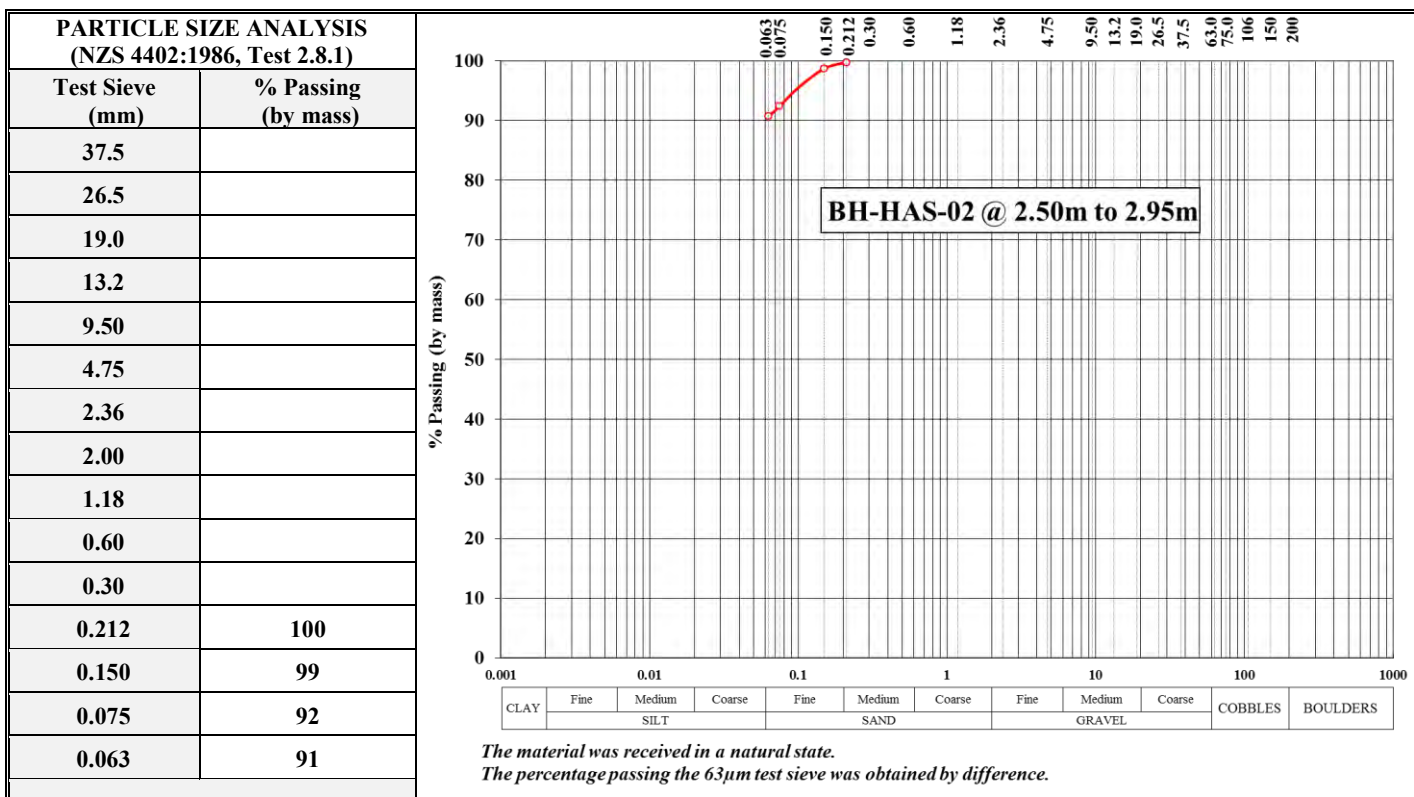
Client Details:	Golder Associates (NZ) Ltd, P.O. Box 2281, Christchurch	Attention:	M. Furniss
Job Description:	Halswell Rd / Halswell Junction Rd – J/N 1078102455-1660	Sample Source:	BH-HAS-02 @ 2.50m to 2.95m
Sample Description:	SILT with minor sand	Sampled By:	M. Furniss
Date & Time Sampled:	27-Aug-12 (Trial 132)	Sample Method:	Borehole

WATER CONTENT & PLASTICITY INDEX RESULTS - NZS 4402:1986, Test 2.1, 2.2, 2.3 & 2.4	
Water Content: (As Received)	29.6 %
Liquid Limit: (LL)	Not Applicable (NA)
Plastic Limit: (PL)	Non Plastic (NP)
Plasticity Index: (PI)	Non Plastic (NP)
Note: The sample received was in a natural state. The plasticity index material tested was whole soil.

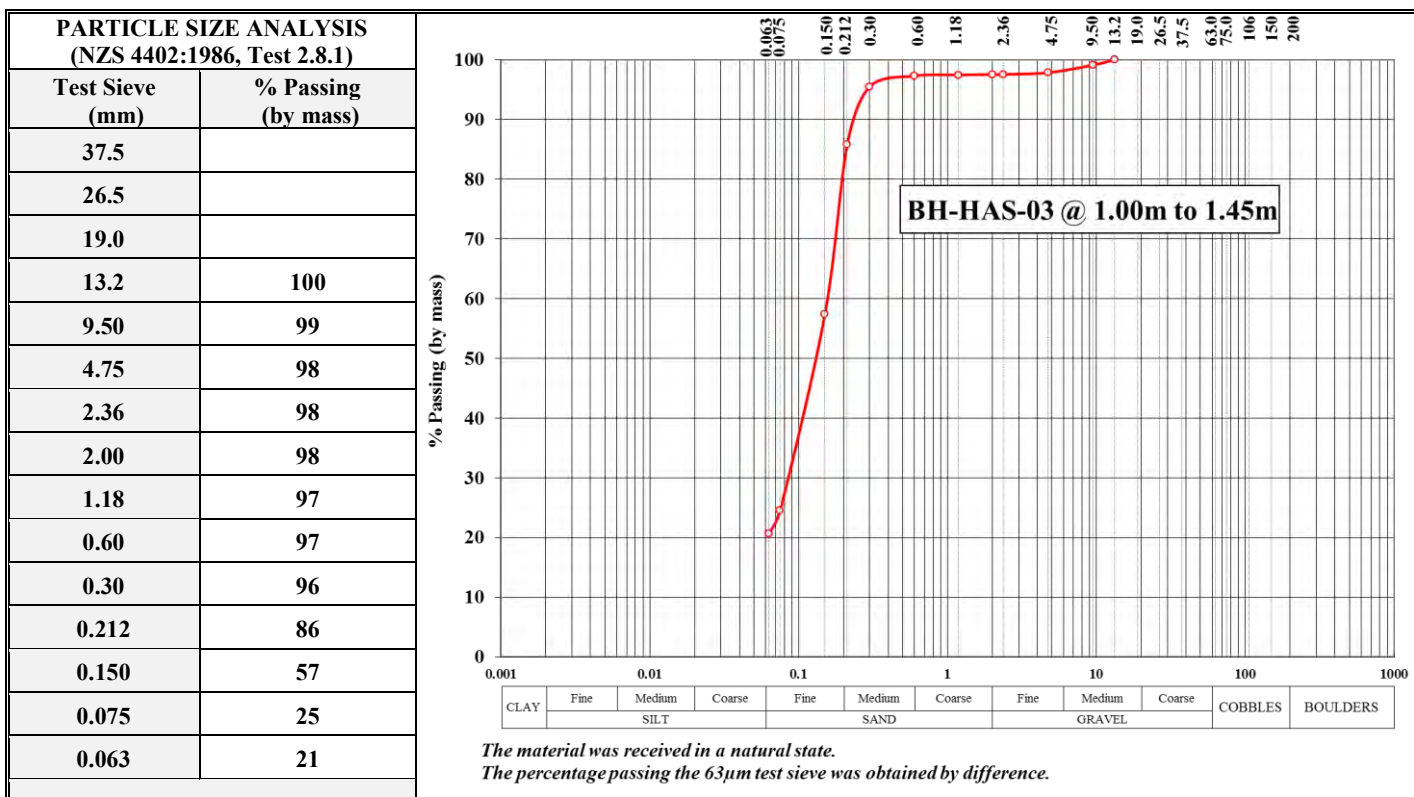
Client Details:	Golder Associates (NZ) Ltd, P.O. Box 2281, Christchurch	Attention:	M. Furniss
Job Description:	Halswell Rd / Halswell Junction Rd – J/N 1078102455-1660	Sample Source:	BH-HAS-03 @ 1.00m to 1.45m
Sample Description:	Silty SAND with trace of gravel	Sampled By:	M. Furniss
Date & Time Sampled:	28-Aug-12 (Trial 128)	Sample Method:	Borehole

WATER CONTENT RESULT - NZS 4402:1986, Test 2.1

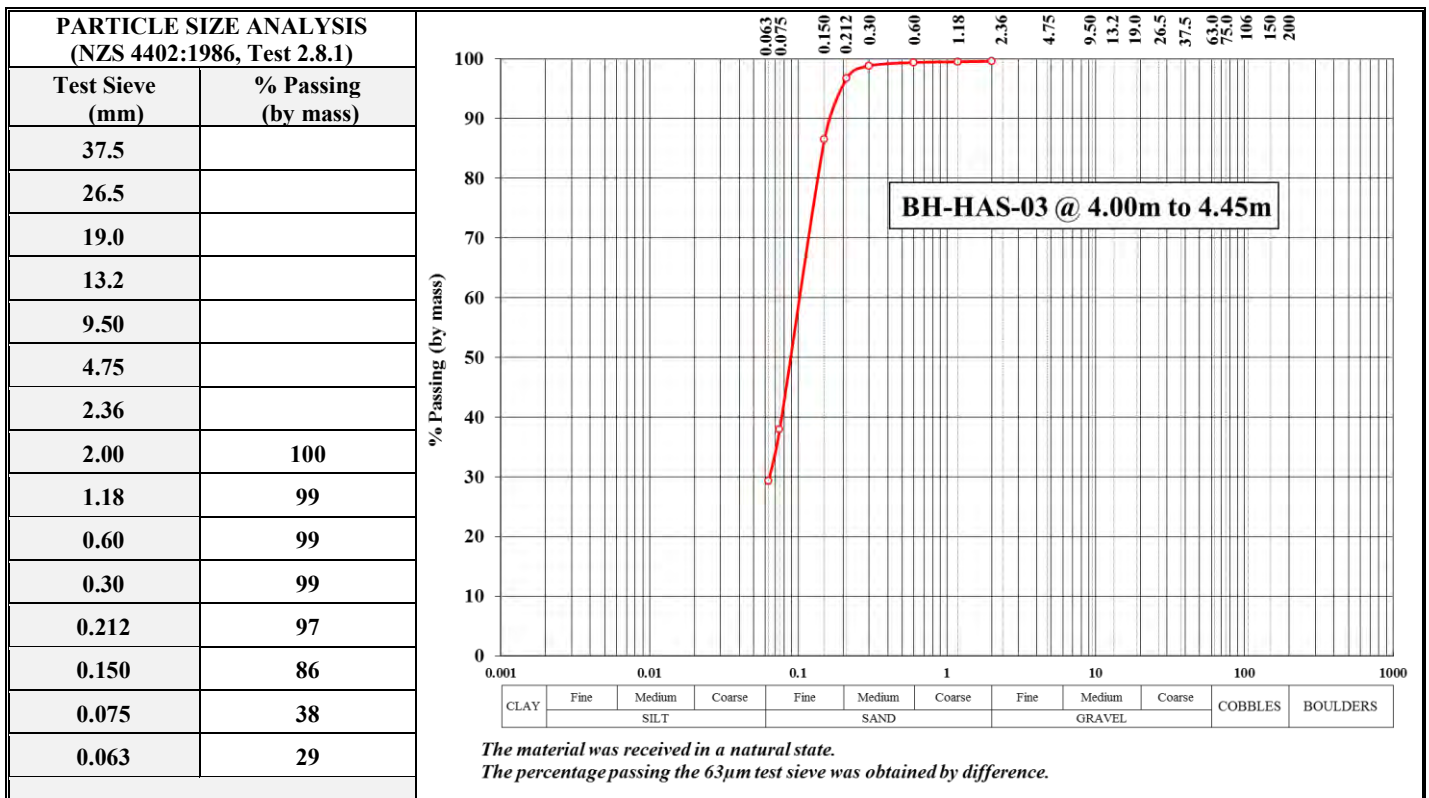
Client Details:	Golder Associates (NZ) Ltd, P.O. Box 2281, Christchurch	Attention:	M. Furniss
Job Description:	Halswell Rd / Halswell Junction Rd – J/N 1078102455-1660	Sample Source:	BH-HAS-03 @ 4.00m to 4.45m
Sample Description:	Silty SAND with trace of gravel	Sampled By:	M. Furniss
Date & Time Sampled:	30-Aug-12 (Trial 128)	Sample Method:	Borehole

WATER CONTENT RESULT - NZS 4402:1986, Test 2.1	
Water Content: (As Received)	25.3 %
Note: The sample received was in a natural state.

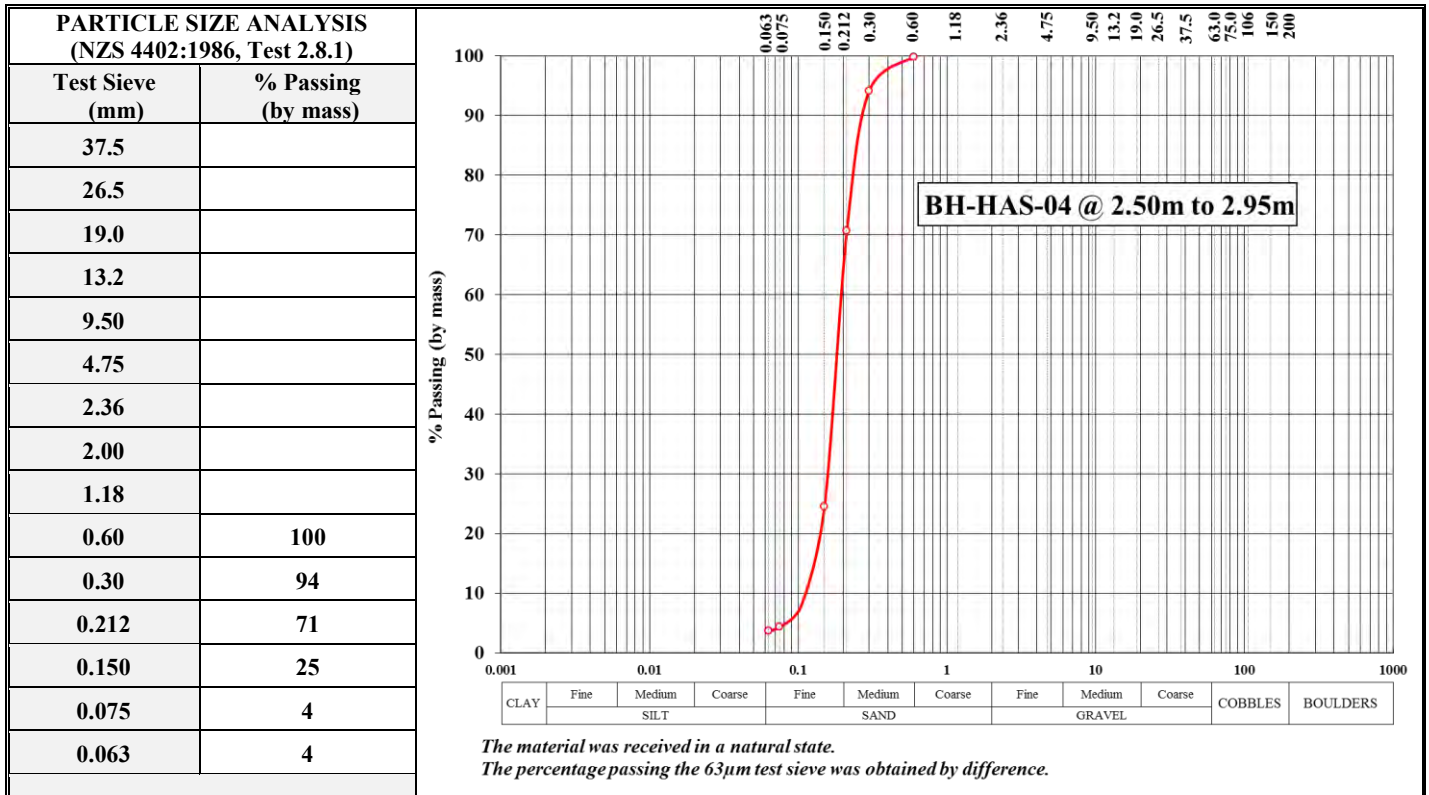
Client Details:	Golder Associates (NZ) Ltd, P.O. Box 2281, Christchurch	Attention:	M. Furniss
Job Description:	Halswell Rd / Halswell Junction Rd – J/N 1078102455-1660	Sample Source:	BH-HAS-04 @ 2.50m to 2.95m
Sample Description:	SAND with trace of silt	Sampled By:	M. Furniss
Date & Time Sampled:	3-Sep-12 (Trial 142)	Sample Method:	Borehole

WATER CONTENT RESULT - NZS 4402:1986, Test 2.1	
Water Content: (As Received)	26.4 %
Note: The sample received was in a natural state.

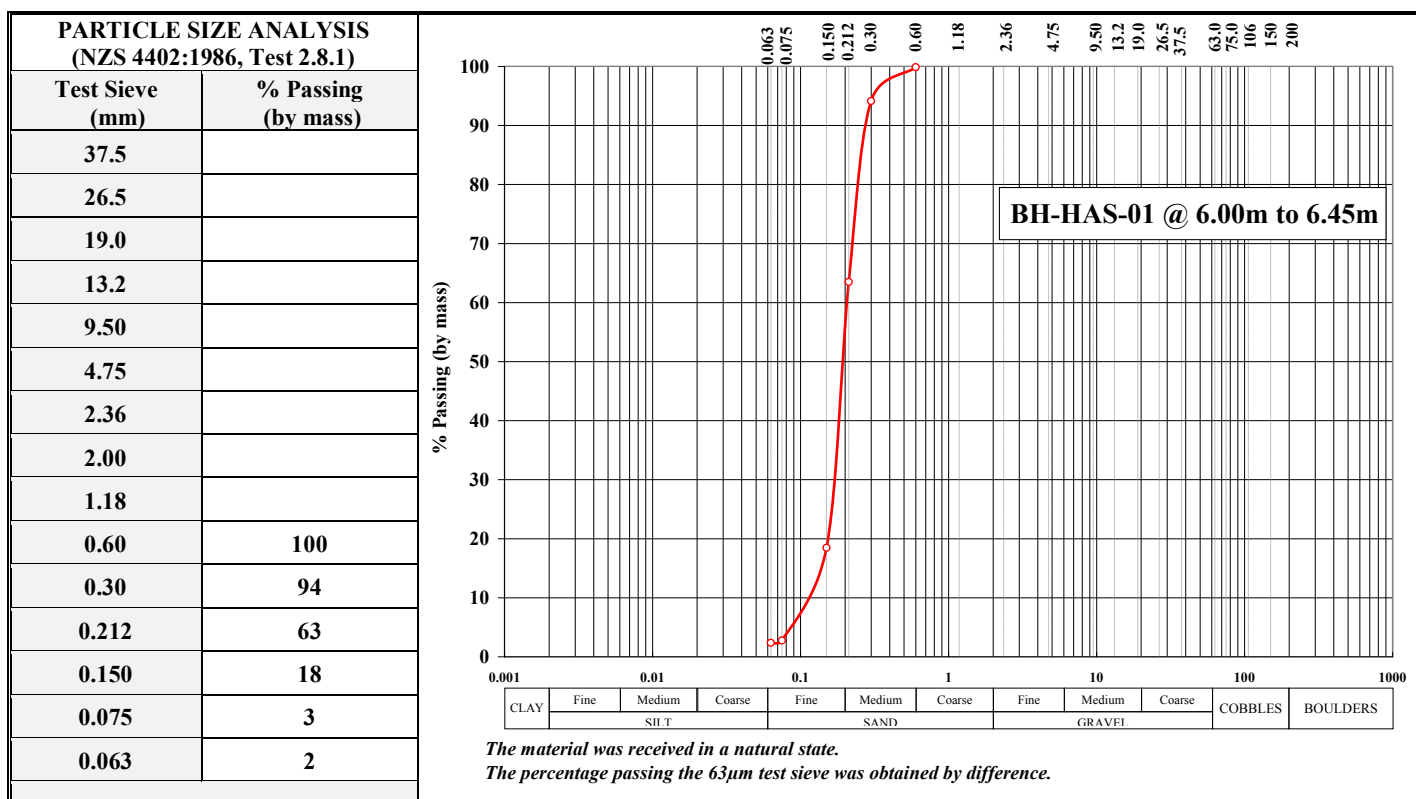
Client Details:	Golder Associates (NZ) Ltd, P.O. Box 2281, Christchurch	Attention:	A. Baldwin
Job Description:	Halswell Group of Houses – J/N 1078102455-1660	Sample Source:	BH-HAS-01 @ 6.00m to 6.45m
Sample Description:	SAND with trace of silt	Sampled By:	Unknown
Date & Time Sampled:	Unknown	Sample Method:	Borehole

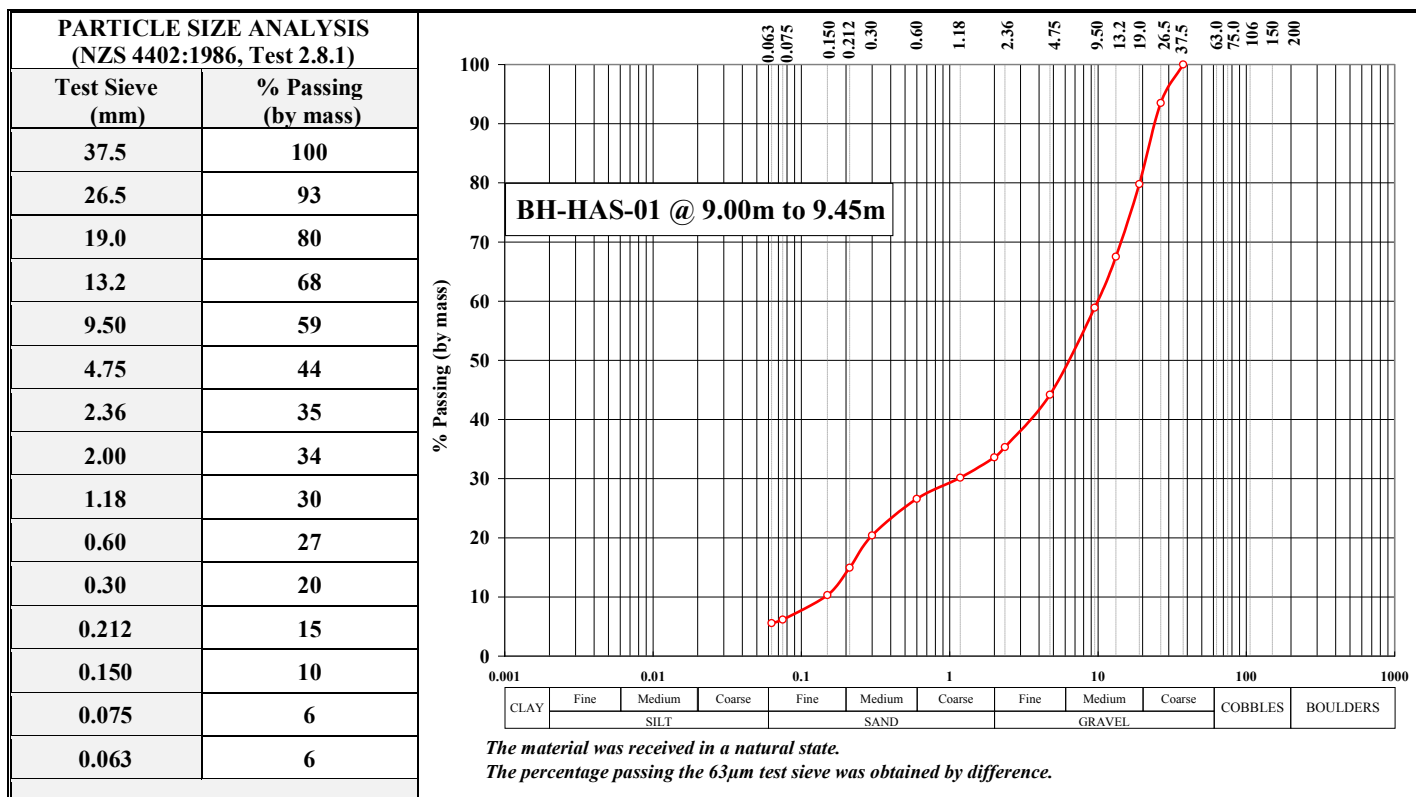
Client Details:	Golder Associates (NZ) Ltd, P.O. Box 2281, Christchurch	Attention:	A. Baldwin
Job Description:	Halswell Group of Houses – J/N 1078102455-1660	Sample Source:	BH-HAS-01 @ 9.00m to 9.45m
Sample Description:	Sandy GRAVEL with minor silt	Sampled By:	Unknown
Date & Time Sampled:	Unknown	Sample Method:	Borehole

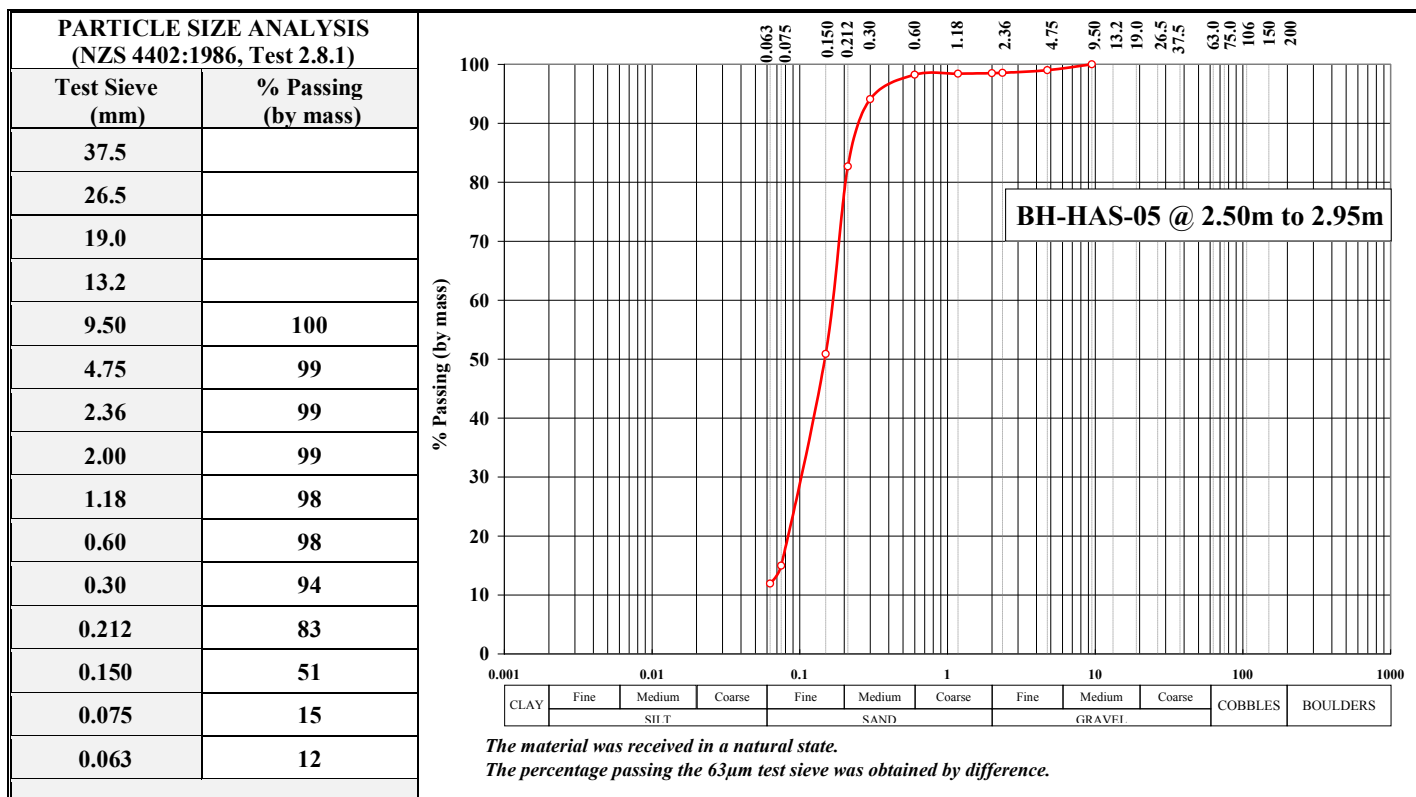
Client Details:	Golder Associates (NZ) Ltd, P.O. Box 2281, Christchurch	Attention:	A. Baldwin
Job Description:	Halswell Group of Houses – J/N 1078102455-1660	Sample Source:	BH-HAS-05 @ 2.50m to 2.95m
Sample Description:	SAND with minor / some silt and trace of gravel	Sampled By:	Unknown
Date & Time Sampled:	Unknown	Sample Method:	Borehole

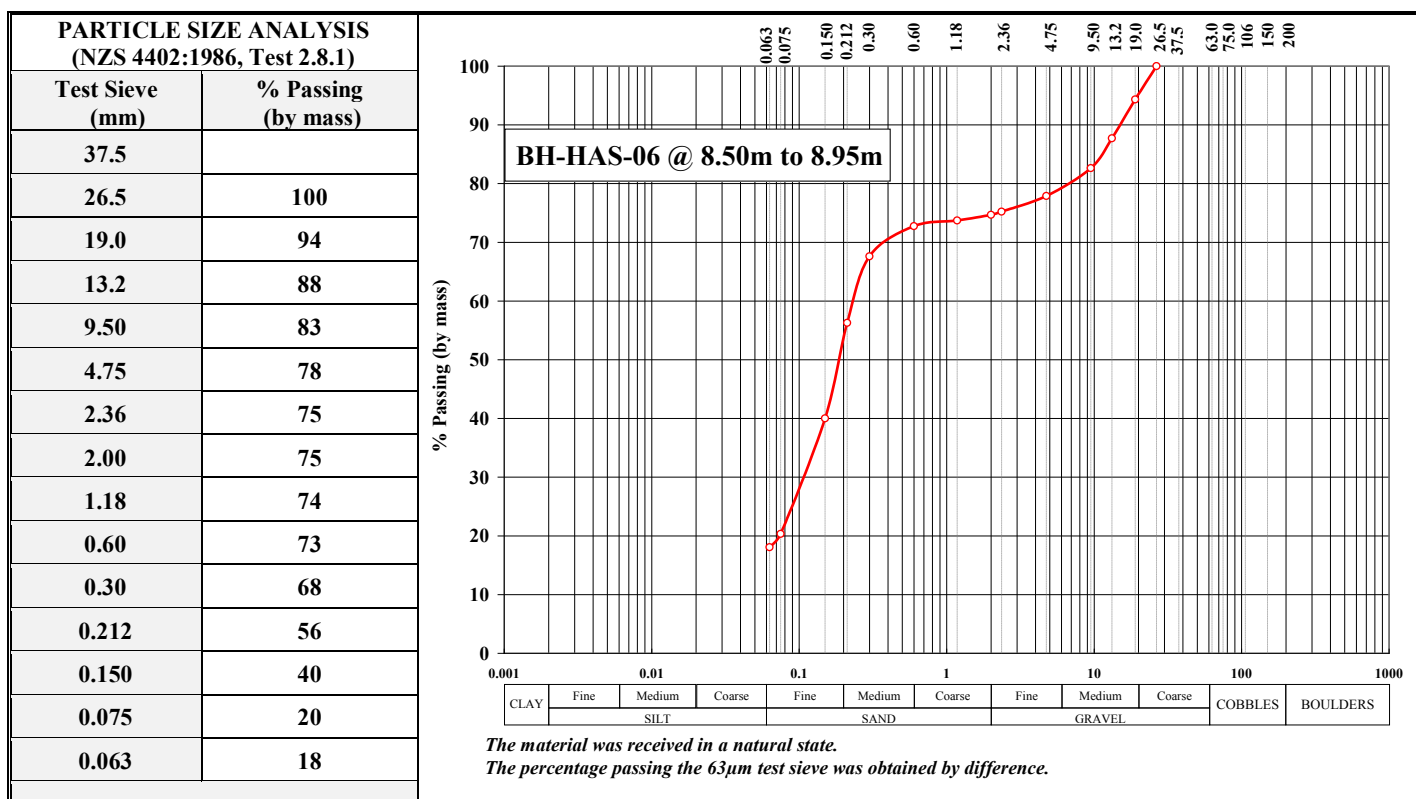
Client Details:	Golder Associates (NZ) Ltd, P.O. Box 2281, Christchurch	Attention:	A. Baldwin
Job Description:	Halswell Group of Houses – J/N 1078102455-1660	Sample Source:	BH-HAS-06 @ 8.50m to 8.95m
Sample Description:	Gravelly SAND with some silt	Sampled By:	Unknown
Date & Time Sampled:	Unknown	Sample Method:	Borehole

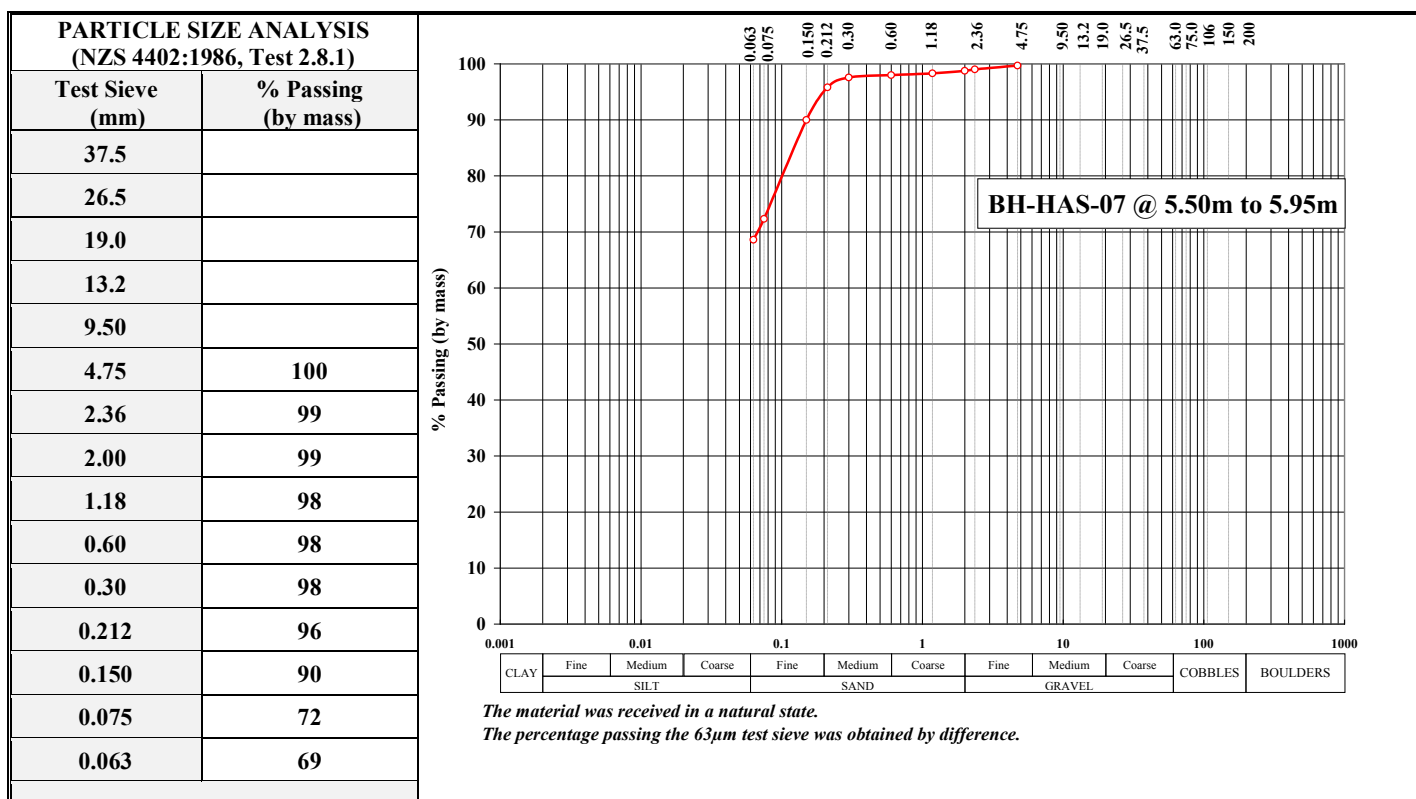
Client Details:	Golder Associates (NZ) Ltd, P.O. Box 2281, Christchurch	Attention:	A. Baldwin
Job Description:	Halswell Group of Houses – J/N 1078102455-1660	Sample Source:	BH-HAS-07 @ 5.50m to 5.95m
Sample Description:	Sandy SILT with minor clay	Sampled By:	Unknown
Date & Time Sampled:	Unknown	Sample Method:	Borehole

WATER CONTENT & PLASTICITY INDEX RESULTS - NZS 4402:1986, Test 2.1, 2.2, 2.3 & 2.4	
Water Content: (As Received)	27.8 %
Liquid Limit: (LL)	23
Plastic Limit: (PL)	19
Plasticity Index: (PI)	4
Note: The sample received was in a natural state. The plasticity index material tested was the -425µm fraction.
