# CASH SETTLED CLAIM(S)

# Scope of Works

## Assessment of Property at 147 KING STREET, SYDENHAM, CHRISTCHURCH 8023 on 26/10/2011

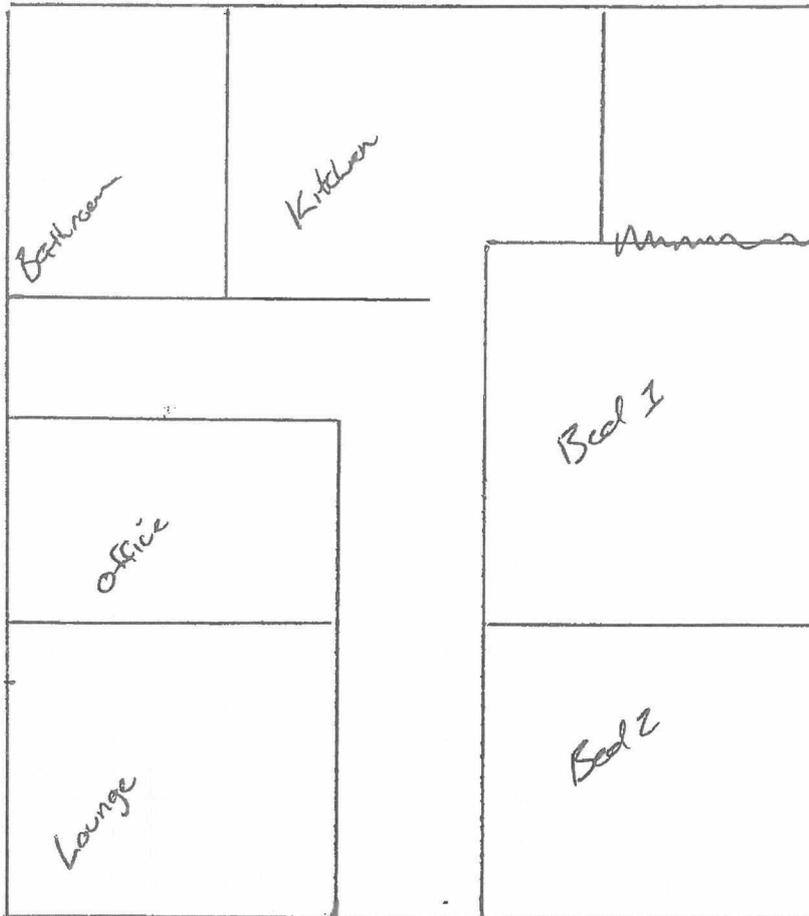
SHEET 1/2

- Use this form to sketch a floor plan of the property. This is required for ASBESTOS SCOPING and ELECTRICAL ASSESSMENTS to assist with identifying areas of the property.
- Ensure plans are clearly labelled and identifies areas of the property (i.e. Ground floor, Second floor, Lounge, Kitchen, Bed 1, Bed 2 etc) and are consistent with those referred to for asbestos scoping or electrical assessment checklists.
- A Floor Plan may also be useful for general construction purposes.
