## LAND INFORMATION MEMORANDUM

Property address:  
19 Belfield Street

**Geotechnical Engineering Investigation  
Dwelling Foundation Assessment  
19 Belfield Street  
Dallington  
Christchurch**

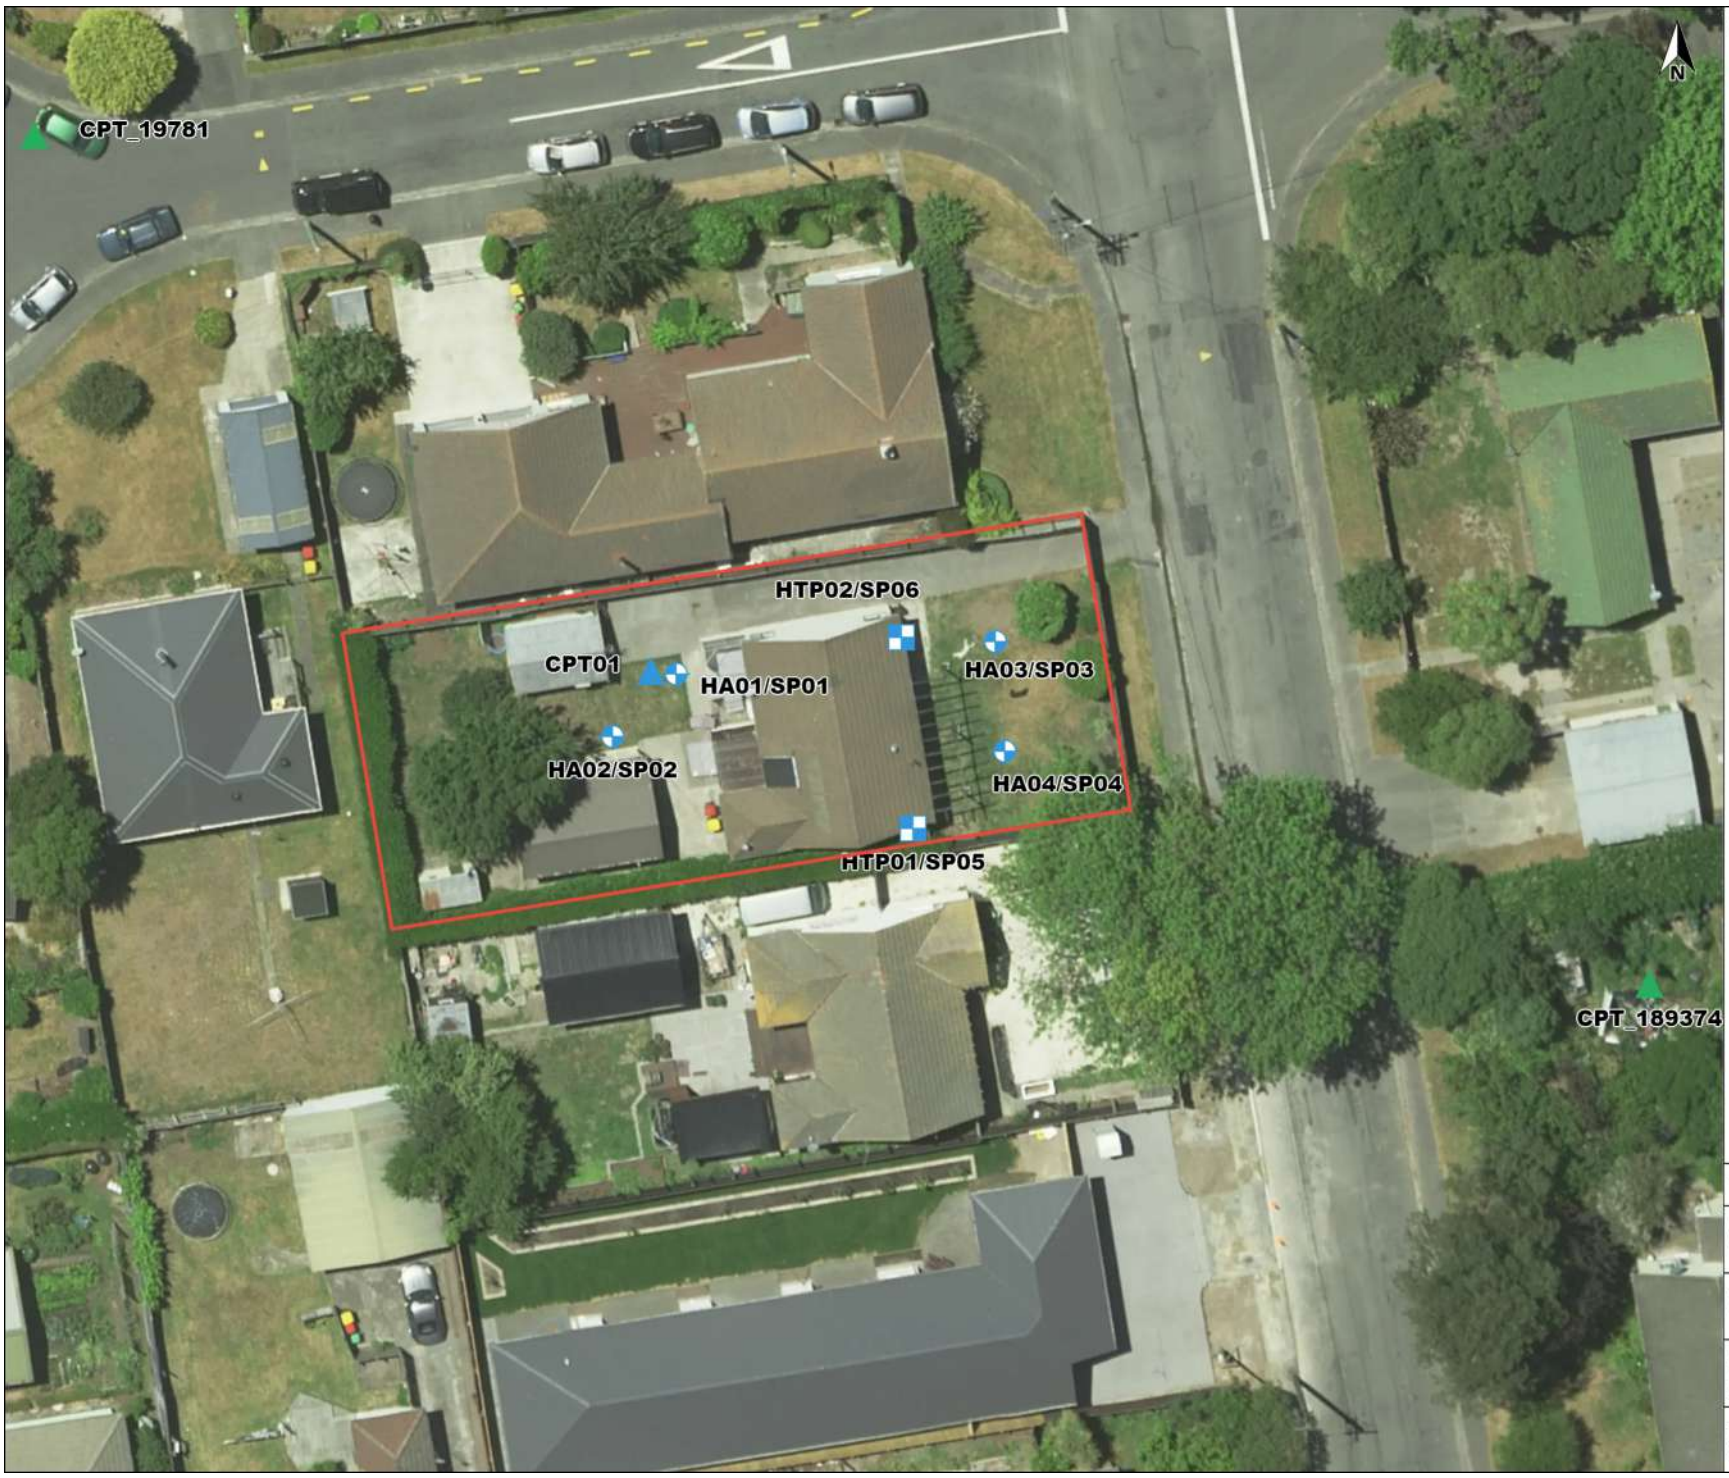
- Legend**
- Site Boundary
  - Hand Auger Boreholes and Scala Penetrometer Test Location (Landform Projects on behalf of KGA, 14 June 2023)
  - Hand-dug Trial Pit and Scala Penetrometer Test Location (Landform Projects on behalf of KGA, 14 June 2023)
  - CPT Location (Ground Investigation Ltd on behalf of KGA, 14 June 2023)
  - NZGD CPT Locations
