Threemile Creek Restoration Design

THREEMILE CREEK RESTORATION SITE

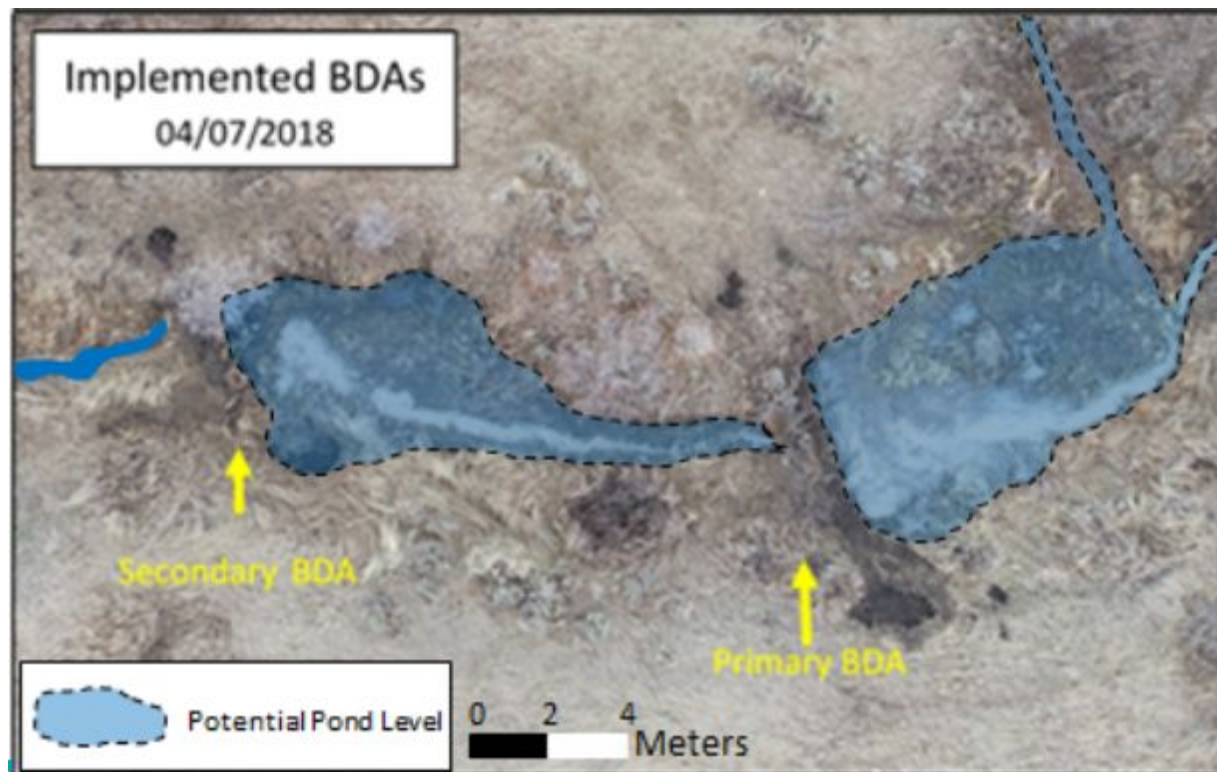
Hypothesis	Intended Outcome
The BDA structures will increase floodplain connectivity by raising the water levels and causing aggradation.	The presence of the BDA structures will decelerate the flow of the water, causing the water levels to rise and increase the area of inundation. Because the flow is decelerated, the water will become less turbid, allowing sediment to deposit upstream of the structure and increase the floodplain connectivity.

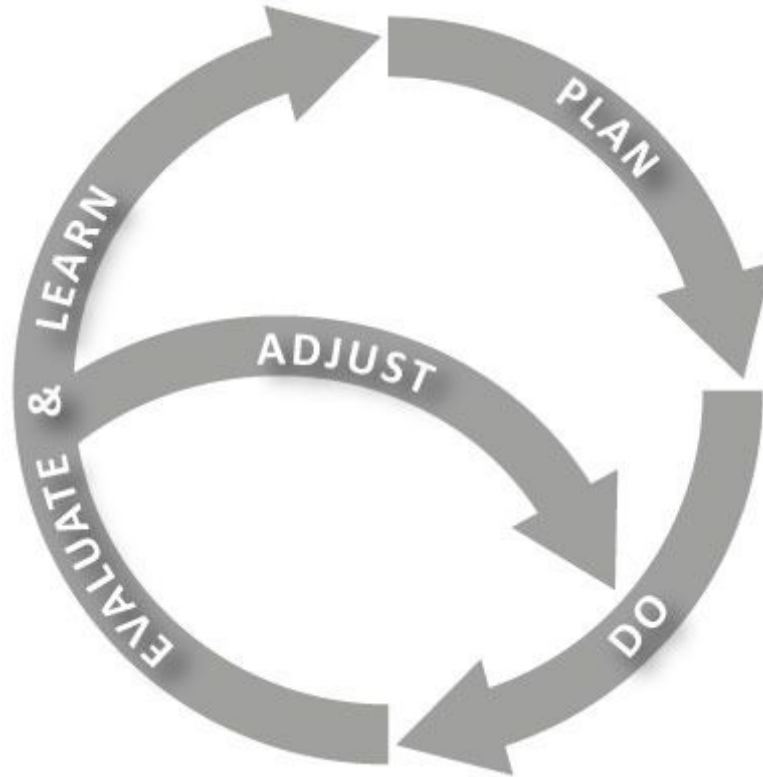
Adaptive Management

Pathway in flowchart	Action	Reason
Complex achieving objectives?	If yes, <ul style="list-style-type: none"> Continue to 'Functional lifespan exceeded?' step. 	The desired outcome is being achieved by the structure. Beaver have been recruited and there is progress in incision recovery. See (Phase 4 in Figure 3)
	If no, <ul style="list-style-type: none"> Continue to 'Causing harm?' step. 	One or more objectives are not being met for the structure and/or beaver have not been recruited. Movement into the next stage of incision recovery has not been initiated. Mitigation may be needed and should be determined on site.

Causing harm?	<p>If yes,</p> <ol style="list-style-type: none"> 1. Repair/ rebuild or 2. Remove structure 	<ol style="list-style-type: none"> 1. "Harm" would be considered as causing inverse effects to the incision recovery process. Repairing the "harmful" structure would assist it to function properly and promote incision recovery. 2. If the structure is causing additional incision, removing the structure could prevent further damage to the system. Removal would also add woody material to the system and could benefit structures downstream.
	<p>If no,</p> <ul style="list-style-type: none"> • Continue to 'New opportunities or risks?' step 	<p>The structure is not producing the intended outcomes, but is not causing harm to the system either. Further assessment needs to be made on site to determine whether any additions or improvements can be made.</p>

New opportunities or risks?	<p>If yes,</p> <ul style="list-style-type: none"> • Make necessary improvements to existing structure 	<p>If the structure is not performing as expected but is still repairable, then improvements to the structure should be based on ideas and observations made during a reevaluation process and geared towards turning it into a more functional wood structure.</p>
	<p>If no,</p> <ul style="list-style-type: none"> • Leave it alone 	<p>If there are no improvements that can be made at the site, then leave it alone and continue future monitoring processes.</p>
