# UPPER THIRTYMILE CREEK RIVERSCAPE RESTORATION PLAN

LOW – TECH  
PROCESS – BASED  
RESTORATION

LOW – TECH PROCESS – BASED RESTORATION

PLANNING AND DESIGN REPORT

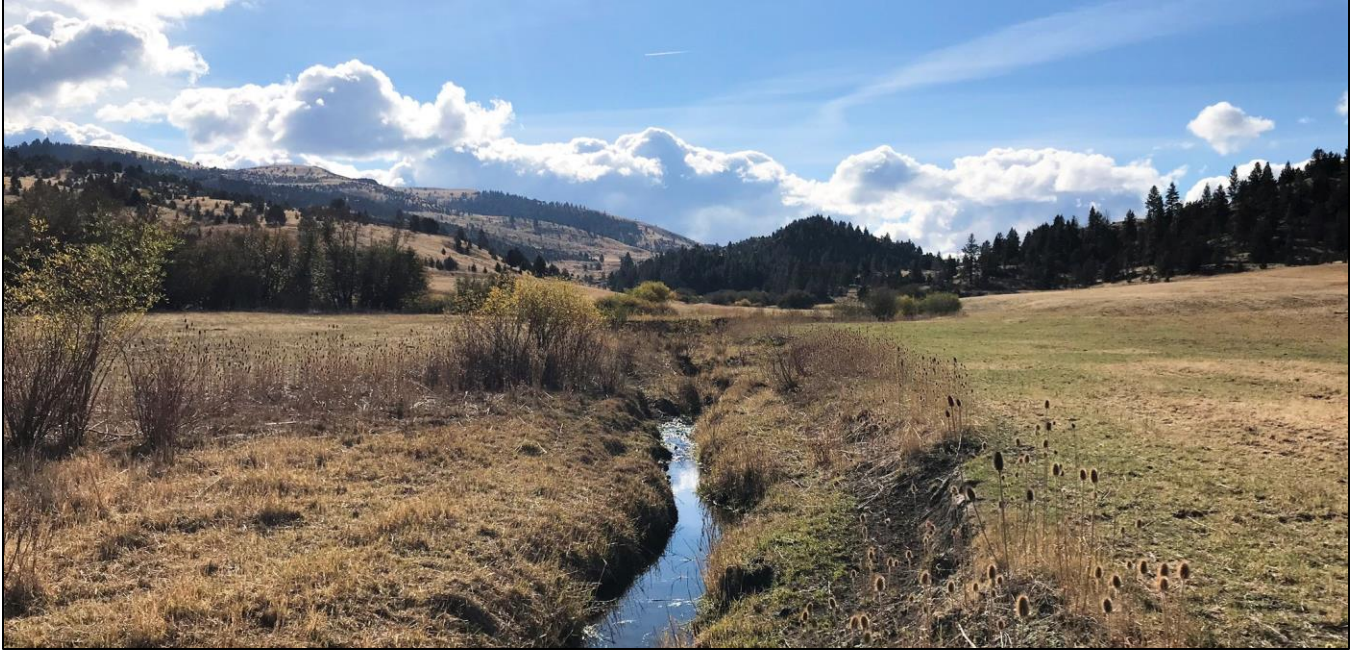
*VIEW OF THE PROJECT AREA ON THIRTYMILE CREEK DEPICTING THE HIGHLY SIMPLIFIED AND STRUCTURALLY STARVED CHANNEL. THIS SECTION AT THE UPSTREAM END OF THE PROJECT AREA OFFERS AN EXTENSIVE AMOUNT OF SPACE FOR EXPANSION OF AQUATIC HABITAT. PHOTO TAKEN DURING THE FALL OF 2020 PRIOR TO RIPARIAN AND CHANNEL RESTORATION ACTIONS SCHEDULED TO BEGIN IN 2023.*

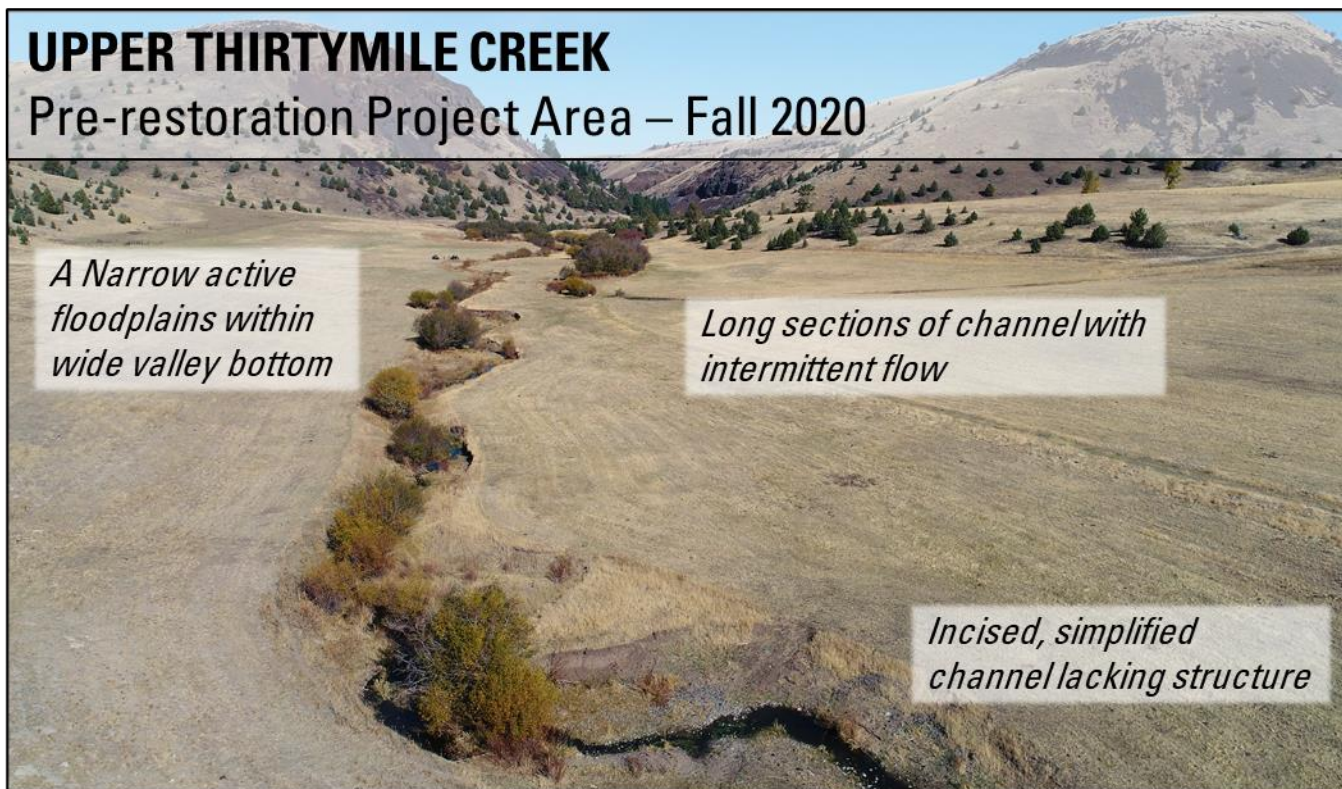
FIGURE 3. PHOTO CAPTURED DURING FALL OF 2020 SHOWING HABITAT CONDITIONS WITHIN THE PROJECT AREA ON THIRTYMILE CREEK.

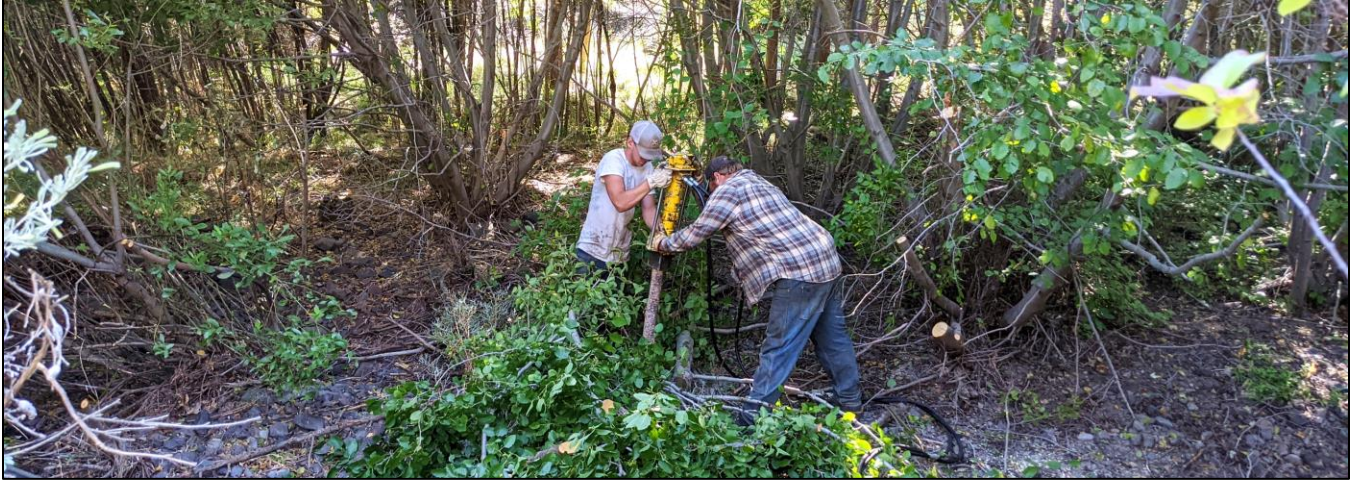
FIGURE 7. JT HAND AND KYLE HAND INSTALL SUPPORTING POSTS TO A NEWLY INSTALLED PALS IN THE LOWER SMITH REACH OF THE THIRTYMILE – WILSON / SMITH LT-PBR PROJECT.

The Thirtymile Creek watershed has been targeted for extensive restoration and recovery actions as part of the Oregon Watershed Enhancement Board’s [John Day focused investment partnership \(FIP\)](#). To date, a similar restoration plan was implemented in the Summer of 2020 on a section of Thirtymile Creek directly downstream of the Upper Thirtymile Creek project area. The Wilson / Smith LTPBR Project consisted of 263 PAL and BDA structures distributed over 4 miles of tributary habitat (Figure 6). The project was implemented by the Gilliam County Soil and Water Conservation District during the summer of 2020 (Figure 7).

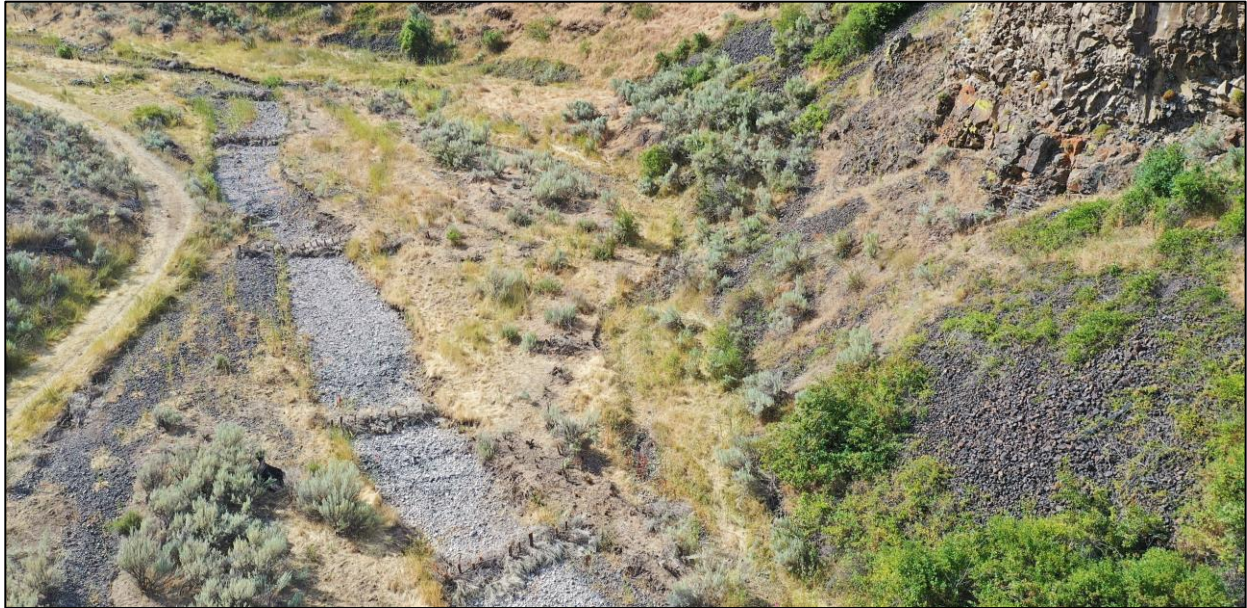
*FIGURE 8. A SERIES OF BDAs CONSTRUCTED FROM LOCALLY HARVESTED SAGEBRUSH AT THE UPPER EXTENT OF THE WILSON / SMITH LT-PBR PROJECT. MUCH OF STRUCTURE CONSTRUCTION WAS DONE DURING DROUGHT PERIODS WHERE SURFACE FLOW WAS ABSENT.*

- **CHOICE OF BUILDING MATERIAL** – Sagebrush has proven to be an effective source of vegetation fill material for LTPBR structures, especially within the construction of BDAs (Figure 8). Alder trunks are also effective for rapid harvest and construction of PALS within incised and heavily vegetated sections.

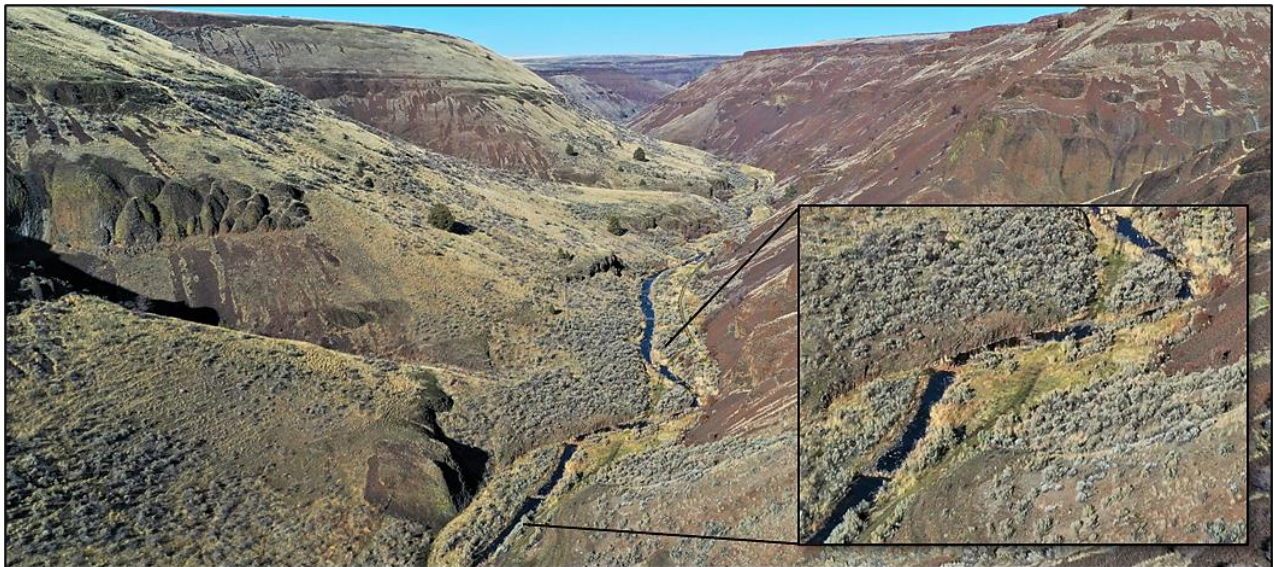
*FIGURE 9. AN AERIAL IMAGE OF THIRTYMILE CREEK LOOKING DOWNSTREAM ALONG THE WILSON REACH OF THE WILSON / SMITH LTPBR PROJECT FOLLOWING STRUCTURAL TREATMENT IMPLEMENTATION. THE IMAGE WAS CAPTURED IN EARLY DECEMBER AFTER THE RETURN OF SURFACE FLOWS THAT WERE ENTIRELY LACKING DURING THE SUMMER AND FALL OF 2020*

- **STAGE SPECIFIC STRUCTURE FUNCTION** – Monitoring of structure function at different flow stages (Figure 9) will allow further refinement of structure and structure complex designs for meeting specific objectives (i.e., erosion vs. overbank flow dispersal and floodplain connectivity).

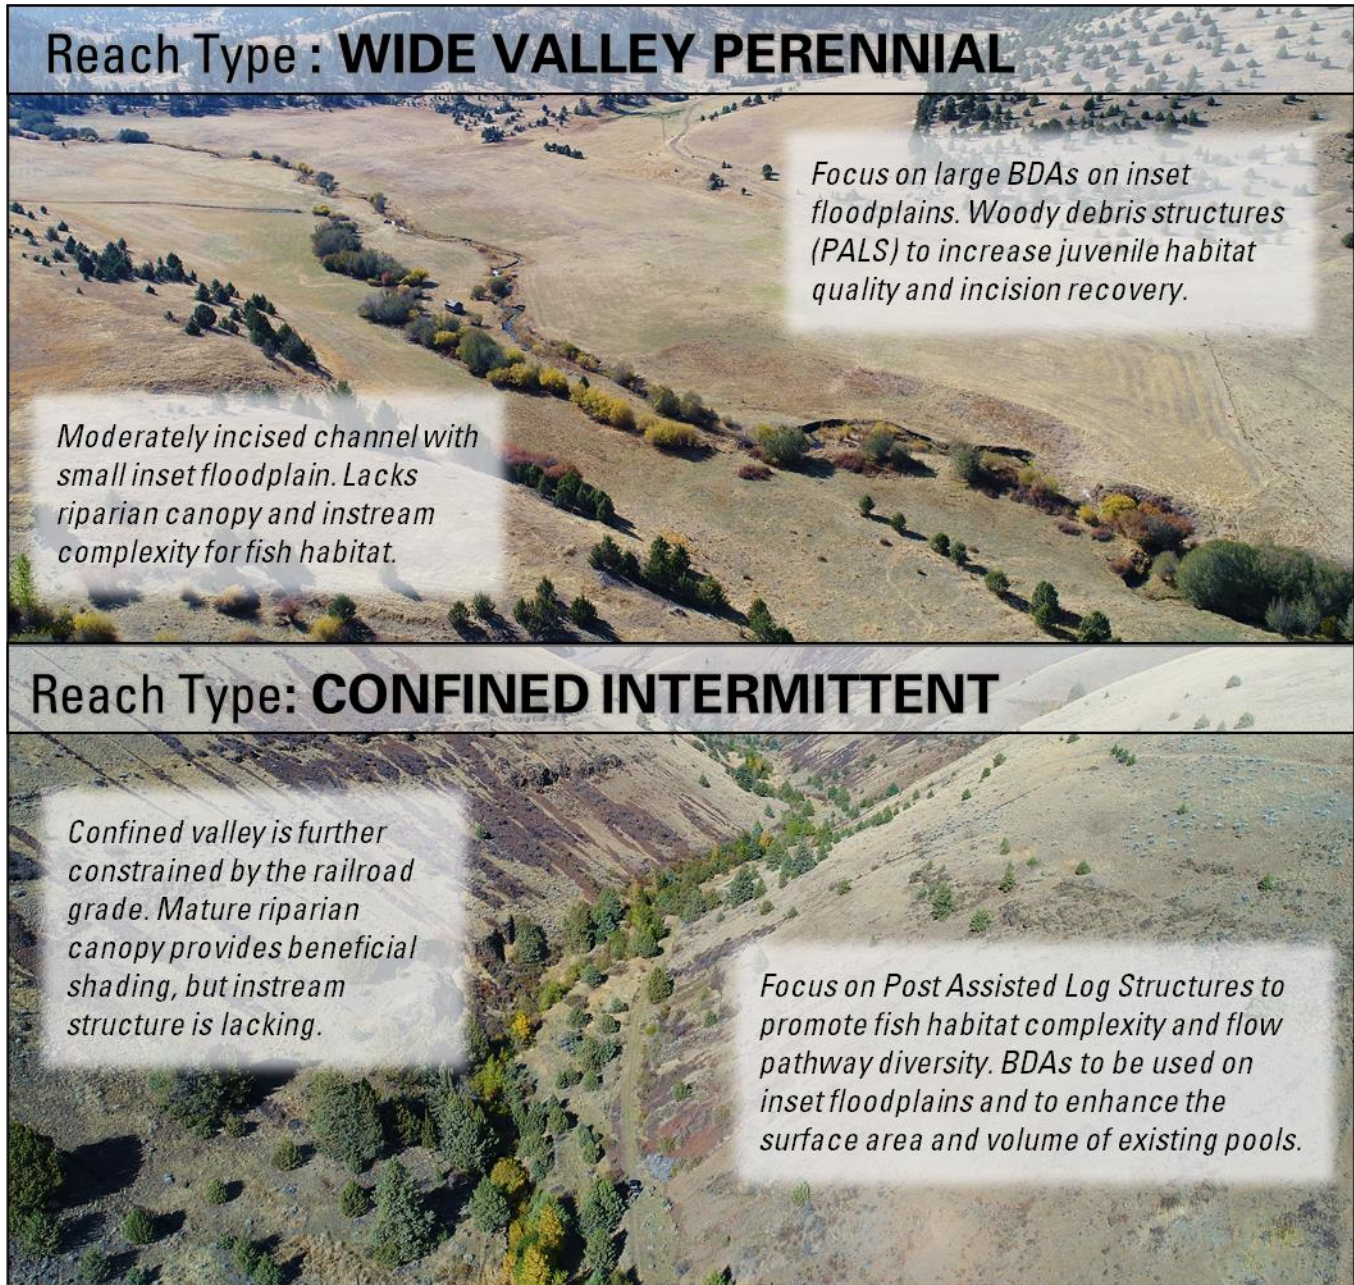
FIGURE 11. REACH TYPES TYPICAL OF THE UPPER THIRTYMILE CREEK PROJECT AREA ACCORDING TO VALLEY BOTTOM GEOMORPHIC COMPOSITION. THE COMPOSITION AND CHARACTERISTICS OF BOTTOM SURFACES IS ULTIMATELY USED TO INFORM THE RESTORATION DESIGN AND SET EXPECTATIONS FOR RECOVERY POTENTIAL.

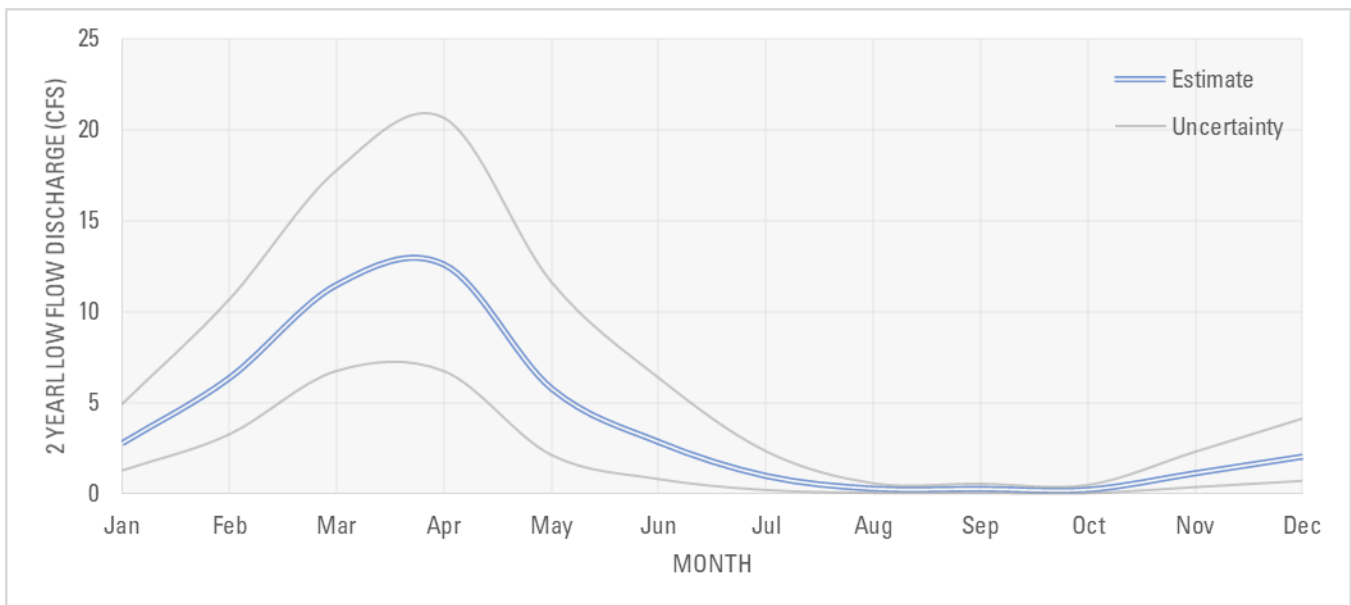
FIGURE 12. LOW FLOW ESTIMATE BY MONTH INFORMATION BASED ON [STREAMSTATS](#). FLOW STATISTICS ARE PRESENTED FOR THIRTYMILE CREEK BELOW ITS CONFLUENCE WITH ELBOW CANYON.

Thirtymile Creek has a rain dominated hydrologic regime and large floods are typically generated from spring rains on frozen ground (Figure 12). There is limited discharge data for Thirtymile Creek but typical baseflows appear to be less than 3 cfs (Figure 13), with flow becoming entirely subsurface or consisting of intermittent isolated pools. Predicted discharge from regional curves suggest that the 2-year return interval for Thirtymile Creek within the project area may exceed 144 cfs, 10-year floods may exceed 513 cfs, and 50-year floods events may exceed 1110 cfs (Figure 14). Based on this information, the frequency and magnitude of flood events on Thirtymile Creek are likely sufficient to invoke many of the processes that would be essential to a process – based riverscape restoration plan. When combined with structural treatments (i.e., PALS), the magnitude of frequent floods is expected to result in sediment scour, transport, and depositional processes necessary for channel aggradation, and creation of increased bedform topographic and substrate heterogeneity. As floodplains become more accessible, moderate floods will also result in active channel and floodplain expansion as a function of valley bottom regrading (i.e., lateral erosion and/or head-cut development).

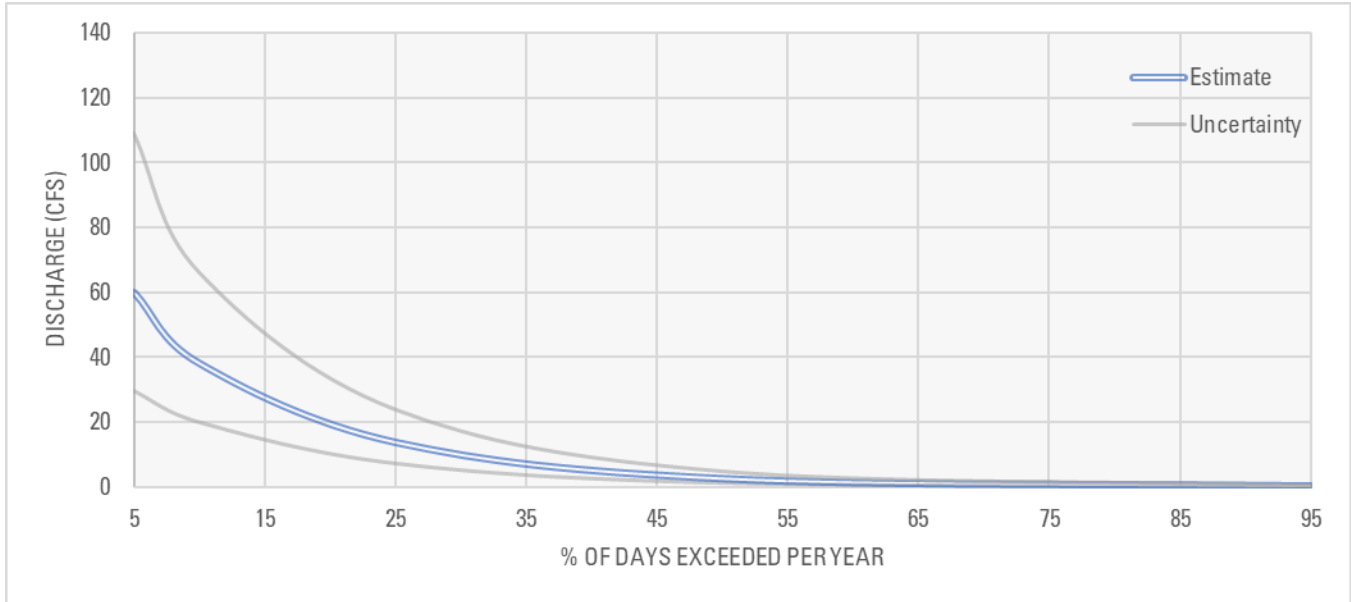
FIGURE 13. PERCENTAGE OF DAYS PER YEAR WHERE THIRTYMILE CREEK (BELOW ITS CONFLUENCE WITH ELBOW CANYON) MEETS OR EXCEEDS LOW FLOW DISCHARGE. INFORMATION BASED ON [STREAMSTATS](#).

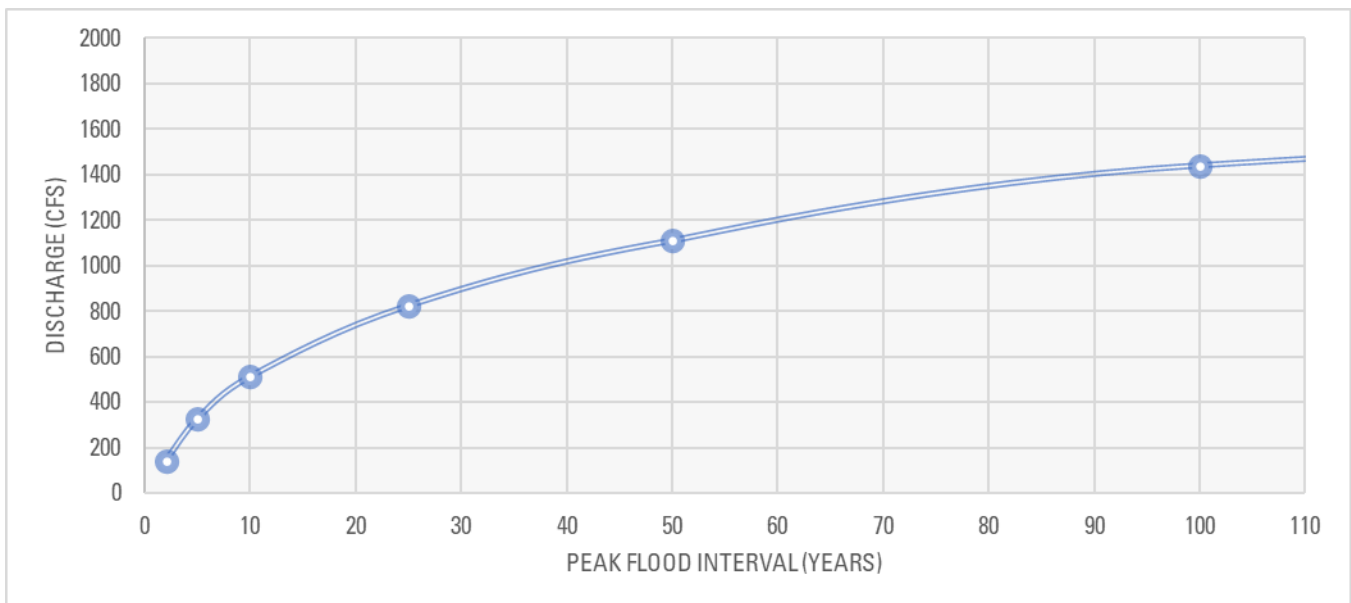
FIGURE 14. ESTIMATED DISCHARGE AT PEAK FLOOD INTERVALS (2,5,10,25,50, AND 100 YEARS) FOR THE MAINSTEM OF THIRTYMILE CREEK BELOW ITS CONFLUENCE WITH ELBOW CANYON. INFORMATION BASED ON [STREAMSTATS](#).

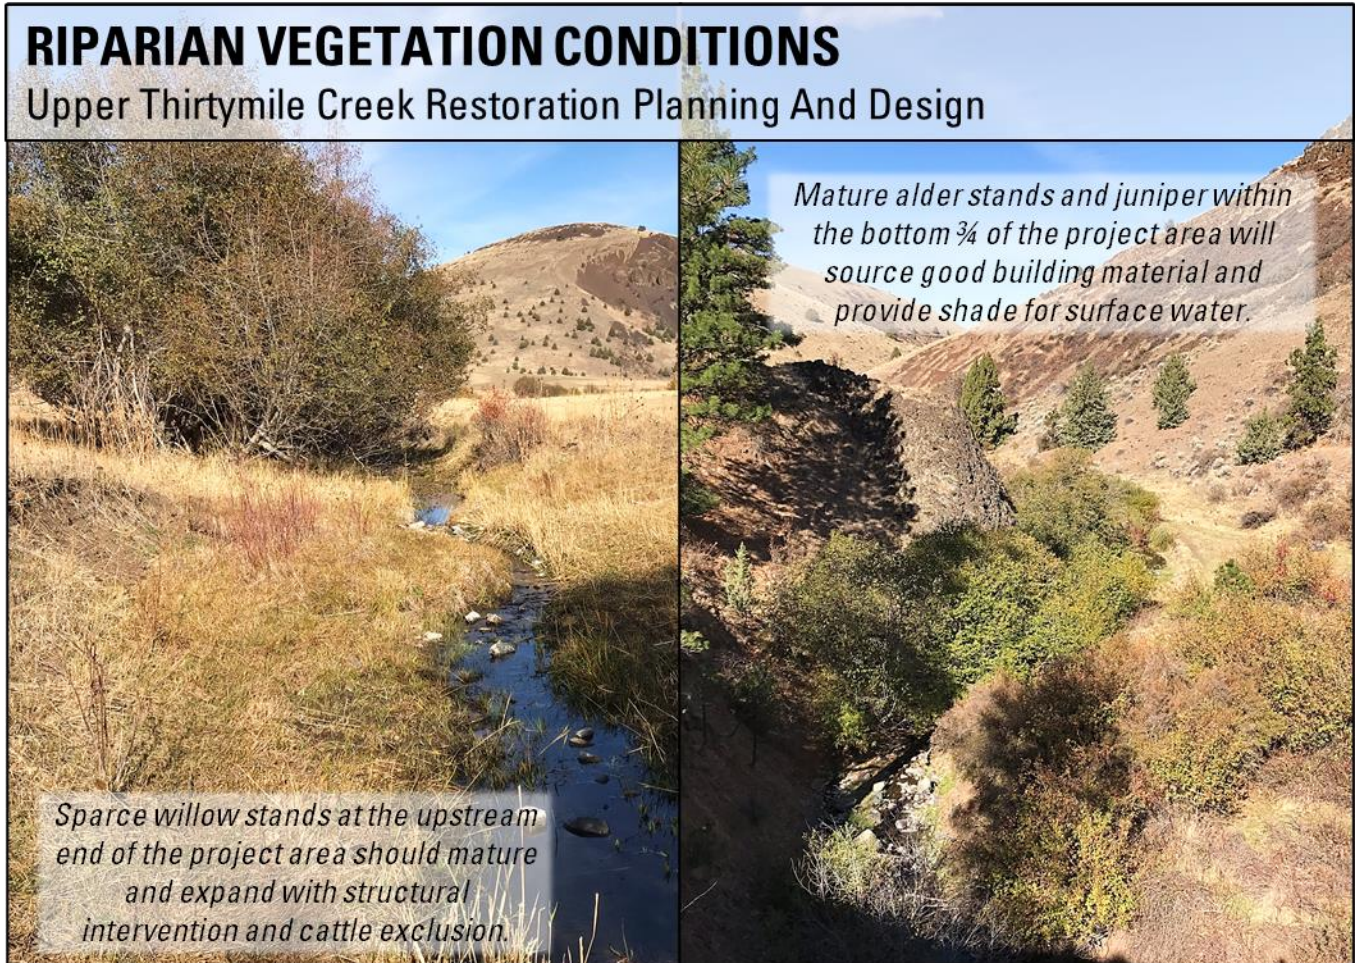
FIGURE 15. CHARACTERISTIC VEGETATION CONDITIONS FOUND WITHIN THE UPPER THIRTYMILE CREEK PROJECT AREA PRIOR TO RESTORATION IMPLEMENTATION DOCUMENTED DURING FALL, 2020. PHOTOS SHOW TWO DISPARATE RIPARIAN VEGETATION COMMUNITIES THAT DIFFER IN ABUNDANCE AND EXTENT WITHIN THE PROJECT AREA.

Current woody riparian vegetation composition and extent varies considerably within the project area. However, catchment climatic and hydrologic conditions should be ideal to support an abundant riparian forest with a high potential for the production, recruitment, and accumulation of woody debris jams. This potential is evident within the majority of the project area where abundant woody riparian vegetation (i.e., alder and willow) occur in proximity to the active channel. However, the existing abundance and distribution of woody riparian vegetation is severely limited in the [Comstock Basin](#) reach and occupies only a small portion of the valley bottom.

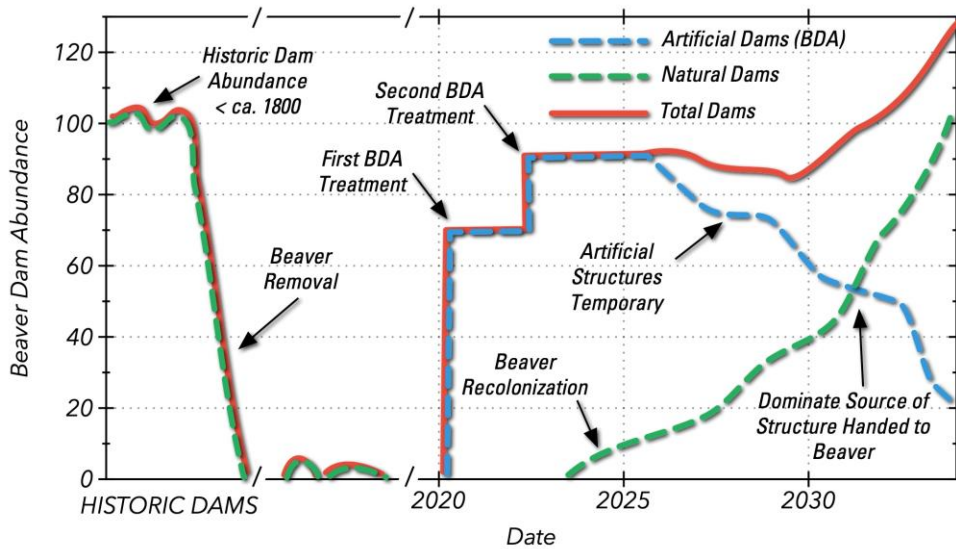
FIGURE 19. CONCEPTUAL REPRESENTATION OF AN LTPBR PROJECT TRAJECTORY IN WHICH NATURAL BEAVER COLONY EXPANSION AND DAM BUILDING BECOMES THE PRIMARY SOURCE OF STRUCTURAL ELEMENTS WITHIN THE RIVERSCAPE. BEAVER AS WELL AS RIPARIAN VEGETATION RECRUITMENT AND ACCUMULATION ARE EXPECTED TO FUNCTION AS A SOURCE OF STRUCTURE WITHIN THE THIRTYMILE CREEK PROJECT AREA.

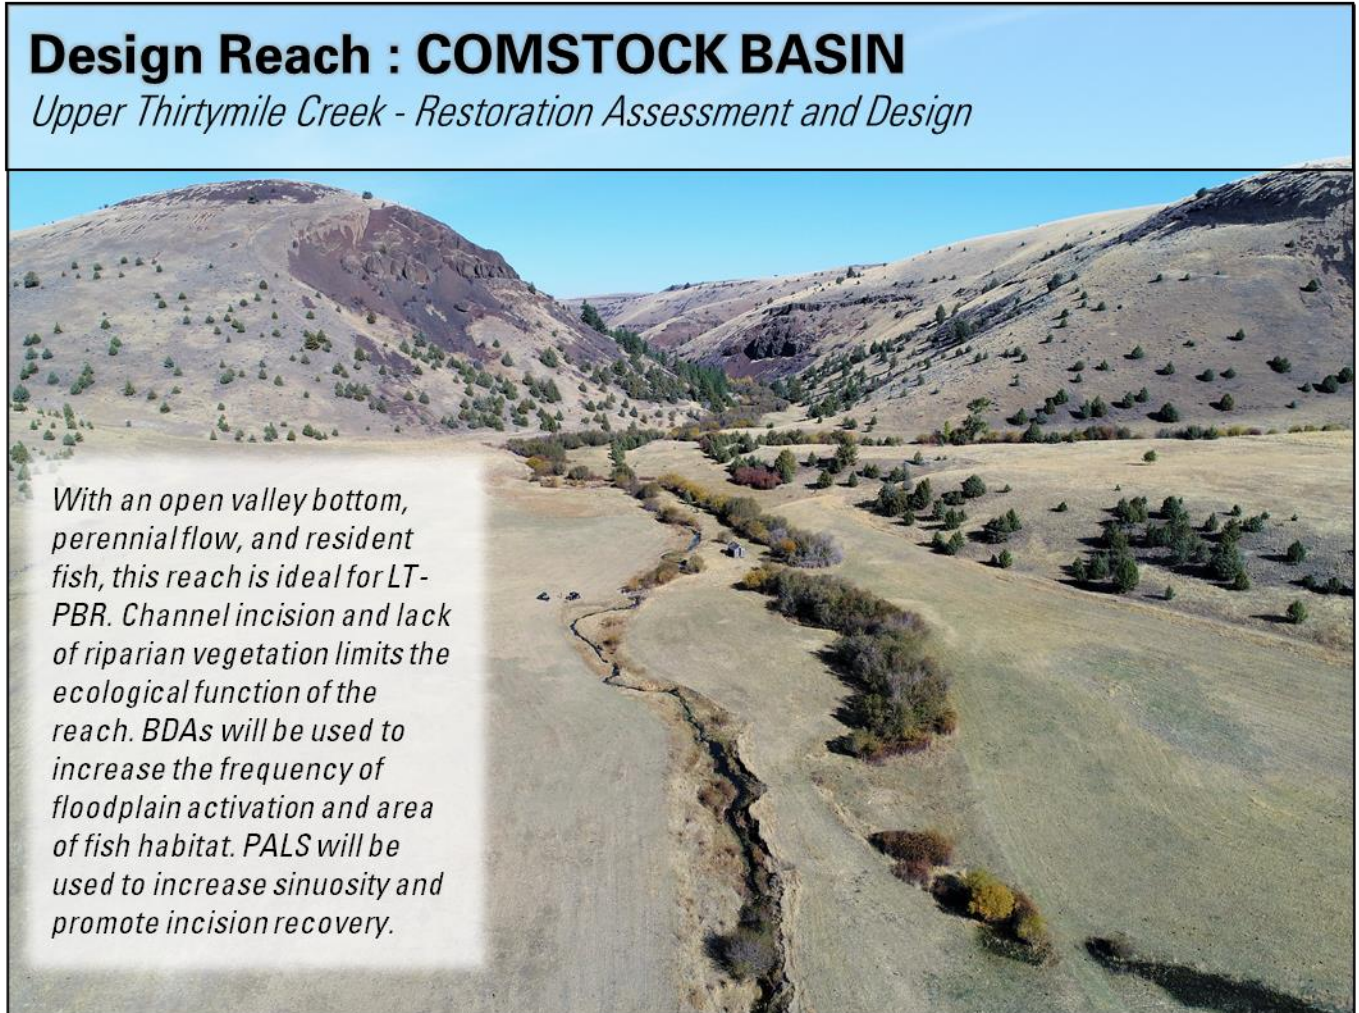
### 4.3.1 DESIGN REACH: COMSTOCK BASIN

In its current state, the Comstock Basin Reach is characterized by sparse riparian vegetation, an incised channel with a limited inset floodplain, and low in-channel habitat complexity for rearing juvenile steelhead. However, the wide valley bottom, low elevation of channel incision, and mostly perennial flow offer exceptional restoration potential. The wide valley bottom provides ample space for expansion of aquatic habitat through floodplain expansion, increased channel sinuosity, and the development of multithread channels. Structural treatments within this reach will consist of BDAs to increase the volume and area of surface flow, increase fish habitat quantity and complexity through pond development, and increase the frequency of floodplain inundation. Increased pond development and expansion of riparian will also increase the likelihood that beaver will establish natural dam complexes within the reach.

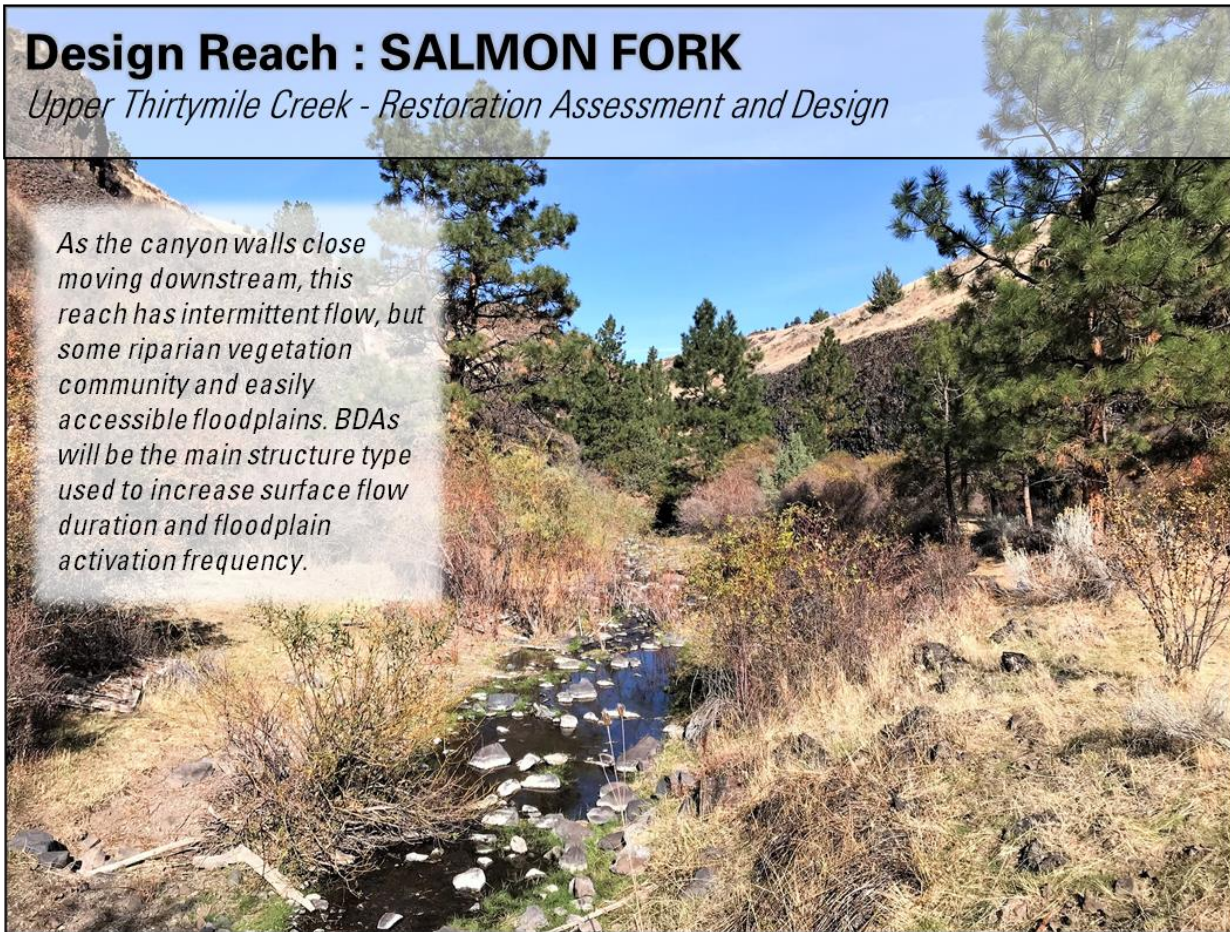
### 4.3.3 DESIGN REACH: SALMON FORK

Surface flow is largely lacking or intermittent within the Salmon Fork design reach during annual draught periods and increasing the duration and extent of perennial surface flow within the reach remains a primary design objective. This reach is typified by a narrow canyon than is observed upstream, an incised stream channel (~ 0.75 m) with frequent inset floodplain surfaces, and a riparian vegetation community mainly dominated by alder. In channel and floodplain substrate compositions feature abundant large cobbles with a porosity that may be contributing to intermittent flow during draught periods. The treatment design will consist of BDA structures placed at the downstream extent of inset floodplains where pond creation and inset floodplain connectivity can be maximized. Ideally, the BDA treatments will contribute to deposition and retention of fine sediment, and a bed composition that is more supportive of continuous surface flow.

Existing mature alder will provide ample structure building material to support the restoration treatments. However, expansion and colonization of riparian vegetation is being limited by intensive grazing within the floodplain and active channel. Grazing reduction/management will be essential within this reach if riparian vegetation abundances are expected to support beaver colonization and long-term complex establishment. The abandoned Kinzua to Condon railroad grade (currently used as a vehicle access road) within the valley bottom also sets a limit on the recovery potential within this reach.

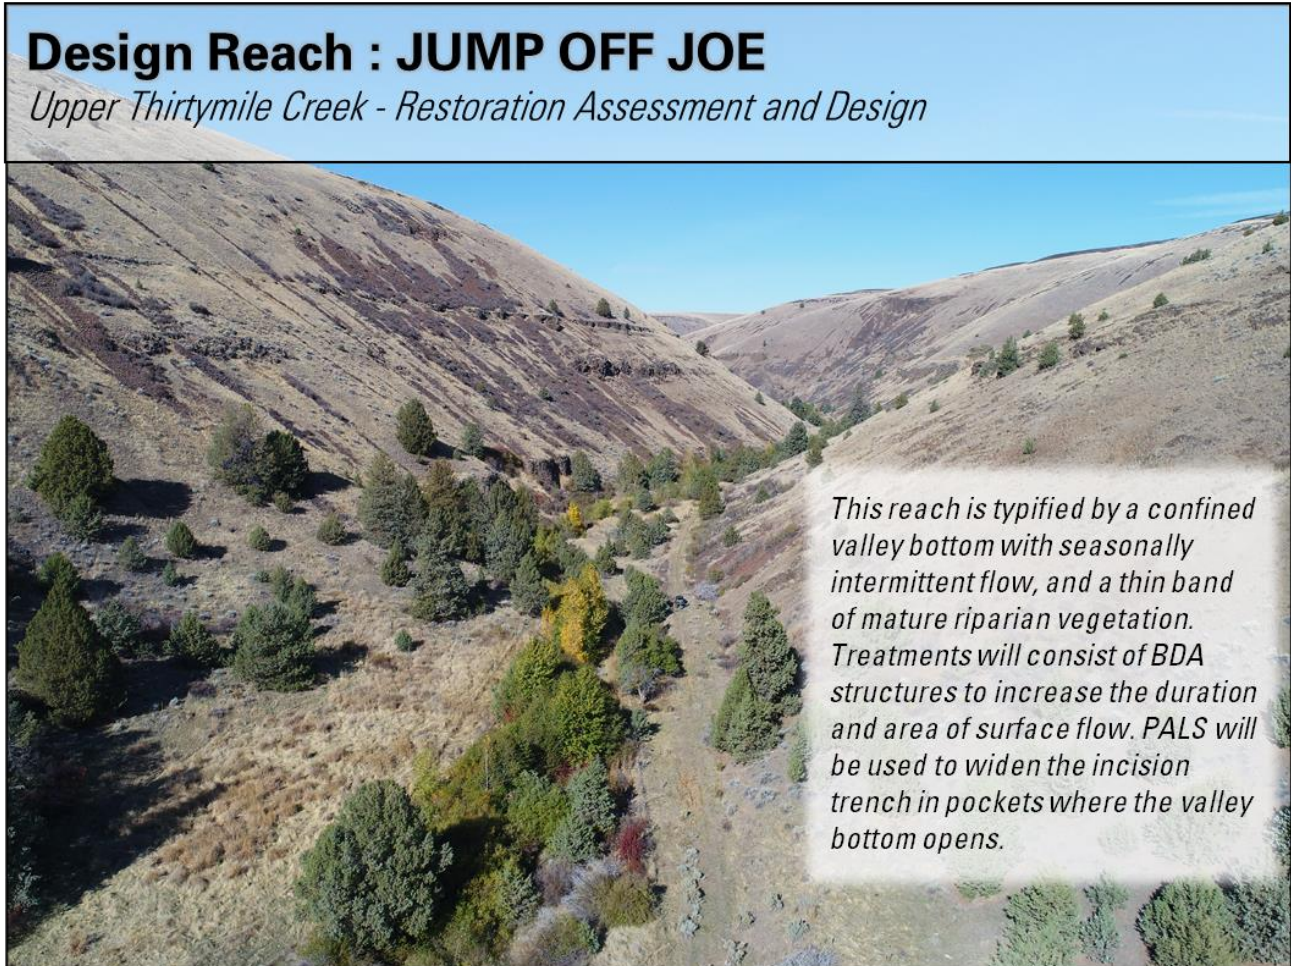
#### 4.3.4 DESIGN REACH: JUMP OFF JOE

At 3.3 miles long, the Jump Off Joe reach is the longest design reach in the project area. This reach has intermittent flow hydrology, a mature band of riparian vegetation running its length, and a deeply (~2.0 m) incised channel and inset floodplain constrained by the abandoned Kinzua to Condon Railroad bed. Due to the level of incision, reconnection to the historic valley bottom is unlikely within this reach. The structural treatments will consist largely of BDA structures designed to induce ponding and groundwater recharge within the inset floodplain. PALS will also be used in narrow sections to widen the incision trench and enhance instream fish habitat complexity. Several structure complexes have been positioned near spring seeps to maximize the residency time and expand the foot of these sources of perennial surface flow.

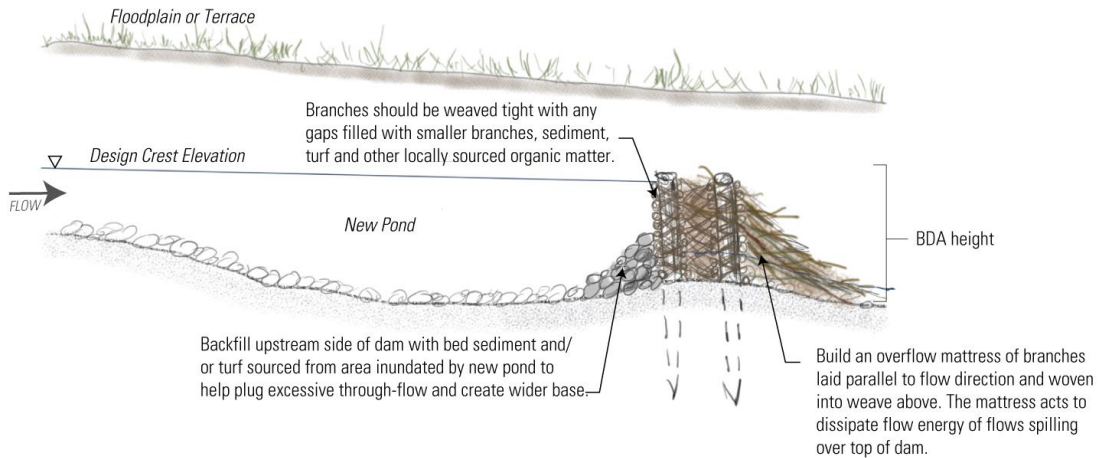
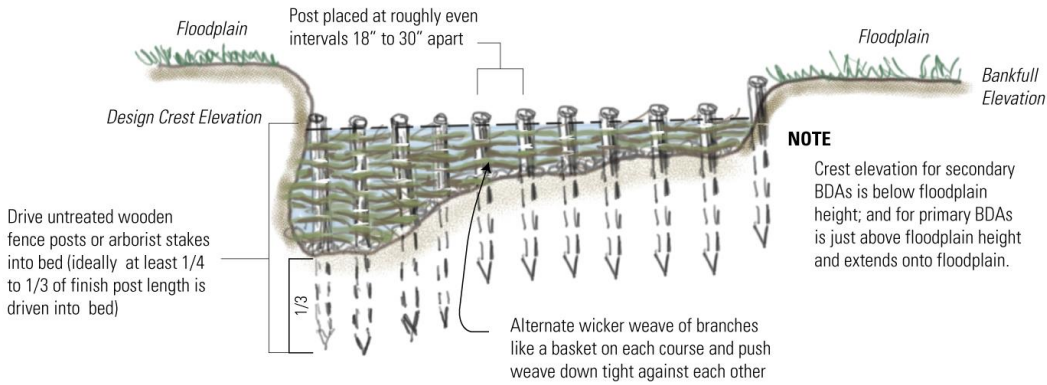
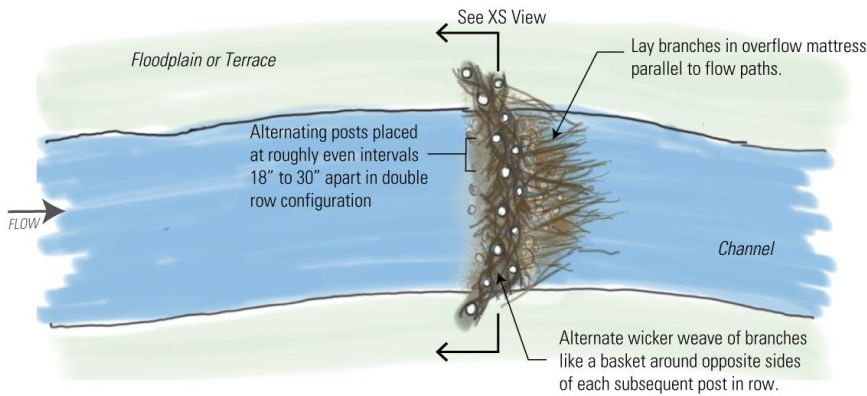
**PROFILE VIEW**

**X-SECTION VIEW**

**PLANFORM VIEW**

**FIGURE 22. BUILDING SCHEMATICS FOR POST – ASSISTED BEAVER DAM ANALOGS THAT WILL BE ADAPTED TO THE THIRTYMILE CREEK STRUCTURAL TREATMENT PLAN.**

STRUCTURE SPECIFICATION	DESCRIPTION	TYPICAL DIMENSIONS
BDA	BDA structures ranging between 15 and 40 ft. that will do most of the pond creation and flow dispersal. Structures will be typical in unconfined sections of channel with wide valley bottoms, and areas featuring wide inset floodplain surfaces.	Length: 15' – 50' Width: 1.5' – 3' Height: 1.5' – 3.5' Volume: 0.9 yds <sup>3</sup>
PALS	Will primarily be used in areas featuring a narrow-inset floodplain to enhance rates of inset floodplain widening and channel complexity (i.e., pool and bar creation). PALS should primarily be constructed of locally harvested mature alder, sagebrush, and juniper.	Length: 10' – 30' Width: 4' – 8' Height: 2' – 4' Volume: 0.5 yds <sup>3</sup>

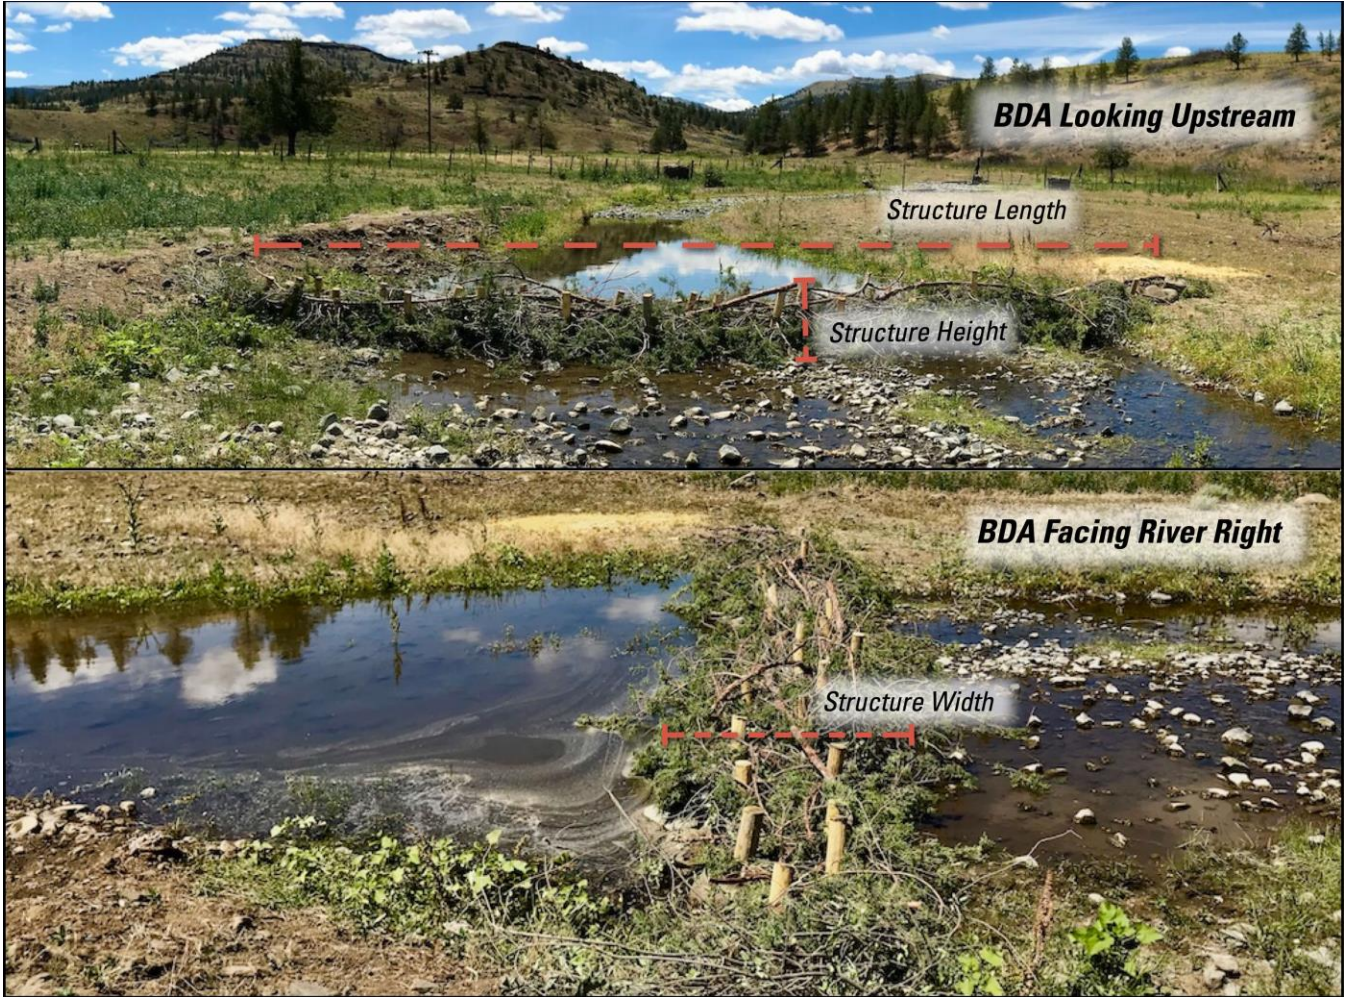
FIGURE 23. EXAMPLE OF BDA STRUCTURES BUILT USING SIMILAR MATERIALS AND OF SIMILAR DIMENSIONS TO THOSE EXPECTED FOR THE UPPER THIRTYMILE PROJECT.

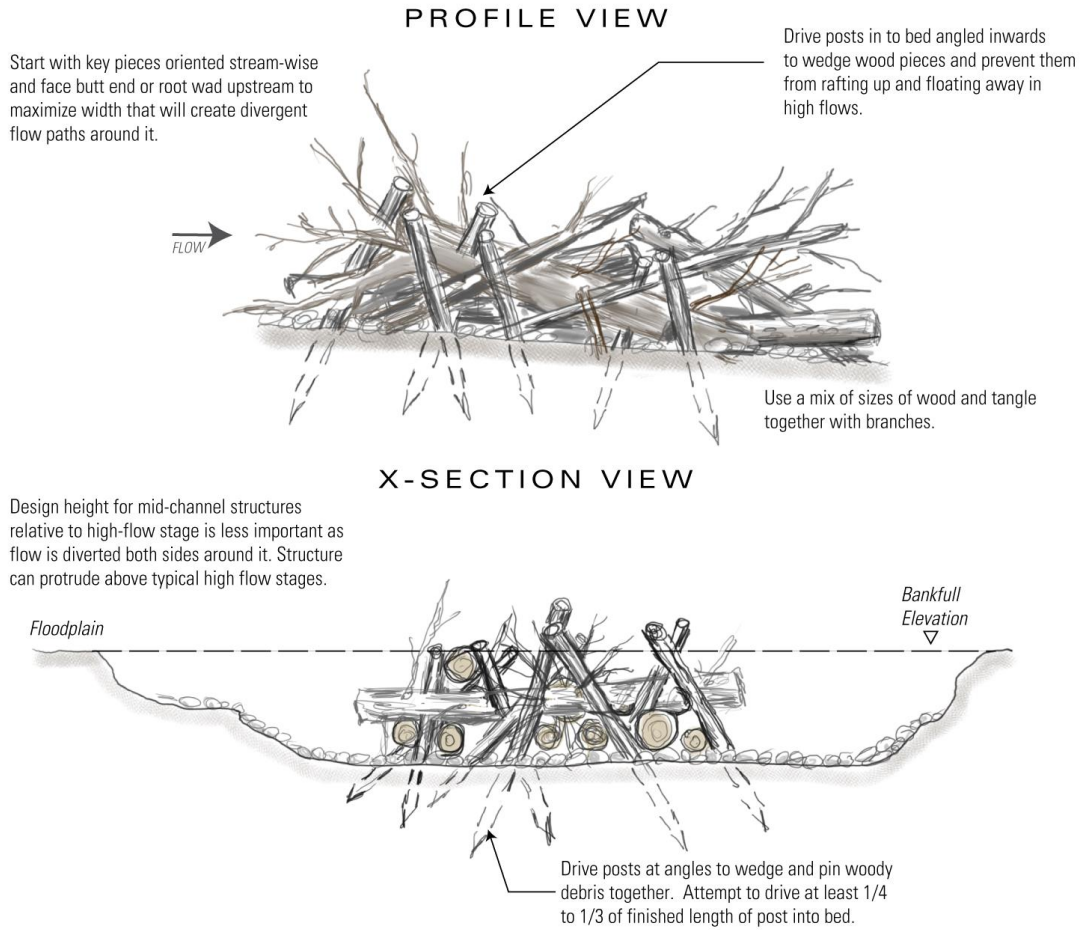
FIGURE 24. CONCEPTUAL SCHEMATIC OF A POST – ASSISTED LOG STRUCTURE (PALS).

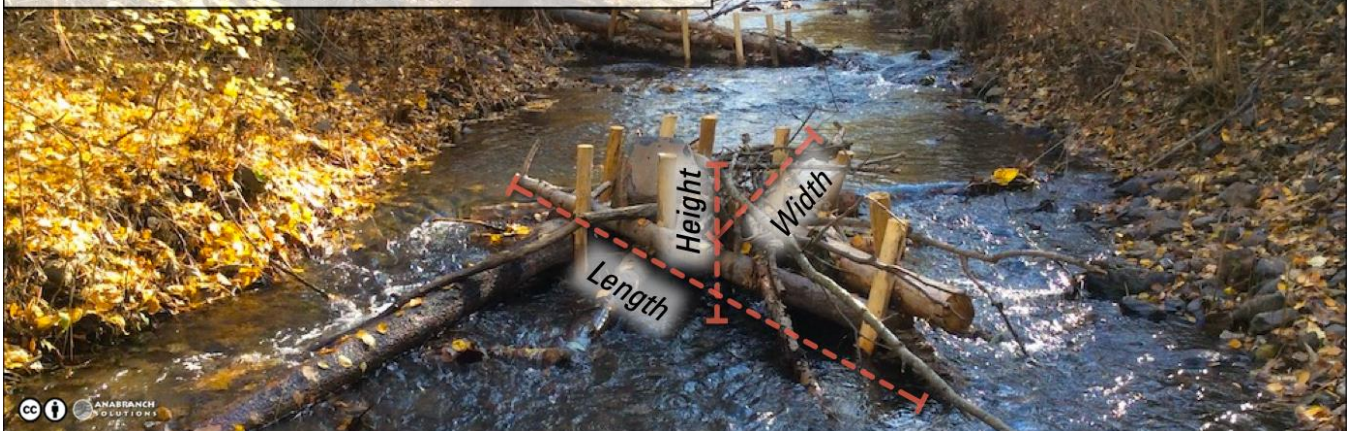
**PALS - POST ASSISTED LOG STRUCTURE  
STRUCTURE DIMENSIONS**

FIGURE 25. TYPICAL EXAMPLE OF A POST – ASSISTED LOG STRUCTURES (PALS) SHOWING STRUCTURE DIMENSIONS USED IN STRUCTURE SPECIFICATION

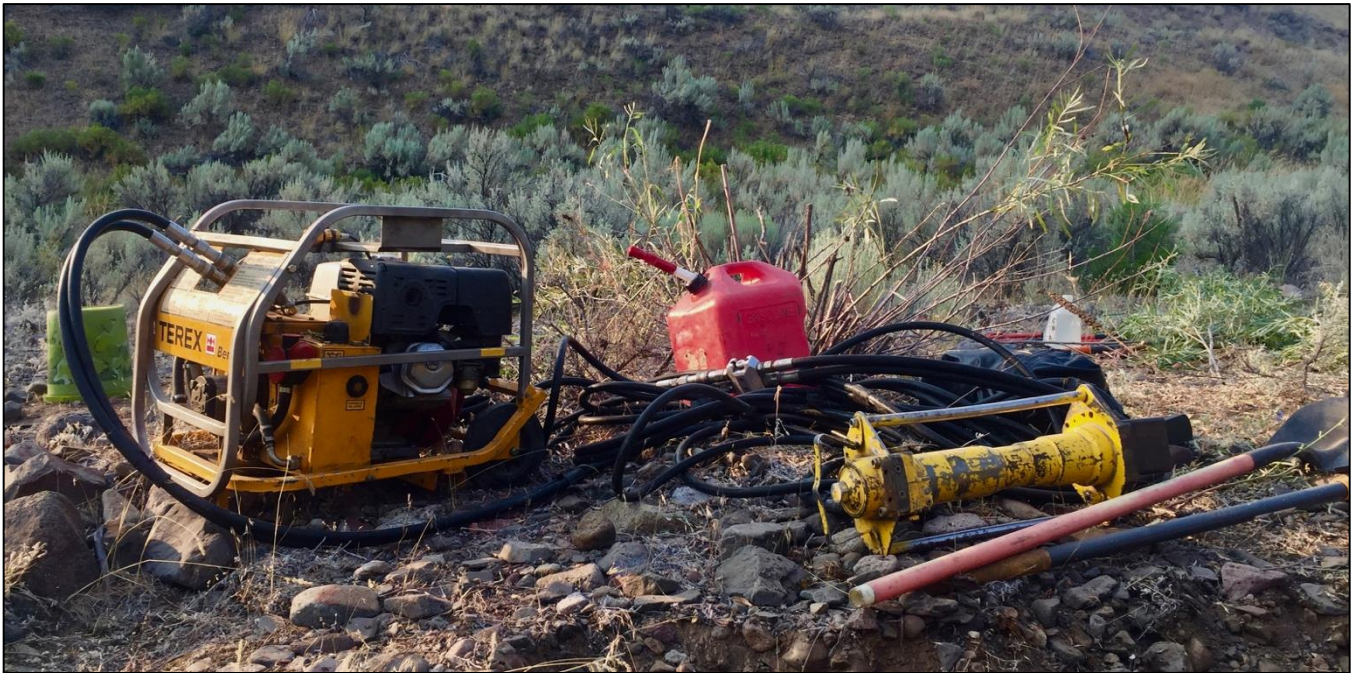
FIGURE 26. TYPICAL HYDRAULIC POWER SOURCE AND POST POUNDER USED TO DRIVE POSTS REQUIRED FOR CONSTRUCTION OF BDAs.

The equipment requirements for installation of LTPBR structures (e.g., PALS & BDAs) is primarily limited to a hydraulic power source used to power a hydraulic post pounder ([Figure 26](#)). The hydraulic power source is mounted on a rolling frame and is roughly the size of a wheelbarrow and can be moved among restoration

locations by a single person. In most cases, posts will be driven to a depth of approximately 30 cm and will not exceed 60 cm. The amount of time spent at individual structures is low (e.g., several hours) and it is unlikely that these activities will result in the formation of permanent trails or significant soil disturbance.
