UTILIZING LASER SCANNING FOR QUALITY CONTROL

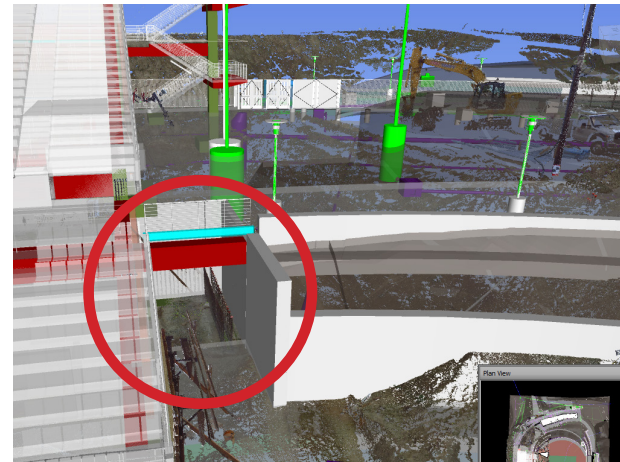
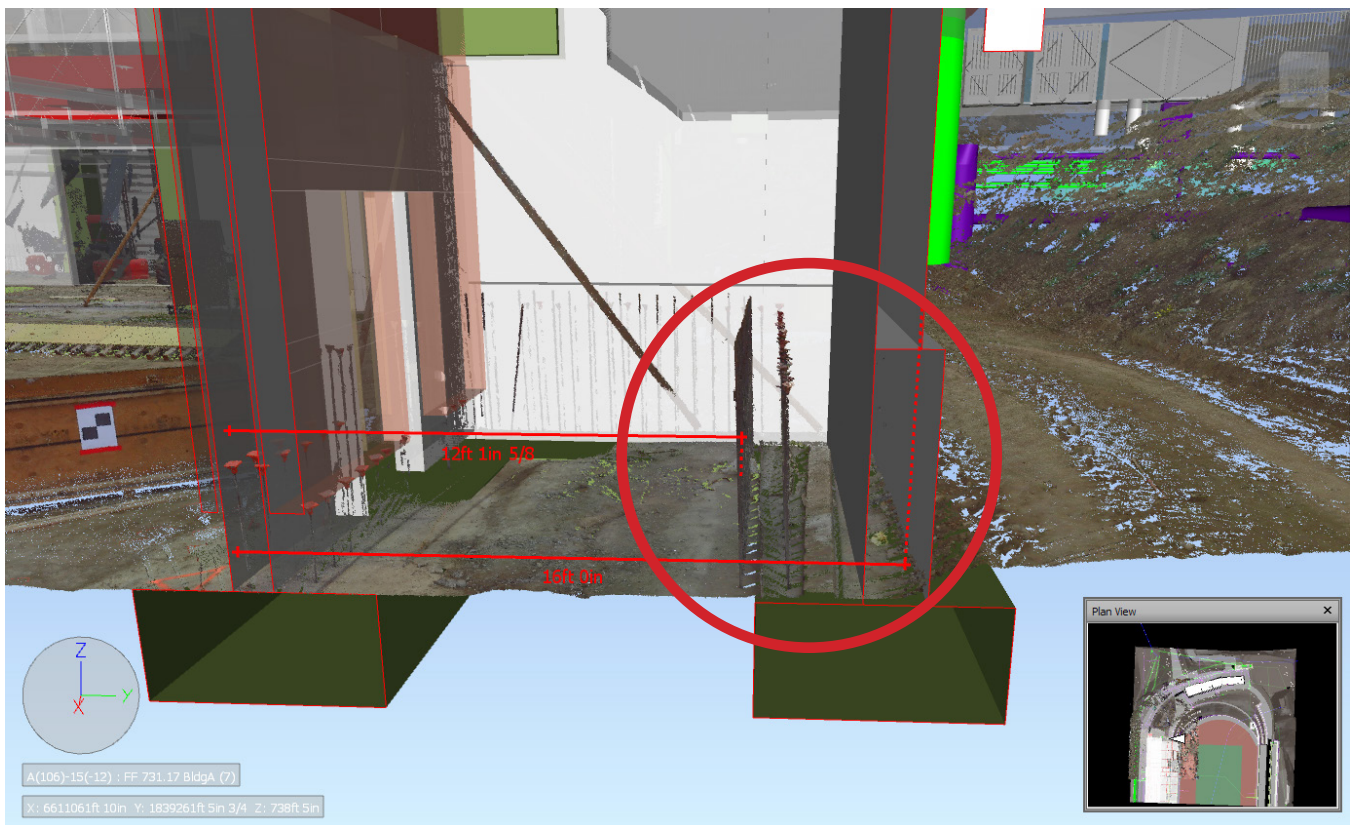
For example, recently during the construction of the Mt. San Antonio College Athletics Complex Project, our team's proactive approach to quality control revealed from a 3D scan of the construction site to verify construction layout that a wall foundation was installed in the wrong place by the subcontractor.

The augmented reality view (pictured below), shows the coordinated building information model overlaid with real-world conditions in a 3D environment. Having this data accessible quickly allowed our team to analyze options to fix the condition without impacting the schedule. The fix was implemented with the subcontractor quickly, prior to the wall being poured mitigating a potential delay.
