Transfer Station

Town of Sudbury ADA Transition Plan

December 2020

**Town of Sudbury
Transfer Station**

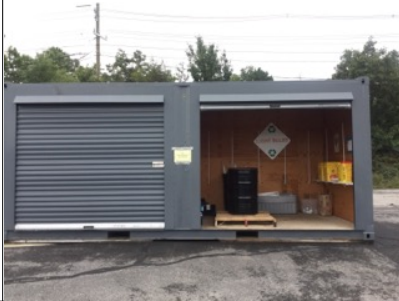
ID	Location	Floor	Room	Element	Type	Photo	Issues	Current Measure	Recommendations	Quantity	Price	Cost Estimation
Approach and Entrance												
Exterior Access Route												
1	Battery Disposal Drop-Off	Ext.		Exterior Access Route	Exterior

Not provided from all site arrival points	8"	Have staff provide assistance accessing the battery drop-off receptacles as needed.	1	Labor	\$0
2	Tires/CRT Monitors	Ext.		Exterior Access Route	Exterior

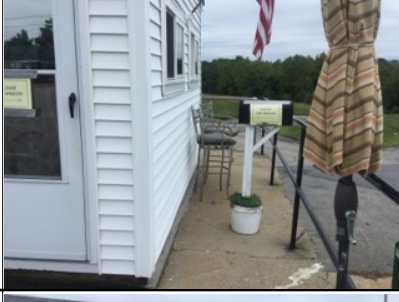
Not provided from all site arrival points	11.5"	Ensure an accessible route is provided from all points of arrival. Have staff provide assistance accessing the Tire/CRT drop-off receptacles as needed.	1	Labor	\$0
3	Service Window at Office	Ext.		Exterior Access Route	Exterior

Not provided from all site arrival points	-	Relocate mailbox so it does not block 36" min. wide accessible route to service counter.	1	Labor	\$0
4	Path to Service Window at Office	Ext.		Exterior Access Route	N/A

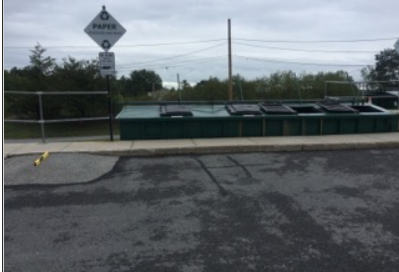
5	Paper/ Newspaper & Mixed Drop-off	Ext.		Exterior Access Route	Exterior

Cross slope > 1:50 (2.00%) Running slope > 1:20 (5%) Level changes > 1/4"	2.1% 14.4% 1.5"	Have staff provide assistance accessing the paper drop-off receptacles as needed.	1	Labor	\$0

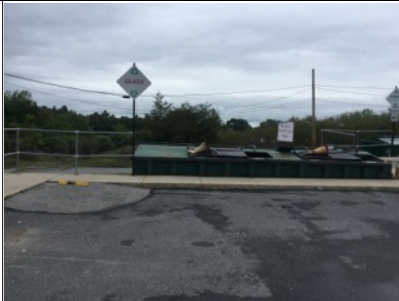
ID	Location	Floor	Room	Element	Type	Photo	Issues	Current Measure	Recommendations	Quantity	Price	Cost Estimation
6	Glass Recycling Drop-off	Ext.		Exterior Access Route	Exterior

Cross slope > 1:50 (2.00%) Running slope > 1:20 (5%) Level changes > 1/4"	4.5% 12.3% 1"	Have staff provide assistance accessing the glass drop-off receptacles as needed.	1	Labor	\$0
7	Plastics 3 to 6 & No Number Drop-Off	Ext.		Exterior Access Route	Exterior

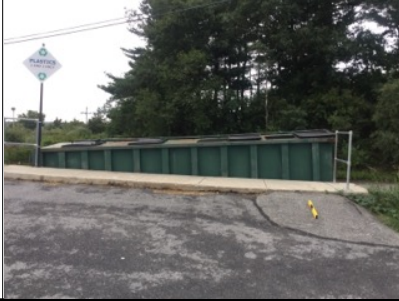
Cross slope > 1:50 (2.00%) Running slope > 1:20 (5%) Level changes > 1/4"	3.1% 7.9% 2"	Have staff provide assistance accessing the plastics drop-off receptacles as needed.	1	Labor	\$0
8	Plastics 1 & 2 Only Drop-Off	Ext.		Exterior Access Route	Exterior

Running slope > 1:20 (5%) Level changes > 1/4"	18.7% 2"	Have staff provide assistance accessing the plastics drop-off receptacles as needed.	1	Labor	\$0
9	Metal Drop-off	Ext.		Exterior Access Route	Exterior

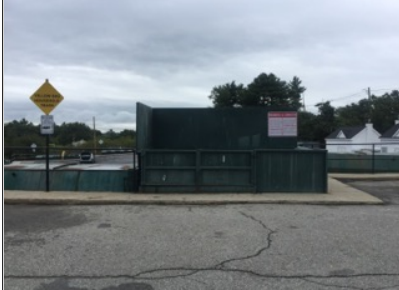
10	Compactor/ Yellow Bag Household Trash	Ext.		Exterior Access Route	Exterior

Level changes > 1/4"	3.5"	Have staff provide assistance accessing the yellow bag household waste drop-off receptacles as needed.	1	Labor	\$0

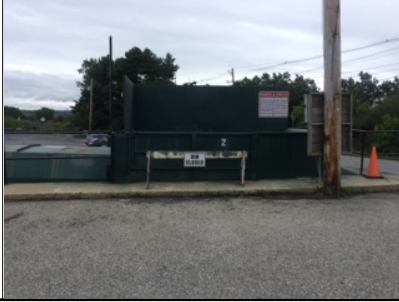
ID	Location	Floor	Room	Element	Type	Photo	Issues	Current Measure	Recommendations	Quantity	Price	Cost Estimation
11	Compactor 2	Ext.		Exterior Access Route	Exterior

Level changes > 1/4"	5"	Have staff provide assistance accessing compactor 2 as needed.	1	Labor	\$0
Access to Goods and Services												
Doors, Doorways, & Gates												
12	Book Shed	Ext.		Doors, Doorways, & Gates	N/A

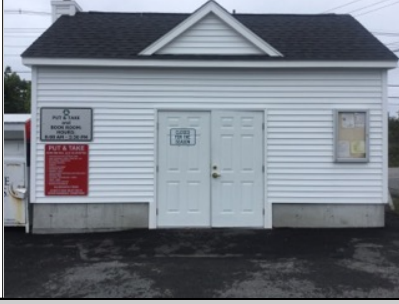
Maneuvering clearance at door > 1:50 (2.00%) (MAAB)	7.4%	Alter so that the slope in all directions is no greater than 1:50 (2.00%) yielding a 5'x5' level landing at the door. Cost to be determined based on specific remedy selected.	1	-	\$0
13	Put-N-Take	Ext.		Doors, Doorways, & Gates	N/A

Maneuvering clearance at door > 1:50 (2.00%) (MAAB)	7.1%	Alter so that the slope in all directions is no greater than 1:50 (2.00%) yielding a 5'x5' level landing at the door. Cost to be determined based on specific remedy selected.	1	-	\$0

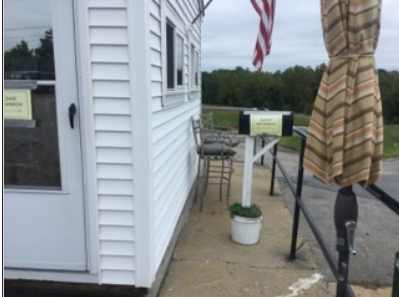
Service Counter												
14	Service Window - Personal Shelter/ Office	Ext.		Service Counter	N/A

Counter > 36" high	56"	Provide a counter that is 36" max. above the ground.	1	880	\$880

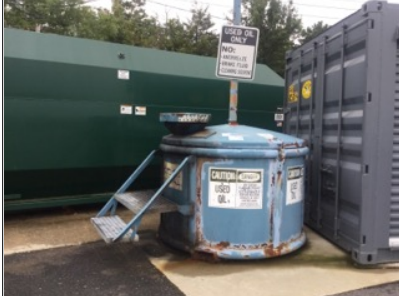
ID	Location	Floor	Room	Element	Type	Photo	Issues	Current Measure	Recommendations	Quantity	Price	Cost Estimation
Operable Parts												
15	Used Oil Drop-Off	Ext.		Operable Parts	N/A

Element not on an accessible route	-	Have staff provide assistance accessing the used oil drop-off receptacle as needed.	1	Labor	\$0
16	Cardboard Compactor	Ext.		Operable Parts	N/A

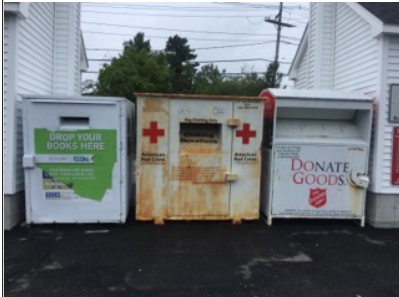
Element not on an accessible route	59"	Have staff provide assistance accessing the cardboard drop-off receptacles as needed.	1	Labor	\$0
Trash / Recycling												
17	Book and Clothing Drop-off	Ext.		Trash / Recycling	N/A

Trash container opening not within reach range	60"	Have staff provide assistance accessing the book and clothing recycling receptacles as needed.	1	Labor	\$0
Toilet & Bathing Rooms												
Portable Toilet												
18	Portable Toilet	Ext.		Portable Toilet	N/A

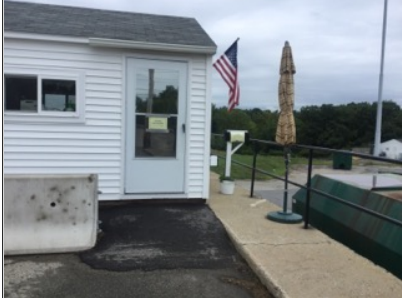
ID	Location	Floor	Room	Element	Type	Photo	Issues	Current Measure	Recommendations	Quantity	Price	Cost Estimation
Buzzer or Intercom												
19	Service Window - Personal Shelter/ Office	Ext.		Buzzer or Intercom	N/A

Recommend providing a buzzer or intercom on an accessible route at base of recommended ramp providing an accessible route to the service window so visitors can notify staff that they may require assistance. Ensure the controls no higher than 48" above the ground.	1	-	\$0
