BUILDING INSPECTION REPORT

148 Hoon Hay Road, Hoon Hay, Christchurch 8025
Building Report

This inspection was carried out in accordance with NZS4306:2005

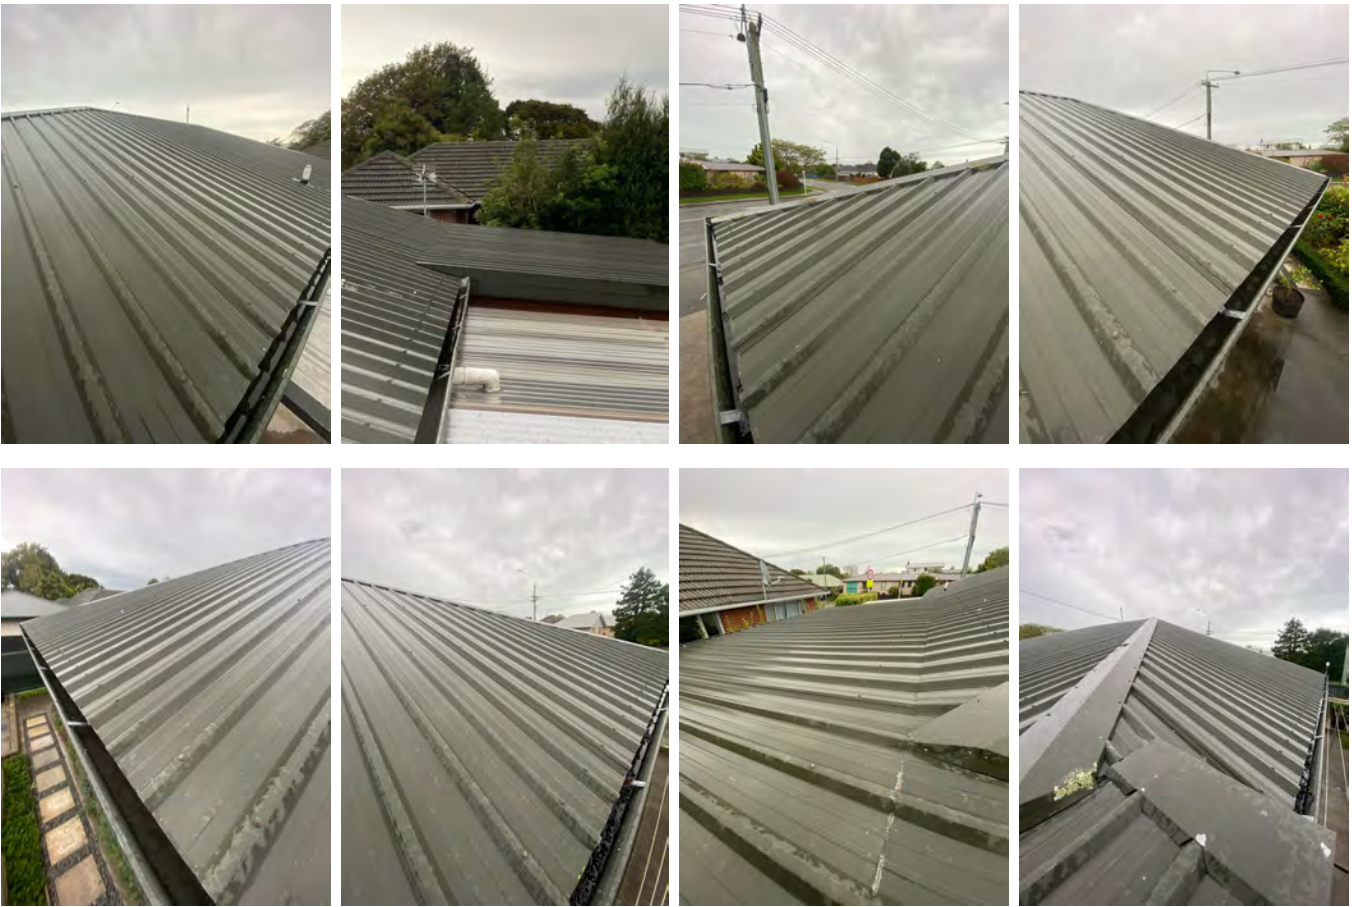
Sufficient slope for water run off. Penetrations through roof flashed well. In need of a clean as ongoing maintenance. Some roofing nail fixings have popped throughout the roof system; this is typical for roofing nails. Replace these where necessary with suitable roofing screws to maintain weather tightness. In need of being treated with herbicide to kill off lichen and moss.

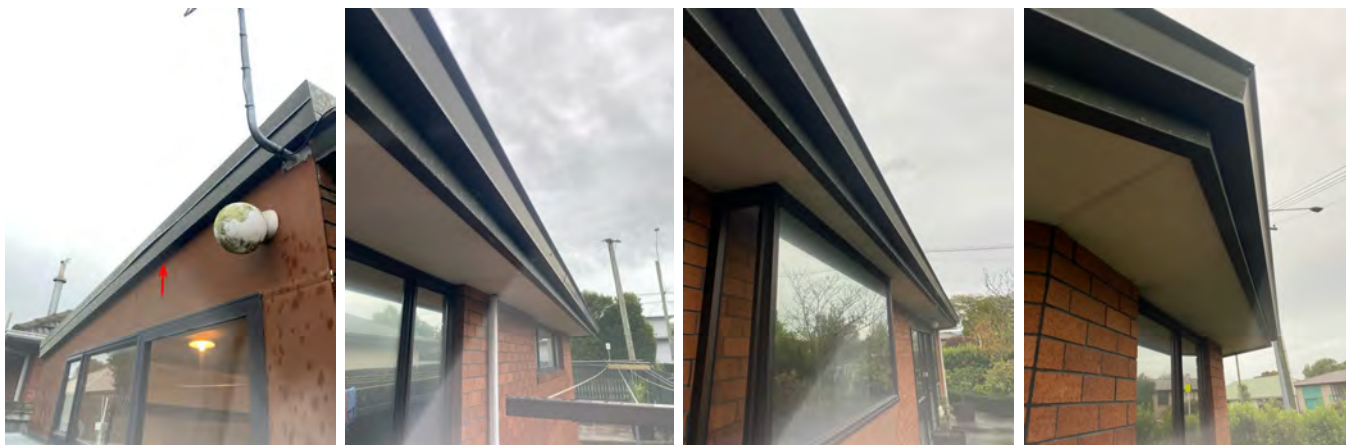
Fascia fixed well to structure. The fascia looks to have been flashed professionally. No obvious popped or protruding fixings noted. Where the soffit meets the wall cladding, check and gap fill any cracks or gaps to improve this intersection cosmetically and for weather tightness. Please note, due to the era this home was constructed, it is possible that this soffit contains asbestos, but this was not

tested or confirmed during this inspection. In need of repainting to help prolong the lifespan of the product.

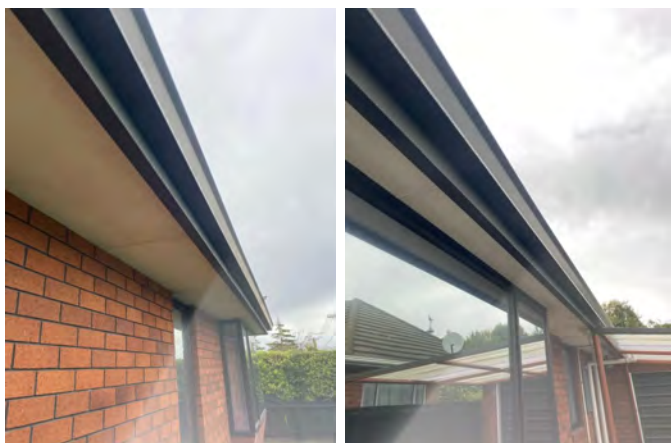
Example of no eaves.

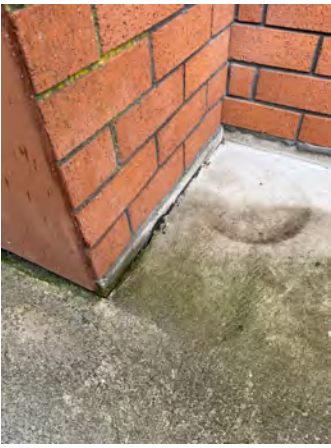
The exterior of the concrete slab foundation has typical cracking noted to some locations. This is commonly seen for this type of construction and does not appear to pose any significant concern.

Typical cracking noted.

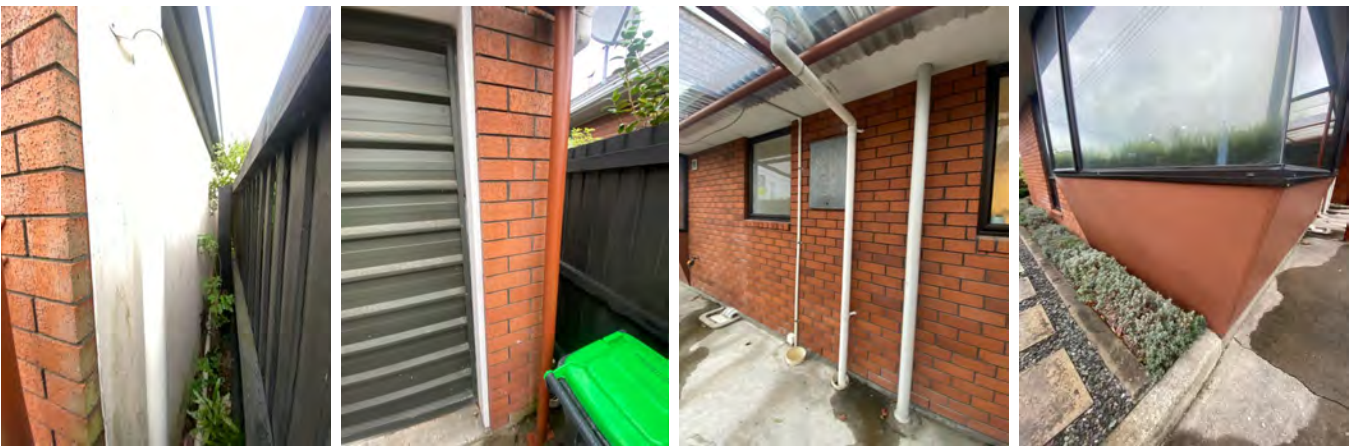
Some cracking in mortar noted, but nothing unexpected or concerning. Grind out and re-point mortar where needed as general and ongoing maintenance of a masonry cladding. Weep holes installed in the masonry cladding to help with airflow and assist with keeping internal frames dry. Please note, due to the era this home was built, the fibre cement claddings have the potential to contain asbestos; however, this was not tested or confirmed during this inspection.

The fibre cement cladding has typical defects and marks visible however, this is typically seen for properties of this age. I would recommend paint touchups and regular cleaning is completed for general ongoing maintenance.

Typical cracking noted.

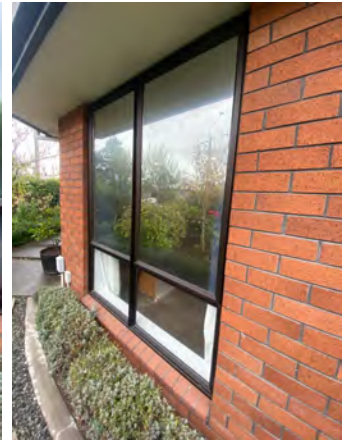
I would recommend having this change of cladding junction flashed to a better standard. This is likely how this location was constructed originally.

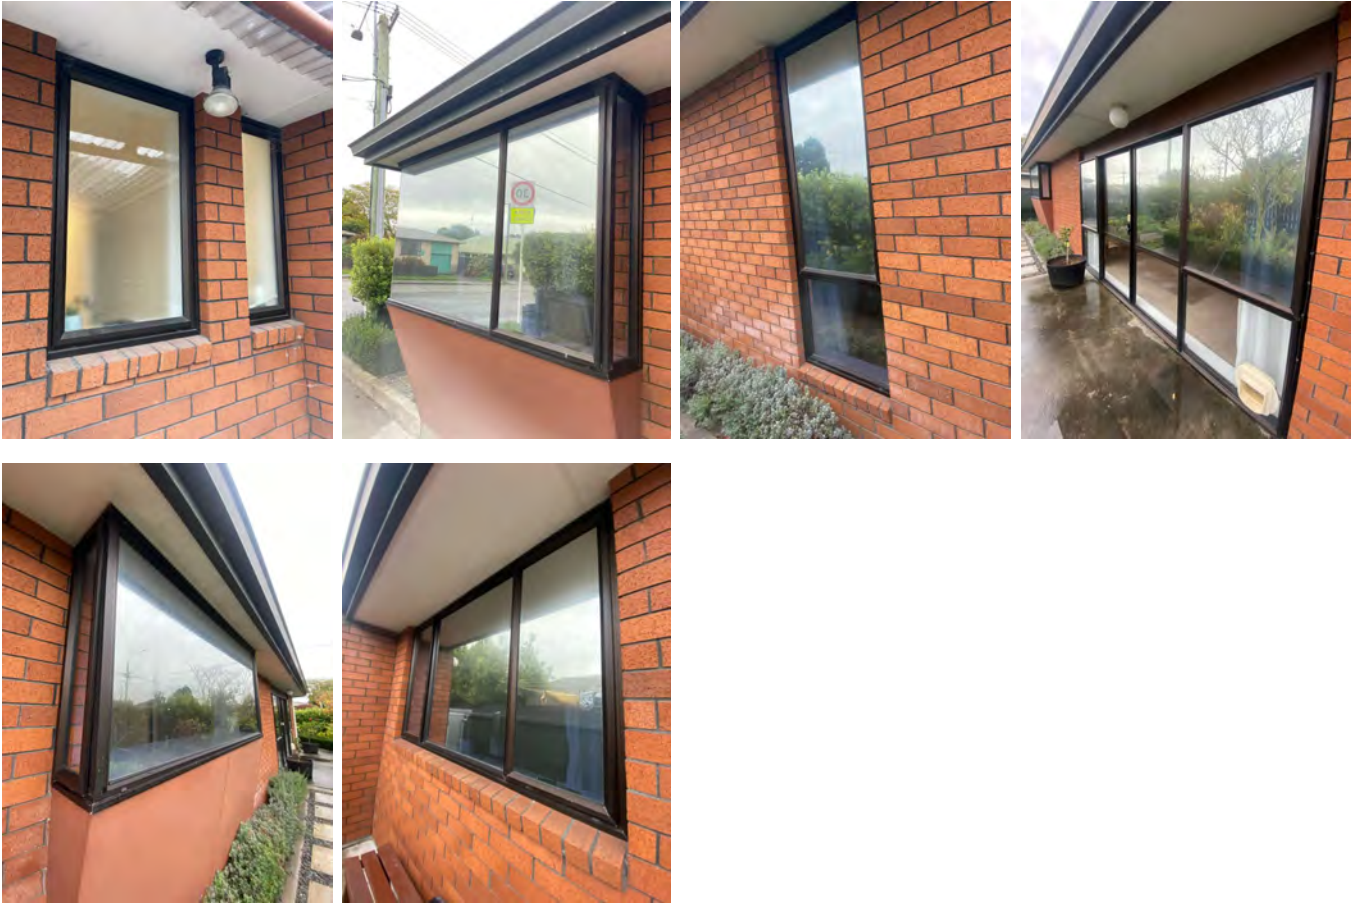
Exterior joinery comments are based on a visual assessment only; testing of the joinery function is found in the interior section of this report. No general concerns. A paint restorer could be used on any frames with sun fade; this will improve their appearance and help protect the current coating. This is typically more prevalent on sun-facing elevations. Where the exterior joinery frames meet the cladding, check and gap-fill/seal any cracks or gaps to improve this intersection cosmetically and for weather-tightness.

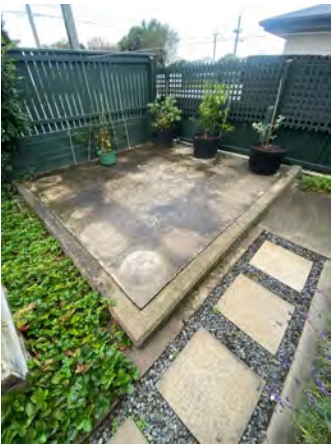
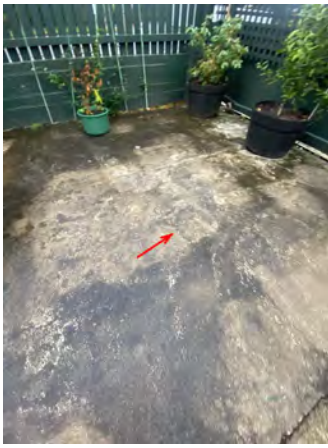
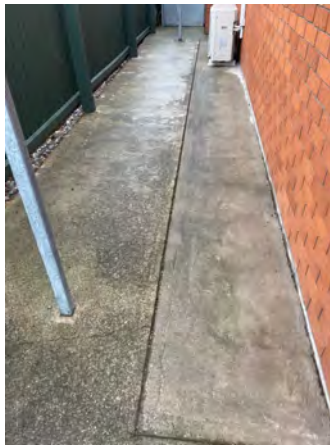
Some typical cracking and settlement was noted to the hardscaping in areas; however, nothing significant was noted. Maintained well with regular cleaning.

Typical cracking.

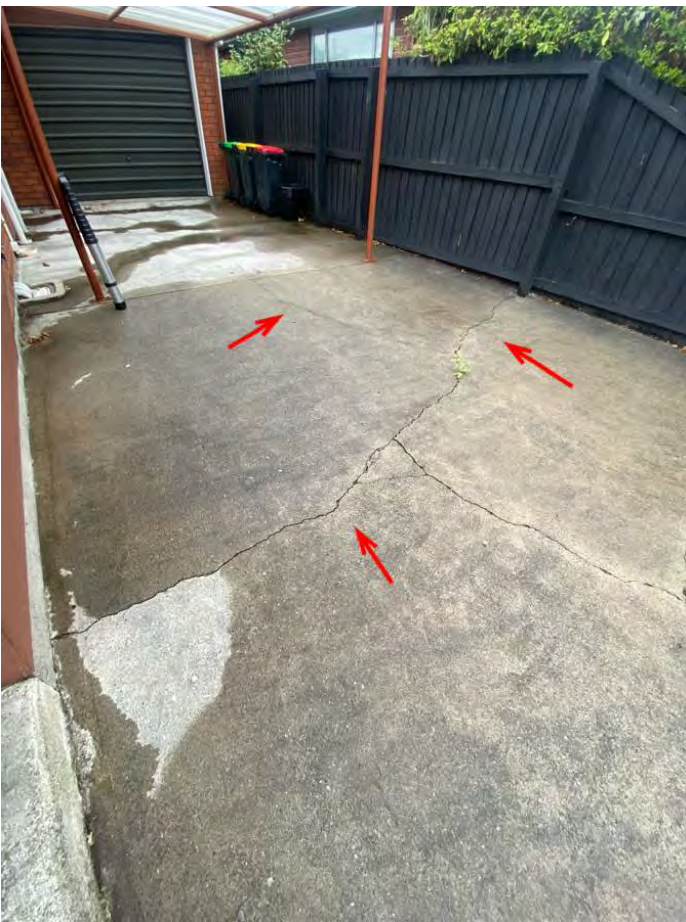
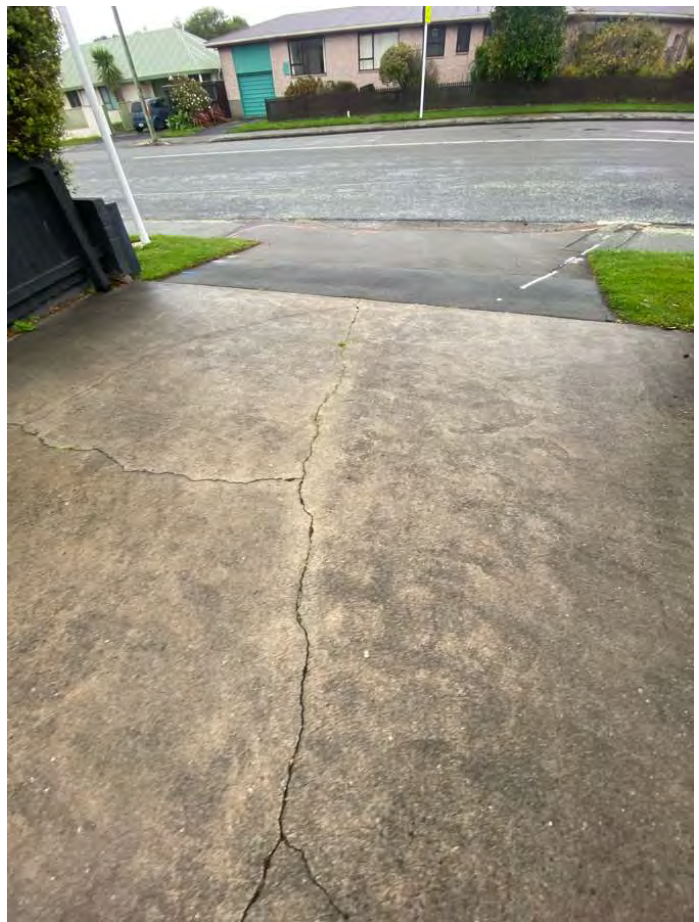
The concrete driveway has typical cracking visible but nothing unexpected or concerning for a property of this age.

Typical cracking noted.

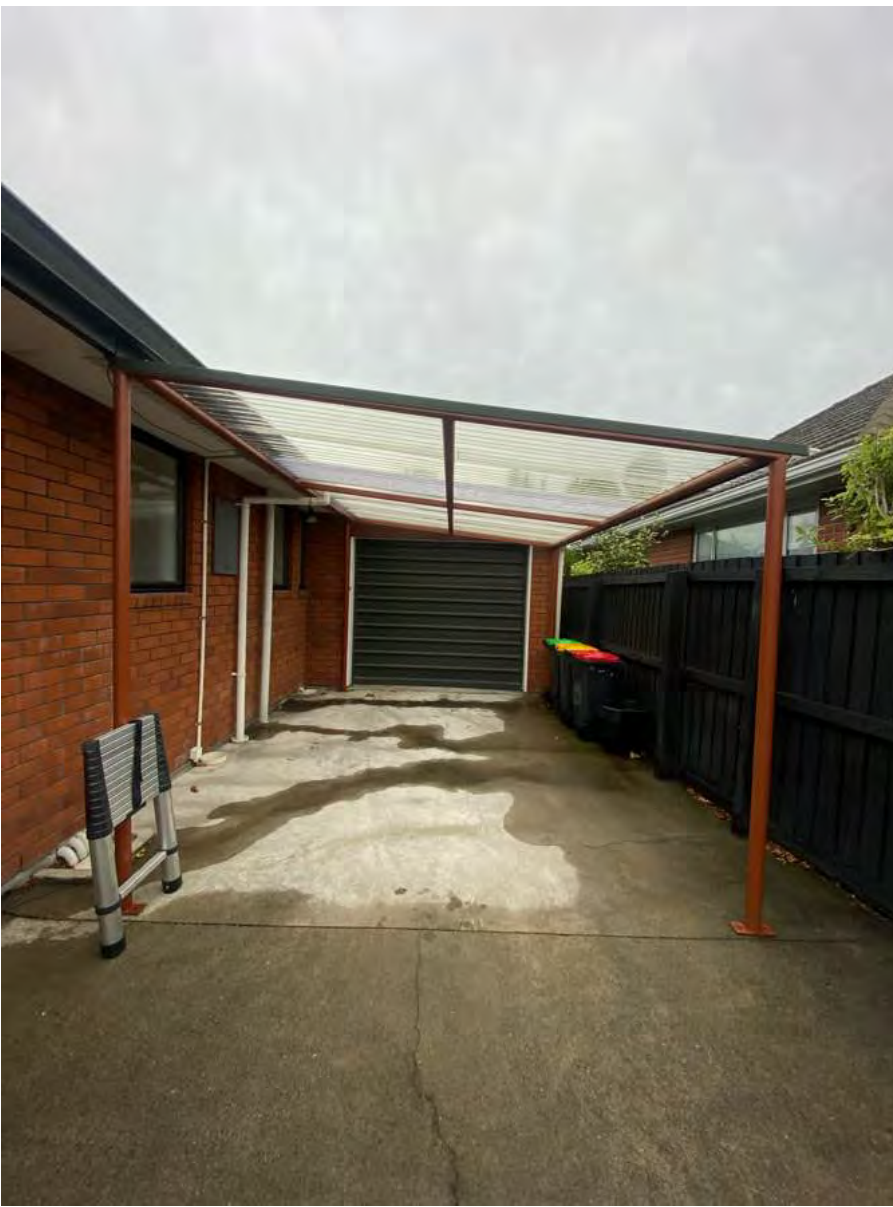
The carport is stable and appears to be fit for purpose. I would recommend having guttering installed so water can divert to the appropriate outlet.

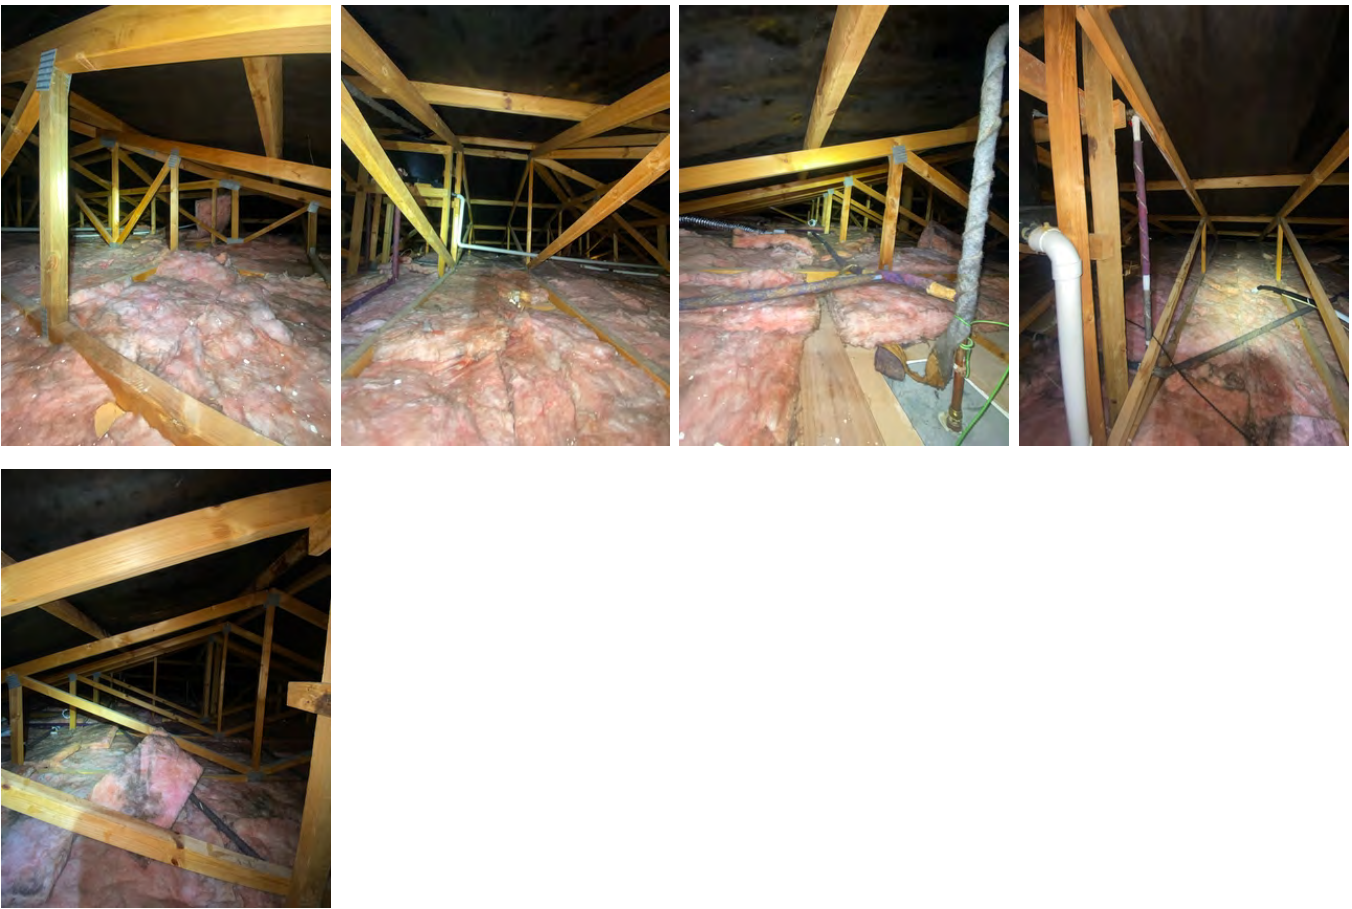
Fixed well into place. No sagging identified. No signs of water damage or rot.

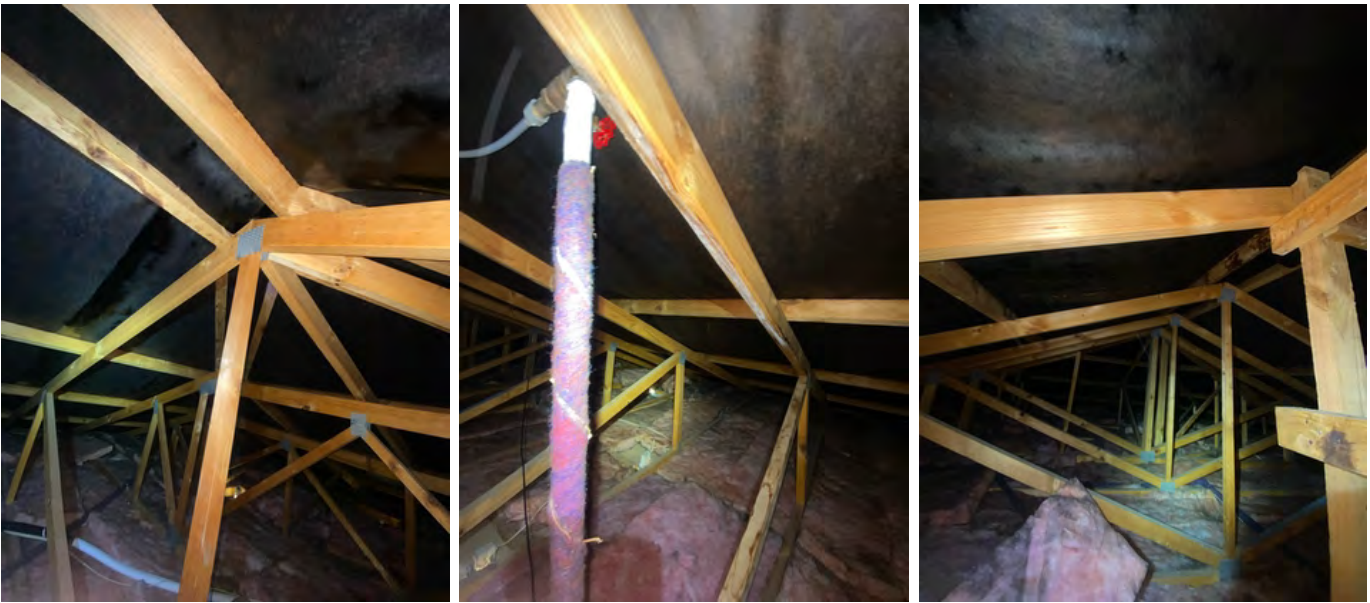
No signs of moisture ingress observed. No general concerns found.

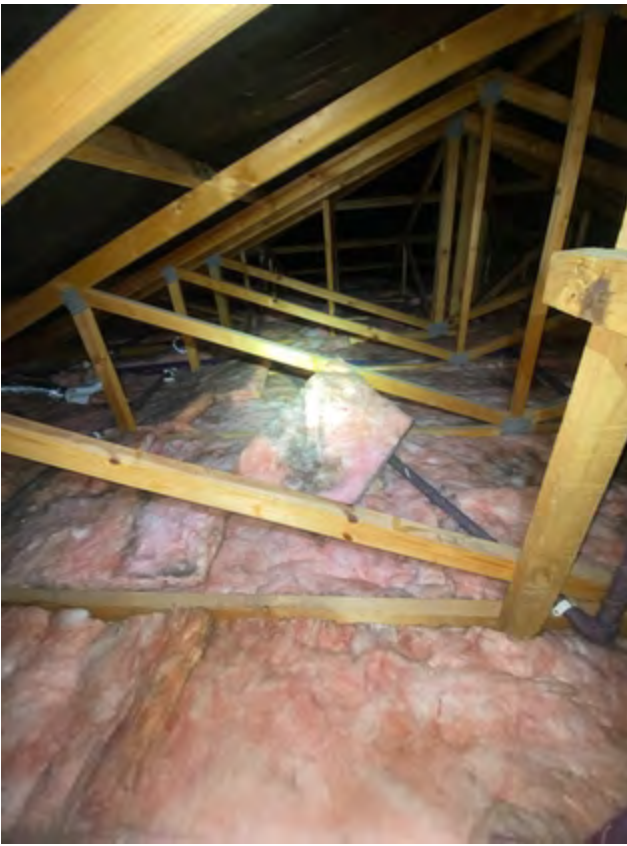
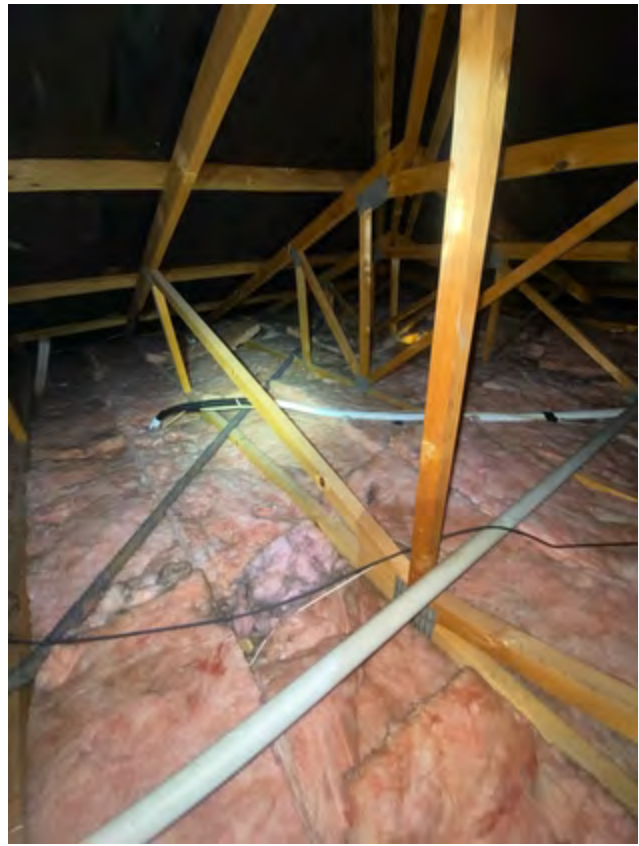
Insulation laid throughout. Not slumped or compressed. No obvious water damage observed. It is strongly recommended all down lights be checked and insulation pulled away from them to prevent a potential fire hazard. Incandescent and halogen lights should not have insulation touching them, a safety gap is required.

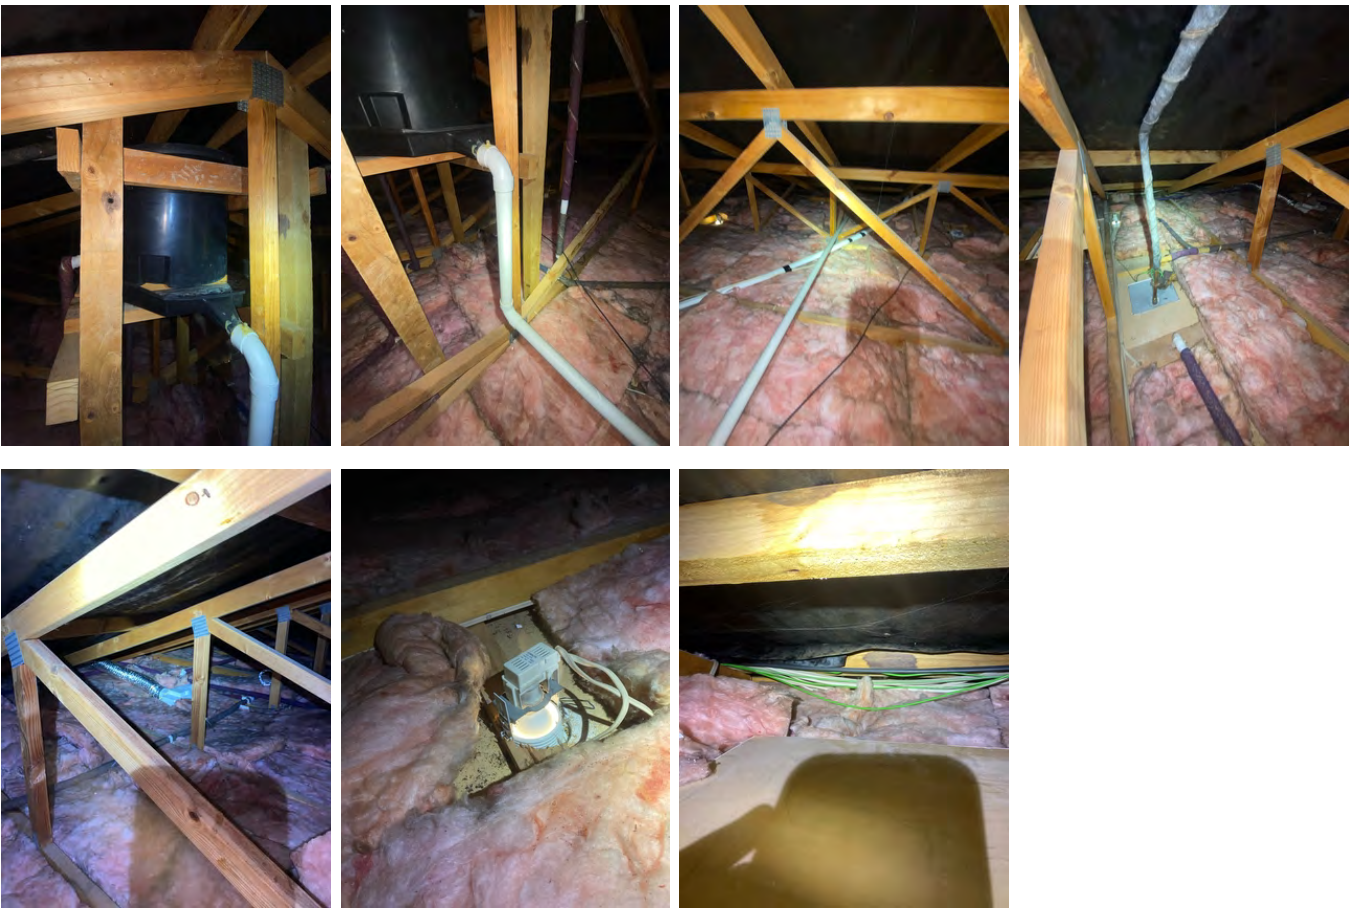
Please note that our view of the plumbing elements is limited to what can be visually sighted, and we cannot confirm anything beyond what is visible or enclosed behind wall linings, under insulation, etc. No general issues noted.

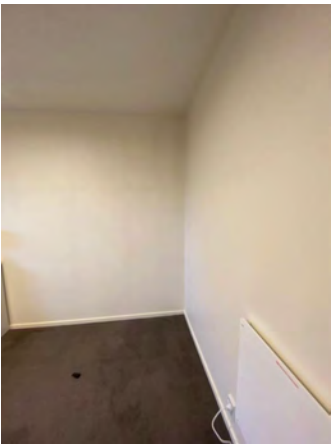
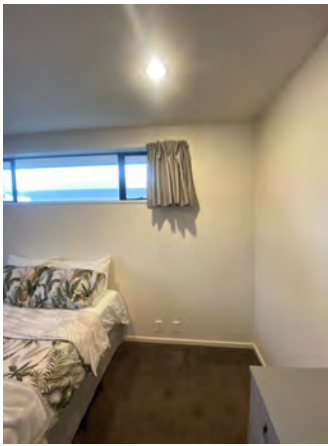
Minimal marks or damage; nothing more than you would reasonably expect for its age.

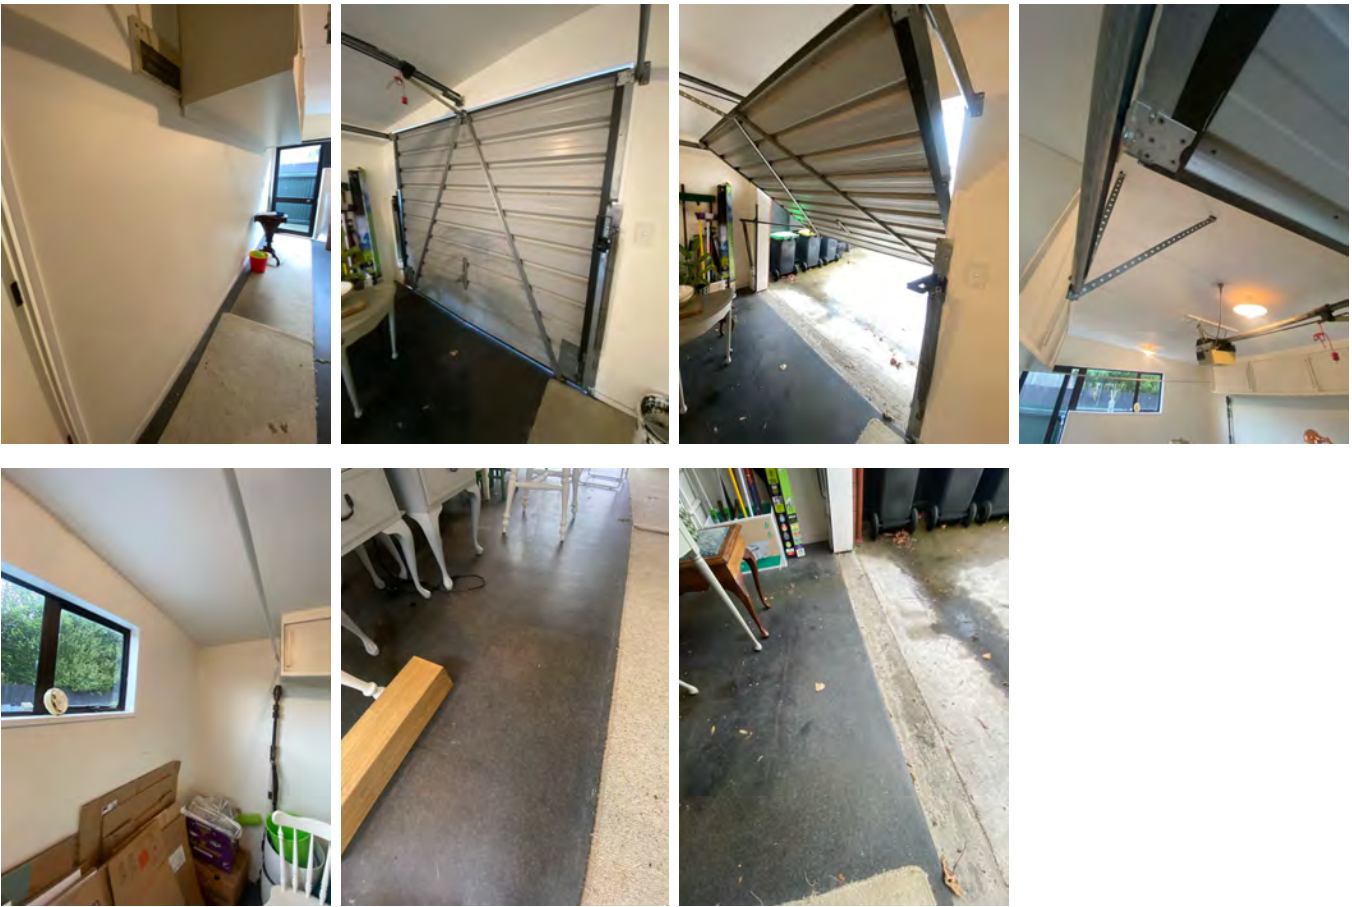
Garage door is electric motorised and working fine. Wall linings have minimal marks or damage; nothing more than you would reasonably expect for its age. No obvious cracks noted to the slab.

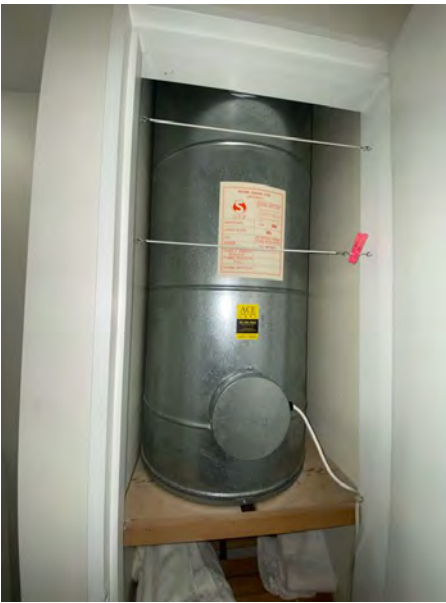
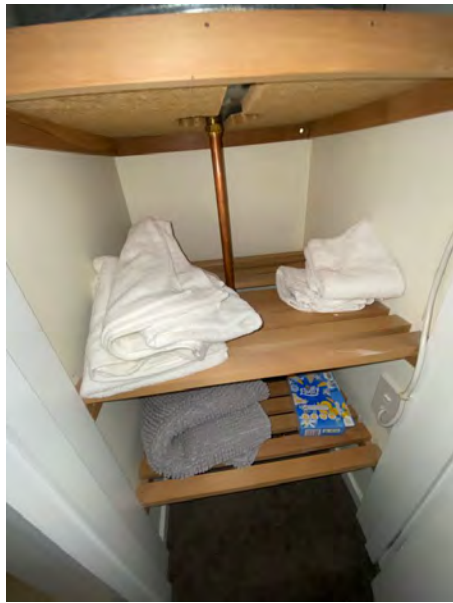
No leaks observed. Cylinder needs proper seismic restraints installed to prevent it tipping over in the case of an earthquake. The cylinder is very dated and should be periodically inspected.

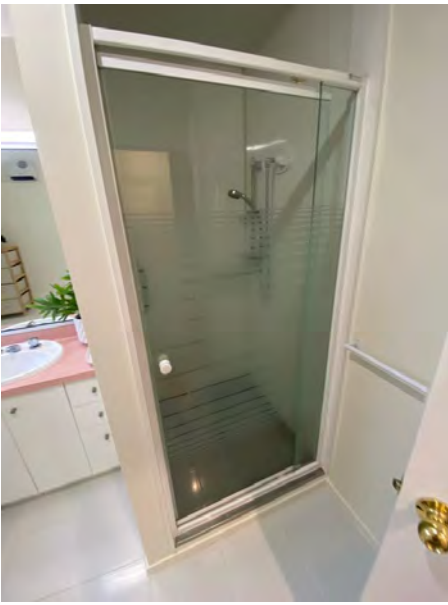
Shower head rail is loose.

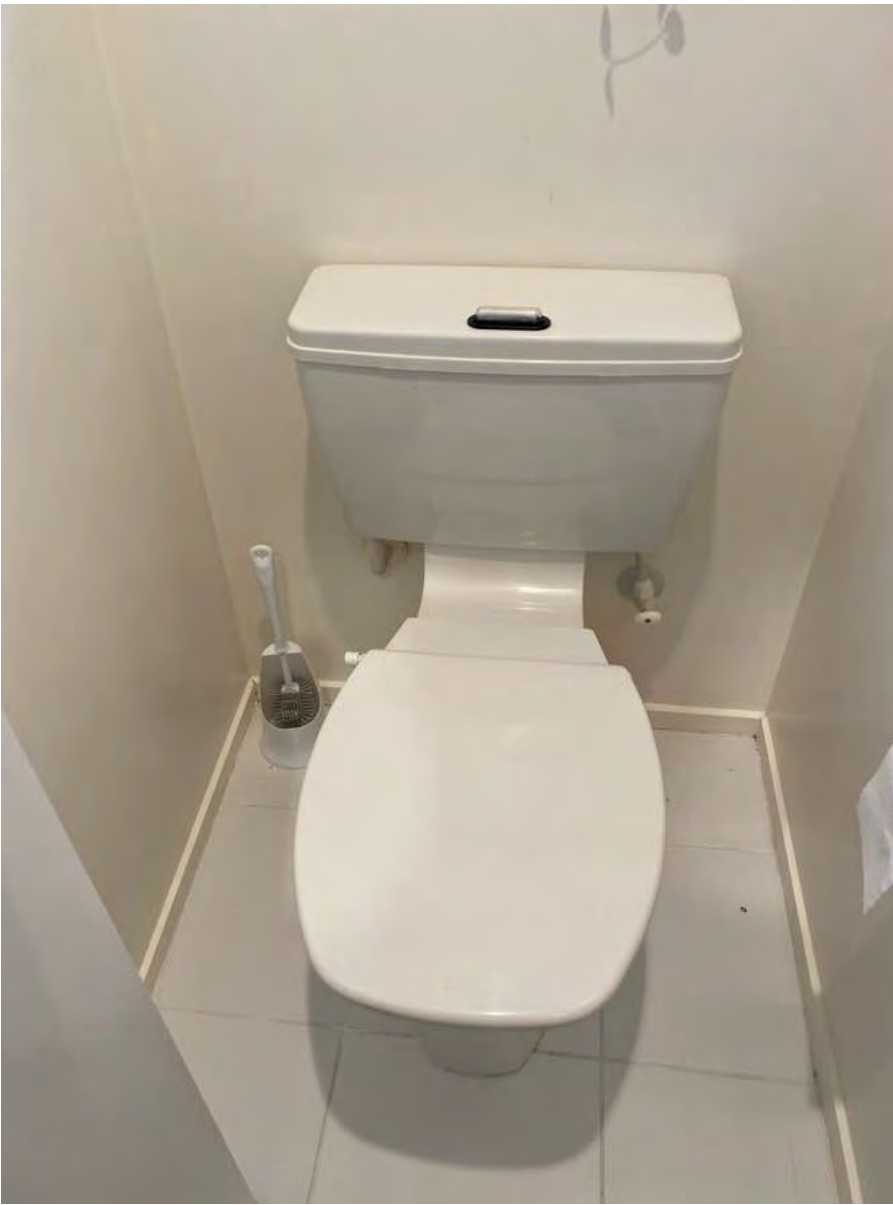
The toilet seat is loose and needs tightening.

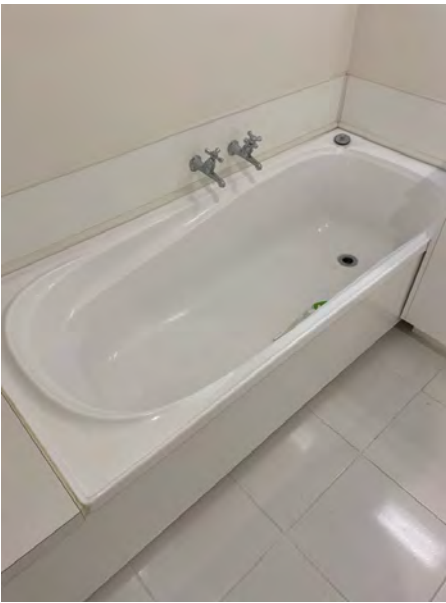
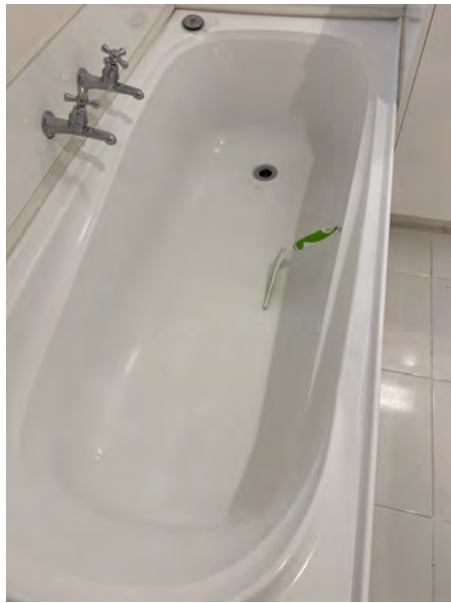
Faucet is loose.
