BUILDING INSPECTION REPORT

76a Memorial Ave, Ilam. Building Report

Property Inspected by Graeme Potts 021 244 1047
graeme.potts@inspectedresidential.co.nz Qualified builder, Licensed Building Practitioner
National Certificate in Carpentry and National Certificate in Construction (Leading Hand). This
inspection was carried out in accordance with NZS4306:2005

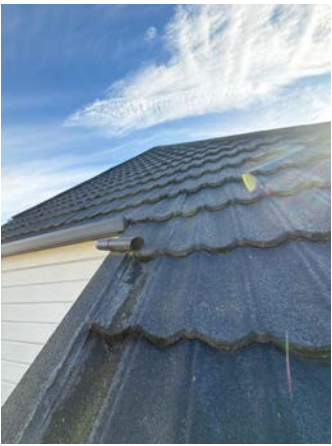
The stone chip tile coating is aging but still looks to be performing with some dented tiles noted.

Stone chip coating aging in some areas and example of dented tiles , likely from foot traffic.

The stone chip tile coating is aging but still looks to be performing with some dented tiles noted. There are some popped tile fixings noted that should be replaced with new fixings.

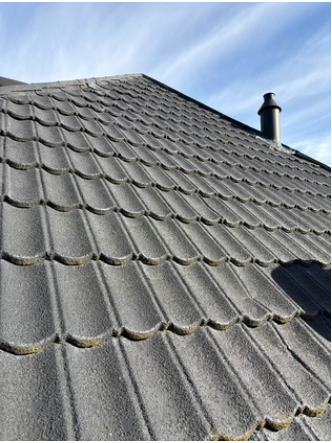
Roofing iron starting to rust. This should be treated. Above garage

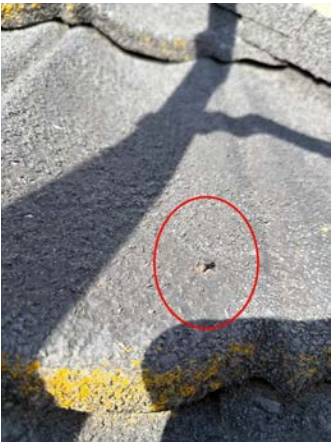
Example of popped roof cladding fixings.

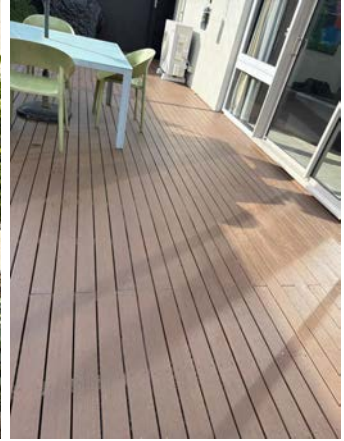
Gap noted to be filled/sealed.
South face.

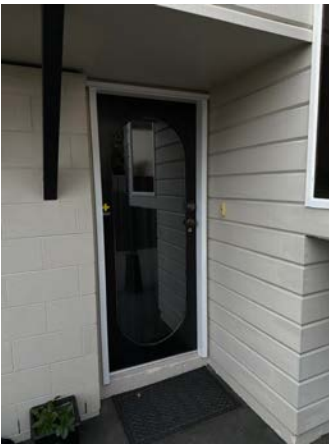
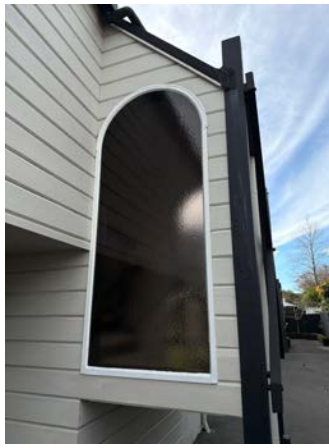
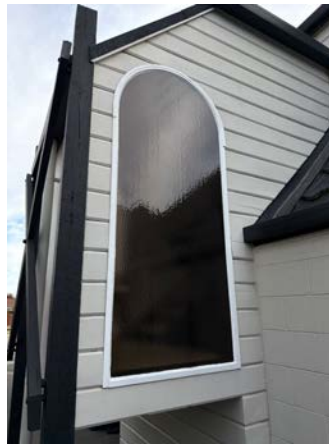
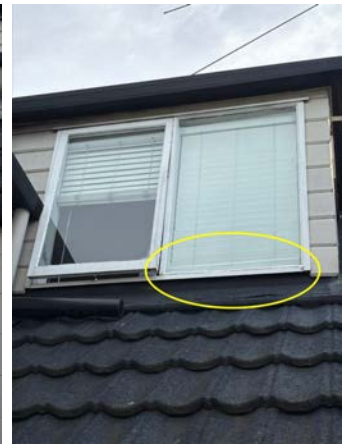
Exterior joinery comments are based on a visual assessment only; testing of the joinery function is found in the interior section of this report. Some redecorating could be done on some of the timber window frames to help prolong the life of the material. Example photo below.

Some redecorating could be done on some of the timber window frames to help prolong the life of the material. Bathroom window.

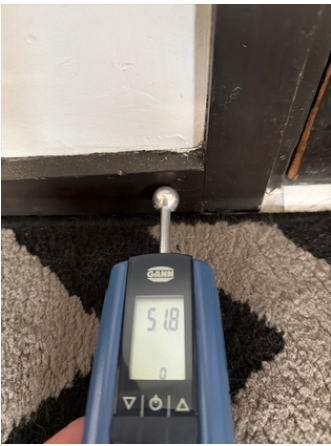
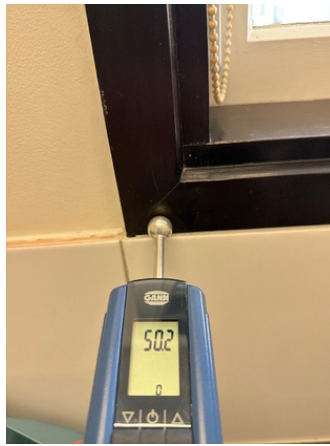
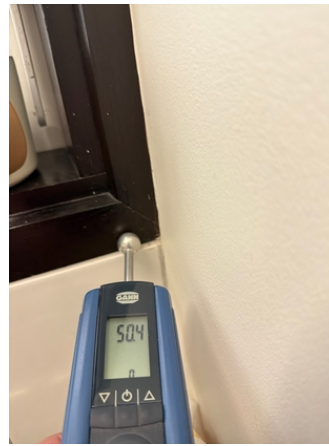
Elevated moisture reading noted. Dining room window. Further investigation required. This could be the glazing needing resealed.

Who to Engage: Advice, Investigation or Repairs

Sash Window Repair Specialist

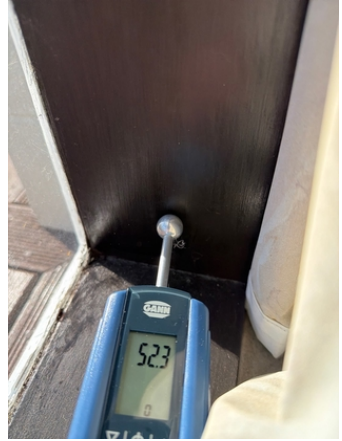
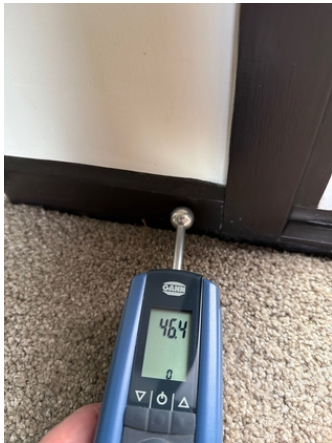
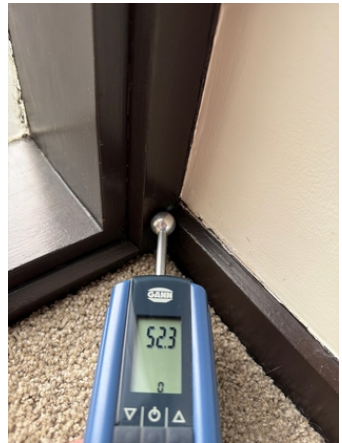
Elevated moisture reading noted. Dining room window.

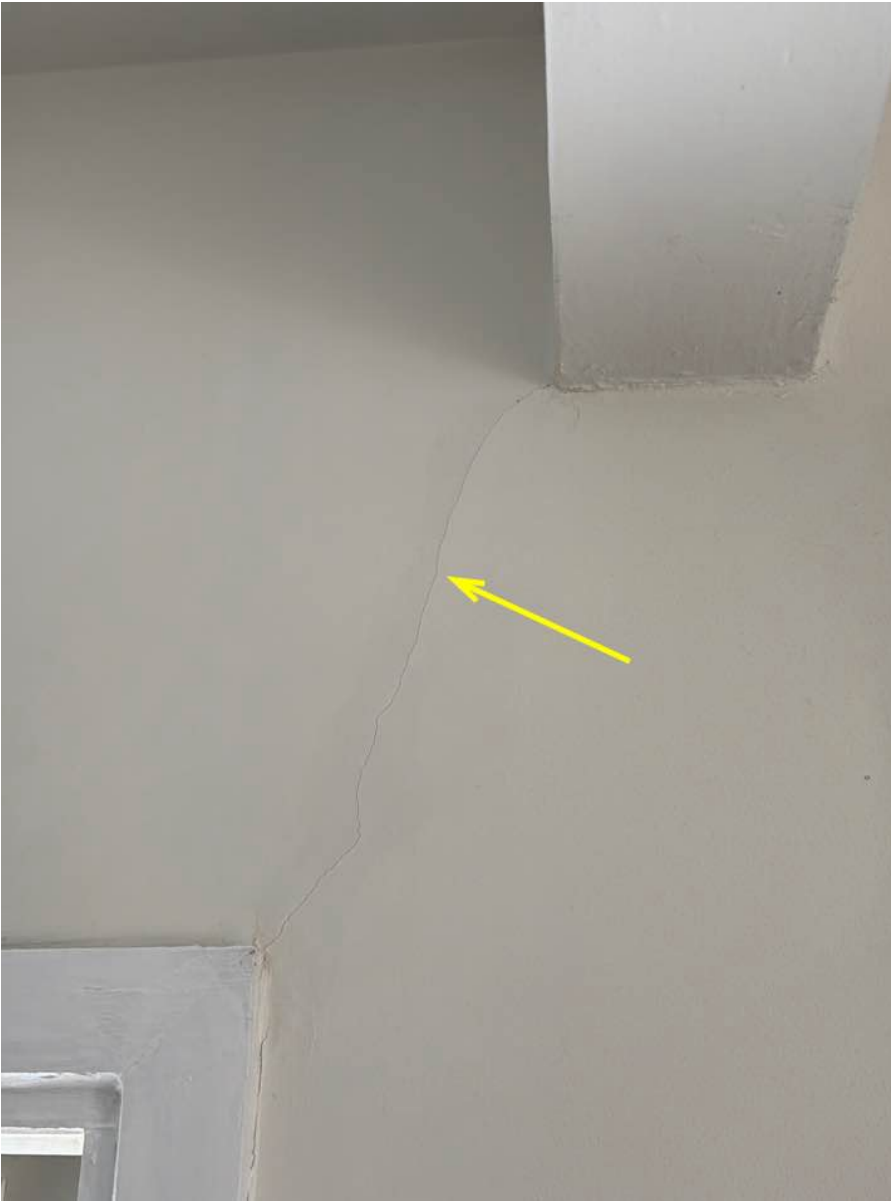
Minimal marks or damage; nothing more than you would reasonably expect for its age. Some cosmetic cracking noted around window openings and wall to ceiling junctions etc.

Example of cosmetic cracking noted.

Who to Engage: Advice, Investigation or Repairs

Painter and Decorator

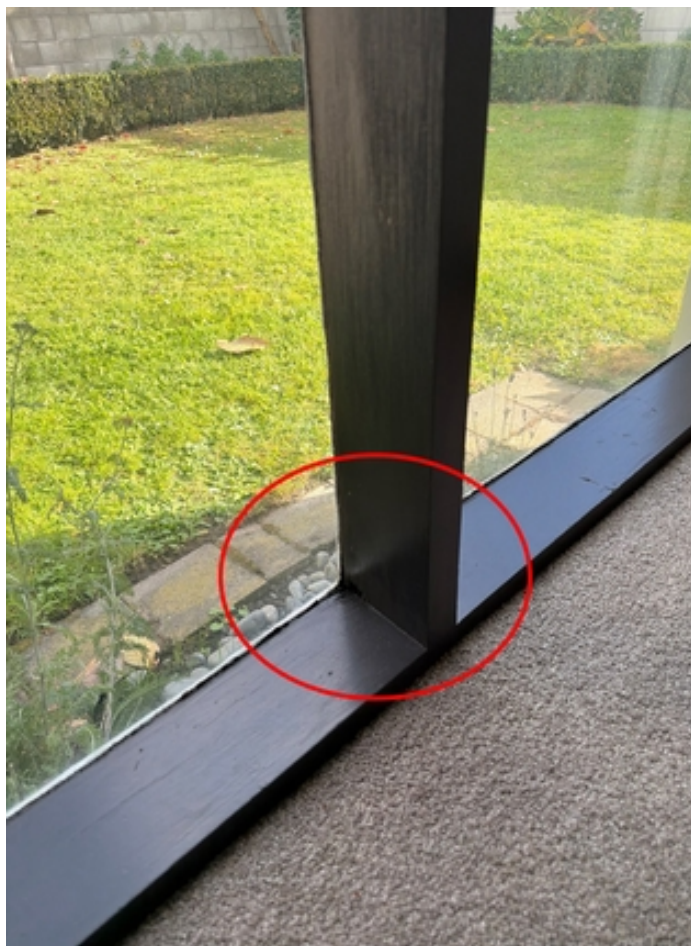
Some moisture damage noted to the dining room window framing. (Also noted in the moisture testing section of this report).

Moisture damage noted to dining room window frame.

Note from agent: This window has since been resealed.
