# Building inspection report here

# 76a Memorial Ave, Ilam.

## Building Report

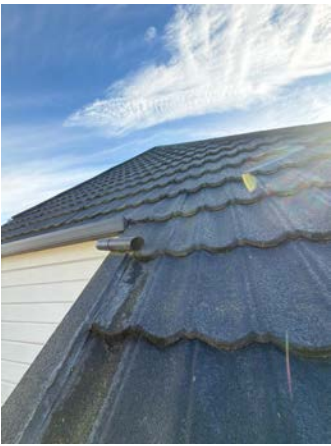
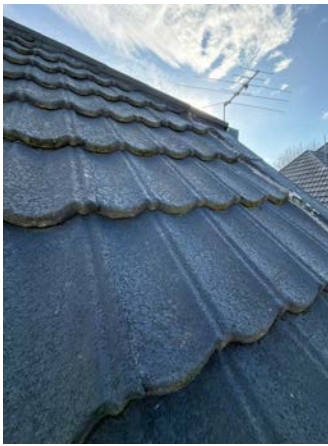
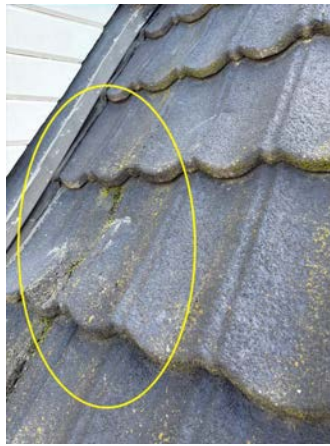
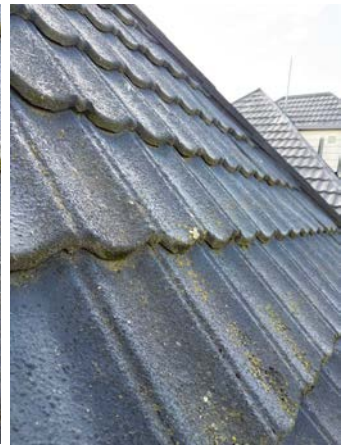
The stone chip tile coating is aging but still looks to be performing with some dented tiles noted.

Stone chip coating aging in some areas and example of dented tiles , likely from foot traffic.

The stone chip tile coating is aging but still looks to be performing with some dented tiles noted. There are some popped tile fixings noted that should be replaced with new fixings.

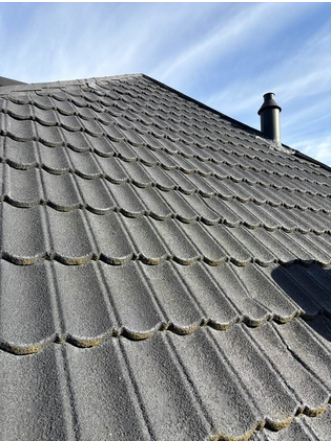
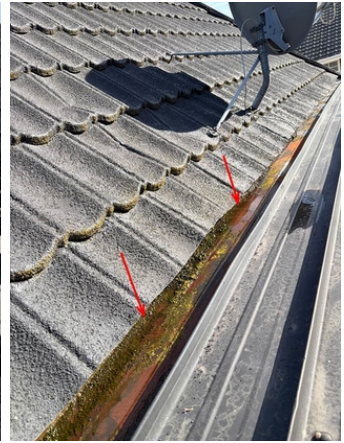
Roofing iron starting to rust. This should be treated. Above garage

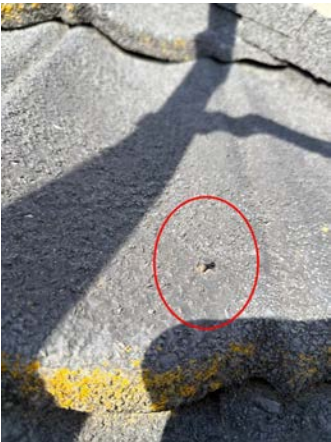
Example of popped roof cladding fixings.

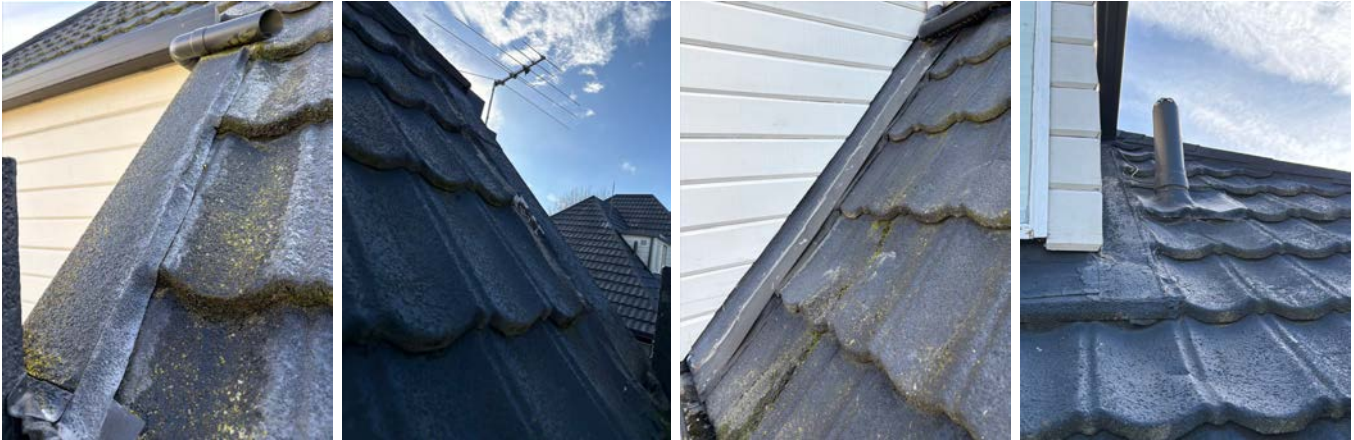
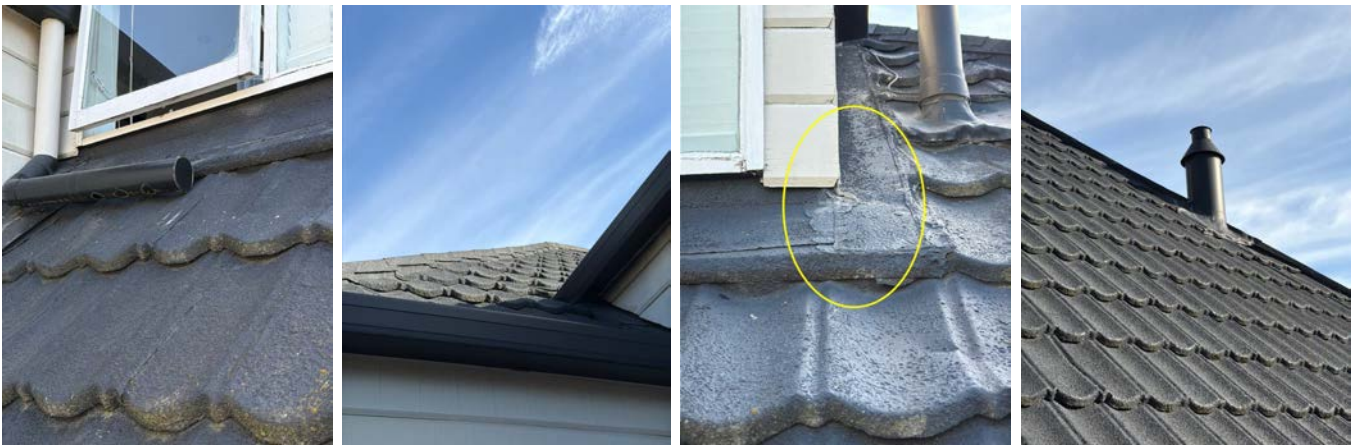
The barge and apron flashings are aging in some areas but still look to be performing. Sealant has been added to some junctions. Monitor these and repair appropriately. Example photo below.

Example of junctions with sealant added to monitor for weather-tightness.

### Who to Engage: Advice, Investigation or Repairs

Qualified Roofer

The flashings are aging in some areas with sealant that has been added to some junctions. Monitor these and repair appropriately.

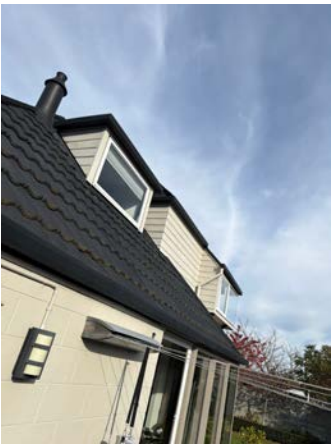
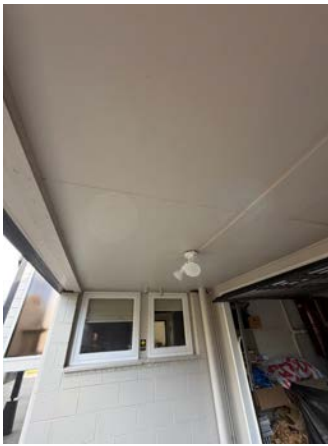
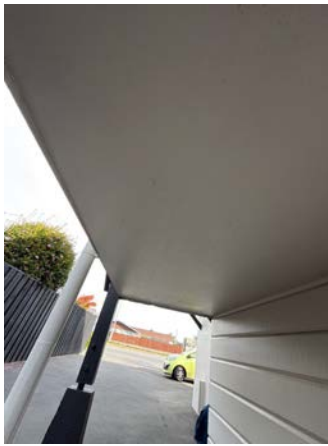
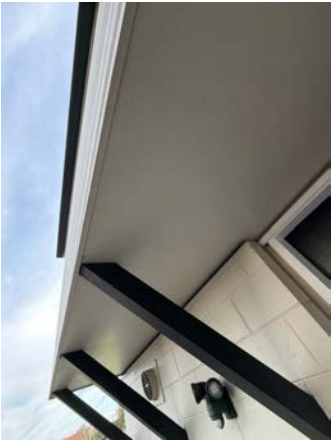
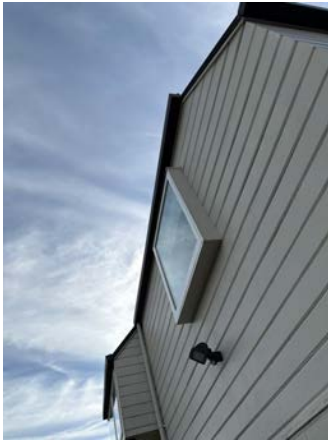
Fascia fixed well to structure. No obvious popped or protruding fixings noted. The products have been maintained well with paint. Please note, due to the era this home was constructed, it is possible that this soffit contains asbestos, but this was not tested or confirmed during this inspection. The majority of the dwelling has no eaves; eaves are the pitched section of the roof that overhangs the exterior walls. The main purpose of these is to decrease the weather-tightness risk of the dwelling. Not having eaves can make the home more susceptible to weather-tightness issues and moisture ingress, as the lack of an overhang exposes the wall-to-roof junction to direct weather. This is still an acceptable construction method to this day, but additional care and maintenance are required to ensure these junctions remain weathertight.

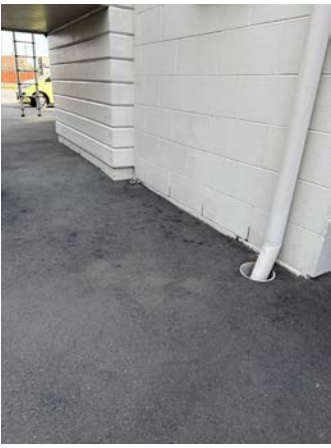
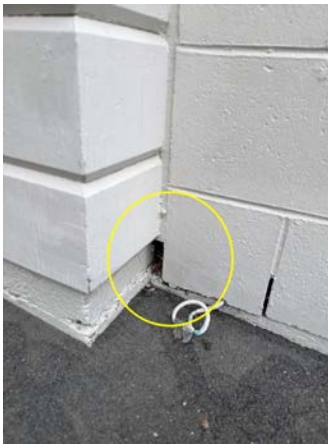
Gap noted to be filled/sealed.  
South face.

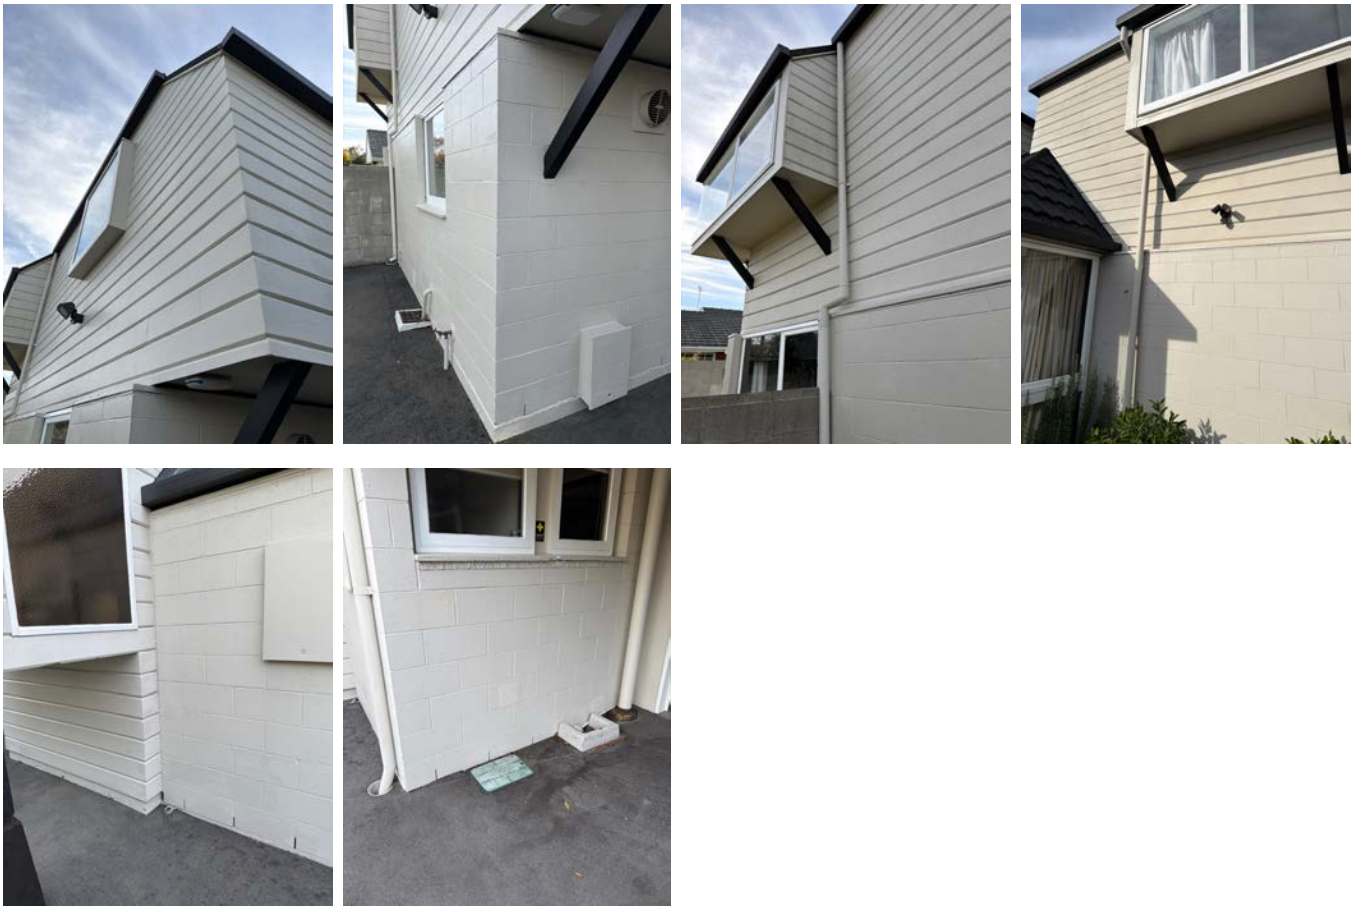
Maintained well for the age of the dwelling. No major concerns noted from what could be observed during the time of inspection.

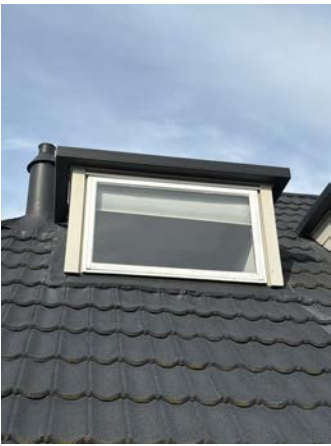
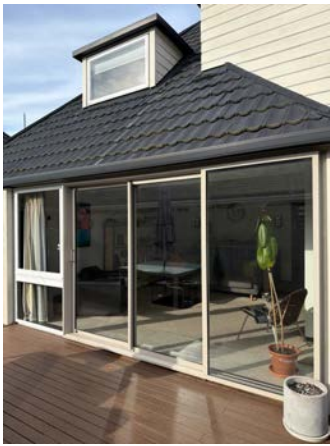
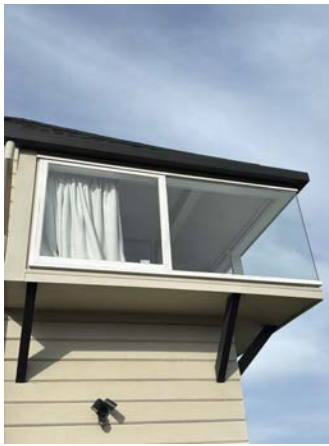
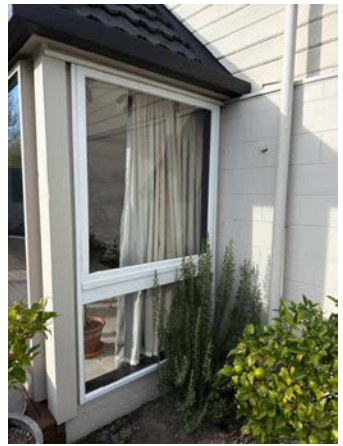
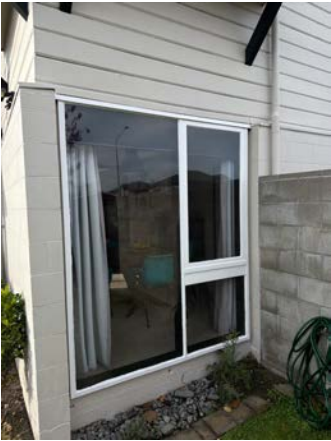
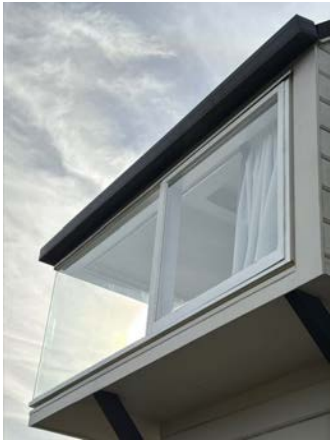
Exterior joinery comments are based on a visual assessment only; testing of the joinery function is found in the interior section of this report. Some redecorating could be done on some of the timber window frames to help prolong the life of the material. Example photo below.

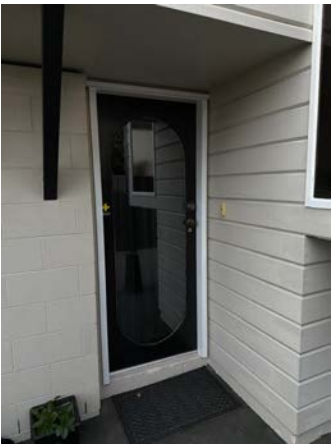
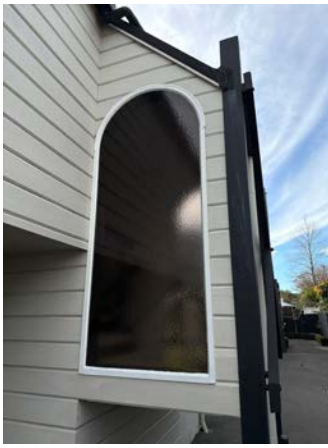
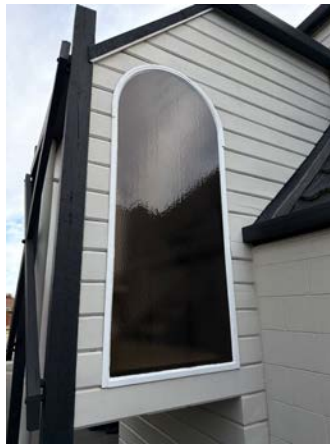
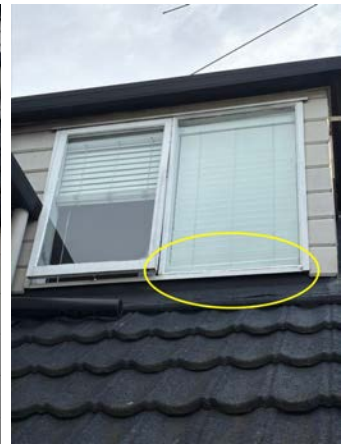
Some redecorating could be done on some of the timber window frames to help prolong the life of the material.  
Bathroom window.

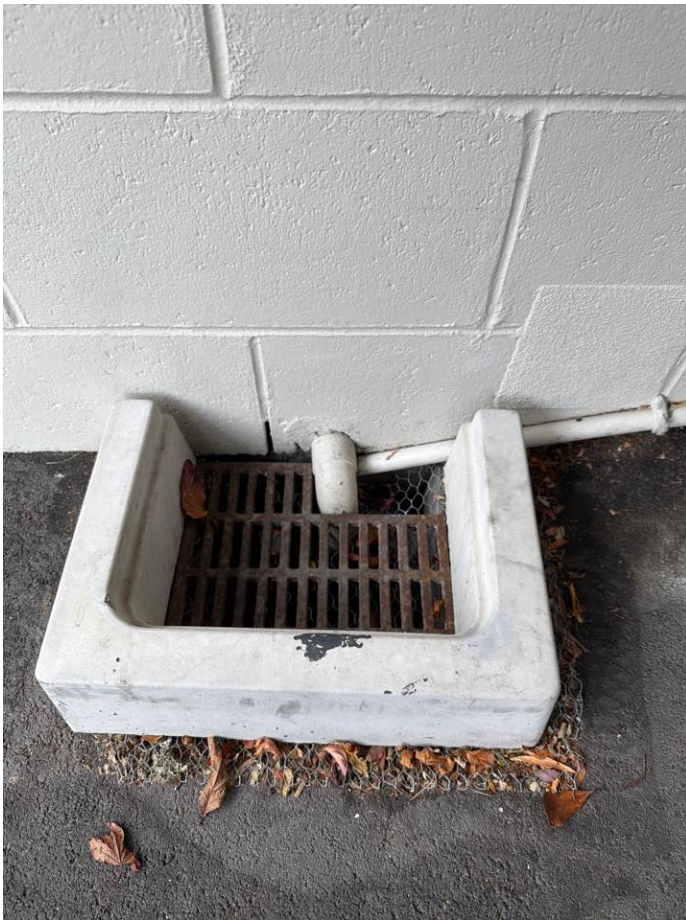
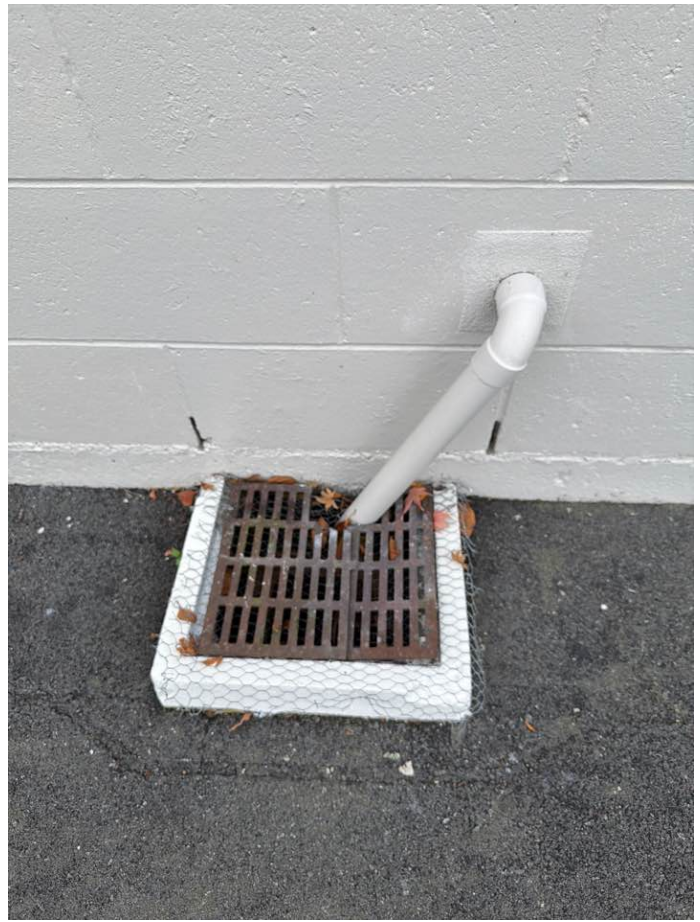
Gully traps are sufficient height off finished ground level. The rim of the trap needs to be at least 25mm above a paved surface, and 100mm above an unpaved surface.

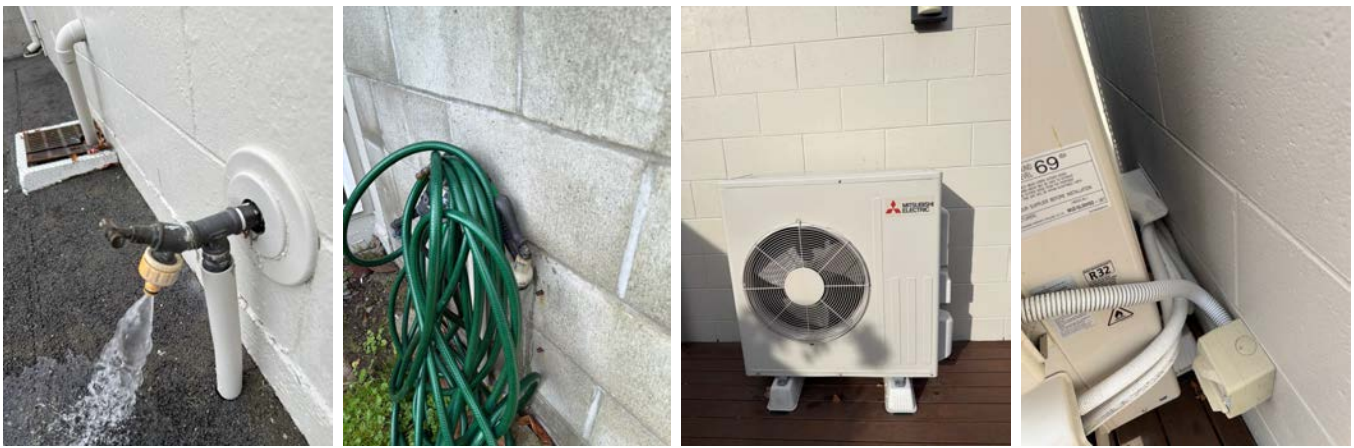
Taps are operating fine. No testing of the exterior electrical elements is undertaken during this inspection; please consult a suitably qualified electrical specialist regarding this.

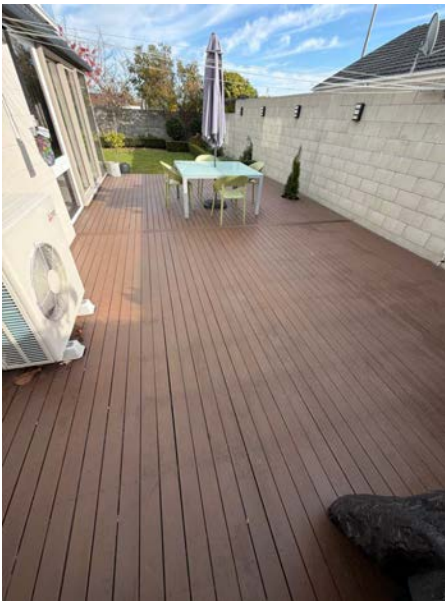
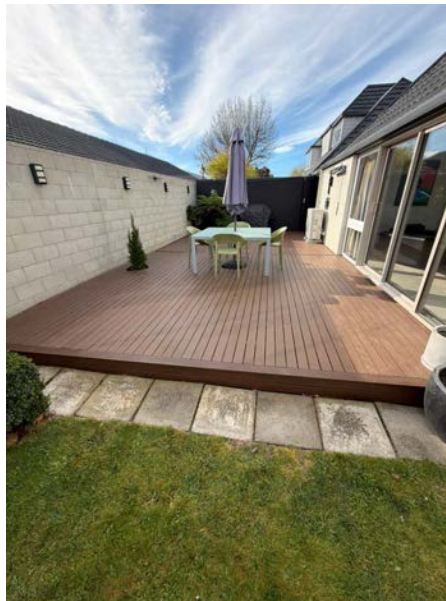
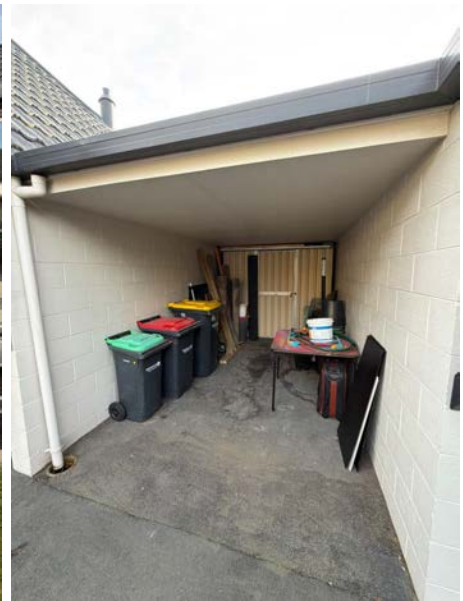
General aging. No major concerns noted.

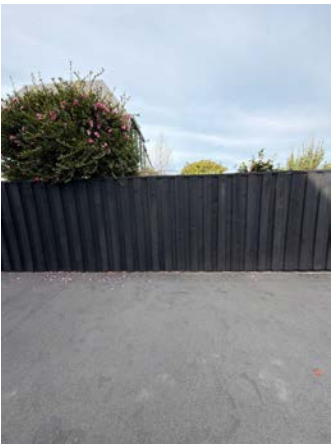
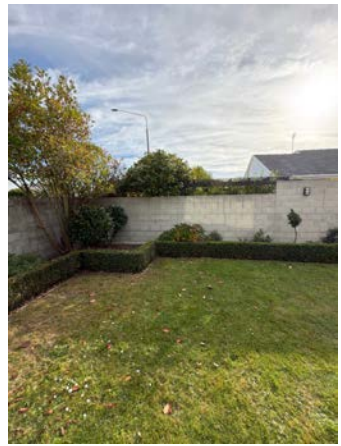
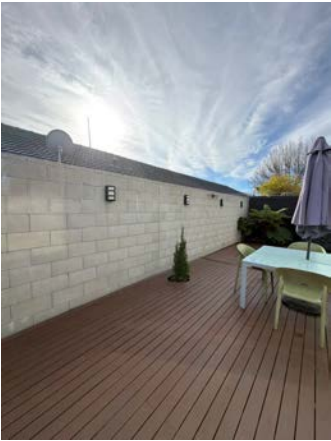
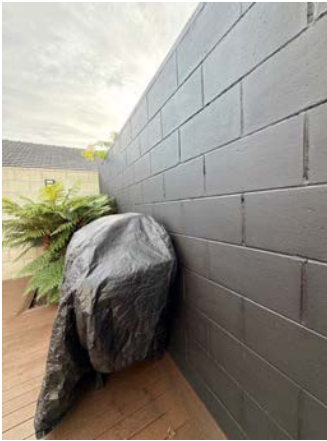
Well maintained. No concerns

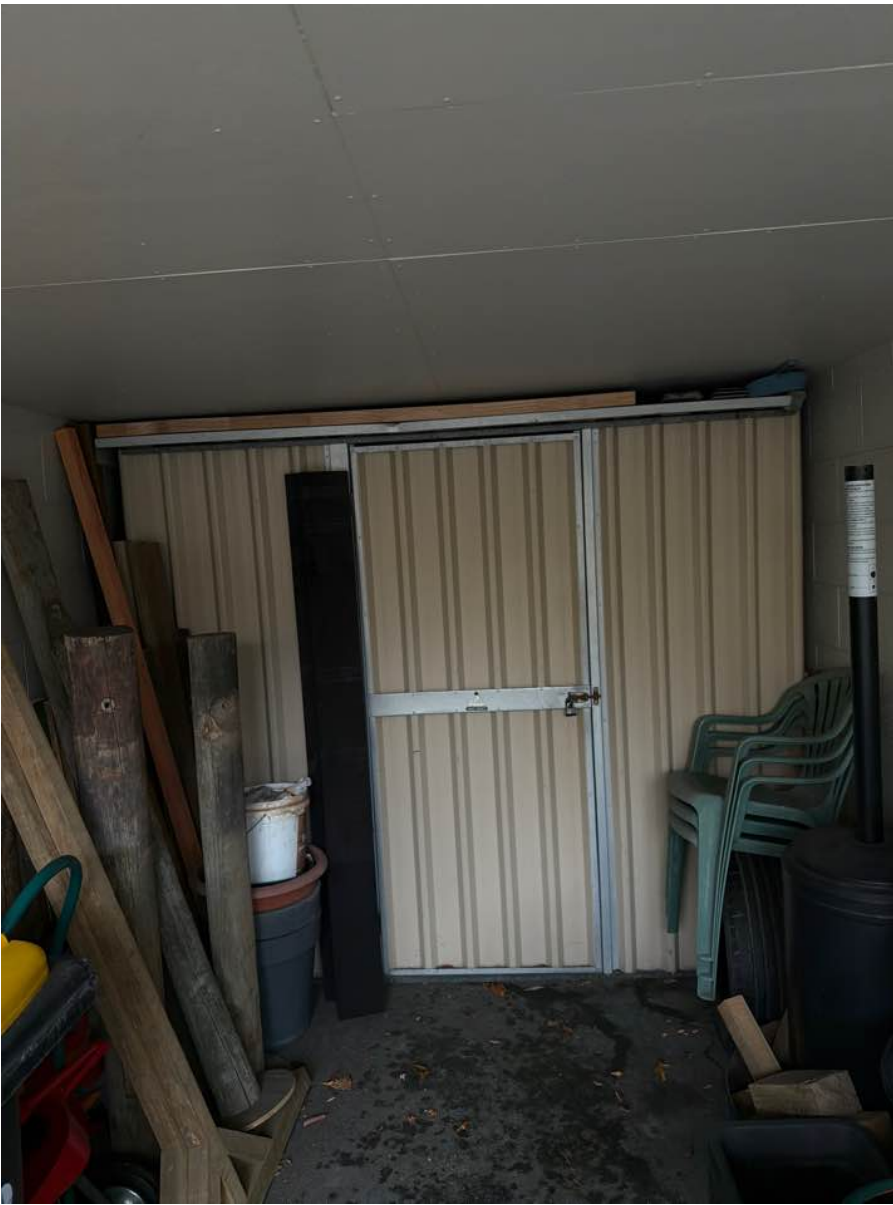
No general concerns found. Shed was locked unable to access.

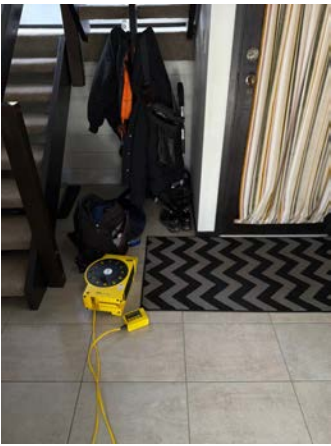
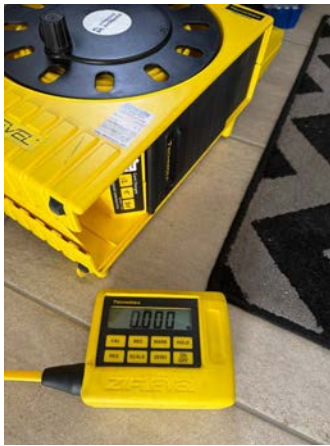
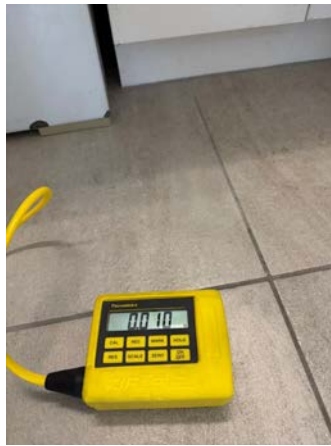
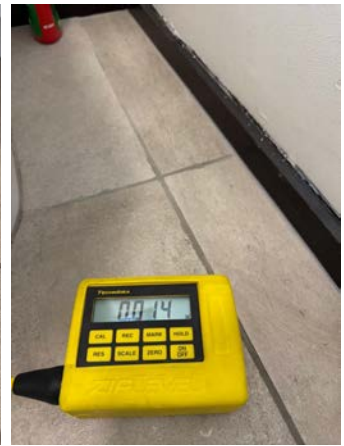
There were no concerning floor levels taken during the time of inspection.

The datum was taken near the main entrance.

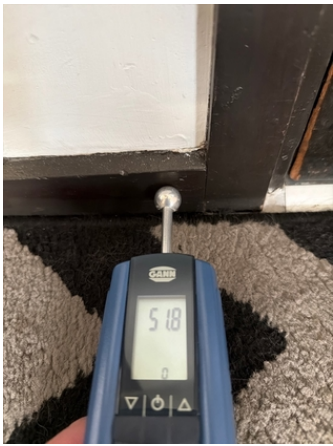
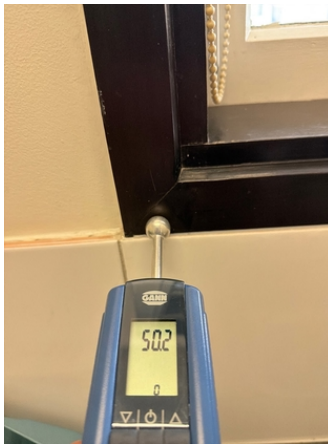
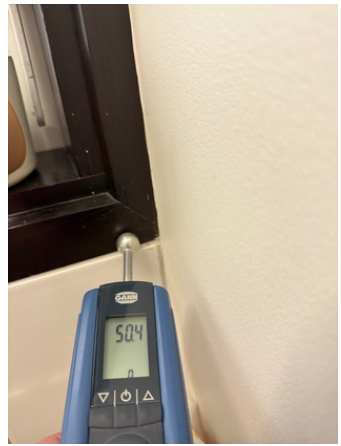
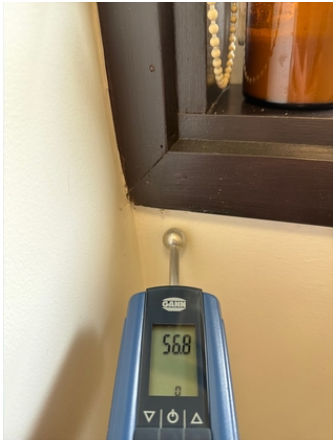
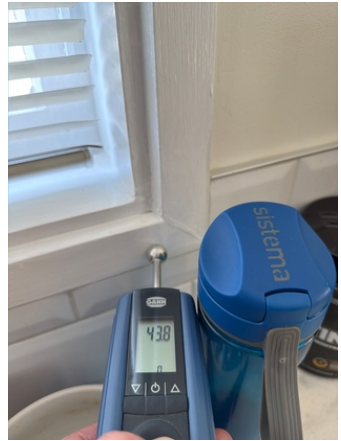
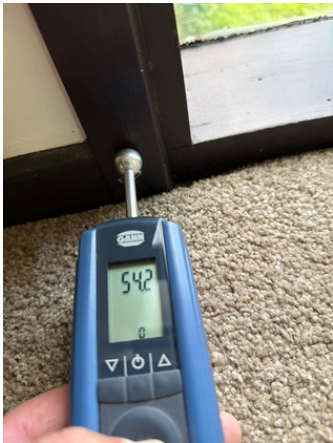
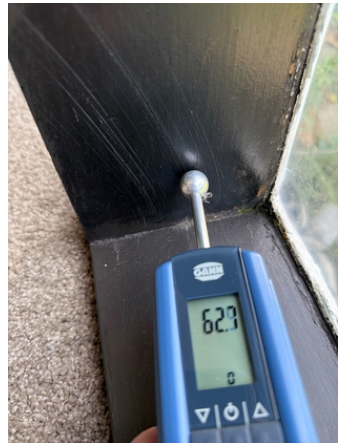
Elevated moisture reading noted. Dining room window. Further investigation required. This could be the glazing needing resealed.

### Who to Engage: Advice, Investigation or Repairs

Sash Window Repair Specialist

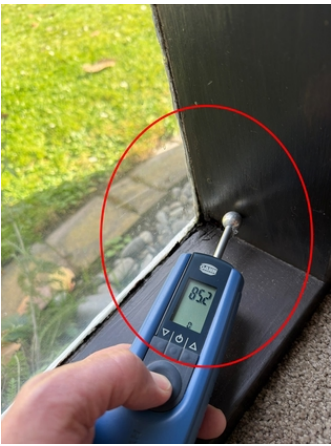
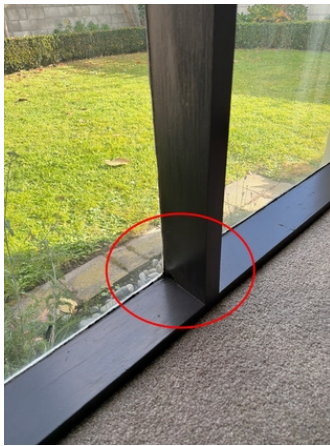
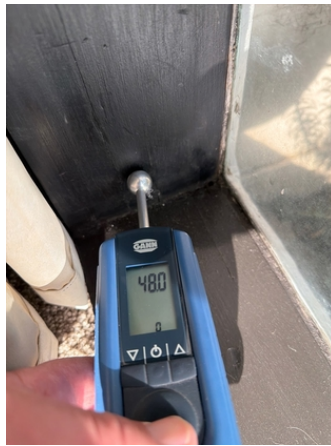
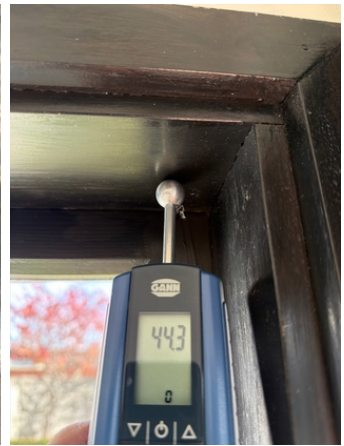
Elevated moisture reading noted. Dining room window.

Elevated moisture reading noted. Dining room window.

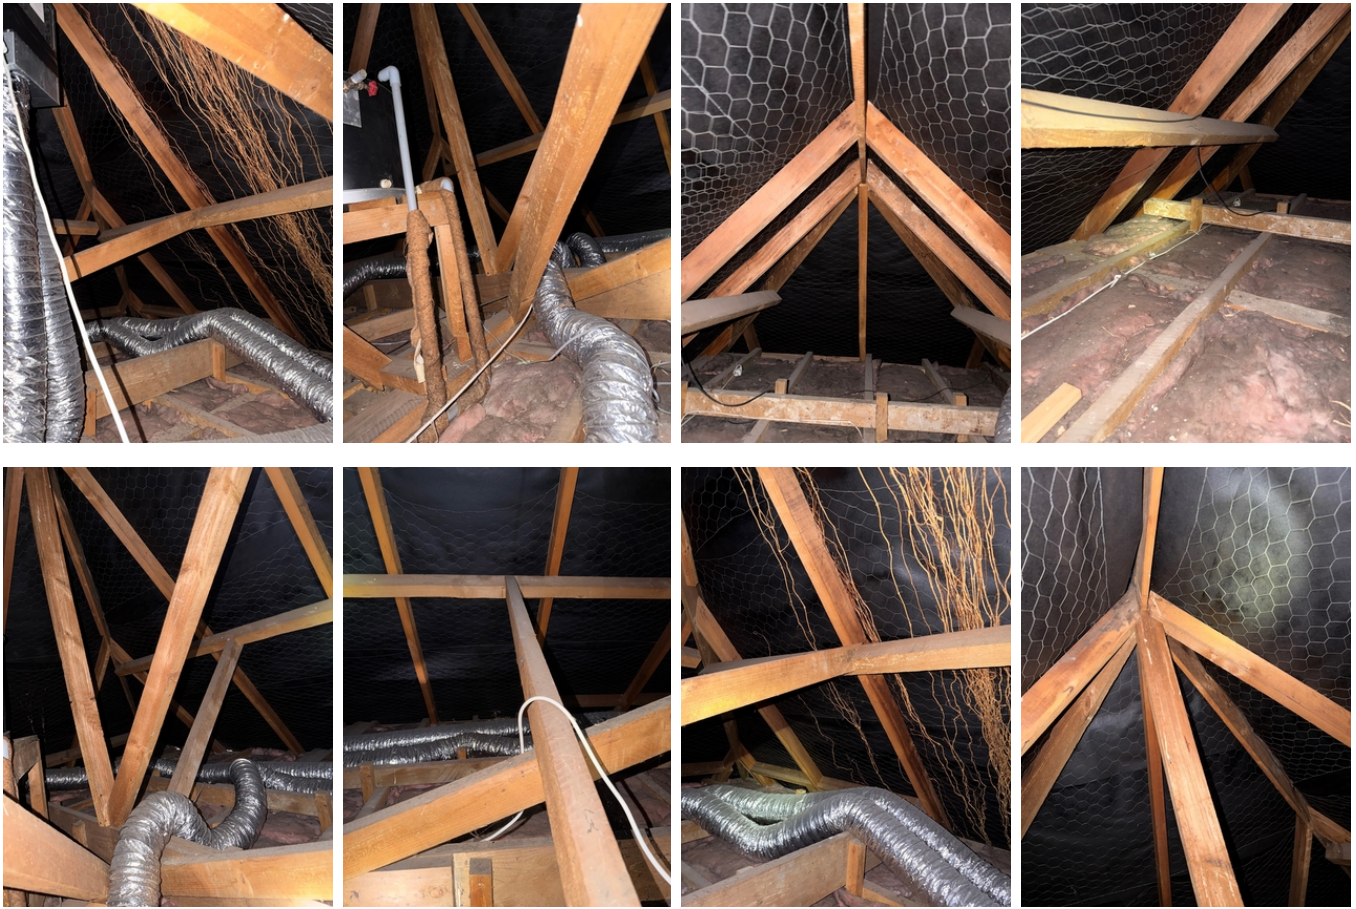
Fixed well into place. No sagging identified. No signs of water damage or rot.

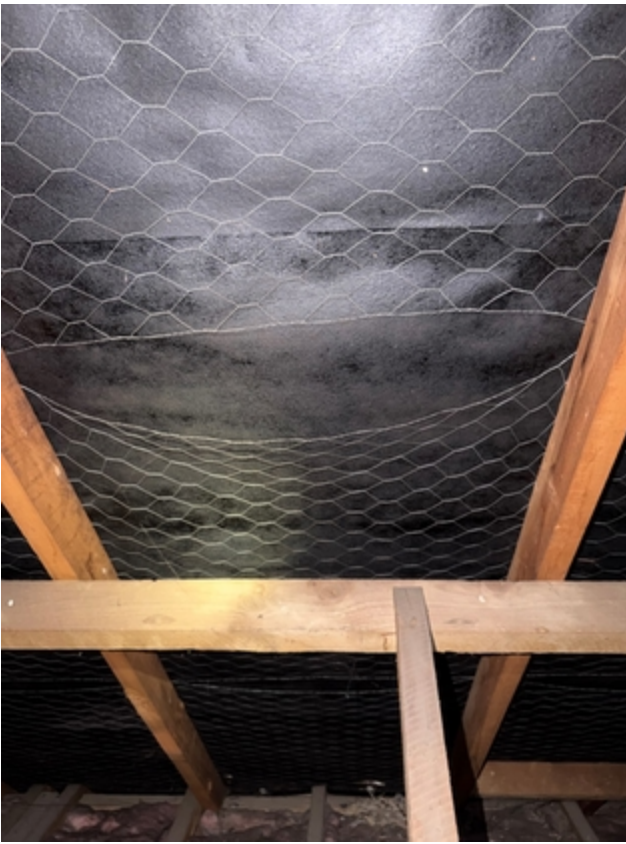
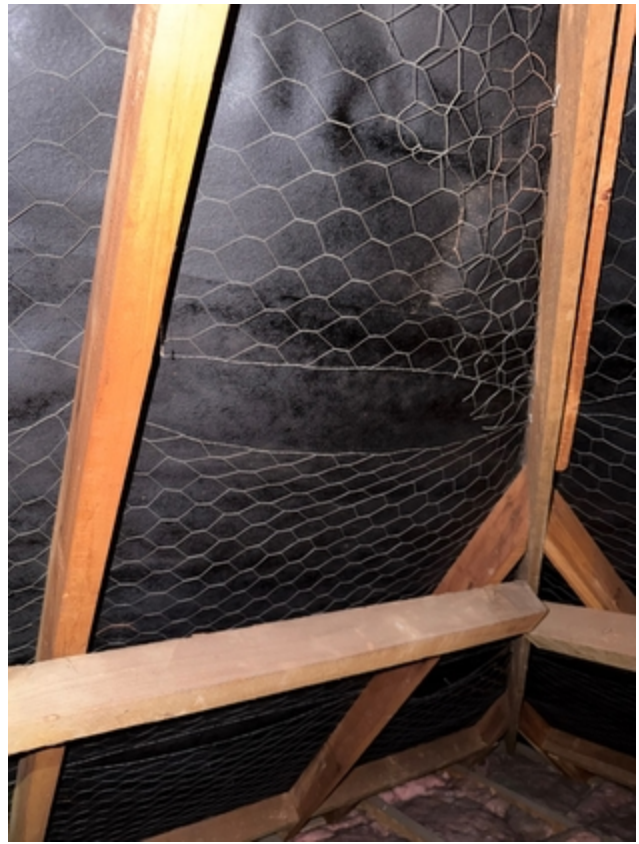
Roofing paper, Wire mesh

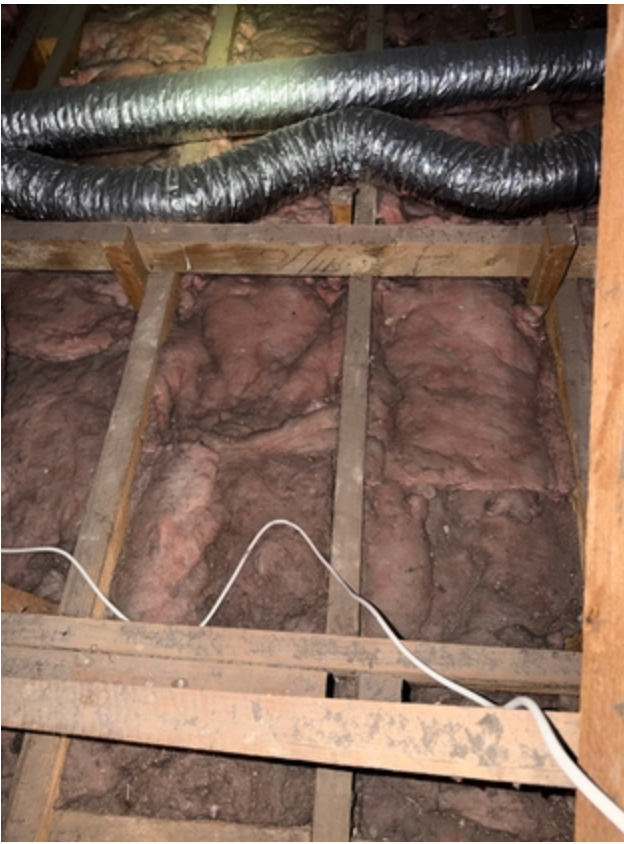
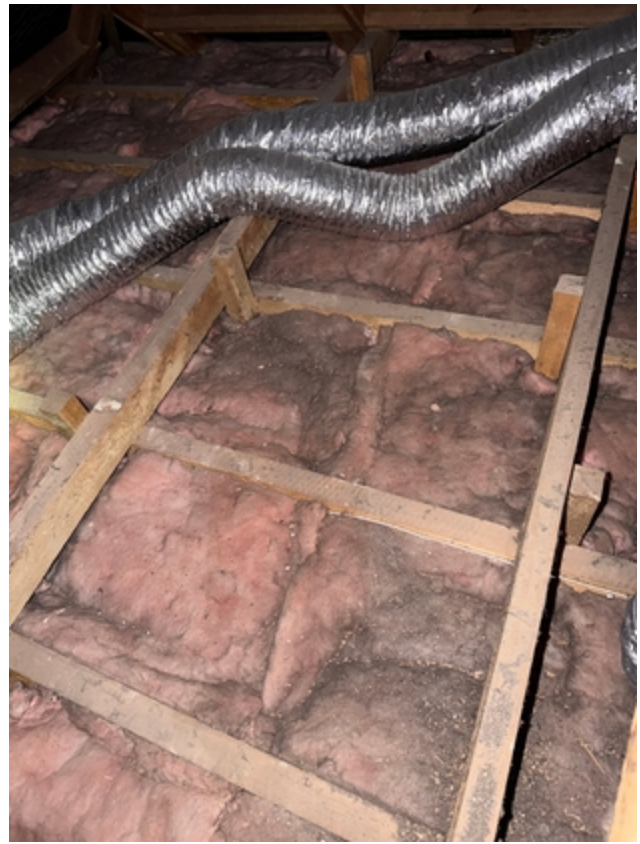
No obvious water damage observed. Insulation laid throughout. Could benefit from additional insulation added.

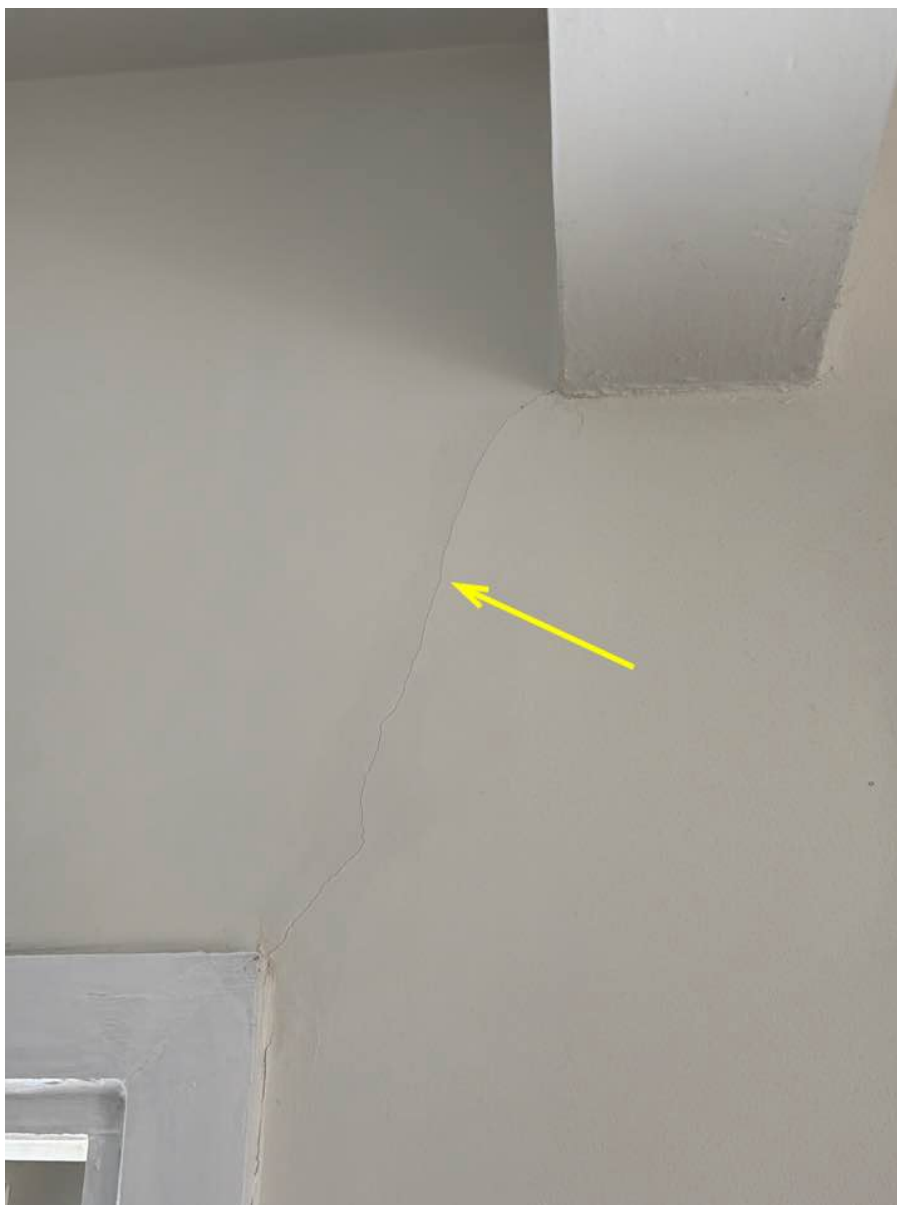
Some cosmetic cracking noted around window openings and wall to ceiling junctions etc.

Example of cosmetic cracking noted.

### Who to Engage: Advice, Investigation or Repairs

Painter and Decorator

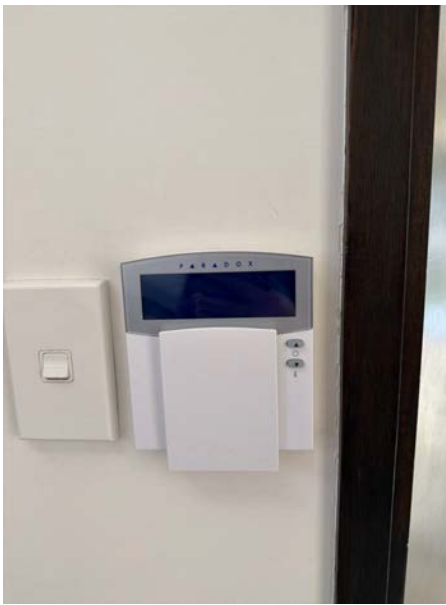
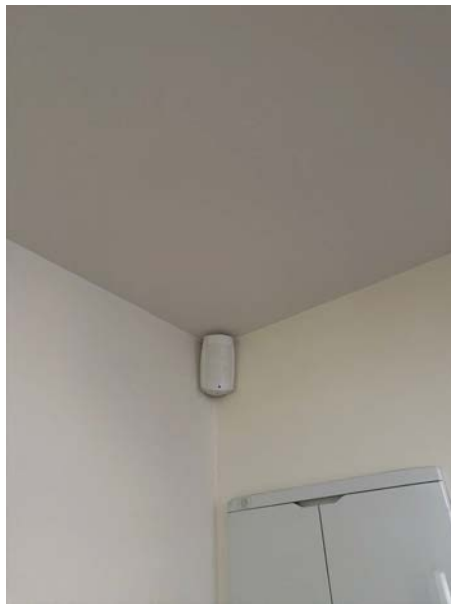
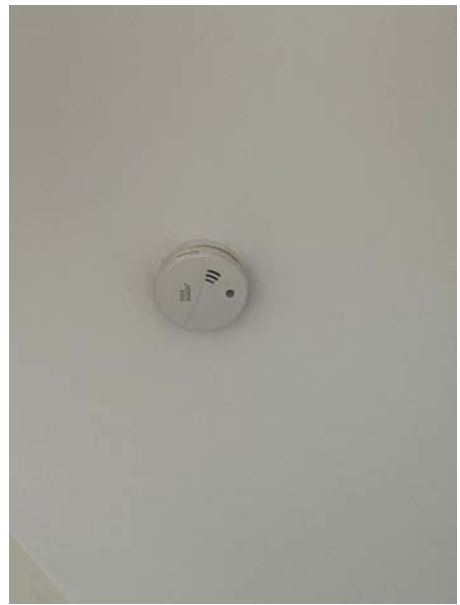
For older homes, photoelectric smoke alarms should be installed within 3 metres of every bedroom door or every room where someone sleeps. There should also be at least one on every level or storey of the home at a minimum. New builds, some modern properties, and dwellings that have undergone substantial renovations require hard-wired/interconnected smoke detectors in all bedrooms, living spaces, hallways, and landings. In multi level dwellings, there must be at least one smoke alarm on each level. Please review building plans and use the government agency online resources to determine any additional requirements, ensuring compliance with legal regulations and best practices for the home. No testing was done during this inspection.

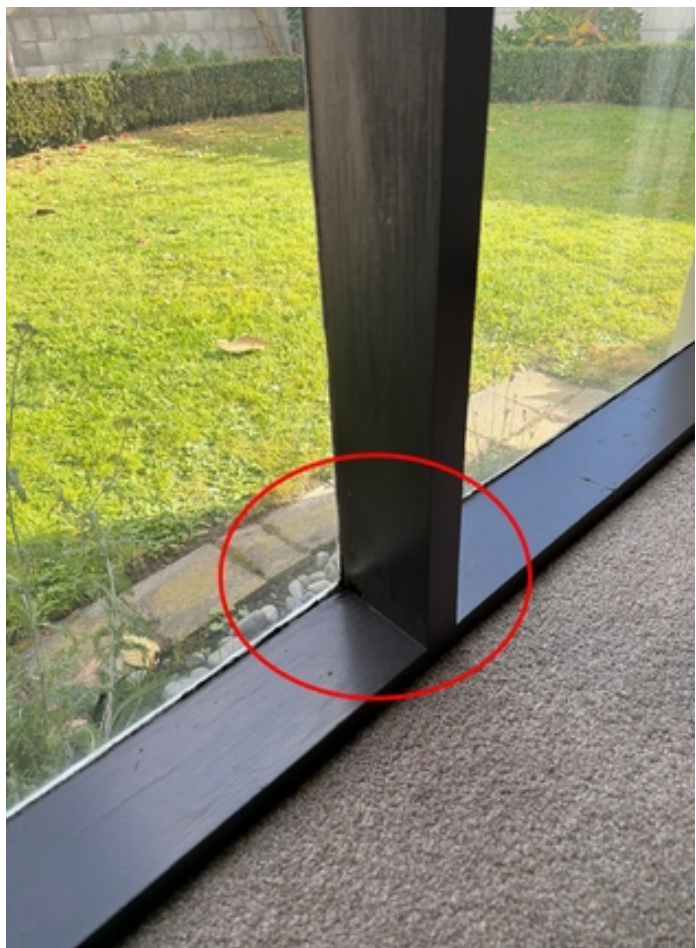
Some moisture damage noted to the dining room window framing. (Also noted in the moisture testing section of this report).

Moisture damage noted to dining room window frame.

Note from agent: This window has since been resealed.

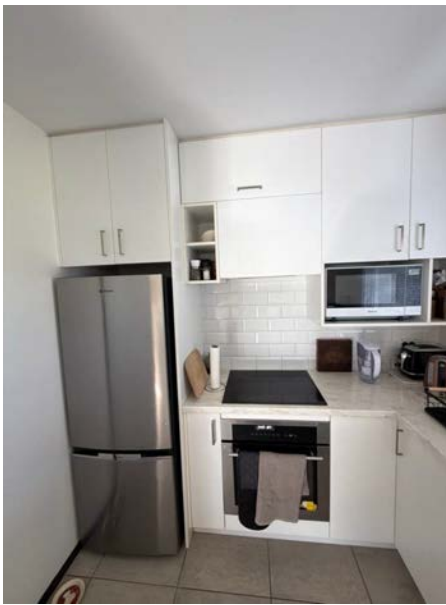
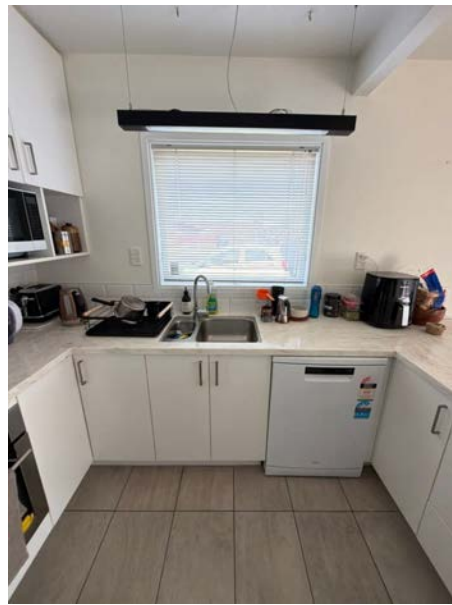
No adjustments needed to cabinetry.

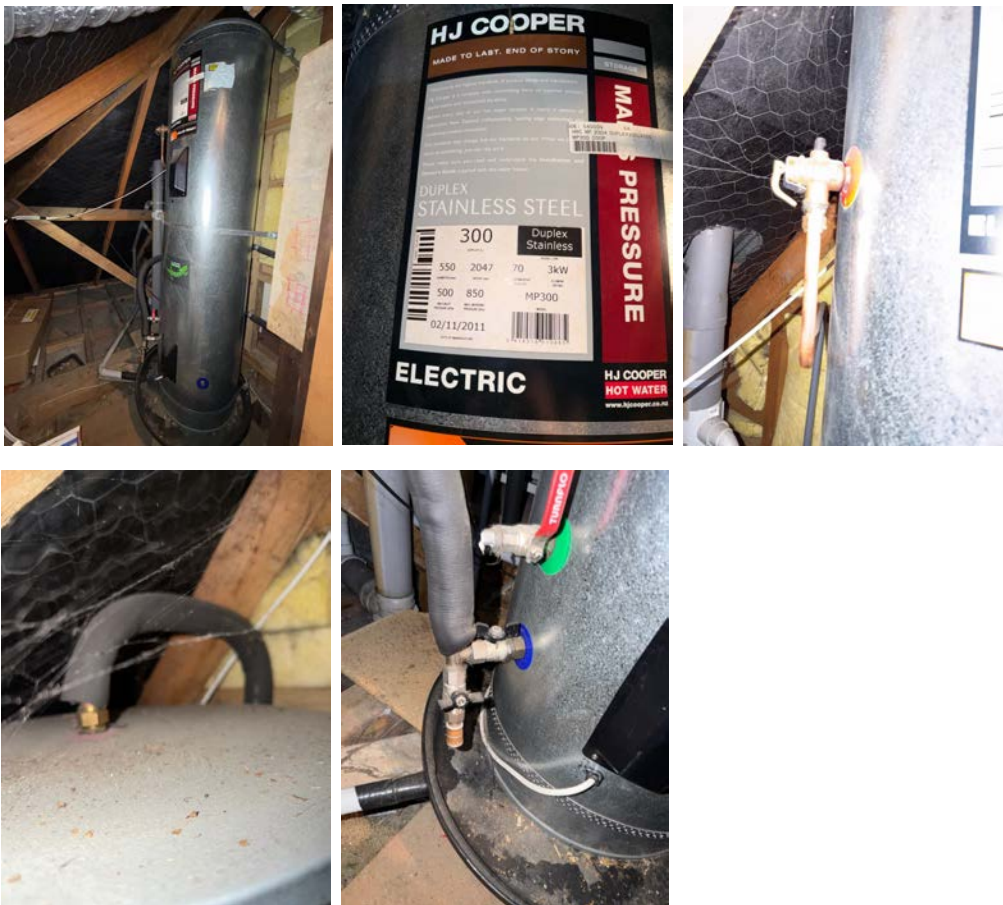
No leaks observed. Proper seismic restraints installed to hot water cylinder. Drip tray installed under the hot water cylinder. Looks to have been professionally installed.

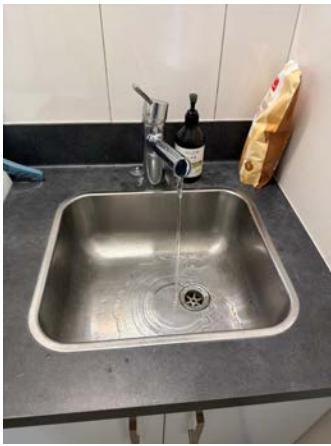
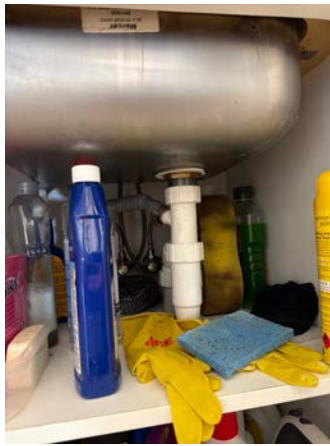
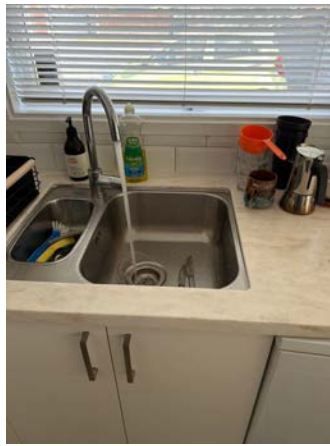
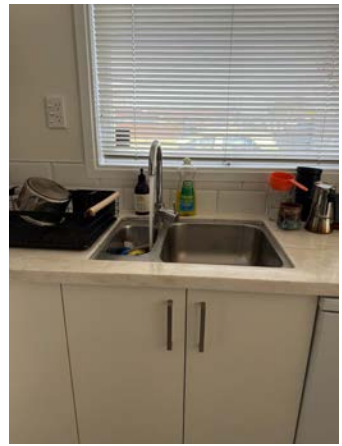
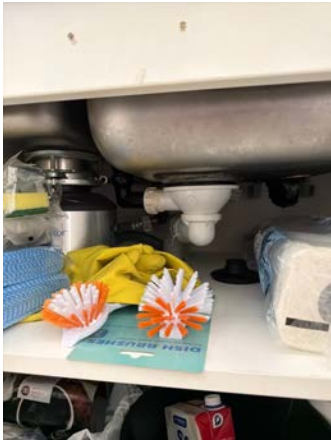
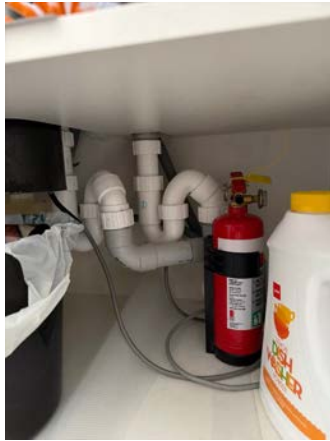
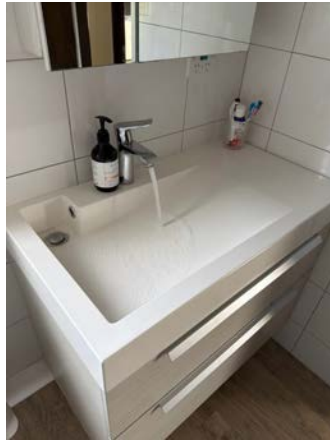
Taps were turned on, and no leaks were observed from the waste piping. No leaks observed from water supply under sinks.
