# Building inspection report here

# 76a Memorial Ave, Ilam.

## Building Report

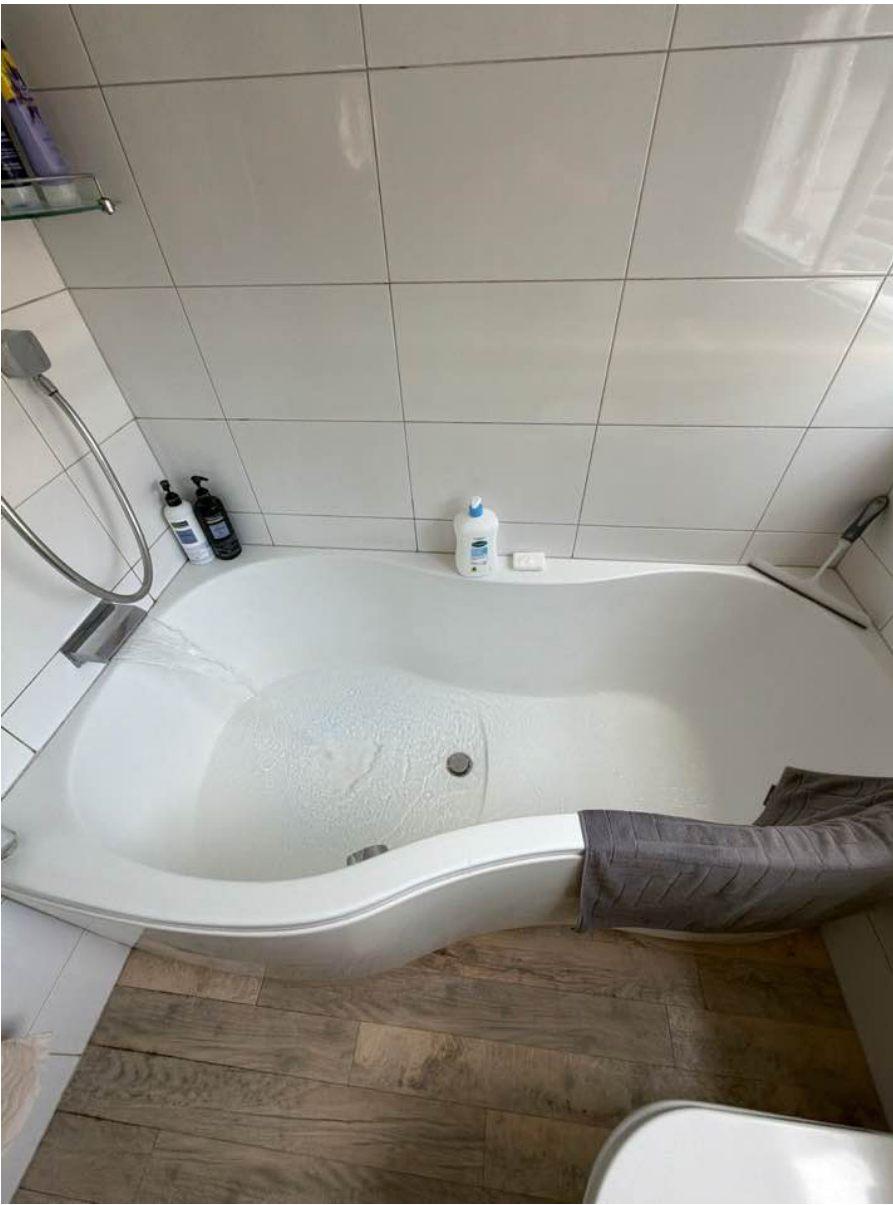
Bath was slow to drain. Keep drainage/waste pipes clear of debris and build up.

**Note from agent:** This has since been addressed.

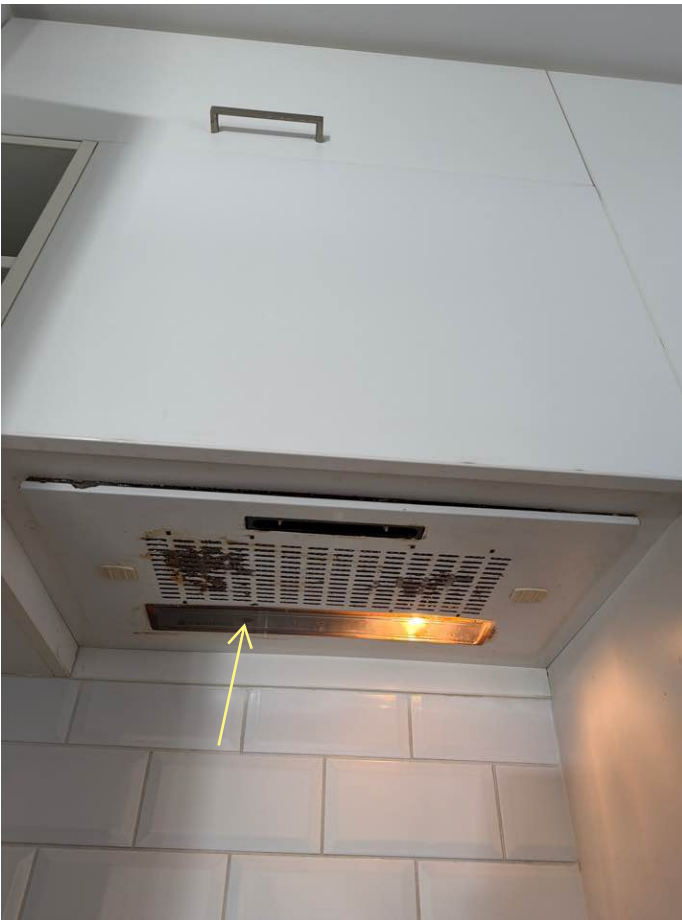
Powered on and appears to be operating fine. Extractors appear to be ducted externally. One rangehood light bulb was not working.

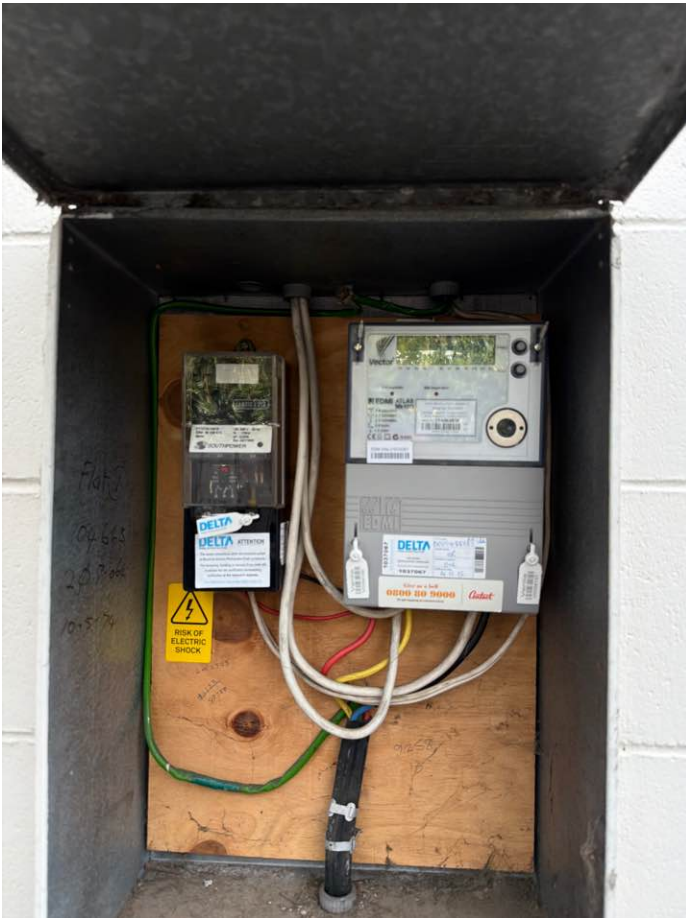
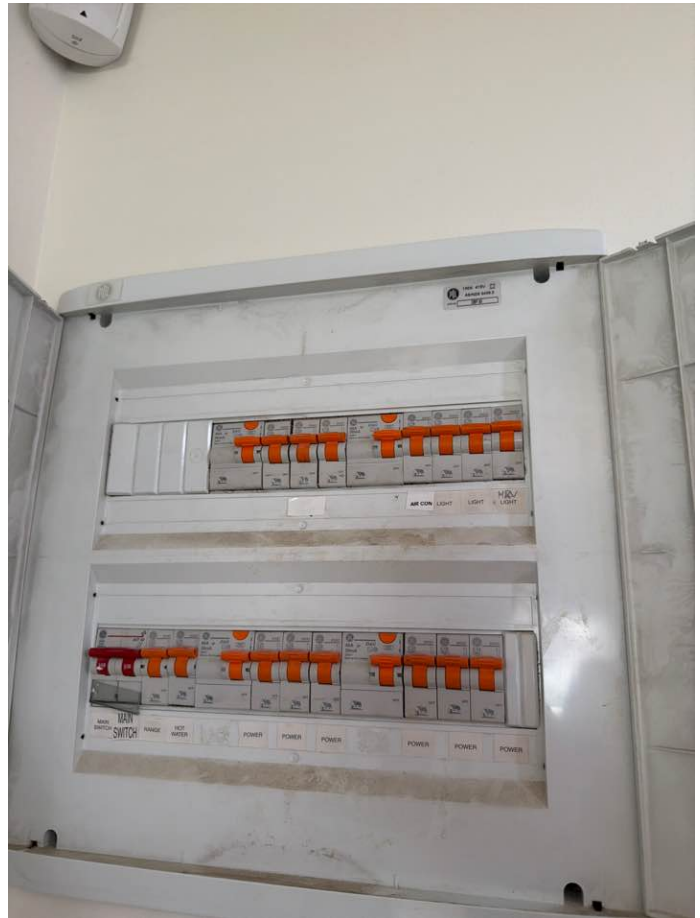
Modern meter box. Looks to have been professionally installed. No signs of excess heat build up.

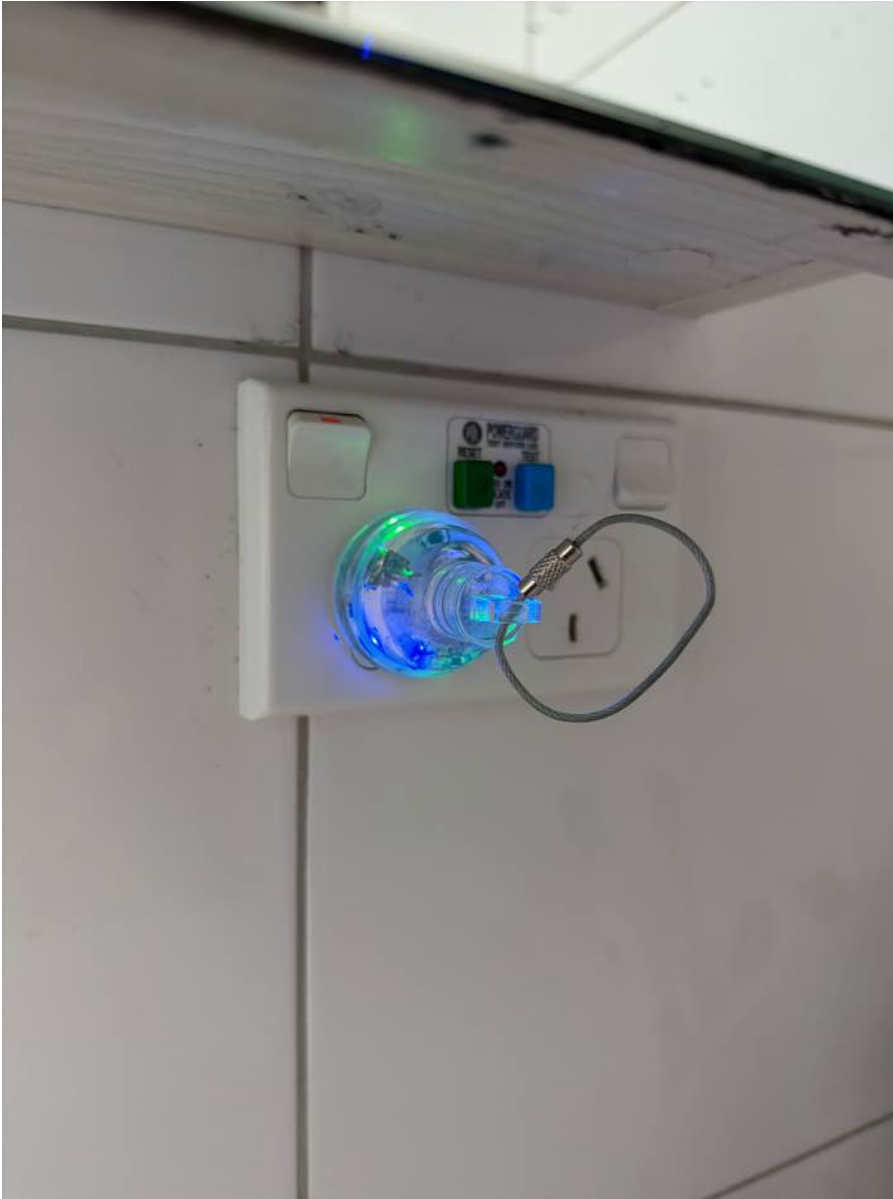
Please note that only sockets that were readily visible and accessible and had nothing plugged into them at the time of inspection were tested; any others are excluded from this report. Sockets that were tested returned no fault.

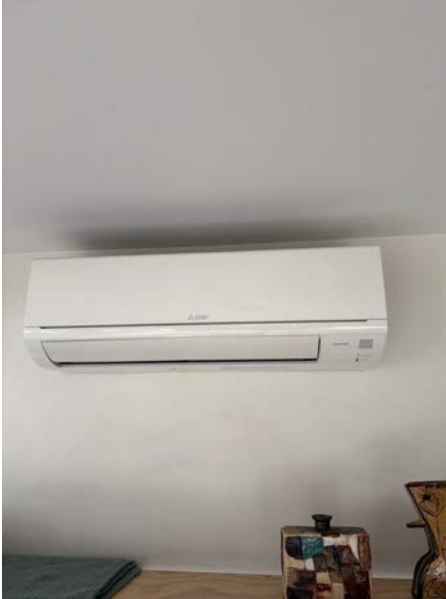
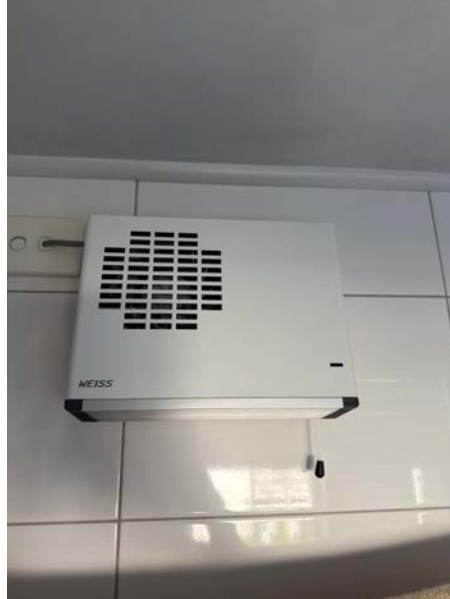
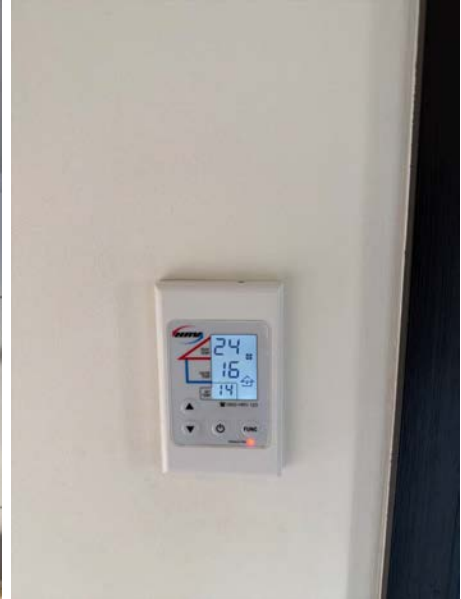
Looks to have been professionally installed. No testing of these elements was carried out during this inspection. Please consult a suitably qualified specialist for testing of these elements.
