Re: Johnston Road Storage Safety Survey Charlotte, NC

## Report Summary

**Scope of Work:** New storage facility is the last few weeks of work before CO is issued.

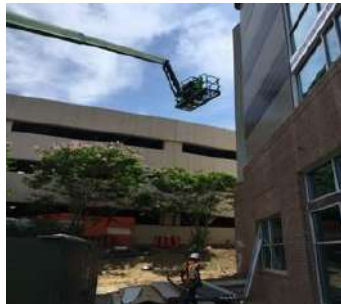
Positive Finding Workers in aerial lift are tied off to an approved anchorage point (1926.453)

**Notes:** Workers were tied off to designated anchor in basket.

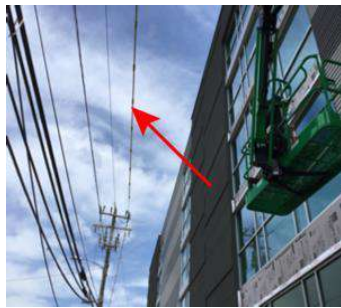
**Issue Identified** **Issues relating to Aerial Lift standards (1926.453) were identified (see notes/photos for detail)**

**Notes:** Distance from lift basket and high voltage power lines does not meet the requirements. Basket was approximately 20 feet from the power lines. Power lines were wrapped with protective sheath. No spotter in area to assist/guide basket operator when unit in use.

Severity: Serious/Extreme (deducts 5%)

Contributing Factor: Planning

High voltage power lines.

**Recommendation** *Review OSHA regulations on Aerial Lifts (1926.453) and adhere to all applicable requirements in the standard. Reference comments, notes and/or photo(s) for details. [View OSHA Standard](#)*

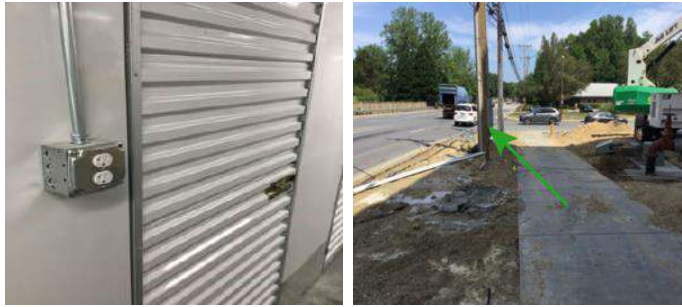
Positive Finding Electrical equipment installed/used as listed or labeled (1926.403)  
**Notes:** Temporary panel on street is used for exterior power supply. Panel to be deenergized today.

Temporary panel outside to de-energized day of audit.

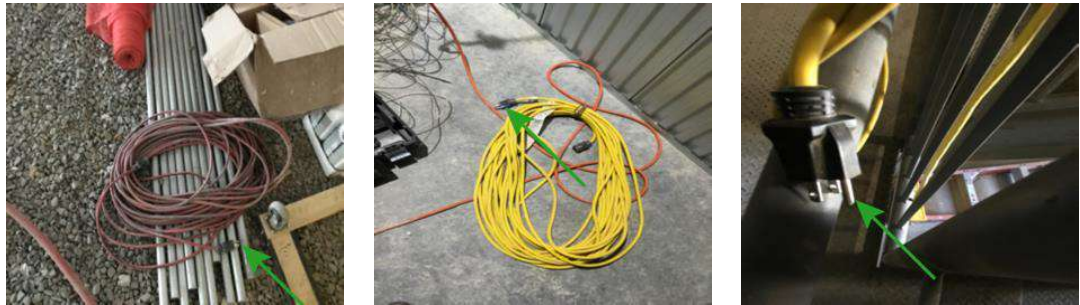
Positive Finding Ground pins are attached to electrical cords (i.e. extension cords and/or flexible cord sets) (1926.404)

Notes: Ground pins attached to electrical plugs.

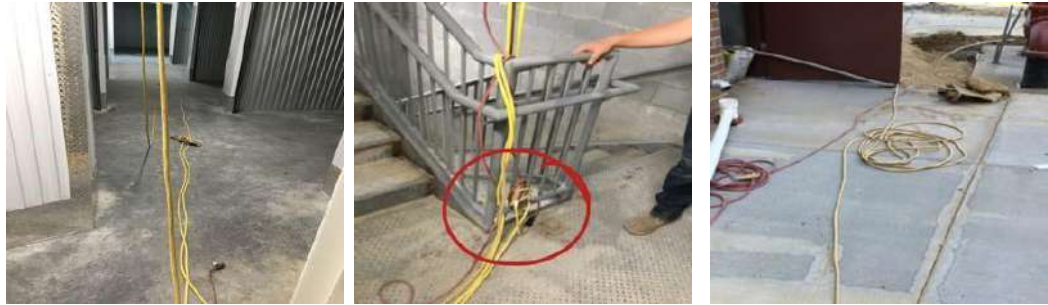
Issue Identified Cord sets and/or Power Supply cords are "daisy chained" (1926.403)

Severity: Advisory (negligible impact)  
Contributing Factor: Planning

Several cords daisy chained in stairwell. Cords supplying power other than to workers on exterior of project.

Recommendation *As a rule, cord sets or power supply cords should not be plugged into one another (i.e. daisy chaining). Daisy chaining increases the likelihood of misuse, excessive voltage drop and overloading of the circuit (due to the cords exceeding the maximum allowed watts) which may create a fire or shock hazard. NEC 110.3(B) requires cord sets/power supply cords to be installed/used in accordance with the Listing installation markings. [reference 1926.403(b)] [View OSHA Standard](#)*

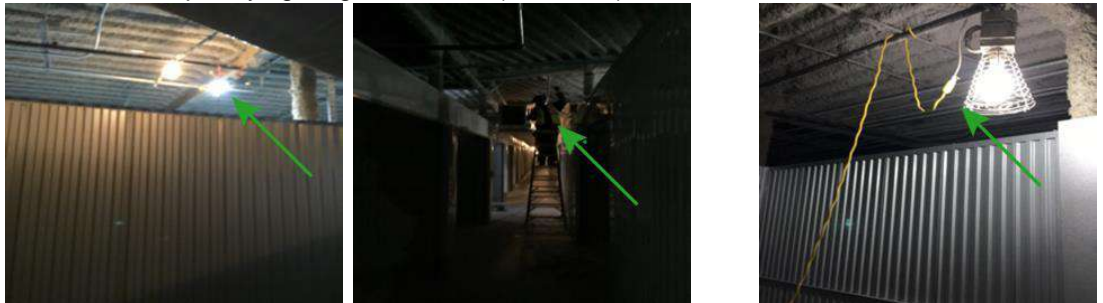
Flexible cords are maintained in good condition (1926.416)  
Lamps used for general illumination protected from accidental contact/breakage (1926.405)  
All sockets in temporary lighting have bulbs (1926.416)

Temporary lights in use, but not available in area of work.

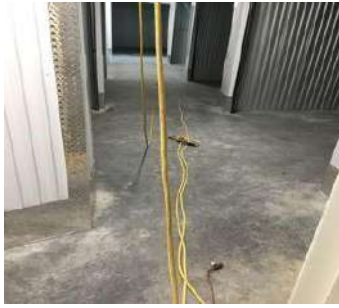
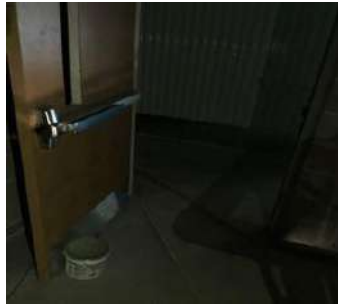
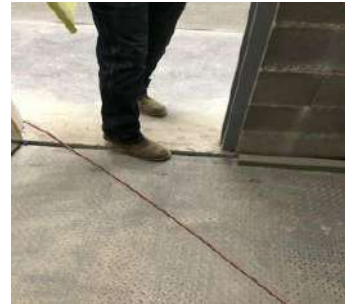
**Issue Identified** **Electrical cords are not adequately protected or kept clear of working spaces and walkways (1926.416)**

**Notes:** Cords are not kept clear of work area or walkways. Cords originate from stair well and travel across/down aisles in work areas. Recommend keeping cords to one side of aisle to ensure clear travel in the aisle.

Severity: Advisory (negligible impact)

Contributing Factor: Planning

**Recommendation** *Instruct workers to keep electrical cords reasonably clear of working spaces, walkways or similar areas to minimize trip/fall hazard and to protect cords from damage [reference 1926.416(b)(2)]. Consider re-routing cords away from active work areas or eliminating cords that are no longer needed. In some situations, it may be necessary to suspend cords (using an approved method) or bury them (using an approved protective cover) to minimize risk of damage or electrical shock. [View OSHA Standard](#)*

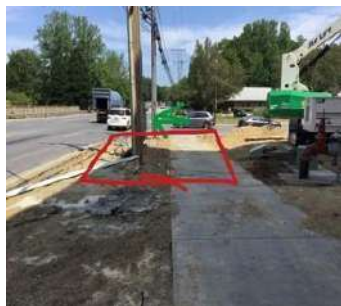
**Proper clearance (minimum 3 ft.) is not maintained in front of or around electrical equipment (1926.403, Table K-1)**

**Notes:** Temporary panel is posted outside and at the edge of a sidewalk. Side walk is not barricaded to protect public. Panel is closed and secured during the audit. Recommend ensuring all exposed electrical wires are taped and capped, boxed or other means of protecting workers from the exposure.

Severity: Advisory (negligible impact)

Contributing Factor: Human Behavior

*The working space in the direction of access to live parts (i.e. electrical panels, transformers, etc.) operating at 600 volts or less and likely to require examination, adjustment, servicing, or maintenance while live must meet 1926.403, Table K-1 requirements (typically 3 feet in the direction of access and not less than 30 inches wide. [View OSHA Standard](#)*

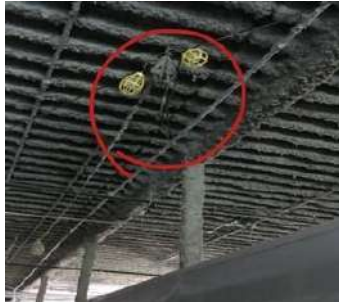
**Issue Identified** **Issues relating to Electrical Safety standards (1926 Subpart K) were identified (see notes/photos for detail)**

**Notes:** Unprotected electrical wires in the ceiling of a poorly lit work area. The other ends of the electrical wires could be or were energized.  
Severity: Serious/Extreme (deducts 5%)  
Contributing Factor: Planning

3 lights with cut electrical cords that are not protected. Cords are not plugged in. Hazard exists when cords are plugged in.

**Recommendation** *Adhere to all OSHA Electrical Safety regulations found in 1926 Subpart K and/or guidelines identified in NFPA 70E). Reference comments, notes and/or photo(s) for details. [View OSHA Standard](#)*

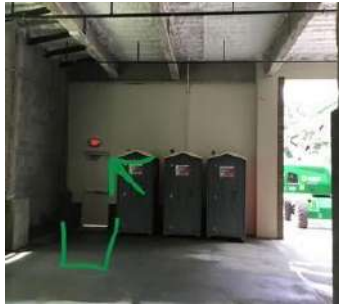
Positive Finding Exits are available and free of obstructions (1926.34)

Lower level exit signs are visible. Area is clear in front and exterior.

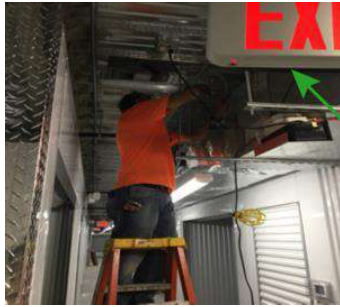
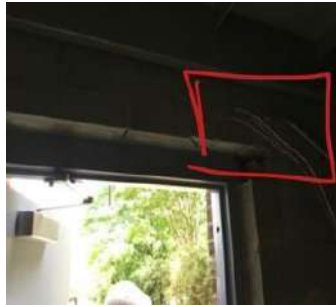
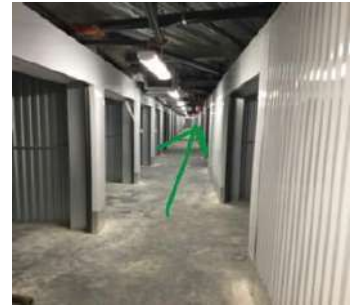
**Notes:** A few work areas have working exit signs. Several floors do not have a working exit sign or paper mounted version.

Severity: Advisory (negligible impact) Contributing Factor: Planning

Lower level exit does not have a visible exit sign.

**Recommendation** Access to exits shall be marked by readily visible signs in all cases where the exit or way to reach it is not immediately visible to the occupants. [Reference 1926.34(b)] [View OSHA Standard](#)

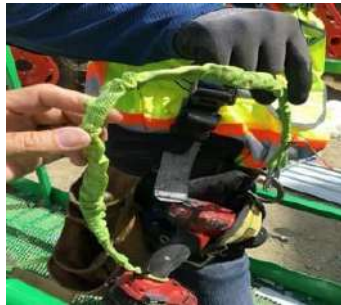
Positive Finding Appropriate steps have been taken (i.e. use of hard hats, toeboards, guardrails, screens, canopy, barricades, keep objects away from edge, etc.) to protect employees from falling objects (1926.501) **Photo(s)**

Tool lanyard in use by worker on aerial lift.

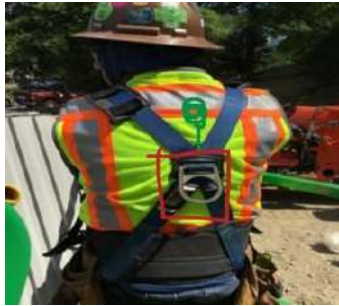
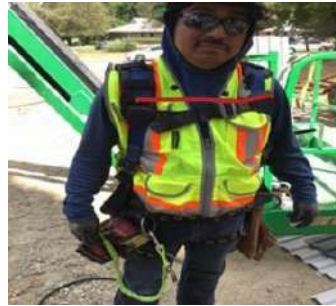
**Notes:** Harness has been visually inspected since in service date, but does not have a competent person check done per manufacturer specifications. Recommend documented inspections to meet manufacturer recommendations.

D ring is a little low in the back. D ring should be resting between the shoulder blades. be adjusted.

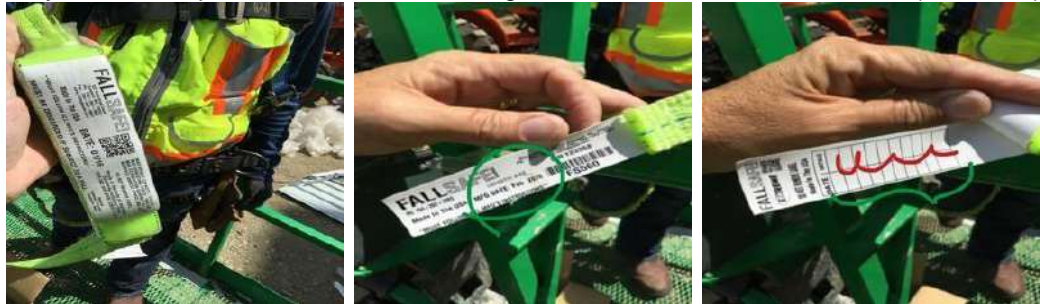
Harnesses are fitted/worn properly (1926.503)  
Lanyards are inspected and maintained in good condition/no obvious defects (1926.502)

Manufacturer tag not populated w 6 month periodic inspections since manufacturer since 2016. Recommend periodic competent inspections per manufacturer.

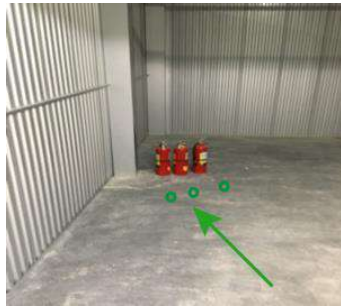
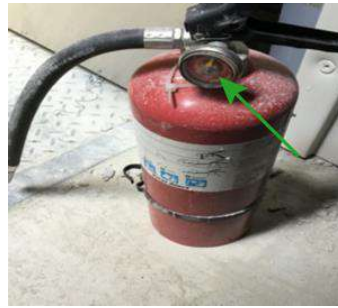
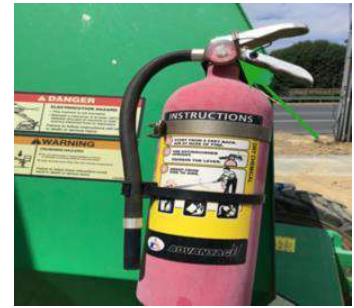
Fire extinguishers are maintained in operating condition (1926.150)

Fire extinguishers in good condition. Fire extinguisher is fully charged and Fire extinguisher is in good condition Fully charged. in good condition. and fully charged.

**Issue Identified** **Portable fire extinguishers are not inspected periodically (i.e. monthly) (1926.150)**

**Notes:** Fire extinguishers were not periodically inspected. Recommend inspection of units periodically to ensure they are fully charged and in good condition. Record the inspection on the service tag.

*Portable fire extinguishers are to be inspected periodically (i.e. monthly) in accordance with guidelines set forth in NFPA 10. Take steps to inspect all portable fire extinguishers (in use at the worksite) to ensure they are in good operating condition. As a Best Practice, it's also recommended that periodic inspections be documented (i.e. using a service tag affixed to the extinguisher). [reference 1926.150(c)(1)(viii)] [View OSHA Standard](#)*

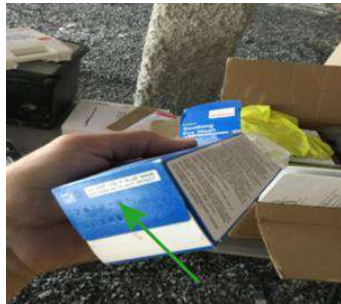
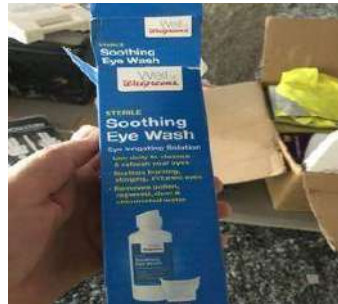
**Positive Finding** Suitable facilities for quick drenching or flushing of the eyes and body is provided when needed/required (1926.50)

Eye wash solution is in date. 5/2020.

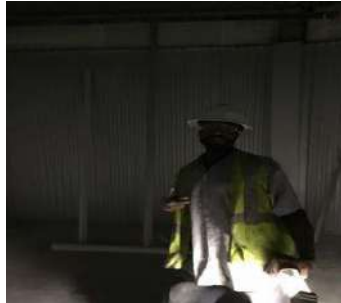
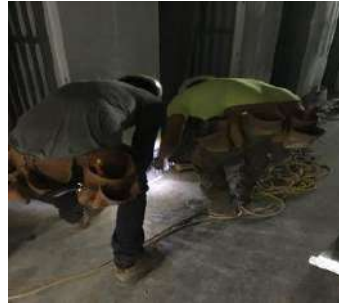
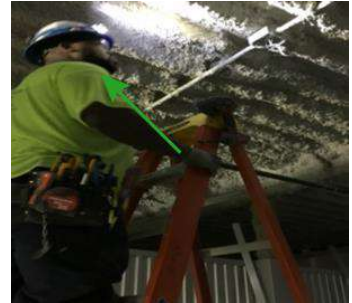
Positive Finding PPE maintained in a sanitary/reliable condition (1926.95)  
**Issue Identified** **Not all employees used ANSI approved eye protection as required (1926.102)**  
**Recommendation** *Take steps to ensure employees are provided with and required to wear appropriate eye protection equipment (i.e. ANSI approved) for the task whenever the potential for eye injury exists. [reference 1926.102(a)(1)] [View OSHA Standard](#)*

Severity: Advisory (negligible impact)  
Contributing Factor: Training

Workers drilling into stainless steel working with out proper eye protection. head.

Eye protection is worn when on electrical box work above his head.

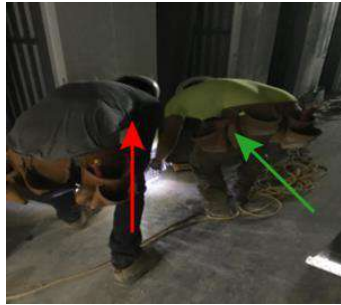
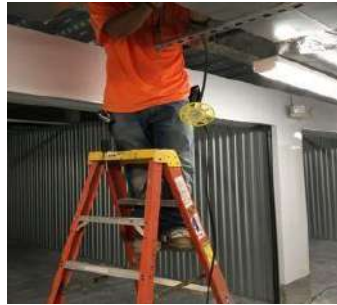
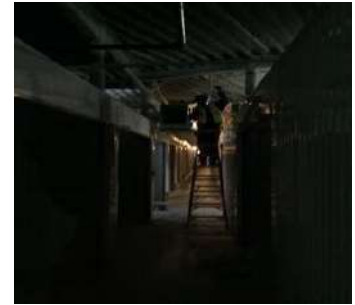
Positive Finding Hard hats are worn as required (1926.100)  
**Issue Identified** **High-visibility clothing is not worn as required (1926.28)**  
**Recommendation** *High-visibility safety garments have been interpreted by OSHA as "Personal Protective Equipment". Therefore, it's recommended that steps be taken to ensure employees where ANSI/ISEA 107-2015 approved high-visibility safety apparel where there is an exposure to hazardous conditions or where using such equipment reduces the hazards to the employees. [reference 1926.28(a)] [View OSHA Standard](#)*

**Notes:** Not all workers are wearing HiVis clothing.  
Severity: Advisory (negligible impact)  
Contributing Factor: Training

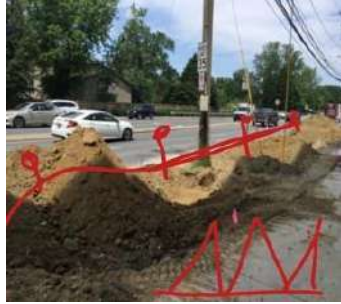
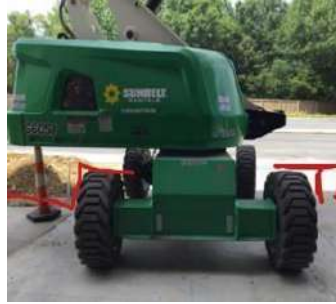
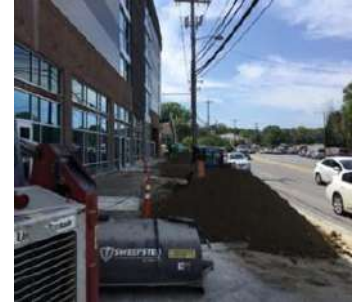
Contributing Factor: Planning

Skid steer work area earlier in audit . Cone is not adequate to restrict Public access to site is not restricted. No protection for public (or other public access or barricade work area 2 booms in area, skid steer, electrical workers in area). for boom lift to maneuver. work and partial accessible sidewalk and busy street.

**Recommendation** Areas that have any mobile equipment that is accessible to the public shall be properly barricaded or guarded prior to and during the operation of such machinery or equipment. Appropriate warning signs, fencing, barricading or personnel shall be placed a sufficient distance from such area and in a timely fashion to ensure that the public cannot inadvertently enter the area [reference ANSI A10.34-2001 (R2012) Section 3.2.7.2].

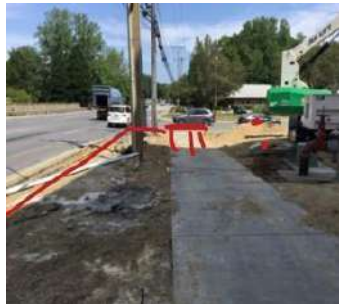
Public access is not restricted on side

street side of project.

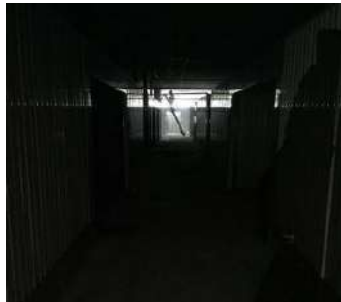
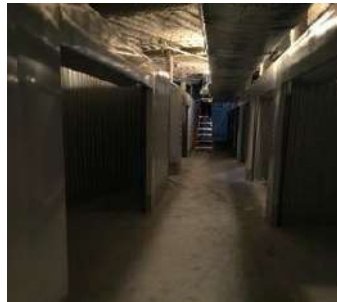
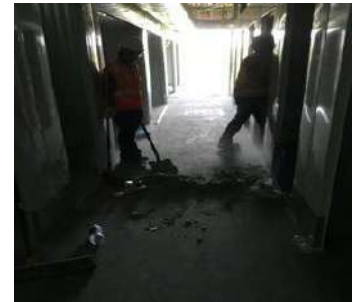
**Notes:** Several floors do not have adequate lighting for workers. Recommend lighting to be provided in all areas where work is active.

Contributing Factor: Planning

**Recommendation** While work is in progress, provide lighting in construction areas, ramps, runways, corridors, offices, shops, and storage areas per illumination intensities listed in Table D-3 [reference 1926.56(a)]. [View OSHA Standard](#)

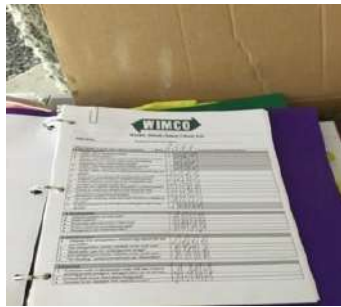
Contributing Factor: Planning

Last in house inspection was late April.  
Recommend weekly walks to ensure workers  
and work areas are safe.

**Recommendation** *Take steps to ensure the jobsite, materials, and/or equipment receive frequent and regular inspections (i.e. daily, weekly) by a competent person [reference 1926.20(b)(2)]. Ideally, inspections should be documented as evidence that they were completed. [View OSHA Standard](#)*
