**HYDROLOGY APPENDIX FOR
LOWER CACHE CREEK FEASIBILITY STUDY
YOLO COUNTY, CALIFORNIA
March, 2001**

**U.S. ARMY CORPS OF ENGINEERS
SACRAMENTO DISTRICT**

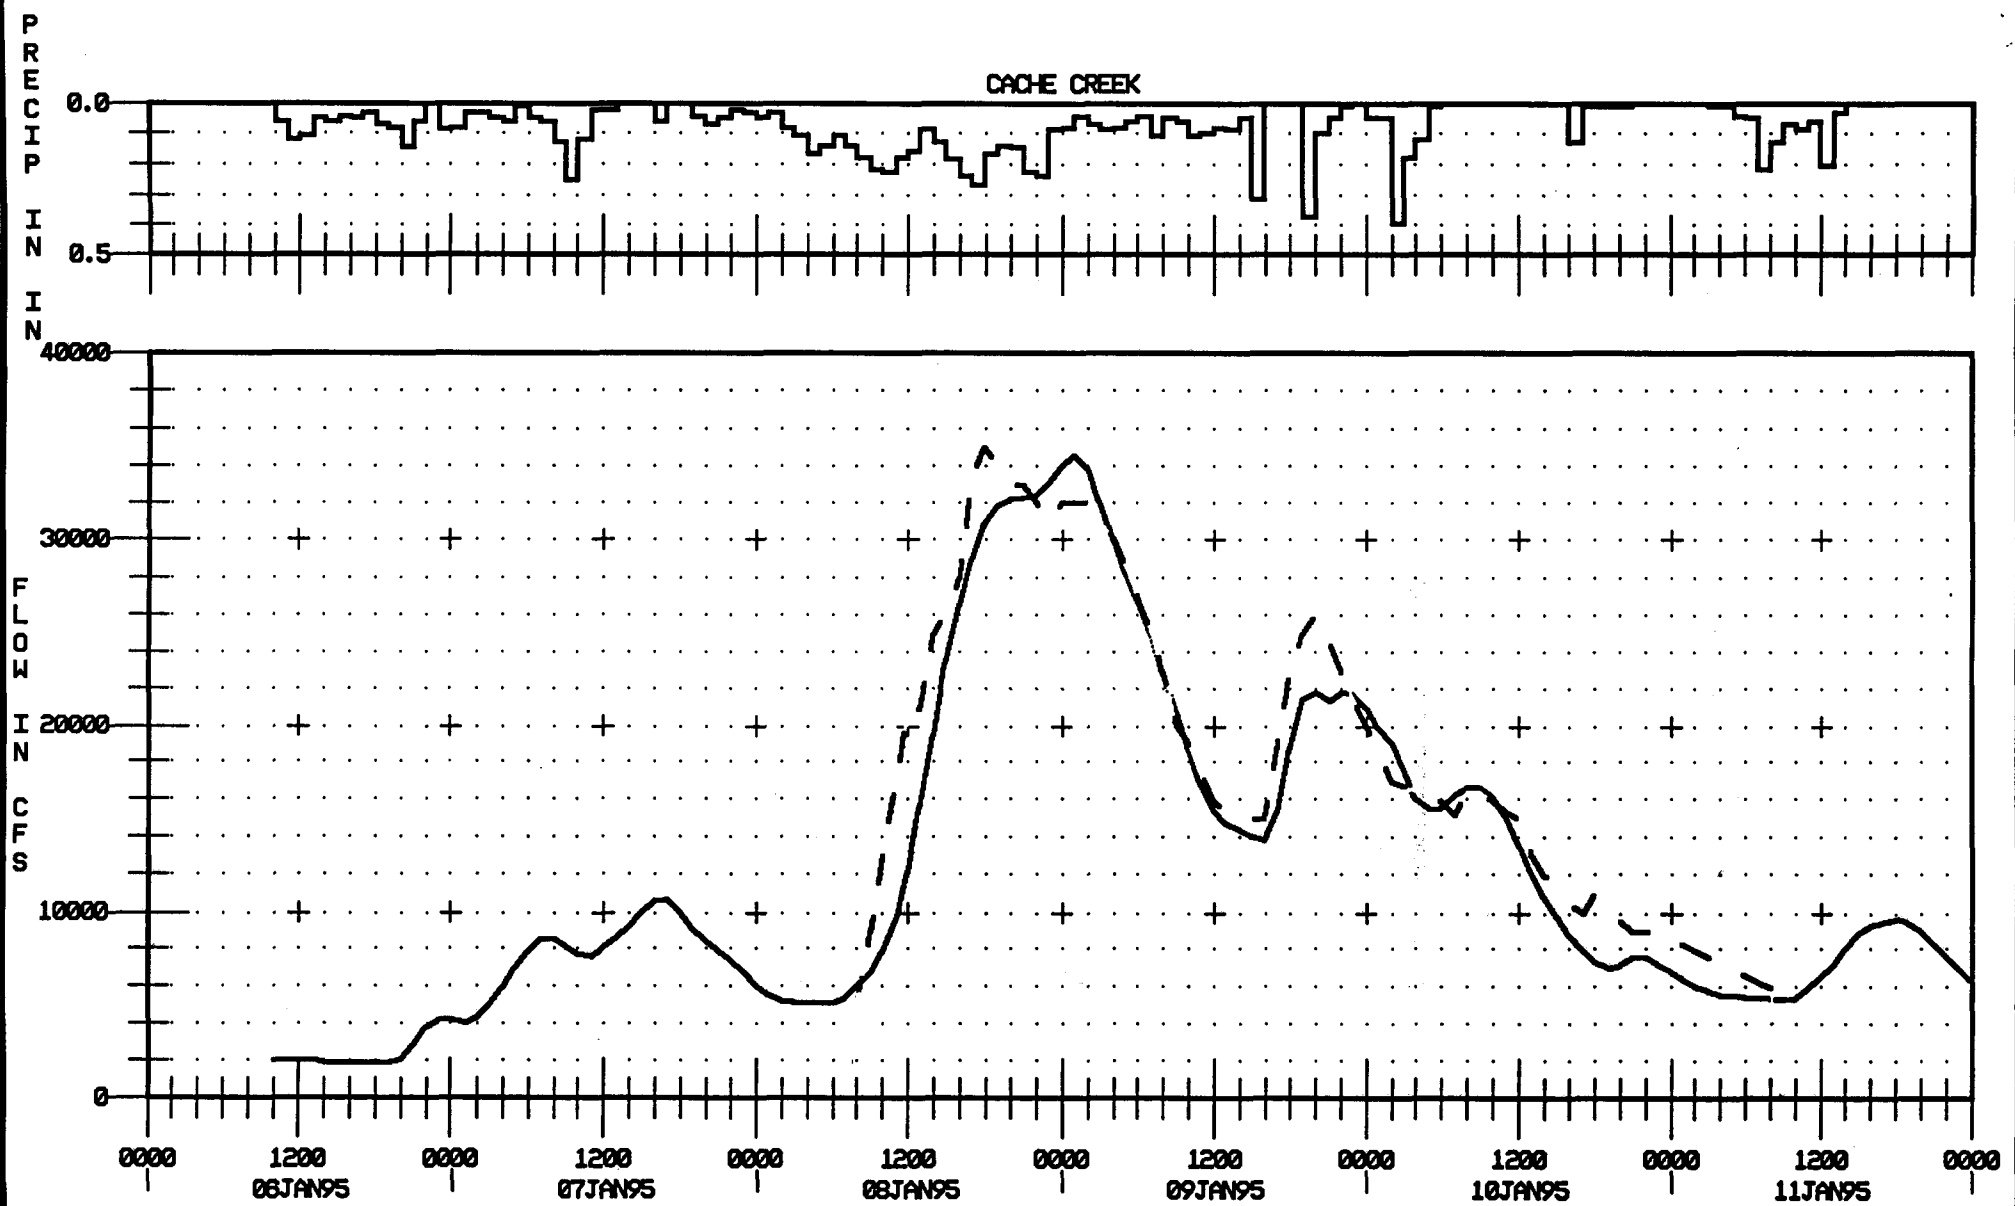
_____ RUMSEY INDIAN VALLEY PRECIP-INC
 _____ RUMSEY COMPUTED FLOW
 - - - - - RUMSEY OBSERVED FLOW

Note:
 Observed event only plotted from
 10:00 a.m. 8 Jan to 10:00 a.m. 11 Jan.

CACHE CREEK AT RUMSEY
RECONSTITUTION OF JAN 1995 EVENT

In 1994, a Reconnaissance Study of the watershed (Reference 5) used the latest HEC-1 model hydrographs as input to a hydraulics model to generate floodplains. In January and March of 1995, two more large storms occurred within the watershed. The March flood caused extensive flooding of land from overtopping of the levees. The two 1995 floods provided additional hydrologic data to use in model calibration, and the hydrology was re-studied after these events (Reference #8). The principal change to the model in the 1995 recalibration was the development of a new unit-hydrograph for a 127 square mile subarea above Rumsey, referred to as “Rumsey Local,” or Subarea 805. Although less rainfall data was available for the analysis than was desired, the revised model reproduced the 1983 and 1995 storm hydrographs well at the Rumsey gage. Among the conclusions of the 1995 Study were: 1) the floodplains produced in the 1994 Study did not need revision, 2) the model worked well at the Rumsey gage, and 3) model hydrographs between Rumsey and the Yolo gage needed further analysis, due to the lack of flow data for calibration in this reach. The model reproductions of the three events are shown on Charts 7 - 9.

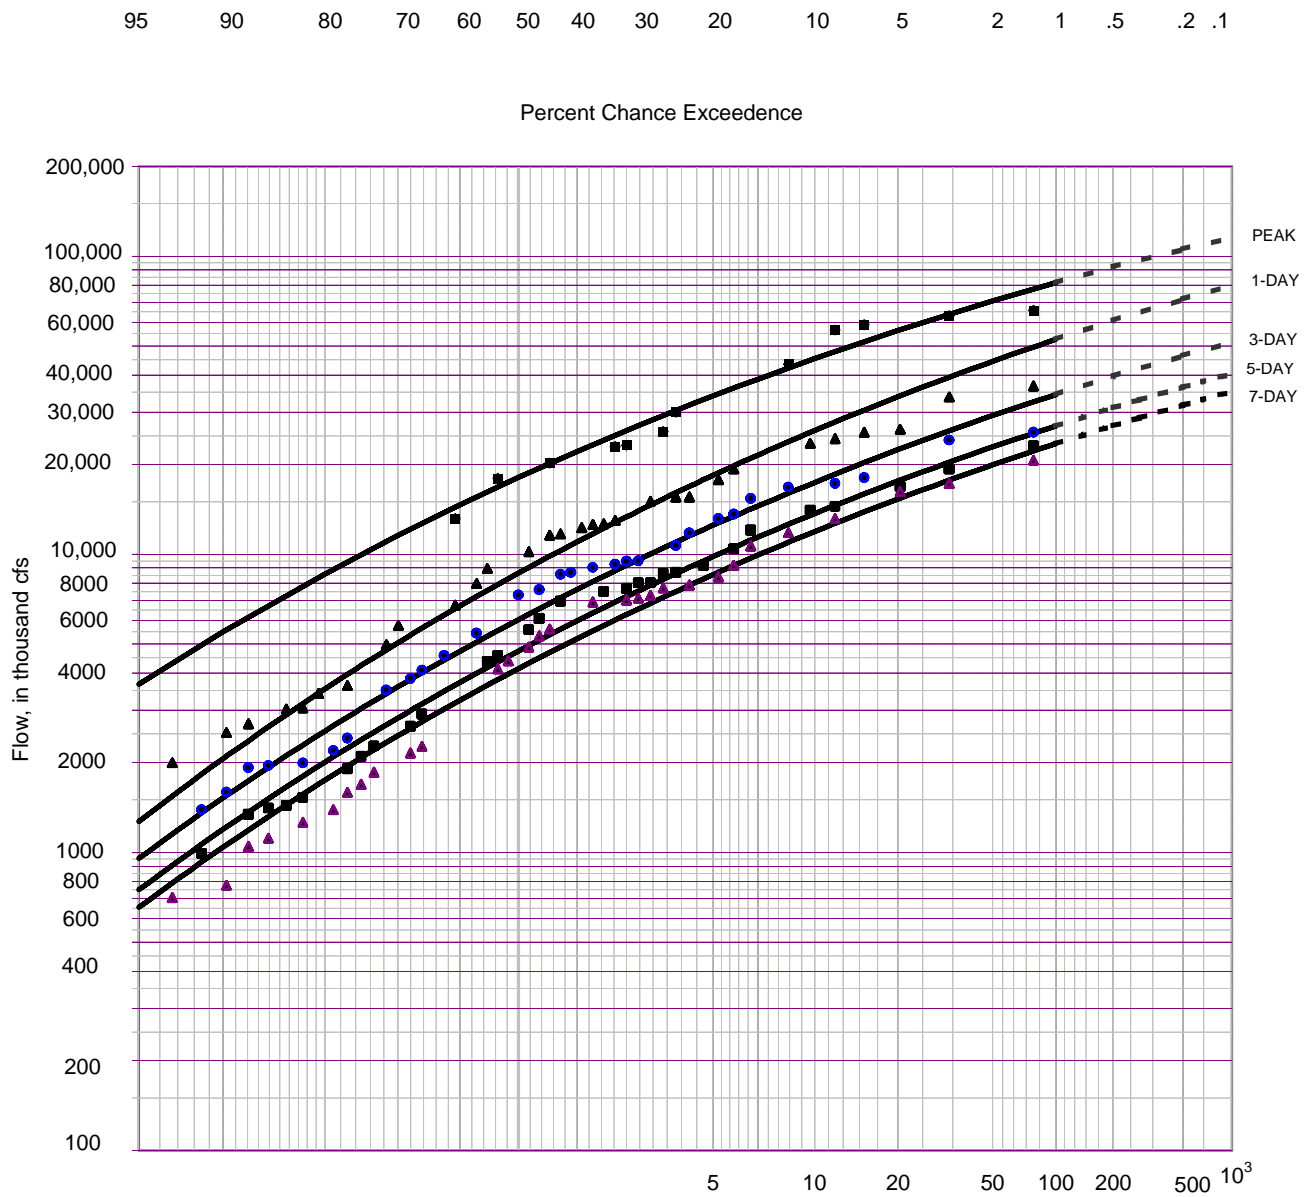
CURVE STATISTICS:

Mean	Std Dev	Skew
Peak	4.223	0.355	-0.60
1-Day	3.895	0.426	-0.60
3-Day	3.741	0.410	-0.60
5-Day	3.636	0.410	-0.60
7-Day	3.576	0.410	-0.60

CACHE CREEK AT ROAD 94B

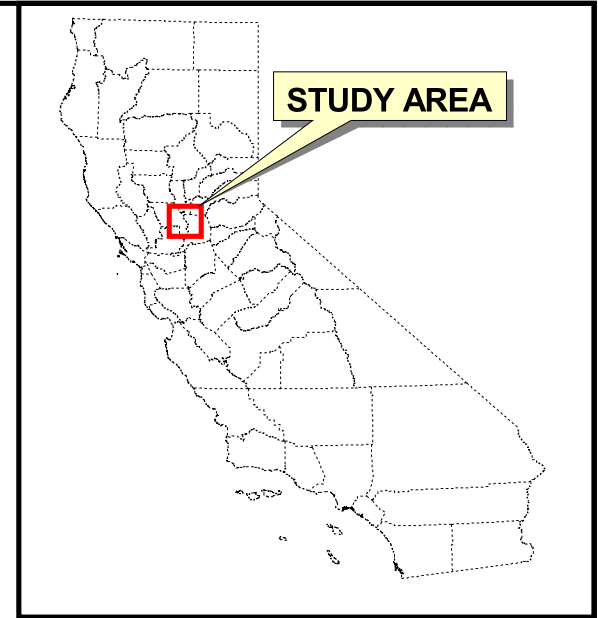
**YOLO BYPASS AND
STREAM GAGING STATIONS**
