Chaff-Lining to Control the Seed Bank of Italian Ryegrass

Lyman, K.C., R. Slood, M. Thorne, D. Lyon, & I.C. Burke

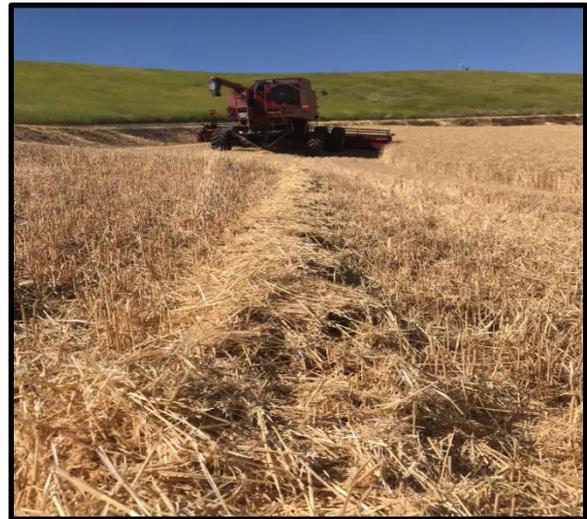
Figure 1: Successful chaff lining windrow in a winter wheat crop using a modified Case 2388 hillside combine.

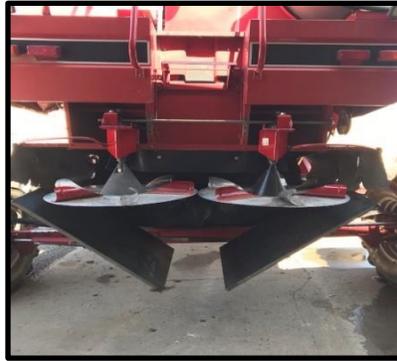
Figure 2: Rear view of spreader system and chute platform.

In the summer of 2020, a hillside combine (a Case Axial-Flow 2388 series) was modified to chaff line. The main modifications to the Case 2388 combine consisted of the addition of another straw spreader/shaft system, a baffle diverter and the chute platform.

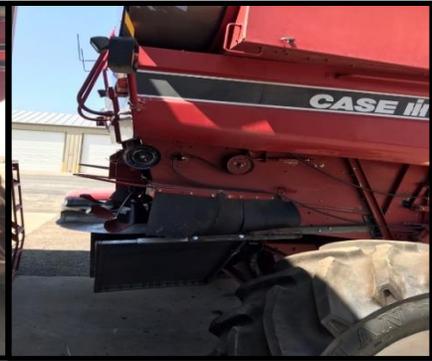
Figure 3: Side view of how the chute platform is mounted to the combine.

Modifying the chute platform was the final and the most challenging step. The chute had to be mounted to both sides of the combine and not to the rear axle of the combine, which seemed like the most logical anchor point. The rear axle was independent of the combine, due to the leveling system. Therefore, the chute would become damaged if attached to the rear axle. Attaching the chute to the side of the combine was the best option due to the durability and stability the chute needed. Two 3' by 4' sheets were cut out from 1/8th inch sheet metal and manufactured to sit at the rear of the combine. The rectangular sheets were then bolted to independent frames that were bolted to the side of the combine. The chute mirrored the same angle of the combine when the leveling system was engaged.

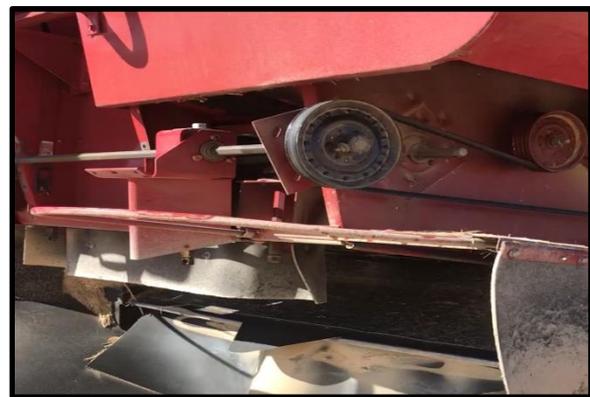
Figure 4: Modified components in the spreader/shaft-system. The drive shaft mounts were reversed, necessitating a longer drive belt for the system.

The straw spreader/shaft system consisted of many common Case parts purchased from a local dealer. The straw spreader/shaft system was the most expensive part of the project, mainly because all the shaft parts and hardware were new. A secondary straw spreader/shaft system was necessary to not jeopardize the regular straw spreader/shaft system, in case the normal function of the combine was needed. The parts consisted of a horizontal shaft that was the width of the combine, 10-inch pulley, longer v- drive belt, shaft supports/bearings/spider gears and hardware (nuts/bolts/washers). Other parts were purchased and incorporated but may be unnecessary, such as new straw spreader cones, straw spreader fins and down shafts. The need of the secondary straw spreader/shaft system on the combine was to move the straw spreader cones back and up, so the chute platform could fit under the straw spreader/shaft system. The new straw spreader/shaft system sat 12 inches back and 4 inches up from the regular straw spreader/shaft system.

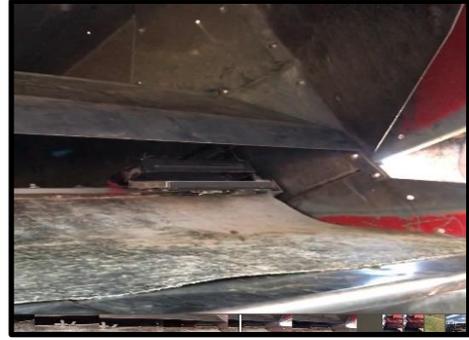
Figure 5: Internal baffle that separates chaff and straw material.

The straw baffle system consisted of one ¼-inch thick metal sheet that is mounted across the inside width of the combine and located behind the straw chopper. The baffle separates the chaff from the straw material. Coming from the straw chopper, the straw is traveling at a high velocity that goes over the top of the baffle and is flung to the back pan of the combine and then pushed out from the combine fan. The baffle then directs the chaff to the bottom pan of the combine and then to the chute. The baffle had to be bent at a certain pitch to facilitate the separation of chaff and the straw material.
