# PRE-PURCHASE BUILDING REPORT

Property Address	46A Pacific Road, North New Brighton, Christchurch 8083		
Client	Lynley Hands		
Date of Inspection	22nd May 2023	Time	9:00 am
Inspector	Jamie Chapman National Certificate in Carpentry		
LBP Number	137228		
Inspection Type	Pre-Purchase Report		
People Present	Inspector, Owner		
House Occupied	Yes

# CERTIFICATE OF INSPECTION IN ACCORDANCE WITH NZS 4306:2005

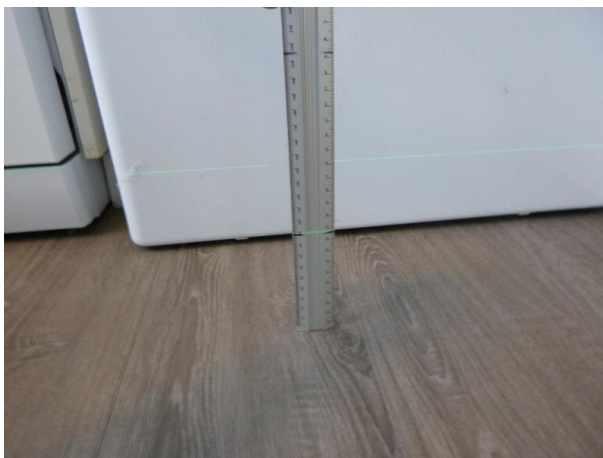
Photo 2

The floor where checked with a self leveling laser.

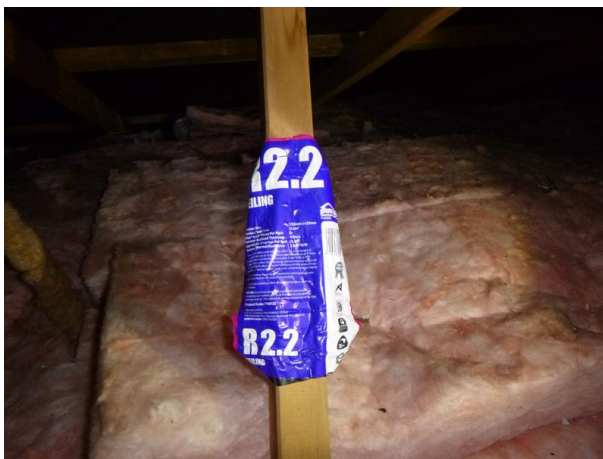
Photo 7

Insulation information.

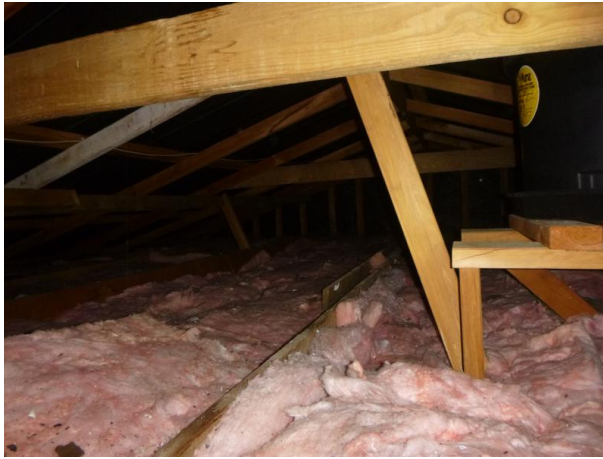
Photo 8

Photo of roof space with glass wool insulation and timber roof structure.

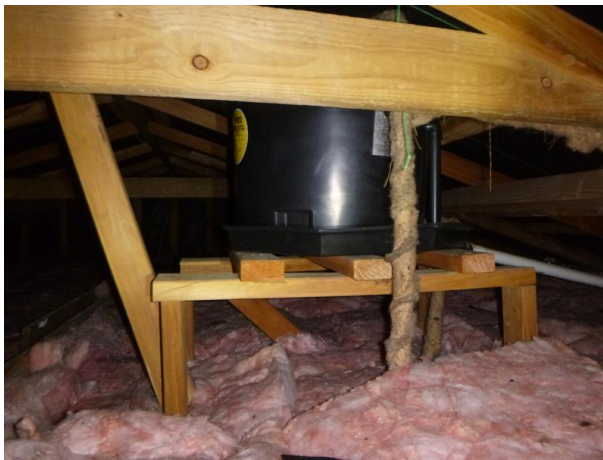
Photo 9

The header tank is located in the ceiling space.

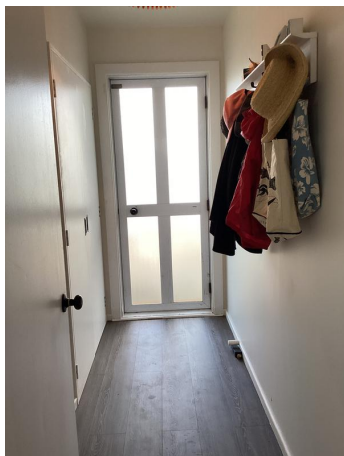
Photo 10

Entrance way.

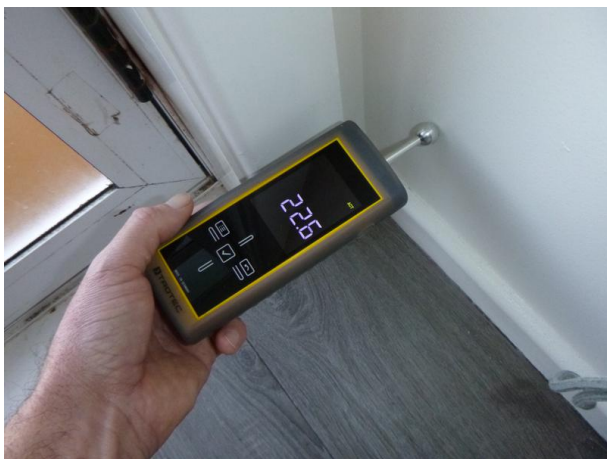
Photo 12

Internal walls with no elevated moisture readings next to front door.

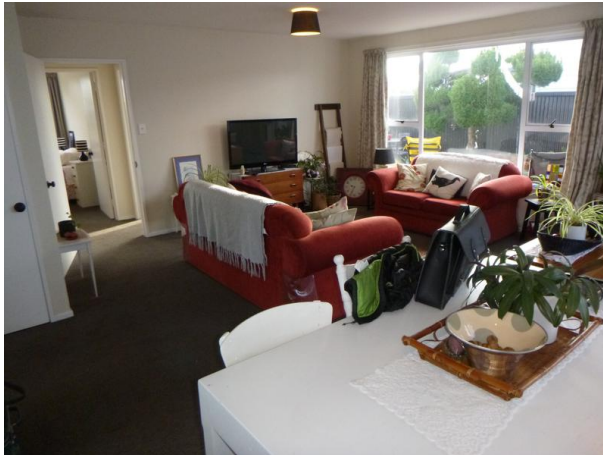
Photo 14

Living space.

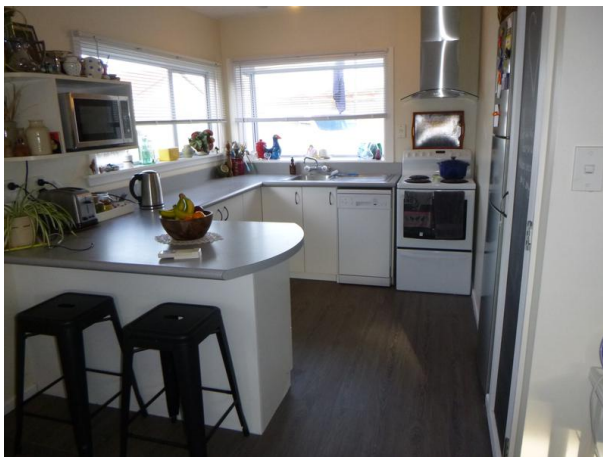
Photo 15

Kitchen.

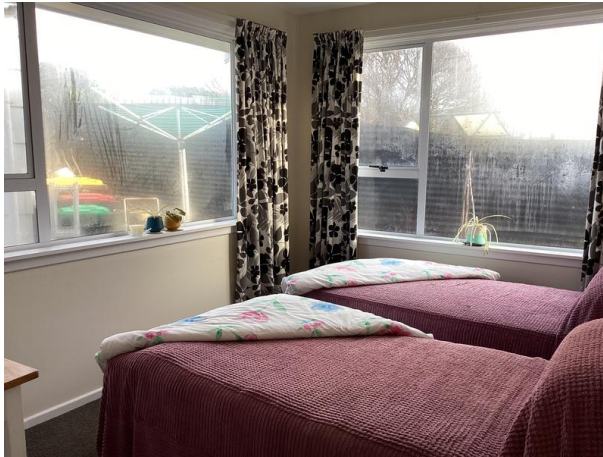
Photo 25

Bedroom 1.

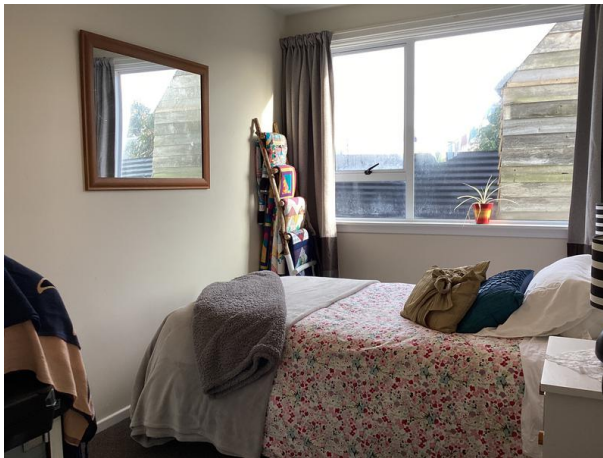
Photo 28

Bedroom 2.

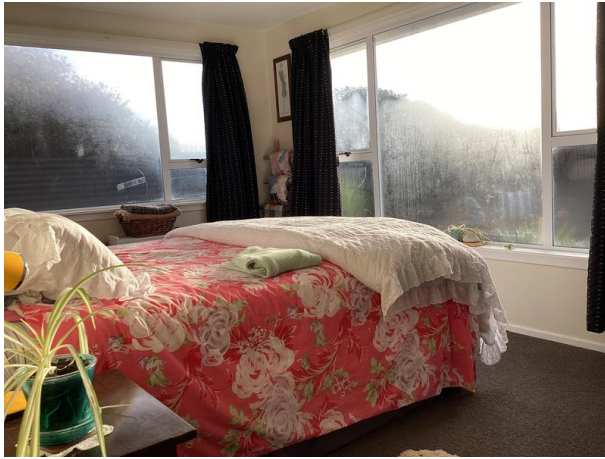
Photo 29

Bedroom 3.

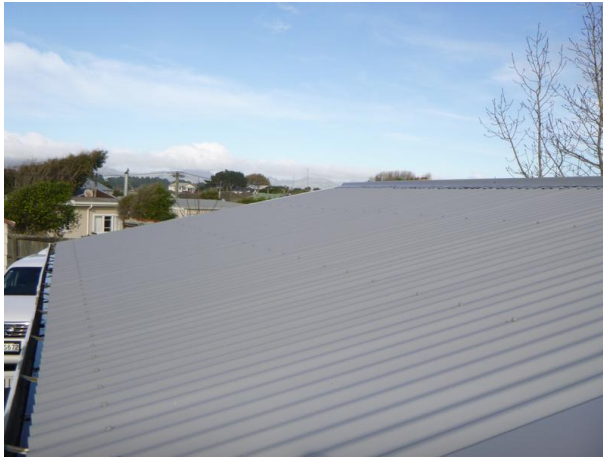
Photo 31

Exterior roof, Profiled metal roof with screw fixings on the south side of the house.

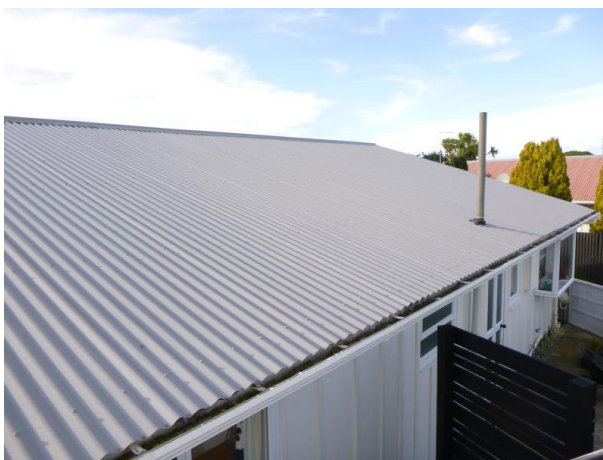
Photo 32

South side of exterior roof as viewed from garage roof.

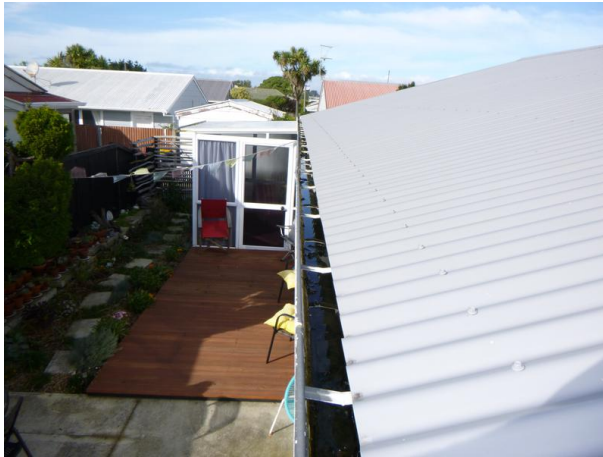
Photo 34

Photo of north gutter.

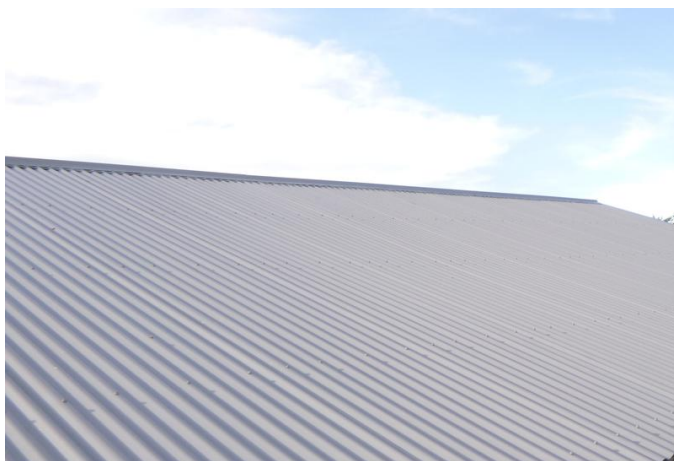
Photo 50

Ridge flashing no visible issues.

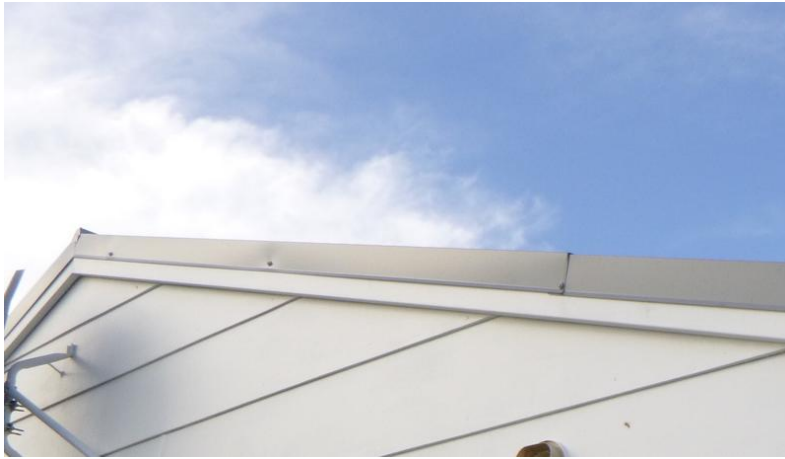
Photo 51

Barge flashing no visible issues at the time of the inspection.

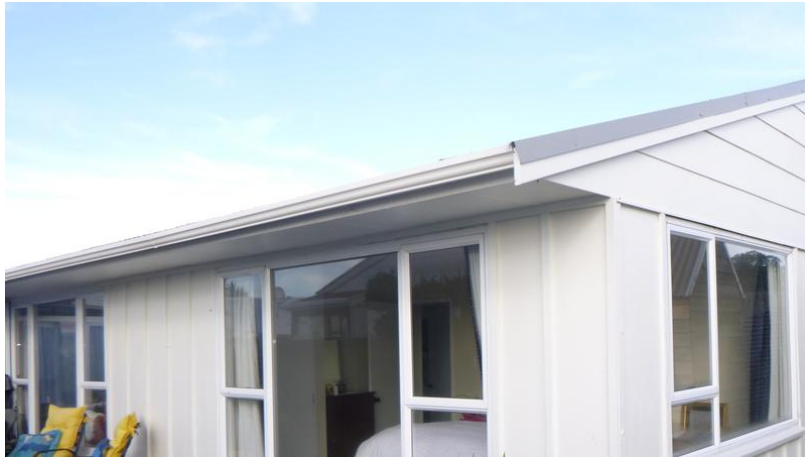
Photo 52

Soffits to north side of the house. No visible issues.

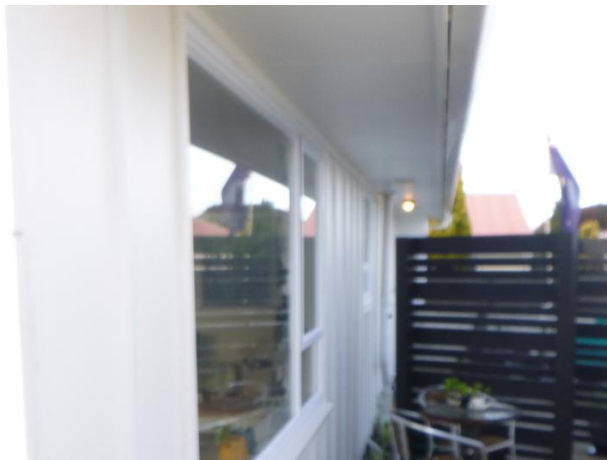
Photo 53

Soffits to south side of the house.

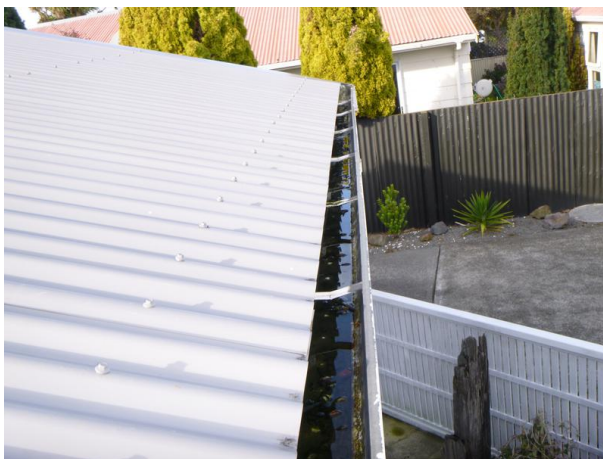
Photo 54

Gutter to the southern side of the house.

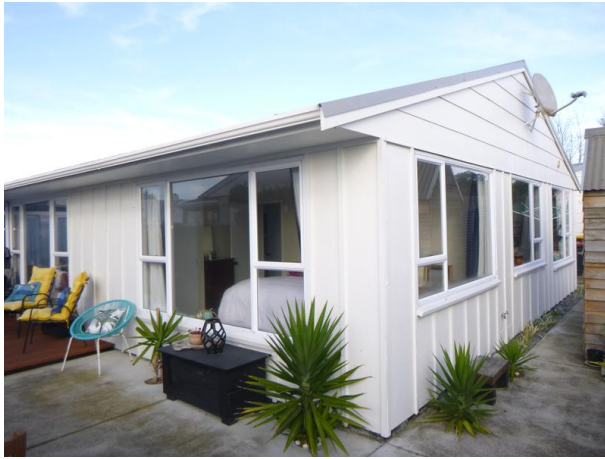
Photo 35

Exterior cladding. North and West elevation.

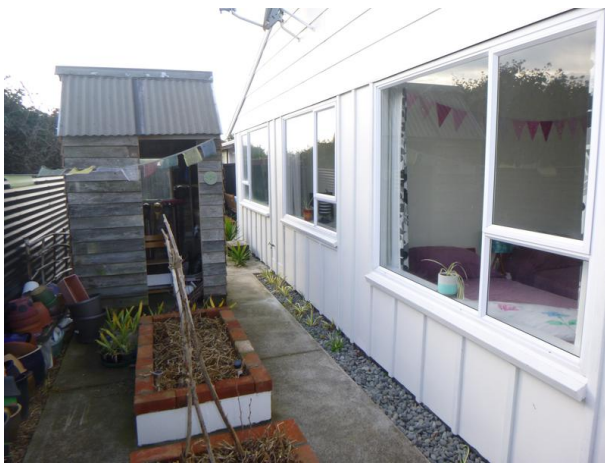
Photo 36

Exterior cladding. East elevation.

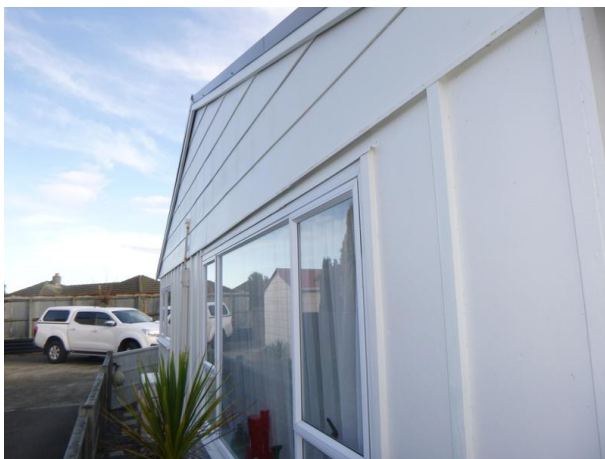
Photo 37

Flashing at change of cladding.

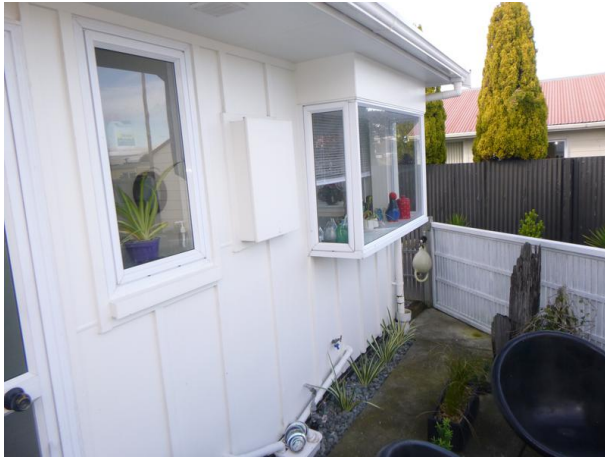
Photo 38

Exterior cladding. South elevation.

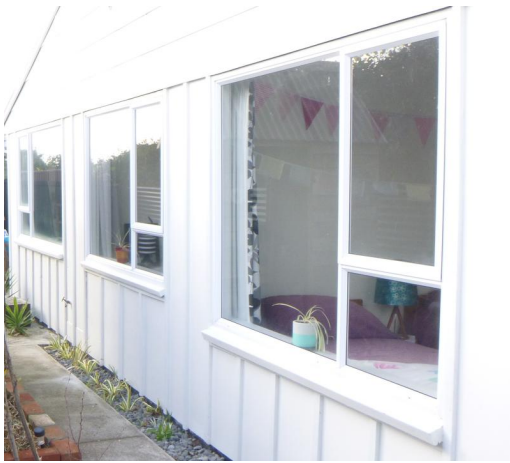
Photo 41

Photo of exterior joinery.

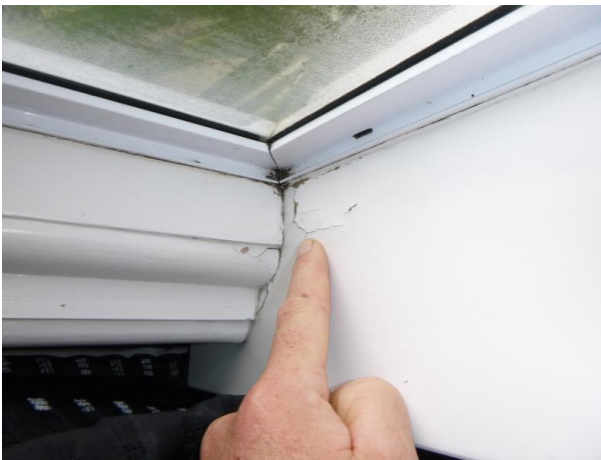
Photo 42

As stated in this report the external joinery reveals are made of MDF, and most reveals have minor to significant damage.

MDF (medium density fibre-board) reveals were withdrawn from the market following the realisation that they are sensitive to moisture. A higher level of maintenance should be expected than timber reveals. Managing moisture is essential.

Elevated moisture levels were detected around the external joinery, with visible swelling to the MDF reveals refer to the external joinery section for further information.

Managing moisture is essential. Higher than normal moisture readings were indicated that may be due to condensation, or the joinery leaking. Further investigation will be required to locate the source of moisture and repair as necessary.

MDF swelling. This is common throughout the property.

Have a specialist in exterior joinery investigate and report on maintenance and repairs required.

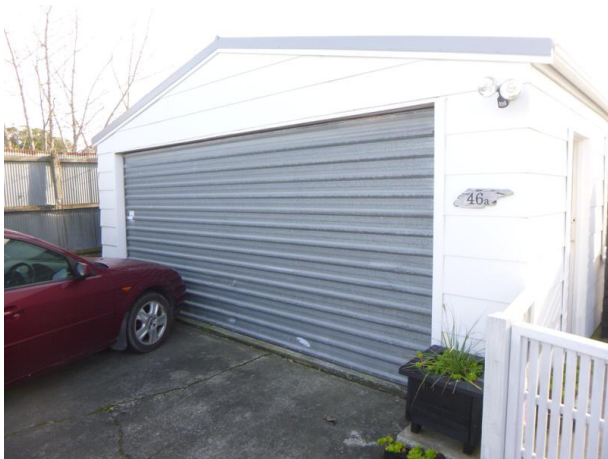
Photo 45

Garage.

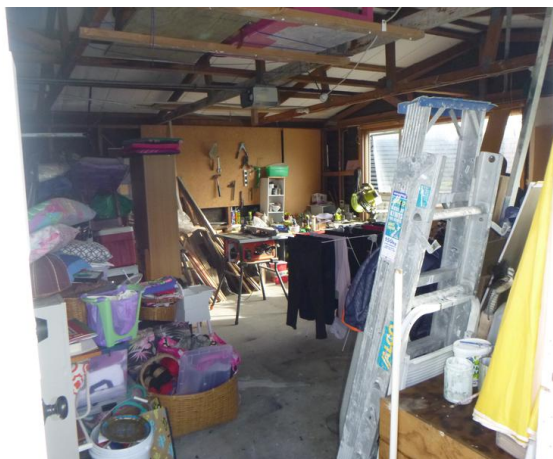
Photo 46

Most areas in the garage was unable to view due to items obstructing the garage.

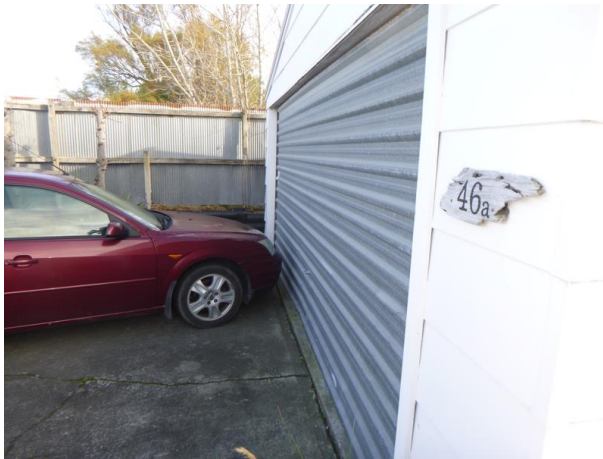
Photo 47

Garage door was unable to be tested due to a car parked in front

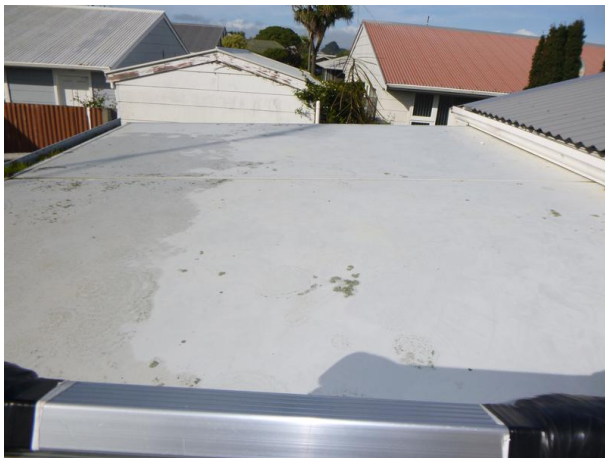
Photo 56

Roof of the conservatory.

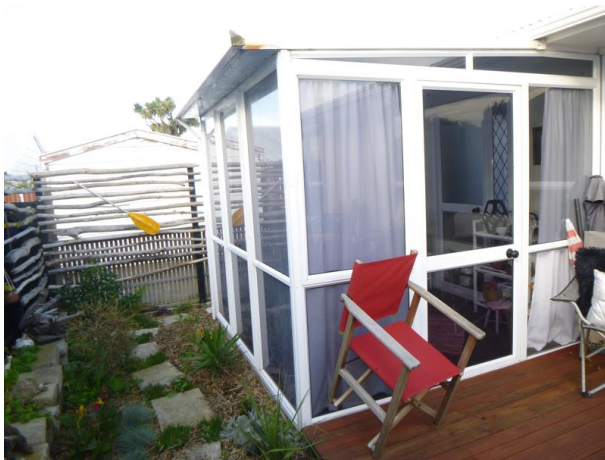
Photo 58

Exterior of the conservatory.

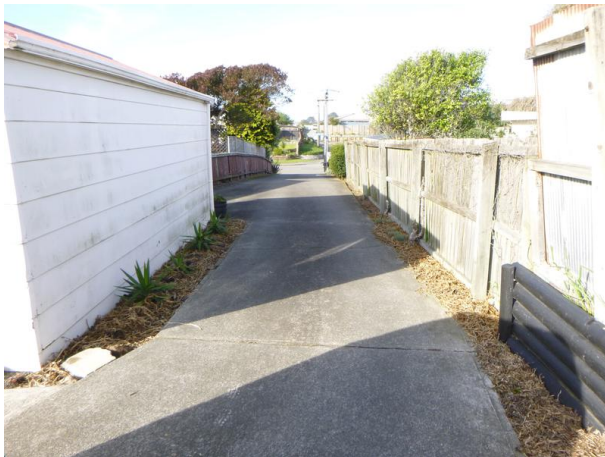
Photo 60

Photo of common driveway.

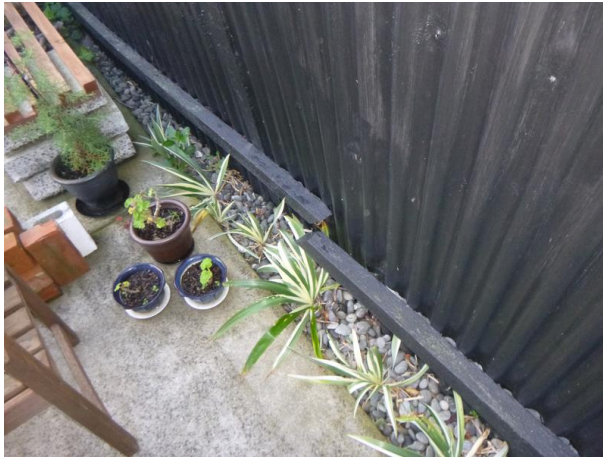
Photo 64

Photo of rails not connecting on the post and separating.

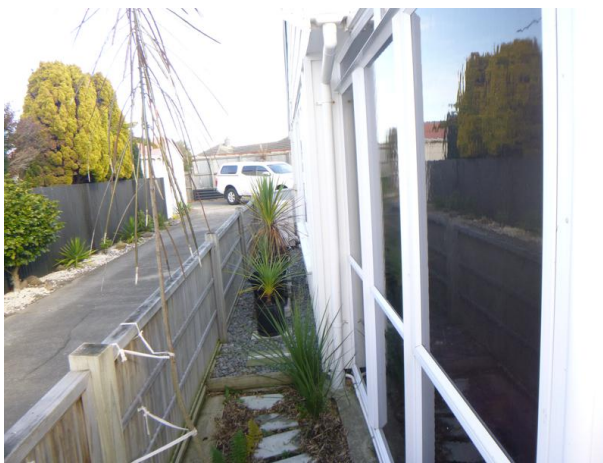
Photo 65

Photo of 1.2m fence.

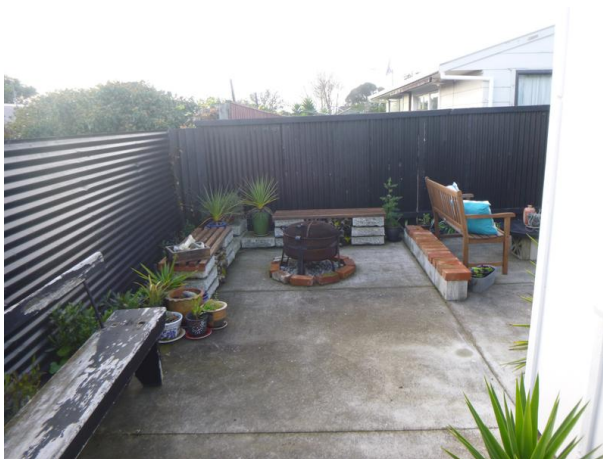
Photo 66

Photo of horizontal and vertical profiled metal fencing.

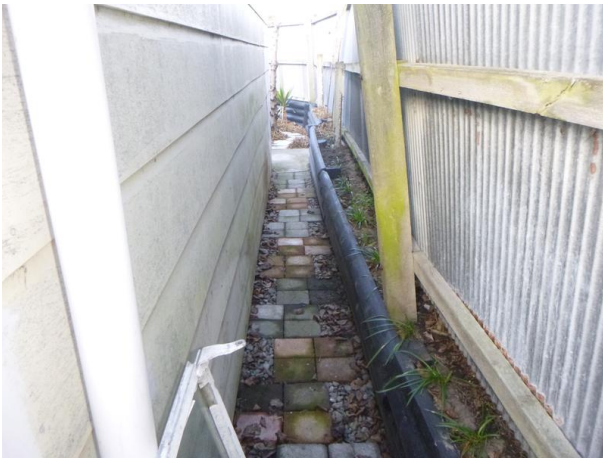
Photo 67

Rotation - Slight rotation.

Retaining wall.

General upkeep and maintenance.

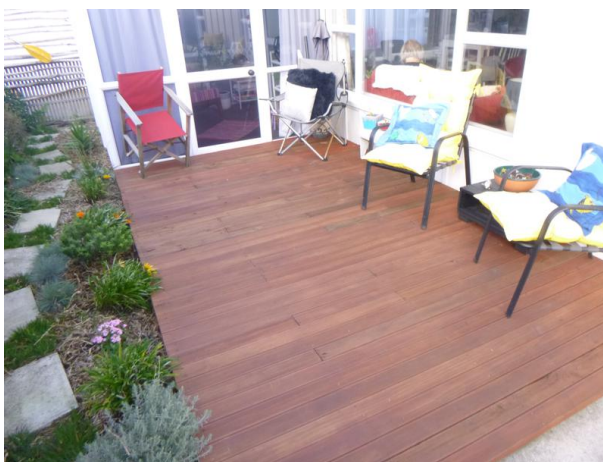
Photo 68

Deck, no visible issues.

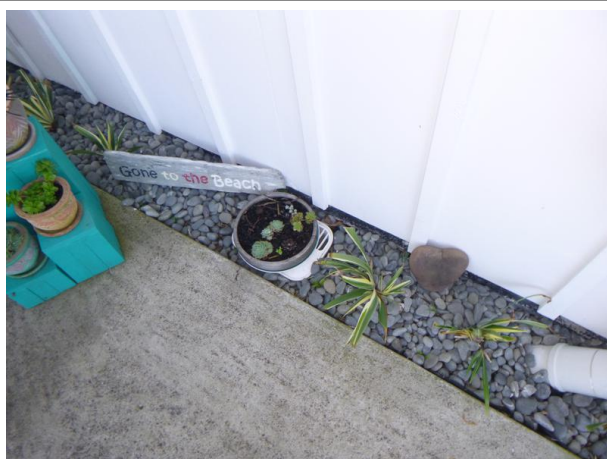
Photo 72

Bathroom gully trap.

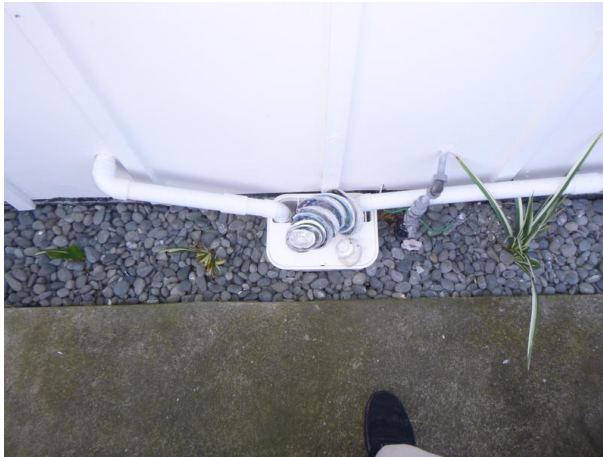
Photo 73

Kitchen gully trap.

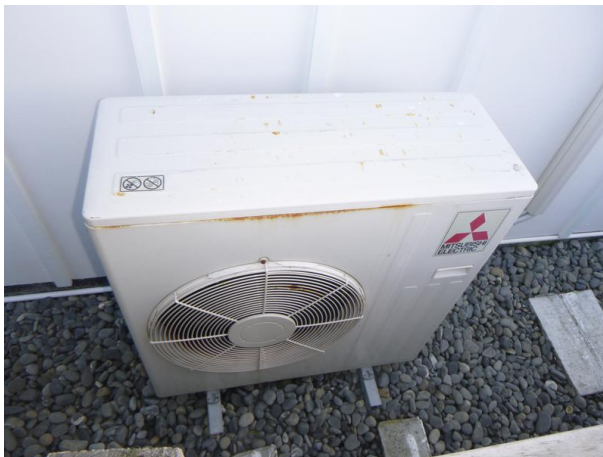
Photo 76

Heat pump exterior unit.

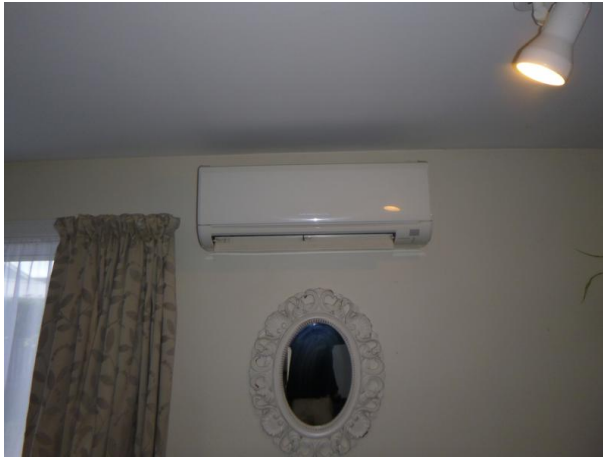
Photo 77

Photo of heat pump, no visible issues at time of inspection.

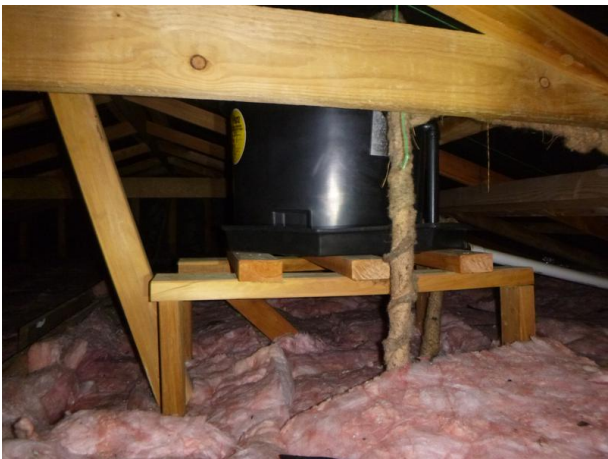
Photo 79

Header tank view from ceiling space.

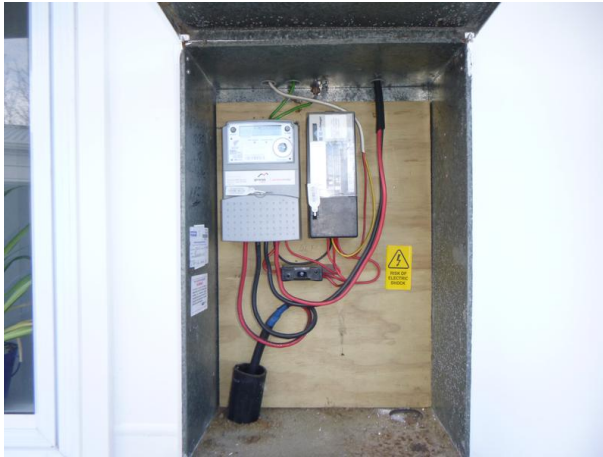
Photo 80

Meter box located from outside kitchen.

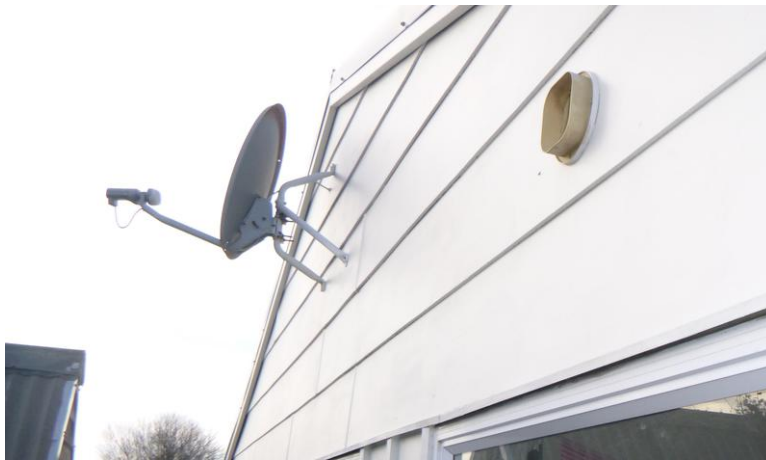
Photo 81

Satellite aerial located on west gable end.

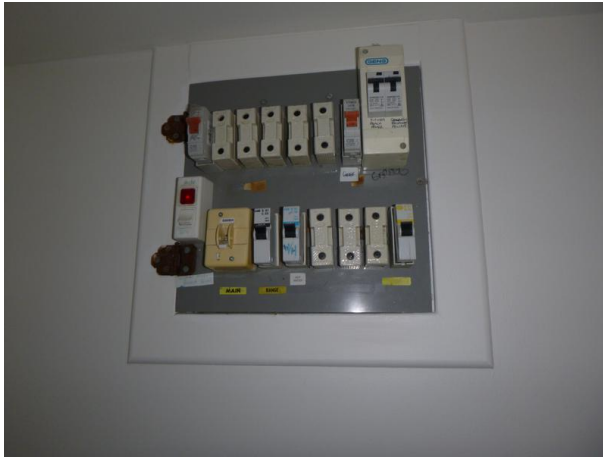
Photo 83

Distribution board located in the entrance way.
