RED LBP PRE-PURCHASE REPORT

PRE-PURCHASE BUILDING REPORT

Property Address	7 Hulme Way Raumati Beach
Client	Terry Wilson
Date of Inspection	28th July 2025
Time	1:00 pm
Inspector	Trevor Garrett MSc, LBP, Advanced Trade Cert Carpentry, Nat Diploma Construction Management. Member of NZIOB.
LBP Number	131790
People Present	Owner
House Occupied	Yes

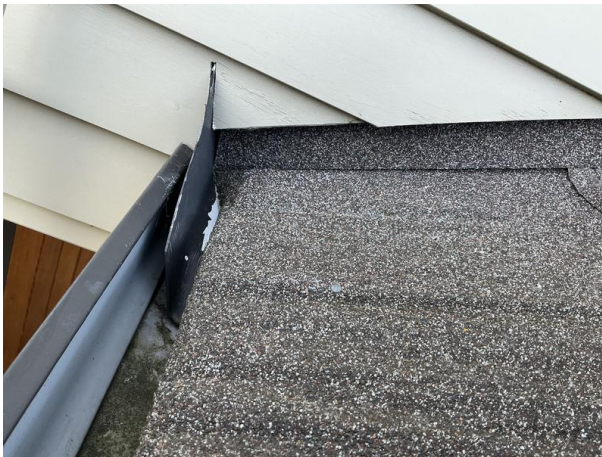
Photo 4

Roof and wall junctions are fitted with a kick out diverter flashing.

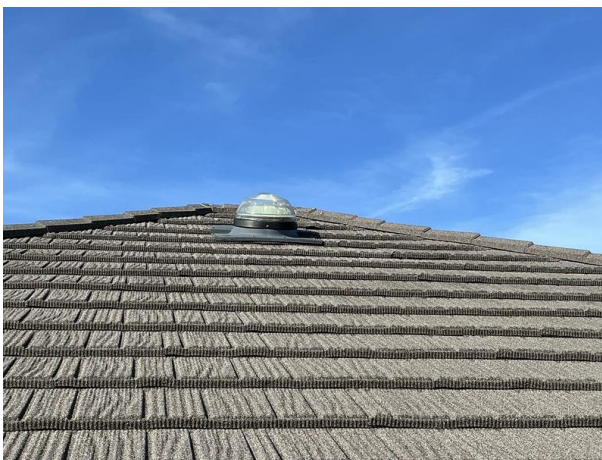
Photo 5

West side skylight penetration.

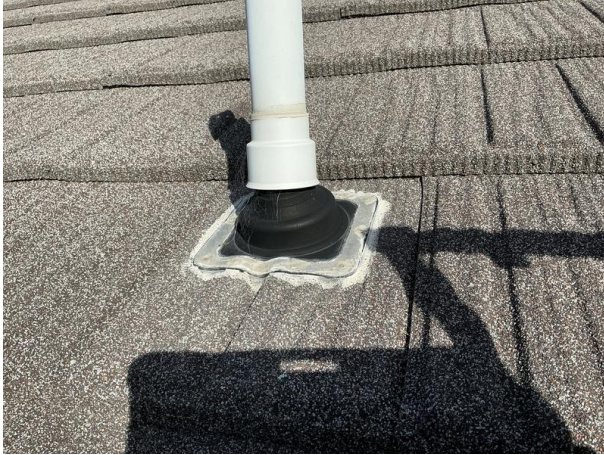
Photo 6
North side vent penetration.

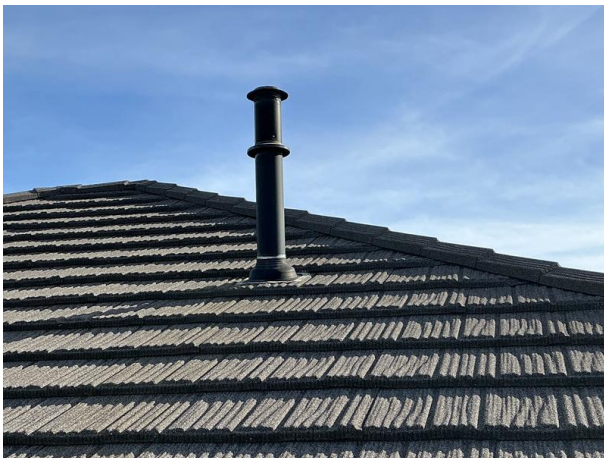
Photo 7
East side califont flue.

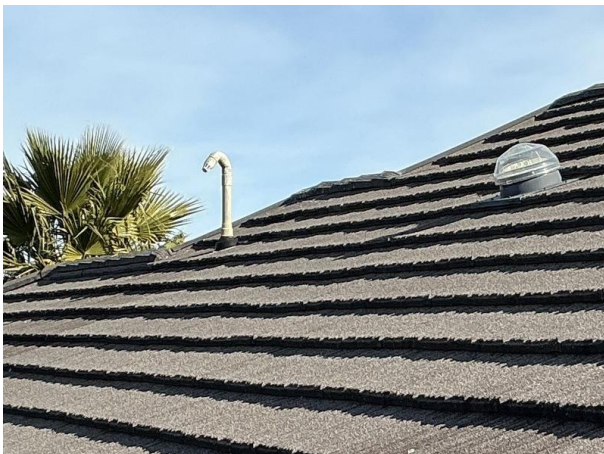
Photo 8
East side heater and skylight penetrations.

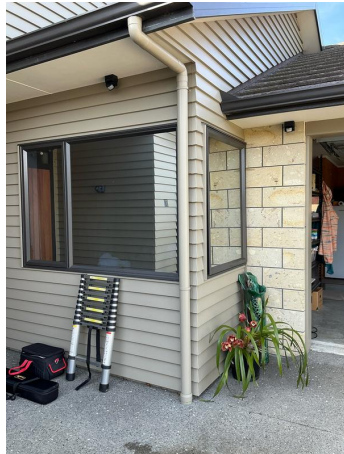
Photo 9

No issues with the downpipes.

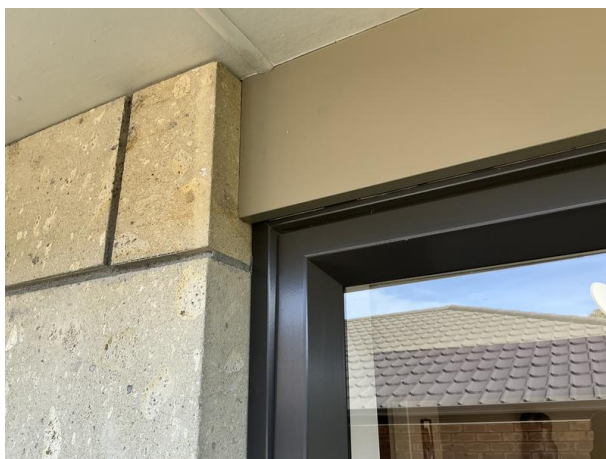
Photo 10

Windows within brick have a cover board over the head.

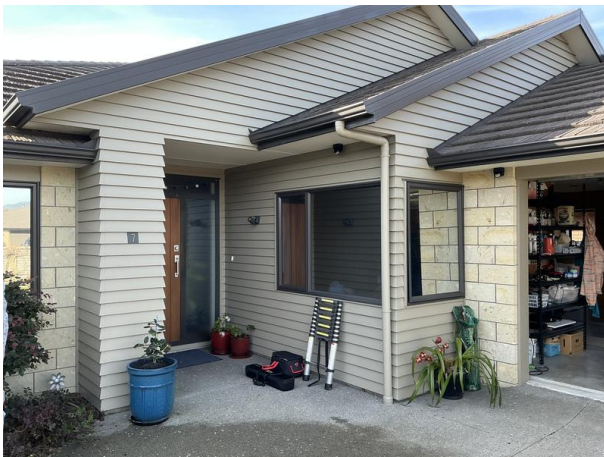
Photo 12
South side weatherboards.

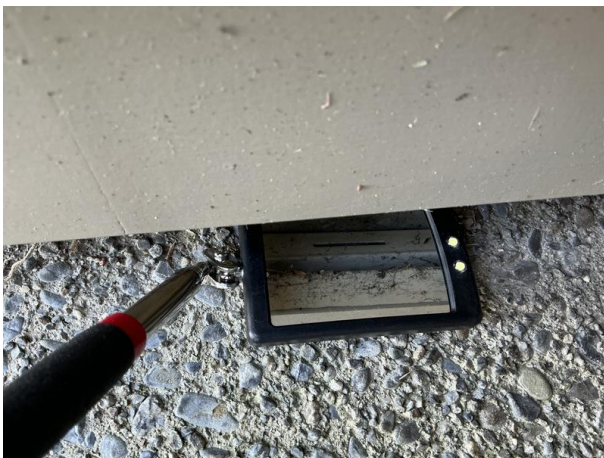
Photo 13
Installed on a vented cavity.

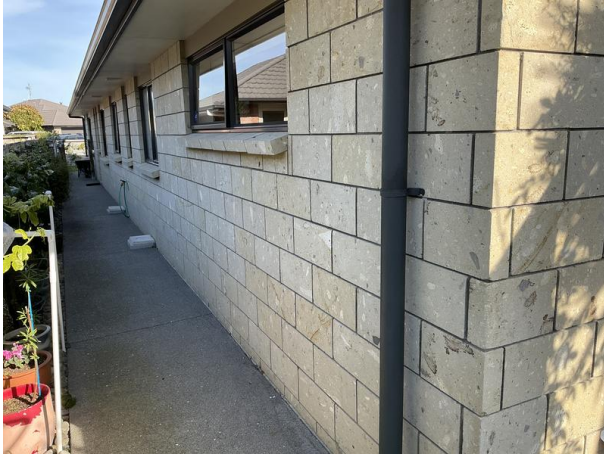
Photo 15

No issues with the brick veneer.

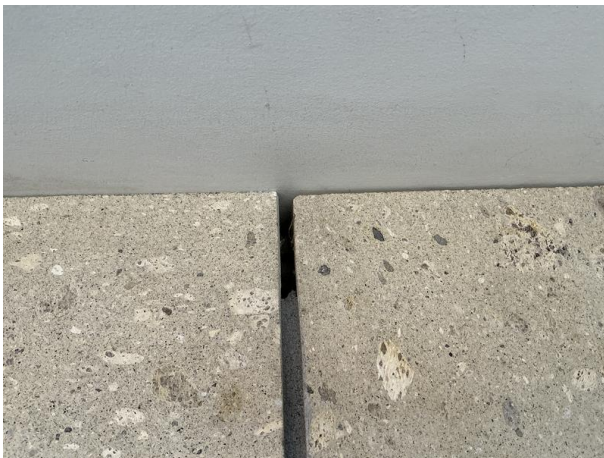
Photo 16

Vent holes are present throughout the brick work.

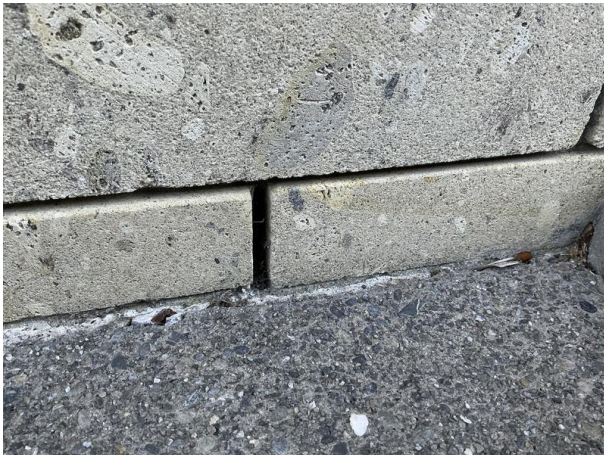
Photo 17

Weep holes are present throughout the brick work.

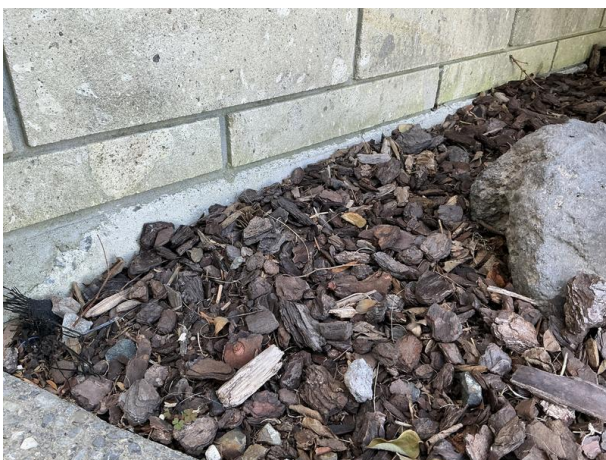
Photo 18
Foundation wall.

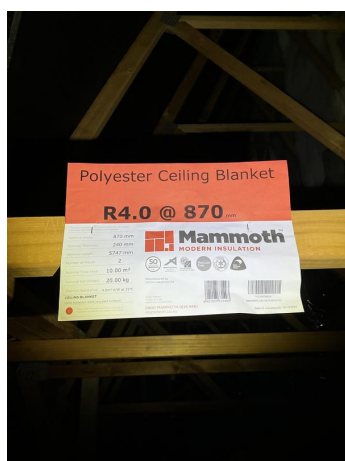
Photo 22

Insulation installation record, R value 4.0.

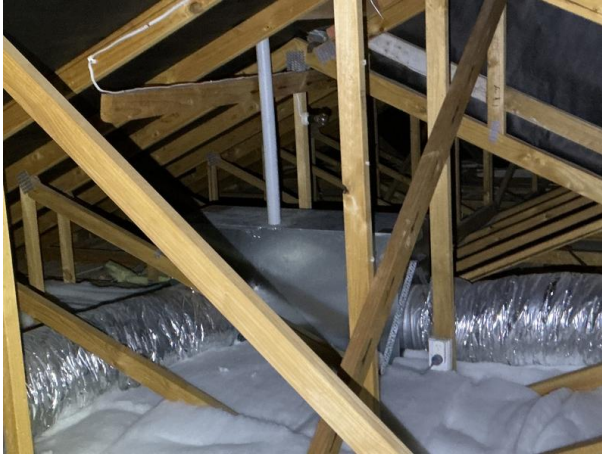
Photo 23

No visible gaps in the insulation. Gas heater.

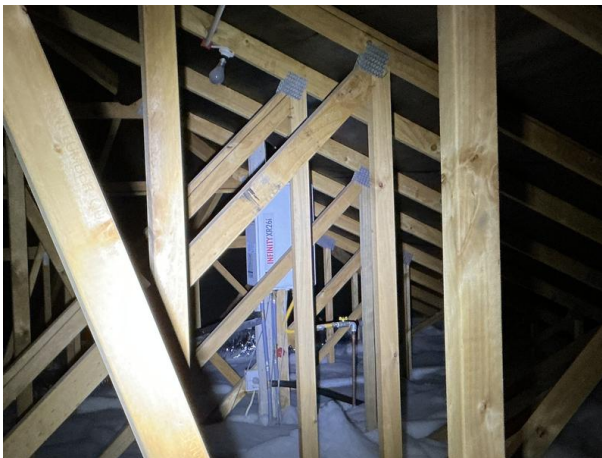
Photo 24

Gas califont.

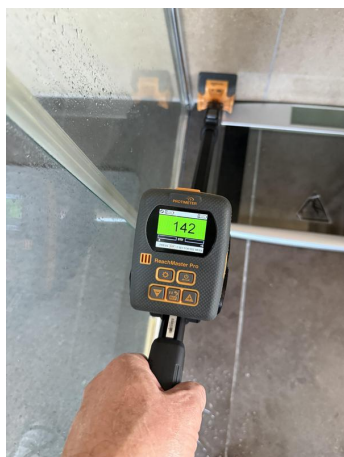
Photo 25

Corner of the ensuite shower has indications of normal moisture.

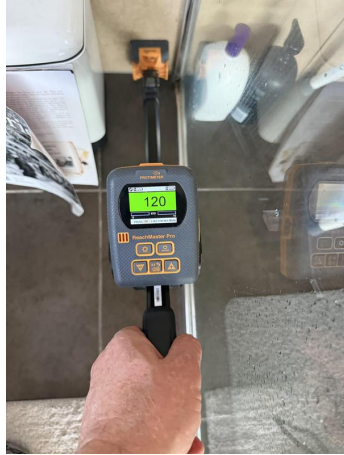
Photo 26

Corner of the ensuite shower has indications of normal moisture.

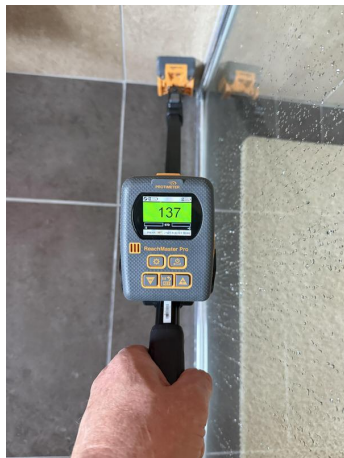
Photo 27

Corner of the bathroom shower has indications of normal moisture readings.

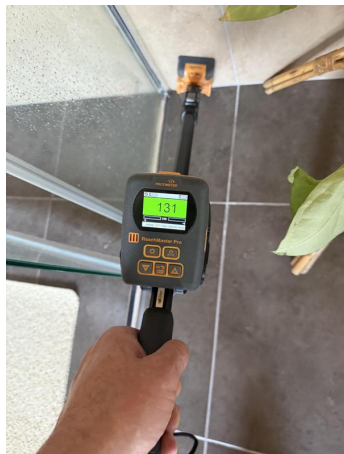
Photo 28

Corner of the bathroom shower has indications of normal moisture readings.

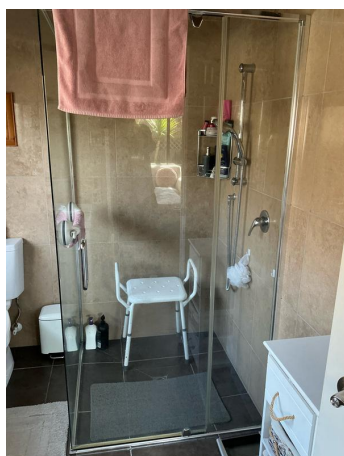
The common fail areas of the shower and plumbed areas were checked for indications of elevated moisture. Moisture levels were within the normal range.

Photo 31
Shower.

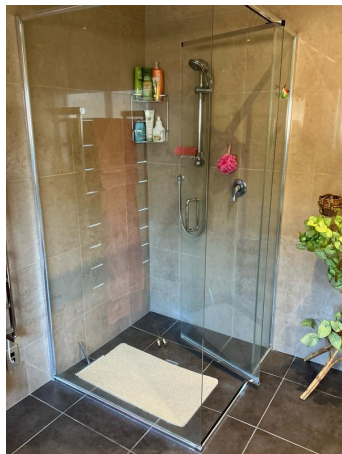
The common fail areas of the shower and plumbed areas were checked for indications of elevated moisture. Moisture levels were within the normal range.

Photo 39
Shower.

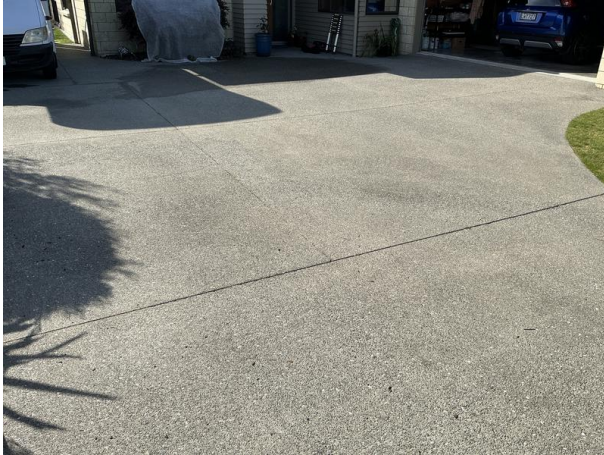
Photo 49
Driveway, functional.

General upkeep and maintenance of driveway by cleaning and keeping free of debris.

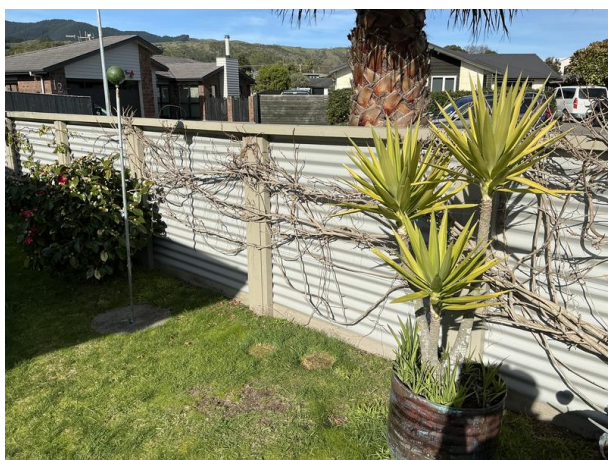
Photo 50
South side, functional.

Ensure regular upkeep and maintenance by keeping vegetation and soil away from exterior timbers. These timbers are treated for external exposure but are not designed for prolonged contact with vegetation or soil, which can trap moisture and accelerate rot. Periodically inspect the area and clear any overgrowth or soil buildup.

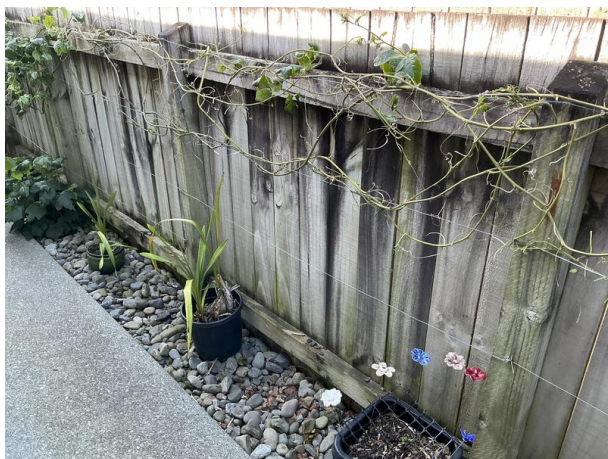
Photo 51
East side, functional.

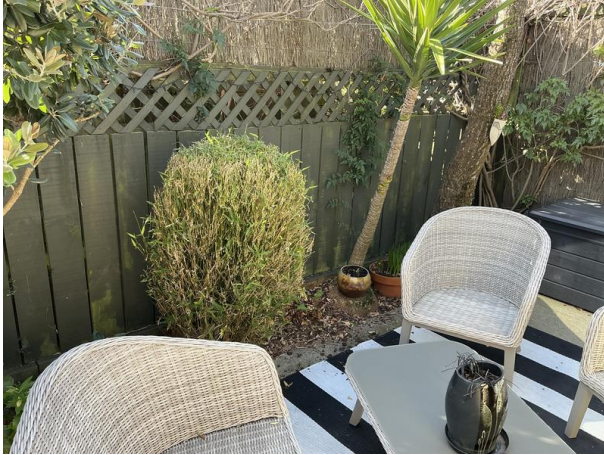
Photo 52
North side, functional.

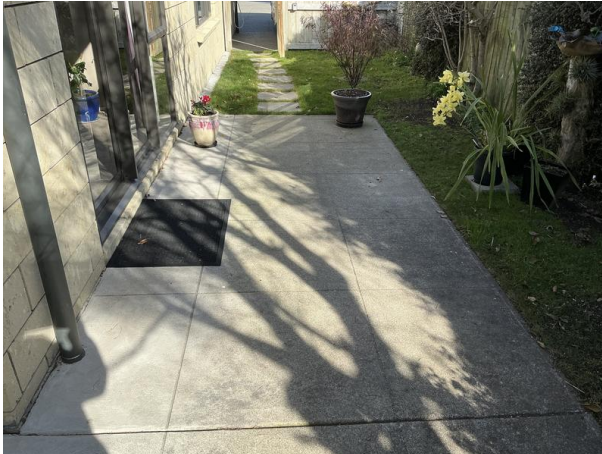
Although the north path has subsided on the boundary side, the path is functional.

Photo 54
West side, functional.

General upkeep and maintenance.

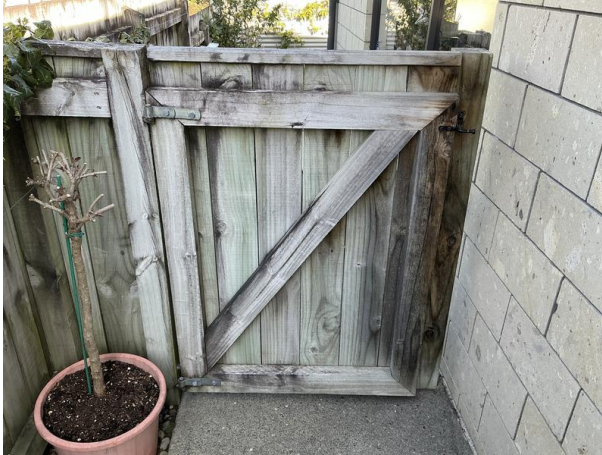
Photo 59
East side, functional.

Recommend regular lubrication of the hinges and latch to maintain full function.

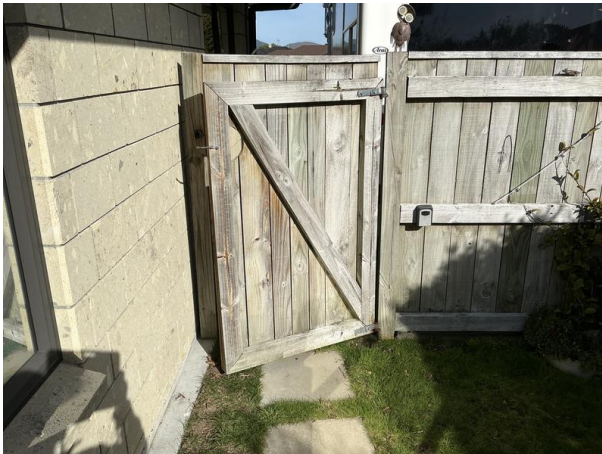
Photo 60
West side, functional.

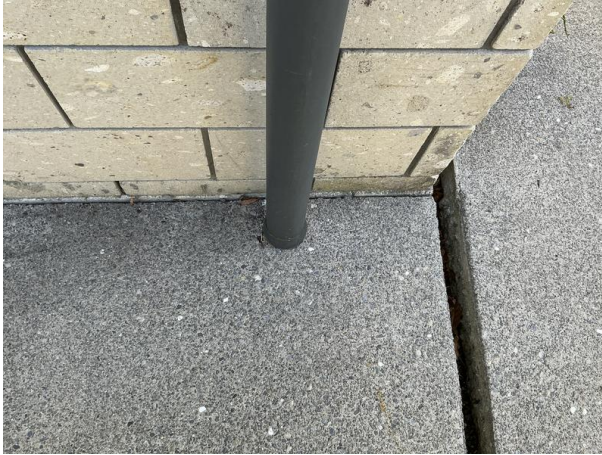
Photo 66

East side downpipe connection visible.

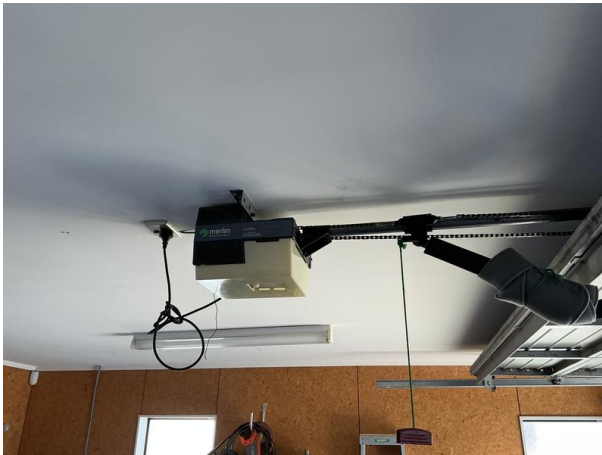
Photo 76
Garage door opener is functional.
