BUILDING INSPECTION REPORT

PROPERTY CHECK EXPRESS REPORT

Job Number	53995
Client	[REDACTED]
Property Inspected	252 Waimairi Road, Ilam, Christchurch
Inspection Date	26 March 2025
Building Surveyor	Darin Devanny
NZIBS Registration Number	BSI0100
Weather Conditions	Fine
Scope of Report	Visual inspection of the buildings that are listed in this report for the purpose of a residential inspection in accordance with NZS4306: Residential Property Inspections.
Report Ordered By	[REDACTED]
Orientation	For the purpose of this report, the elevation of the house facing Waimairi Road is considered to be the west elevation.

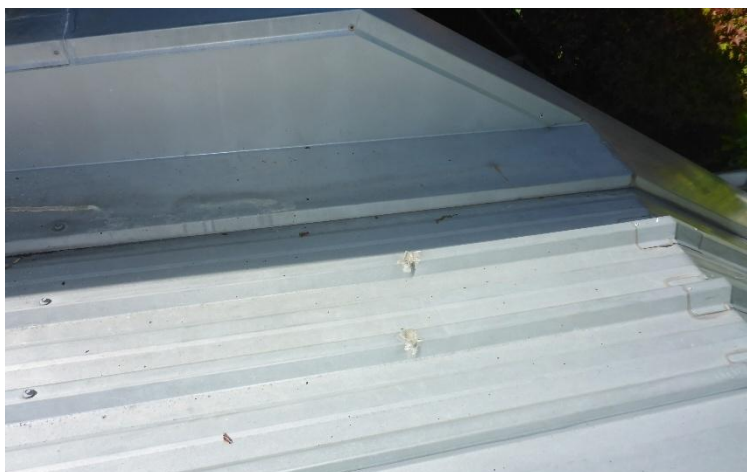
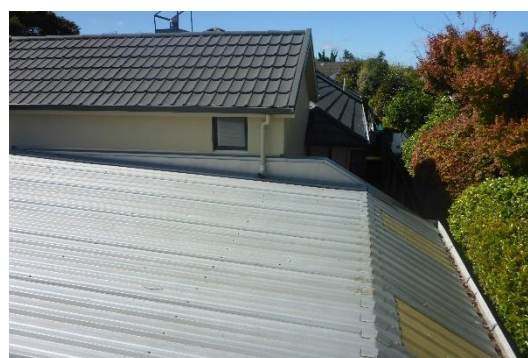
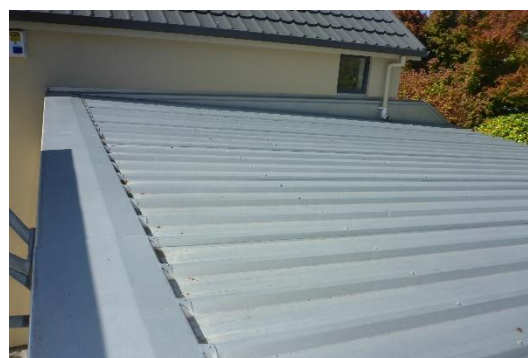
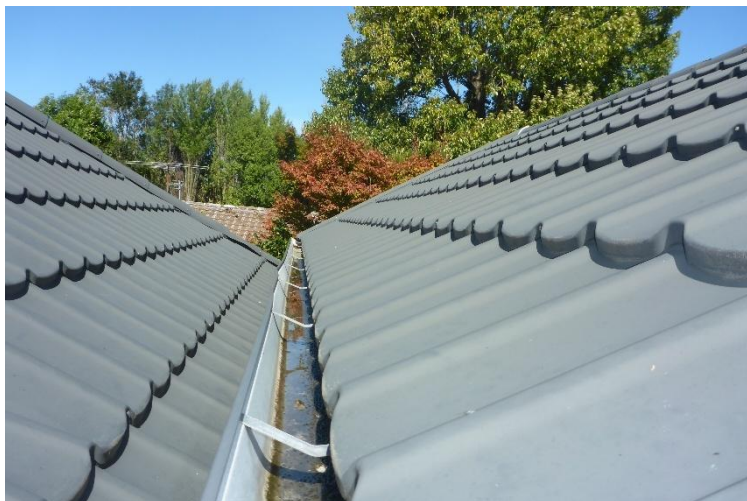
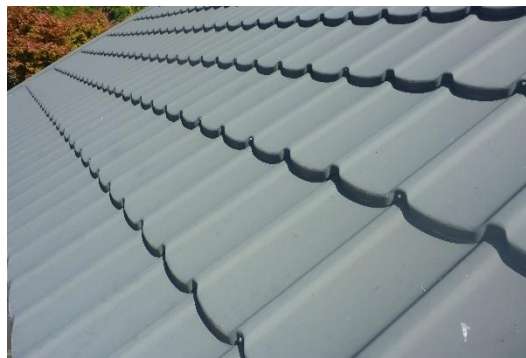
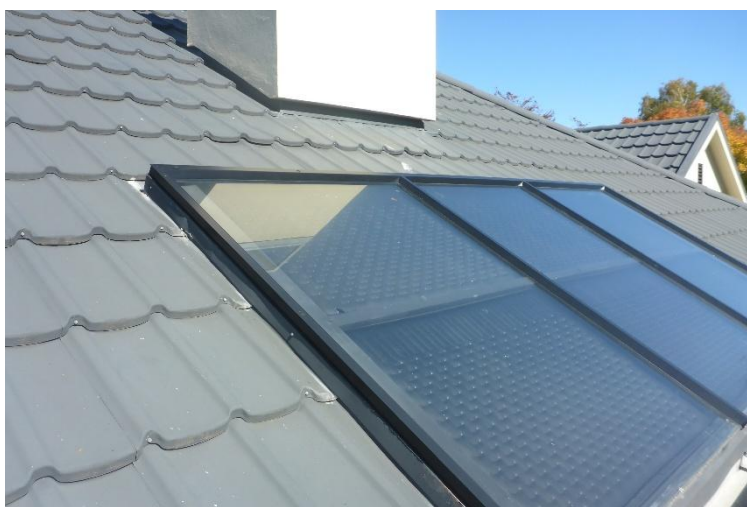
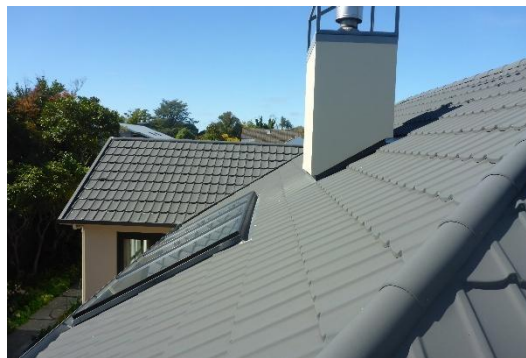
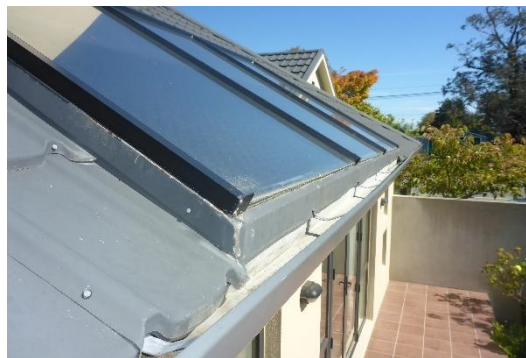
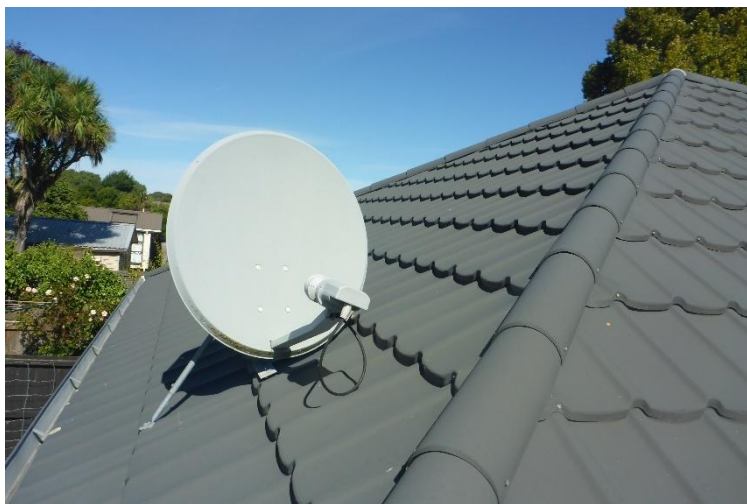
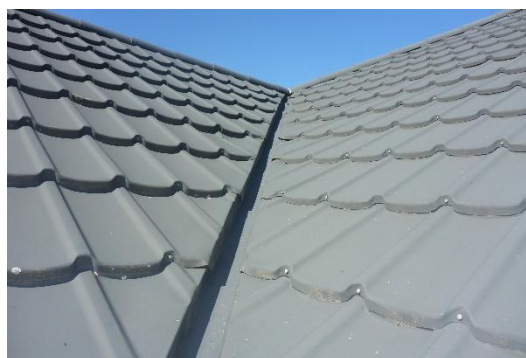
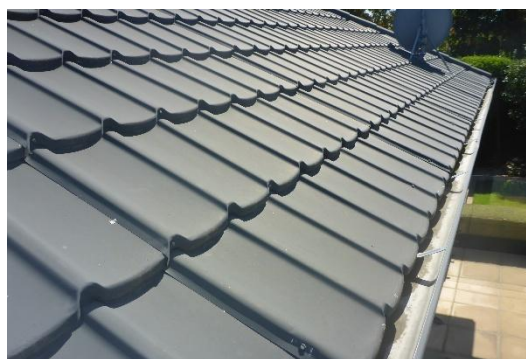
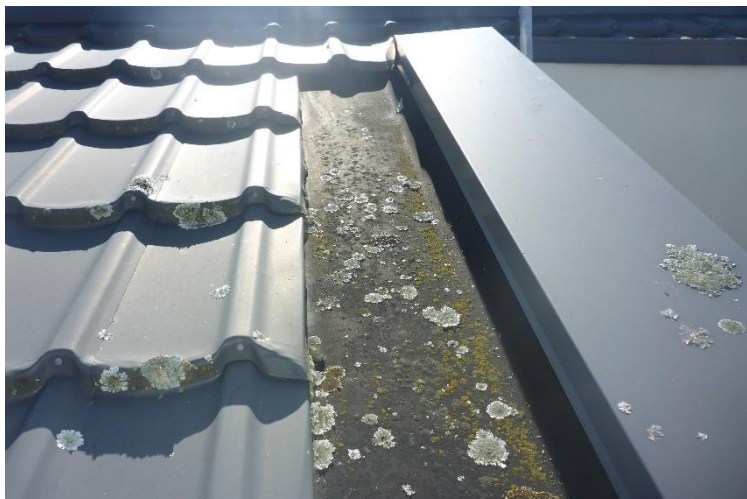
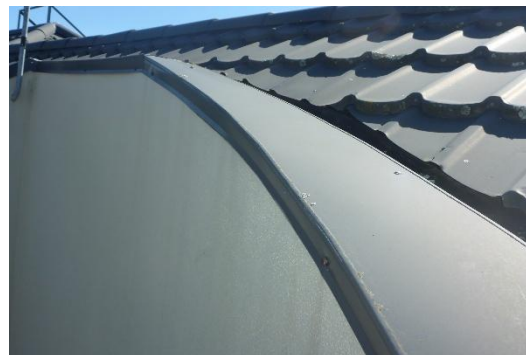
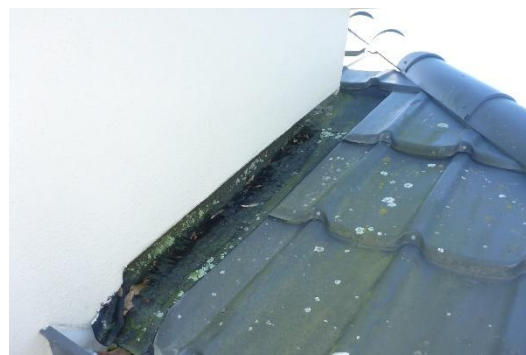
ROOF – Pre-painted pressed metal tiles / Unpainted profiled metal

No significant faults identified.

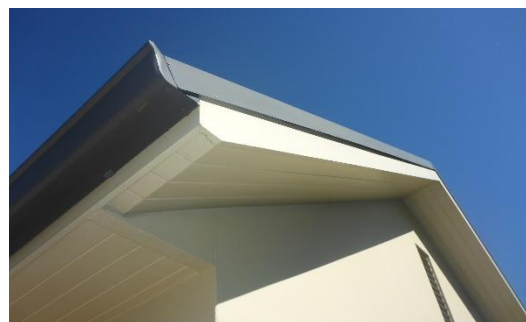
FASCIA – Timber

No significant faults identified.

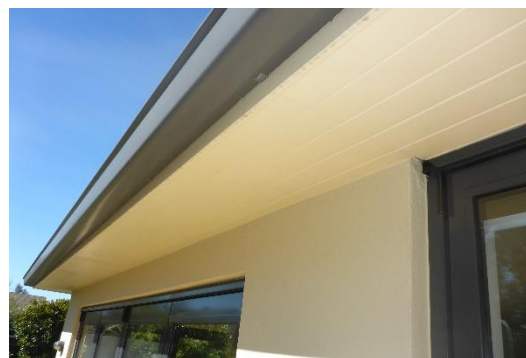
SOFFIT LININGS – Timber

No significant faults identified.

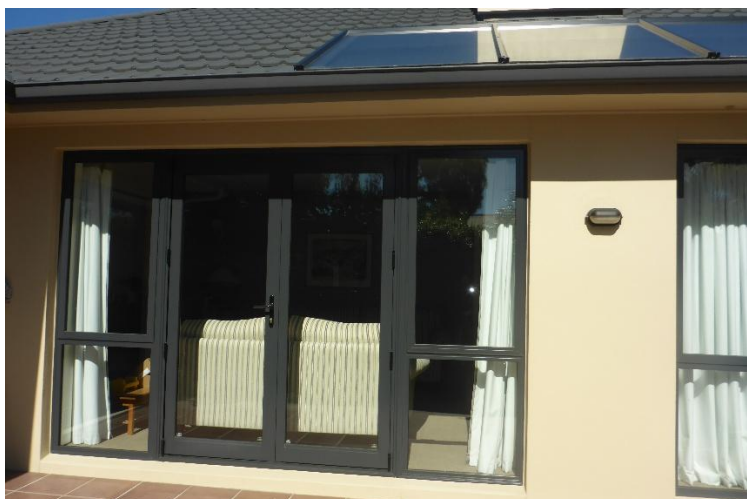
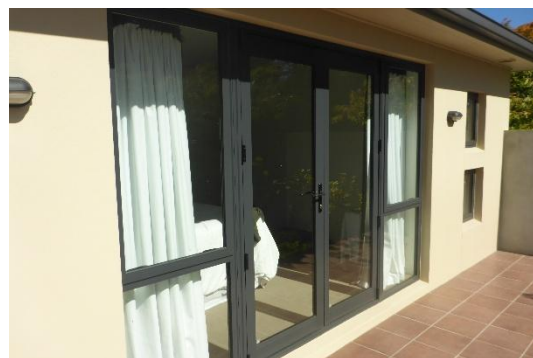
Overview photographs:

No significant faults identified.

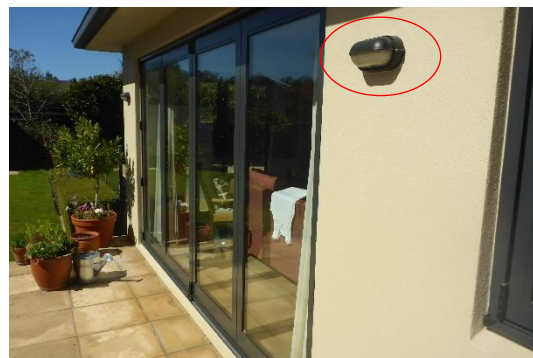
EXTERNAL FIXTURES

No significant faults identified.

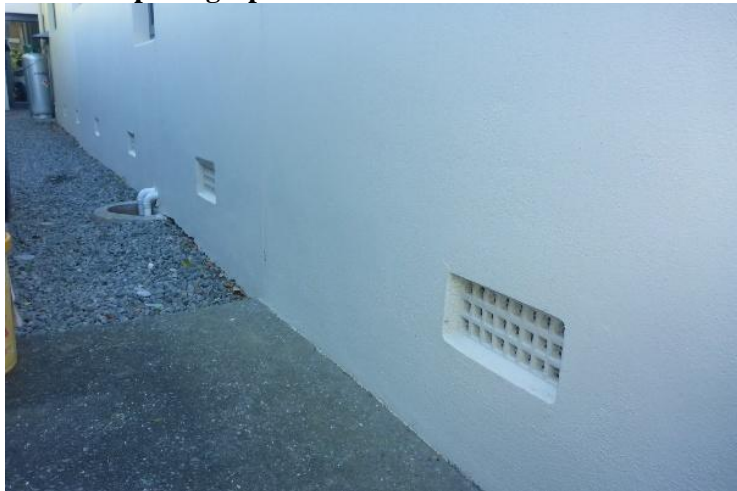
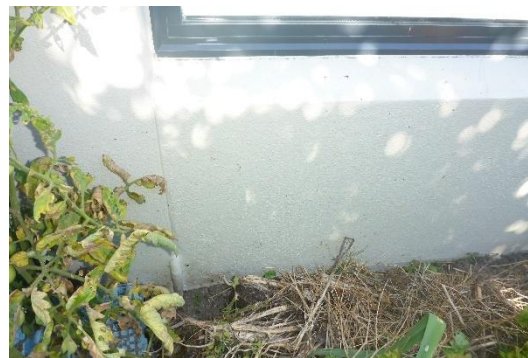
PERIMETER FOUNDATIONS – Concrete strip

No significant faults identified.

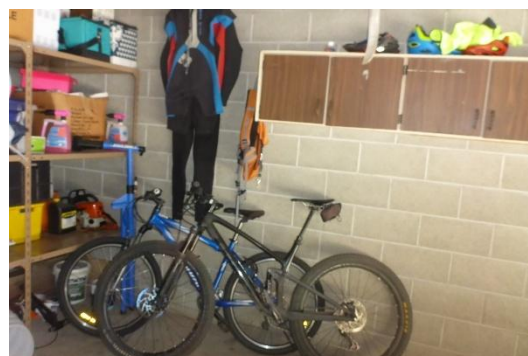
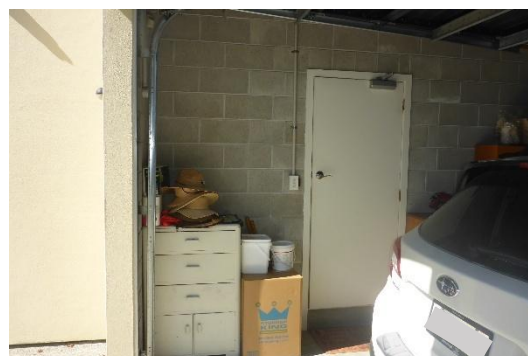
INTEGRAL GARAGE

No significant faults identified.

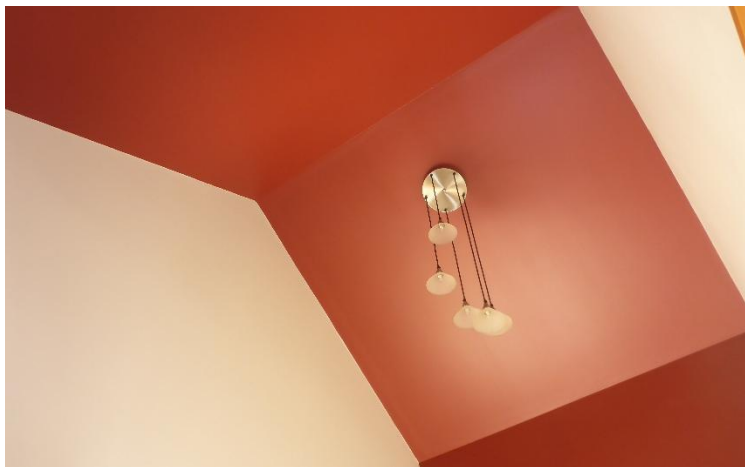
ENTRANCE / HALLWAY

No significant faults identified.

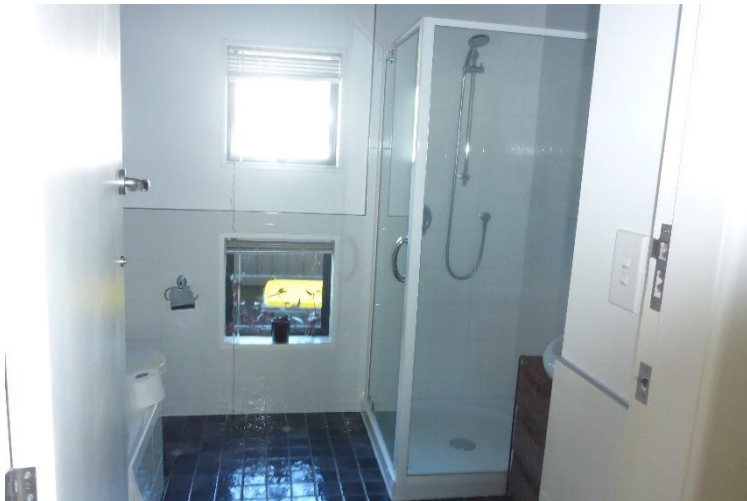
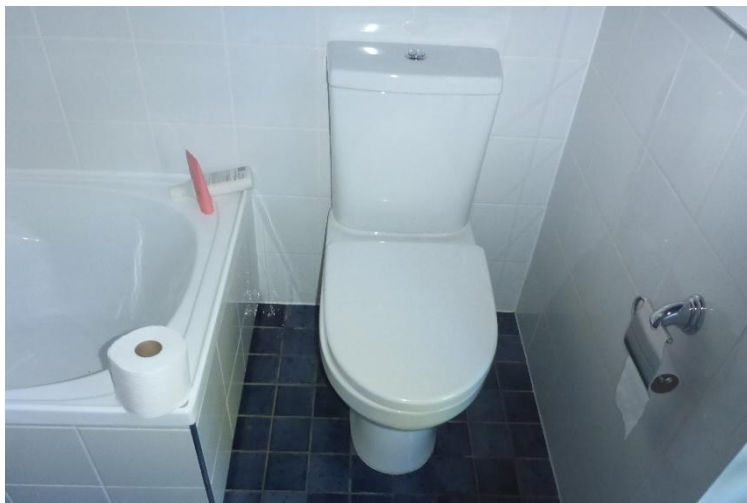
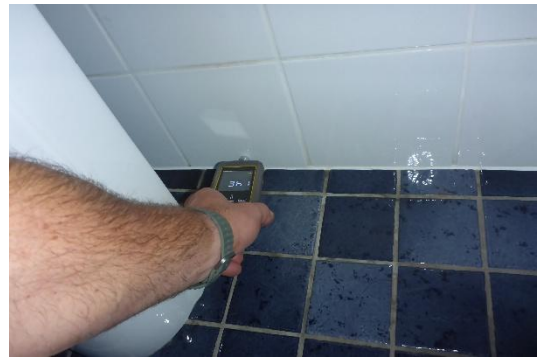
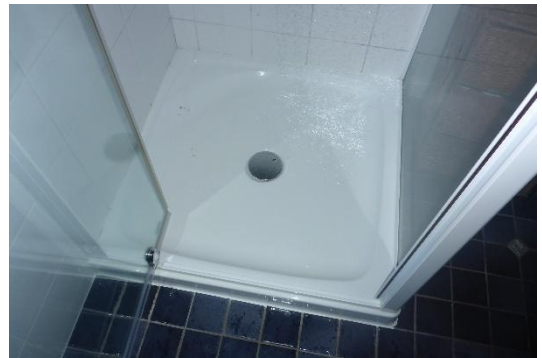
BATHROOM

No significant faults identified.

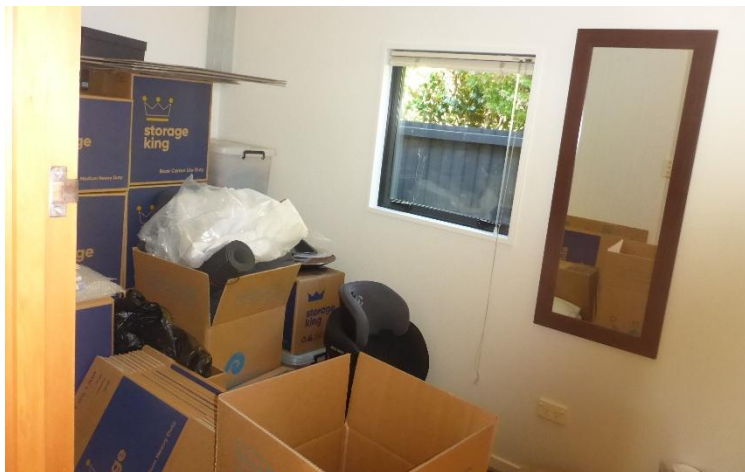
STOREROOM – Next to the garage

No significant faults identified.

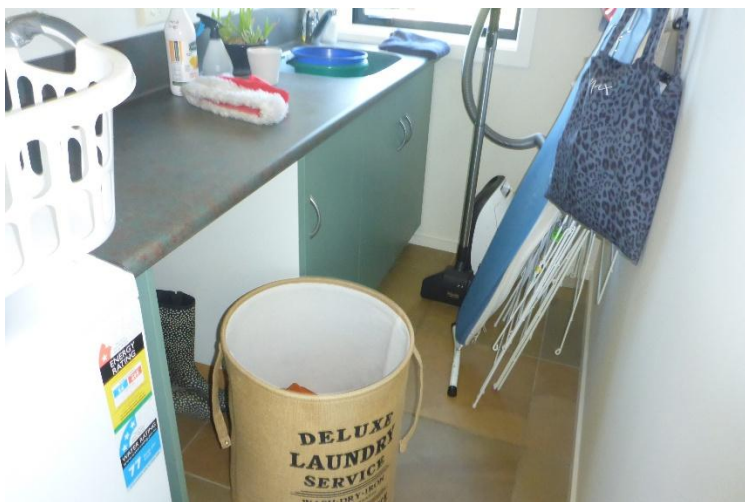
LAUNDRY

No significant faults identified.

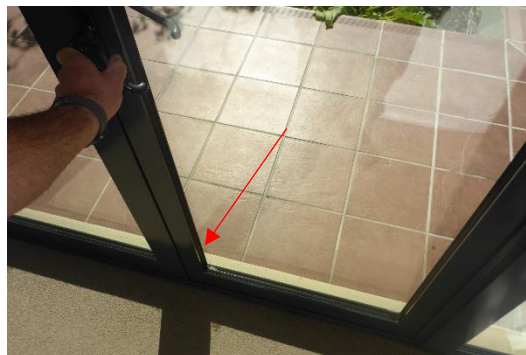
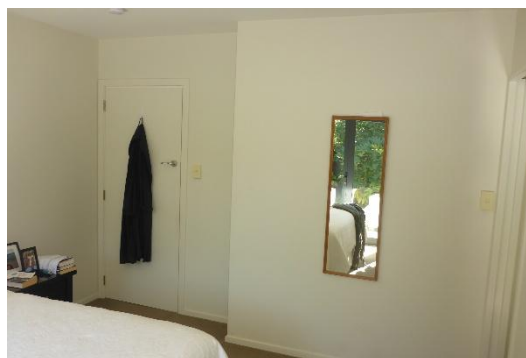
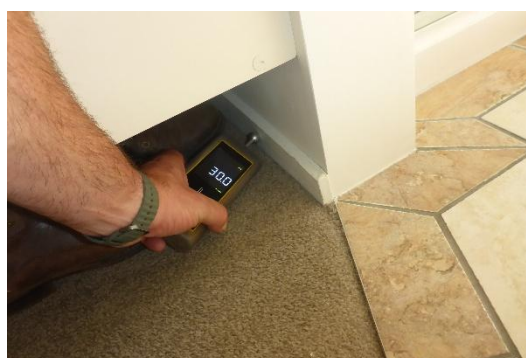
BEDROOM 1 – Next to the main entrance

The French doors are not opening and require adjustments.

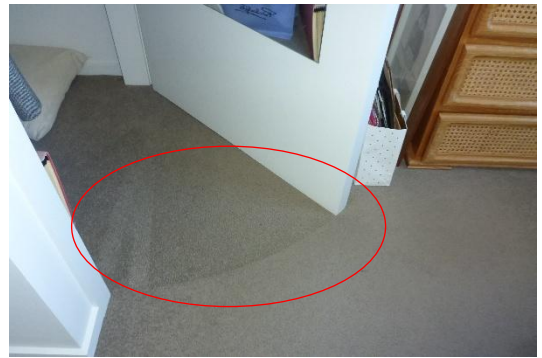
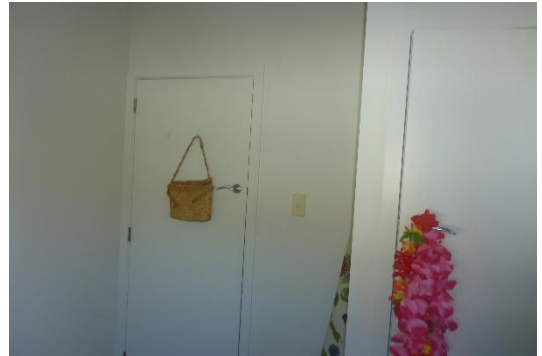
OFFICE – Next to the family room

The wardrobe door rubs heavily on the floor coverings and may require planing back.

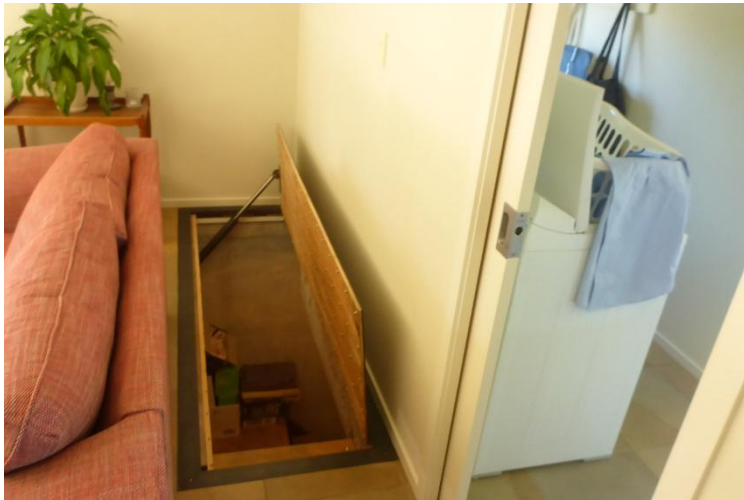
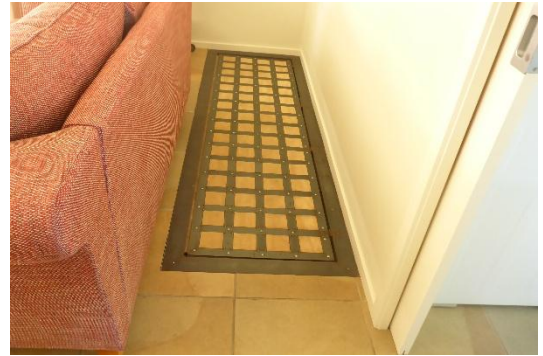
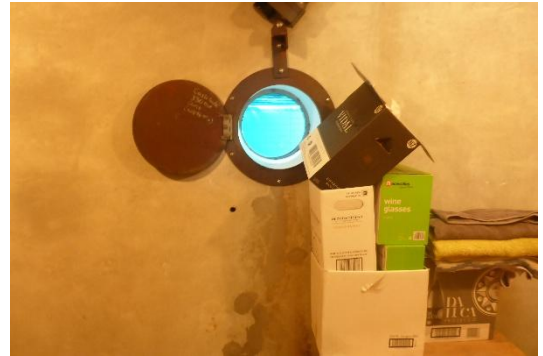
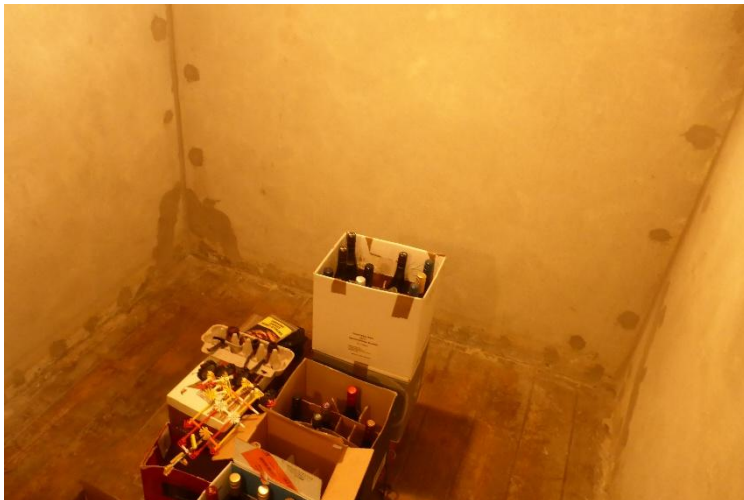
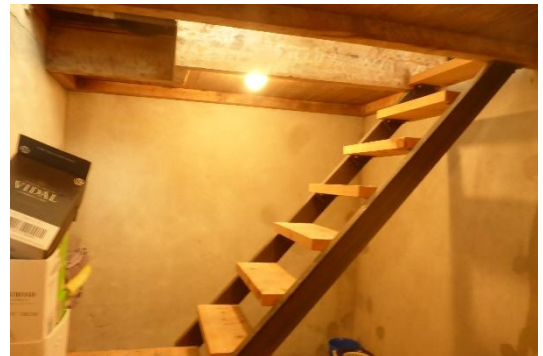
No significant faults identified.

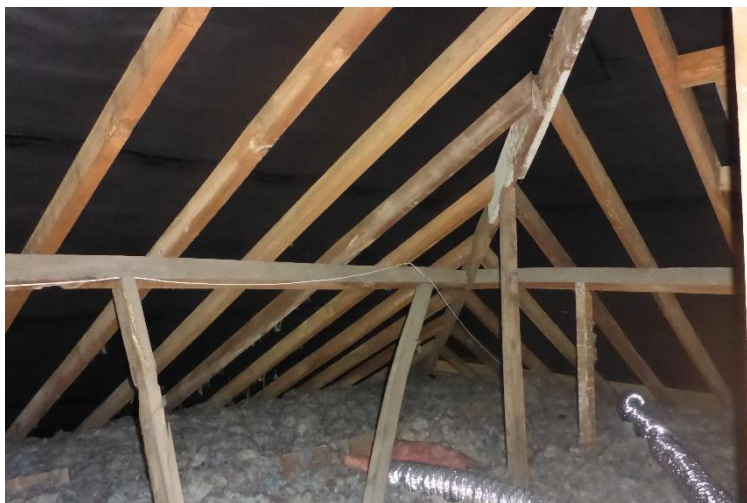
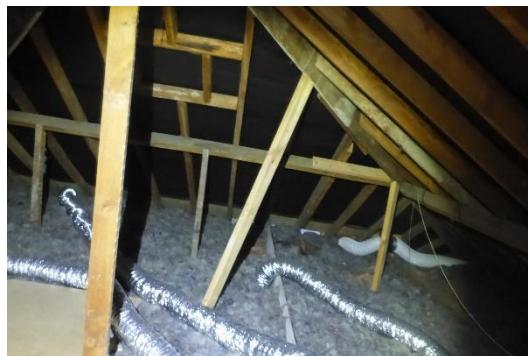
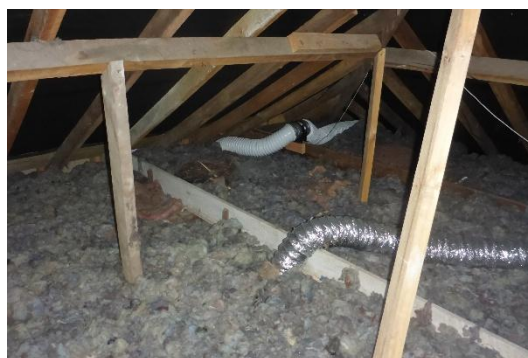
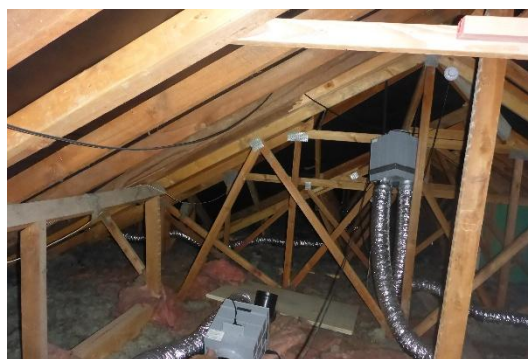
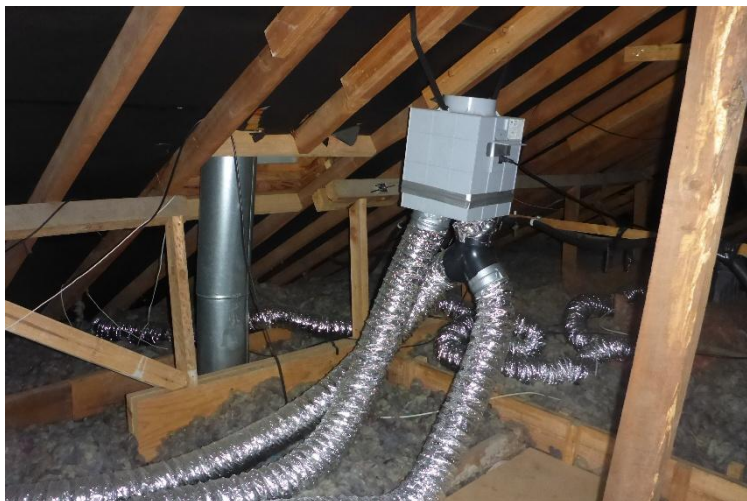
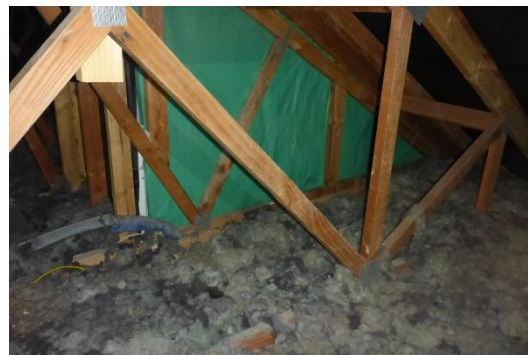
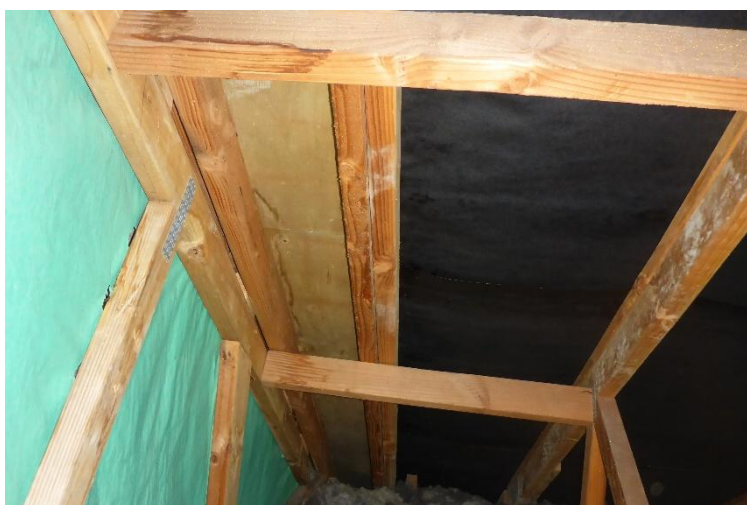
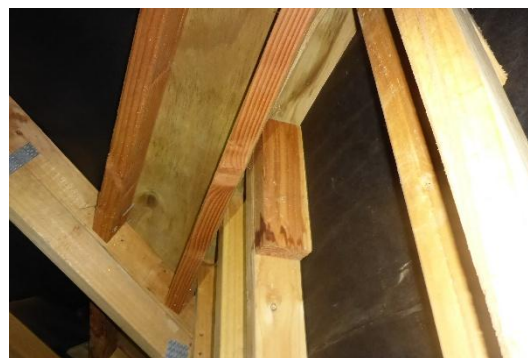
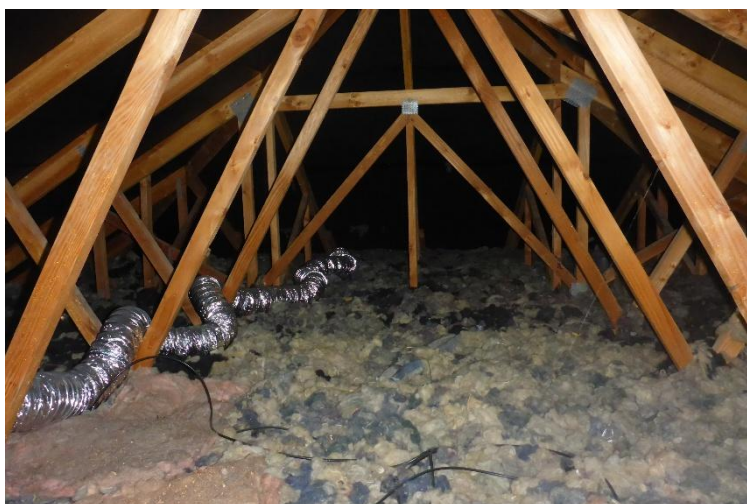
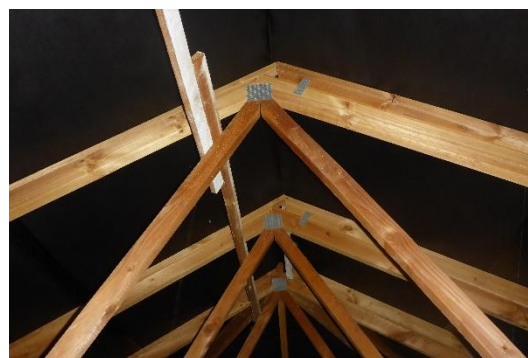
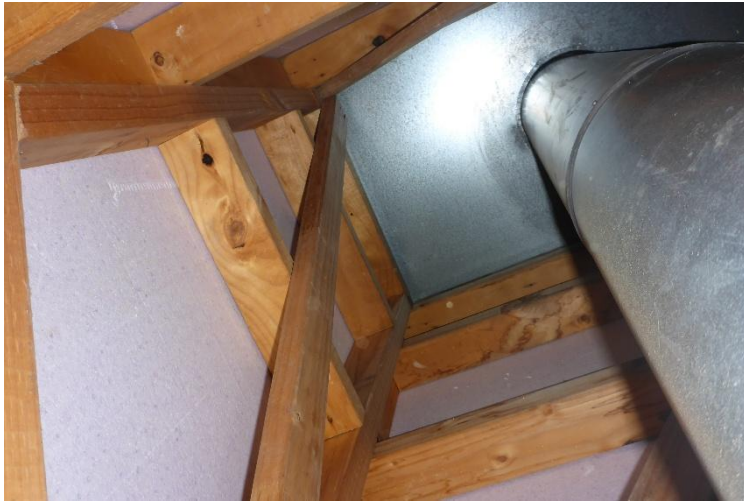
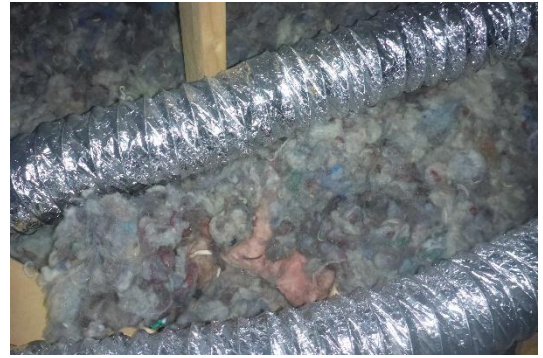
There are signs of historical leaks around the chimney structure. Moisture scans to this area returned normal moisture readings and there were no signs of current leaks.

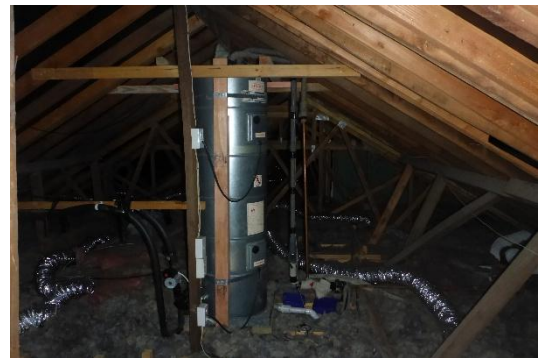
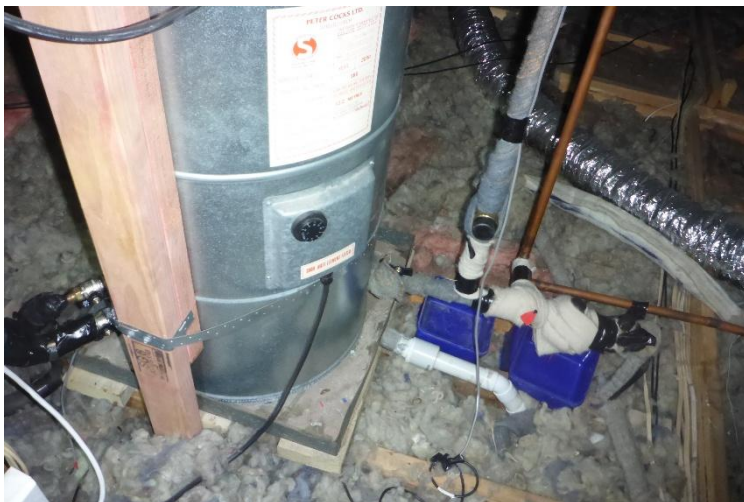
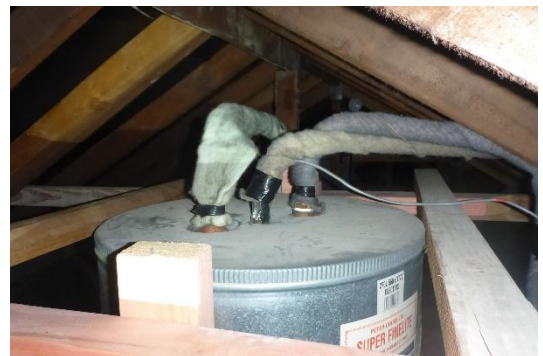
The power to the cylinder was switched on at the time of the inspection and appeared to be operating correctly. No significant faults were identified to the cylinder or pipework.

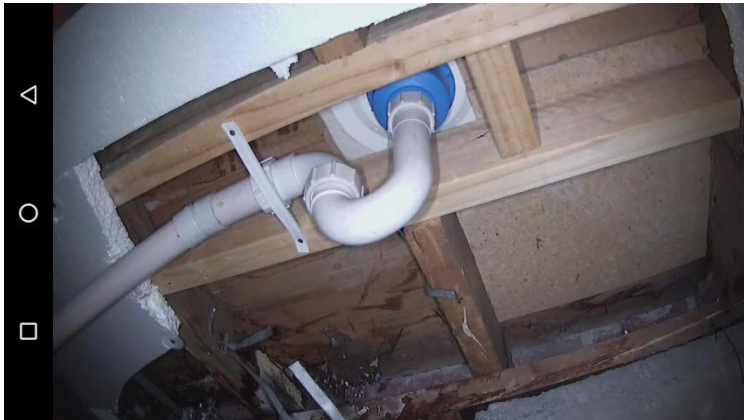
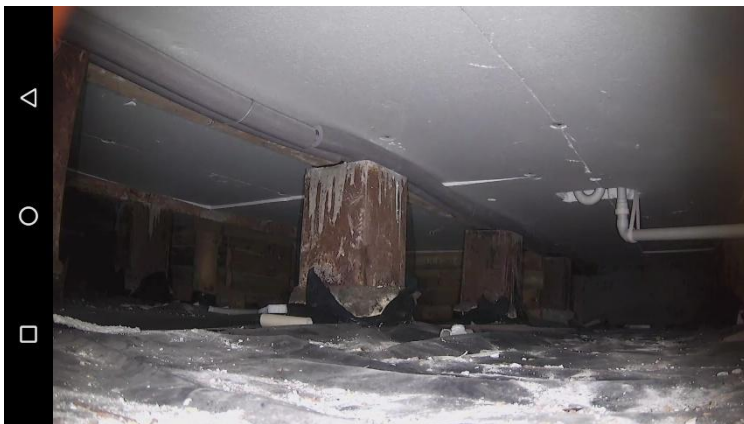
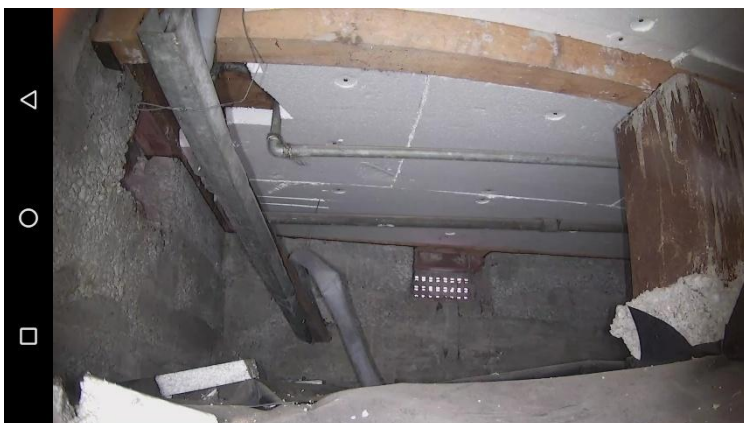
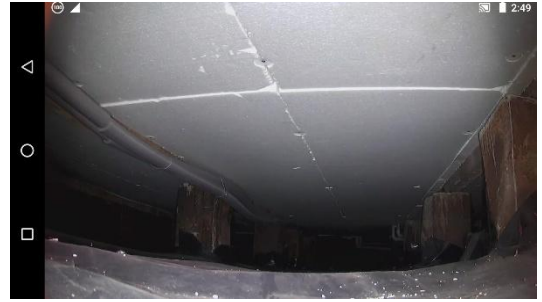
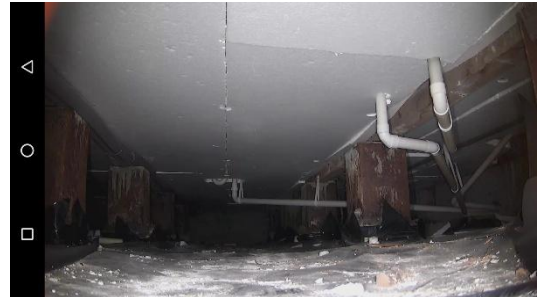
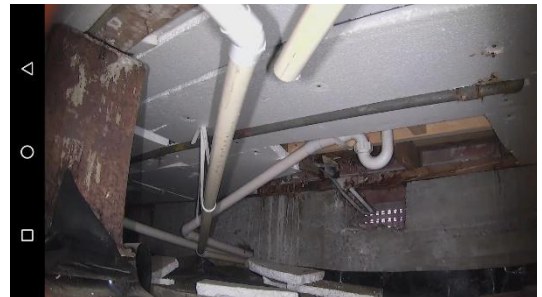
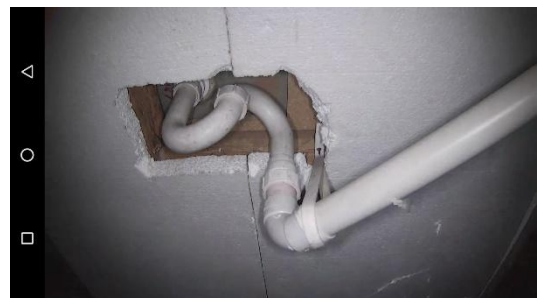
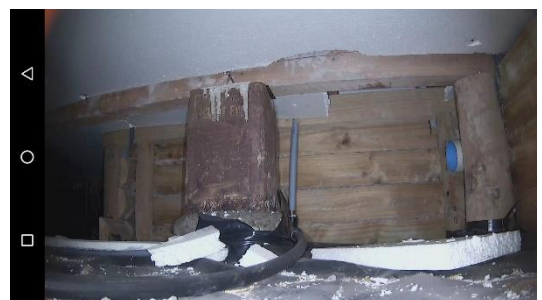
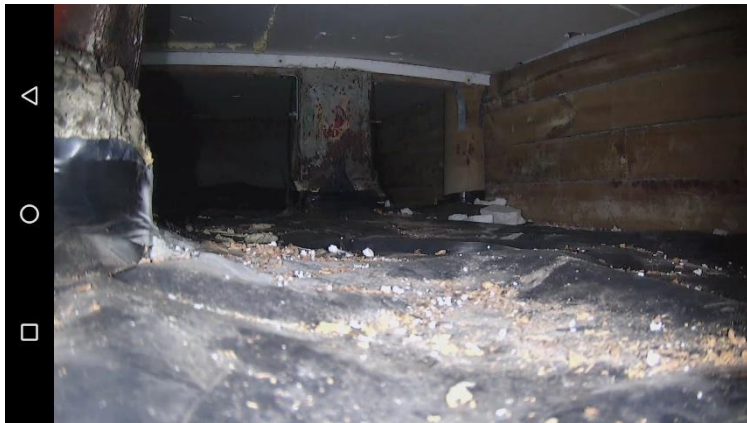
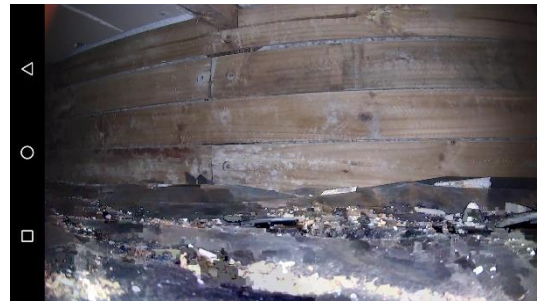
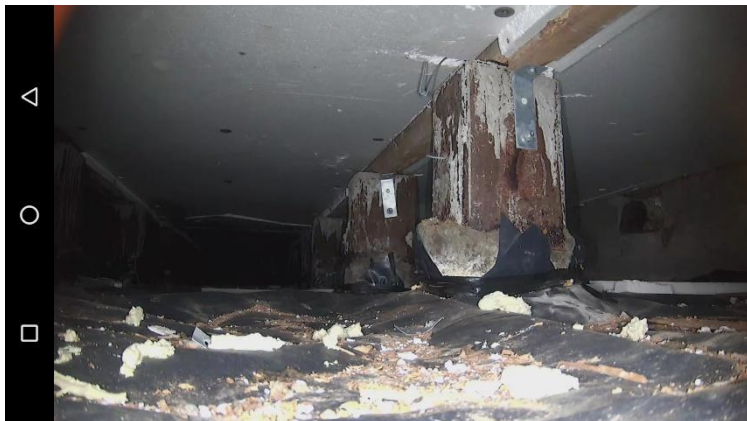
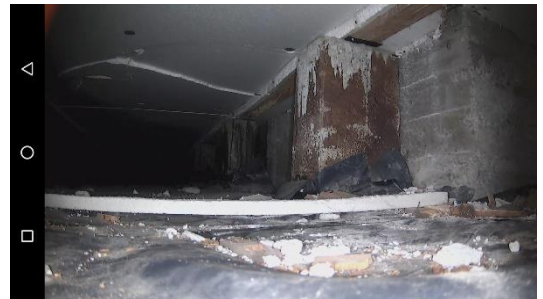
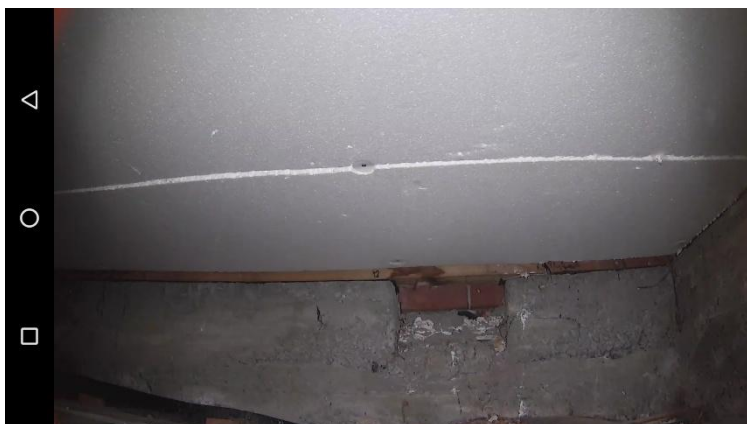
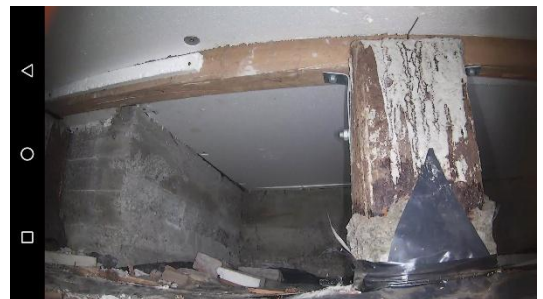
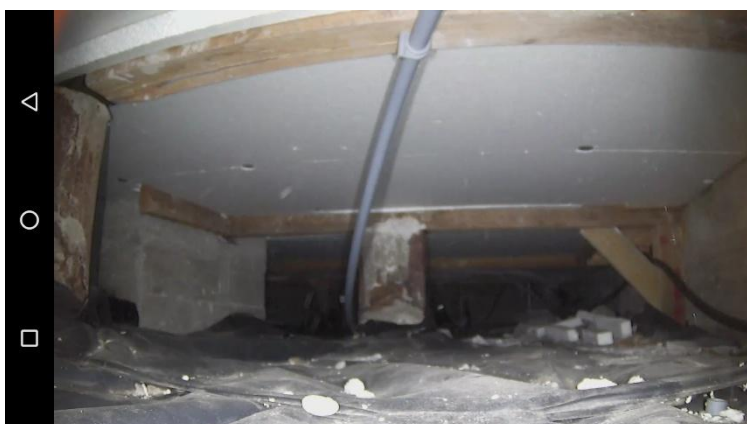
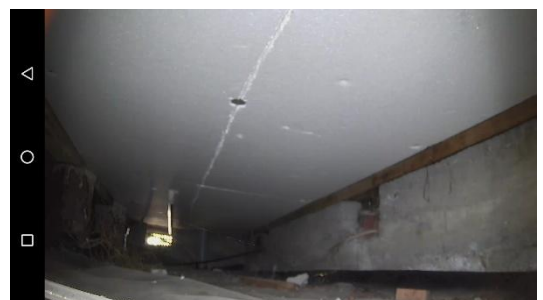
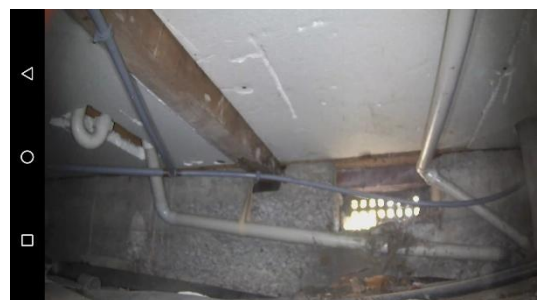
No significant faults identified.

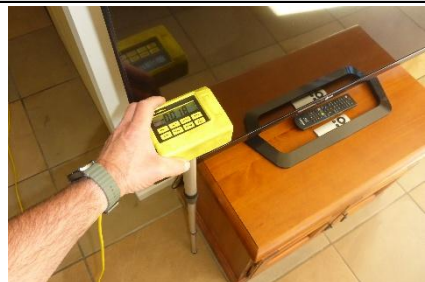
Description	Locations	Photographs
Overall Variation Across Floor (note: some displayed readings may not match the readings provided due to the adjustments made for differing floor covering thicknesses and steps in floor levels)	Lowest reading: Dining room (-18mm)
