BUILDING INSPECTION REPORT

RESIDENTIAL HOUSE INSPECTION

70 Landsdowne Terrace
Christchurch, Canterbury Region 8022

06/08/2025

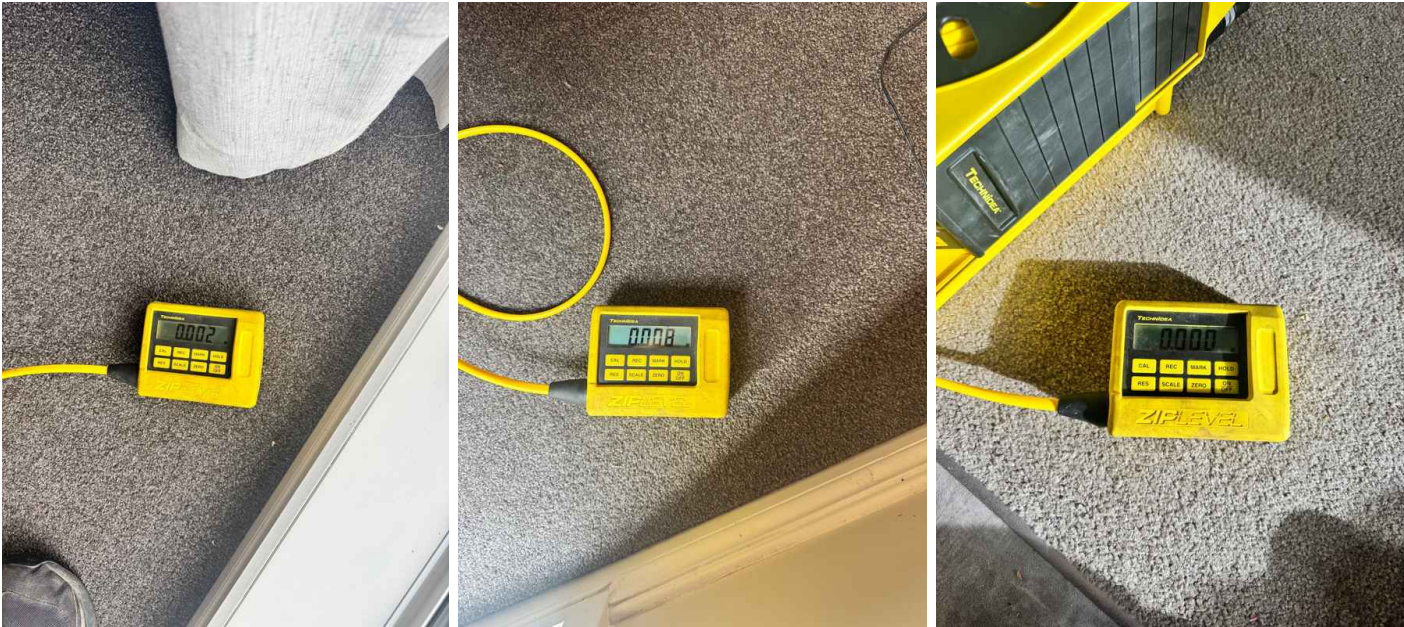
Floor Levels: Floor Levels

Floor levels were randomly checked with a zip level in various locations throughout the dwelling, the dwelling appears to be within the Ministry of Business, Innovation and employment guidelines, variation in level over the floor plan is <50 mm, please note this is not a floor level survey, tolerances in measuring devices and benchmarks may occur.

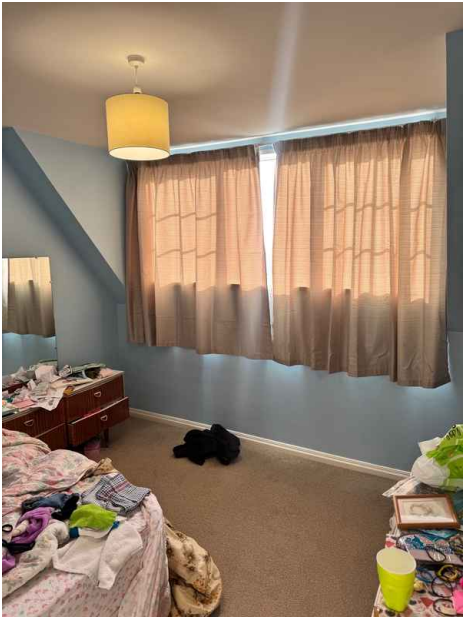
24.1.1 Internal Linings
WEAR & TEAR TO WALLS NOTED
BEDROOM

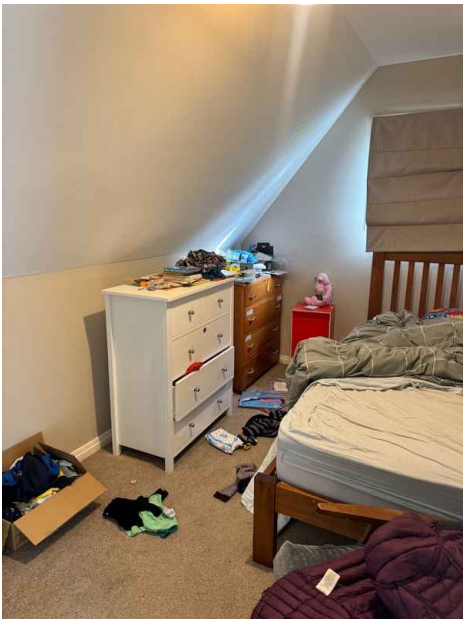
26.4.1 Floor Coverings
WEAR & TEAR NOTED TO THE FLOORING SYSTEM

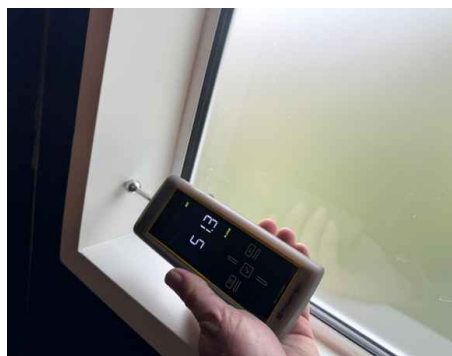
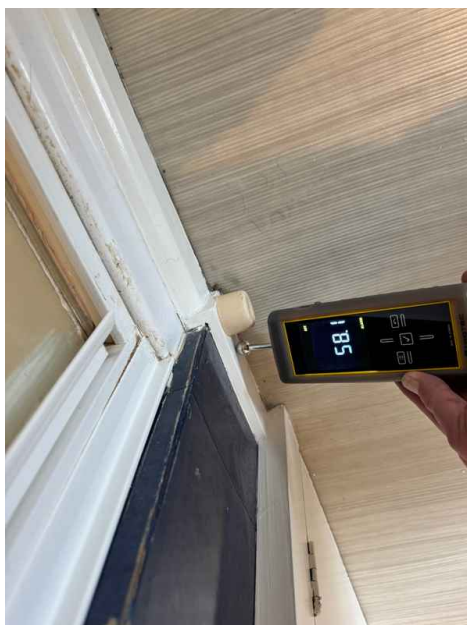
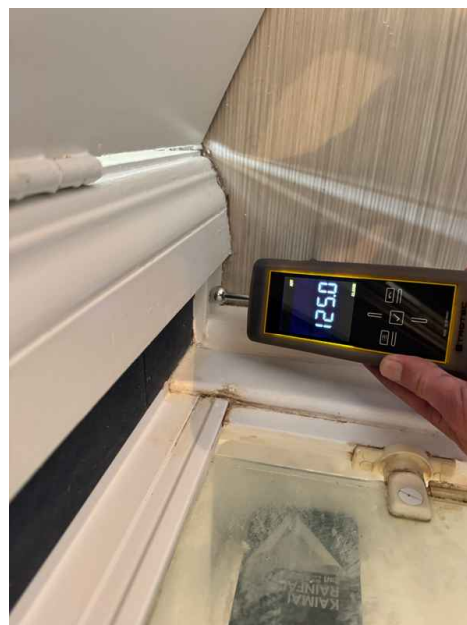
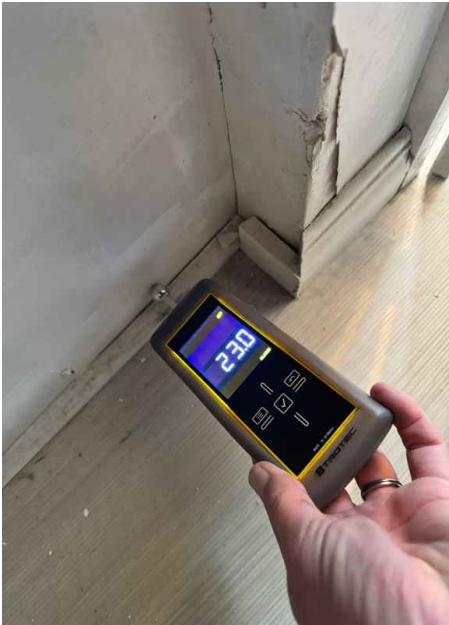
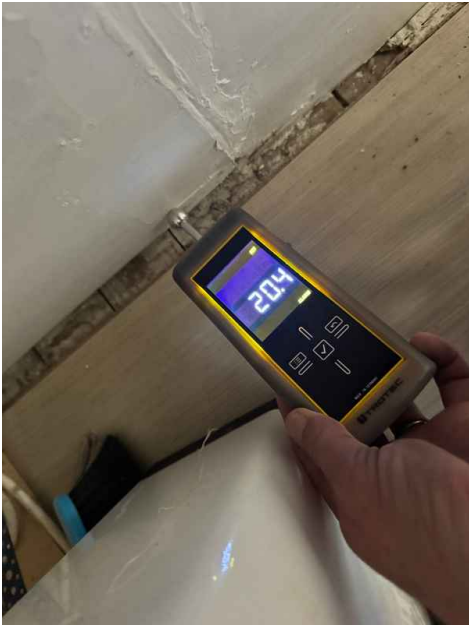
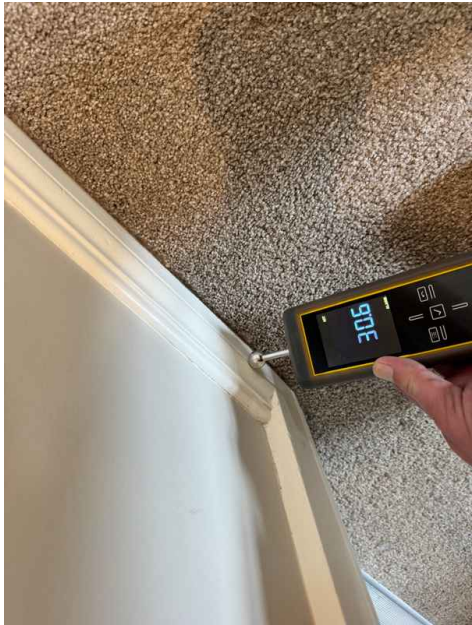
Moisture : Sample Of Readings

Photos are samples of readings taking around the dwelling.

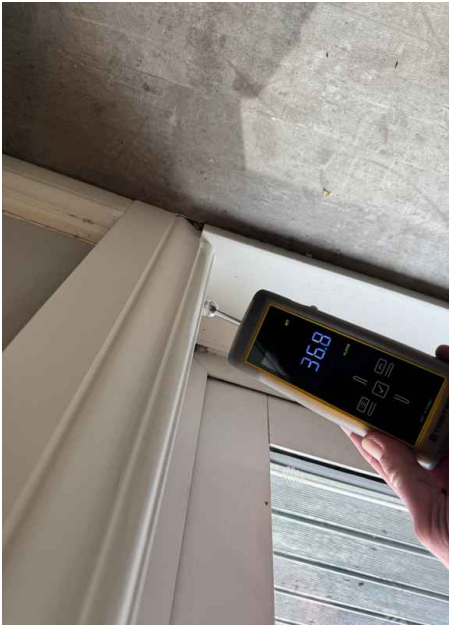
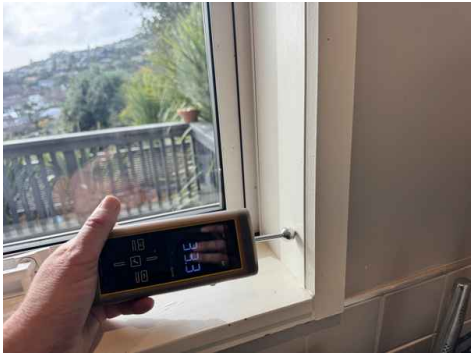
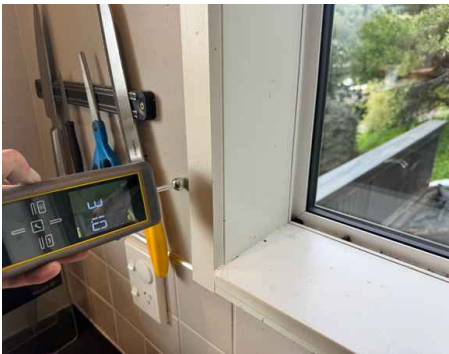
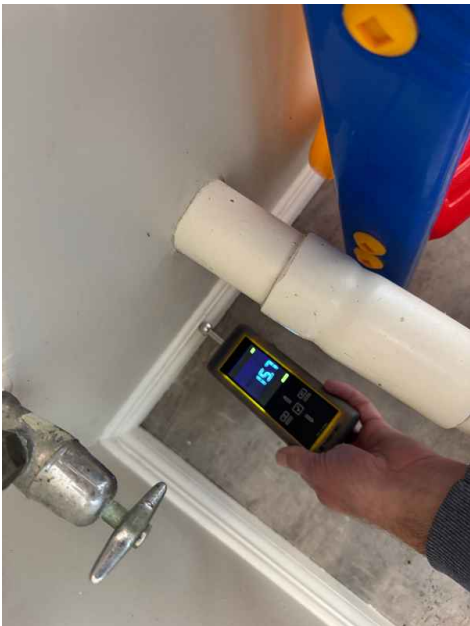
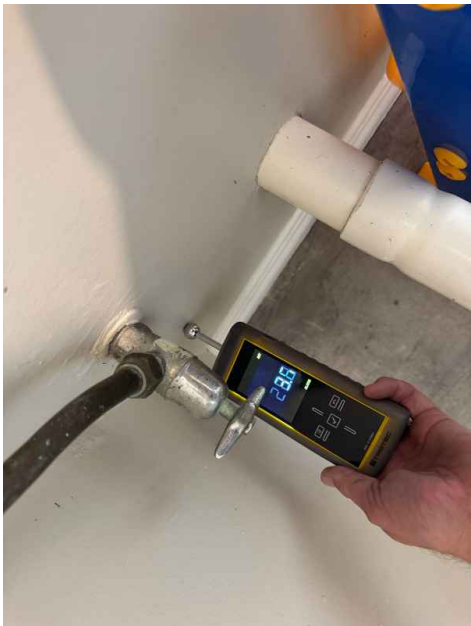
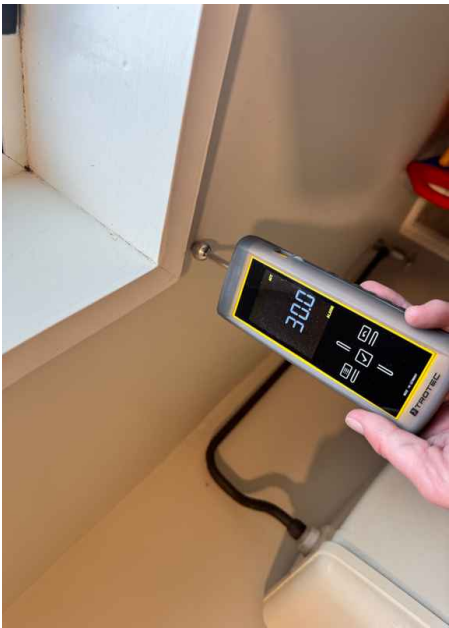
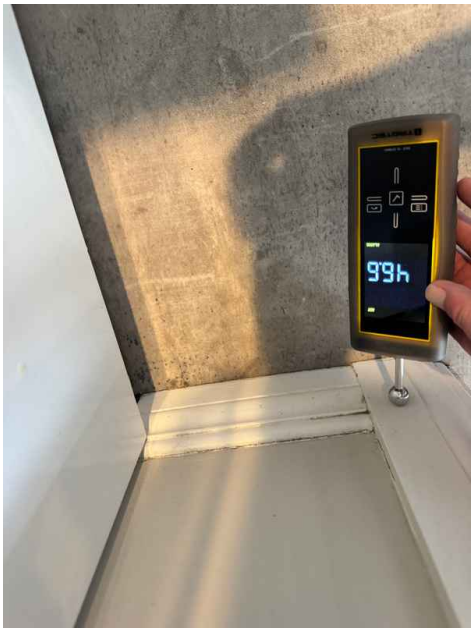
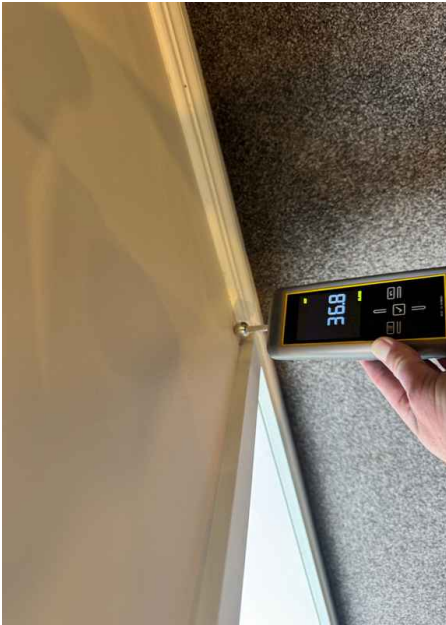
Moisture content readings were taken throughout the dwelling internally at well-known areas for moisture ingress to occur. In this particular dwelling, moisture ingress is only likely to occur in certain areas. Specifically, these are; apron flashings not correctly let out from the cladding; the intersection of timber fascia, boards and cladding which have not been correctly sealed; and, any cracking in the cladding above windows and particularly around the sill areas where surface water is easily drawn in over a period of time if the joinery is not kept well sealed to the cladding.

When moisture ingress occurs in these areas, the moisture is generally detectable above and below the windows and the bottom plates directly below windows; internally directly behind apron flashings and fascia/cladding intersections.

Moisture content readings were taken throughout the dwelling at areas potentially at risk using a Tro Tec T660 or Gann capacitive non-invasive moisture meter.

Generally, moisture content readings of framing that read between 20 and 60 are considered to be dry, in that, timber framing will always retain an element of moisture, even after it has been kiln dried and generally it is accepted that internal timber framing may have the linings fixed with a moisture content reading of 50 or less. Further to this, moisture content readings tend to be 2-3% higher than normal during high humidity and colder air temperatures.
