STATEMENT OF PASSING OVER INFORMATION

Reference
Repairs to deck as per
building inspection dated
may 2025

The purpose of the inspection is to identify major current deficiencies that are visually identifiable at the time of the inspection. The report shall include: grounds, structure, exterior, roofs, plumbing, electrical, interior, and insulation/ventilation. The property report does not include in depth testing of services such as, underfloor heating, specific and specialized heating systems, heat pumps, water pumps, functionality of any solar power source, swimming pool heating or alike.

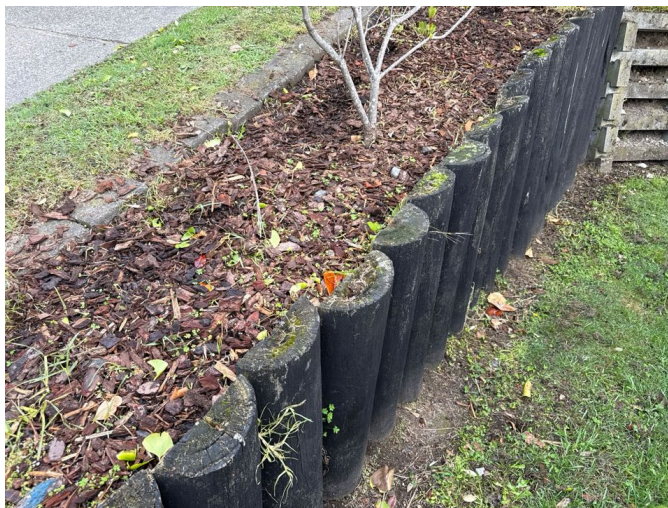
Some of the timber half round retaining walls are showing signs of deterioration which will need to be monitored periodically. Consider the need to eventually replace the aging sections of retaining. Still need effective.

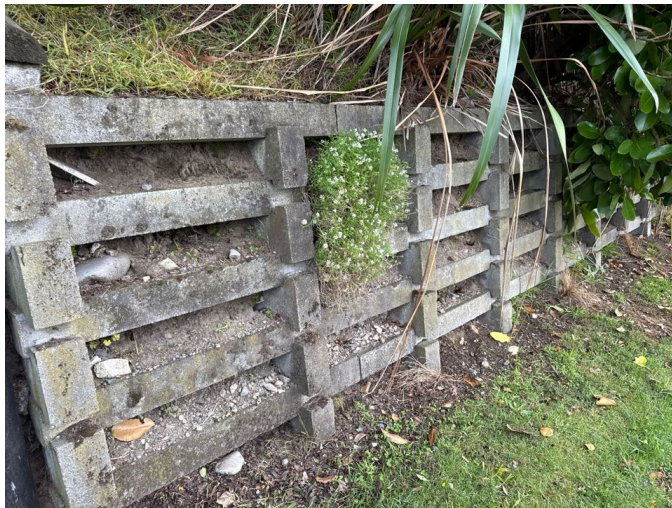
Concrete crib walls are showing no evidence of movement or deterioration

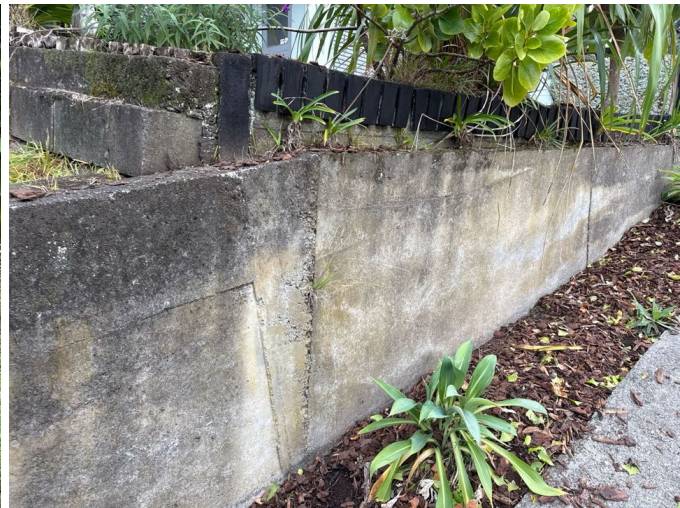
Concrete walls are showing no evidence of movement or deterioration

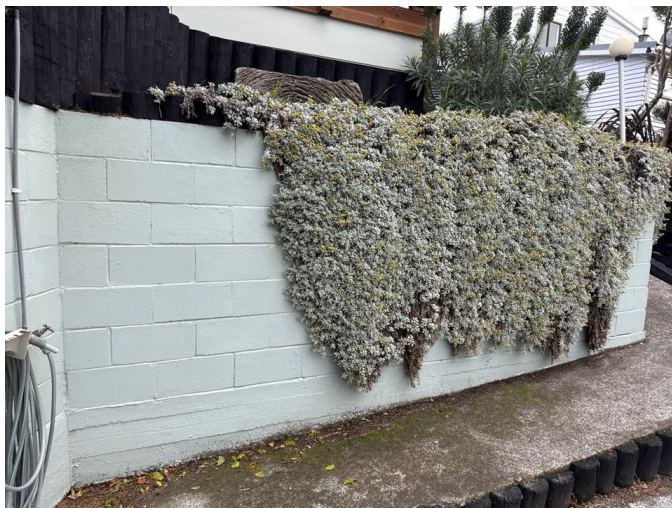
Concrete block walls are showing no evidence of movement or deterioration

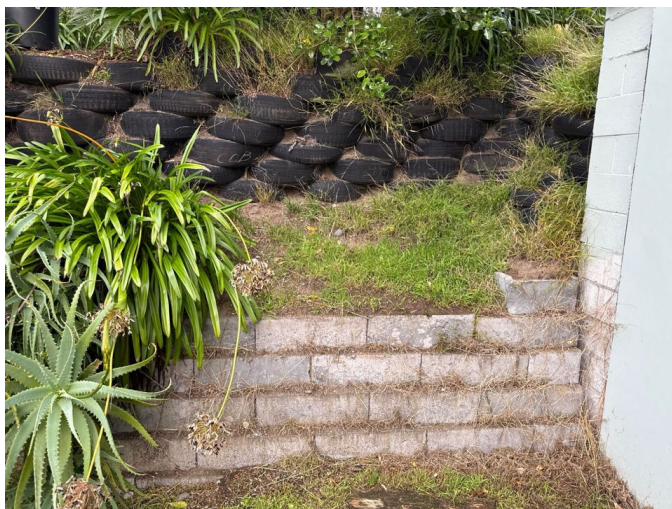
Earth filled concrete block and tyre retaining walls are still effective

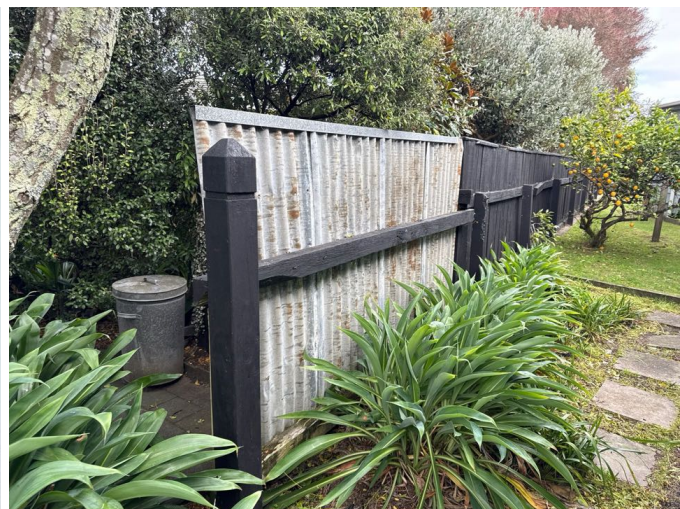
The section is mostly fenced. The fencing is secure and in an average condition for the age

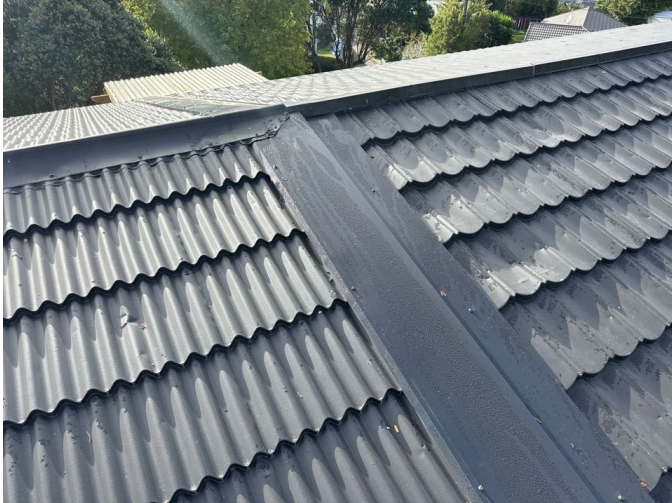
A once or twice yearly wash will help maintain the roofs surface condition and prevent premature deterioration

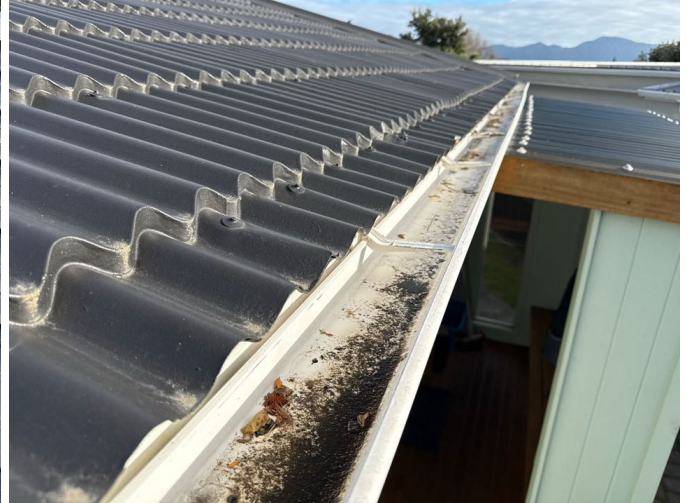
The spouting is in good condition and is clear. The effectiveness of the spouting will need to be checked during rainy periods. Due to the dry conditions that were evident on the day of our inspection we cannot comment on any leaks that maybe evident to the spouting or down pipes.

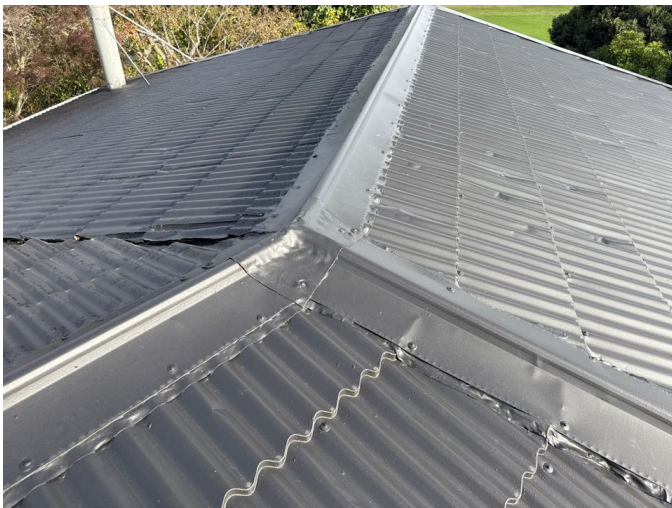
The roof flashings appear to be secure, intact and are effective. No sign of failure could be found beneath where accessible to view.

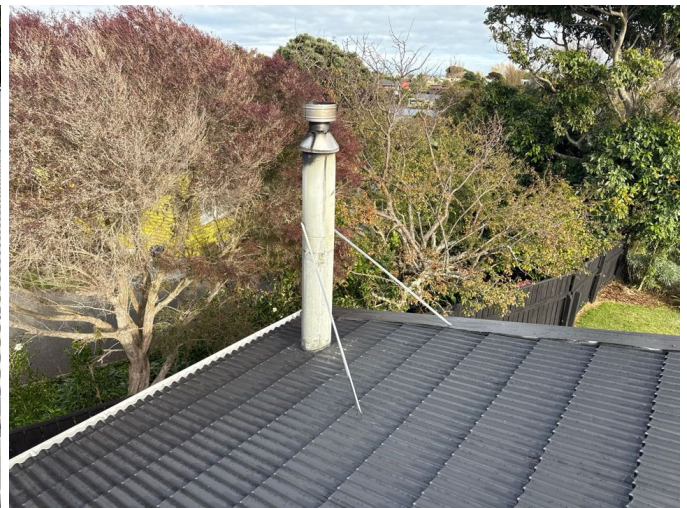
The steel flue is in a reasonable condition, it is effectively flashed. Bracing to the flue are secure.

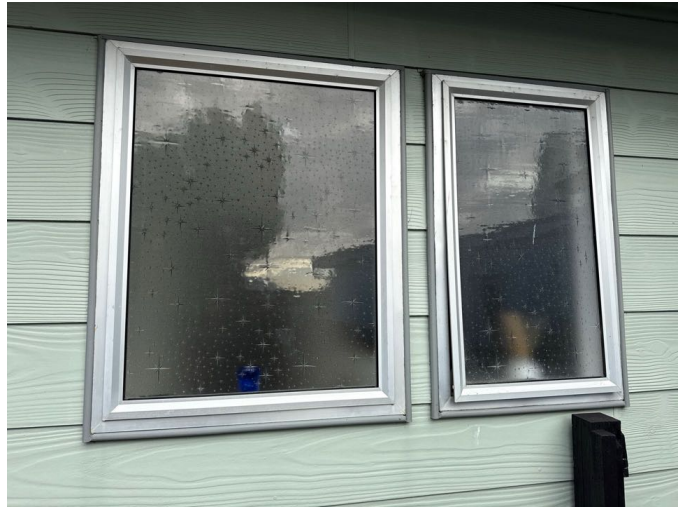
The typical single glazed aluminium window detail consists of a head flashing, timber scribes and sill.

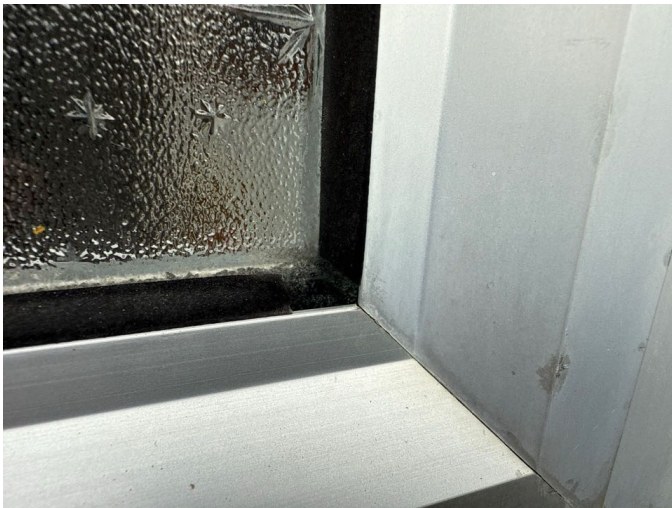
Some of the joinery seals have shrunk which is common for their age. The shrinking seals should not be a water tightness risk as long as the internal seal remains intact and effective. All internal moisture readings taken beneath the windows and doors were within the normal range.

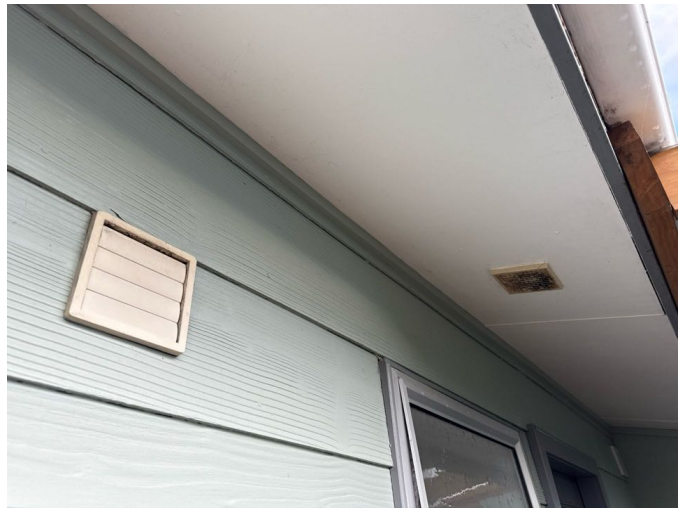
Extraction vents exit through the soffits and walls

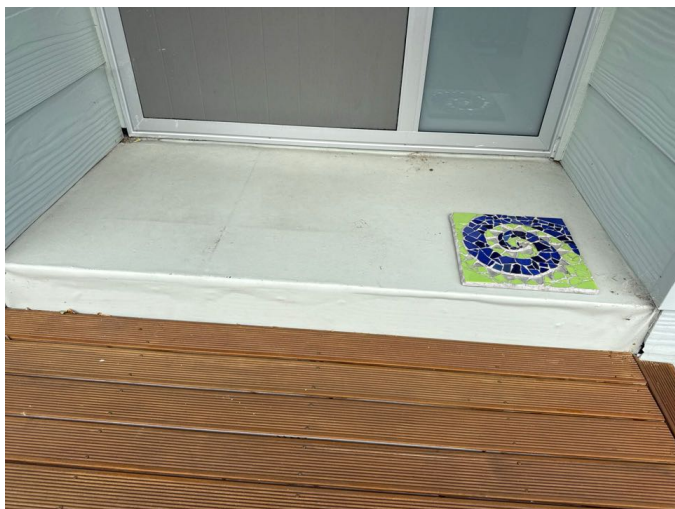
The waterproof membrane lined entrance is intact. If there are any concerns with the membrane in the future, a quality membrane installer should be engaged for remediation.

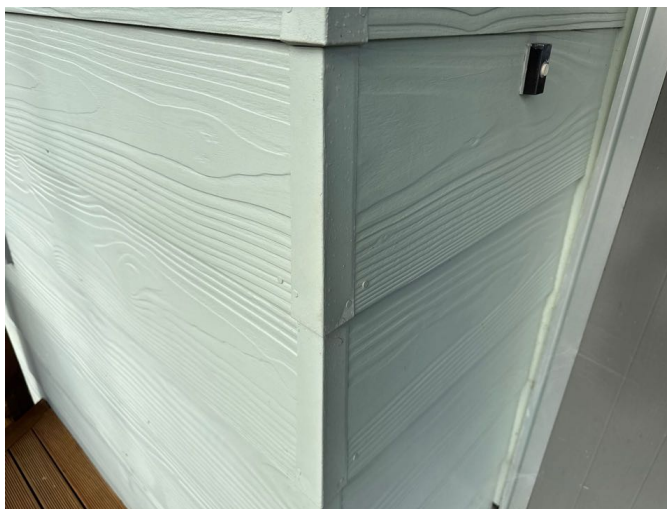
Corner soaker detail to the external weatherboard junctions. These help protect the corners from moisture ingress and deterioration.

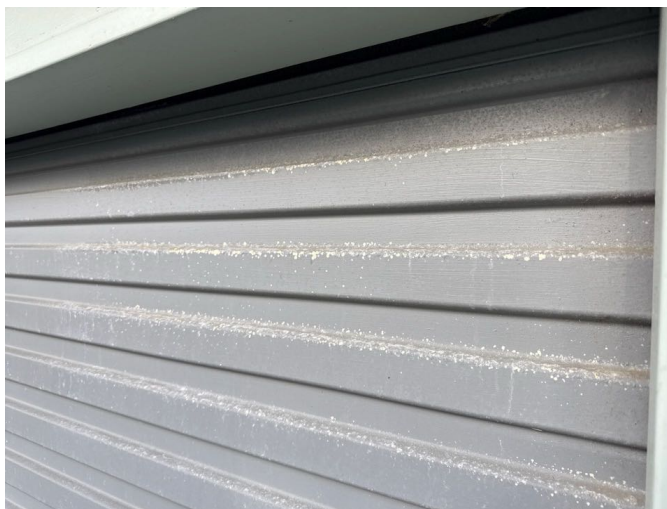
Early stage corrosion to the garage door. A thorough prep including rust treatment is required prior to a paint upgrade.

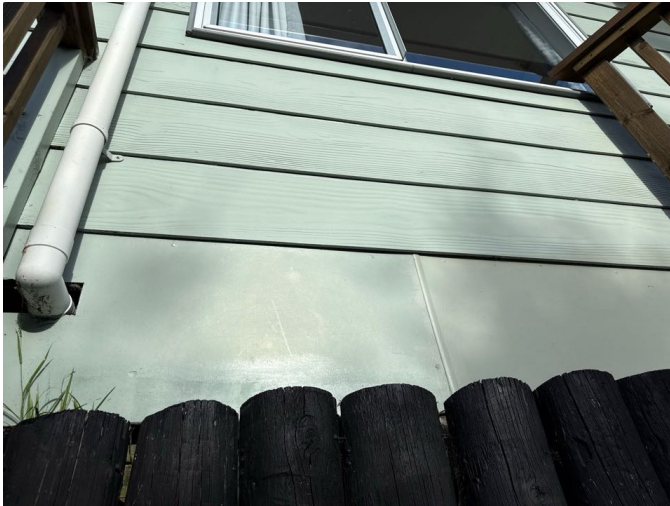
Due to the age of the home, some of the materials installed may contain elements of Asbestos. Please note this is safe in an inert state and must be kept well sealed. If any work is to be completed in areas that likely contain Asbestos then there are certain health and safety precautions that should be followed.

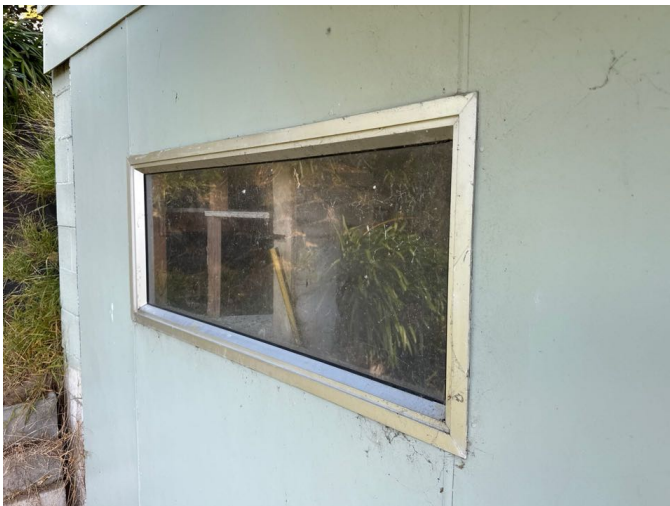
No head flashing installed above age garage windows. To prevent water ingress, head flashings channel water away from the cladding to the front face of the window. The head must be kept well sealed to prevent water entering. Ideally head flashings should be installed.

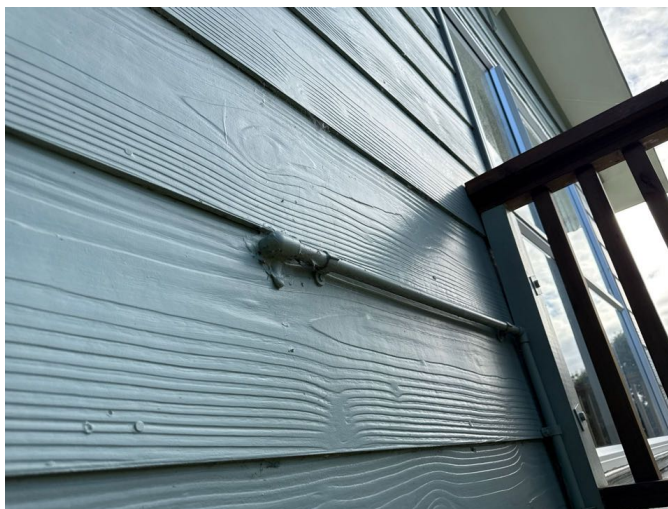
Cladding penetrations in general are a weather tightness risk area. Penetrations such as taps, screw fixings, gas or water pipes etc. No evidence of failure could be found.

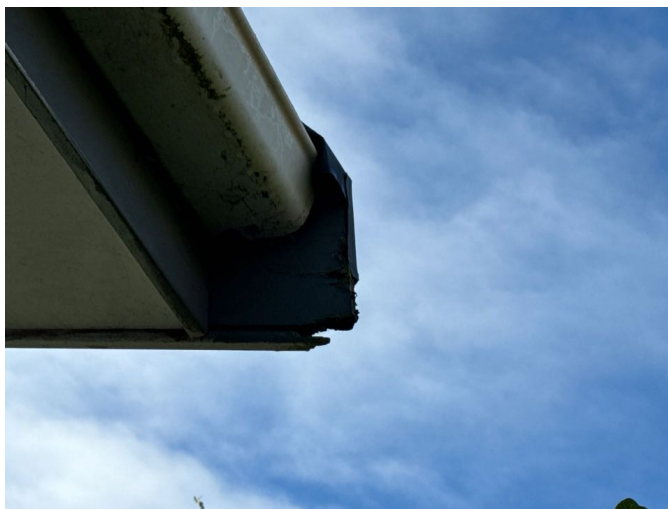
Damage to the base of the barge board will need to be addressed prior to the next paint upgrade

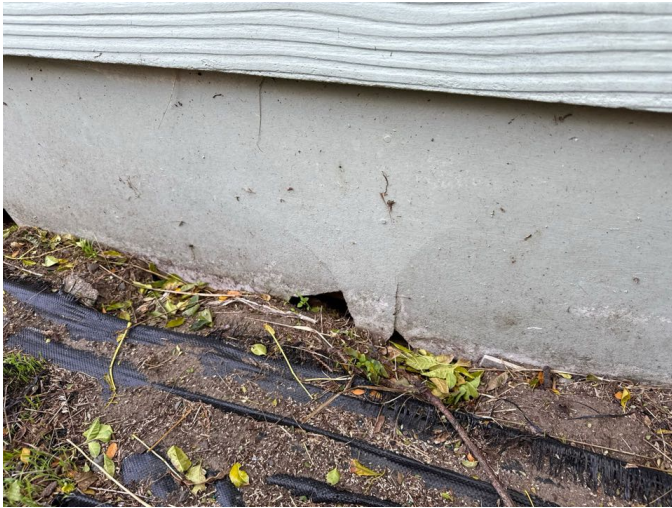
Damage to the base cladding is not a significant concern

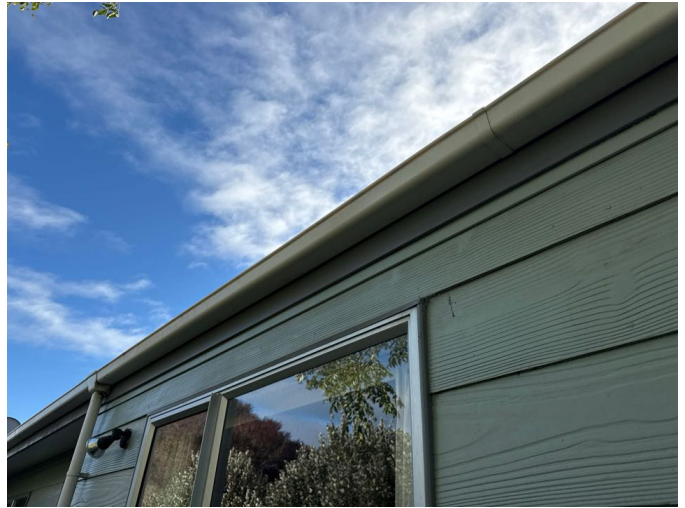
Roof sections where there are no soffits are a higher weather tightness risk. Soffits provide more weather protection to the walls. These areas must be kept in good condition and sealed well to prevent the possibility of moisture ingress. Any failure here has the potential to spill over the top of the wall to the inside of the home. Note there are no current issues here, this is something to watch out for over time.

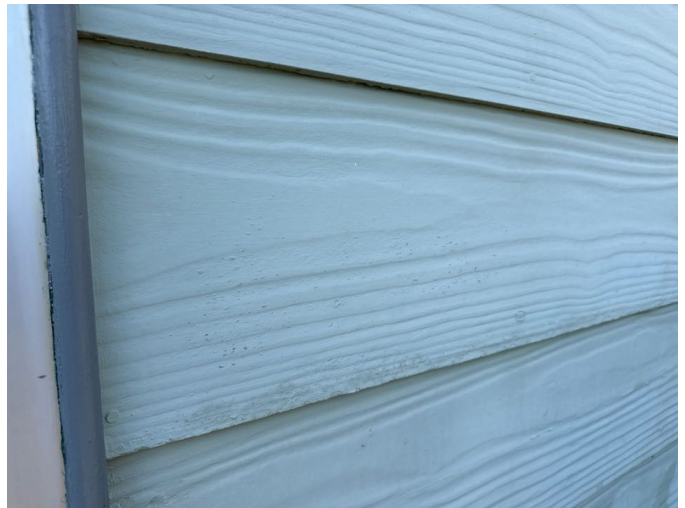
Early stage paint deterioration to the weatherboards

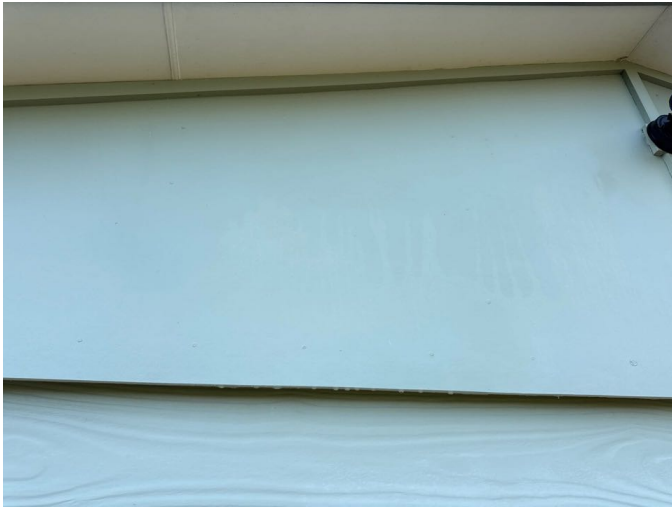
The paint quality to the fibre cement sheets is average/good

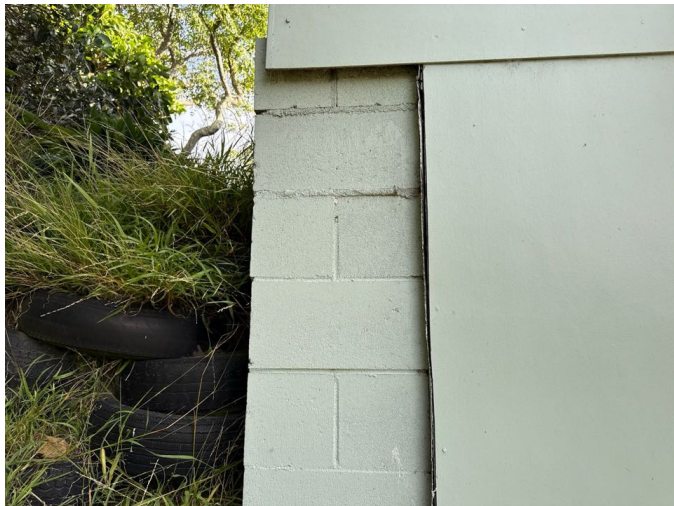
The concrete block foundation walls are in a typical condition for the age. No sign of cracking or significant stress.

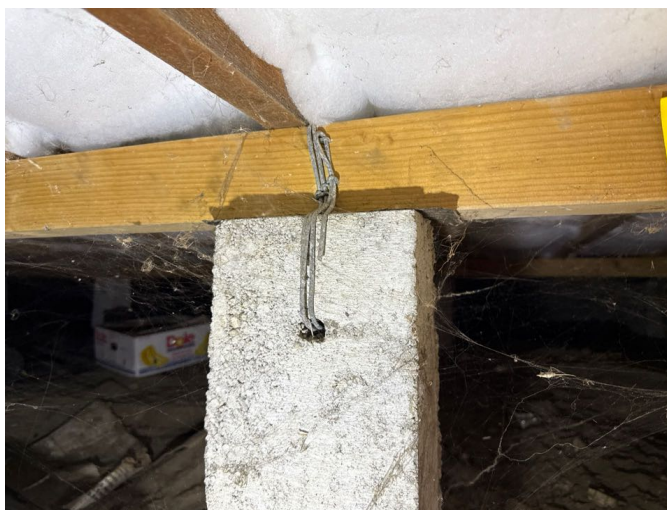
The concrete piles are solid at the time of inspection. Galvanised wire connects the bearers to the piles and anchors the structure to the ground.

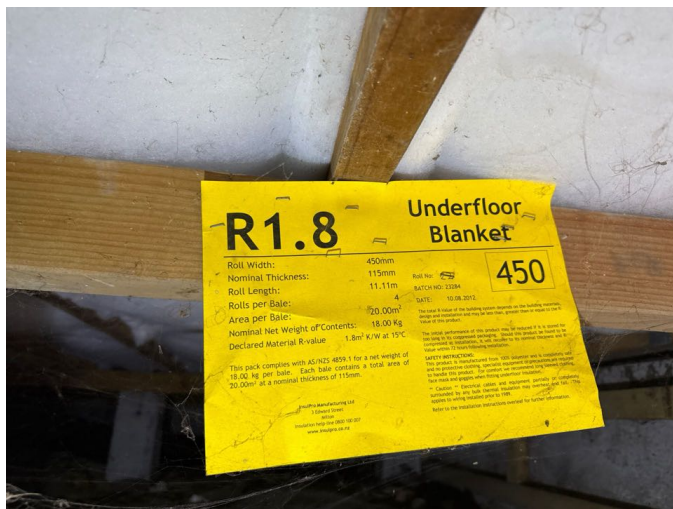
Polyester insulation has been installed throughout the sub floor and to a good standard. The thermal resistance rating or R-Value is the measure used most commonly in the building and construction industry to determine a material's ability to resist the transfer of heat. The higher the R-Value the better thermal resistance the product will provide.

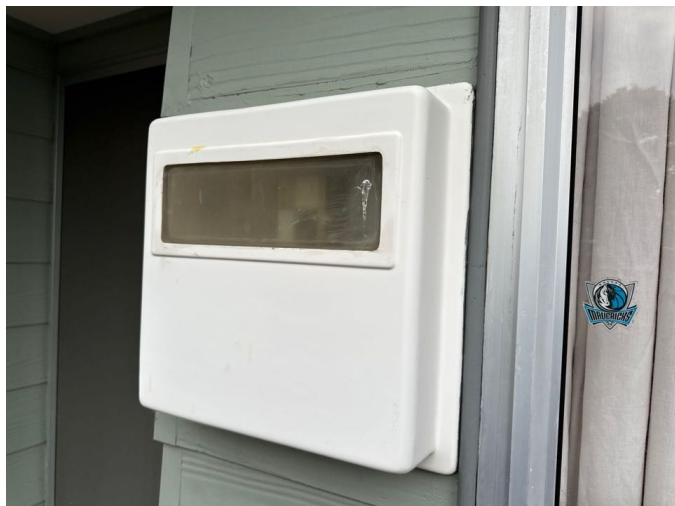
The meter board appears to be sufficiently sealed at the time of inspection. Smart meter installed, no obvious concerns sighted.

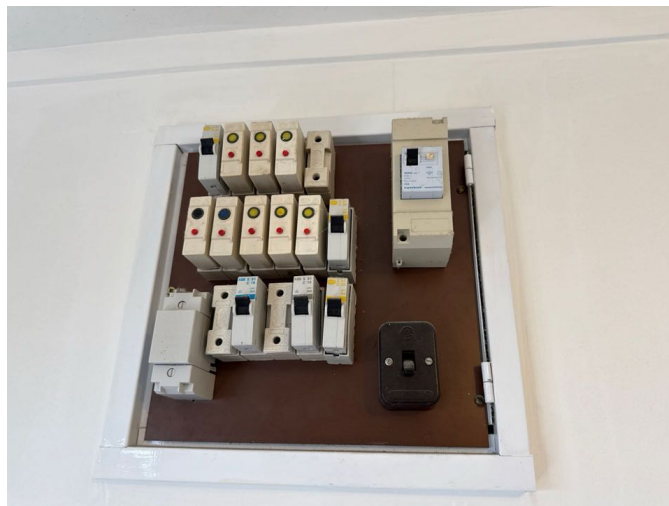
A visual inspection of the electrical system did not show any evidence of electrical overload to switches or power points. Cover plate(s) were not removed and the wiring behind the distribution board not inspected. This is beyond our scope of expertise. Please note. The assessor is not a registered electrician; no electrical safety tests or electrical component tests were undertaken. Power points, lights and switch testing therefore does not form part of this report.

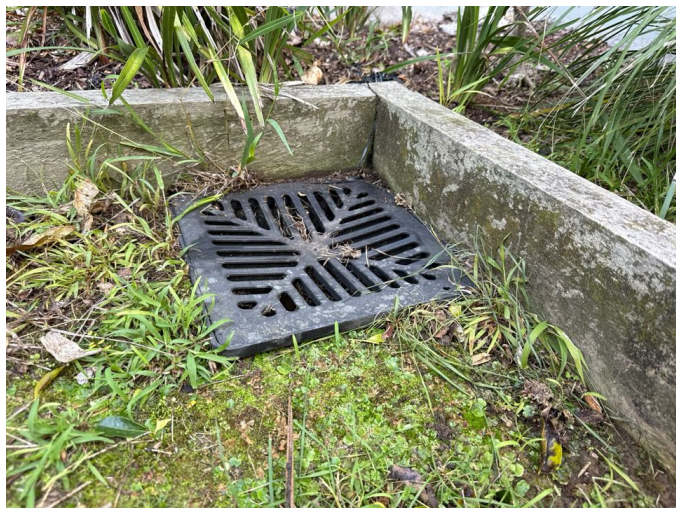
Drainage sump to the southwest side. No sign of current blockages or overflows. The effectiveness of the drains will need to be monitored over time.

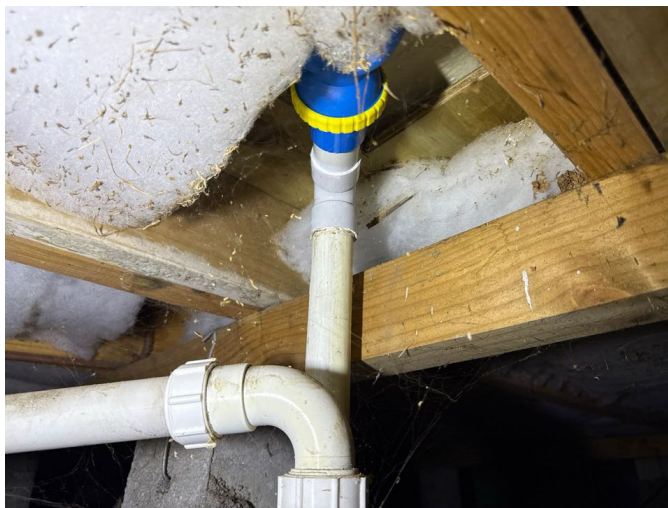
No sign of current leaks under the plumbed areas

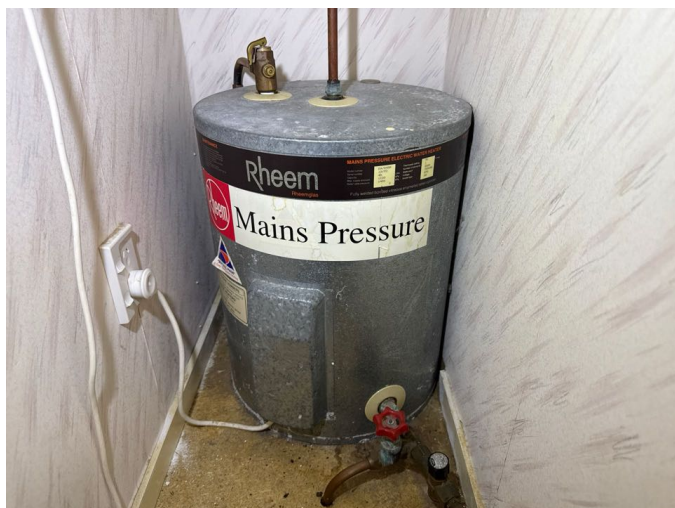
Bedroom 2 cupboard.
Rheem 45L Mains Pressure Electric water heater.
Currently switched off and will need to be tested once engaged.

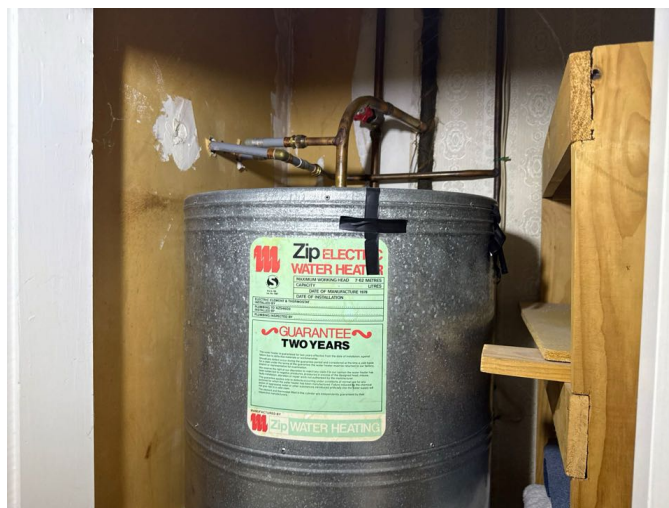
Hallway cupboard.
Zip 180L Low Pressure Electric Hot Water Cylinder.
Seismic restraints should be installed to prevent the risk of excessive movement in a reasonably earthquake. These must be installed within 100mm of the top and bottom.

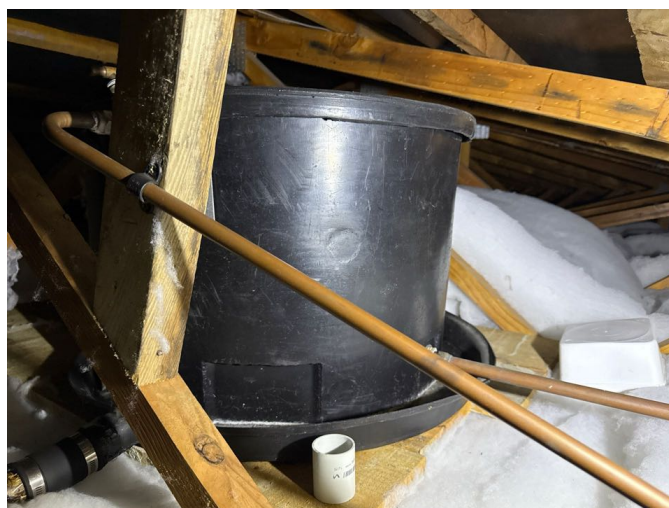
No concerns with the plastic header tank, water feeds, safe tray or drainage outlet at the time of inspection

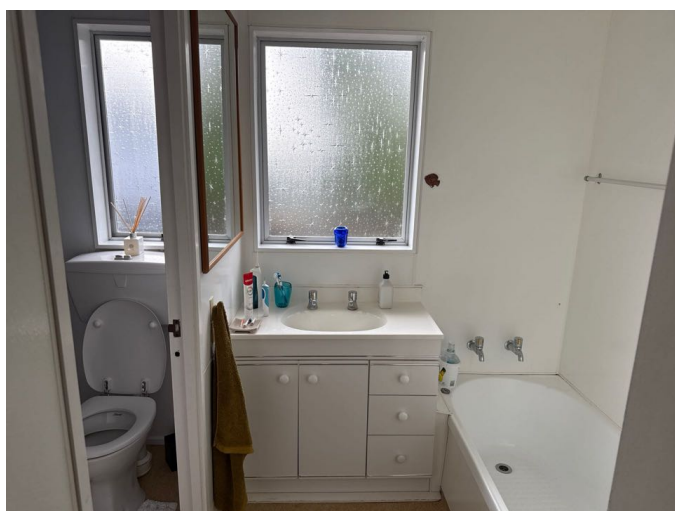
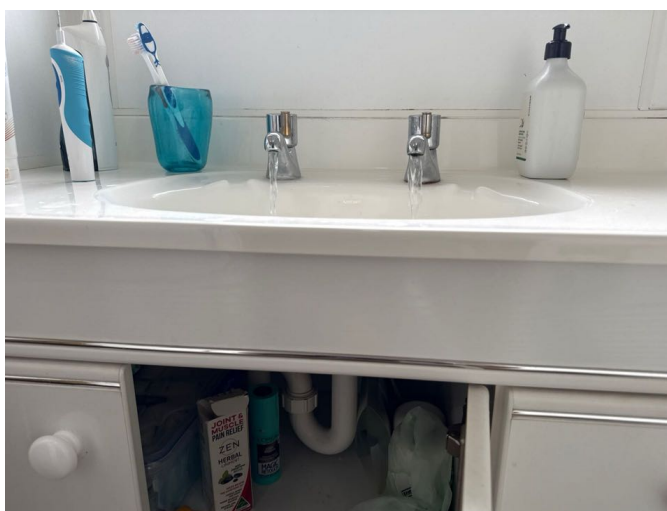
The rear edge of the vanity is well sealed. The taps are functioning well. No concerns with the water feeds or waste under the vanity.

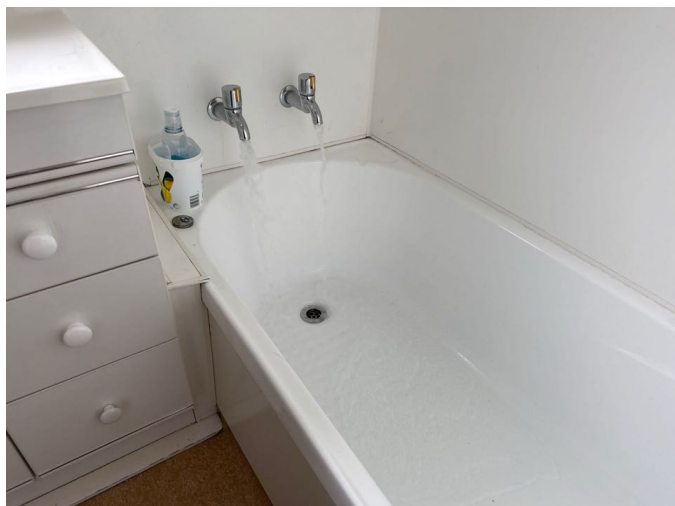
The perimeter of the bath is well sealed. The taps are functioning well.

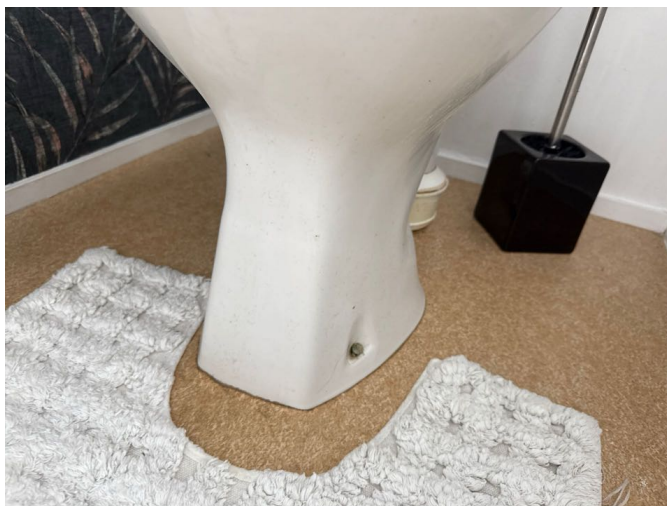
The base of the toilet is well sealed and secure. The toilet is in a functioning condition.

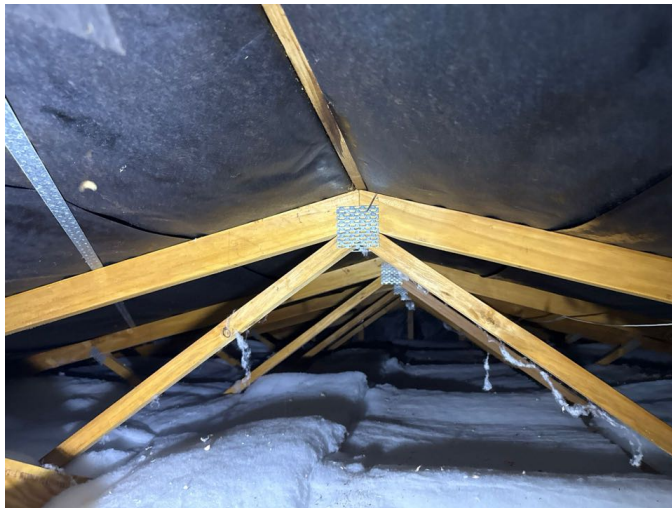
I could see no evidence of current or past moisture ingress issues under the roof framing or linings (where accessible) at the time of inspection. The roof framing structure appears to be solid.

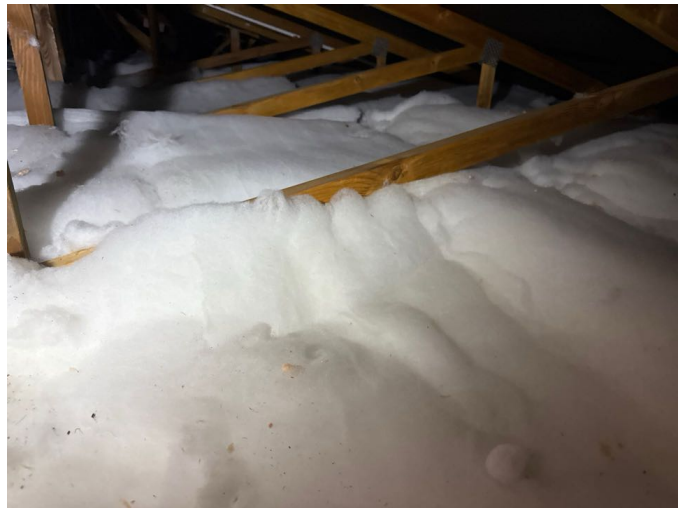
The polyester insulation has been installed to a good standard.

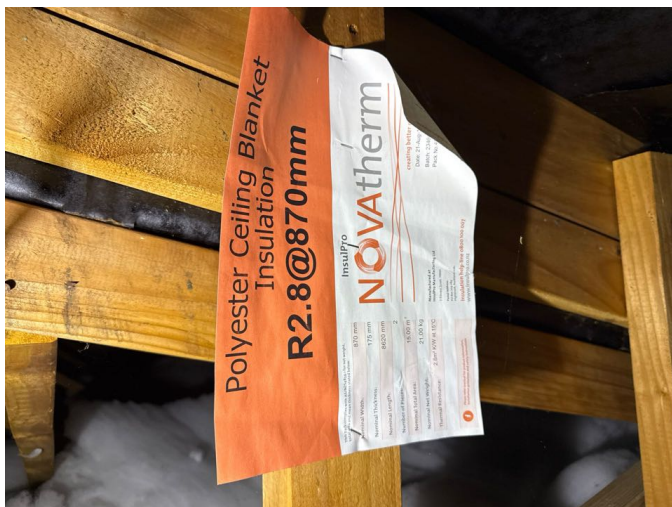
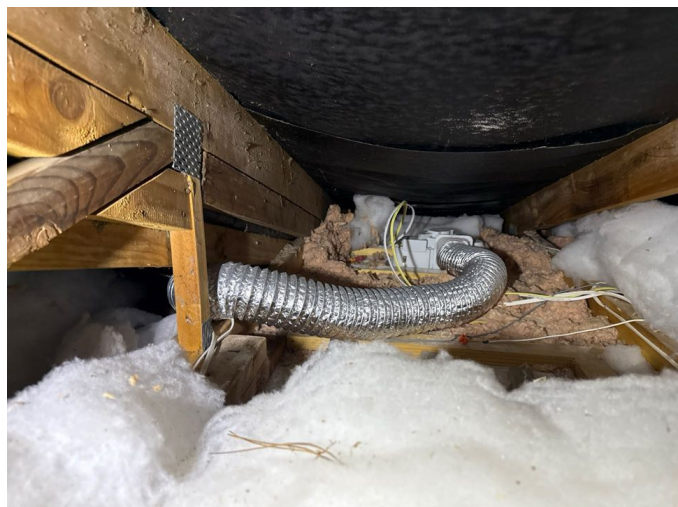
Extraction units vent to the exterior

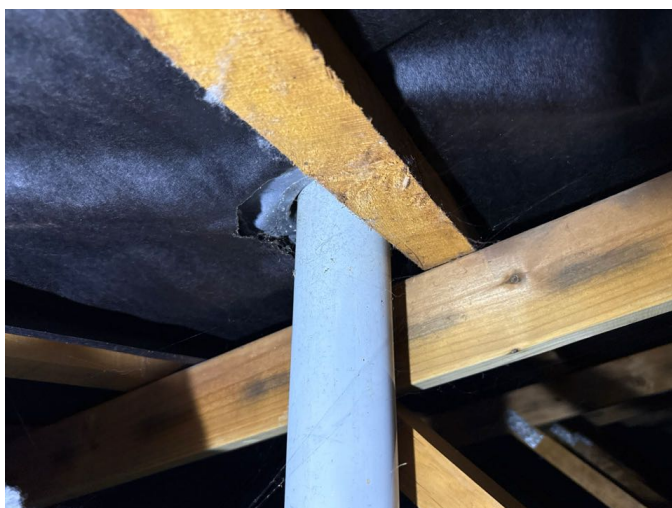
Roof penetrations are effectively sealed

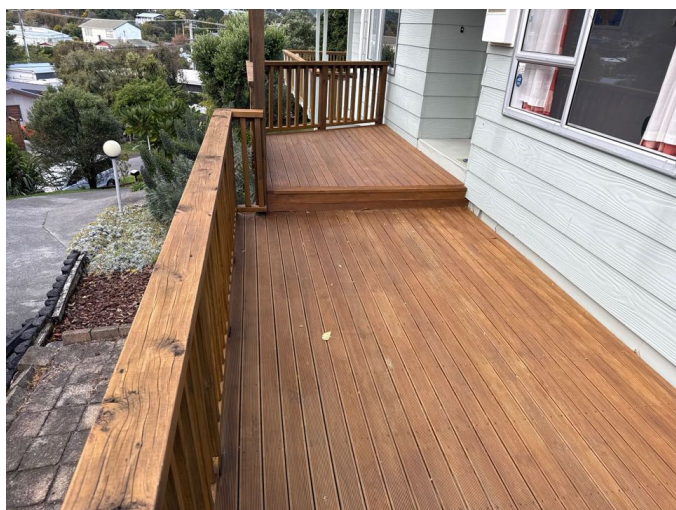
The decking is in good condition

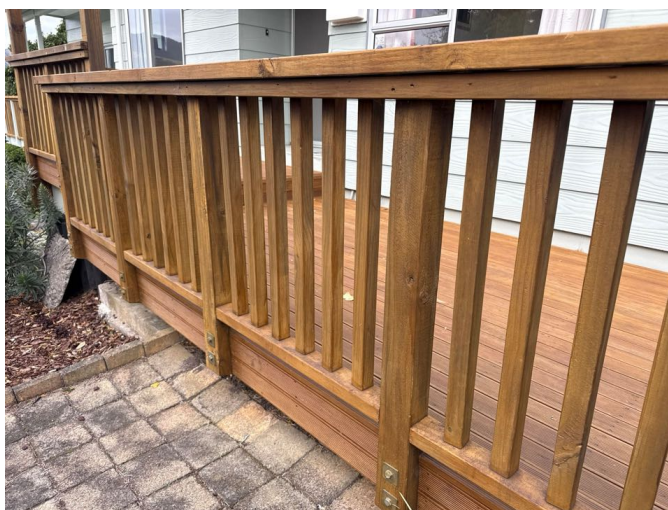
The balustrade is solid and connected sufficiently at the base

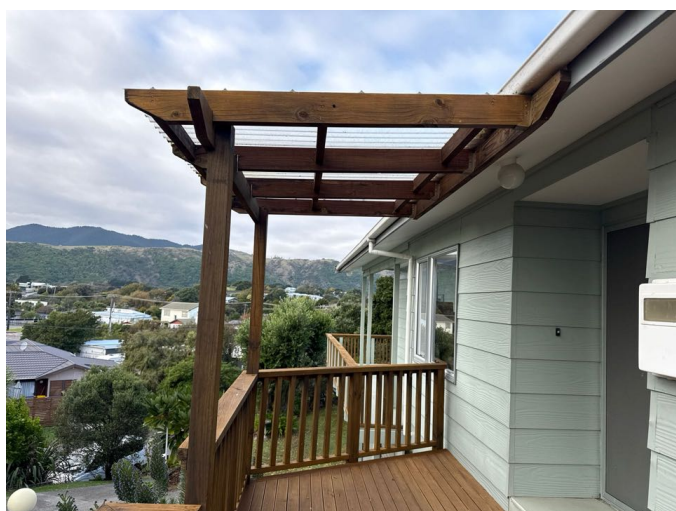
The roof section is solid and well connected. The plastic roofing is intact and secure.

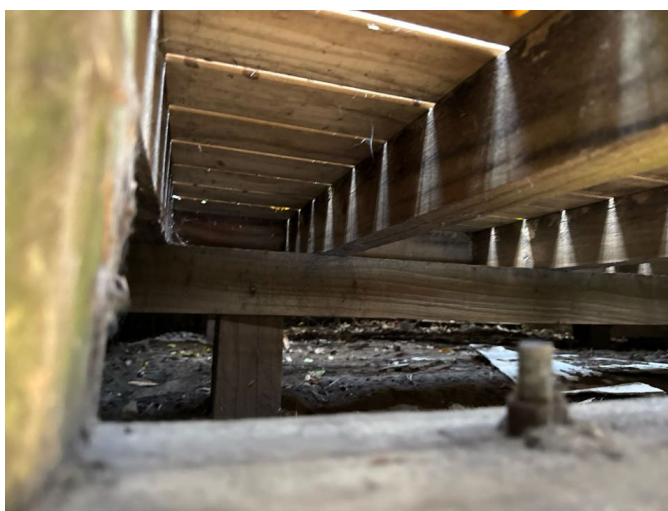
No concerns with the framing structure. Solid and well connected.

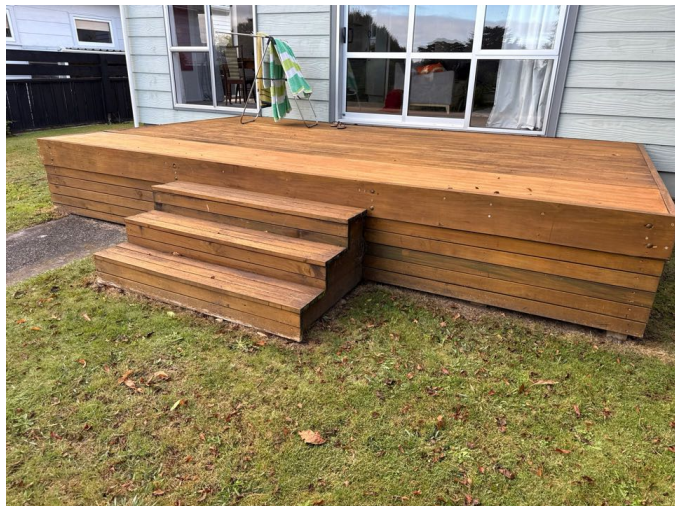
The decking is in good condition. The timber stairs are safe and secure.

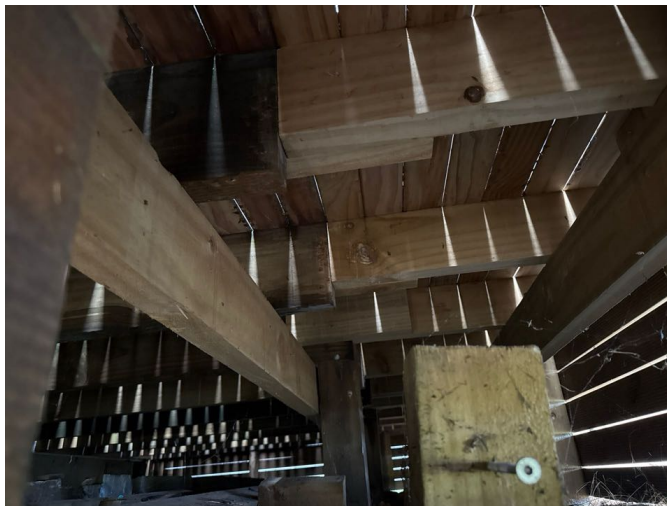
The deck structure was extended in an unorthodox manner however it is still functional. There were no signs of current structural issues found.

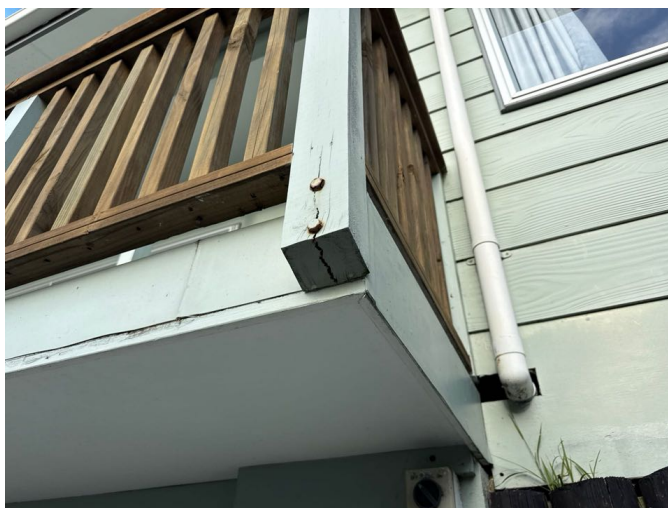
The rusting balustrade connections have caused the timber to split at the west end. Treating the rust may help slow the deterioration however the connections bolts will need to be eventually replaced with stainless steel.

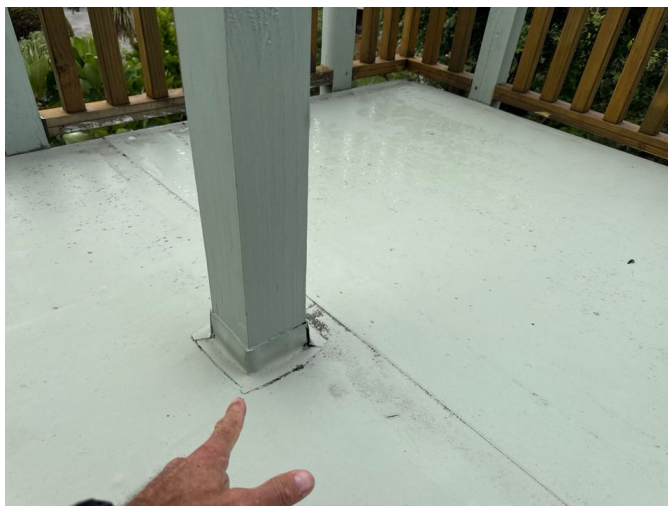
The membrane has failed at the base of the posts and rot damage is present beneath. Further investigation is recommended by a licensed builder initially.

The base of the timber roof supports has been poorly detailed and have failed. The timber is soft at the base of the deck. Further investigation is required.

Deck 3 - The membrane has failed at the base of the posts and rot damage is present beneath. Further investigation is recommended by a licensed builder initially.

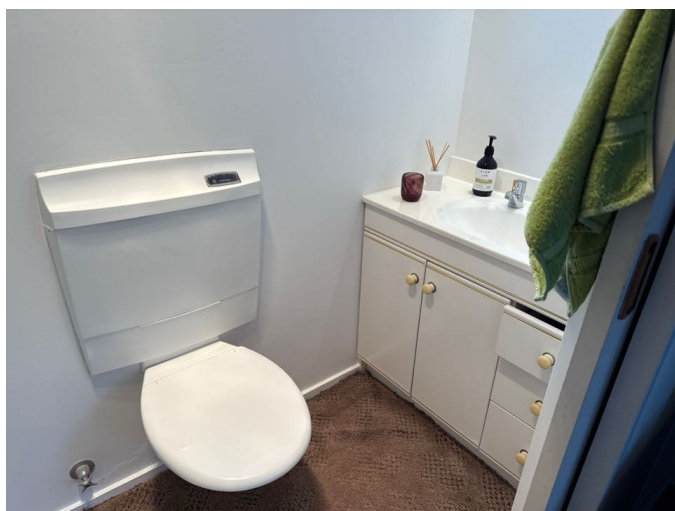
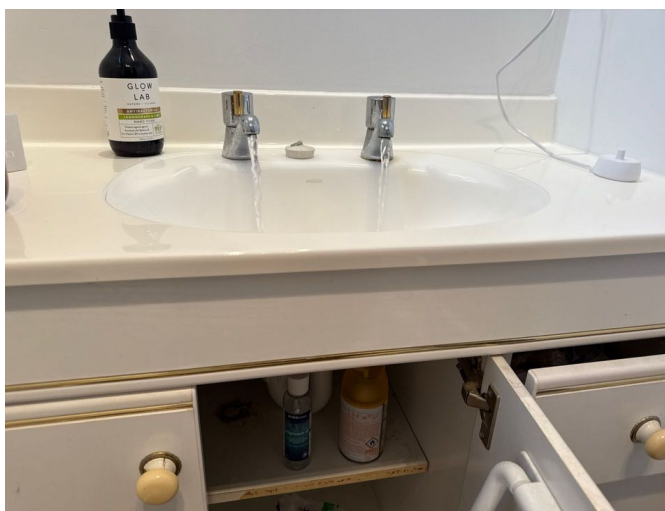
The rear edge of the vanity is well sealed. The taps are functional. No concerns with the water feeds or waste under the vanity

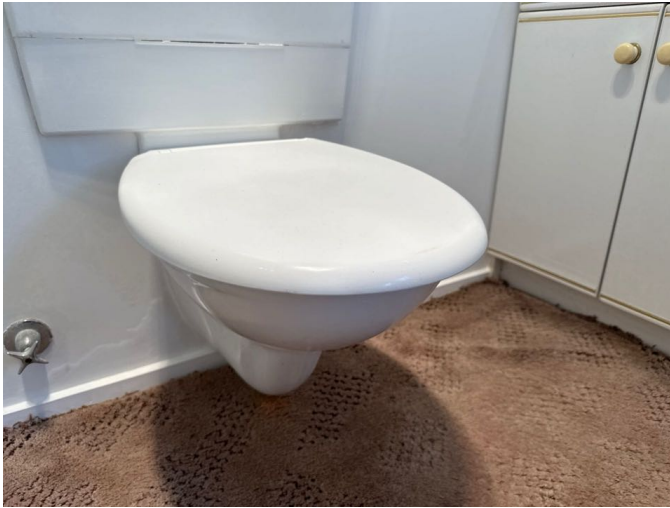
The wall hung toilet is secure

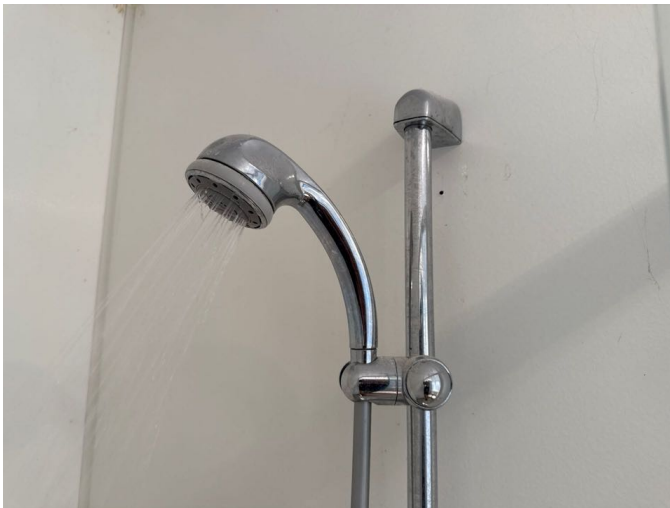
Average water pressure to the shower

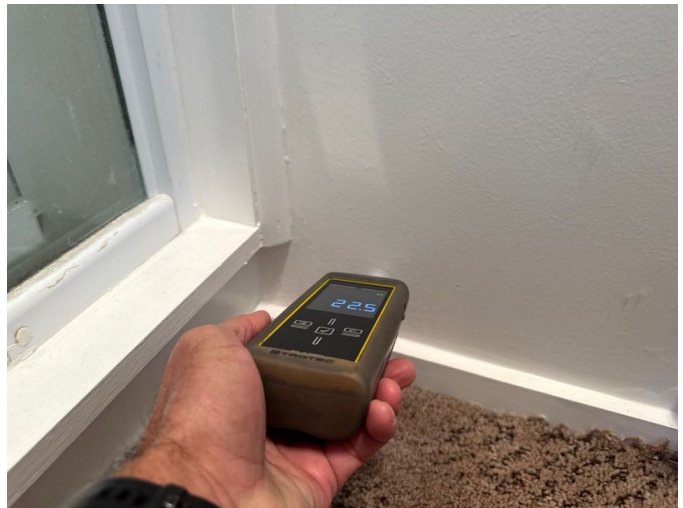
The common fail areas of the shower and plumbed areas were checked for elevated moisture. Moisture levels were within the normal range.

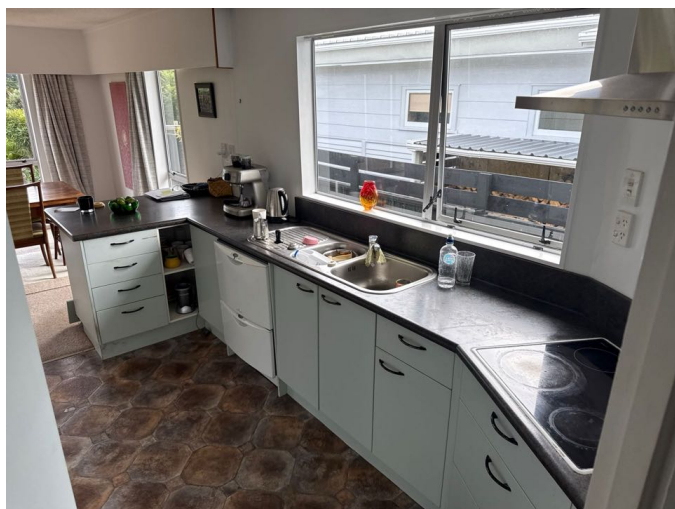
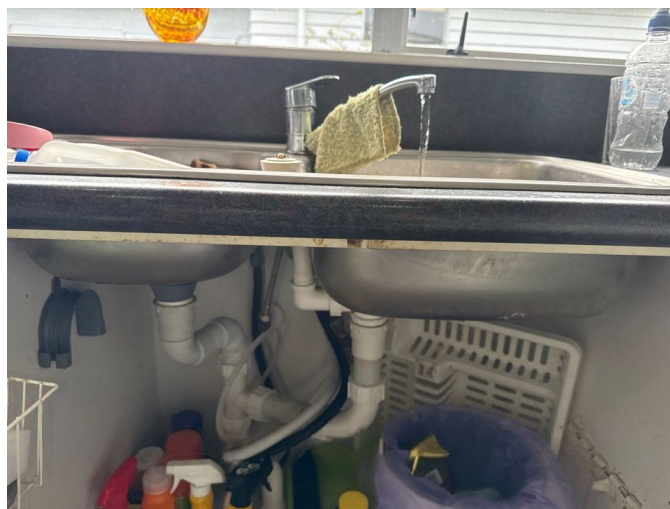
The rear edge of the bench top is well sealed. The tap is functional. No concerns with the water feeds or waste pipes under the sink.

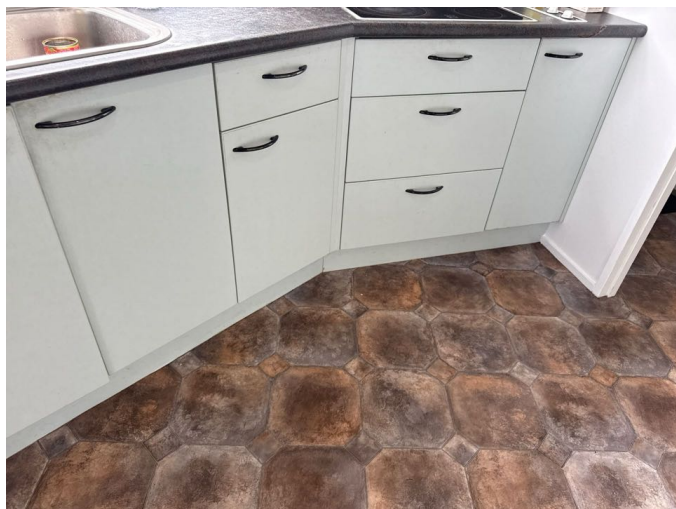
The kitchen cabinetry and vinyl floor are in a tidy condition

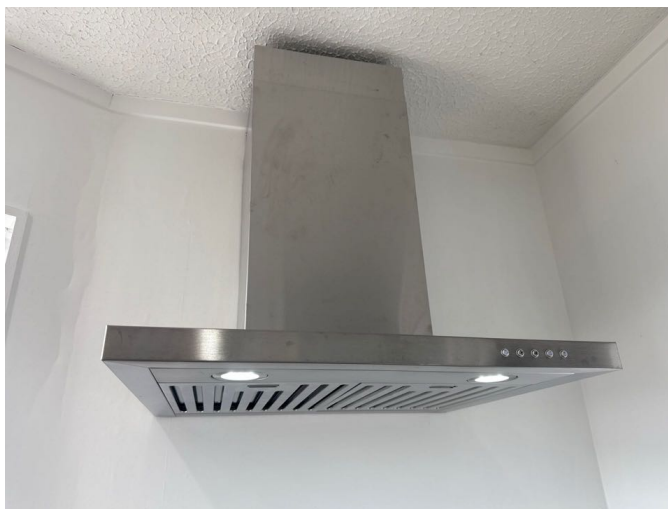
The range hood extraction unit is functioning
