STATEMENT OF PASSING OVER INFORMATION

Reference
Repairs to deck as per
building inspection dated
may 2025

The purpose of the inspection is to identify major current deficiencies that are visually identifiable at the time of the inspection. The report shall include: grounds, structure, exterior, roofs, plumbing, electrical, interior, and insulation/ventilation. The property report does not include in depth testing of services such as, underfloor heating, specific and specialized heating systems, heat pumps, water pumps, functionality of any solar power source, swimming pool heating or alike.

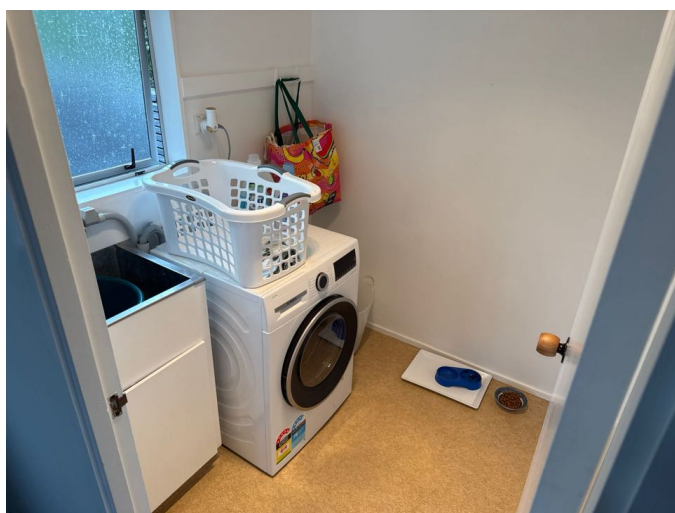
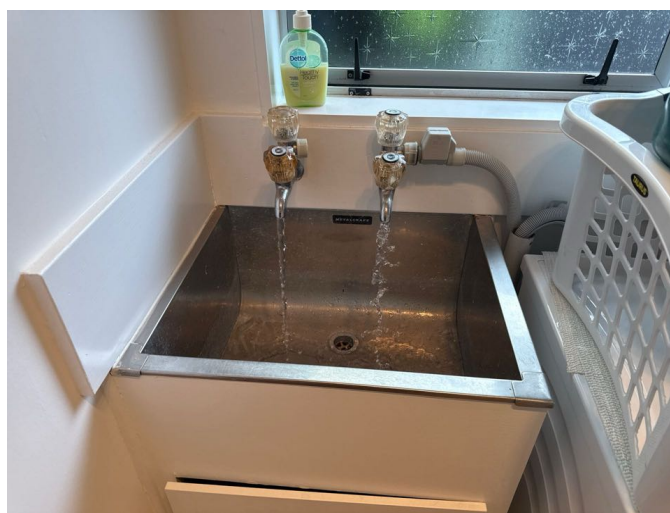
The tub is well sealed. The taps are functioning well.

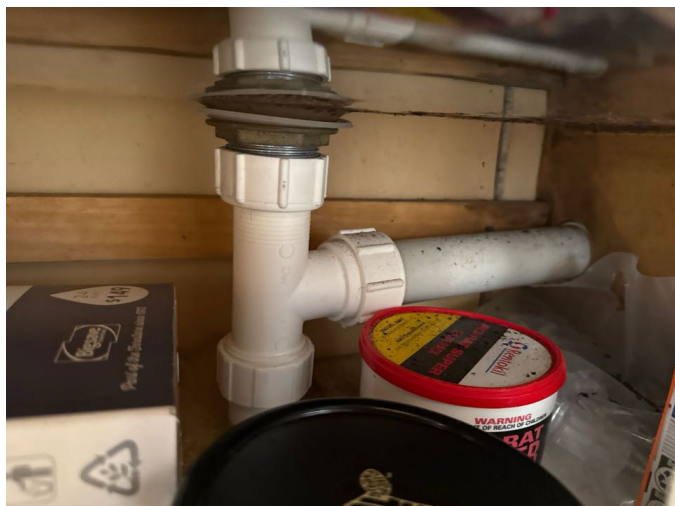
No visible concerns with the water feeds or waste under the tub.

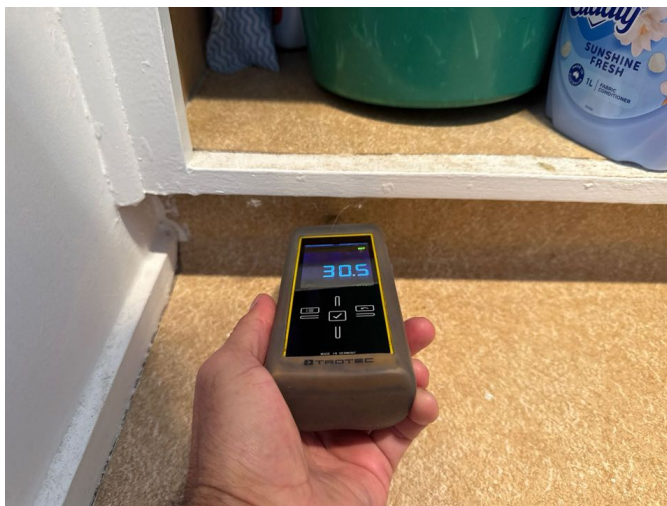
Moisture levels in the laundry scanned within the normal range at the time of inspection.

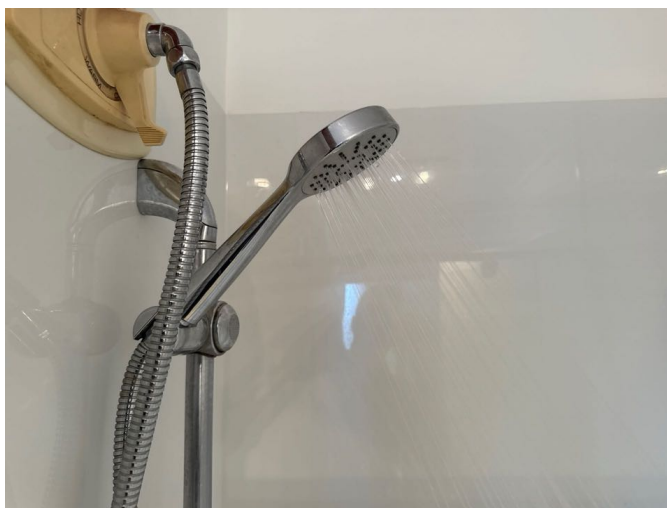
Average water pressure noted

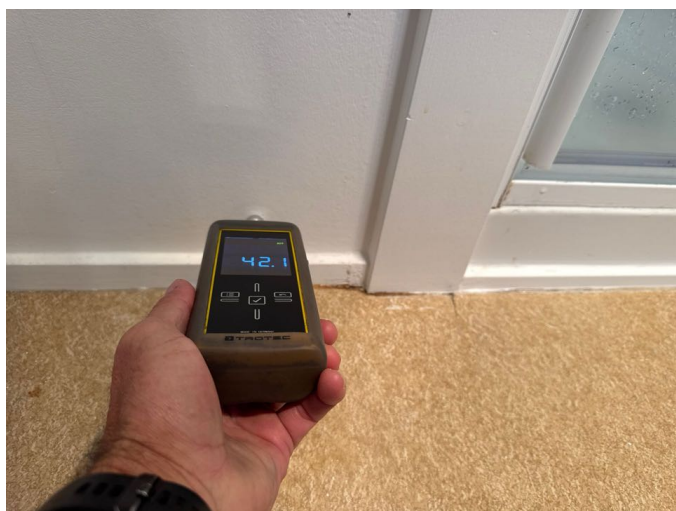
Moisture levels by the shower were within the normal range. Older lino may contain Asbestos and should be tested prior to disturbing it in the future if it is to be replaced.

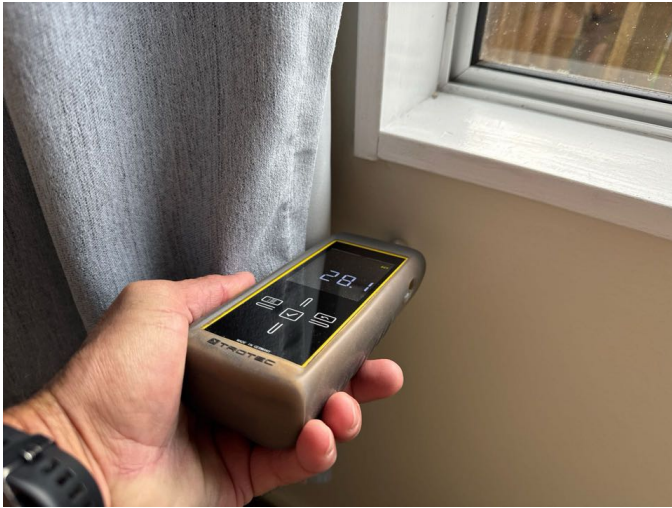
Moisture levels to the external walls scanned within the normal range at the time of inspection

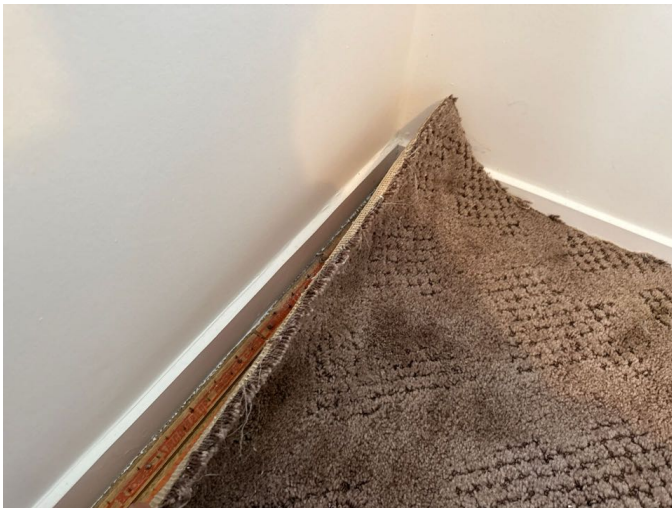
The carpet is loosely fitted in this room. The owner disclosed that the carpet is to be replaced.

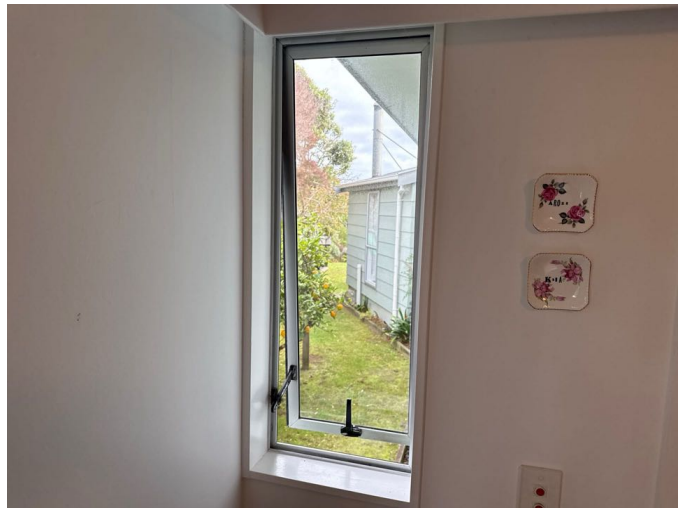
The windows are functional throughout

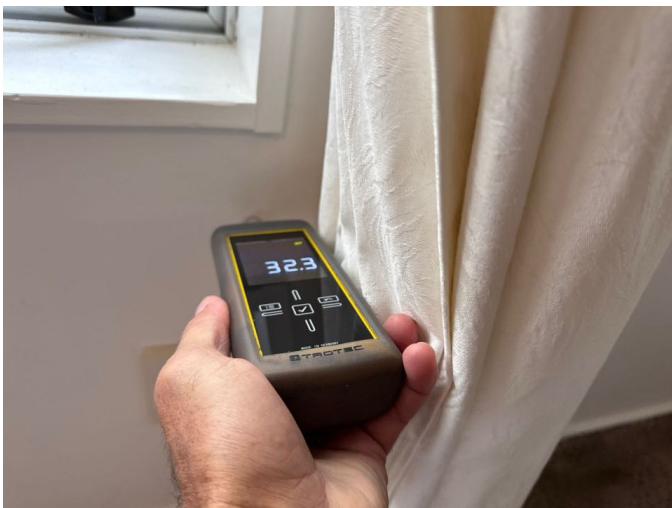
Moisture levels to the external walls scanned within the normal range at the time of inspection

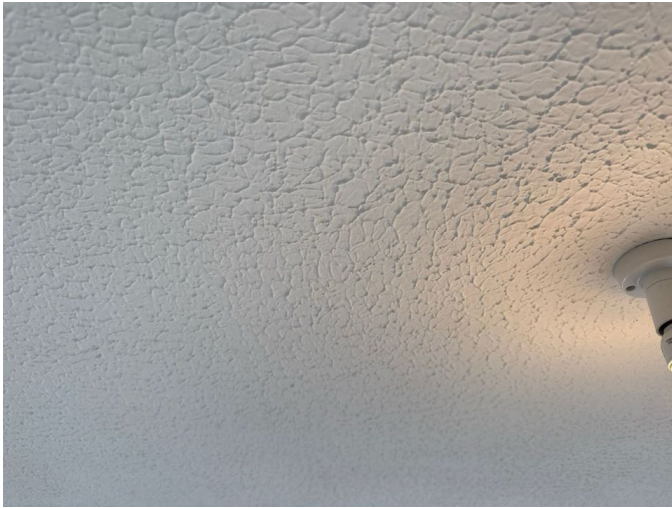
Textured plaster surfaces may contain an element of Asbestos. Safe in current condition. Due to the age of this home, Asbestos compounds may still have been used as a binding agent in the plaster. If any works to a textured lining are being considered, an Asbestos test should be carried out by an industry trained professional.

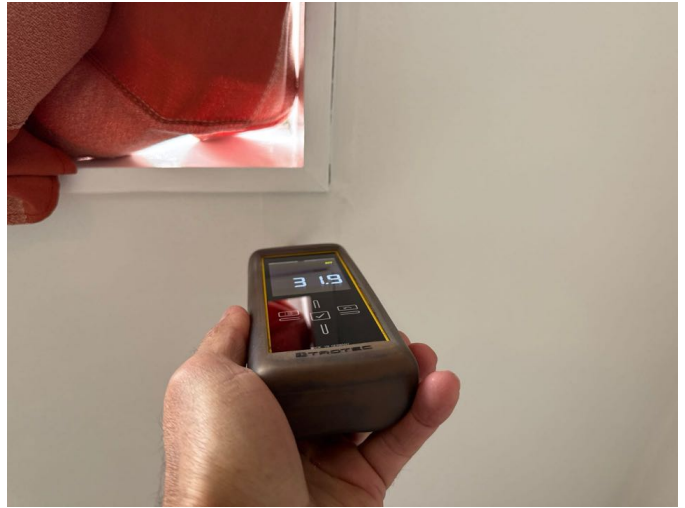
Moisture levels to the external walls scanned within the normal range at the time of inspection

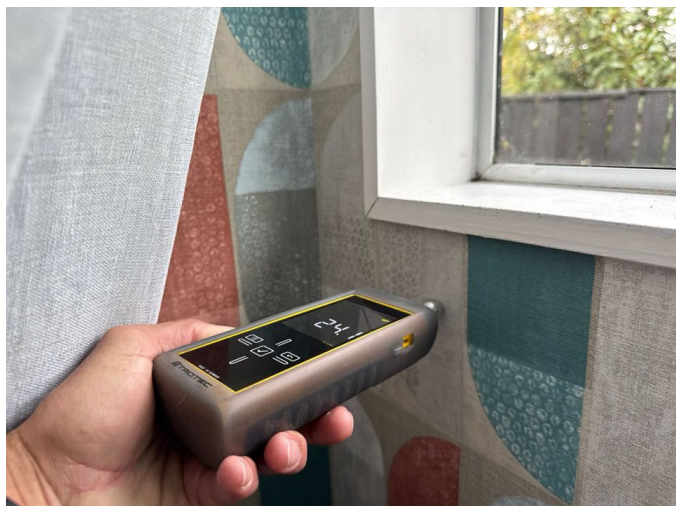
Moisture levels to the external walls scanned within the normal range at the time of inspection

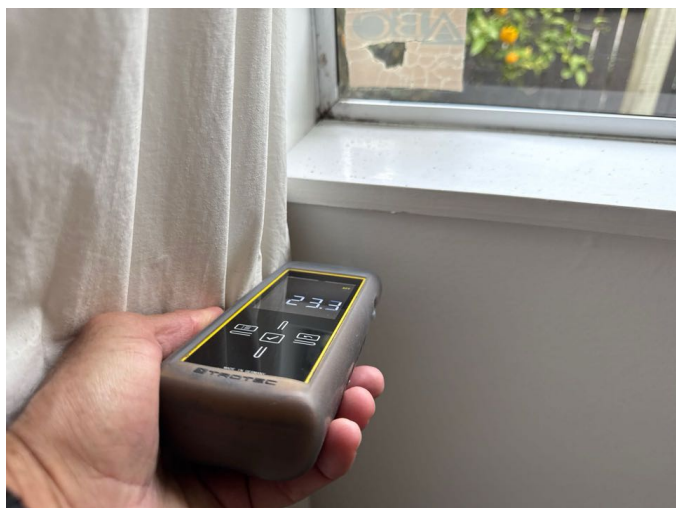
Moisture levels to the external walls scanned within the normal range at the time of inspection

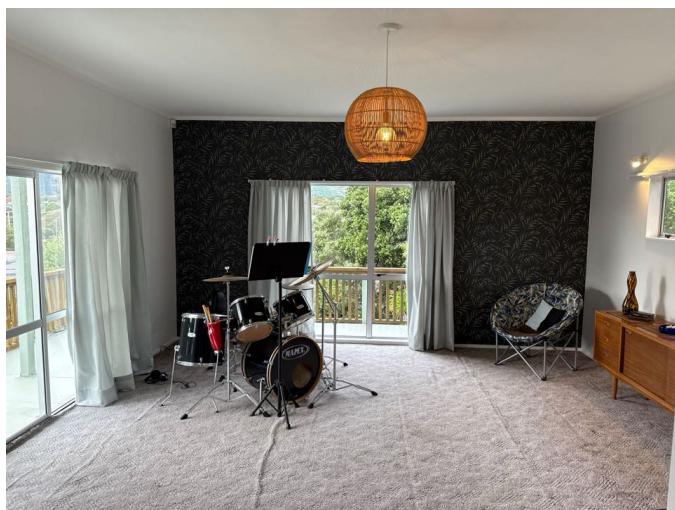
The carpet has stretched

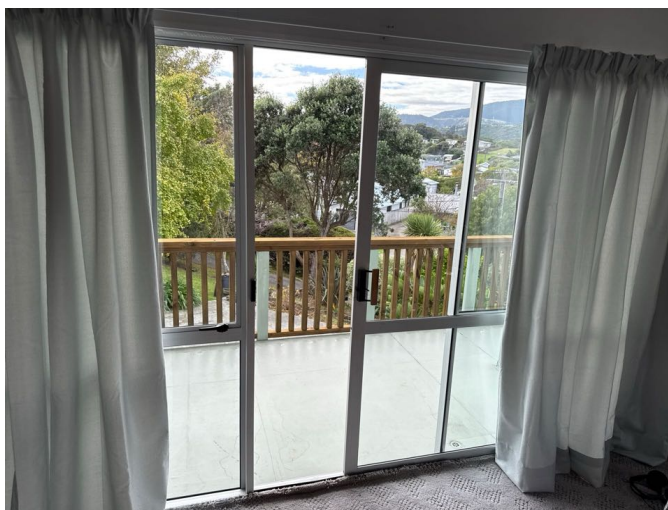
The sliding door and windows are functional

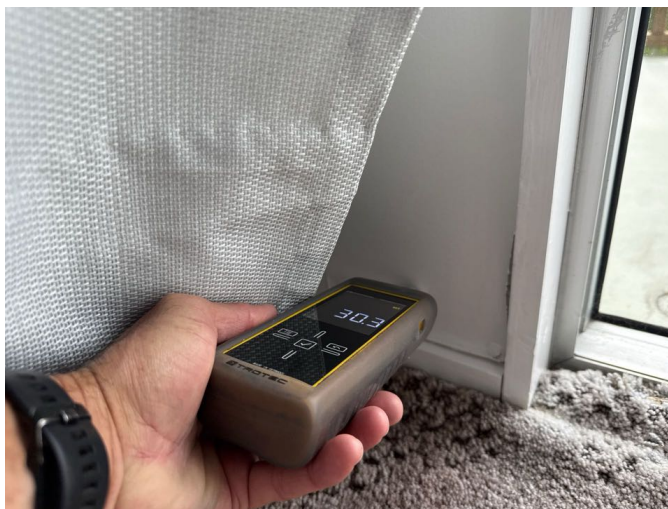
Moisture levels to the external walls scanned within the normal range at the time of inspection.

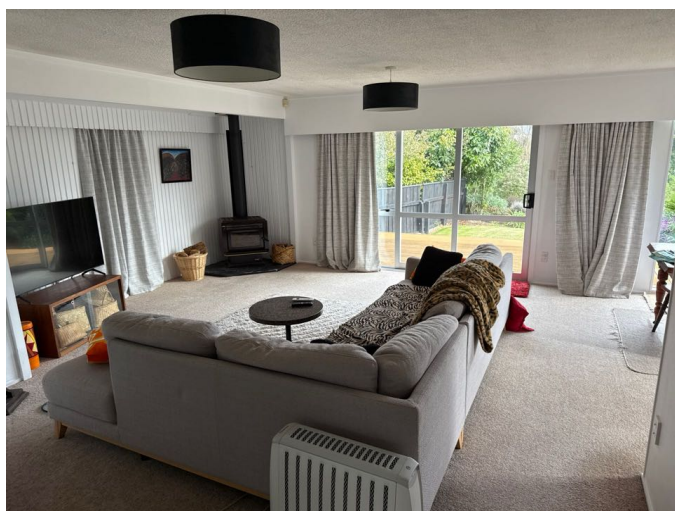
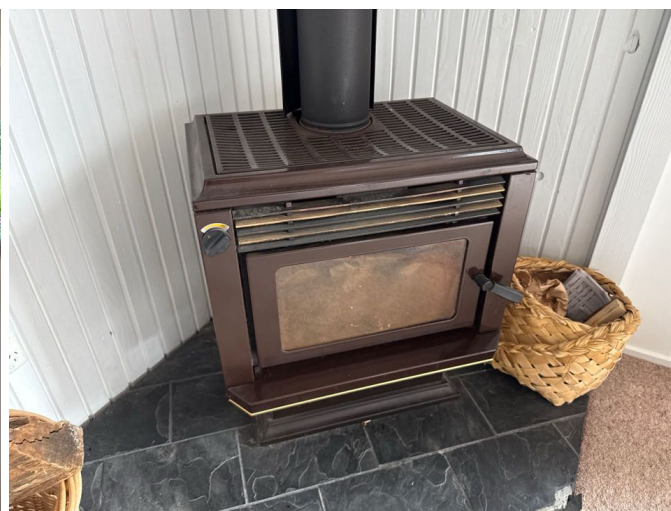
The fireplace and chimney were not checked as part of the inspection process. All fireplace manufacturers stipulate an annual service and insurance companies require evidence of due care and maintenance in the event of a claim. Purchasers should check when the fireplace was last serviced prior to the first use and have a service completed if necessary. The chimney was not checked as part of this inspection process.

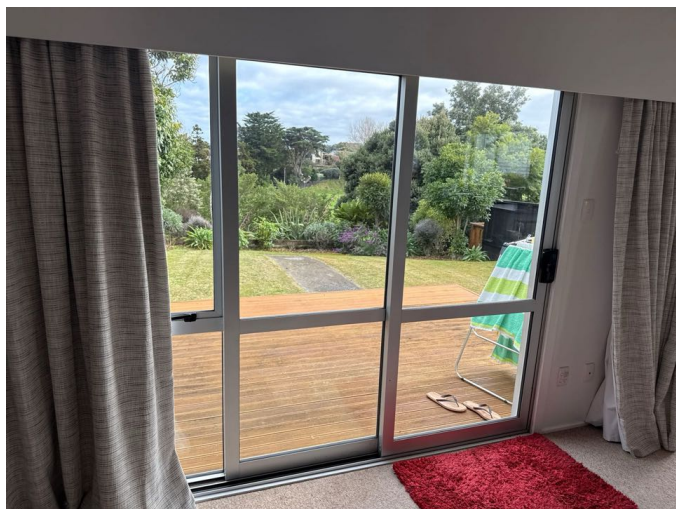
The sliding door and windows are functional

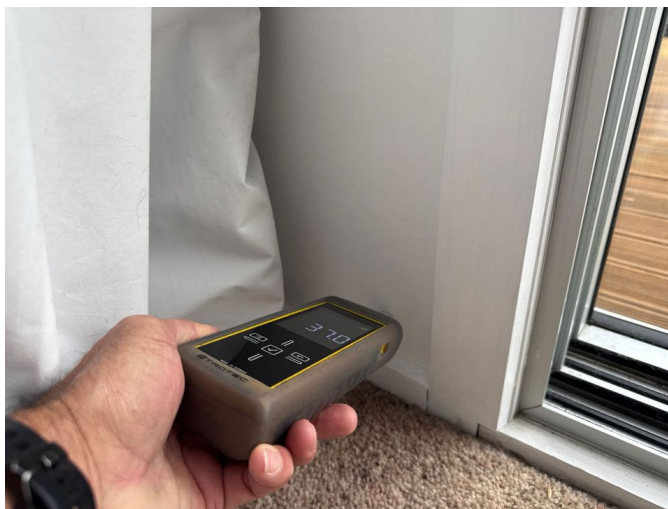
Moisture levels to the external walls scanned within the normal range at the time of inspection

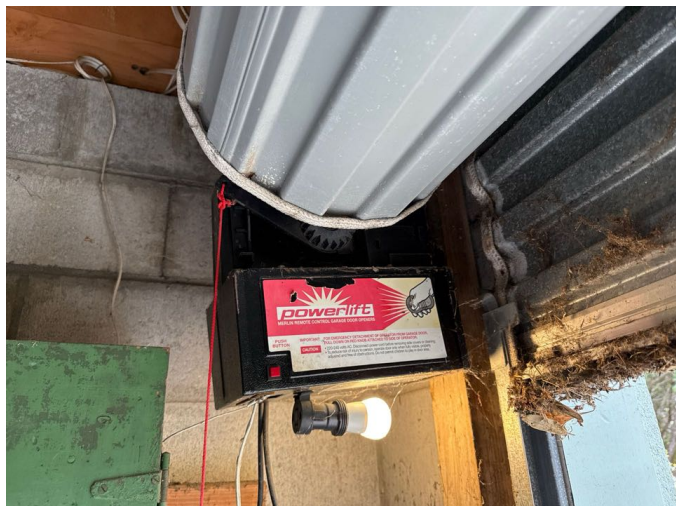
The electric garage door on the right side (facing in) is functioning.

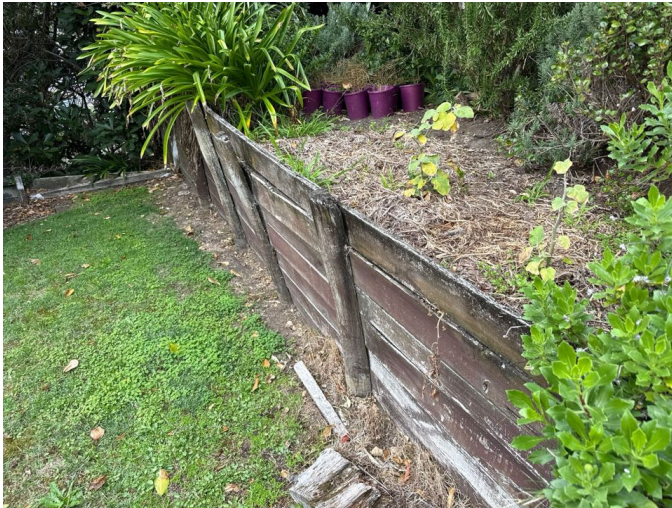
Retaining walls that are leaning significantly at the front should be replaced to prevent the risk of eventual failure.

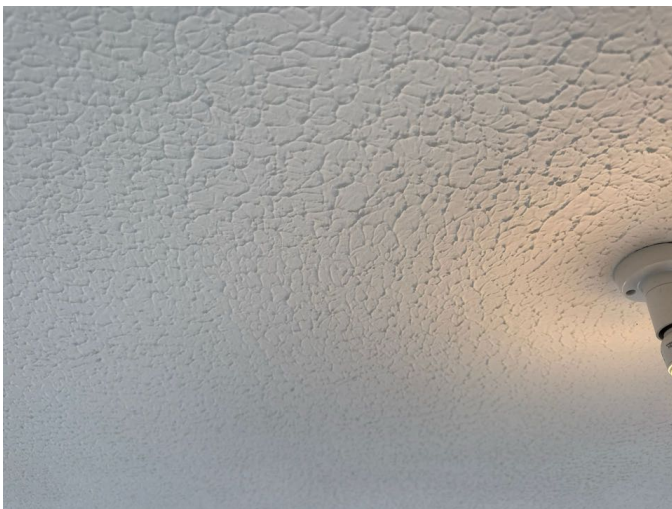
Textured plaster surfaces may contain an element of Asbestos. Safe in current condition. Due to the age of this home, Asbestos compounds may still have been used as a binding agent in the plaster. If any works to a textured lining are being considered, an Asbestos test should be carried out by an industry trained professional.
