RED LBP PRE-PURCHASE REPORT

CERTIFICATE OF INSPECTION IN ACCORDANCE WITH NZS 4306:2005

Company: ProInspect HB Ltd trading as RedLBP Hawke's Bay.
Client: Whistle Trustees Limited
Date of Inspection: 28th July 2025
Site Address: 151 Durham Drive, Havelock North, 4130
Inspector: Henare Waapu
Qualifications: National Certificate in Carpentry

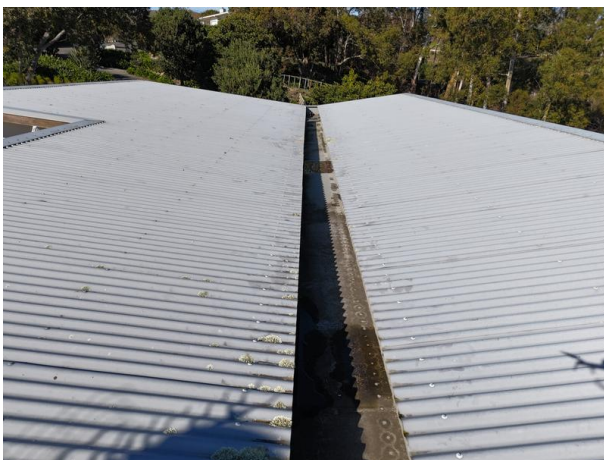
Photo 4
Profile metal roofing with nail fixings.

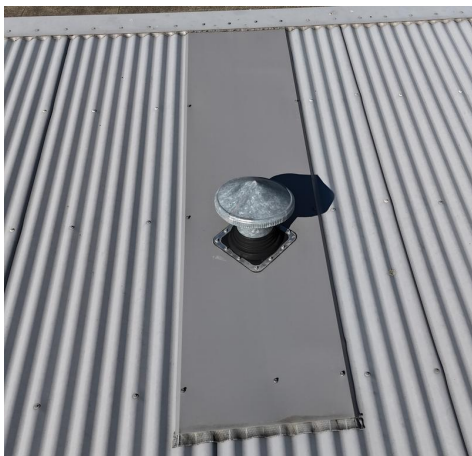
Photo 9

Vent for ensuite extractor fan with back flashing installed.

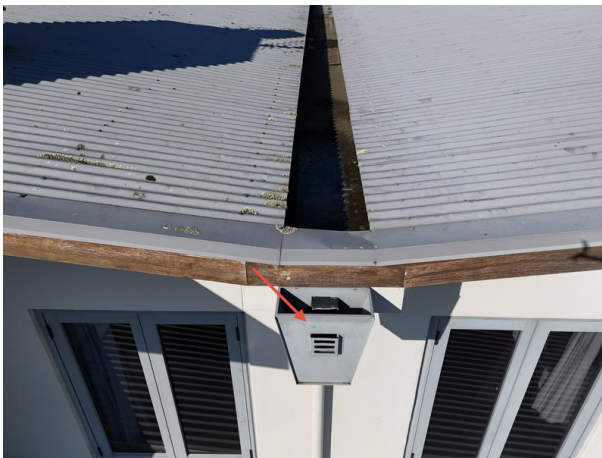
Photo 14
Rain water head on southern side of the house is clear at the time of inspection.

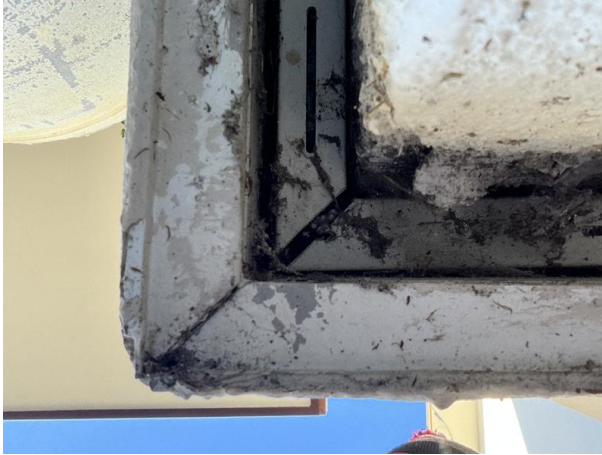
Photo 19

The cladding is plastered on to fibrous cement board over a cavity system. Photo taken at front entrance.

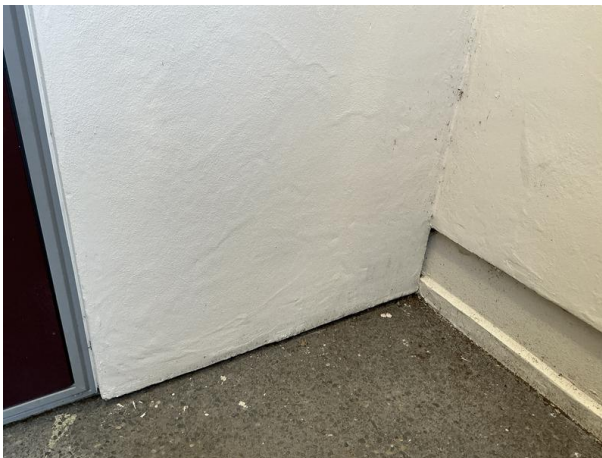
Photo 20

Ground clearance is reduced at the garage entrance.

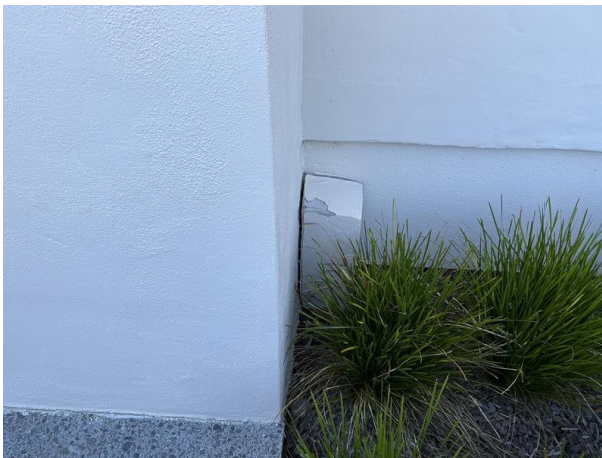
Photo 23

The gas line and power cable cover on the western side of the house is not sealed.

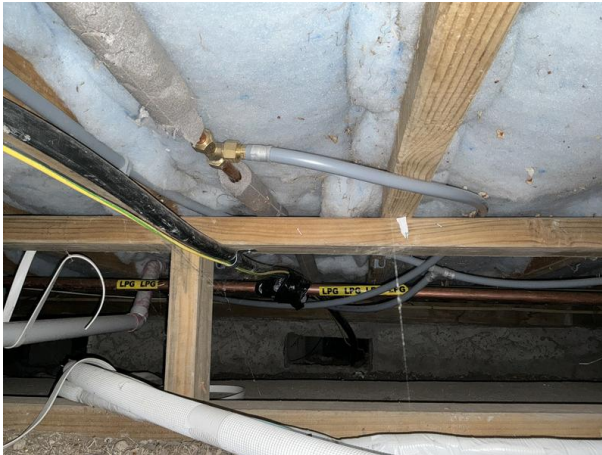
Photo 34

The original concrete ring foundation is visible from the man hole.

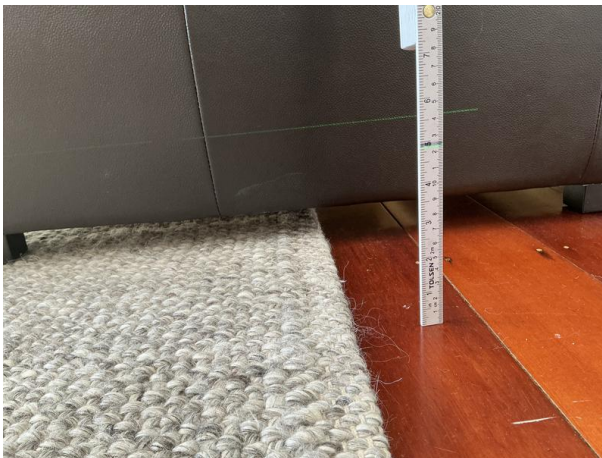
Photo 38

Floor level reading is level in lounge, 2m from datum.

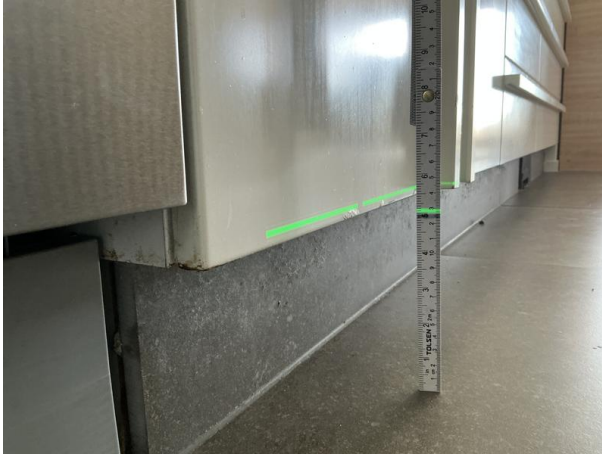
Photo 40

Floor level reading -2mm in kitchen, 6m from datum.

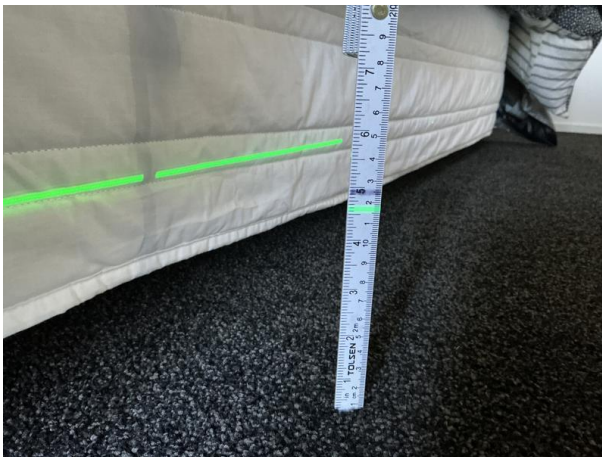
Photo 42

Floor level reading +8mm in bedroom 2, 6m from datum.

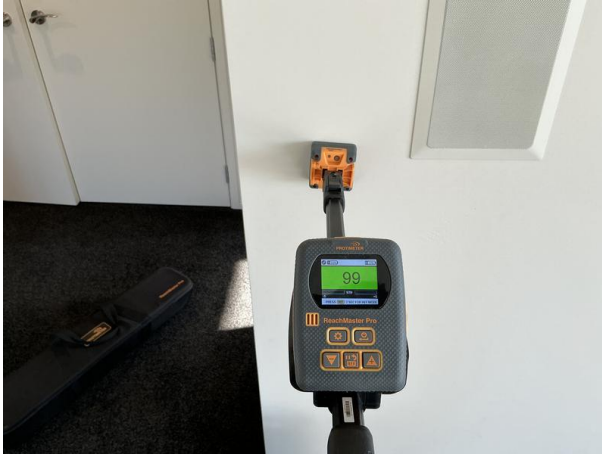
Photo 43

Baseline moisture reading of 99 taken on interior wall. No indication of elevated moisture levels were detected.

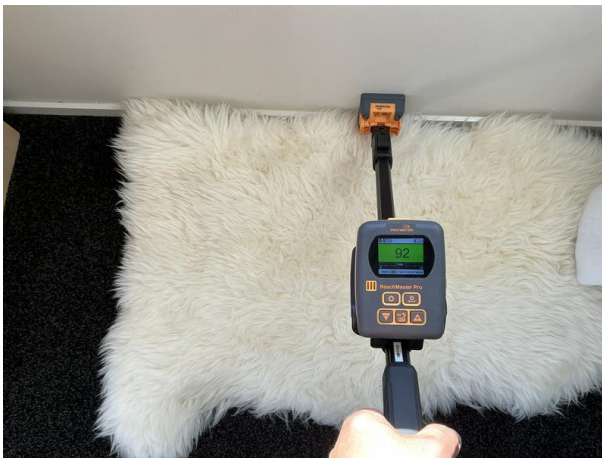
Photo 44

Moisture reading of 92 to exterior wall on the northern elevation. No indications of elevated moisture levels were detected.

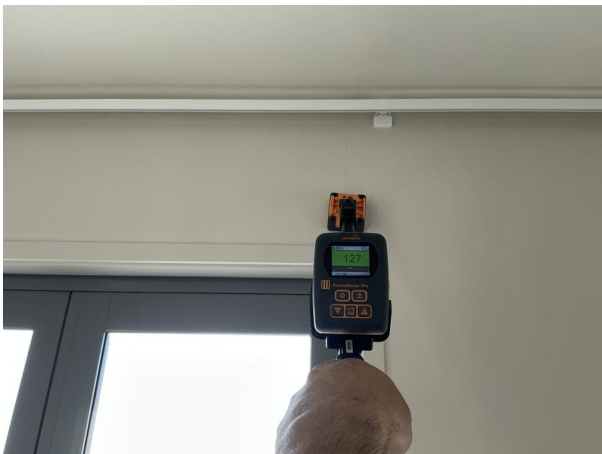
Photo 45

Moisture reading of 127 to exterior wall above the window on the southern elevation. No indications of elevated moisture levels were detected.

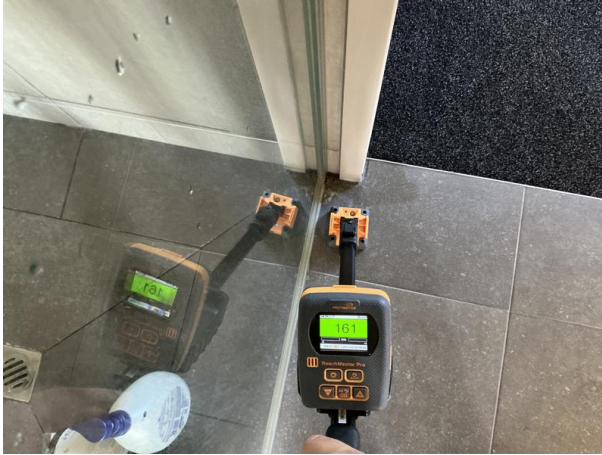
Photo 46

Moisture reading of 161 to the floor on the exterior of the shower ensuite in bedroom 4. No indications of elevated moisture levels were detected.

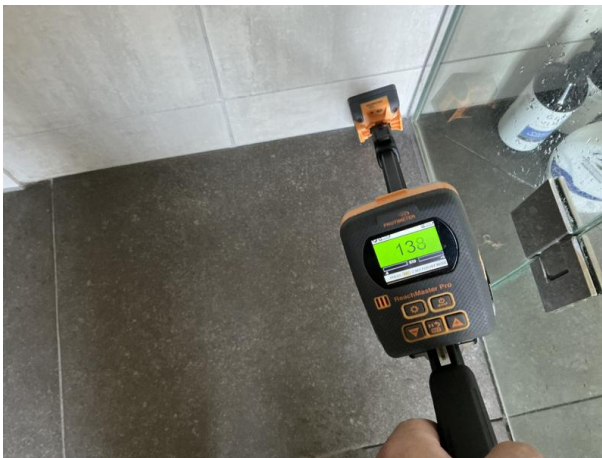
Photo 47

Moisture reading of 138 to the exterior of the shower ensuite in bedroom 4. No indications of elevated moisture levels were detected.

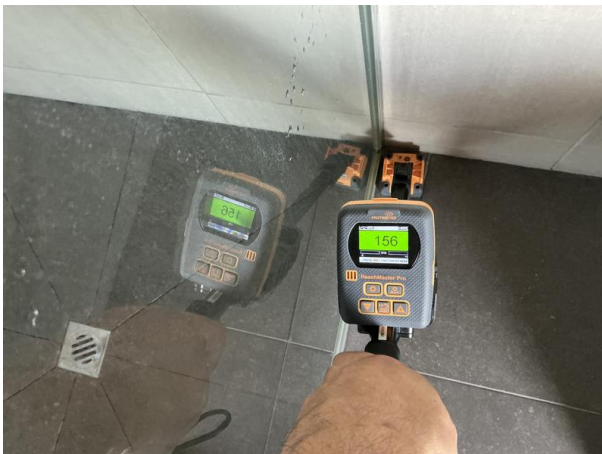
Photo 48

Moisture reading of 156 to the exterior of the shower ensuite in bedroom 2. No indications of elevated moisture levels were detected.

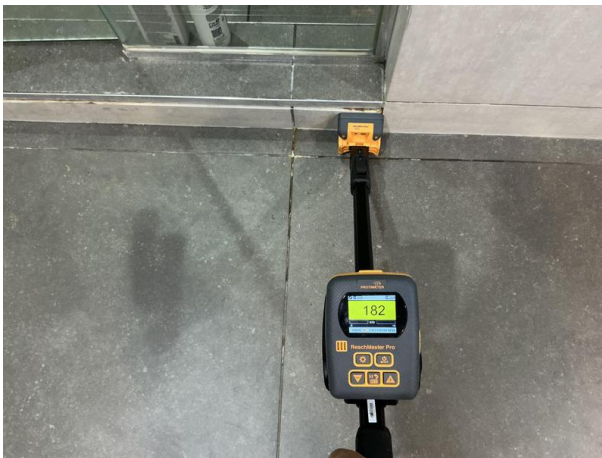
Photo 50

Moisture reading of 182 to the exterior of the shower ensuite in bedroom 1. No indications of elevated moisture were detected.

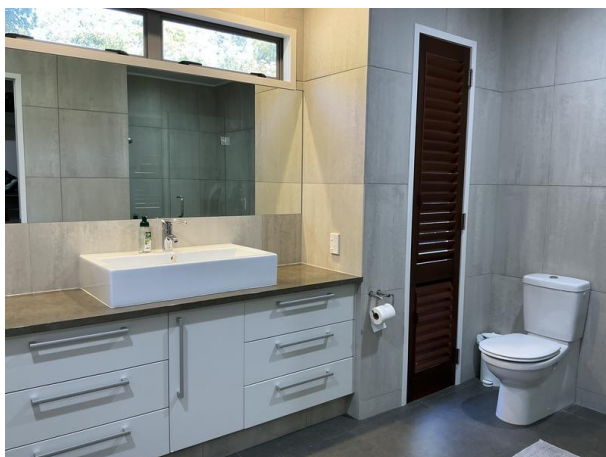
Photo 60
Ensuite.

Water leakage is visible at the corner of the shower enclosure, particularly where water flow is directed toward these areas. It is recommended to engage a qualified professional to assess the issue and properly remove, reseal, and reinstall the affected components of the enclosure to prevent further leakage and potential water damage.

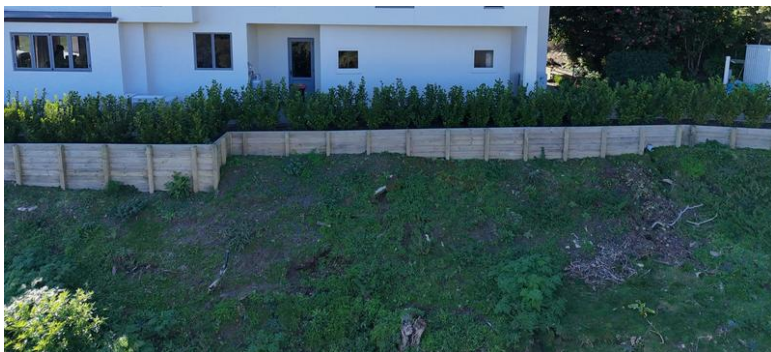
Photo 77

Timber retaining wall along the western side of the house.

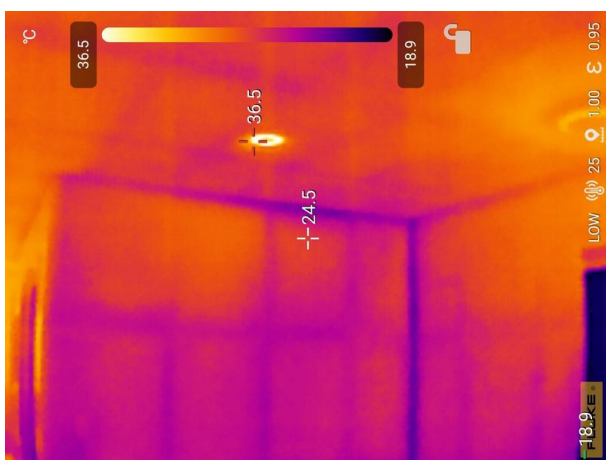
Photo 85

Thermal image to ceiling and exterior wall in bedroom 2. No notable temperature differences.

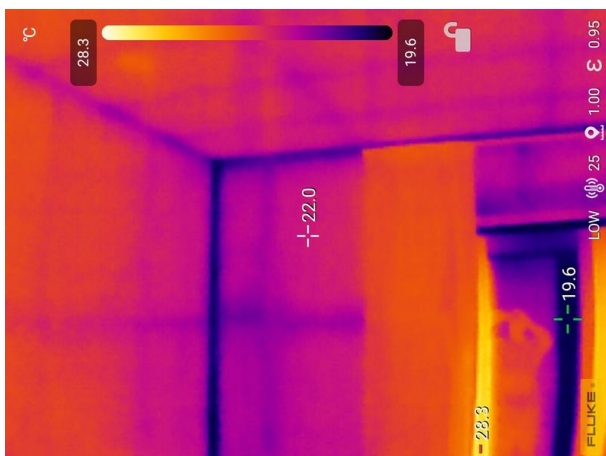
Photo 86

Thermal imaging of ceiling and exterior wall in lounge. No notable temperature differences.

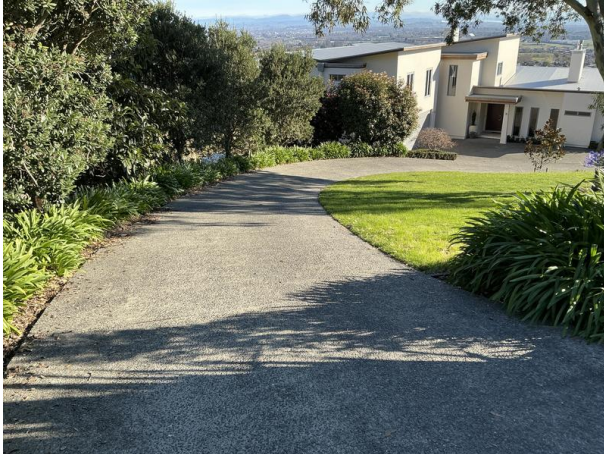
Exposed aggregate with saw cuts
Cracking - Areas of cracking visible - functional.

Photo 90
Driveway.

General upkeep and maintenance of driveway by cleaning and keeping free of debris.

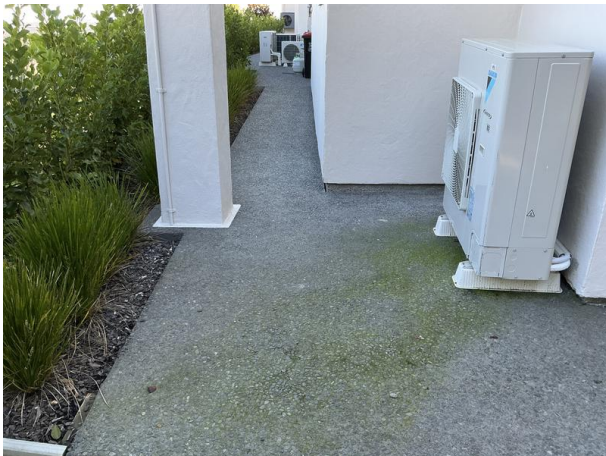
Photo 93

Exposed aggregate path on western side of the house. Areas of surface moss.

General upkeep and maintenance.

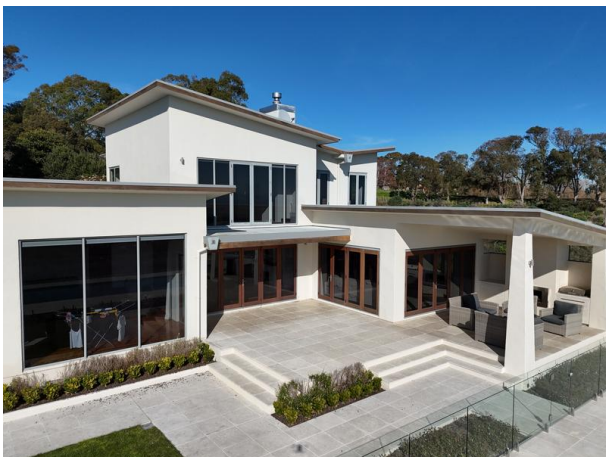
Photo 94

Tiled patio on the northern side of the house.

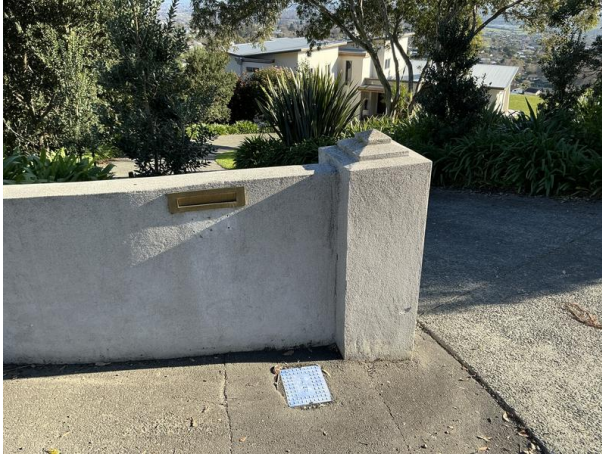
Photo 95

The water toby is located at the driveway entrance.

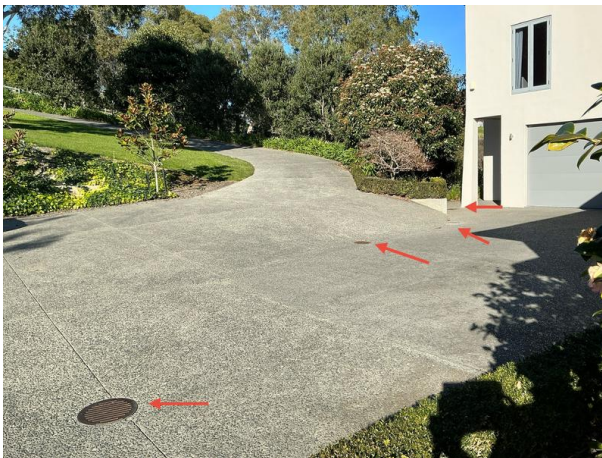
Photo 96

There are stormwater drains to collect surface moisture of the driveway and car park area.

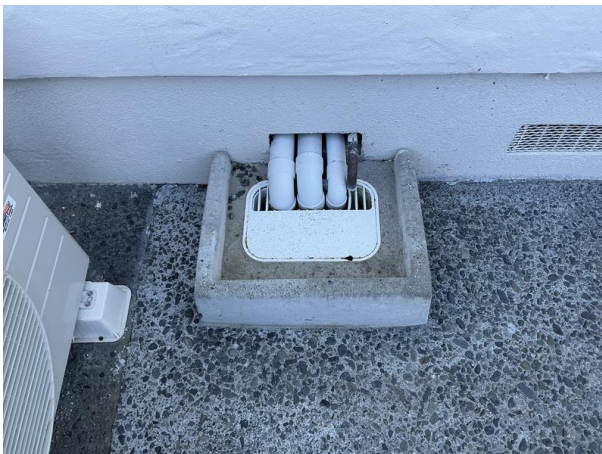
Photo 97

Gully trap for laundry and second story bathroom.

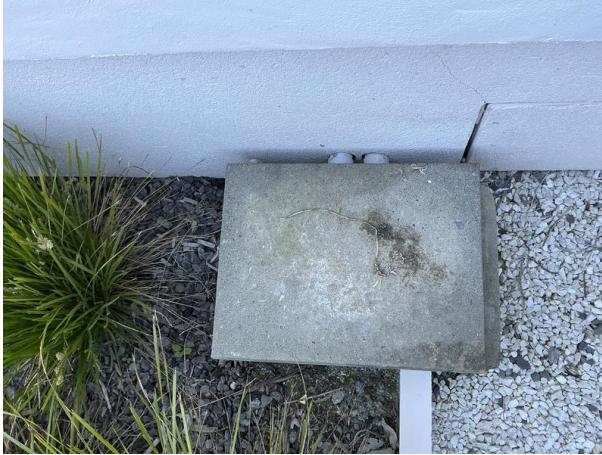
Photo 98
Gully trap for kitchen on the side of the house.

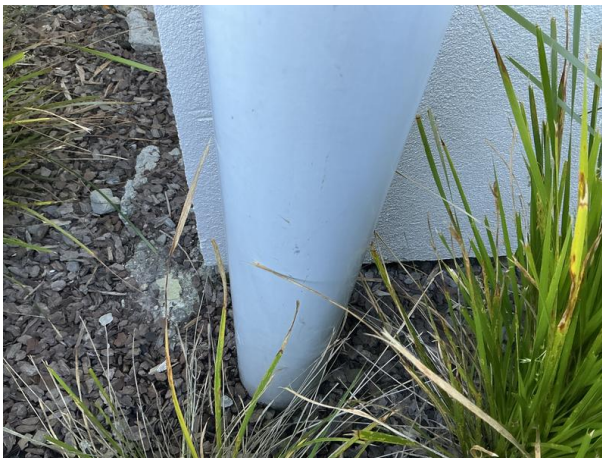
Photo 99
Downpipe western side of the house.

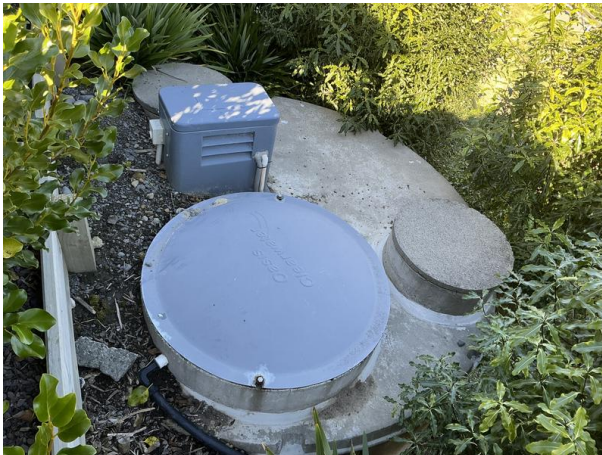
Photo 100
Septic storage tank on western side of the house.

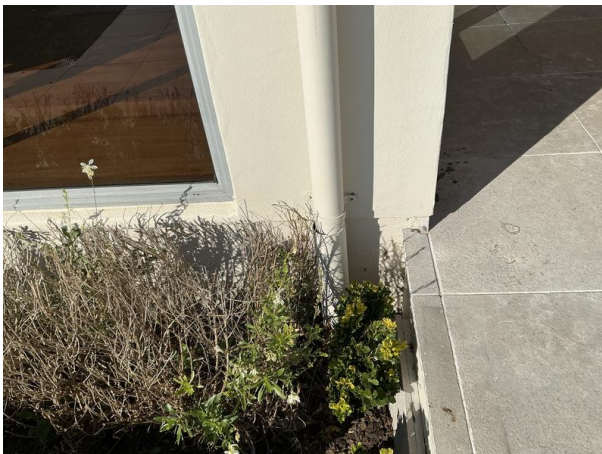
Photo 103

Riser on northern side of the house.

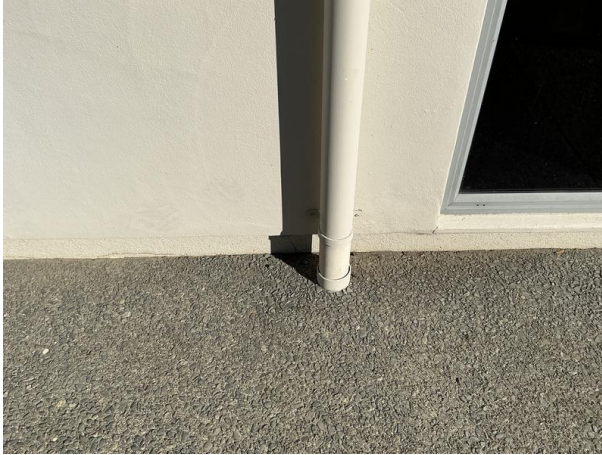
Photo 104

Riser on eastern side of the house.

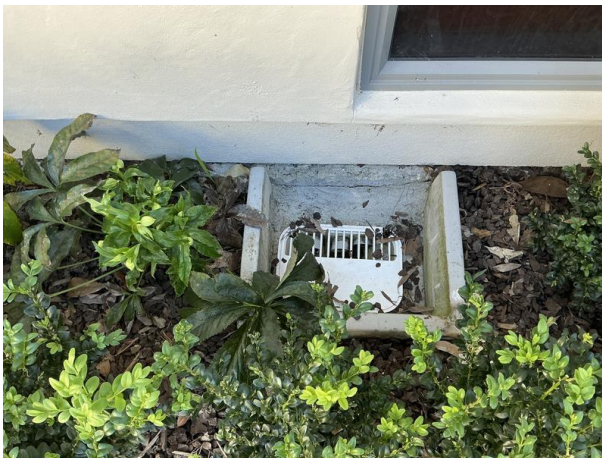
Photo 105

Gully trap for ensuite on southern side of the house.

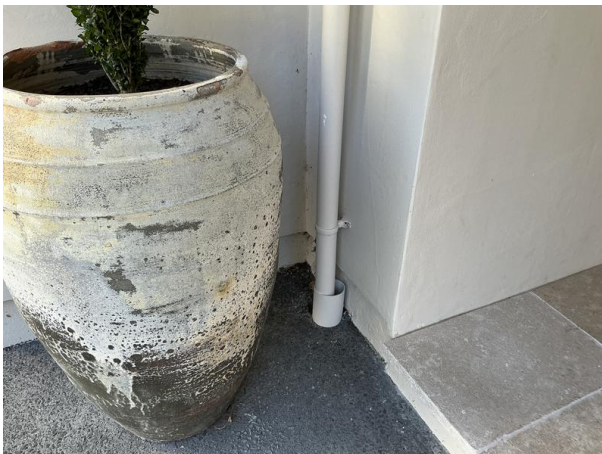
Photo 106

Riser located on south side of the house.

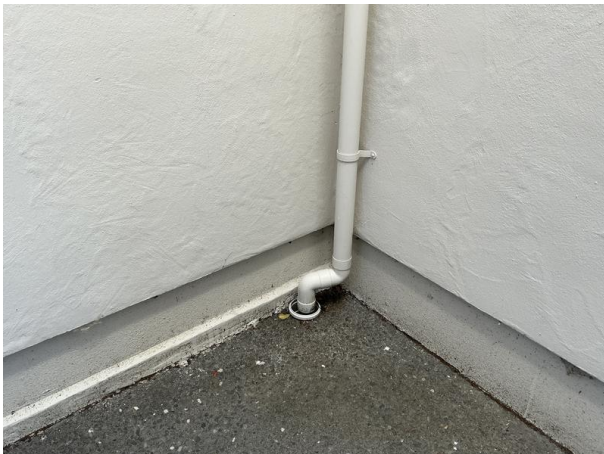
Photo 107

Downpipe on southern side of the house discharges into pipe connected to stormwater system.

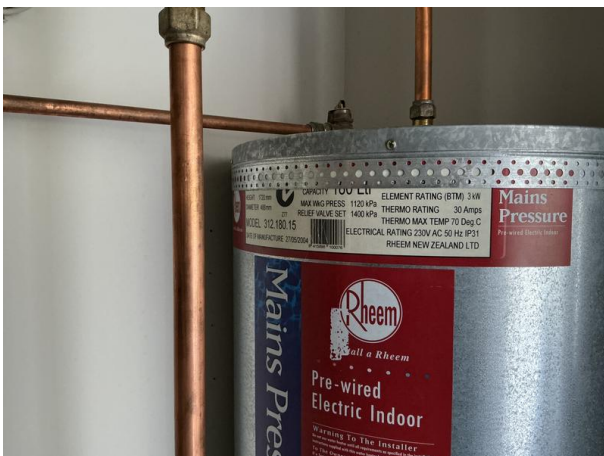
Photo 109

Hot water cylinder in the hallway cupboard for the second level of the house.

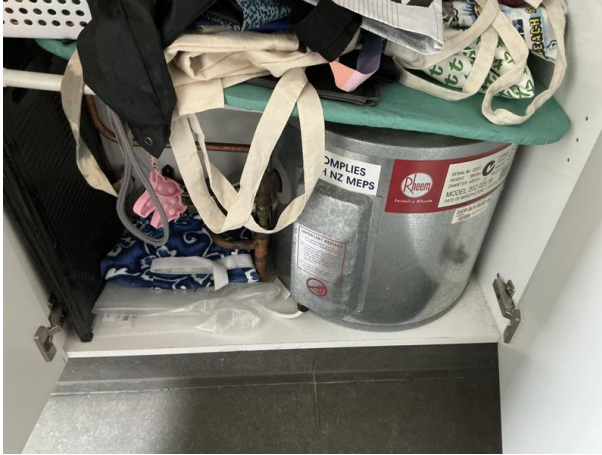
Photo 110

Hot water cylinder in the laundry cupboard to service the laundry.

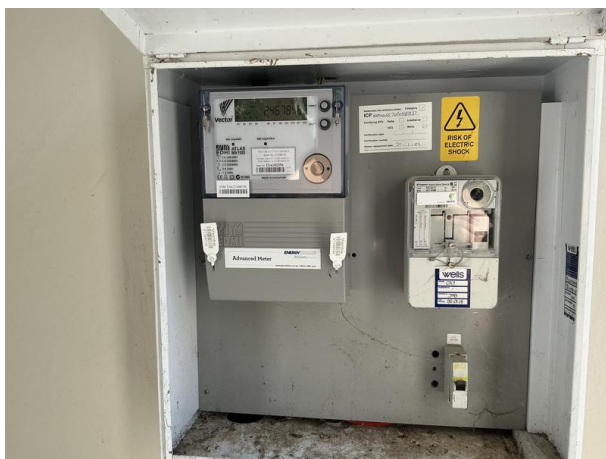
Photo 111

The meter board is located on the southern side of the house.

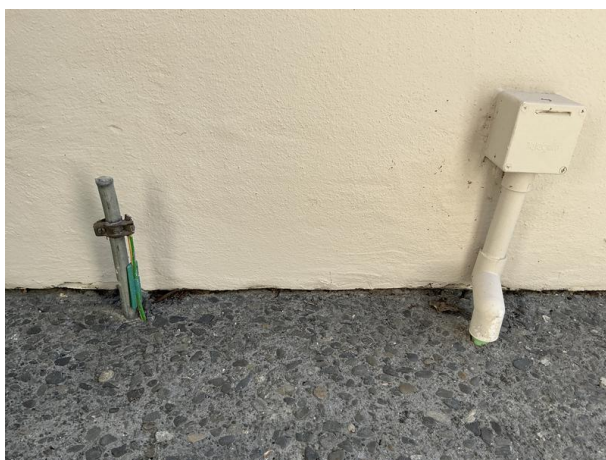
Photo 112

The earthing rod and data cable are located on the southern side of the house.

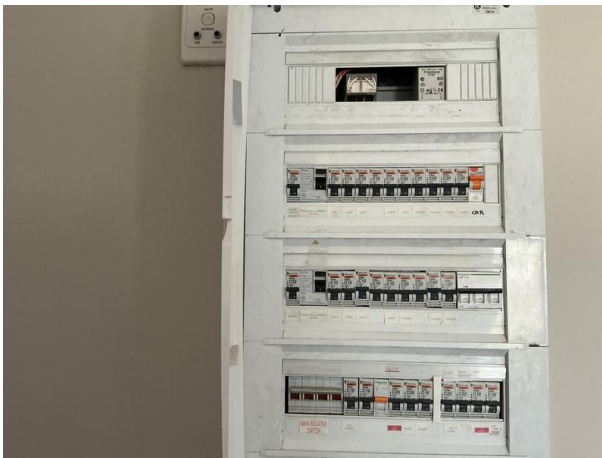
Photo 114

The distribution board is located in the garage.

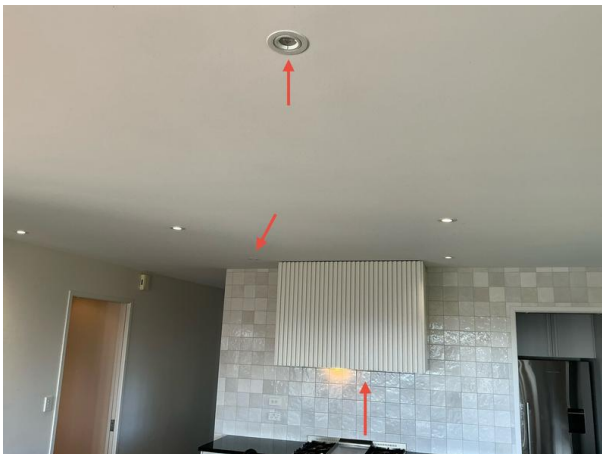
Photo 115

There are several lights in the kitchen that aren't in working order.

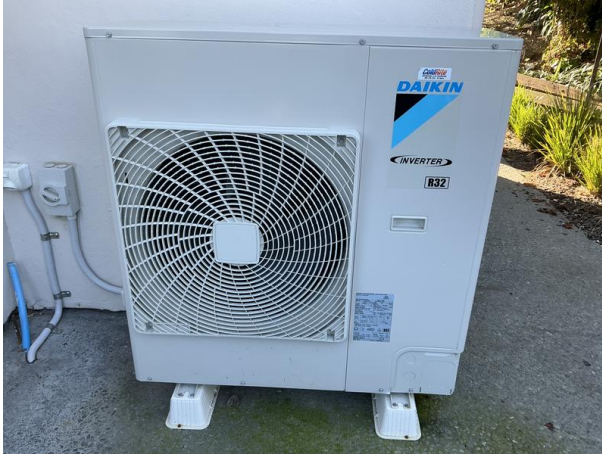
Photo 116
Exterior heat pump unit located on the western side of the house.

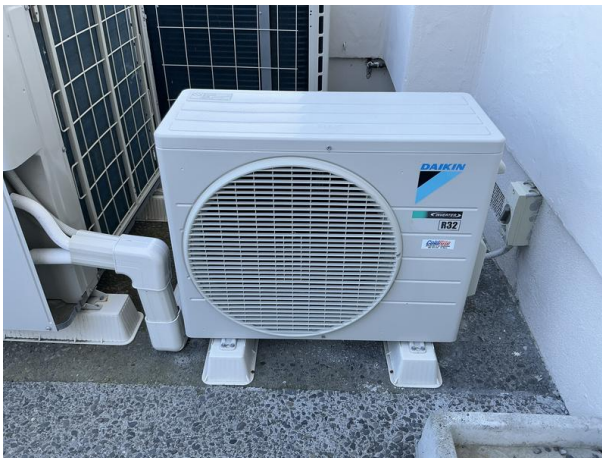
Photo 117
Exterior heat pump to service second story.

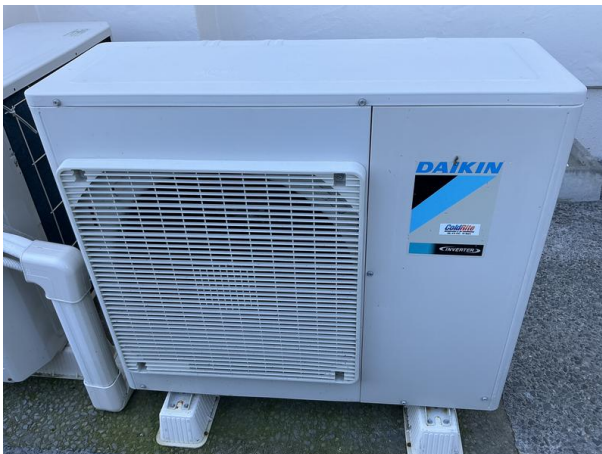
Photo 118
Exterior heat pump unit located on western side of the house.

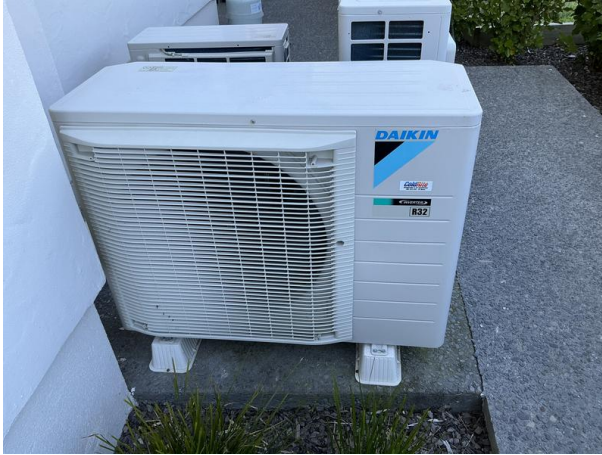
Photo 119
Exterior heat pump unit located on the western side of the house.

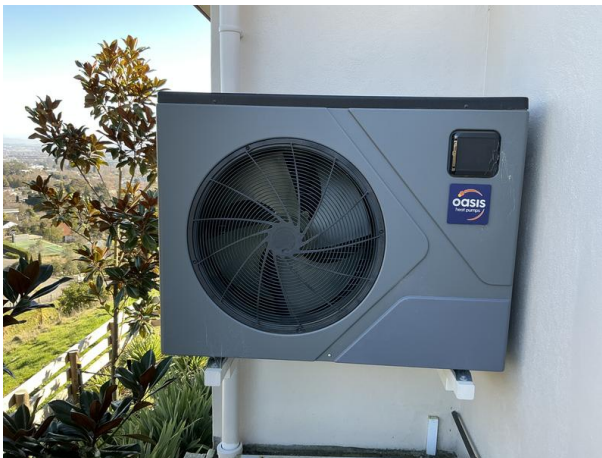
Photo 120
Heat pump for swimming pool.

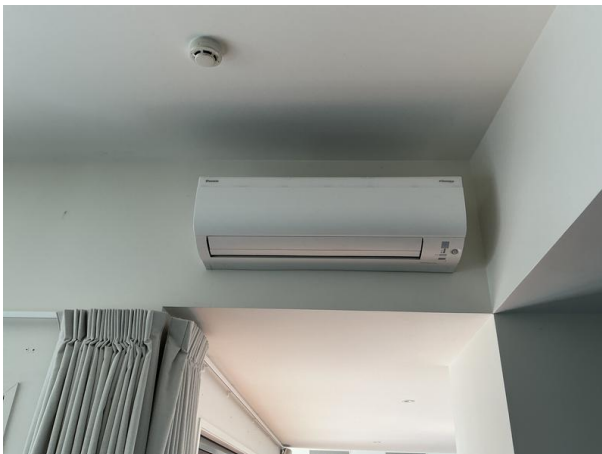
Photo 121
Heat pump unit in living room.

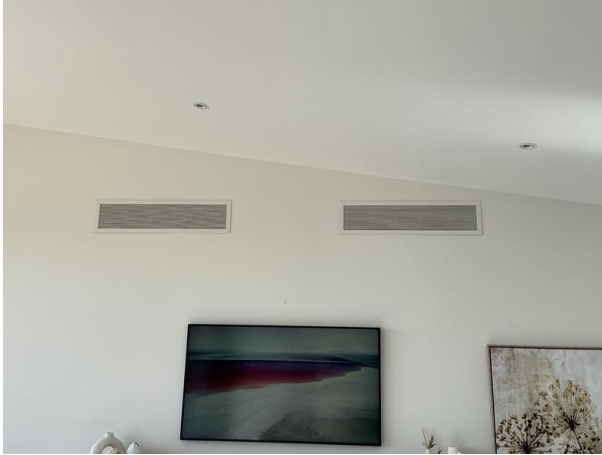
Photo 122
Heat pump unit in lounge.

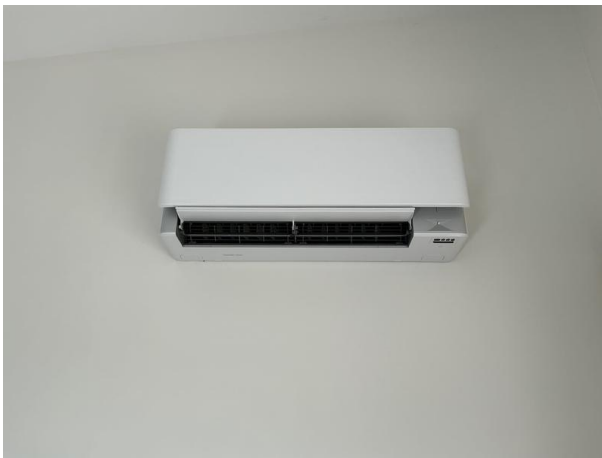
Photo 123
Heat pump unit in bedroom 1.

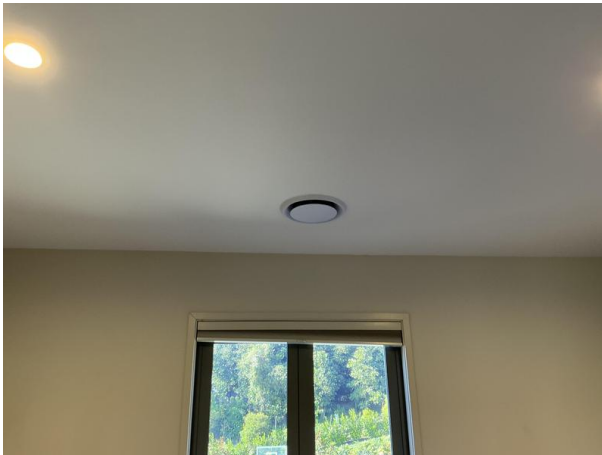
Photo 124
Ventilation duct for heat pump/ventilation system.

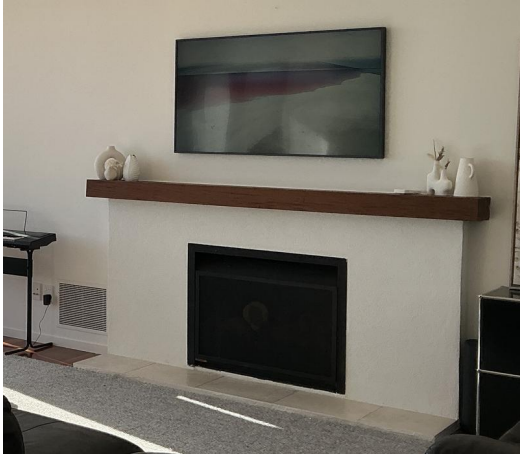
Photo 125

There is a woodburner fireplace in the lounge.

Check with territorial authority for solid fuel burners compliance.

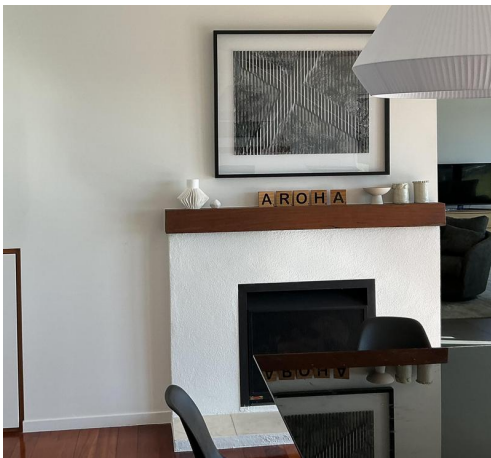
Photo 126

There is a decommissioned fireplace in the dining room with aerial cables routed through the flue.

It is recommended to seal the opening of the decommissioned solid fuel burner in the dining room to prevent unnecessary draughts. Also check that there is a chimney cap in place to prevent moisture entering the chimney.

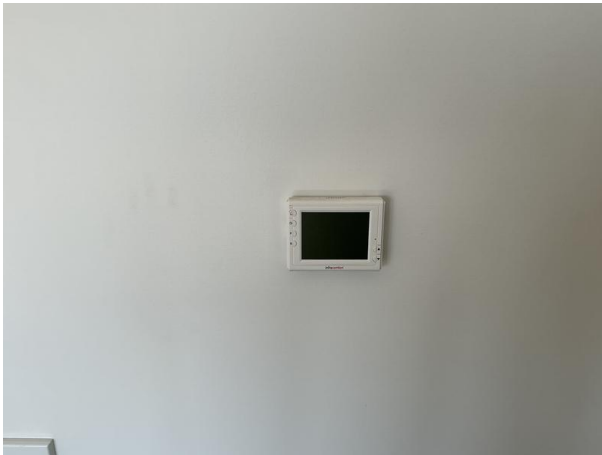
Photo 127

Control panel for heat pump in bedroom 1.

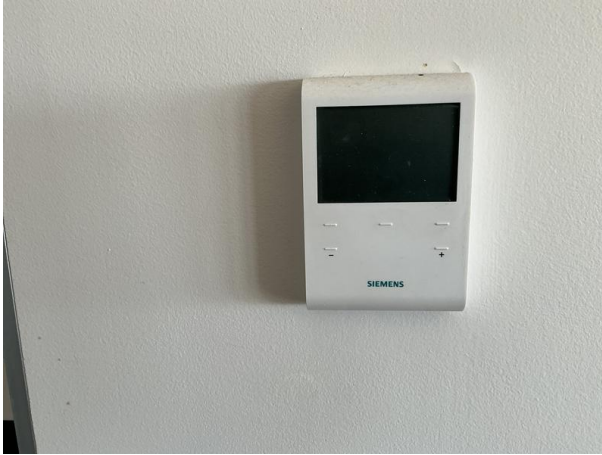
Photo 128

Control panel for heated flooring in kitchen. Disconnected.

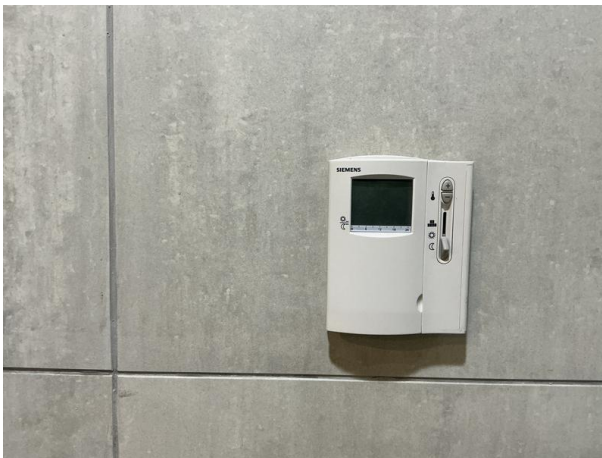
Photo 129

Control panel for under-floor tile heating in bedroom 1 ensuite.

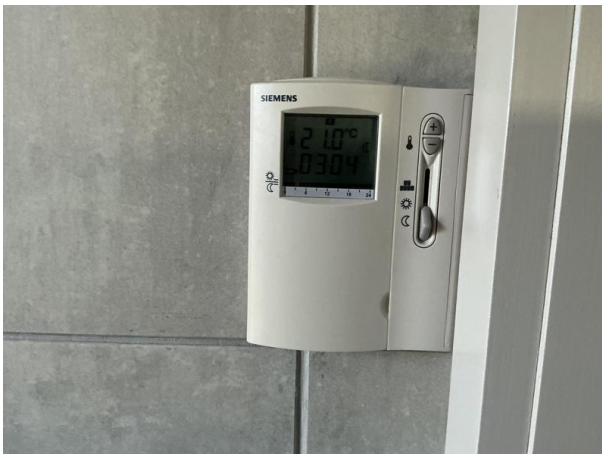
Photo 130

Control panel for under-floor tile heating in bedroom 2 ensuite.

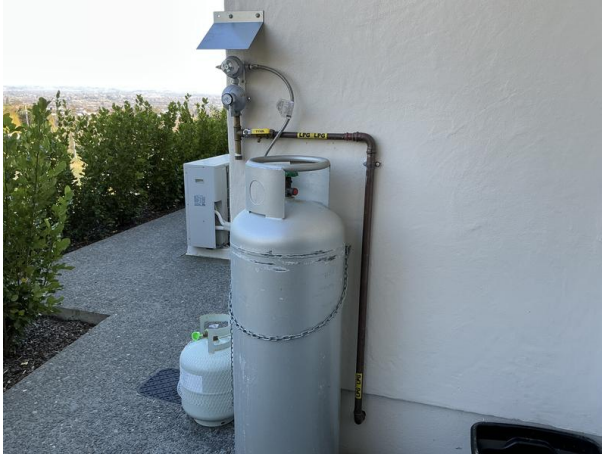
Photo 131

There is a gas bottle on the western side of the house to service the cooktop in the kitchen, the gas fire and cooker on the patio.

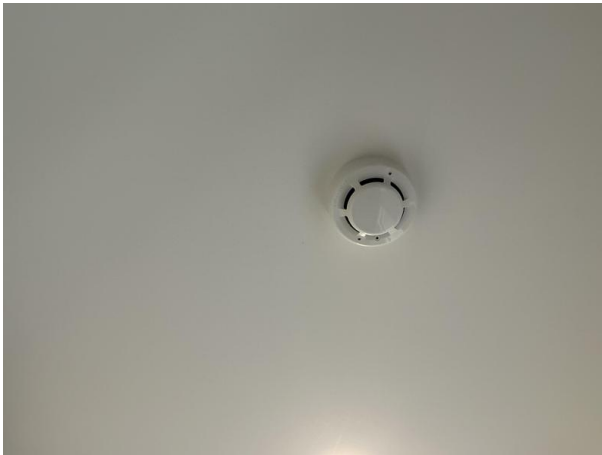
Photo 133

Interlinked smoke detectors throughout the home. Not tested.

Regular checks to ensure smoke detectors are functional.

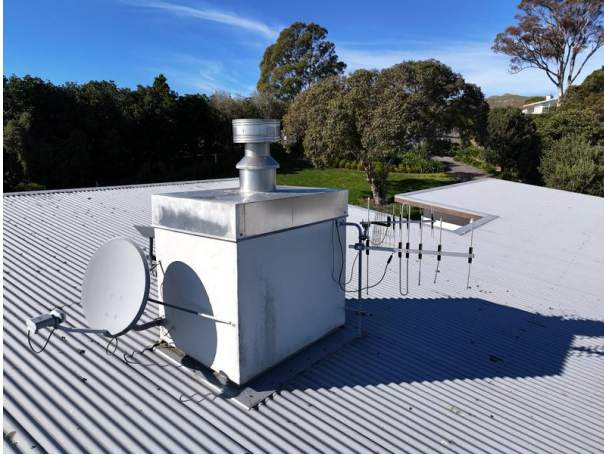
Photo 134

Sky and tv aerial fixed to chimney.
