## BUILDING INSPECTION REPORT

## RED LBP CONDITION REPORT

# CONDITION REPORT

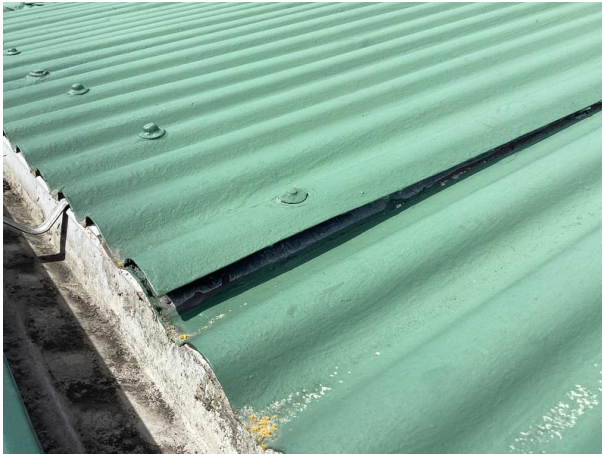
**Photo 4**

A few lifting lap joints were noticed around the roof system.

As detailed above, it is recommended to have a licensed roofer to advise further on this roof system. Further information on this roof system is also described in the roof space section of this report.

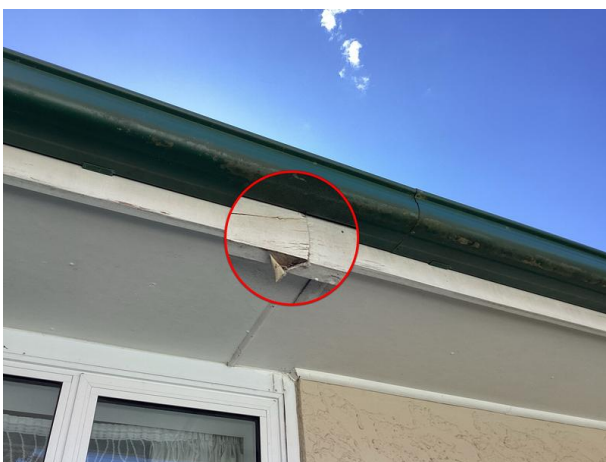
**Photo 12**

Example of paint flaking and timber splitting noticed on the south side of the dwelling.

There are areas of the timber fascia and fibre cement soffits that require sanding back any loose flakey paint, apply a sealer coat then redecoration to prevent further deterioration.

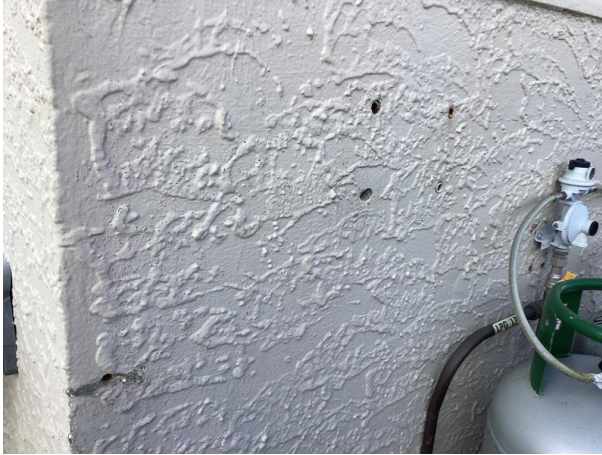
**Photo 20**

Unsealed penetration holes were noticed on the south side of the dwelling.

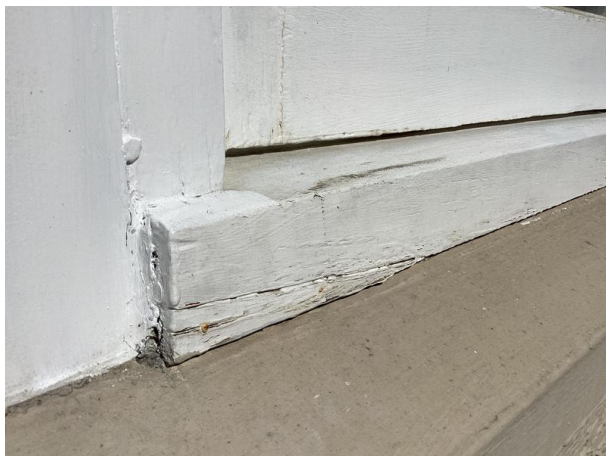
**Photo 26**

General ageing was noticed on some areas of the timber windows. Photo of the north side elevation.

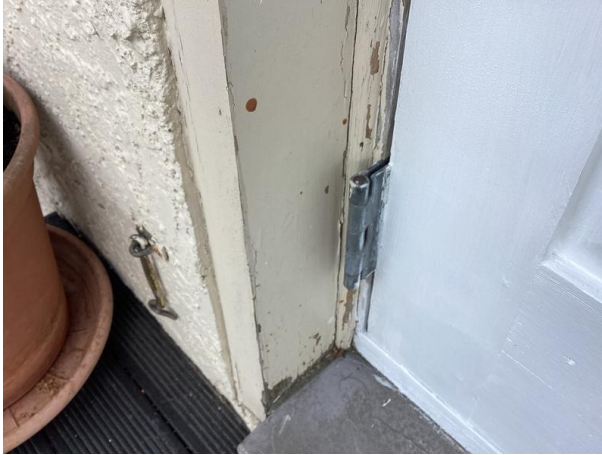
**Photo 27**

The West dining room timber doors are due for general maintenance.

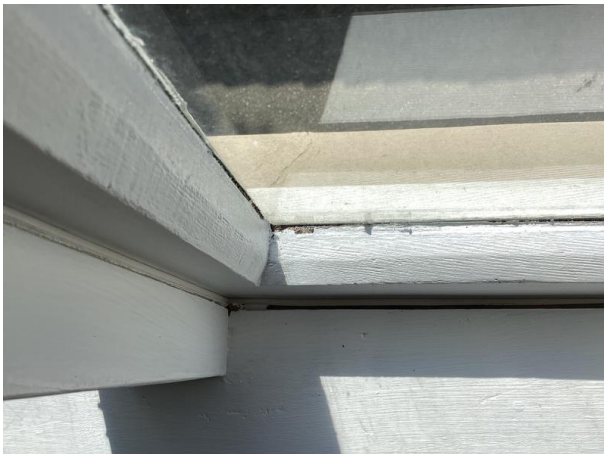
**Photo 30**

Some gaps were noticed between the timber window frame and windowsill. These areas have been sealed.

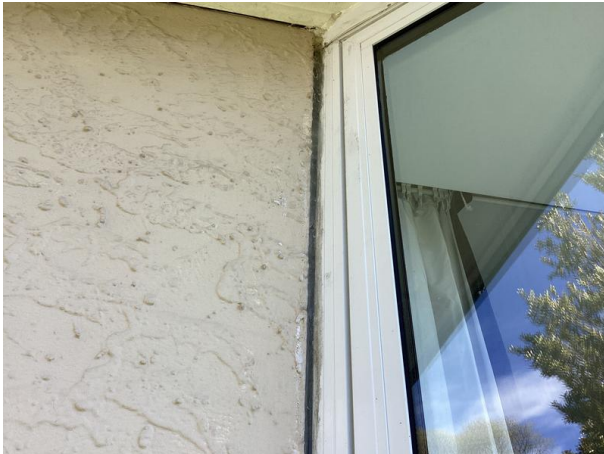
**Photo 32**

Ensure to keep the plaster to aluminium window junctions well sealed and maintained.

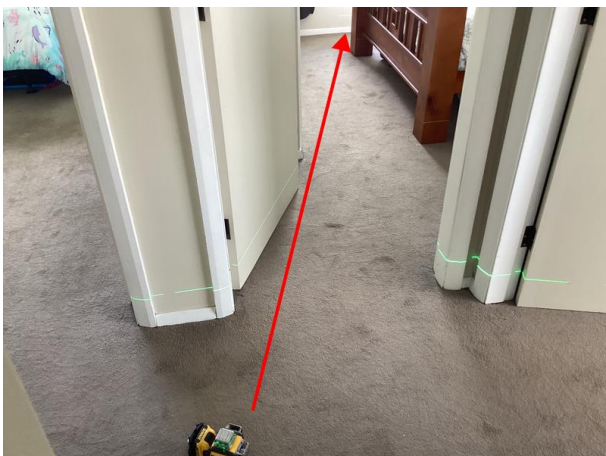
**Photo 39**

A 15mm difference was also noticed over a 4.3m distance in the other direction of the previous photo from the hallway into bedroom 2. A total of 35mm was noticed over the dwelling.

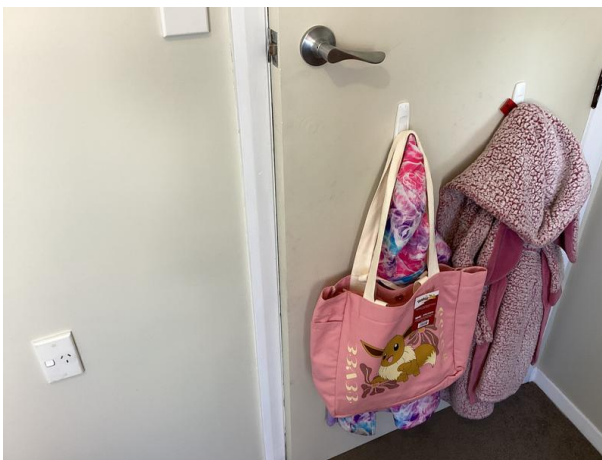
**Photo 66**  
The bedroom three internal door requires adjusting for better functionality.

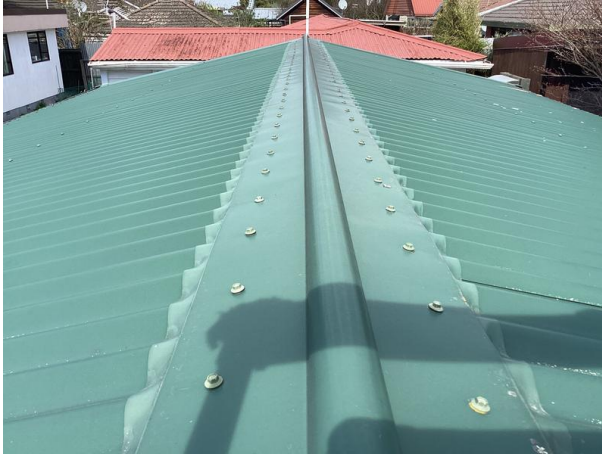
**Photo 75**

Metal roof with screw fixings is located over the garage.

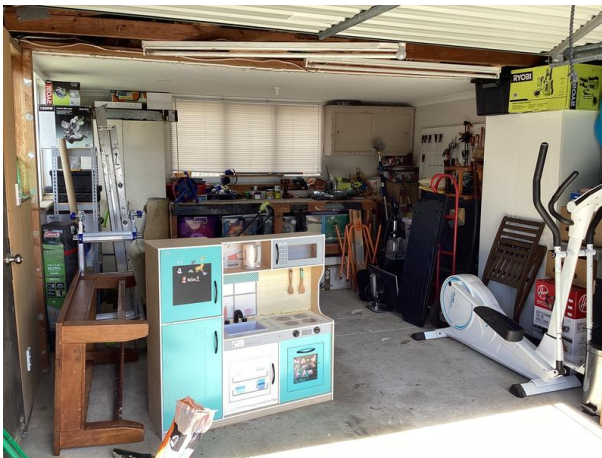
**Photo 76**

View of inside the garage. Limited inspection due to personal belongings.

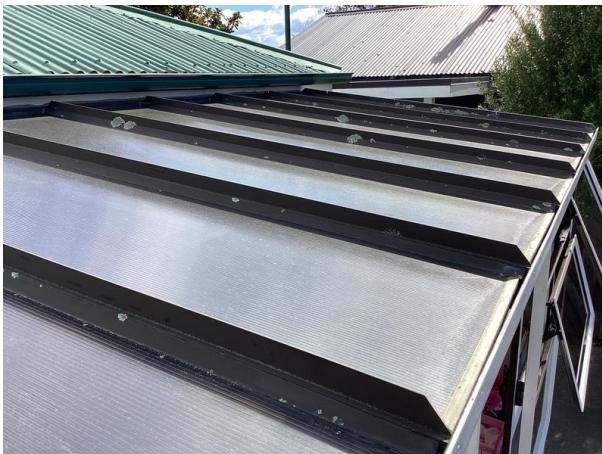
**Photo 82**

View of the conservatory roof. Minor areas of moss, mould or lichen was noticed.

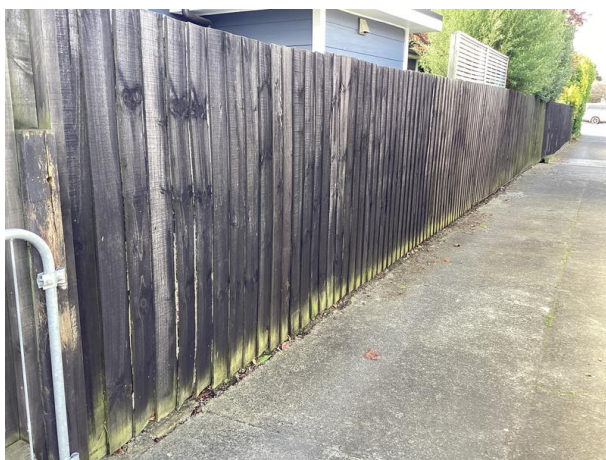
**Photo 88**

The timber fences are in a condition expected for age.

Ensure regular upkeep and maintenance by keeping vegetation and soil away from exterior timbers. These timbers are treated for external exposure but are not designed for prolonged contact with vegetation or soil, which can trap moisture and accelerate rot. Periodically inspect the area and clear any overgrowth or soil buildup.

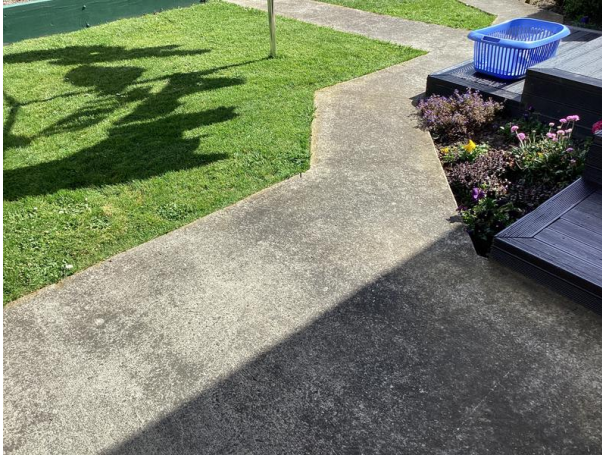
**Photo 89**

No significant issues with the concrete paths.

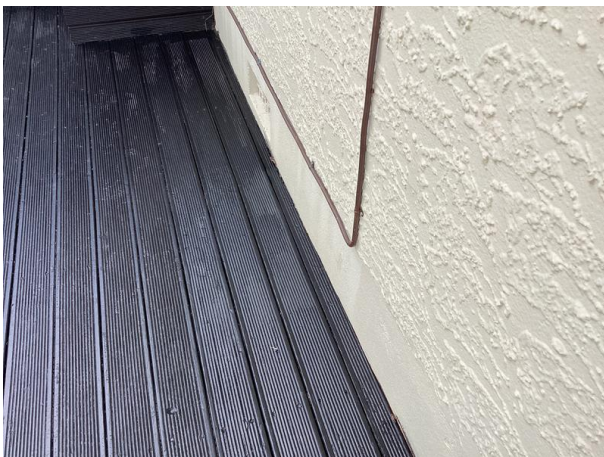
**Photo 91**  
Normally the deck would have been kept 12mm off the dwelling.

Trim back the decking from the wall cladding, the decking should be a minimum of 12mm off the wall cladding to prevent water pooling against the cladding and deteriorating the building elements.

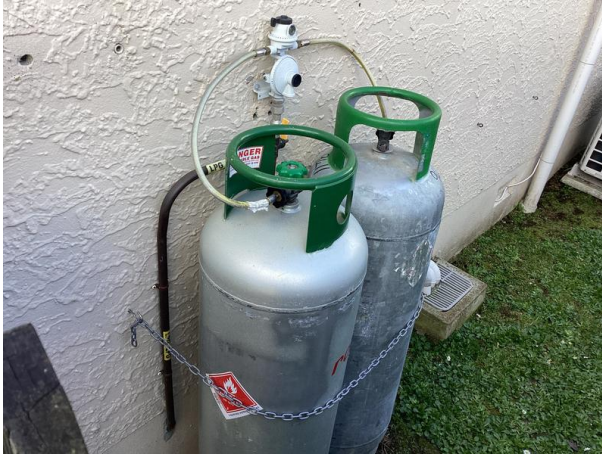
**Photo 93**

Gas bottle station located on the south side of the dwelling. Normally there is a cover installed above the bottles.

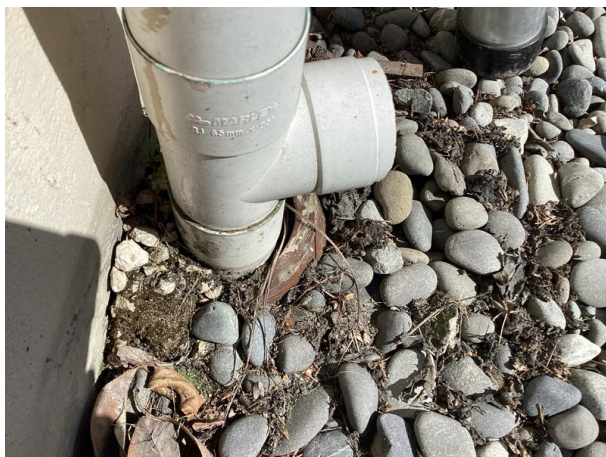
**Photo 96**

East side stormwater riser. Ensure the debris and vegetation is kept clear of the risers.
