## RED LBP PRE-PURCHASE REPORT

# CERTIFICATE OF INSPECTION IN ACCORDANCE WITH NZS 4306:2005

**Company:** Ragnarok Building Inspection Ltd trading as RedLBP Christchurch South  
**Client:** Rachel Bartlett  
**Date of Inspection:** 22nd August 2025  
**Site Address:** 29 Neville Street, Spreydon, Christchurch 8024  
**Inspector:** Shannon Faulkner  
**Qualifications:** National Certificate in Carpentry. Licensed Building Practitioner

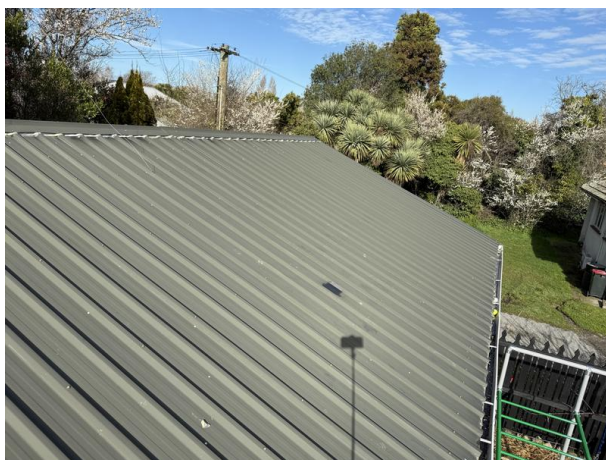
**Photo 3**

The roof is in a serviceable condition.

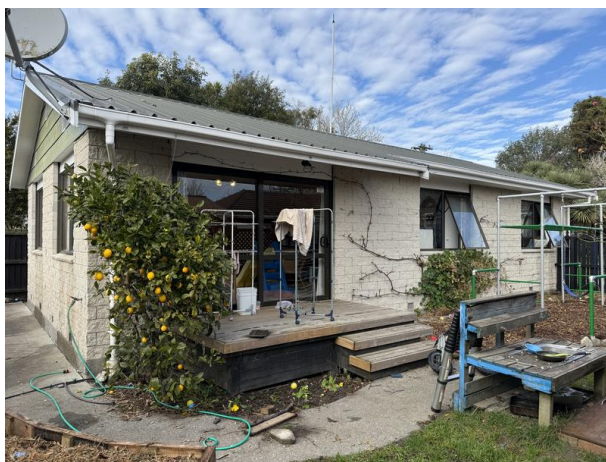
**Photo 14**

The dwelling is clad in a Summer Hill Stone veneer.

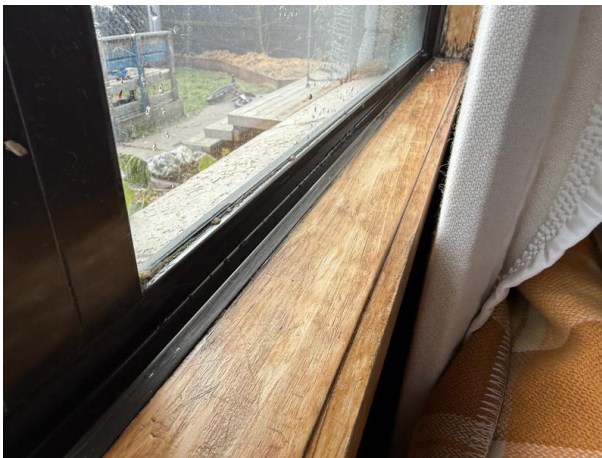
**Photo 24**

Some windows throughout the dwelling require cleaning at the time of inspection.

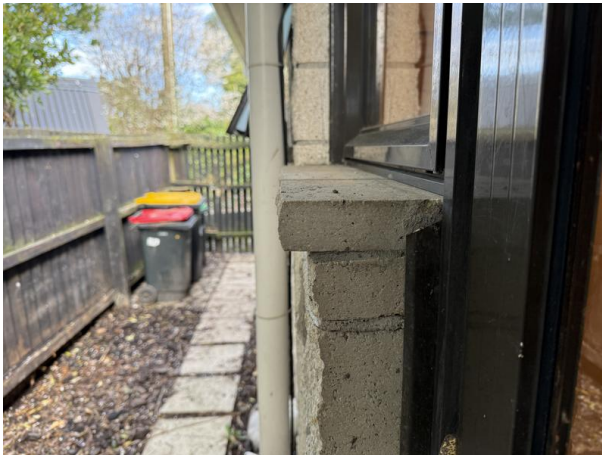
**Photo 25**

Most of the brick windowsills do not a 15° fall. The laundry window sill is flat.

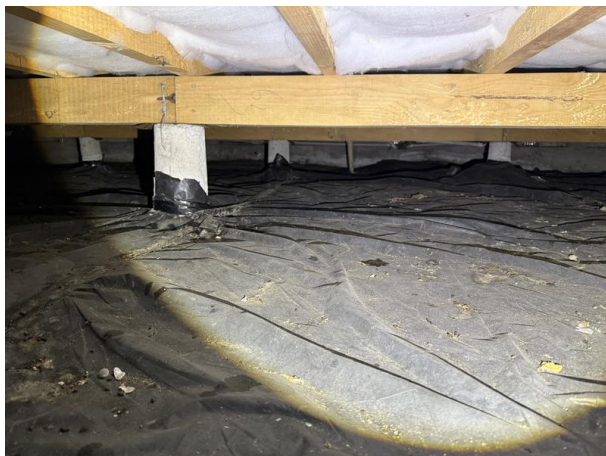
**Photo 26**

Subfloor view from access hatch—concrete piles and polythene ground cover visible.

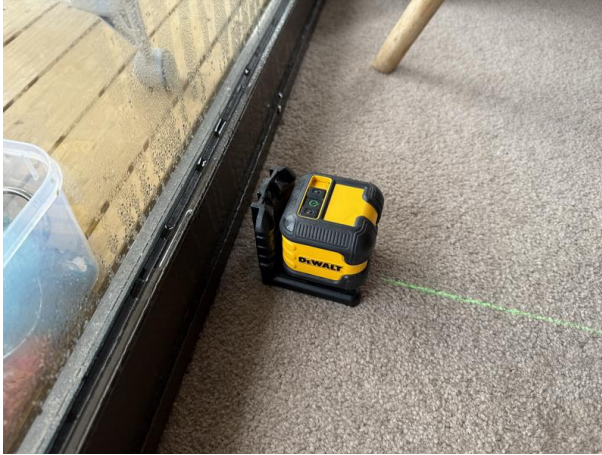
**Photo 27**

Floor levels were checked using a DeWalt self levelling laser. All measurements were within MBIE tolerances.

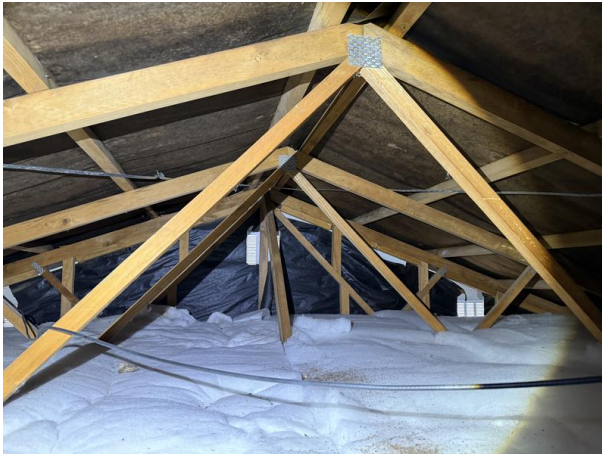
**Photo 28**

An example of the roof space.

Evidence of vermin activity was noted in the roof space. It is recommended to engage a licensed pest control specialist to implement an appropriate trapping or baiting programme and monitor effectiveness. Seal any identified entry points once activity has ceased to prevent re-infestation.

Damaged or torn roofing underlay should be repaired in accordance with the manufacturer's specifications to ensure it performs as intended and meets the requirements outlined under Clause B2 Durability of the New Zealand Building Code. Proper repairs are essential to maintain the underlay's role in providing secondary protection against moisture ingress, enhancing the roof system's overall weathertightness.

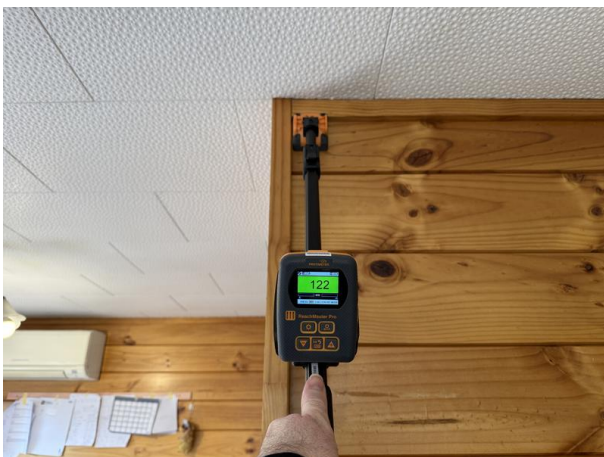
**Photo 33**

A base reading of 122 was taken from an internal wall using a non-invasive moisture meter. Based on industry guidelines, this is typically interpreted as a dry reading.

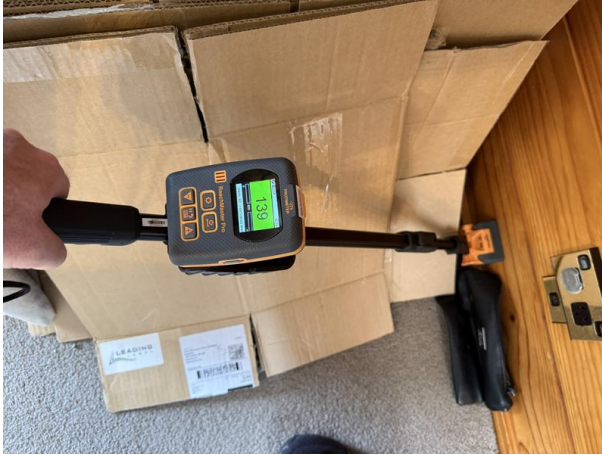
**Photo 36**

Supplementary moisture testing photo,  
no indications of elevated moisture.

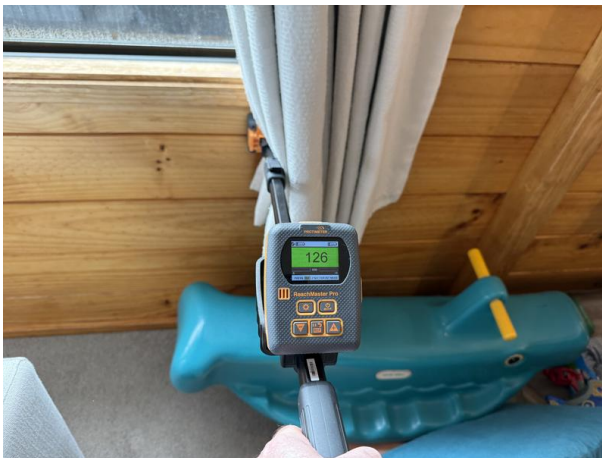
**Photo 37**

Supplementary moisture testing photo,  
no indications of elevated moisture.

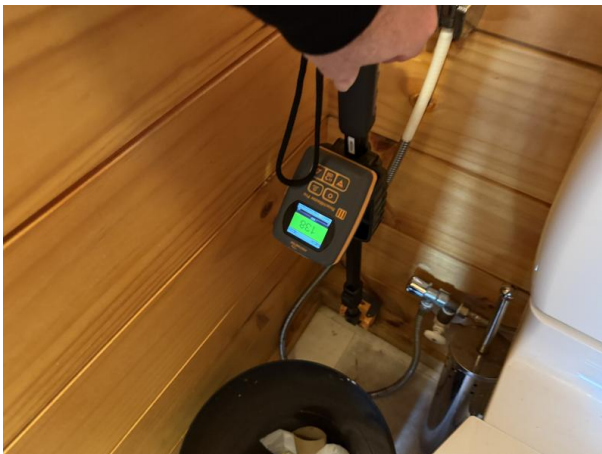
**Photo 38**

Supplementary moisture testing photo,  
no indications of elevated moisture.

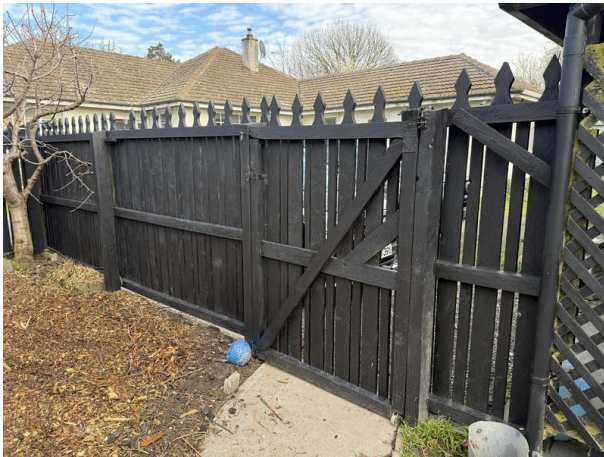
**Photo 54**

An example of the timber fence and gate to the northern boundary of the property.

Ensure regular upkeep and maintenance by keeping vegetation and soil away from exterior timbers. These timbers are treated for external exposure but are not designed for prolonged contact with vegetation or soil, which can trap moisture and accelerate rot. Periodically inspect the area and clear any overgrowth or soil buildup.

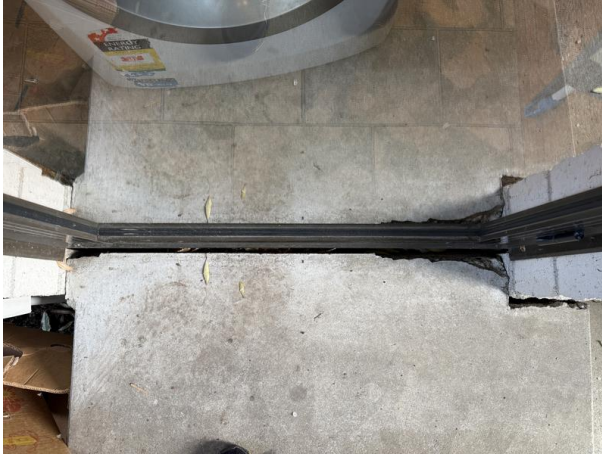
**Photo 59**

Concrete steps have pulled away from the dwelling leaving a gap at the back door. This may allow water to enter the subfloor space.

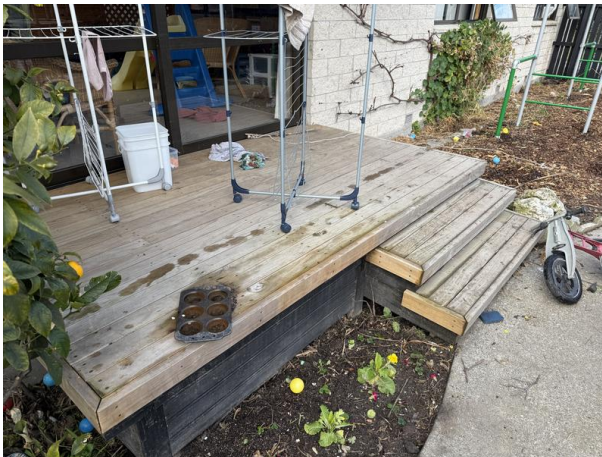
**Photo 60**

Deck - Functional.

General upkeep and maintenance.

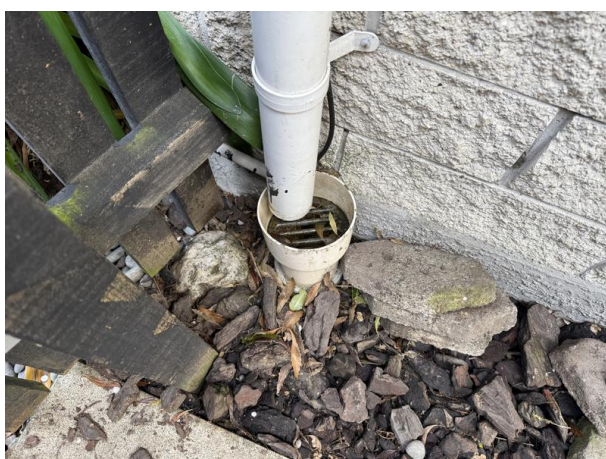
**Photo 63**

An example of a uPVC stormwater riser. All downpipes are discharging into the risers.

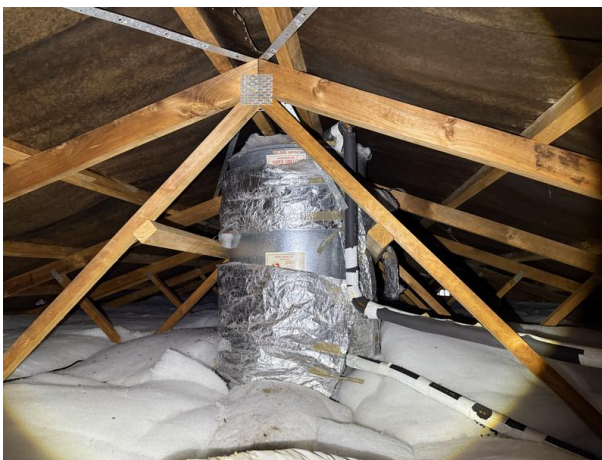
**Photo 65**  
Hot water cylinder located in the roof space. Timbers have been installed on two sides.

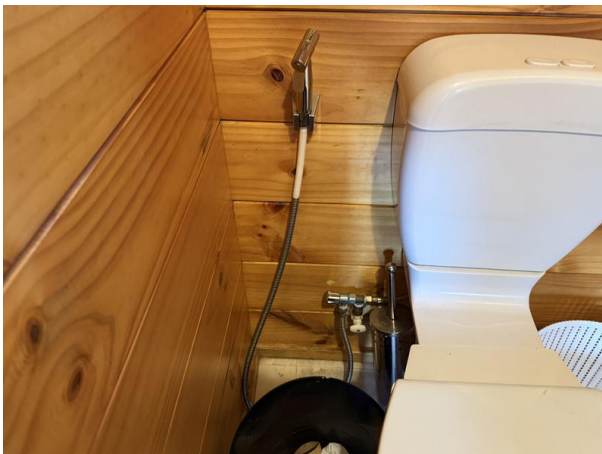
**Photo 66**  
Bidet sprayer installed adjacent to toilet with shared water supply

A handheld bidet sprayer has been installed using the toilet's water supply. While this is a common retrofit, it is recommended to confirm that the installation includes a backflow prevention device to comply with G12/AS1 and prevent potential contamination of potable water. If not present, a licensed plumber should install a suitable vacuum breaker or dual-check valve. Regular inspection for leaks or hose deterioration is also advised to prevent water damage to surrounding finishes

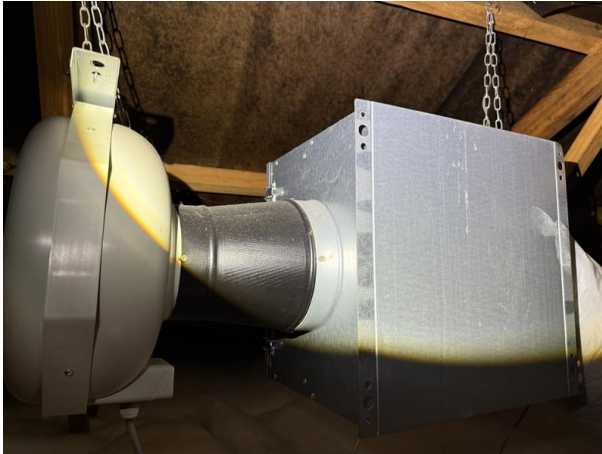
**Photo 69**

Ventilation system installed in the roof space.

Ventilation system filters should be inspected annually and replaced periodically or as required by the manufacturer.

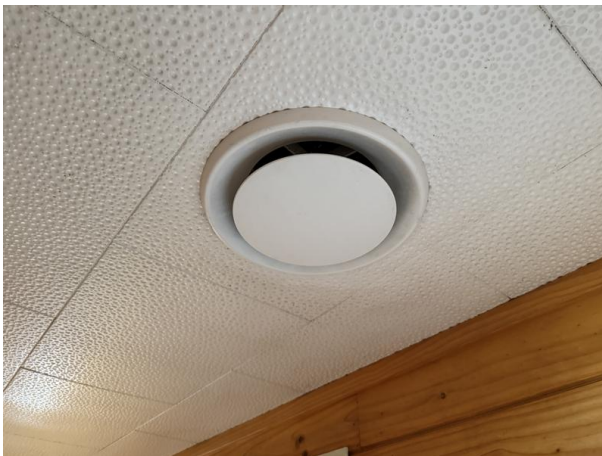
**Photo 70**

An example of a ventilation system vent.

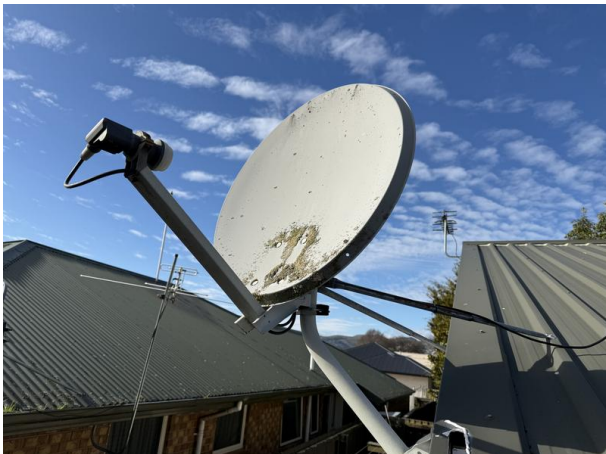
**Photo 71**  
Satellite aerial installed.

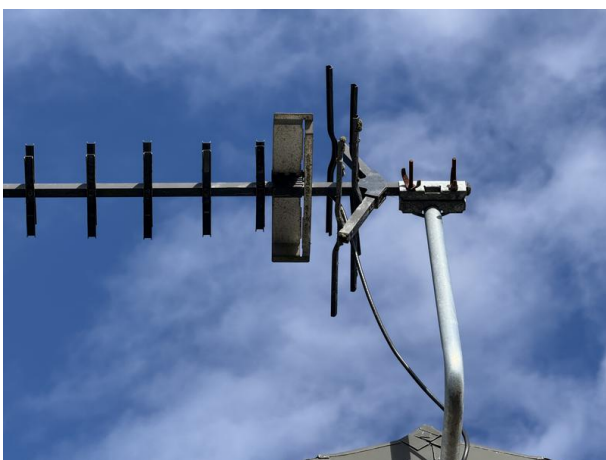
**Photo 72**  
TV aerial installed.

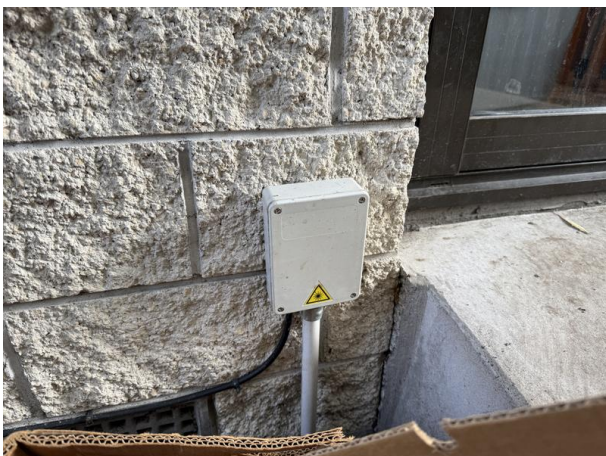
**Photo 73**  
Fibre connection to the property.

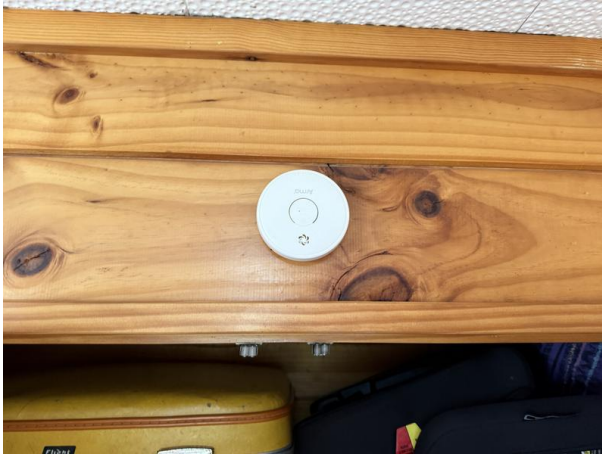
**Photo 74**  
An example of a smoke alarm.

Regular checks to ensure smoke detectors are functional.

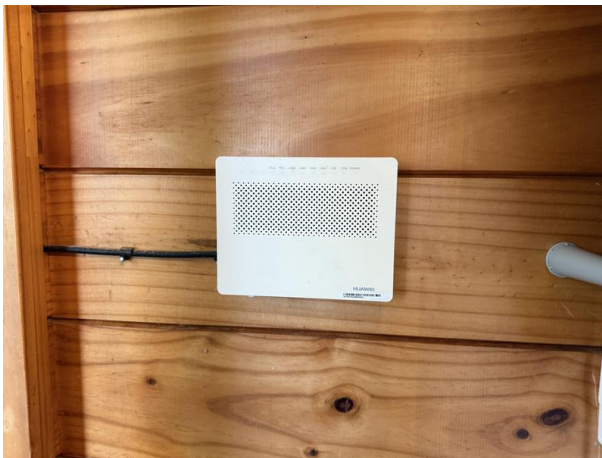
**Photo 75**  
Fibre ONT box located in the laundry.
