BUILDING INSPECTION REPORT

House Inspection at

51 Wayside Avenue Burnside

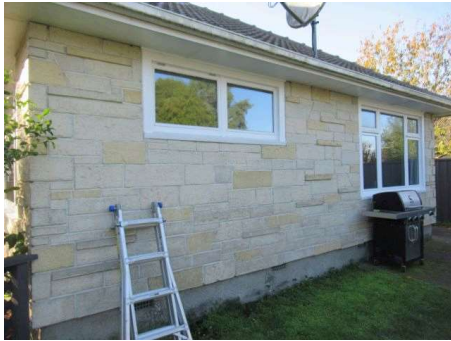
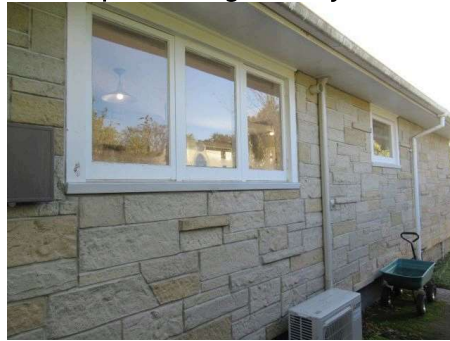
WALL STRUCTURE	TYPE	timber framed
	CONDITION	appears sound but unable to sight
	COMMENT	
BASEMENT	TYPE	not applicable
	FINISH	
	CONDITION	
WALL CLADDING	COMMENT	
	TYPE	Rock type sheetboard
	FINISH	natural
	CONDITION	generally good unable to determine condition of timber behind cladding.
	COMMENT	Step cracking/sheet joint movement noted

example of step cracking on cladding noted,

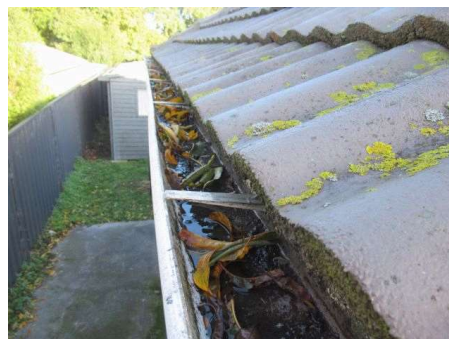
example of paint flaking on timber
fascia, will need painting in future

example of spouting requiring cleaned in
areas

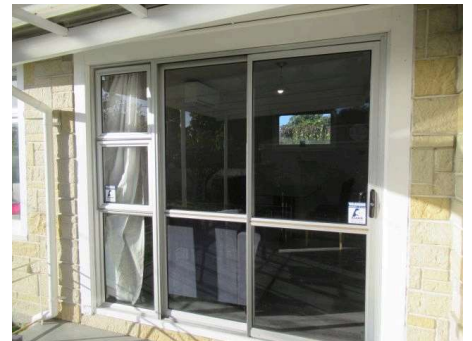
Side door

FRONT DOOR	FINISH	aluminium with glass double glazed
	CONDITION	generally good
	COMMENT	
BACK DOOR	FINISH	aluminium with glass double glazed
	CONDITION	generally good
	COMMENT	
OTHER DOORS	FINISH	aluminium with glass single glazed
	CONDITION	average to generally good
	COMMENT	rollers rumbling noted
EXTERNAL WINDOW CHECK	FINISH	timber single and double glazed, and aluminium single glazed
	CONDITION	generally good
	FLASHINGS	
	COMMENT	Gaps noted

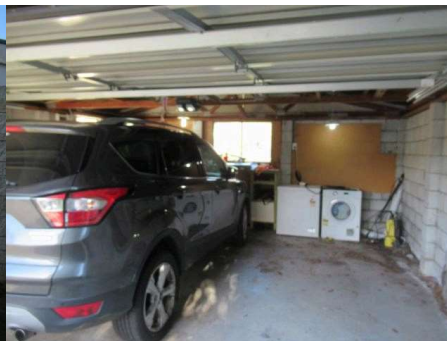
example of garage roof surface
rust/ clean/prime to prolong life,
check fixings
