## BUILDING INSPECTION REPORT

## 41 Parnwell Street, Burwood

17/09/2025

Property Inspected by Adam Brownie 027 914 9087  
Adam@inspectedresidential.co.nz Qualified builder and  
Licensed Building Practitioner  
National Certificate in Carpentry  
This inspection was carried out in accordance with  
NZS4306:2005

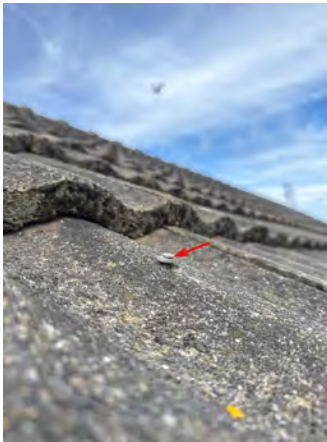
Example - check over tiles above barge boards and replace the popped nails with suitable roofing screws.

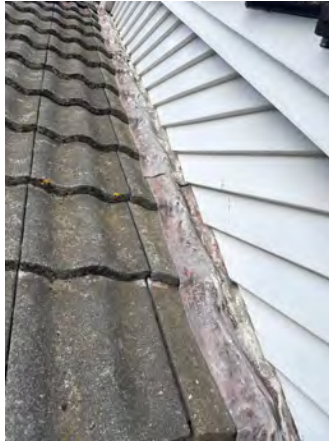
Example - typical cracking and separating to mortar on tile capping in places.

Crumbling mortar needs filling and tiles re-fit so they don't sit up.

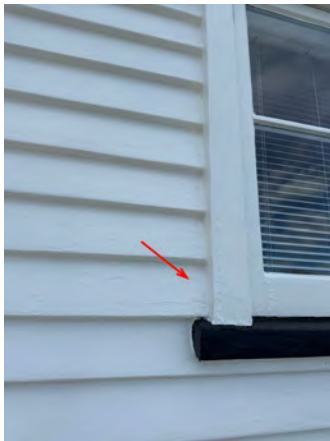
Some rot under paintwork here western corner.

Some rotting under paintwork here.

The weatherboards are predominantly okay with some typical aging; however the western elevation is showing some deterioration and several boards that have rotted and been painted over. Replace rotten boards where necessary. Several joinery frames have had heavy filler use or have current rotting. Check over and replace any frames that have rotted or have had significant filler used on them.

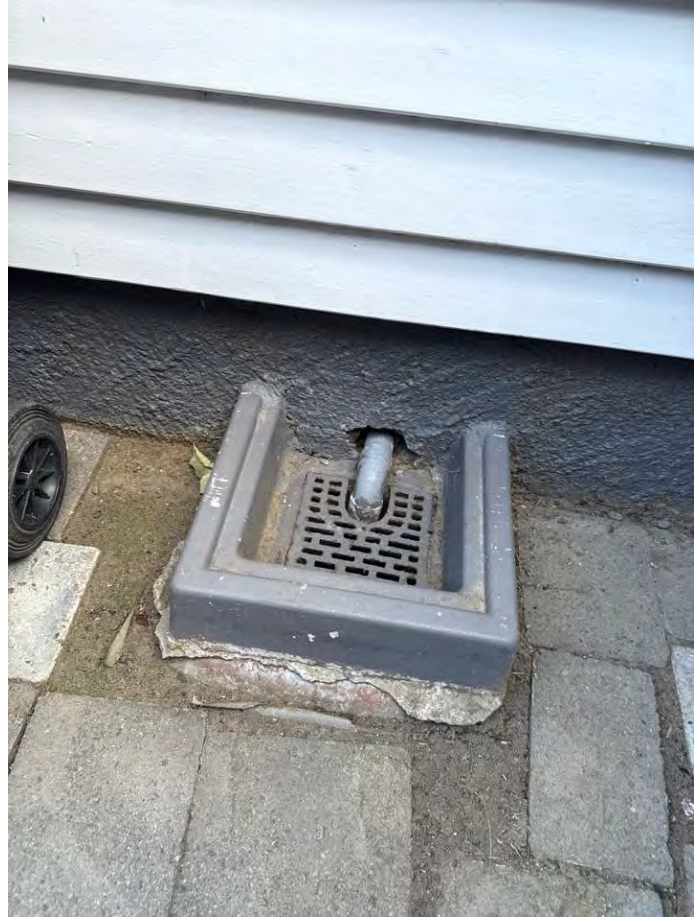
These gully trap pipes are above the grate and could be extended below the grate.

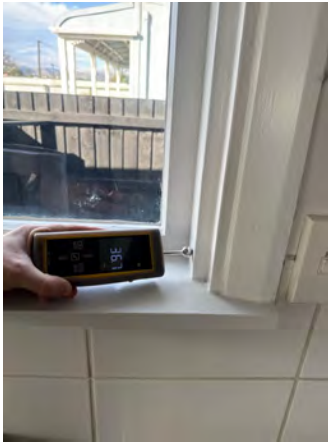
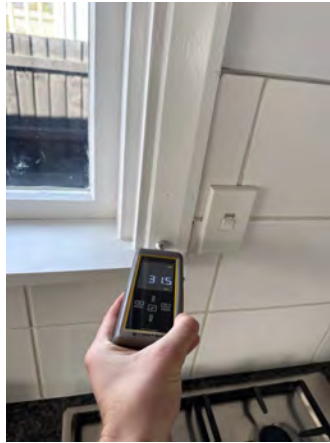
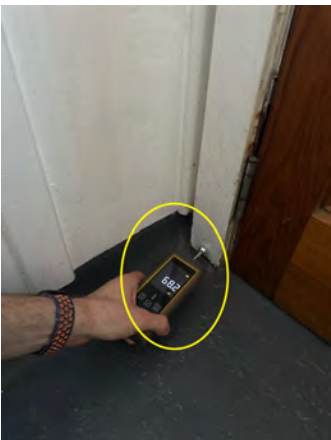
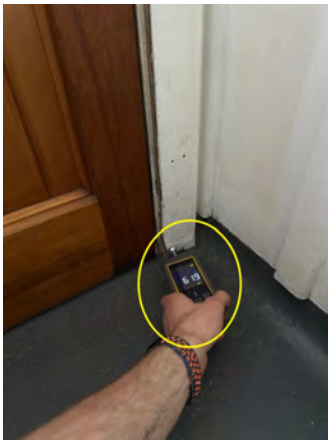
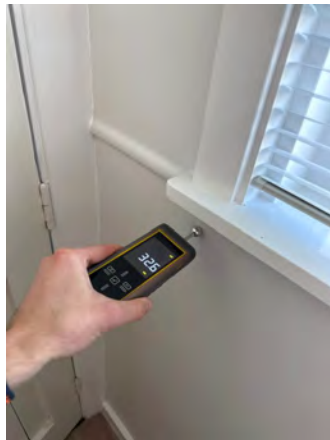
Slightly damp either side of rear door. Fit a better seal around here to help mitigate this. The timber is also likely drawing some excess moisture from the concrete. No other elevated readings taken.

Slightly damp either side of rear door.

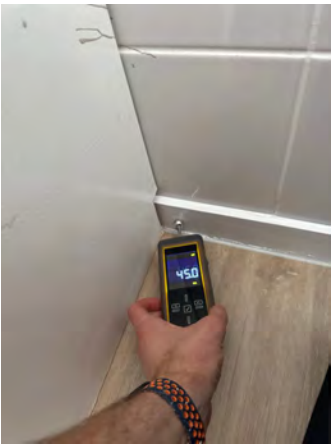
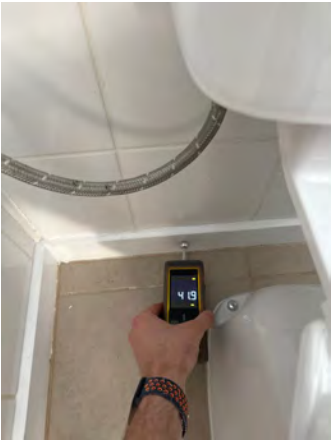
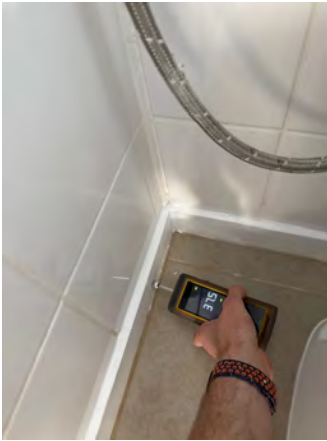
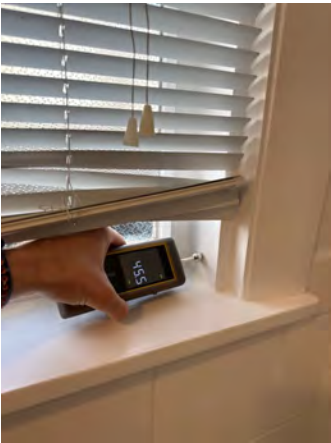
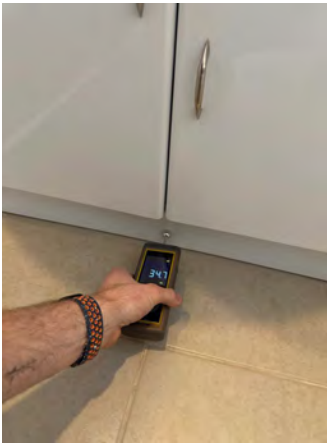
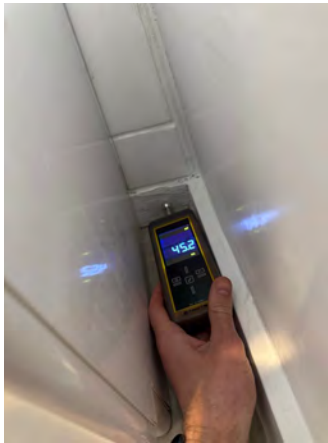
Some evidence of some previous water damage here.

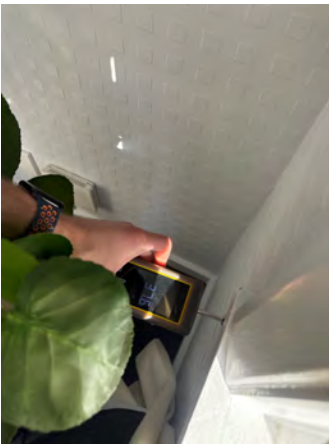
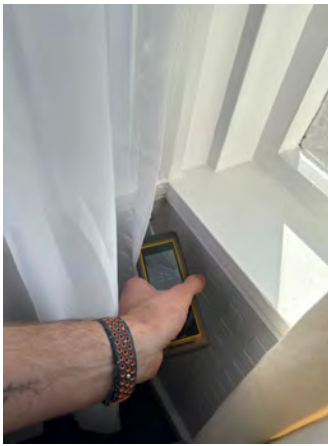
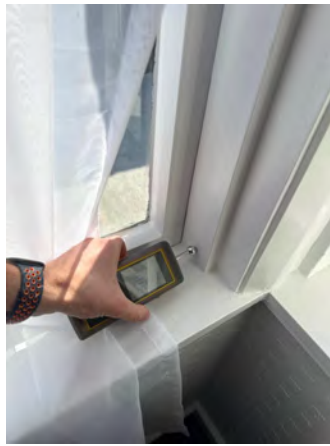
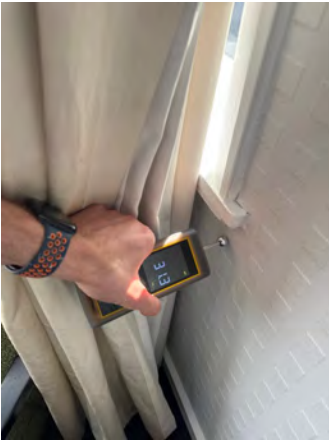
Behind shower.

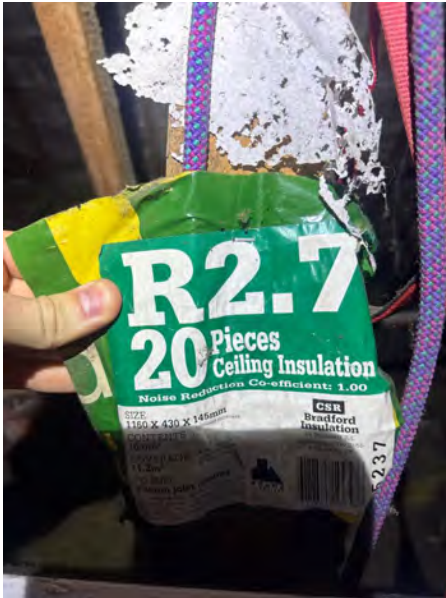
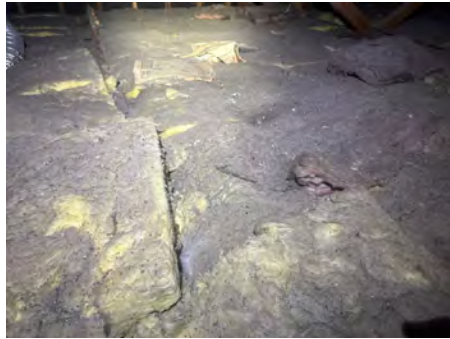
Some typical aging and compressing throughout.

Remove rubble from on-top of the insulation from demolished chimney.

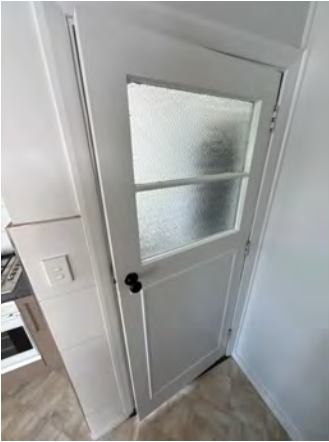
Latch return is a little weak.

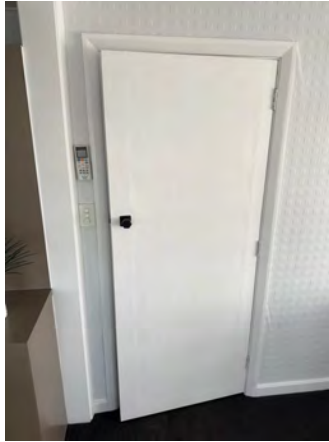
Adjust striker plate so door latches.

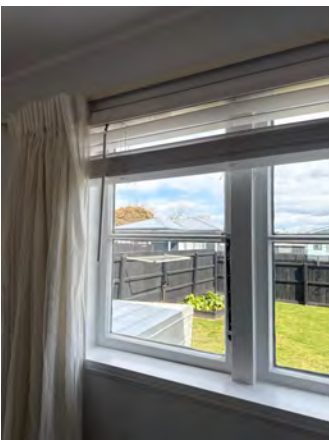
Window is jammed.

Windows that are jammed have likely been painted shut and need cutting to free them.

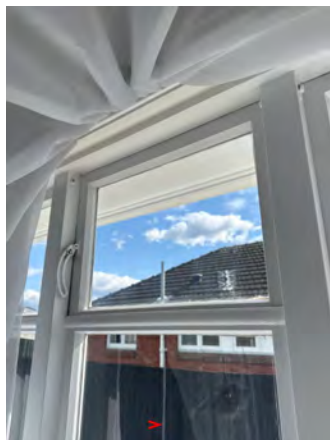
Window jammed.

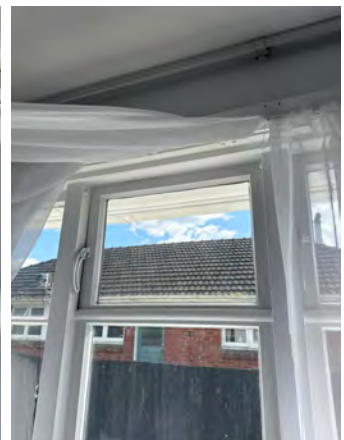
Window jammed.

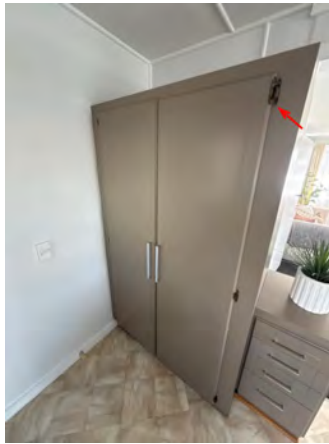
Re-attach hinge.

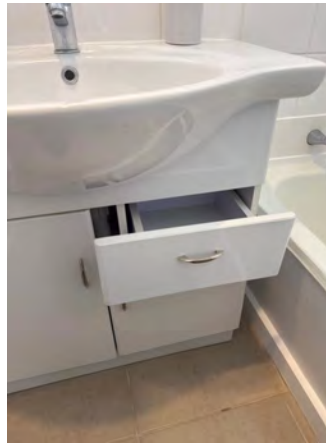
Top drawer isn't working and needs fixing.

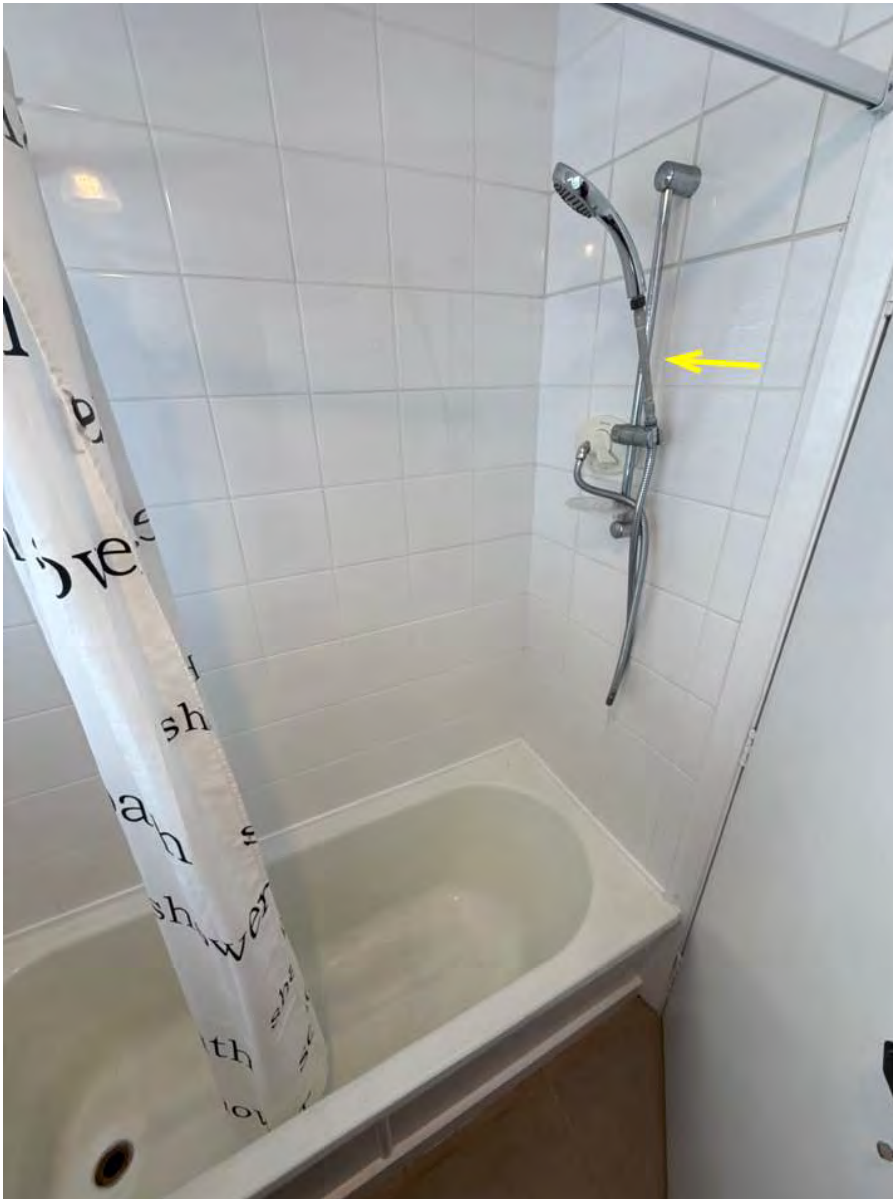
Shower head has been extended with a water supply pipe.

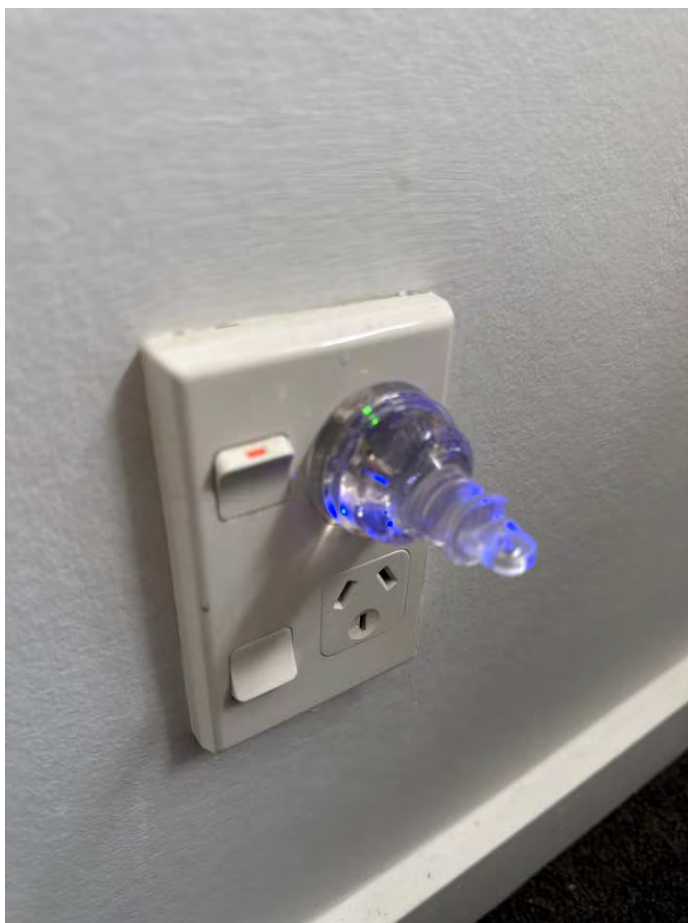
Example of test carried out.
