# Independent Builders Report

Total Home Inspection Services Porirua City Ltd

Fri 21 Feb 2025

**21 Matai Rd, Raumati South, Paraparaumu, 5032, New Zealand**

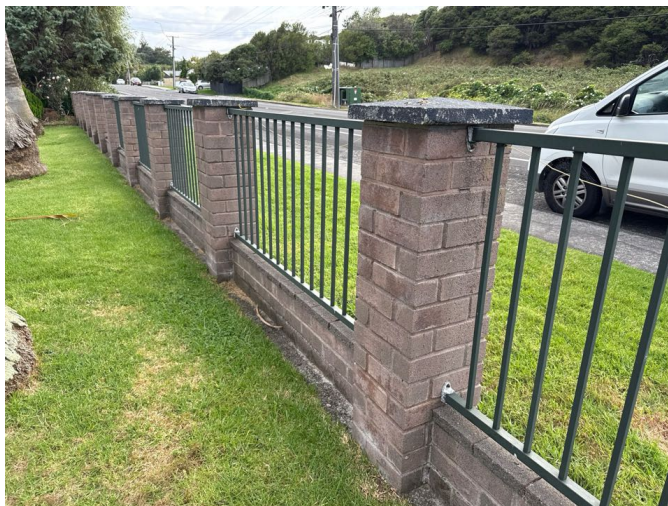
The brick and steel fencing is solid and secure

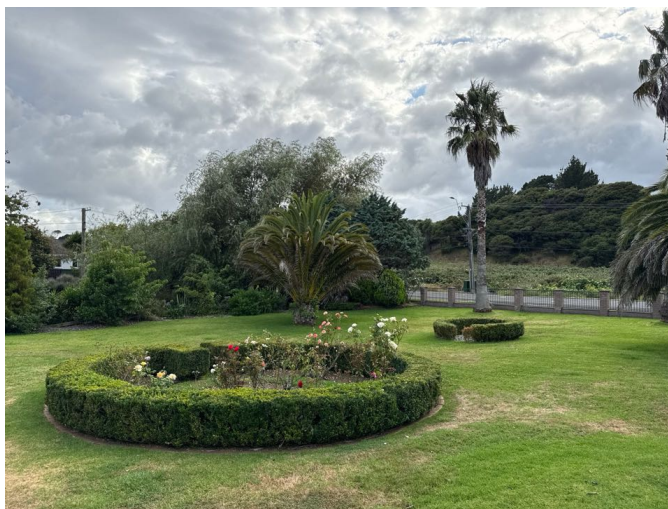
Well established vegetation to the section

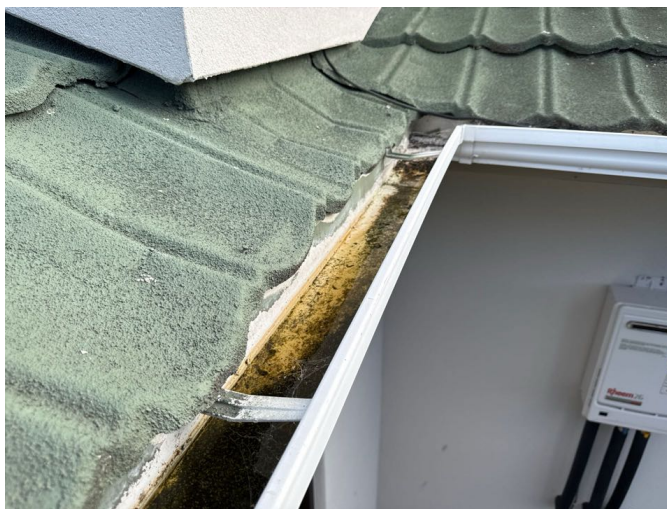
The spouting is in an average condition and are clear. The effectiveness of the spouting will need to be checked during rainy periods. Due to the dry conditions that were evident on the day of our inspection we cannot comment on any leaks that maybe evident to the spouting or down pipes.

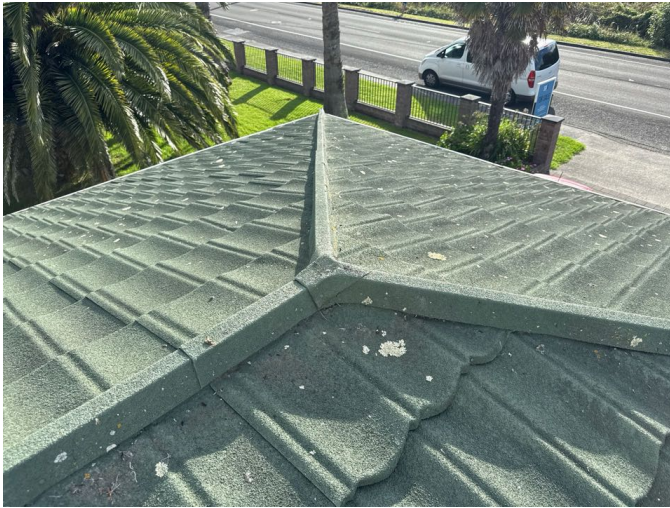
The roof flashings appear to be secure, intact and are effective. No sign of failure could be found beneath where accessible to view.

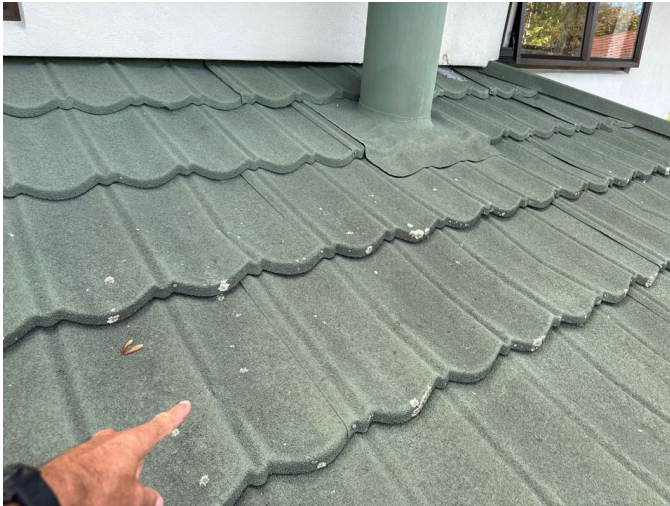
There is a split tile near the main flue which should be replaced

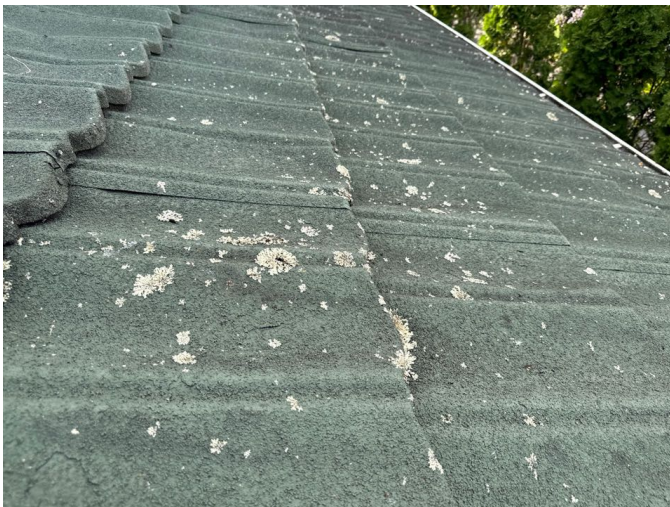
The Lichen growth should be chemically treated to prevent it spreading.  
The spraying of Lichen with a chemical treatment is recommended every 2-3 years as part of ongoing roof maintenance. Lichen growth will speed up deterioration to the roof surface and will need to be monitored and treated as required.

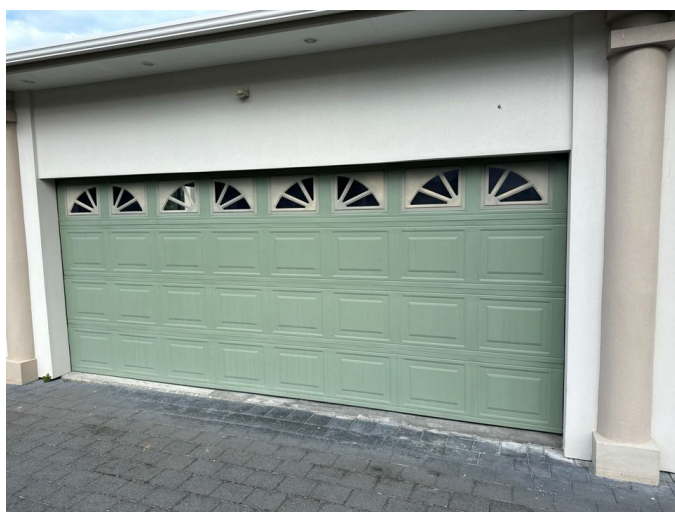
The surface condition of the garage door is good

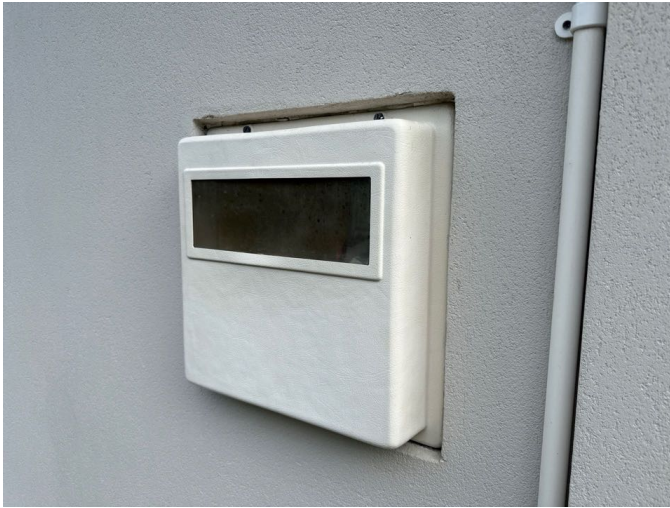
Cladding penetrations in general are a weather tightness risk area. Penetrations such as taps, screw fixings, gas or water pipes etc. A good seal must be maintained around all cladding penetrations over time to prevent issues.

No evidence of failure could be found.

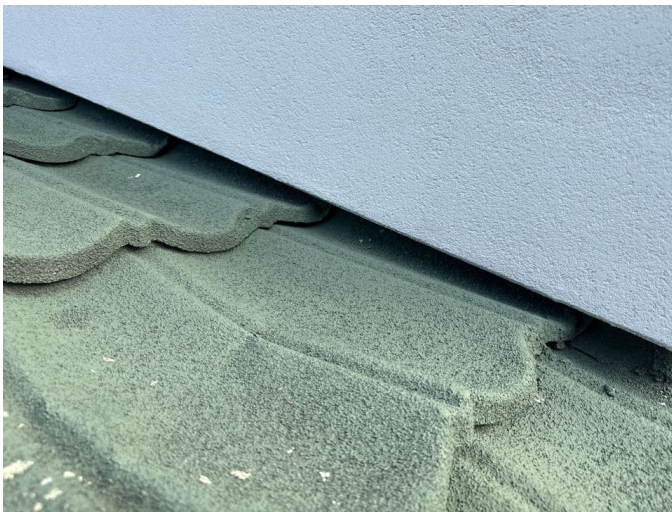
Reasonable clearance between the roof and the cladding

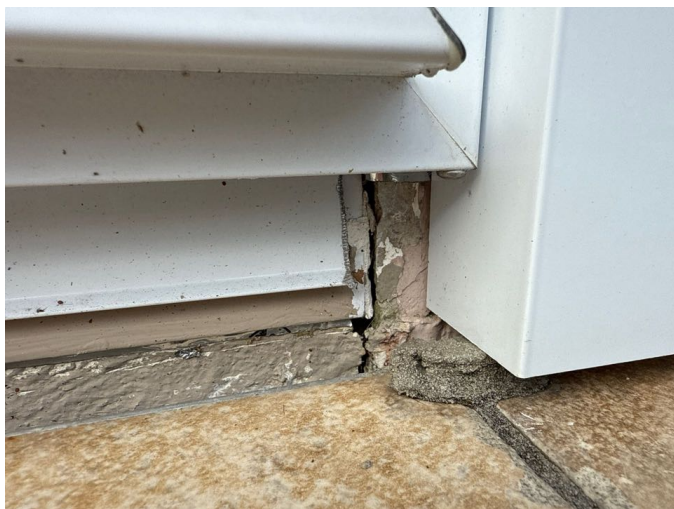
The gaps in the base sheets should be water proofed better. Installing face soakers would be a good improvement.

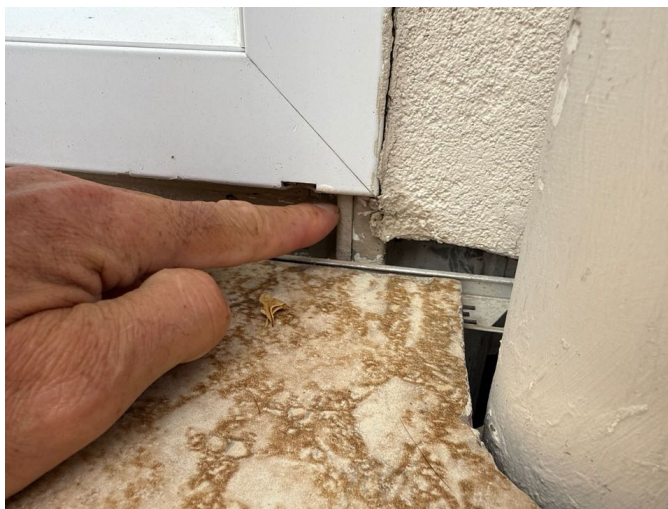
A side flashing was sighted on the right side of the single glazed aluminium door unit. These are an effective water proofing detail however we are unable to confirm the present of these at all locations.

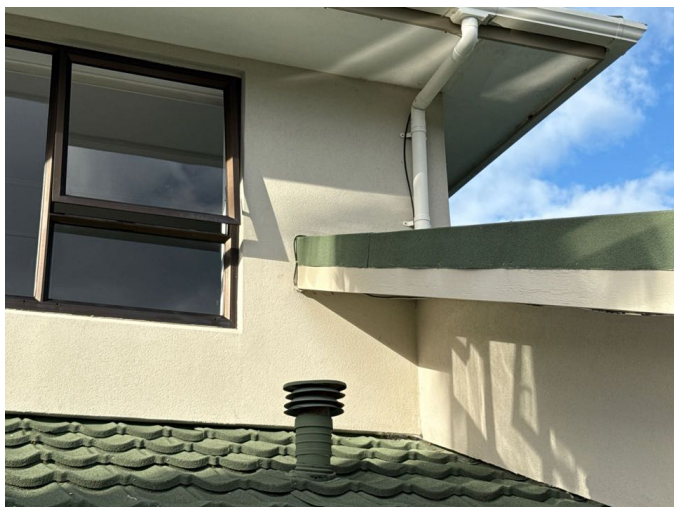
The barge board/cladding junction is a common weather tightness risk area which must be kept thoroughly sealed

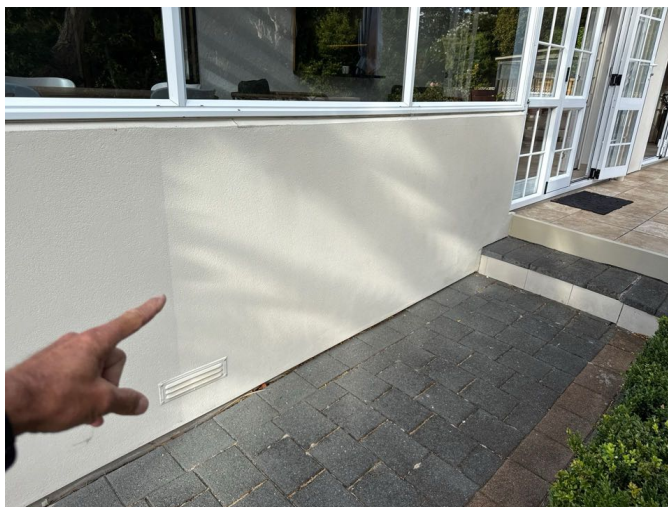
This section of EIFS cladding is loose and bulging out slightly. This has resulted in the creased appearance at the join. This section should be secured better by a qualified EIFS installer/experienced licensed builder.

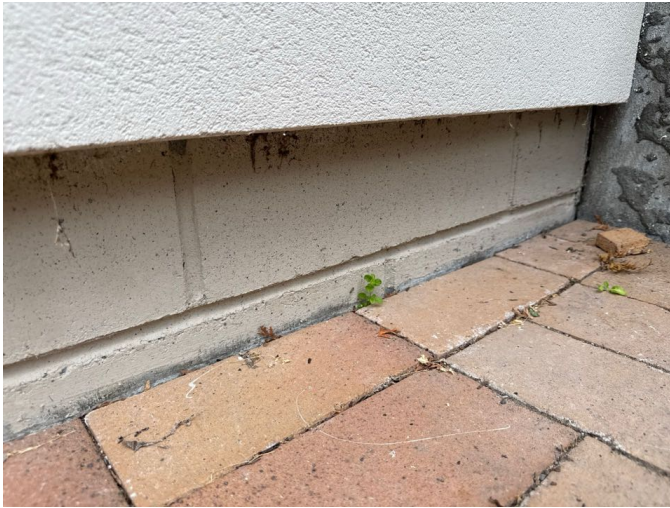
Very limited space to sight the concrete block foundation but where visible it appears solid. No damage or significant deterioration could be found at the time of inspection.

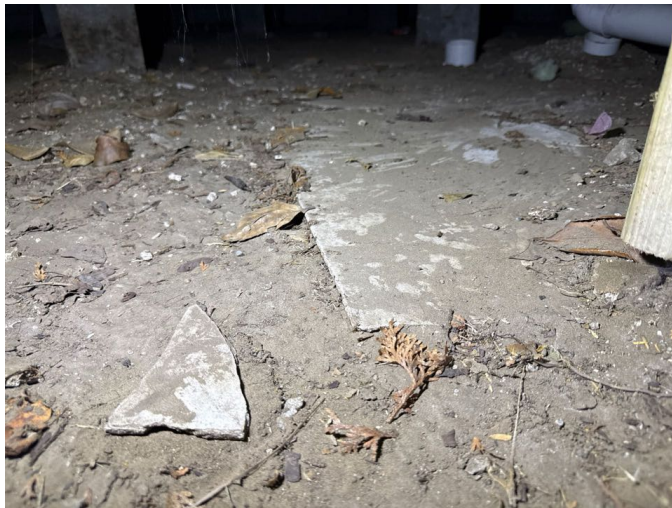
Asbestos pieces sighted in various locations. The Asbestos should be safely removed by an industry professional and certified safe before anyone enters the area.

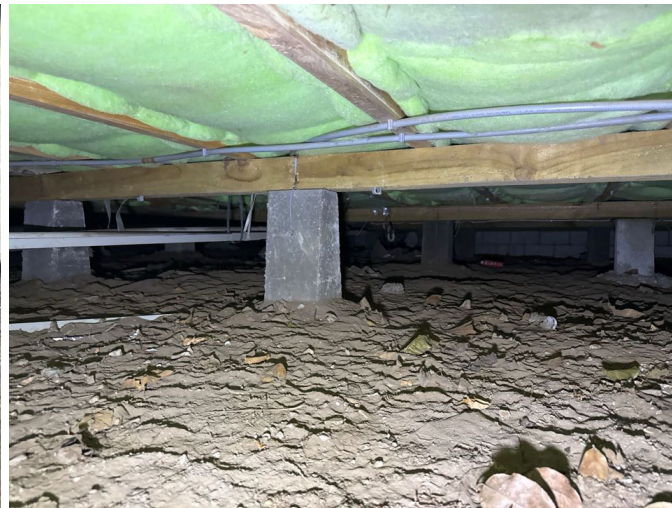
The concrete piles are solid at the time of inspection. Galvanised wire connects the bearers to the piles and anchors the structure to the ground.

Polyester insulation is installed in the sub floor. No labelling present to indicate the R-Value of the material.

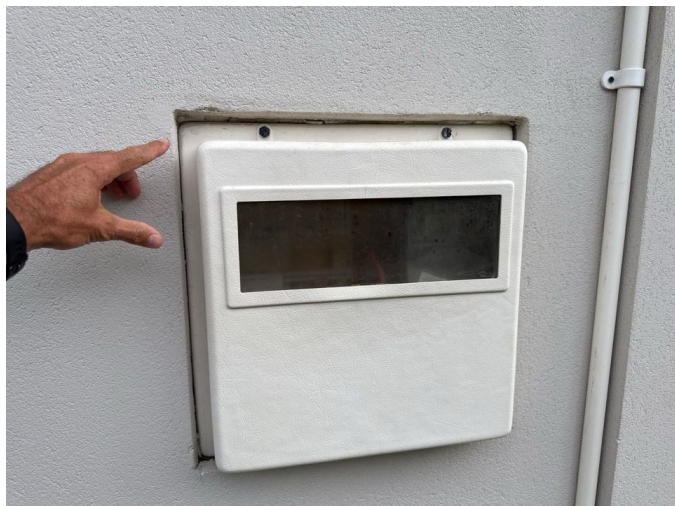
No flashings around the meter board. This is a potential weather tightness risk. The cover should be removed so the gaps can be sealed.

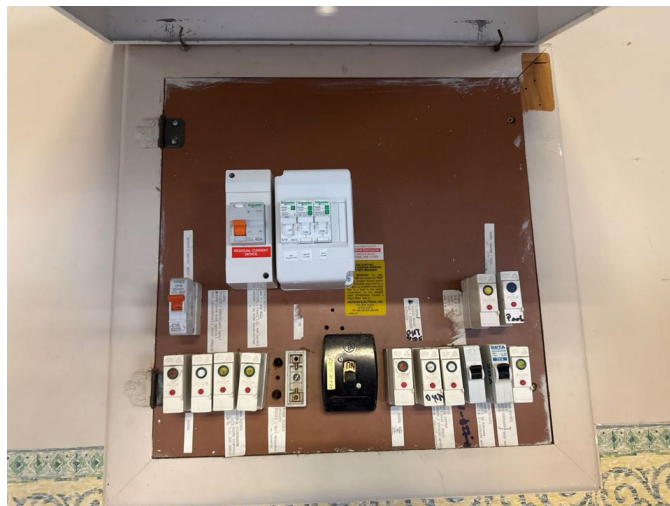
A visual inspection of the electrical system did not show any evidence of electrical overload to switches or power points. Cover plate(s) were not removed and the wiring behind the distribution board not inspected. This is beyond our scope of expertise. Please note. The assessor is not a registered electrician; no electrical safety tests or electrical component tests were undertaken. Power points, lights and switch testing therefore does not form part of this report.

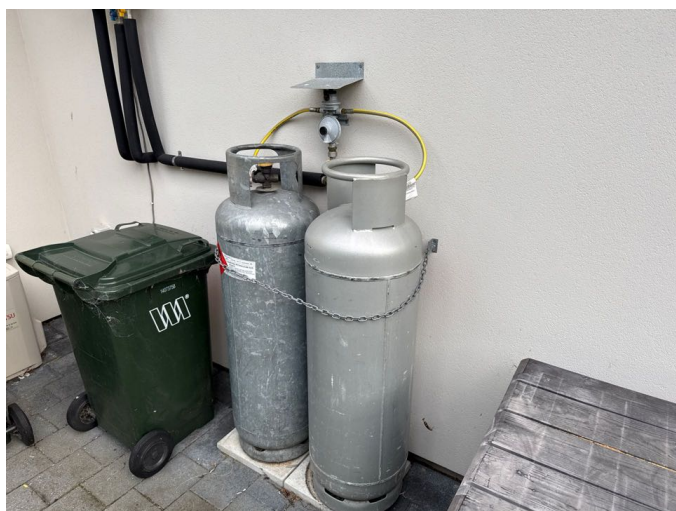
The gas system is not tested as part of this inspection. T.H.I.S recommends that gas appliances are serviced regularly to ensure correct combustion, maintaining optimum efficiency and correct performance of safety devices prior to use.

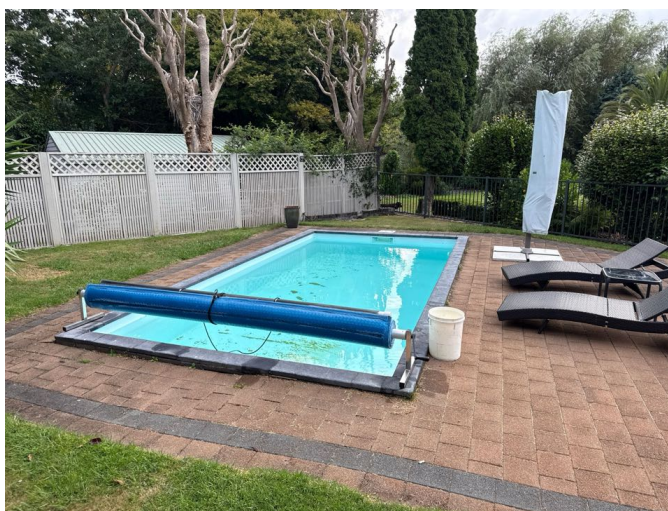
The condition of the pool, filtration or heating were not checked as part of the inspection process. The pool fencing was not checked to determine if it complies with the pool fencing act.

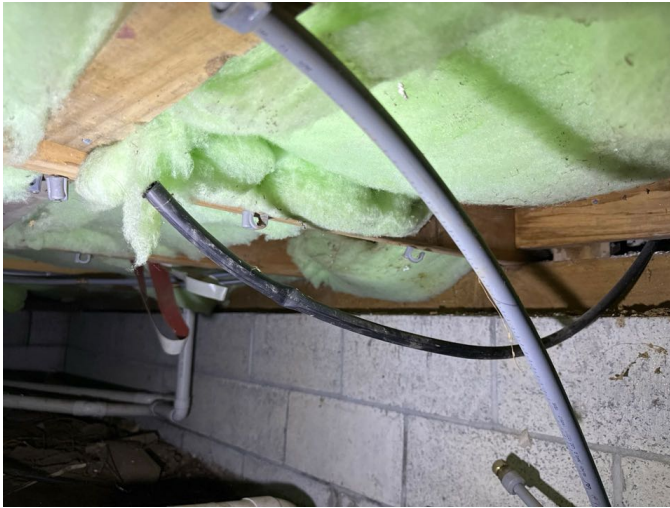
Most Dux Qest appears to have been replaced

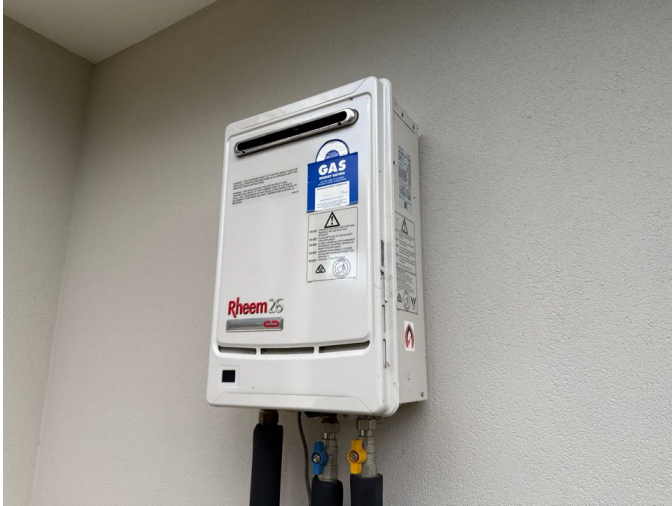
South side.

For reliable operation, gas continuous water heaters in residential applications should be serviced every two years. Servicing and repair should only be carried out by authorised personnel. No visible signs of issues that may affect the performance of the gas water heater.

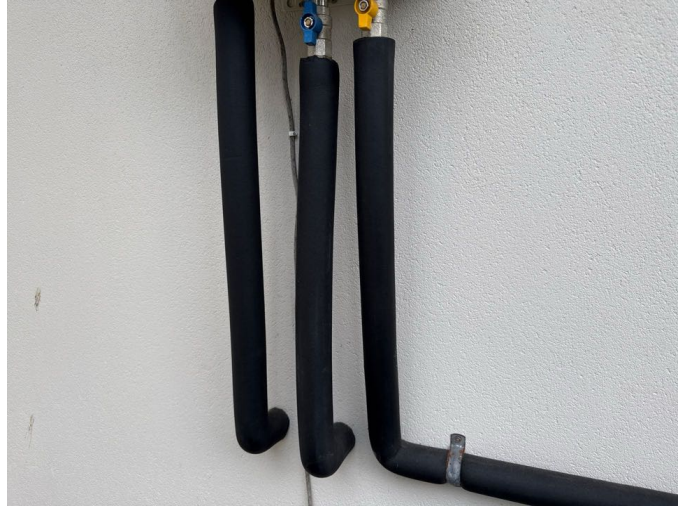
The presence of the insulation over the pipes will help prevent UV damage

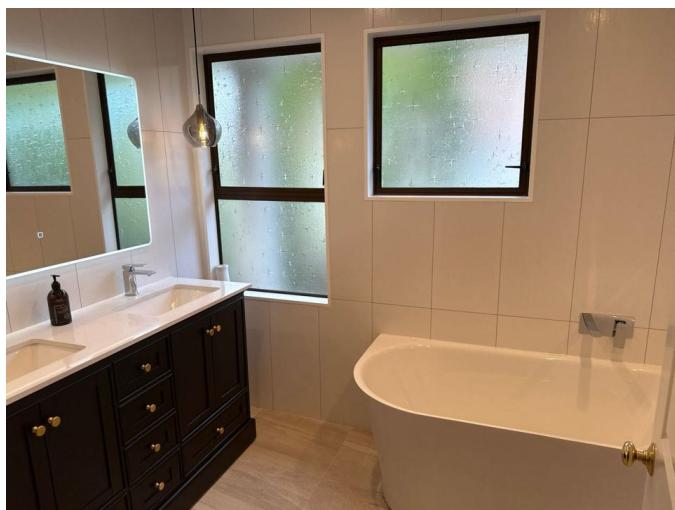
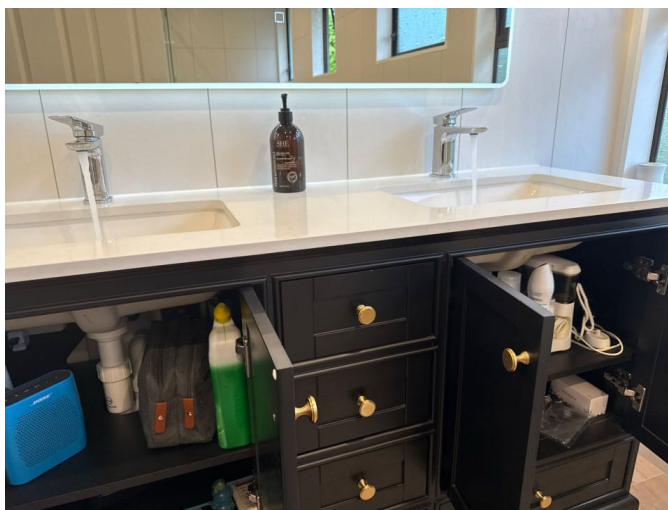
The rear edge of the vanity is well sealed. The taps are functioning well. No concerns with the water feeds or waste under the vanity

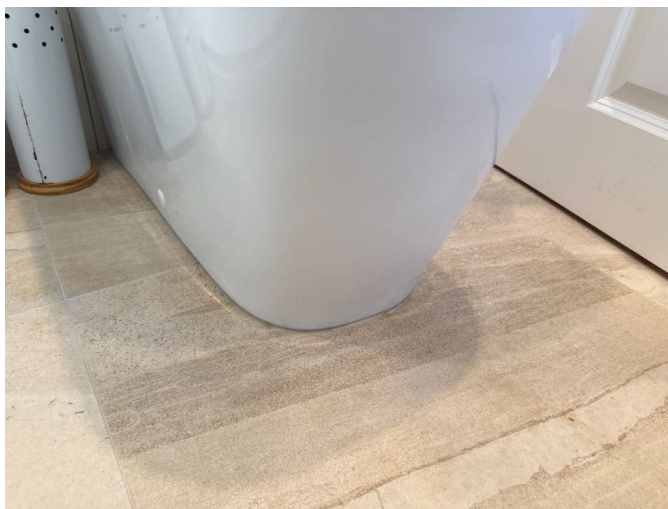
The base of the toilet is well sealed and secure. The toilet is in a functioning condition.

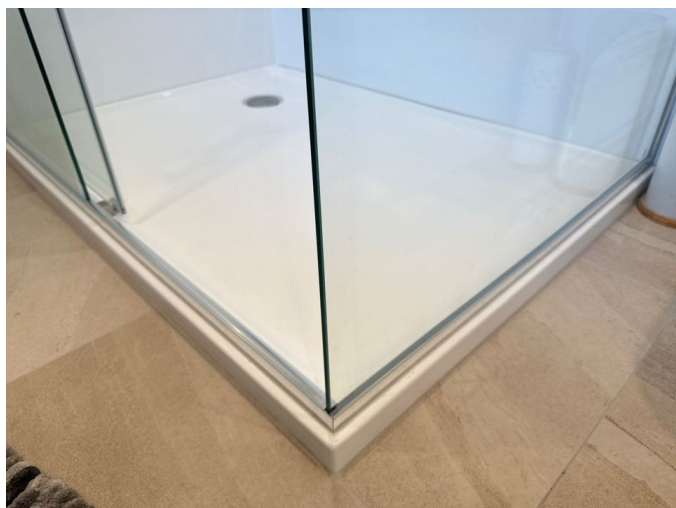
The base of the shower is well sealed

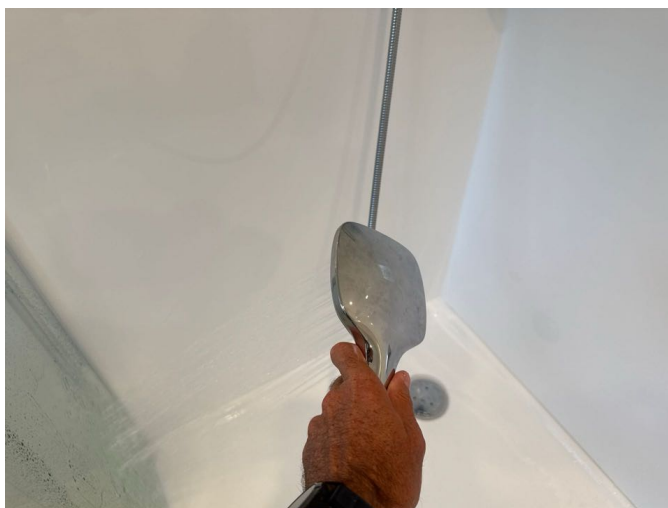
Good water pressure noted. No sign of current leaks from the shower frame during water testing.

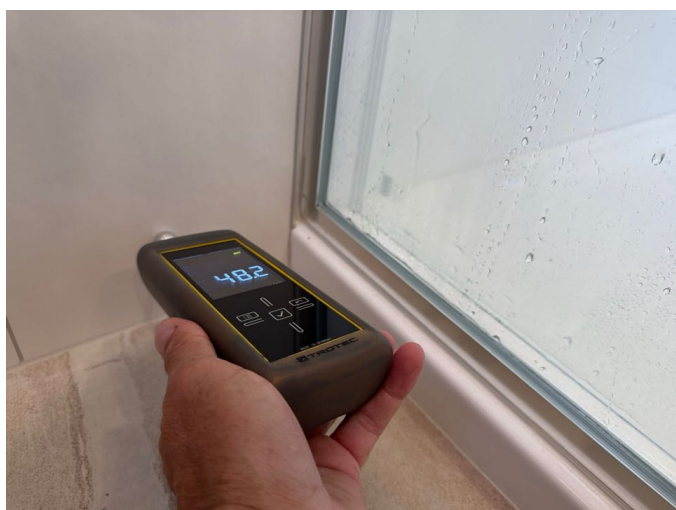
The common fail areas of the shower and plumbed areas were checked for elevated moisture. Moisture levels were within the normal range.

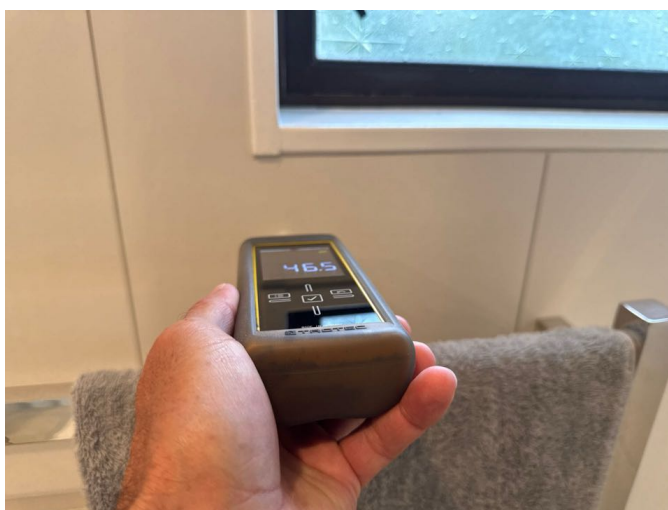
The moisture levels to the external walls were within the normal range

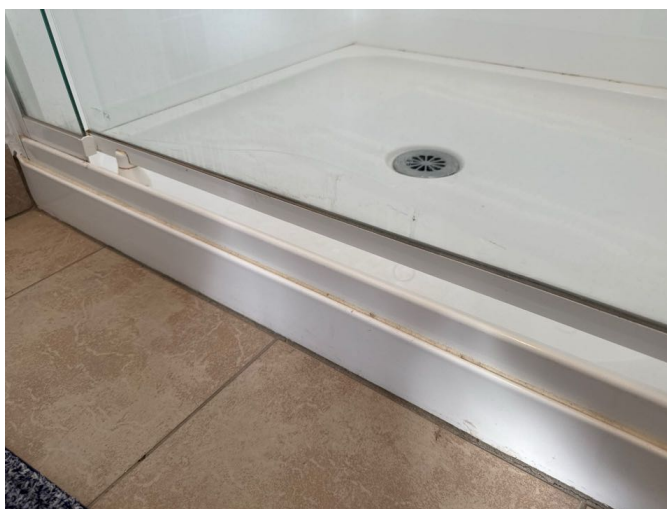
The base of the shower is well sealed

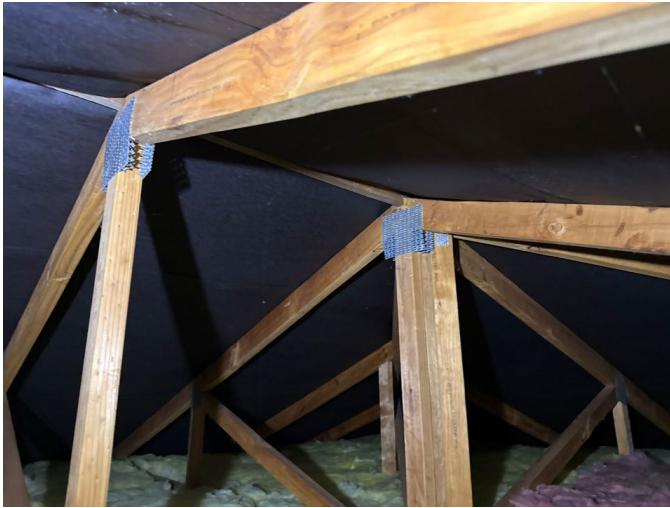
I could see no evidence of current or past moisture ingress issues under the roof framing or linings (where accessible) at the time of inspection. The roof framing structure appears to be solid.

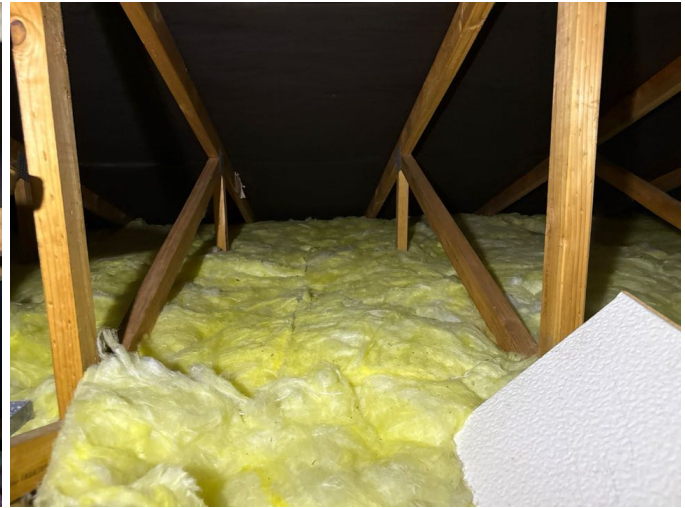
Double layer of insulation installed in the top ceiling cavity

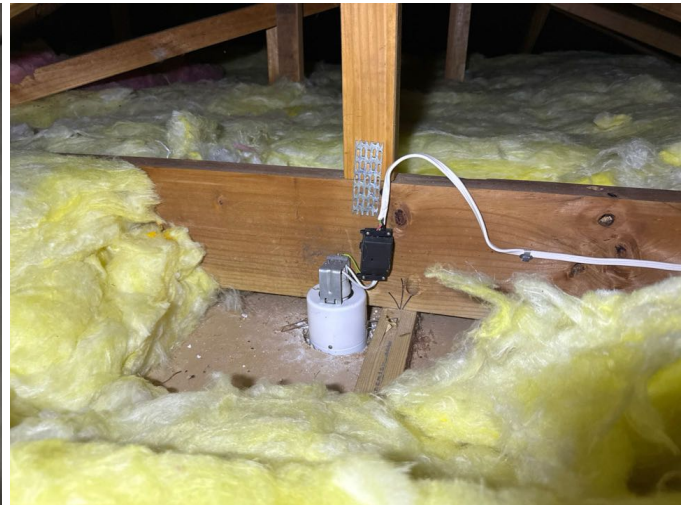
Where there are older types of recessed downlights, insulation must be kept 200mm away or 100 mm with a fixed guard to prevent the lights, ceiling materials or insulation from overheating. Recessed downlights labelled "CA80" or "CA90" can have insulation abutted against them. BRANZ recommends replacing older downlights with surface-mounted lights or with IC or IC-F recessed downlights that can have insulation placed over them.

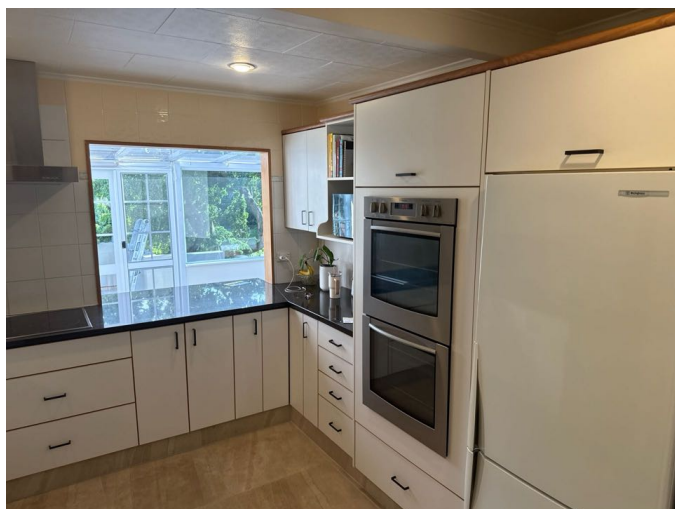
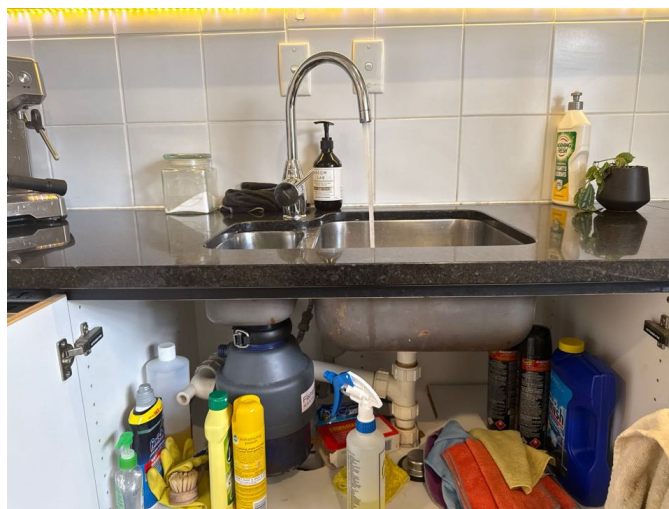
The rear edge of the bench top is well sealed. The tap is functioning. No concerns with the water feeds or waste pipes under the sink.

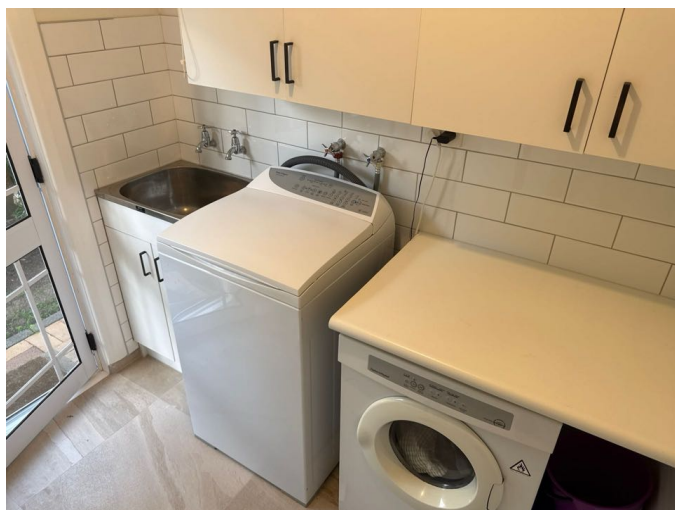
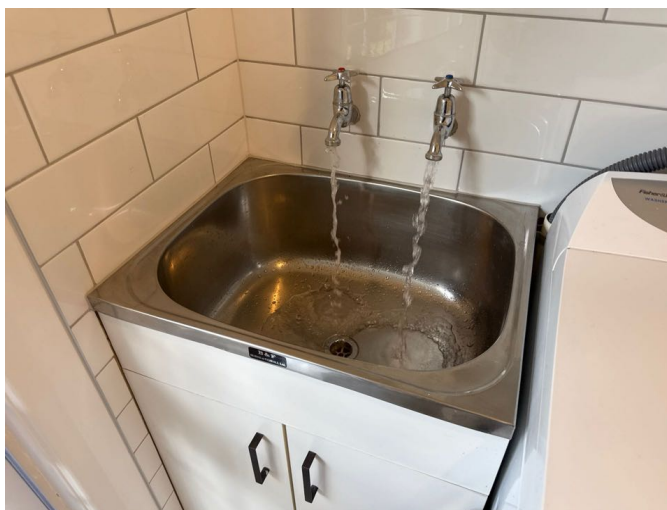
The tub is well sealed. The taps are functioning well.

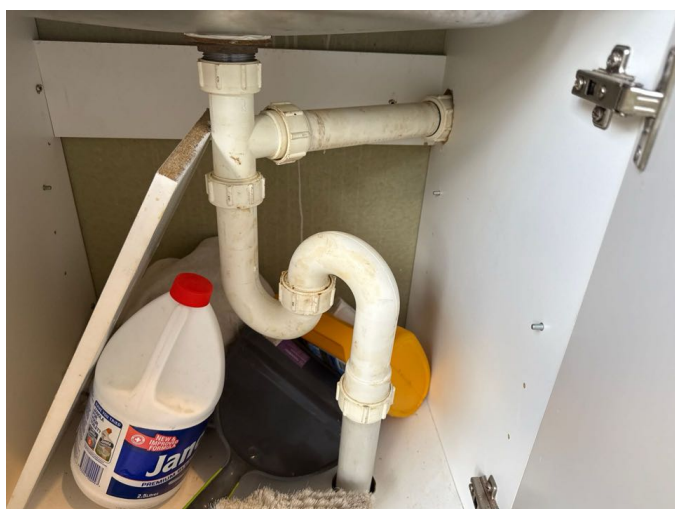
There was no evidence of current plumbing issues beneath the tub

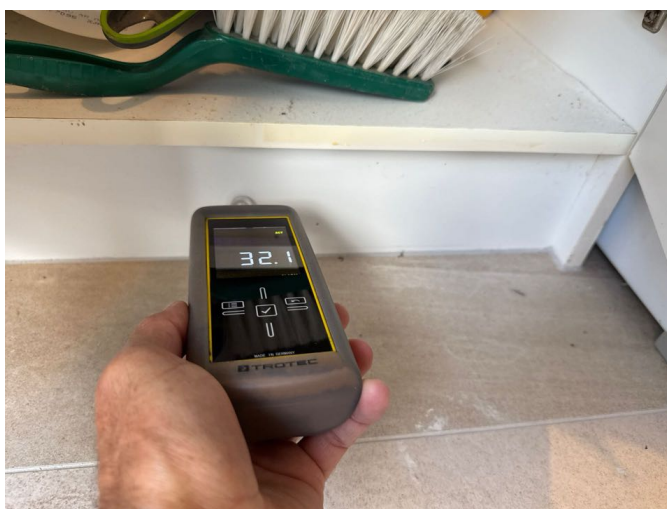
Moisture levels in the laundry scanned within the normal range at the time of inspection.

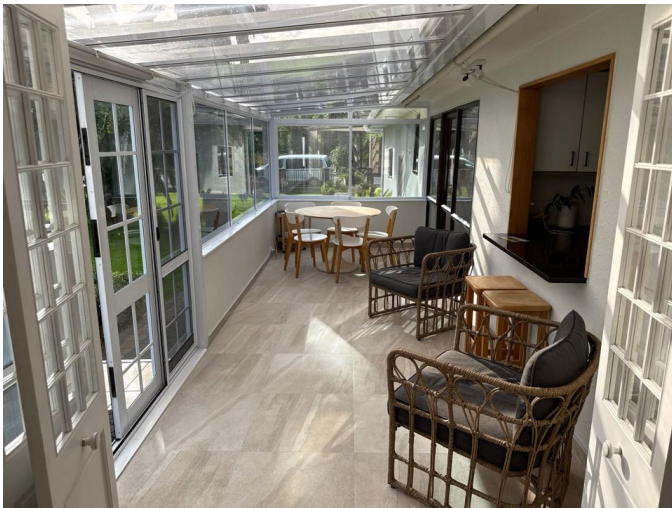
The tiles are intact and are well adhered to the floor beneath

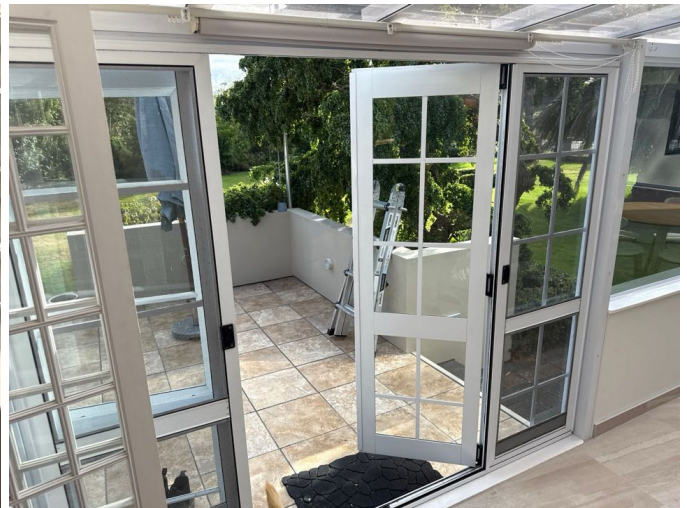
The doors and windows are functional

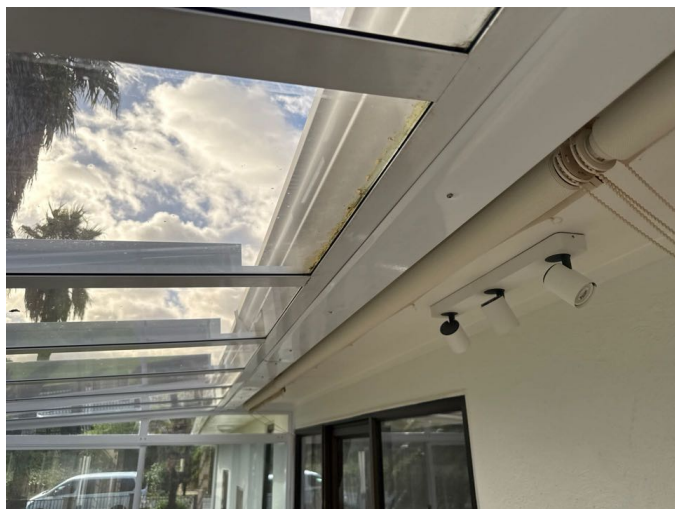
There was no evidence of current leaks beneath the roof. Conservatory roofs are prone to leak issues and condensation which will need to be monitored and maintained accordingly.

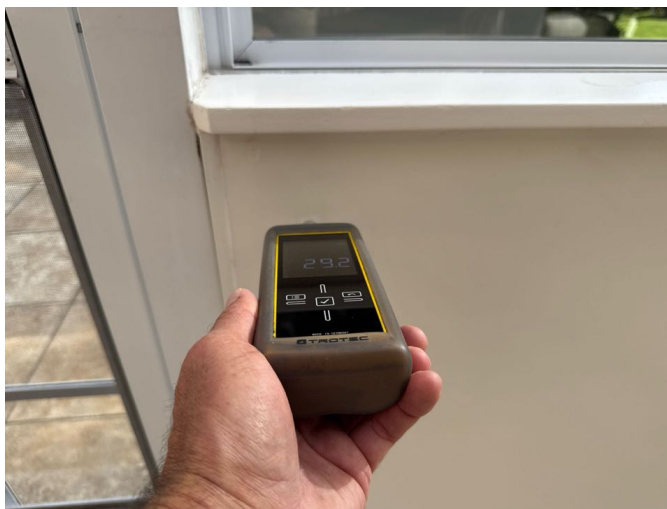
Note that the moisture levels were checked at multiple locations in every room and mainly under the windows.

Moisture levels to the external walls scanned within the normal range at the time of inspection.

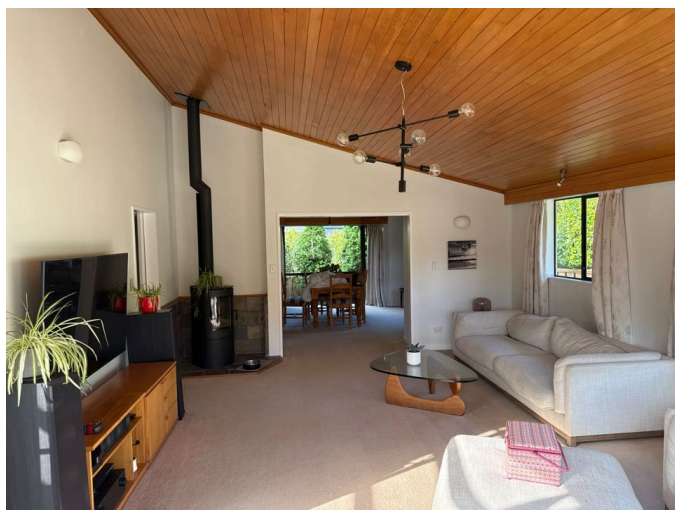
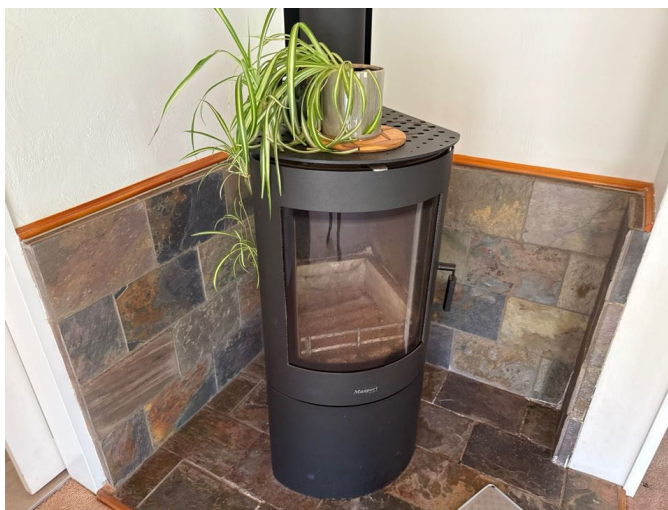
The fireplace and chimney were not checked as part of the inspection process. All fireplace manufacturers stipulate an annual service and insurance companies require evidence of due care and maintenance in the event of a claim. Purchasers should check when the fireplace was last serviced prior to the first use and have a service completed if necessary. The chimney was not checked as part of this inspection process.

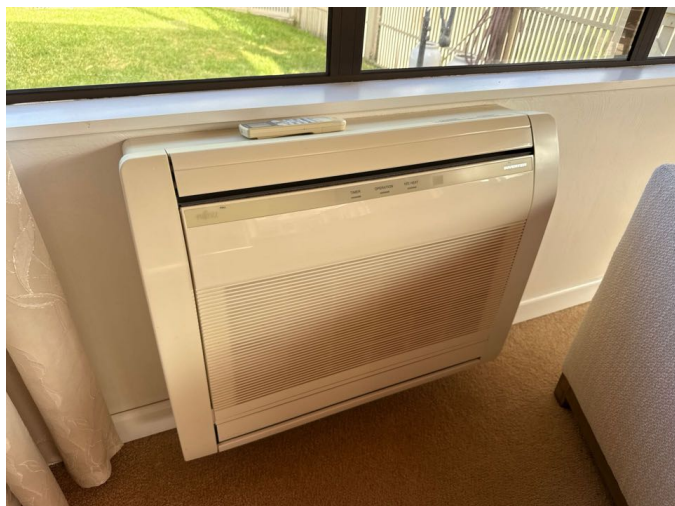
Heat pump installed,untested.  
Heat pumps require regular servicing to be efficient.  
The manufacturers instructions should be checked  
and understood with regards to future servicing  
requirements.

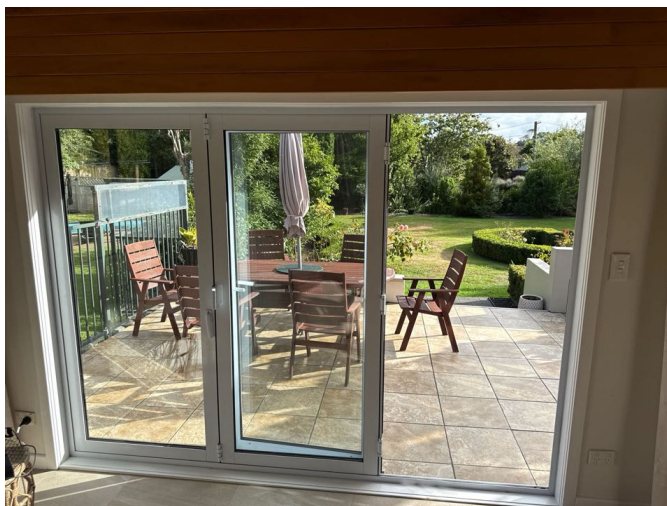
The bifold doors and windows are functioning

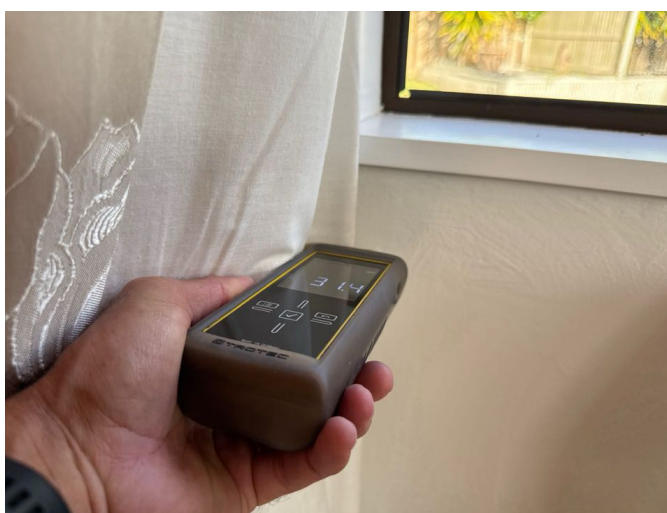
Moisture levels to the external walls scanned within  
the normal range at the time of inspection

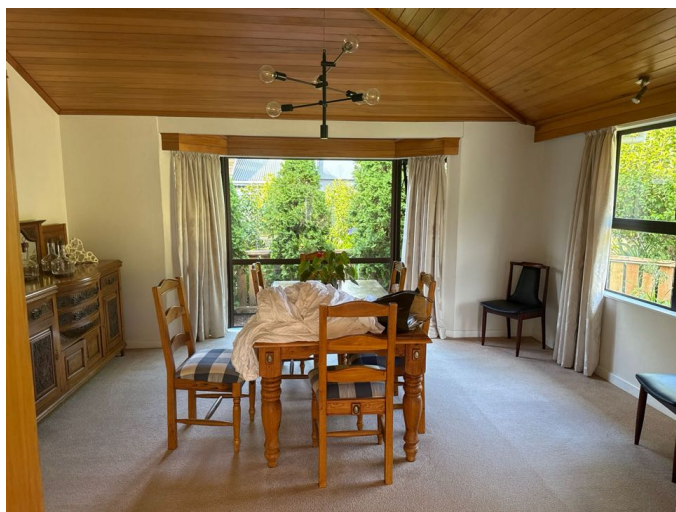
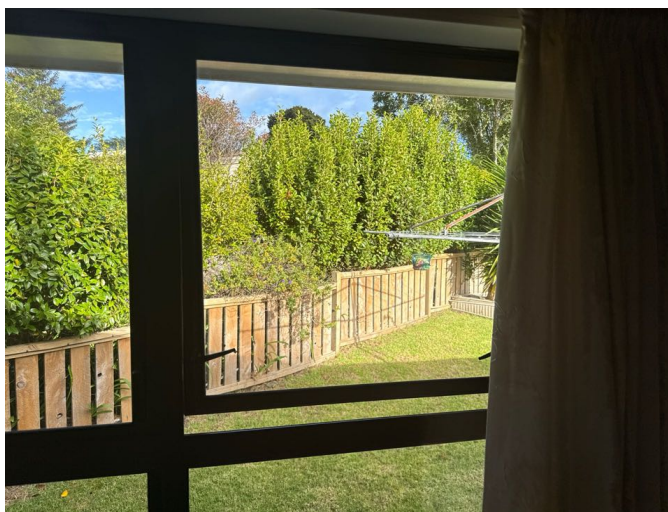
The windows are functional

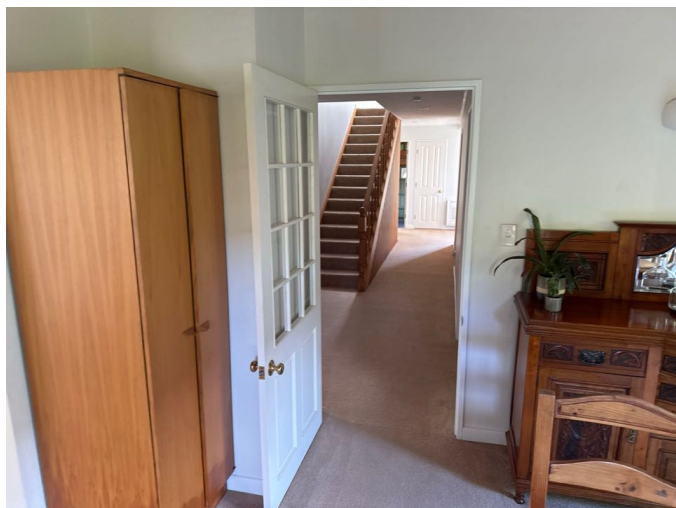
The internal door is functional

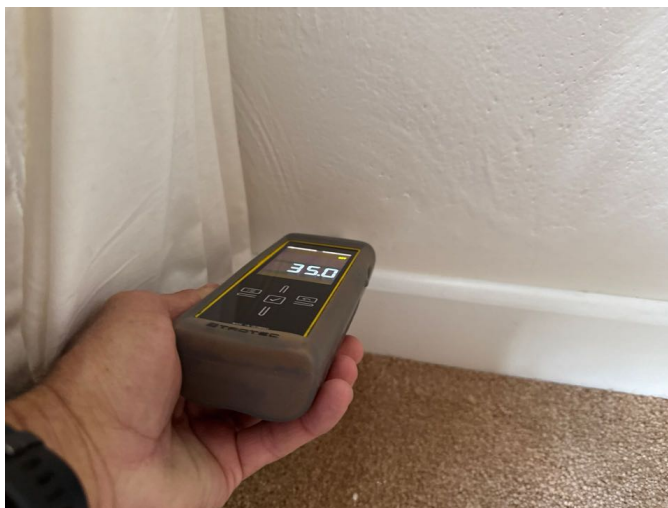
Moisture levels to the external walls scanned within the normal range at the time of inspection

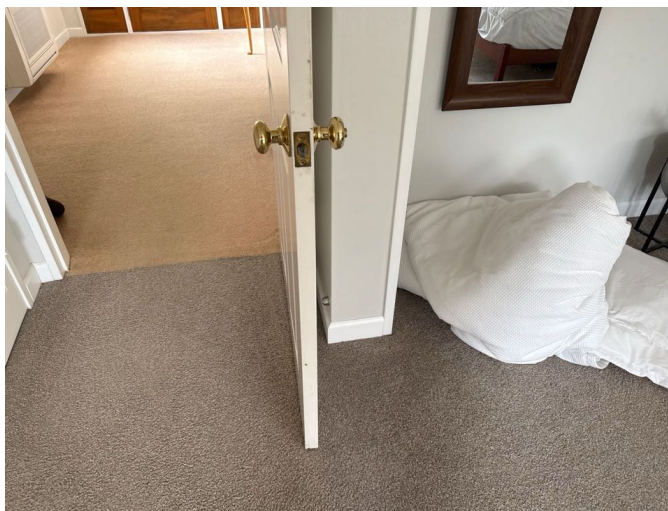
The internal doors are functioning well. Door stops installed behind the doors.

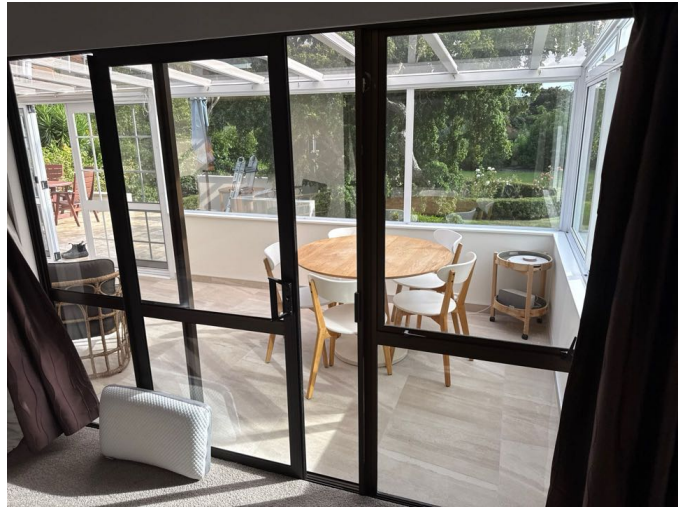
The sliding door is functional

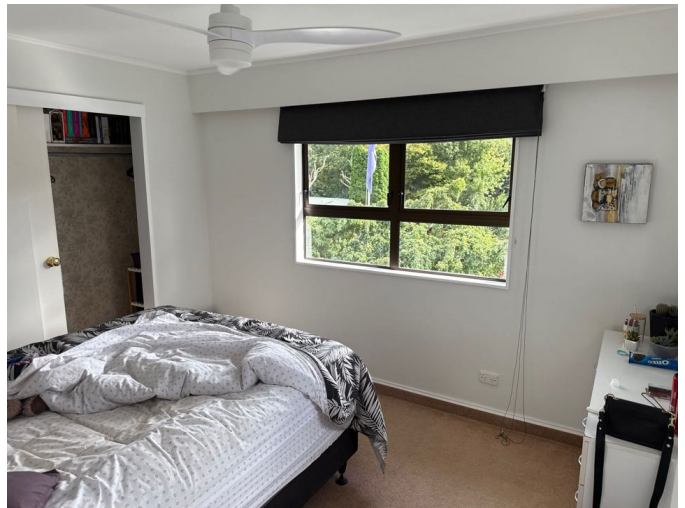
Bedroom 2

The ceiling fan is functioning

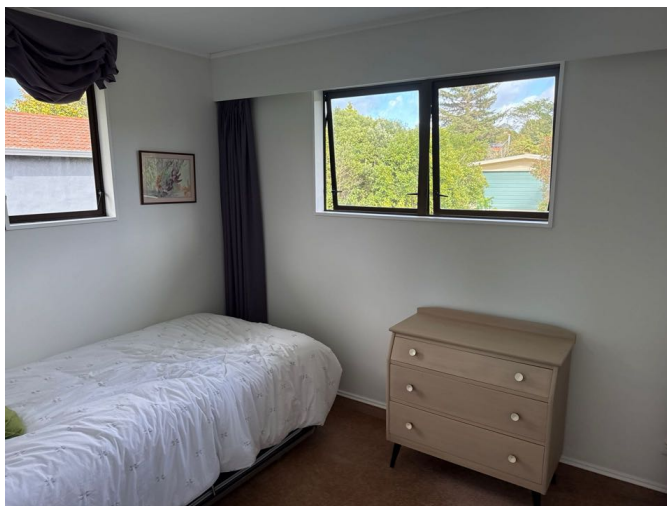
Bedroom 3

The windows are functioning throughout

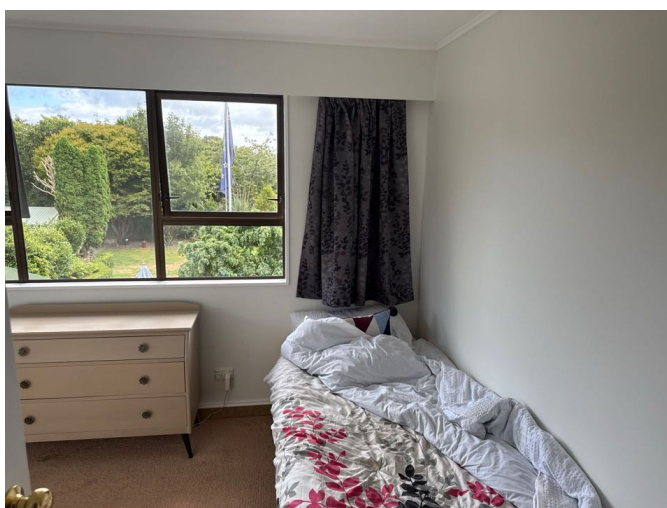
Bedroom 4

Moisture levels to the external walls scanned within the normal range at the time of inspection

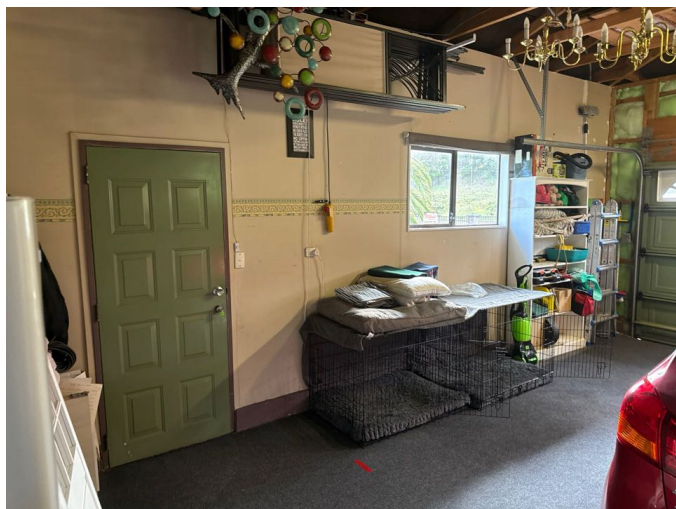
Not all areas of the garage could be fully inspected due to the presence of stored items. A full inspection is recommended once cleared. This applies to all concealed locations throughout the house.

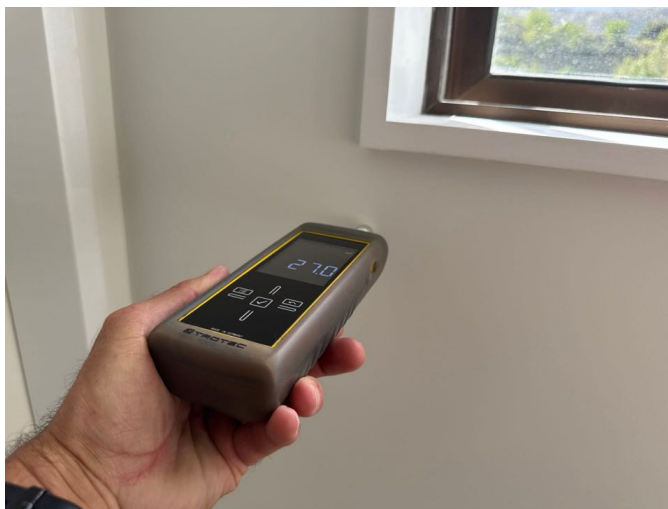
The moisture levels under the upper level east hallway window were within the normal range
