## BUILDING INSPECTION REPORT

## Building Inspection Report

51 Wayside Avenue, Burnside

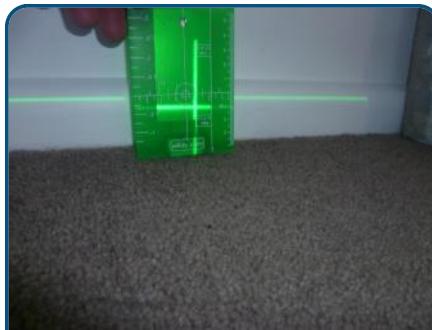
acceptable

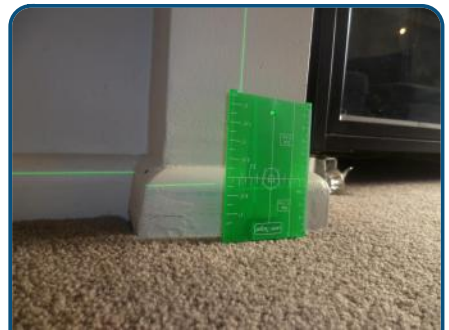
acceptable

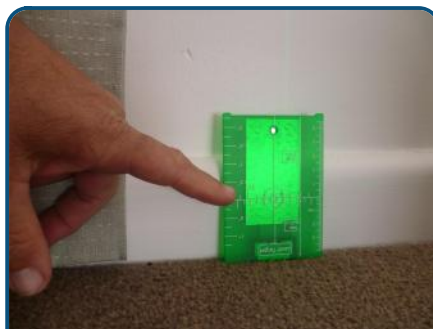
acceptable

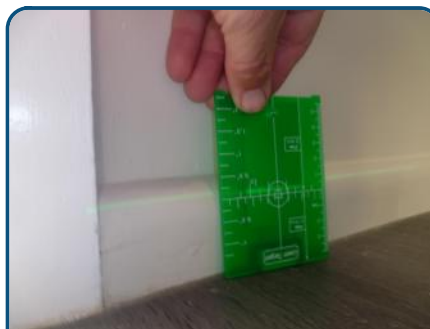
acceptable

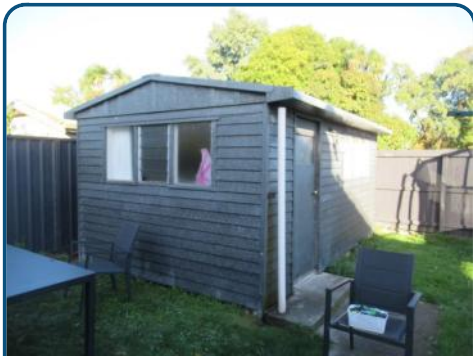
sleepout

| Other | sleepout, skyline type construction, lined, not inspected. |

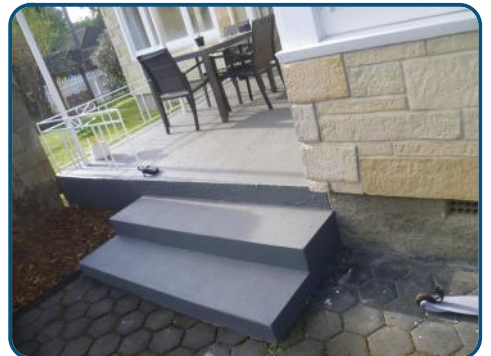
| Paths | concrete. cracking noted, appears sound. |

example of cracking to paths  
appears sound.

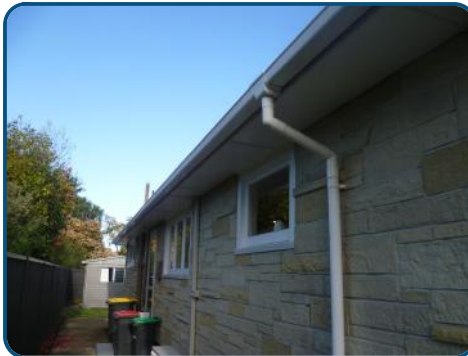
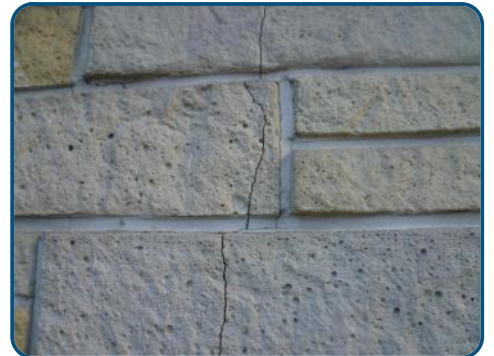
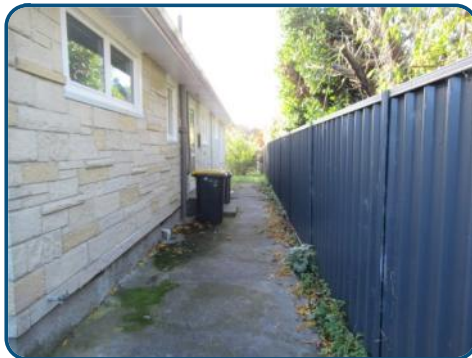
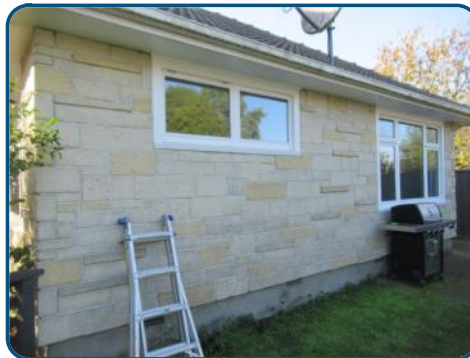
view of bottom of cladding, unable to sight all.

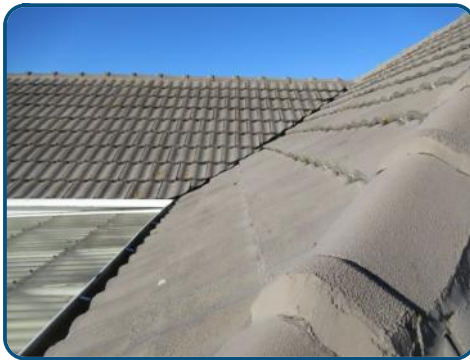
example of lichen, can treat chemically to control noted.

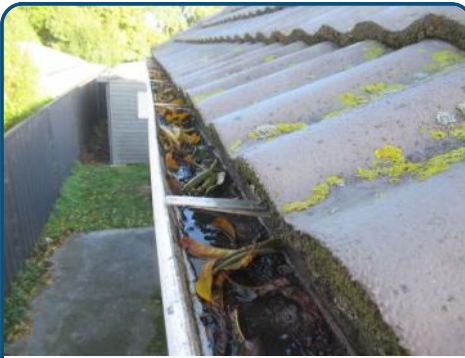
spouting needs clean in areas noted.

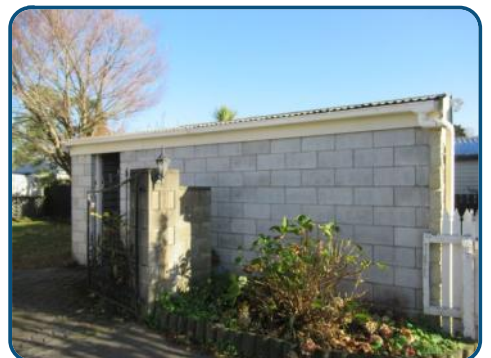
example of borer holes in garage  
timber trims noted

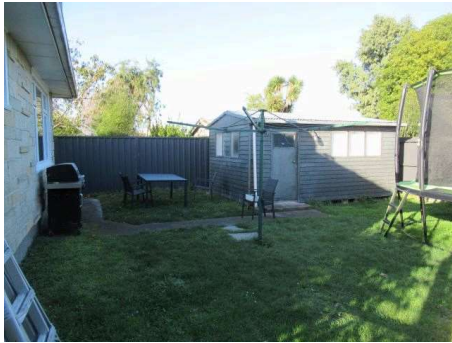
outdoor area, secure.

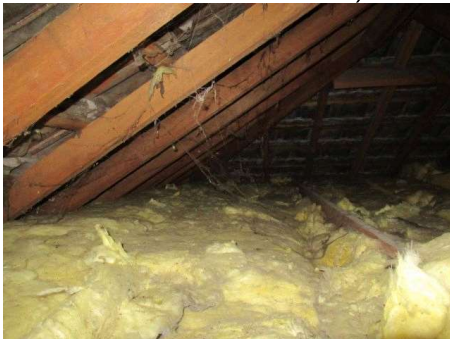
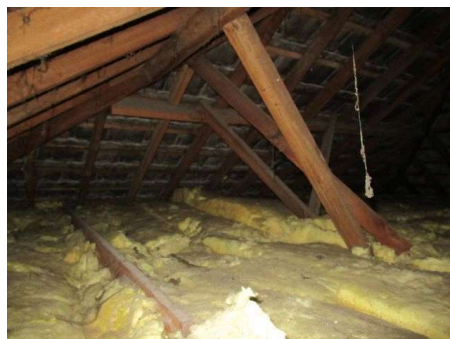
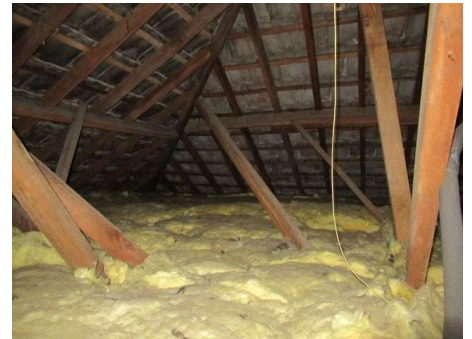
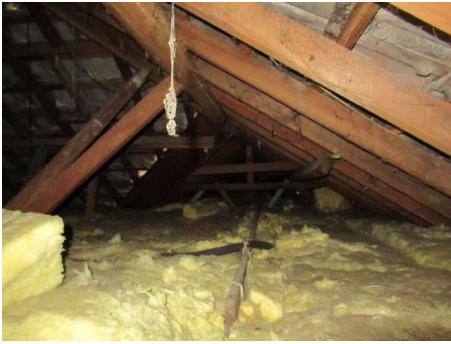
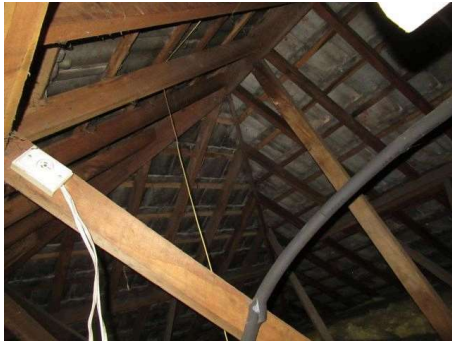
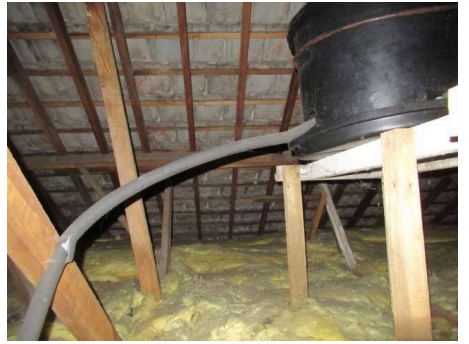
minor borer damage noted

only a small amount of holes noted Yes, borer may be in other timbers but not always visible, treat regularly with chemicals to control

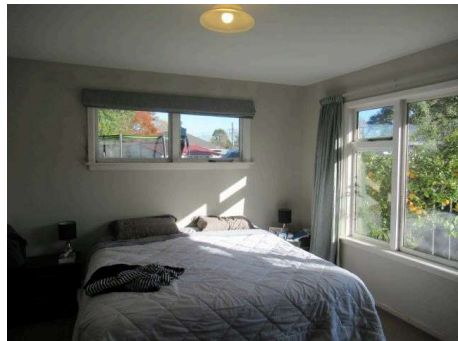
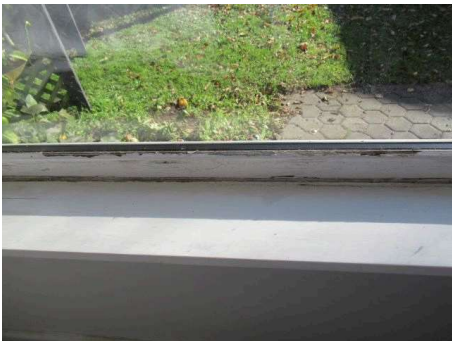
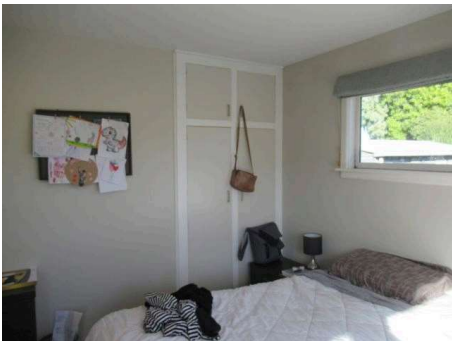
**BEDROOM One**

| WINDOWS | timber wear to window paint noted |

surface wear to window timber paint,  
can repaint noted noted,

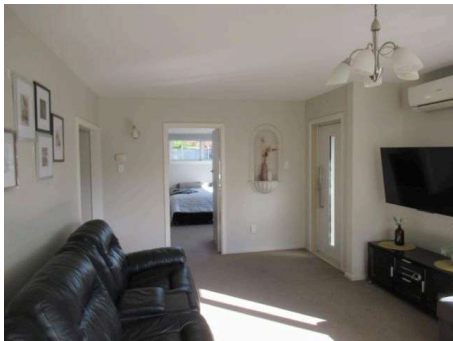
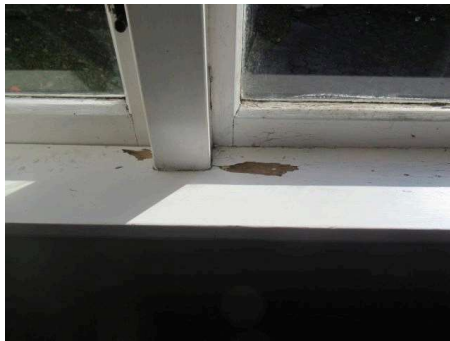
## LOUNGE

| WINDOWS | timber some sticking and need easing, and paint wear noted |

surface wear to window trim noted,  
can re paint

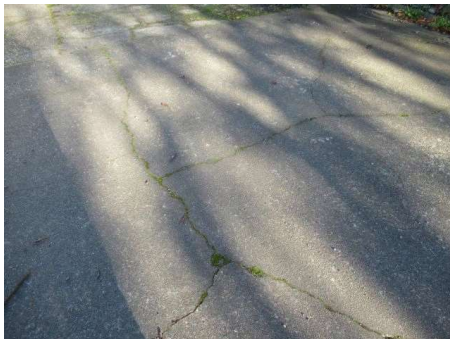
example of cracking in driveway noted

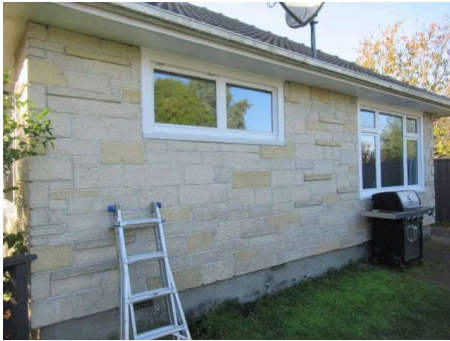
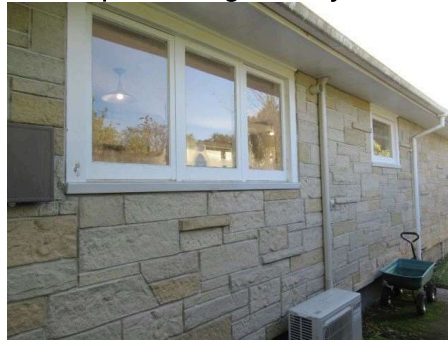
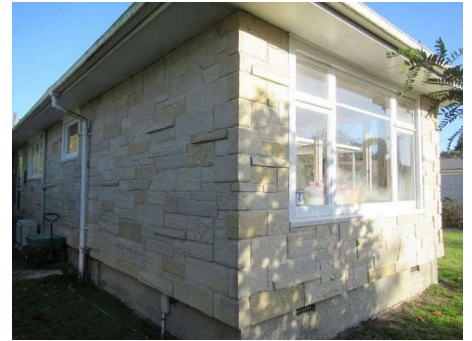
| | COMMENT | Step cracking/sheet joint movement noted |

example of step cracking on cladding noted,

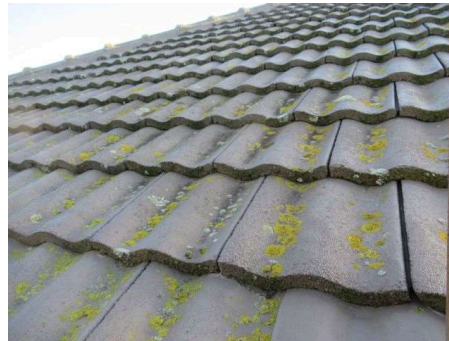
example of lichen on roof ,treat chemically to control
