## RED LBP PRE-PURCHASE REPORT

**Company:** Property Support Ltd trading as RedLBP Kapiti Porirua  
**Client:** Charlotte Ross  
**Date of Inspection:** 7th October 2025  
**Site Address:** 53 Tiromoana road Raumati south  
**Inspector:** Trevor Garrett  
**Qualifications:** MSc, LBP, Advanced Trade Cert Carpentry, Nat Diploma Construction Management. Member of NZIOB.

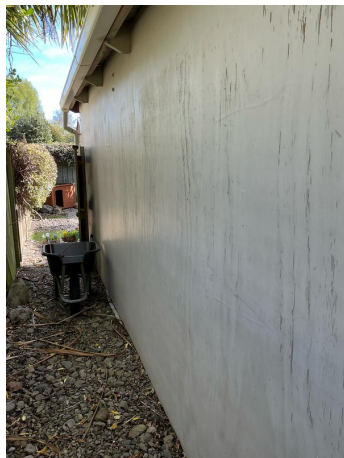
**Photo 15**  
West side plywood has flaking paint.

Condition of finish - some flaking to the plywood.

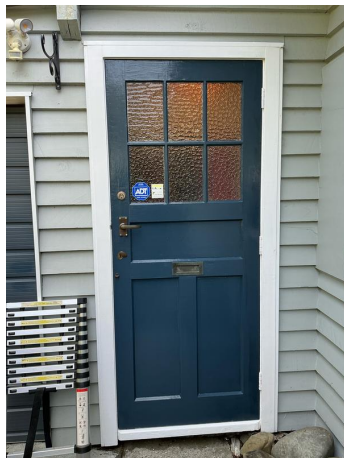
**Photo 18**

Entrance door is timber framed.

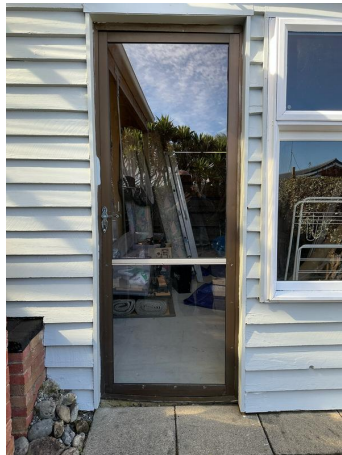
**Photo 21**  
West side garage door.

Indications of elevated moisture were detected to the side of the garage door. Recommend an LBP in carpentry reviews and advises remediation solutions.

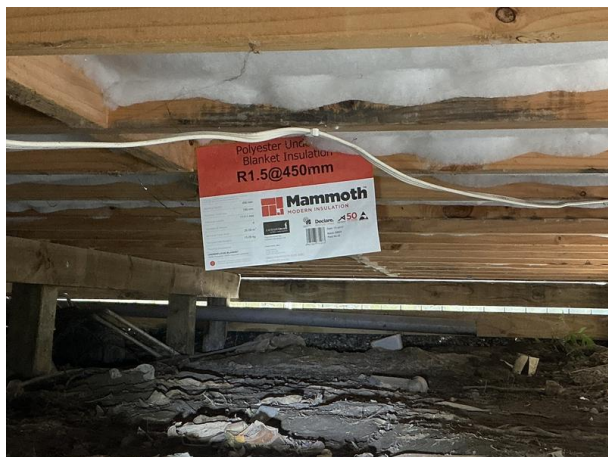
**Photo 24**

Insulation installation record, R value 1.5.

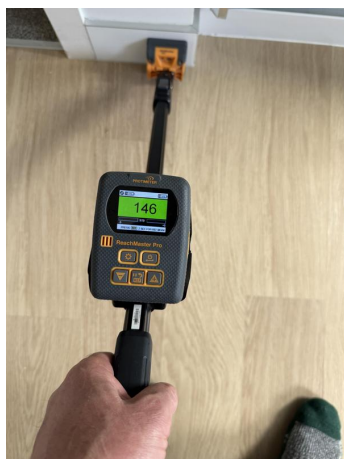
**Photo 27**

Corner of the shower has indications of normal moisture readings.

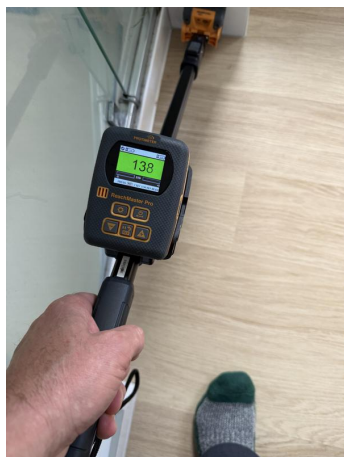
**Photo 28**

Corner of the shower has indications of normal moisture readings.

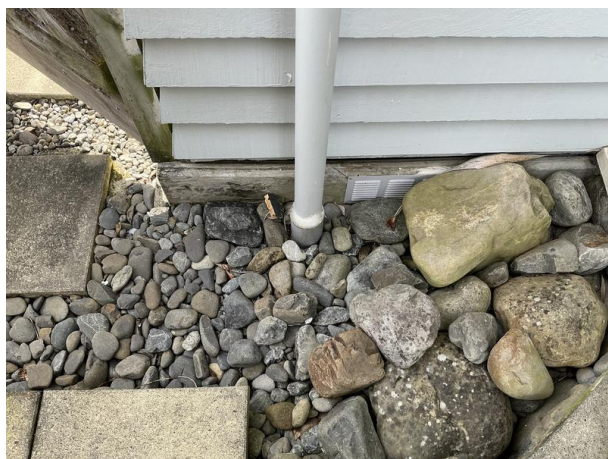
**Photo 58**

West side downpipe connection visible.

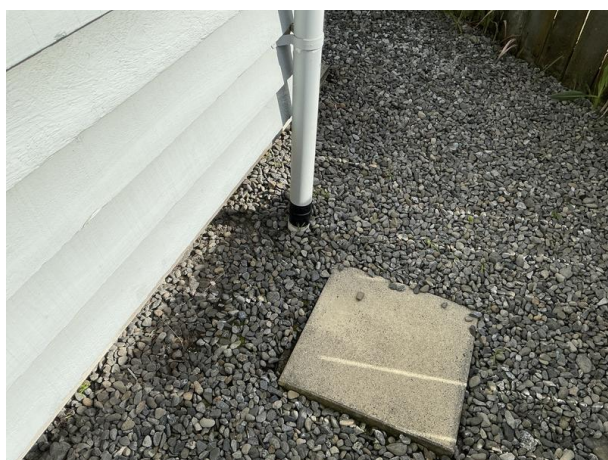
**Photo 59**

East side downpipe connection visible.

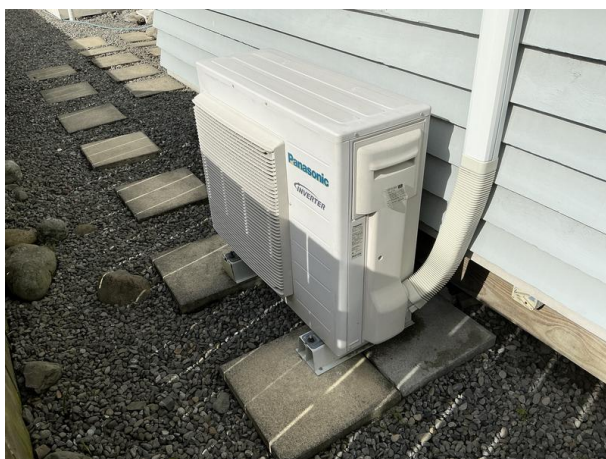
**Photo 66**

Outdoor unit located on the east side.

Follow the manufacturer's recommended servicing schedule to ensure the equipment operates efficiently and maintains optimal performance. Adhering to these guidelines helps identify and address potential issues early, reducing the risk of costly repairs and ensuring compliance with warranty requirements.

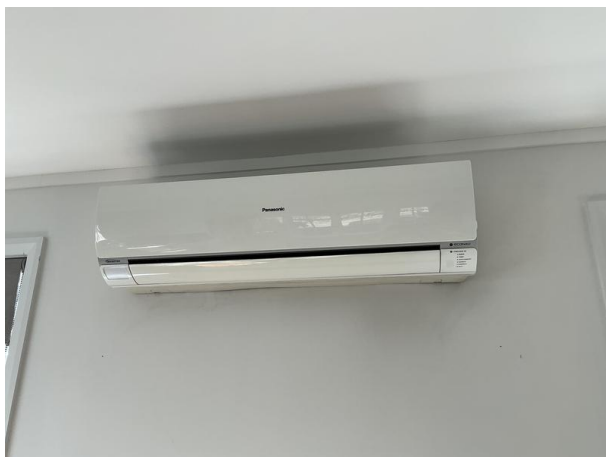
**Photo 67**

Indoor unit is located in the living room.

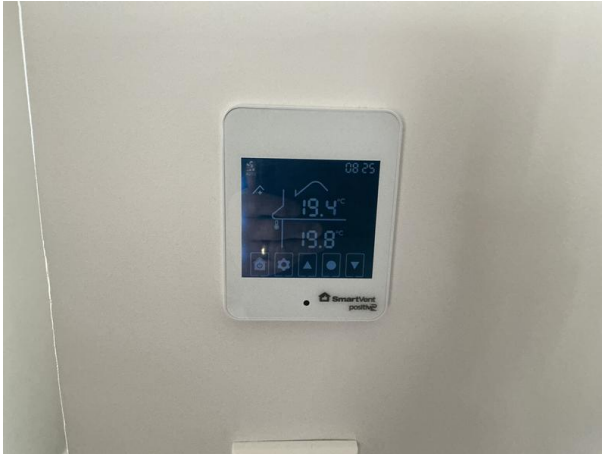
**Photo 68**

Ventilation system controller is located in the hallway.

Ventilation system filters should be inspected annually and replaced periodically or as required by the manufacturer.

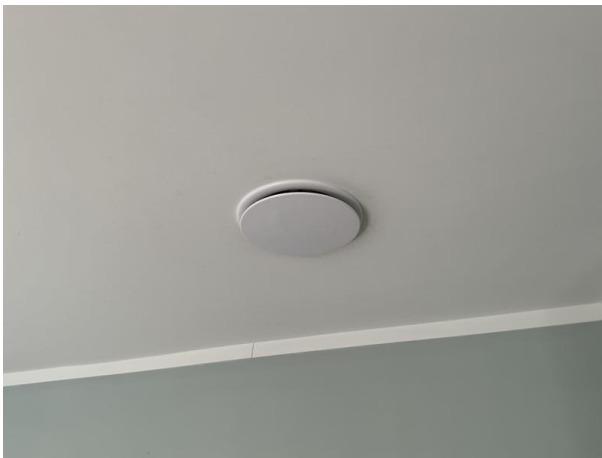
**Photo 69**

Outlets located in the bedrooms.

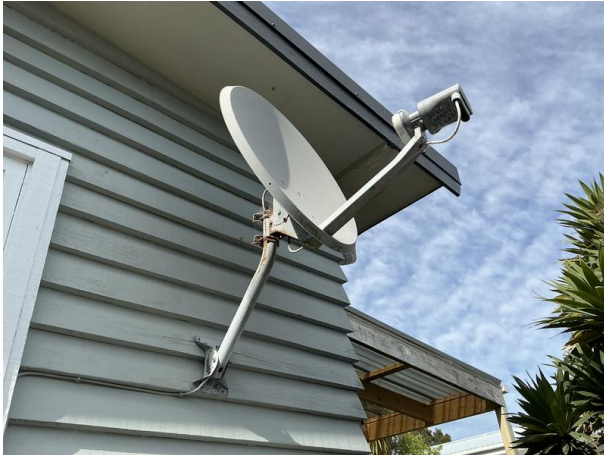
**Photo 70**

Sky dish located on the north side.

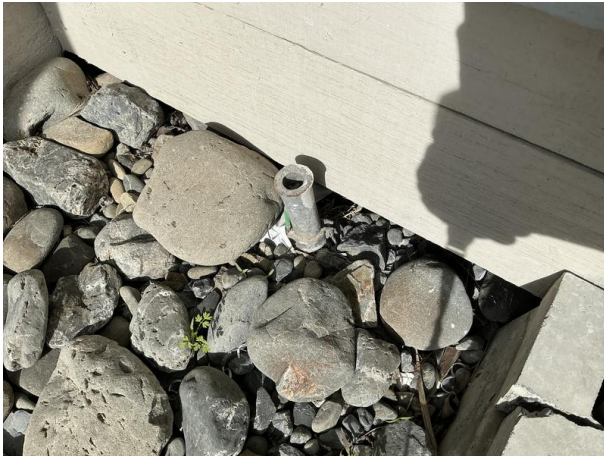
**Photo 71**

Earth stake located on the east side.

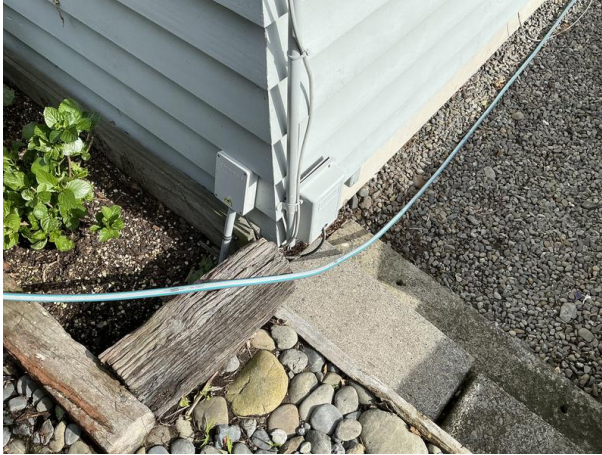
**Photo 72**  
Data and cable TV located on the southeast corner.

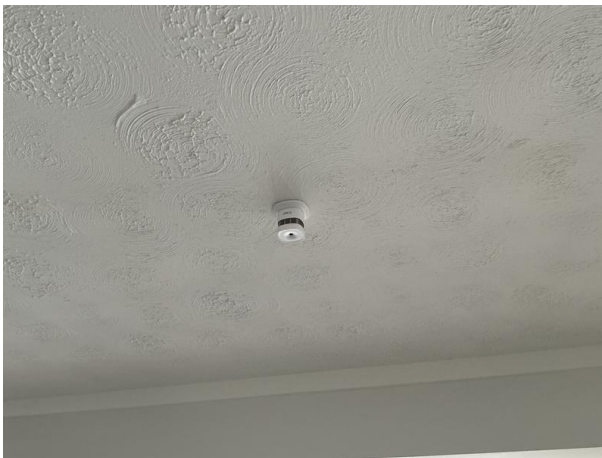
**Photo 73**  
Smoke detector located in the dining room.

Regular checks to ensure smoke detectors are functional.

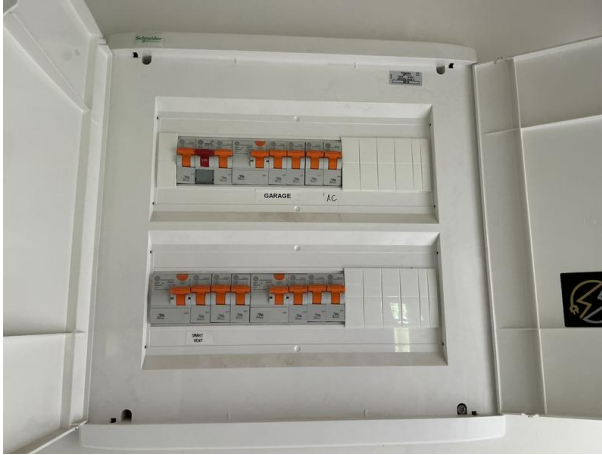
**Photo 75**  
Distribution board is located in the hallway.

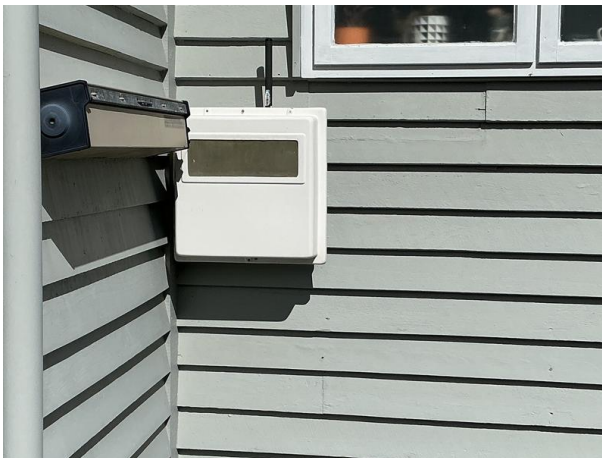
**Photo 76**  
Meter board located on the east side.

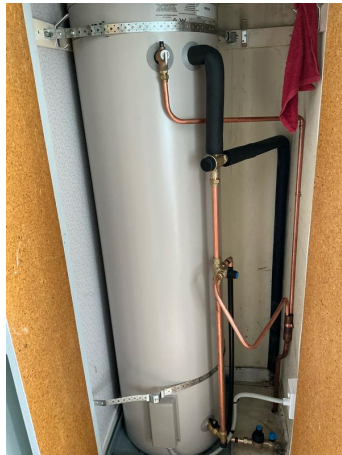
Type - Mains pressure electric cylinder.  
Capacity - 180L.  
Approximate age - 2024.  
Seismic bracing - Strapping.  
Area serviced - Entire house.  
Any visible defects - None visible.

**Photo 77**  
Hot water cylinder located in the laundry cupboard.

All building services should be regularly tested, serviced, and maintained by appropriately certified professionals in accordance with the manufacturer's specifications and guidelines. This ensures optimal performance, safety, and longevity of the systems while reducing the risk of malfunctions or failures.
