Brian Marsh Property Inspection

17 Victoria Street
Foxton
Manawatu

Inspection Overview

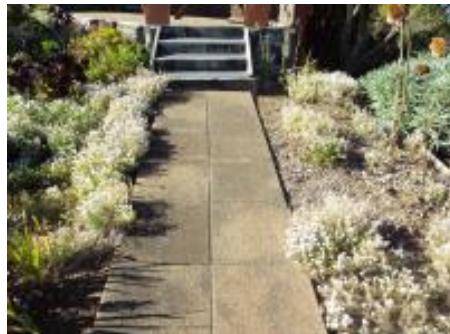
paths fine

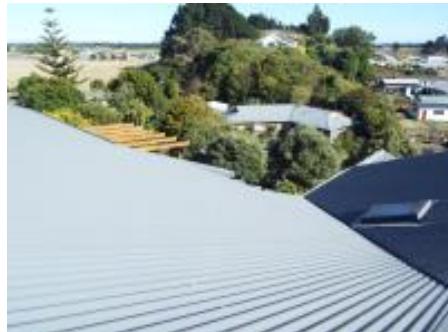
roof clean at the time of inspection

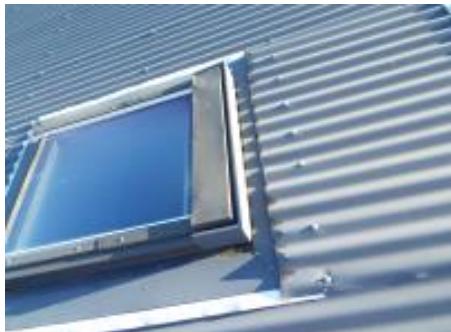
skylights appear well flashed

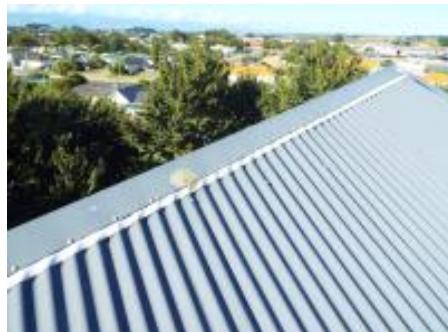
small area of lichen-no other lichen sighted

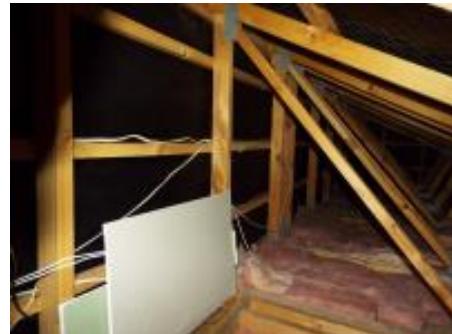
all dry at the time of inspection

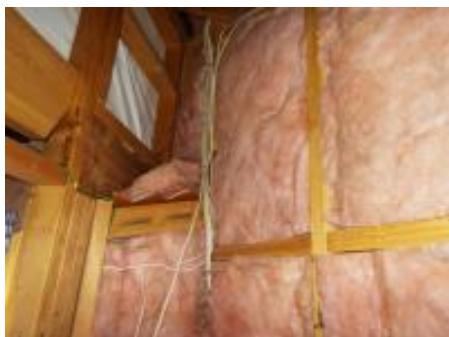
appears well insulated

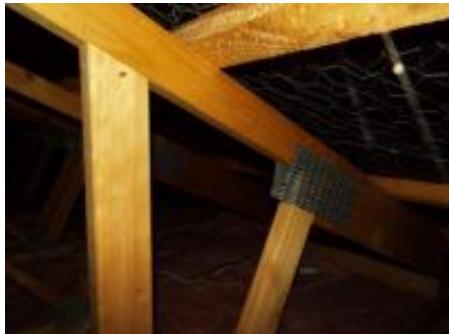
no issues

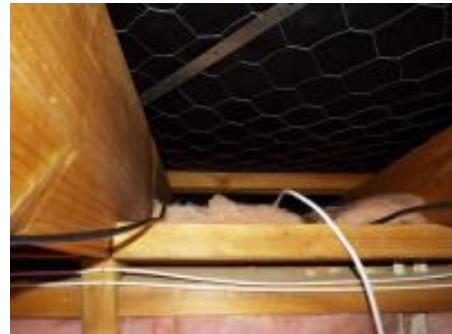
no issues

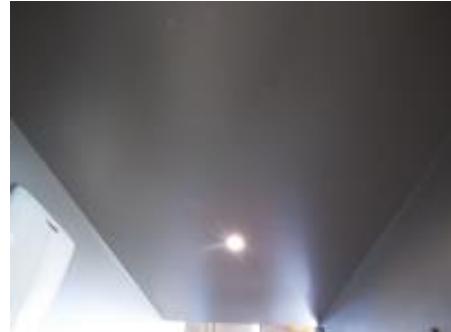
interior well painted

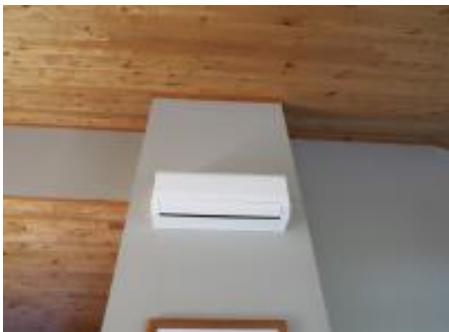
not tested

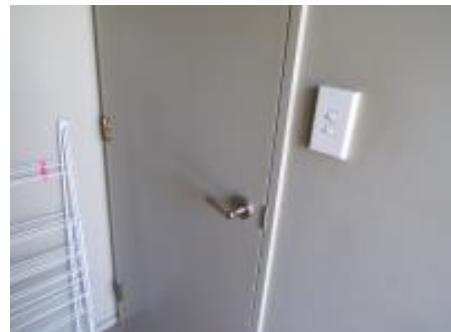
doors in good working order

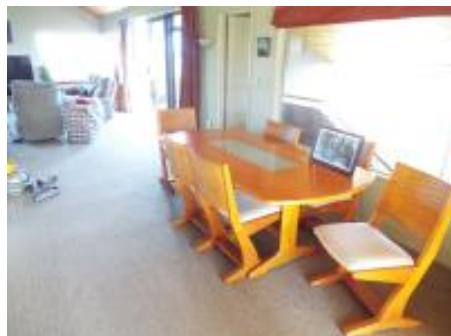
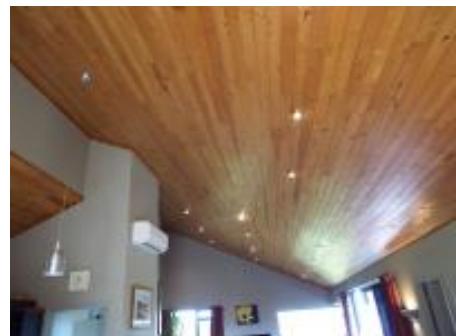
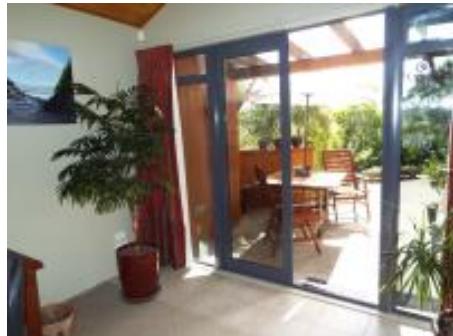
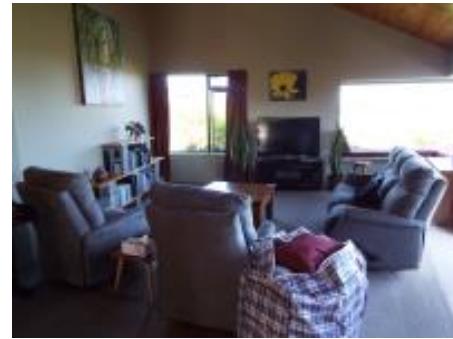
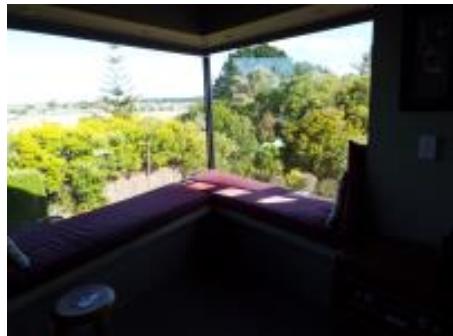
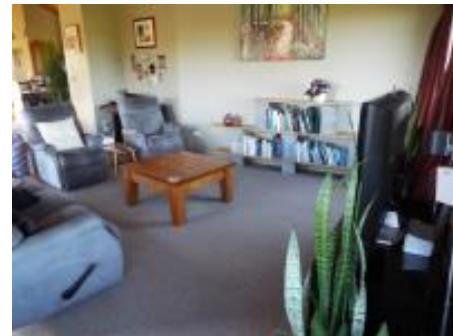
Lounge - Dining Room

Floor	Carpet Average Wear and tear noted
Wall	Plasterboard Generally Good
Ceiling	Timber Generally Good
Windows	Aluminium Generally Good
Doors	Hollow Core Generally Good

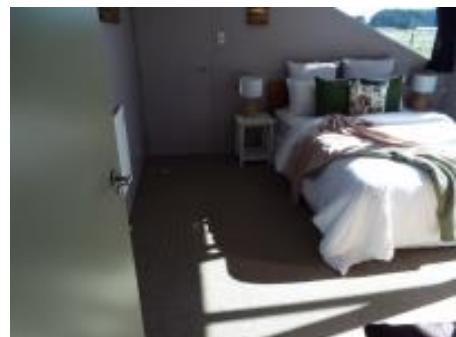
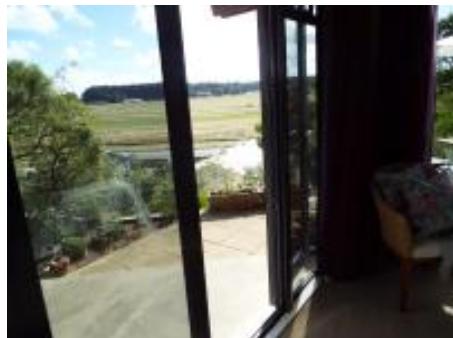
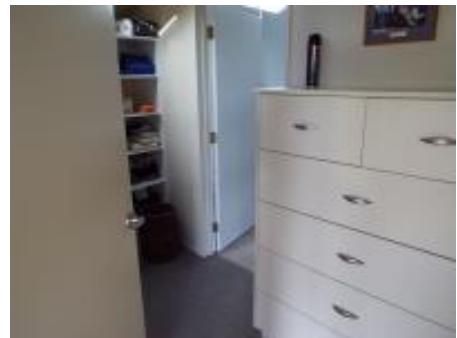
Bedrooms

Floor	Carpet Average Wear and tear noted
Wall	Plasterboard Generally Good
Ceiling	Plasterboard Generally Good
Windows	Aluminium Generally Good
Doors	Hollow Core Generally Good

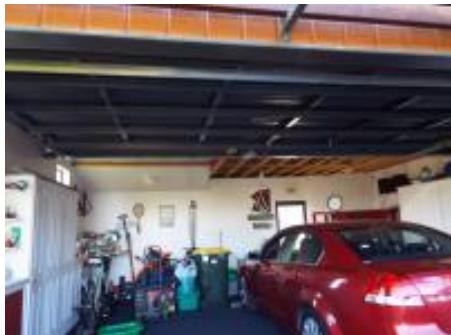
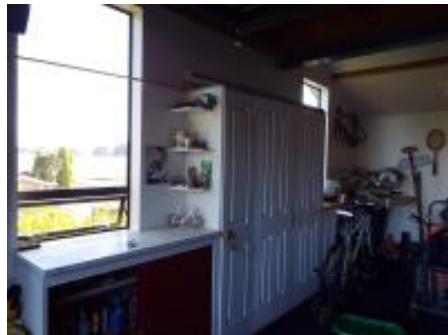
Garage Door	Sectional Door Generally Good Runs well
Size	Double Car Location ground floor
Location	Attached to house
Floor	Carpet Generally Good
Roof	N/A
Subfloor	Concrete Slab Generally Good
Cladding	Same as the house Generally Good
Electrical	Connected
