## BUILDING INSPECTION REPORT

## RED LBP PRE-PURCHASE REPORT

**Company:** JBC Builders Limited Ltd trading as RedLBP Christchurch North  
**Client:** Simon McSherry  
**Date of Inspection:** 27th October 2025  
**Site Address:** 10 Sophora Place, Parklands, Christchurch 8083  
**Inspector:** Jamie Chapman  
**Qualifications:** National Certificate in Carpentry

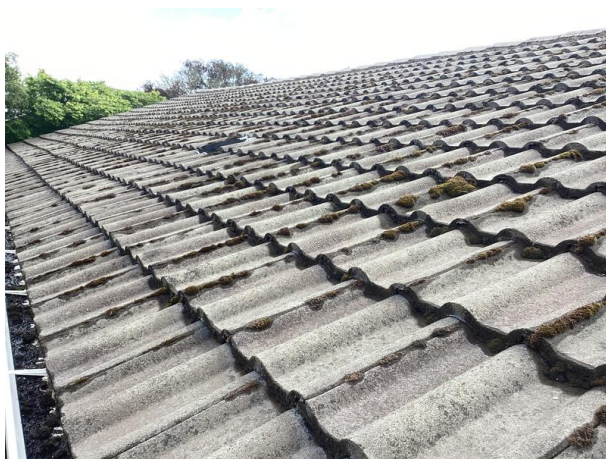
**Photo 3**

Masonry tiles are located over the roof system.

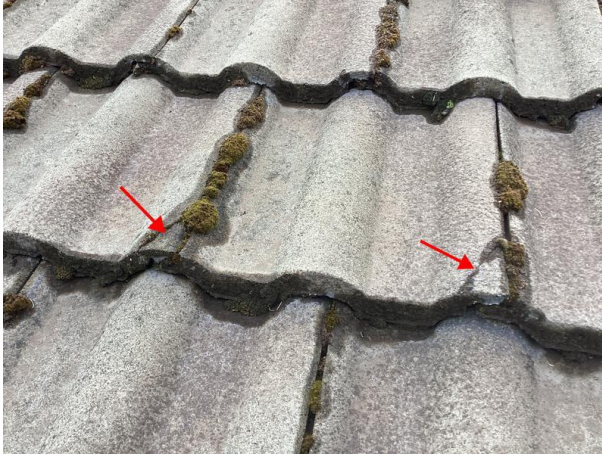
**Photo 5**

Corner chipping of the tiles were noticed and common around the roof system.

Due to the amount of cracked and chipped Masonry tiles noticed around the roof system, as well as the surface fading and moss, mould, or lichen visible, it is recommended to have a licensed roofer advise further on the roof system.

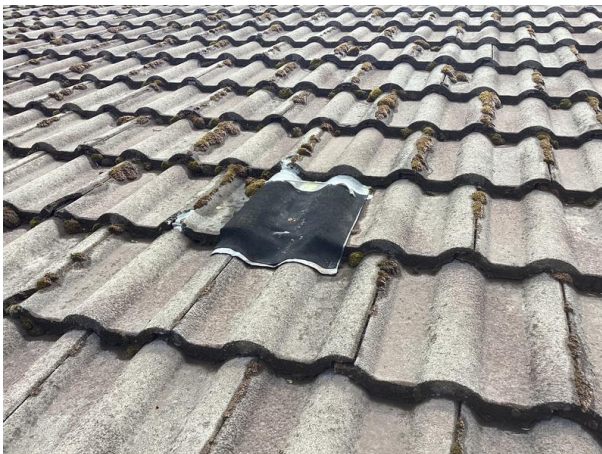
**Photo 7**

A pitch has been installed on the south side of the roof system.

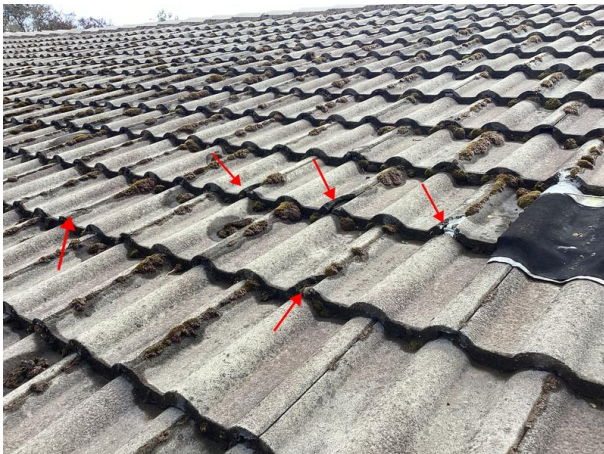
**Photo 8**

Example on the amount of chipped masonry tiles that was common around the roof system.

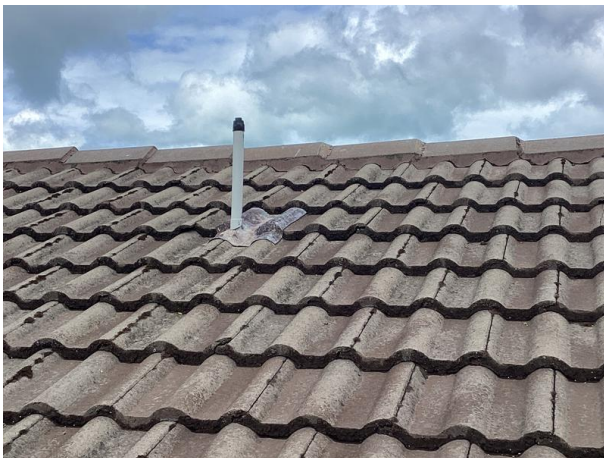
**Photo 11**

Roof penetrations with lead flashings are located on the north side of the dwelling.

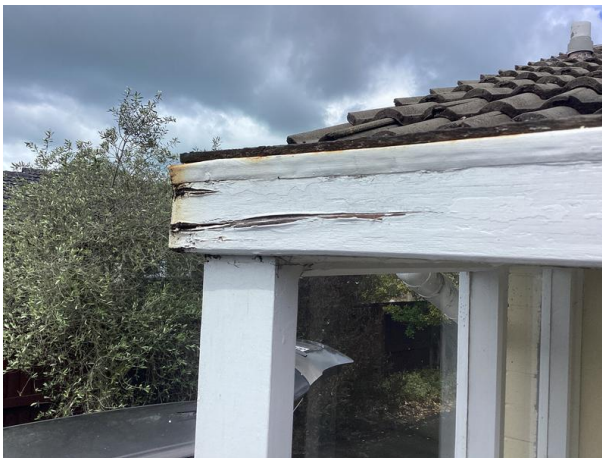
**Photo 13**

Signs of possible rotting were visible on the barge boards located outside of the back entrance. Sections may require replacing.

There are areas of the timber fascia and barge that require sanding back any loose flakey paint, apply a sealer coat then redecoration to prevent further deterioration. Some sections may require replacing above the back entrance.

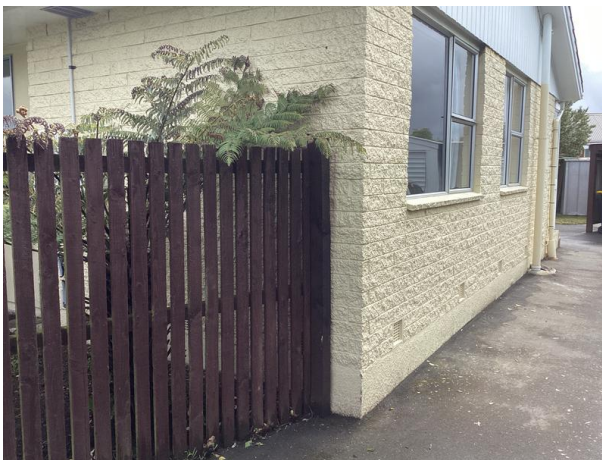
**Photo 17**

Painted split face masonry bricks are located around most of the dwelling.

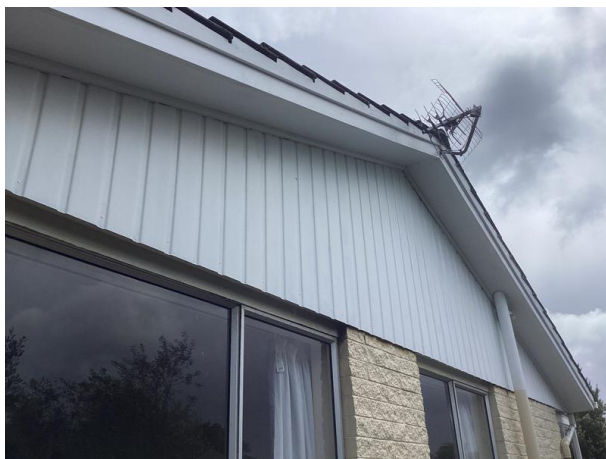
**Photo 21**

Fibre cement sheeting is located on the gable ends and around some external walls.

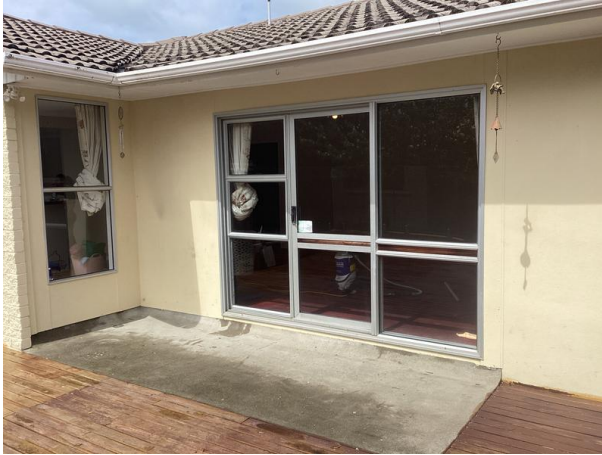
**Photo 22**

Keep the fibre cement sheeting well maintained and painted.

It is recommended to regularly maintain the painted surfaces, in accordance with the manufacturer's recommendations for the specific cladding type, is essential to preserving weathertightness. Proper upkeep helps protect the cladding from environmental exposure, prevents deterioration, and ensures the building's exterior remains effective at repelling moisture.

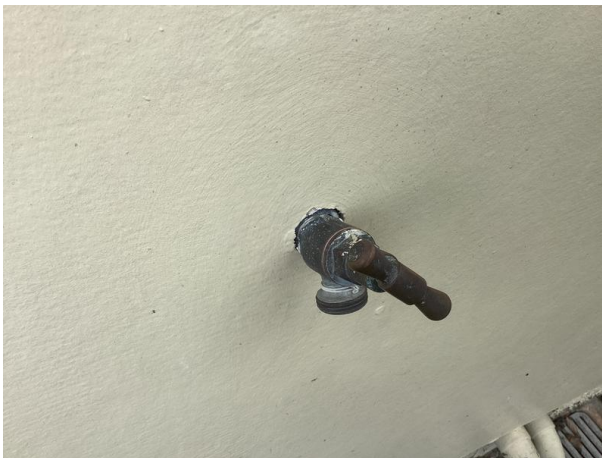
**Photo 23**

A couple unsealed penetration holes were noticed around the dwelling.

There were a couple unsealed penetration holes noticed around the dwelling. It is recommended to seal these.

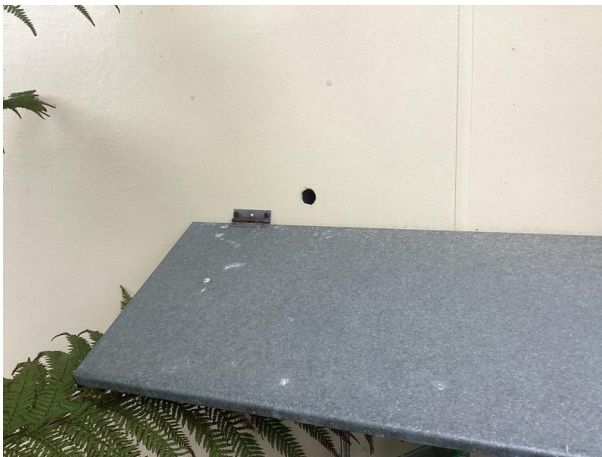
**Photo 24**

An unused penetration hole was visible above the gas bottle station. Ensure this is sufficiently sealed.

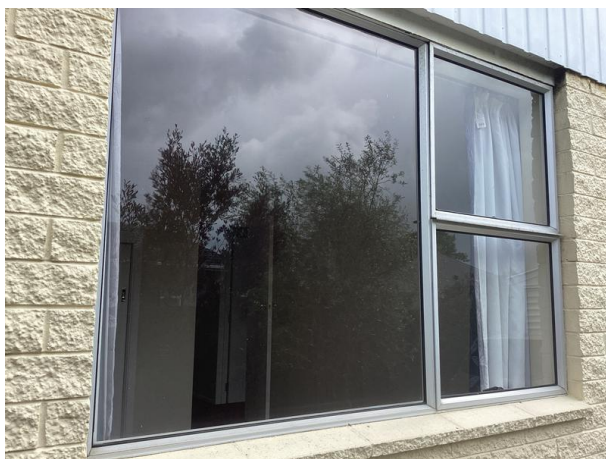
**Photo 25**

Single glazed aluminium windows are located around the dwelling.

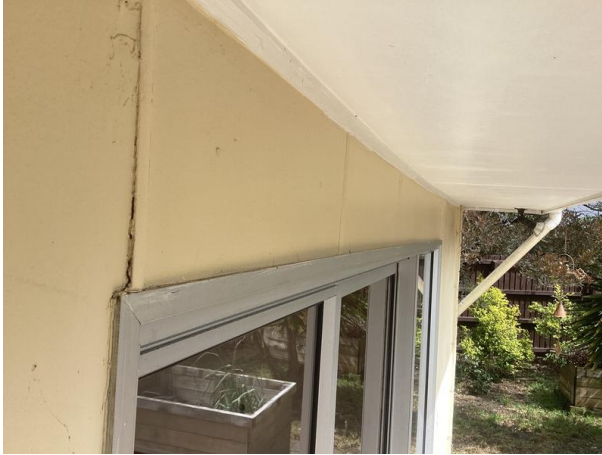
**Photo 26**

Where the cladding is fibre cement sheeting, no head flashings were installed. This was common at the time of construction.

Where the cladding is fibre cement sheeting, no head flashings were installed. This was common at the time of construction. It is recommended to keep these well sealed and maintained. Above some windows were not sealed however, there were no visible issues when viewed from inside the dwelling.

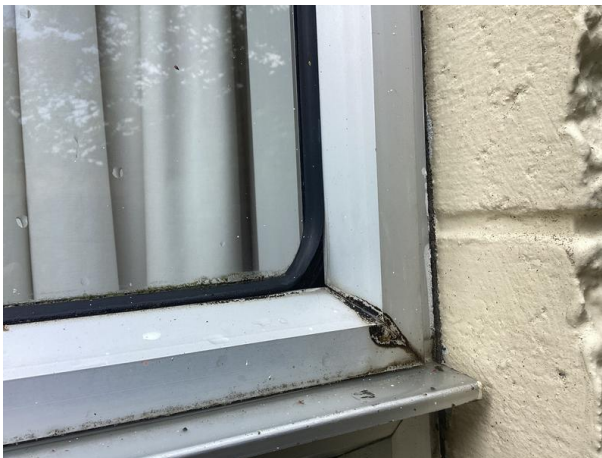
**Photo 27**

A couple window rubbers were shrinking or pulling away from the corners.

To prevent water and draughts from entering, it is recommended to replace or properly re-seat the rubber seals on the exterior of the joinery. By doing so, you can ensure a tight seal that effectively safeguards against water & draught ingress.

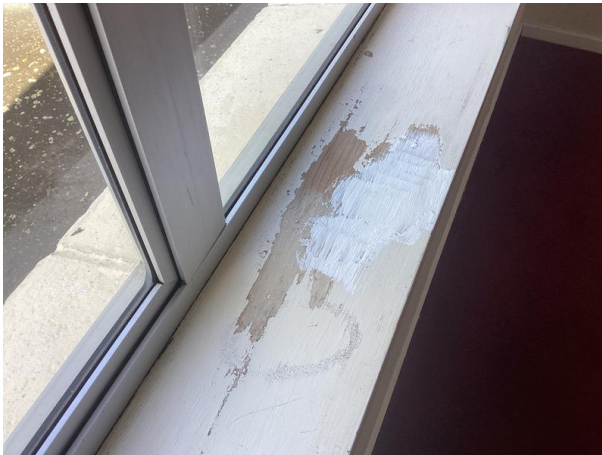
**Photo 28**

Some timber window reveals are overdue from maintenance.

Make sure paint is maintained and moisture is kept at a minimum.

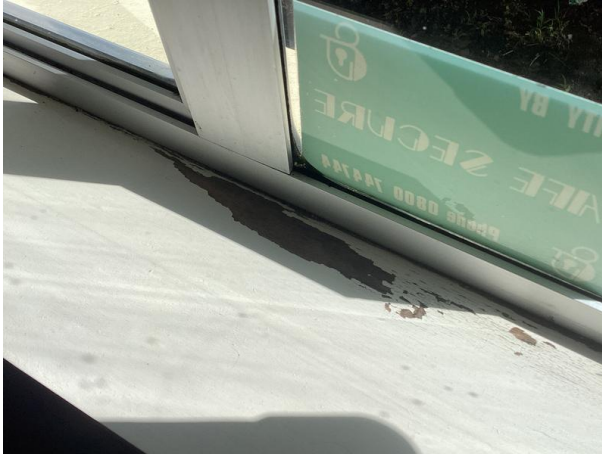
**Photo 29**

Example of a timber window reveal that is overdue for maintenance and repainting.

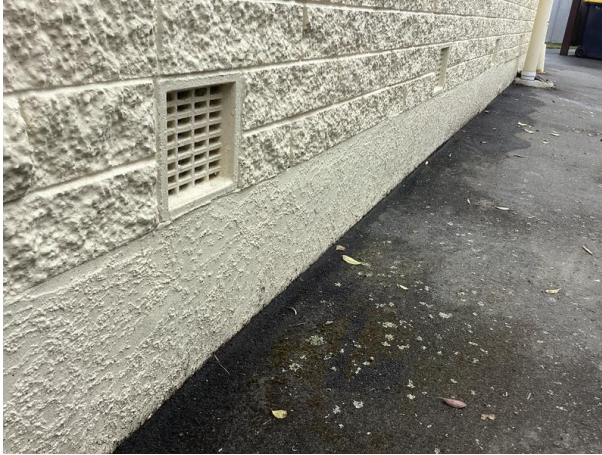
**Photo 31**

A concrete ring foundation with vent holes is located around the dwelling.

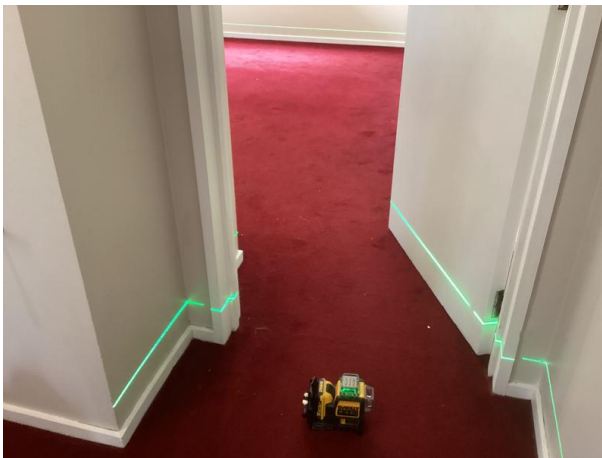
**Photo 32**

The floor levels were spot checked around the dwelling using a self levelling laser.

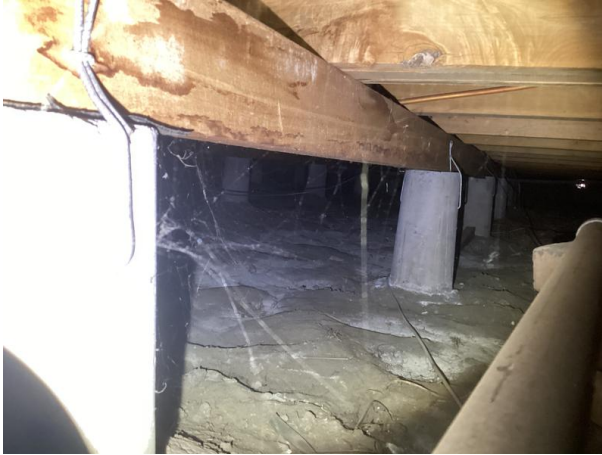
**Photo 34**

View of inside the subfloor. Limited access and visibility due to the plumbing located around the subfloor access hatch.

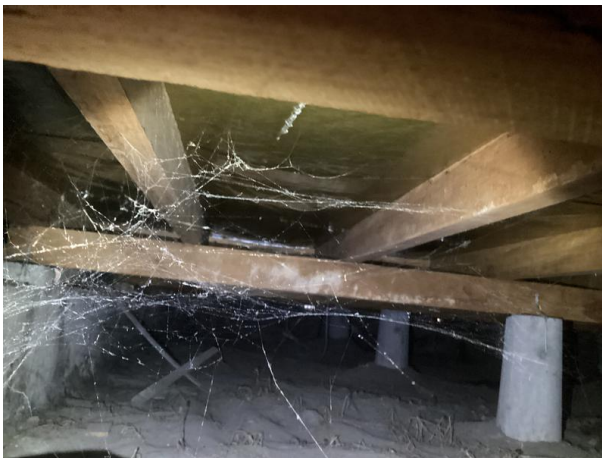
**Photo 35**

Silver foil insulation is visible in the subfloor.

A ban has been declared on the installation and/or repair of foil insulation in residential buildings with existing electrical installations. This ban is due to safety concerns associated with the method of attaching the foil to the building. It relates to Building Code Clause G9 Electricity. This ban is declared from 1 July 2016.

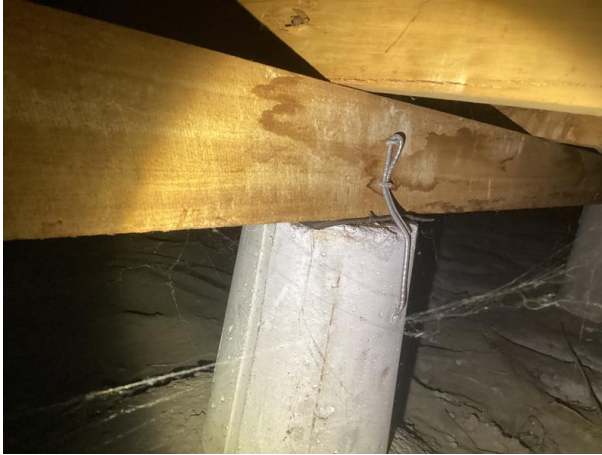
**Photo 37**

Tie wire connections were visible between the concrete piles and timber bearers.

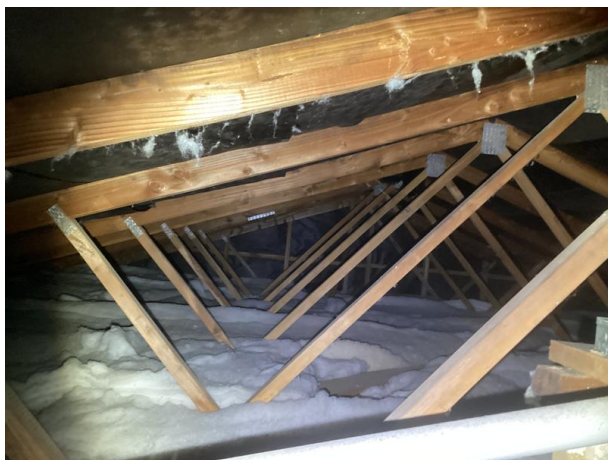
**Photo 39**

View of inside the roof space.

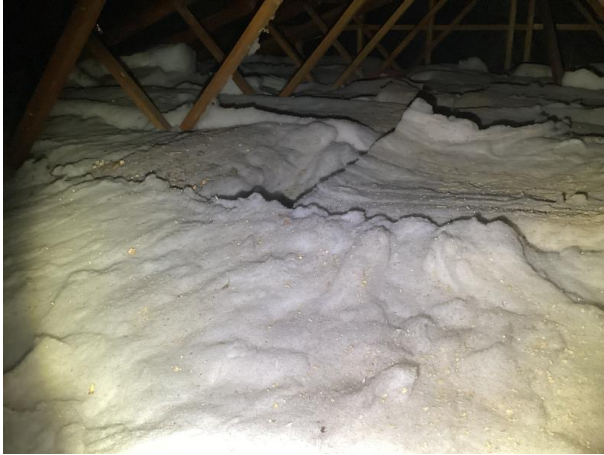
**Photo 40**

Acceptable coverage of insulation where visible.

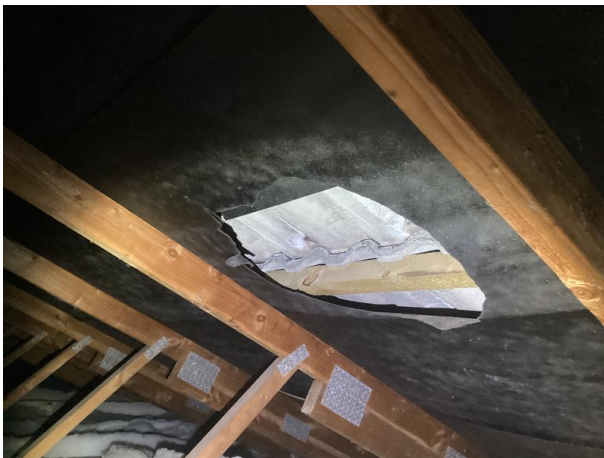
**Photo 41**

Torn and hanging self supporting roofing underlay was visible in a couple locations.

As detailed in the photos below and in the roof system section of this report, masonry tile cracking and chipping was noticed around the roof system. When viewed inside the roof space, signs of moisture staining was noticed in a couple locations. It is recommended to have a licensed roofer to inspect and advise further.

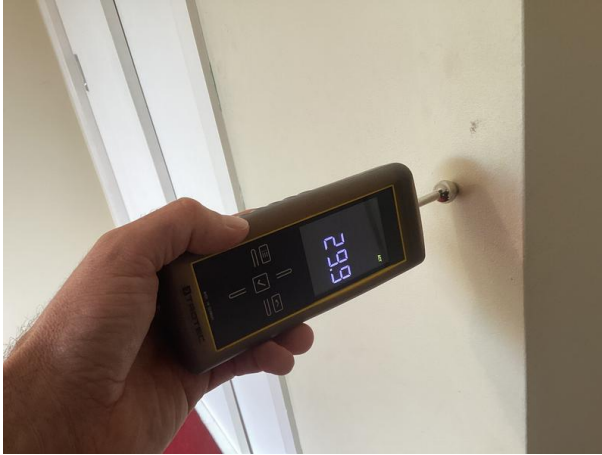
**Photo 44**

Example of a base reading that was taken on an internal wall. This is the average moisture reading for this dwelling during the time of inspection.

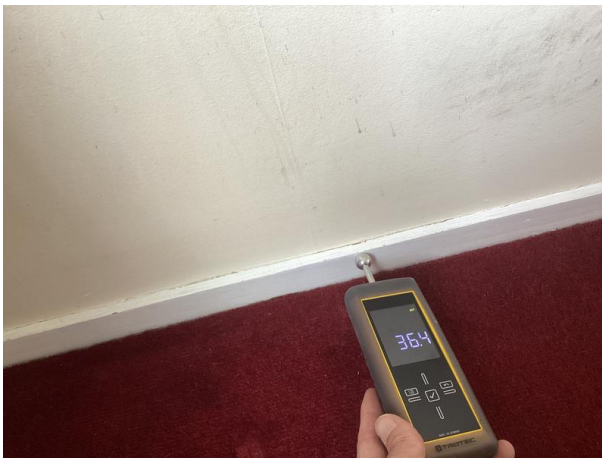
**Photo 45**

Moisture testing was done around the external walls.

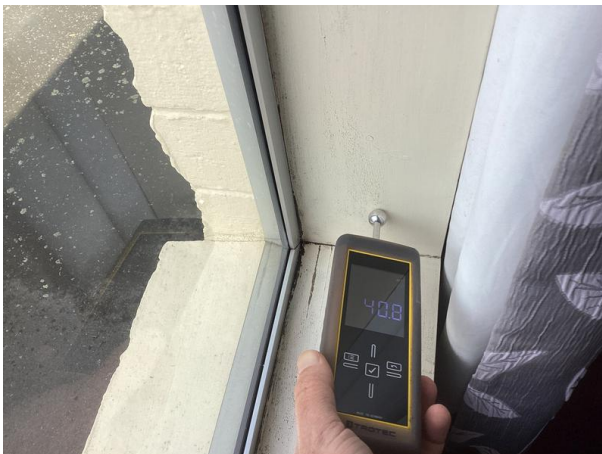
**Photo 46**

Moisture testing was done around the external window joinery.

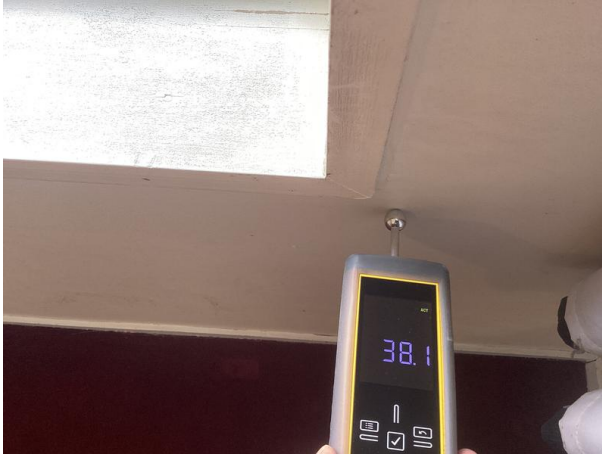
**Photo 47**

Moisture testing was done around the external window joinery.

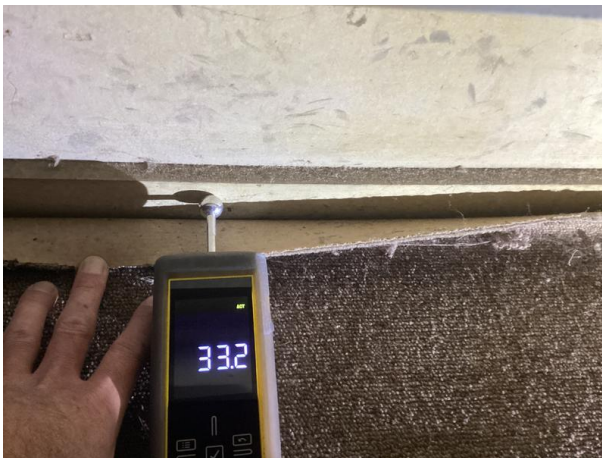
**Photo 52**

Moisture testing was then done on the other side of the entrance in the bedroom one wardrobe with no elevated moisture readings detected at the time of the inspection.

As detailed in the photos below, indications of elevated moisture and thermal abnormalities were discovered on the right-hand side of the entrance door. Moisture testing and thermal imaging were done on the other side of this wall in the bedroom, one wardrobe, with no visible issues identified during the inspection. It is likely that driven rain or cold, damp air may be getting through the entrance door and the reveal junction. It is recommended to have a qualified builder advise further.

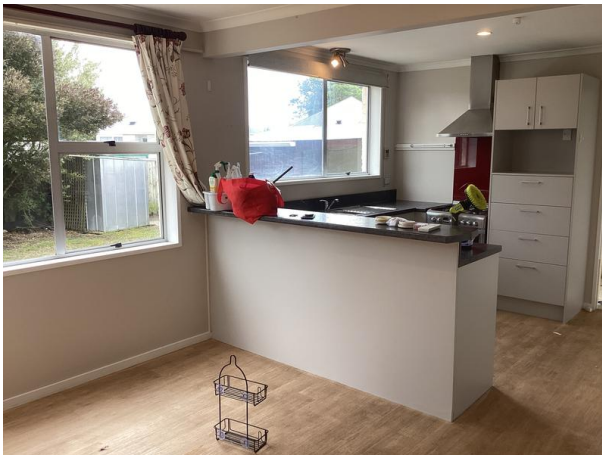
**Photo 56**

Dining room and kitchen.

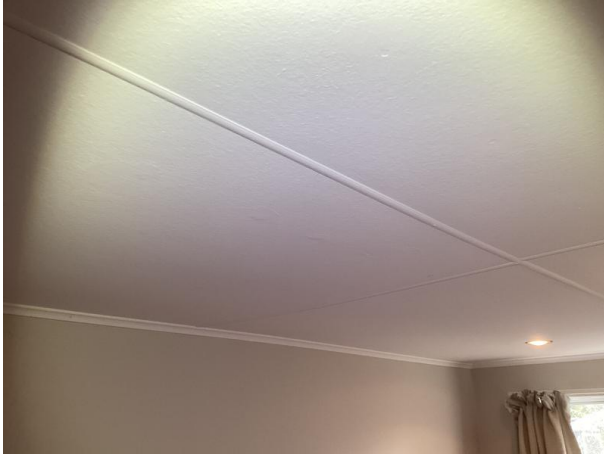
**Photo 61**

Hard to tell in this image however, the soft board sheeting was sagging along one of the joints and may require extra fixings to secure it up.

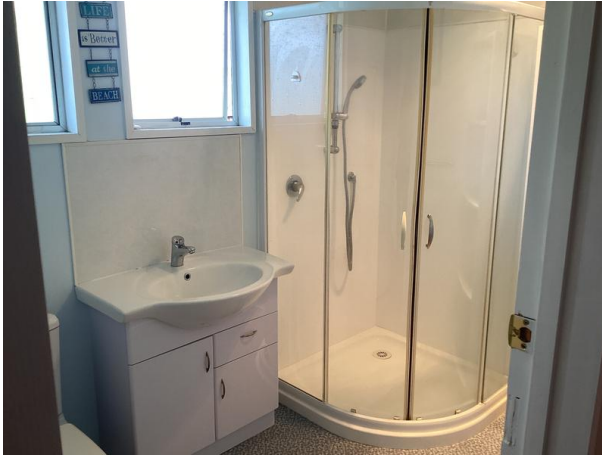
**Photo 64**  
Bathroom.

As detailed in the photos below, moisture damage was visible either side of the shower enclosure with elevated moisture readings and thermal abnormalities also discovered. It is recommended to have the shower replaced or repaired and installed by a certified shower installer, it is also recommended for them to check

the surrounding areas of the timber framing due to the water notice coming through and behind the plasterboard linings when directing the showerhead at the bottom corners of the shower enclosure.

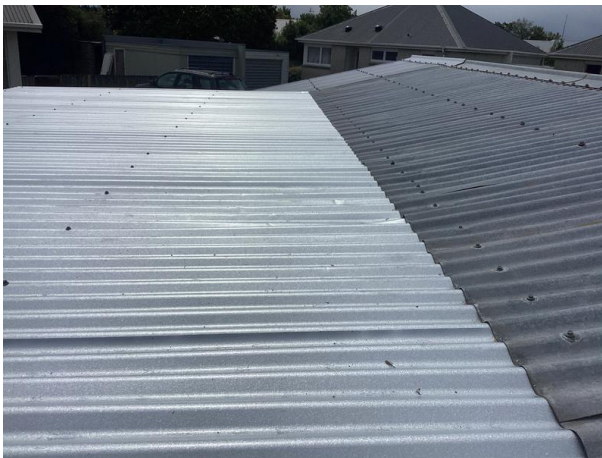
**Photo 74**

A profiled metal roof is located over the garage.

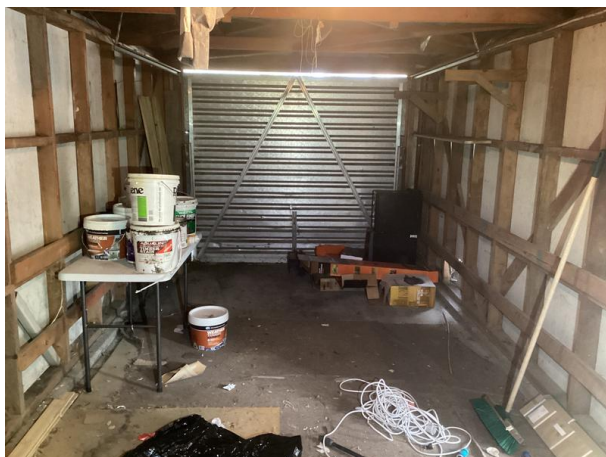
**Photo 76**  
View of inside the garage.

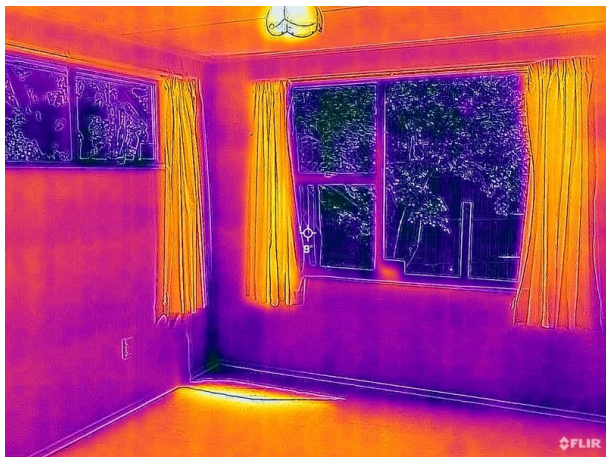
**Photo 78**

Bedroom 1, normal and consistent abnormalities were discovered.

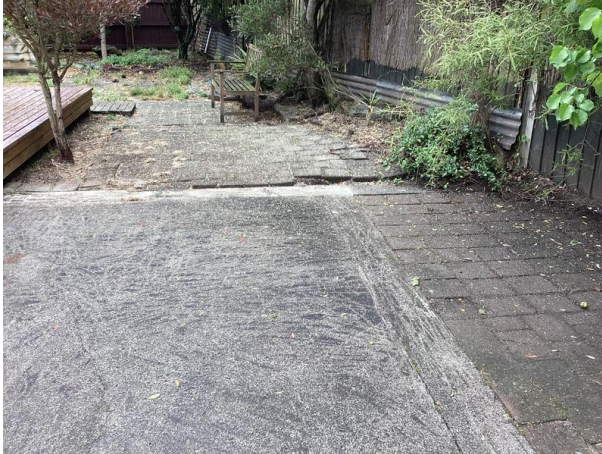
**Photo 88**

Plain concrete pavers.  
Condition - Some uneven pavers noted.

Some unevenness was noticed on the north side concrete pavers.

General upkeep and maintenance.

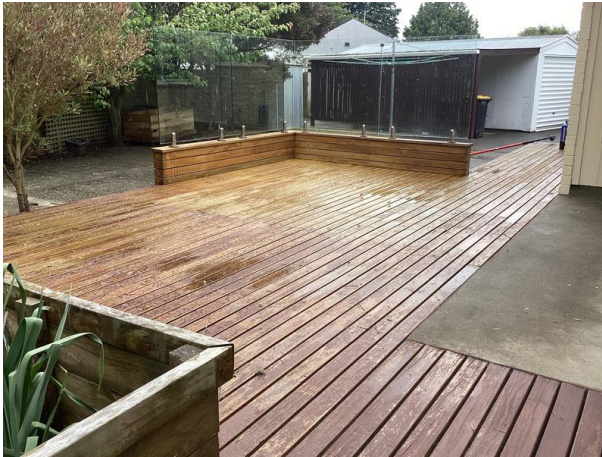
**Photo 89**

Condition of visible timbers - Some timbers are splitting from the ends.

North side timber deck, in a condition expected for age.

General upkeep and maintenance.

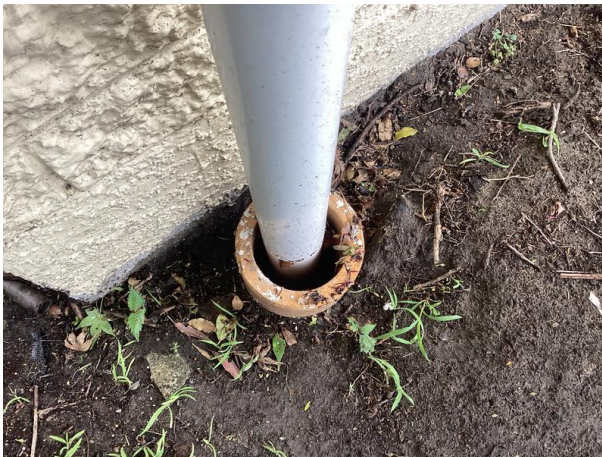
**Photo 94**

South side stormwater riser.

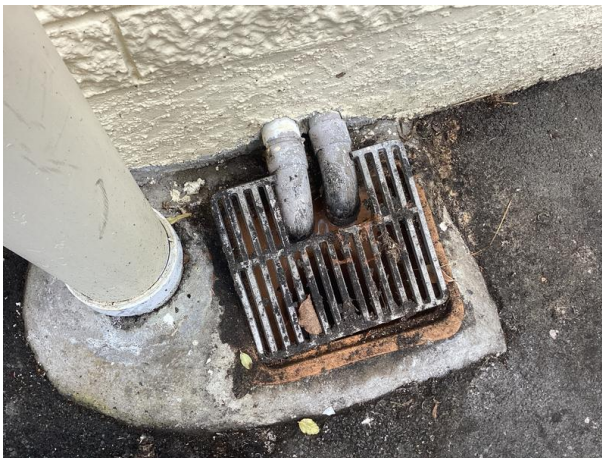
**Photo 96**

East side gully trap.

Surface water needs to be prevented from flowing into a trap by ensuring that the rim of the gully dish is at least: 25 mm higher than a paved surface and/or 75 mm higher than an unpaved surface. As per G13 AS2

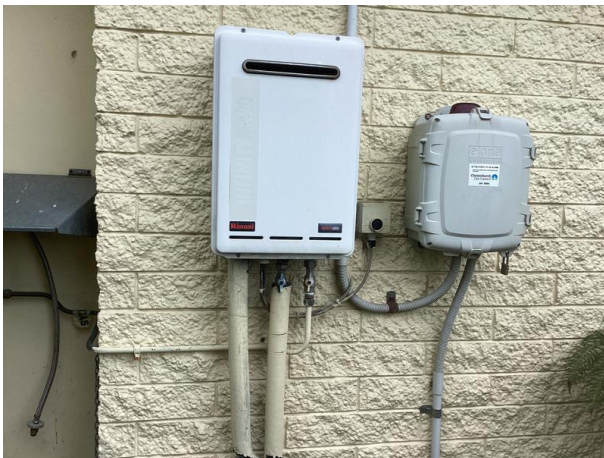
**Photo 99**  
Gas hot water Calfont located on the south side of the dwelling.

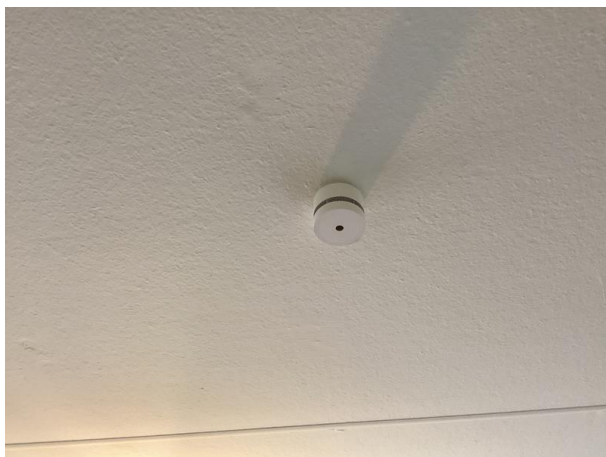
**Photo 106**

Smoke alarms are located around the dwelling. Ensure these have not expired and tested frequently.
