RESIDENTIAL HOUSE INSPECTION COPY

37 Sugden St
Christchurch, Canterbury Region 8024

23/10/2025

Inspector
Aaron Krahagen
Kiwi House Inspections
[+64275522004](tel:+64275522004)
aaron@kiwiinspections.nz

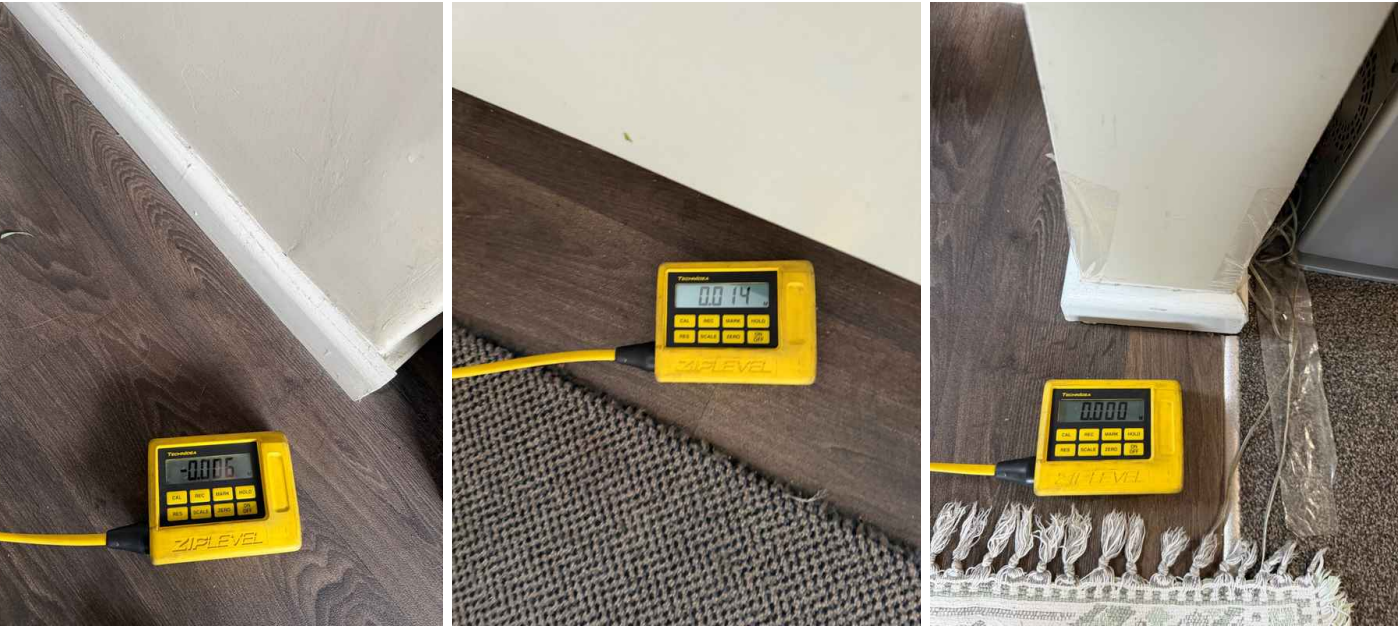
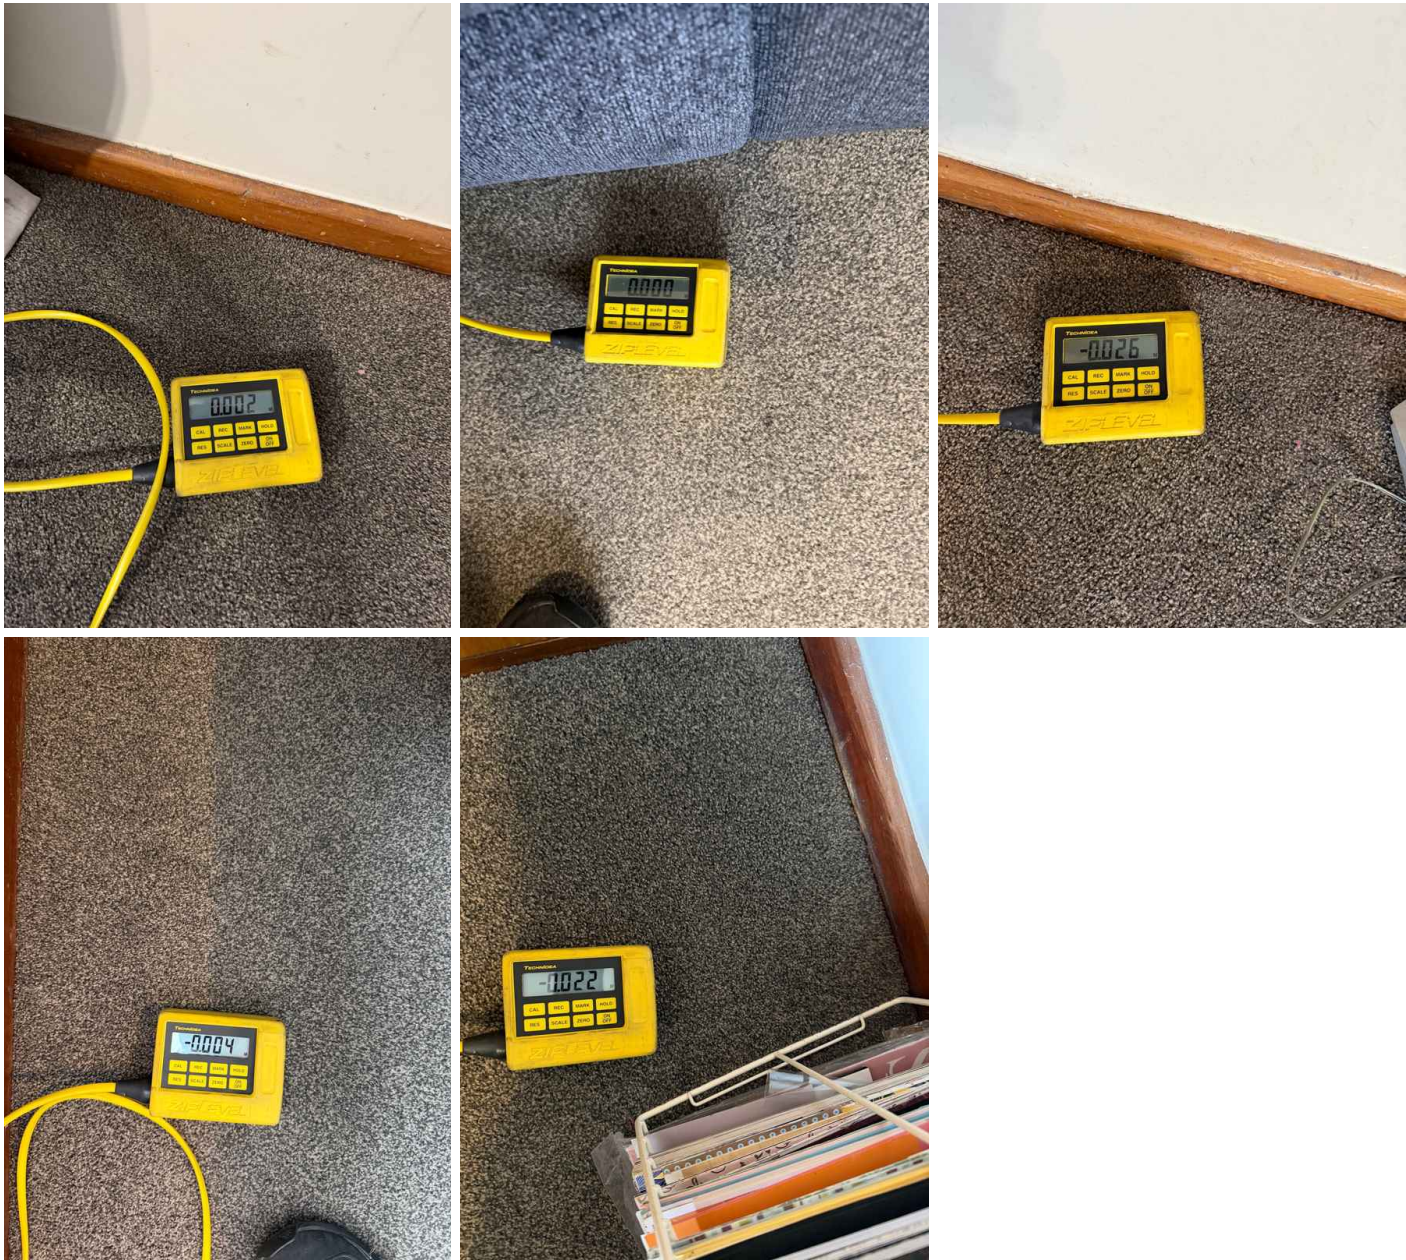
Deviations in floor levels are noted, it is in our professional opinion that these are of an historical nature when the age of the dwelling and construction methods and alterations are taken into account.

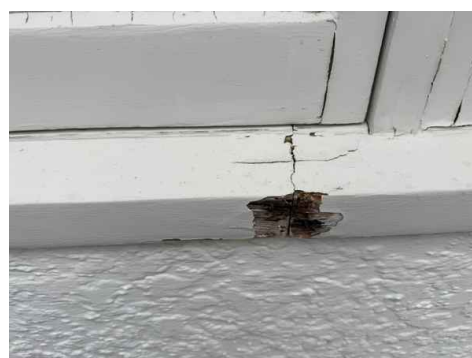
8.1.4 Exterior Joinery

NO HEAD FLASHINGS

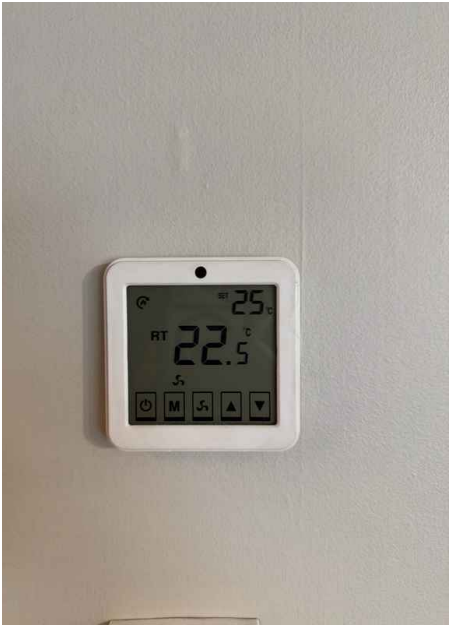
This was not tested, we recommended that a service is completed, and a handover of the system use is completed, to ensure the correct operation and service intervals.

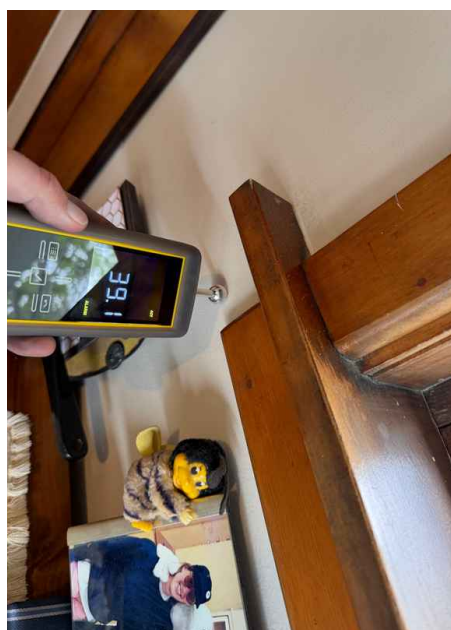
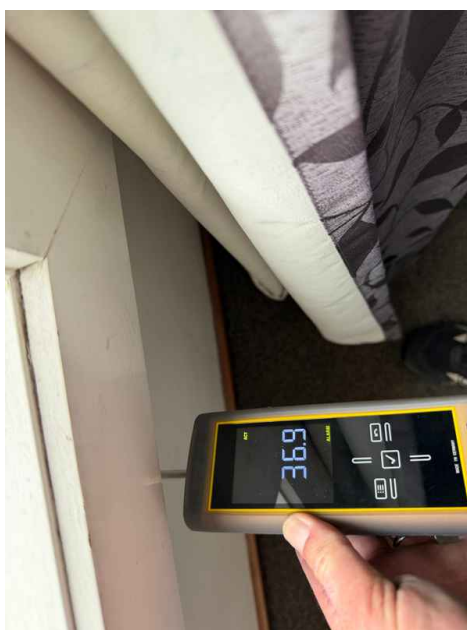
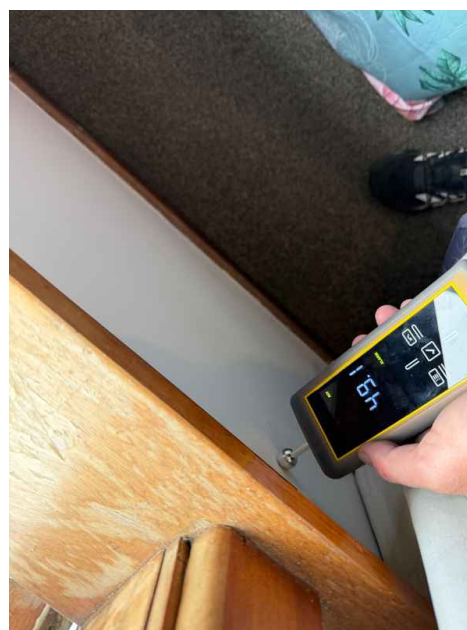
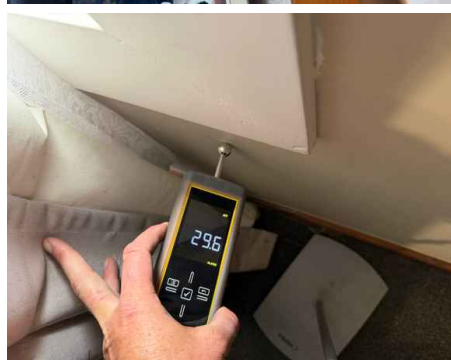
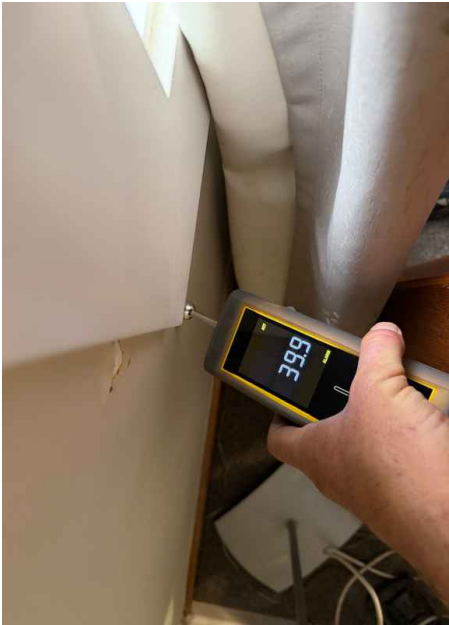
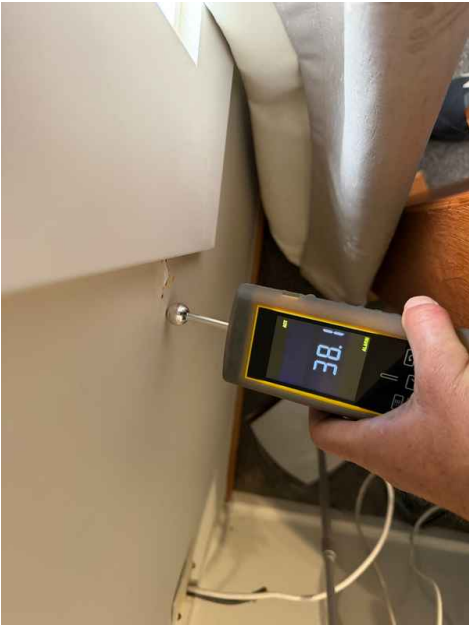
Moisture : Sample Of Readings

Photos are samples of readings taking around the dwelling.

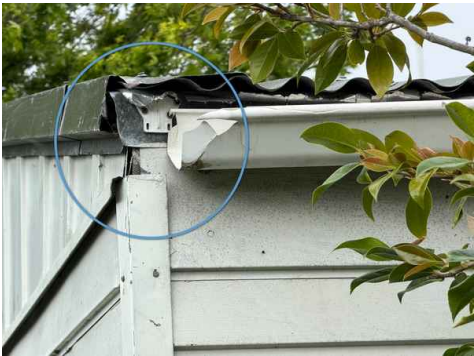
25.3.2 Defects Roof System

SPOUTING DAMAGED

Maintenance Item
