# Independent Builders Report

Total Home Inspection Services Porirua City Ltd

Mon 3 Nov 2025

**73 Langdale Ave, Paraparaumu, Kāpiti, 5032, New Zealand**

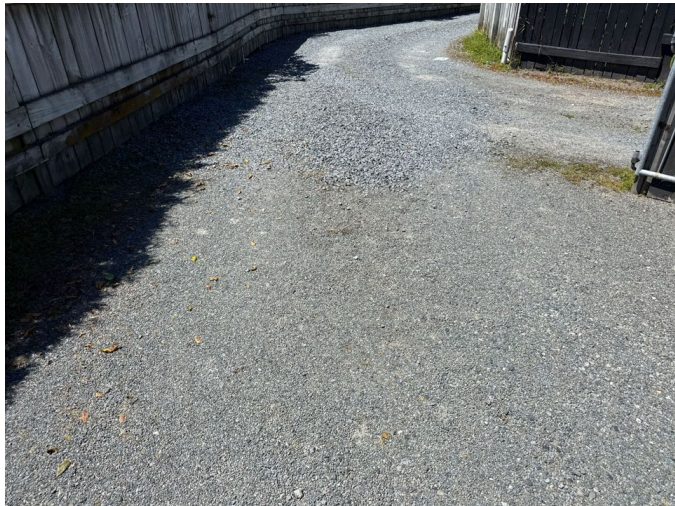
The gravel driveway is tidy and functional

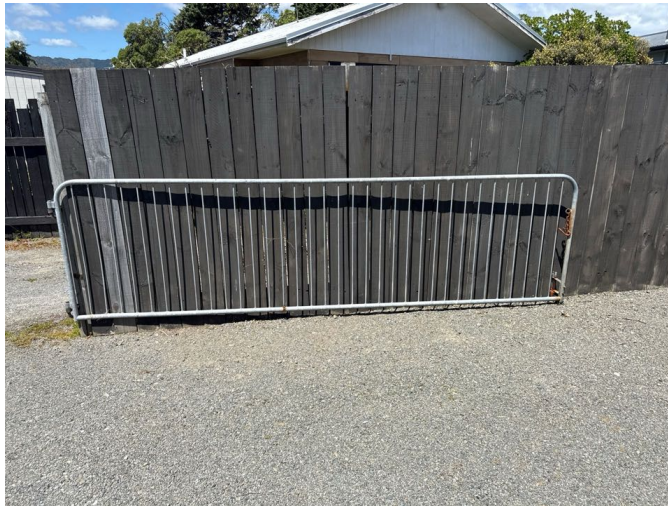
The steel gate to the driveway is functional

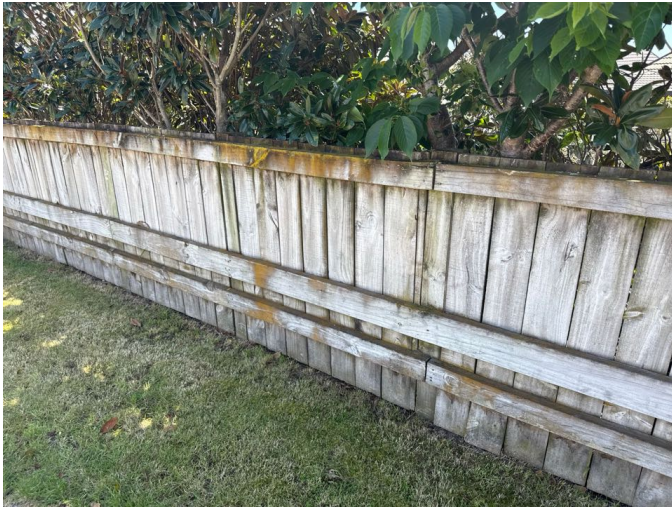
The perimeter fencing is solid and intact.

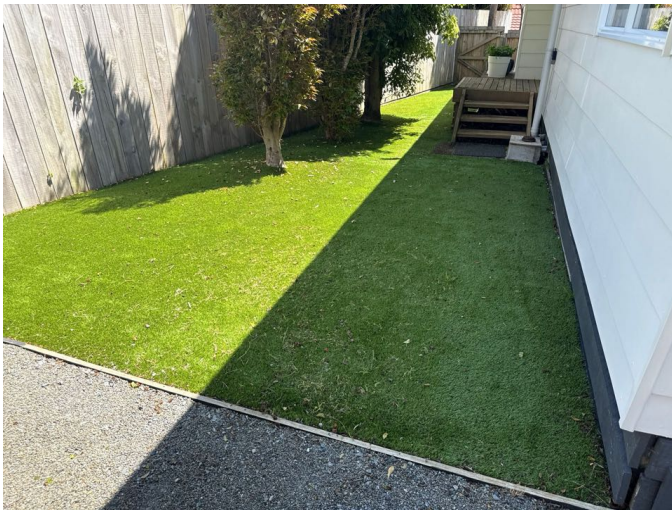
The artificial grass area to the back is in good condition

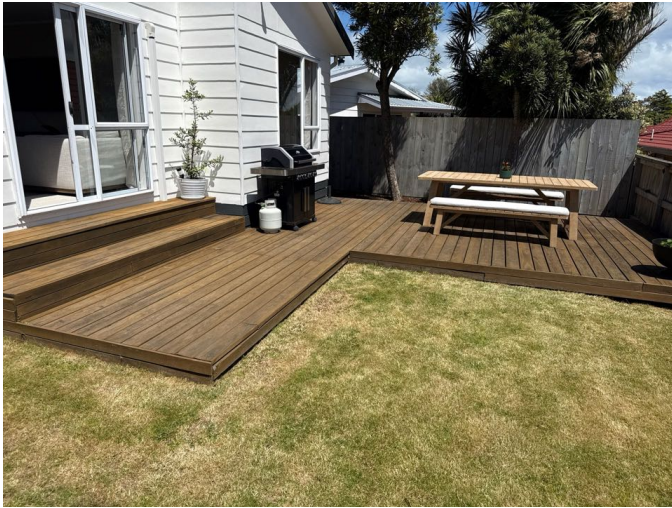
No concerns with the low height deck.

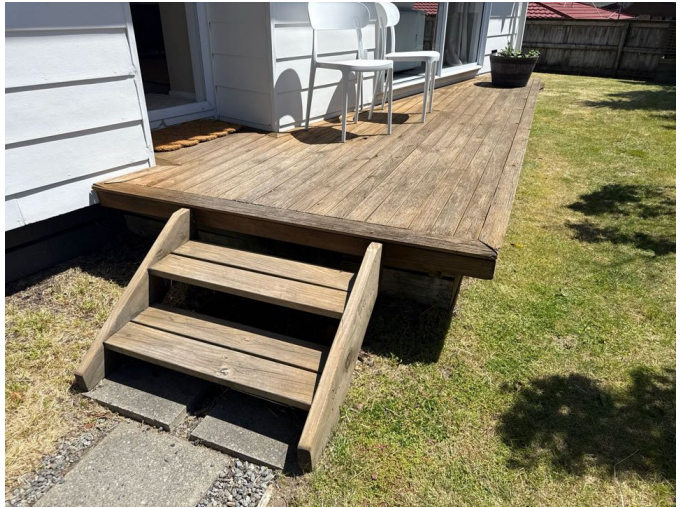
The timber stairs and deck to the entrance have some age related wear but are generally solid and functional .

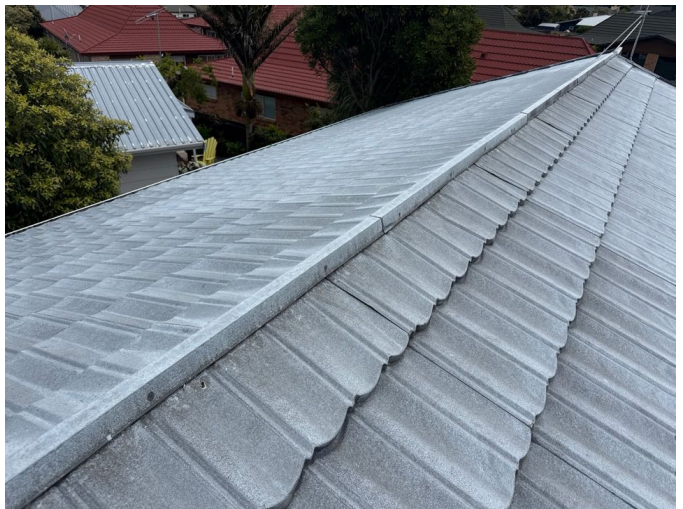
The roof flashings appear to be secure, intact and are effective. No sign of failure could be found beneath where accessible to view.

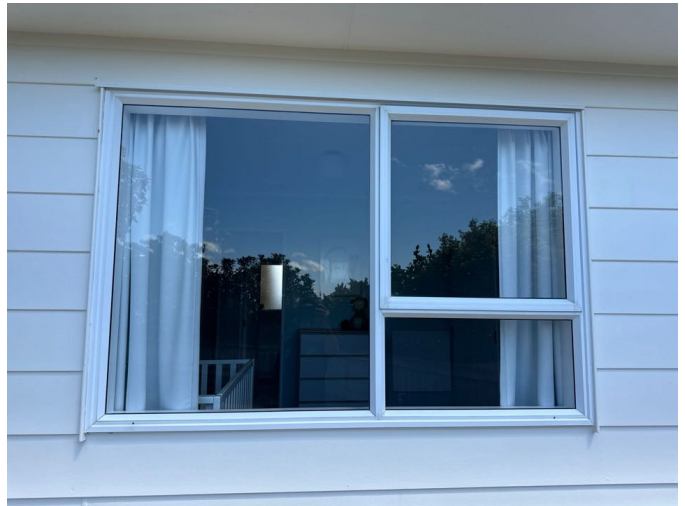
The typical single glazed aluminium window detail consists of a head flashing and timber scribes. The aluminium joinery is tidy, functional and is effectively sealed.

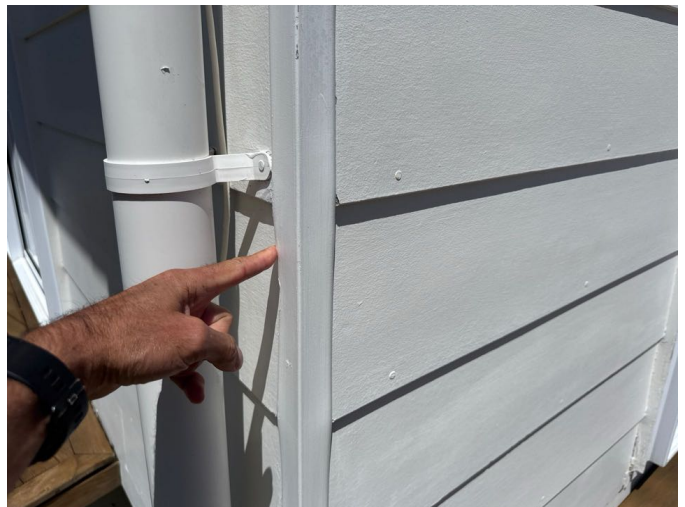
UPVC flashings to the external corners. These protect the corners from moisture ingress.

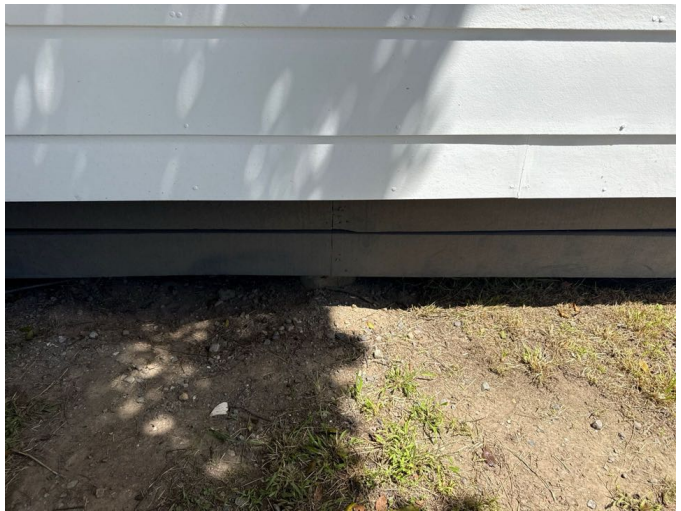
Good clearance to the main house

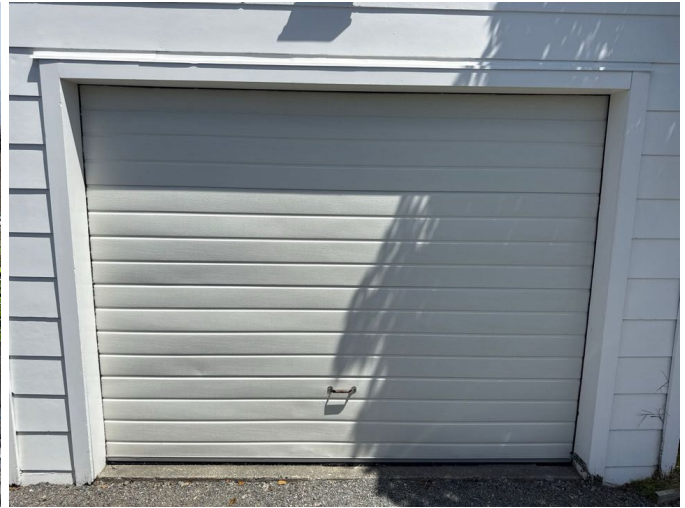
The surface condition of the garage door is good

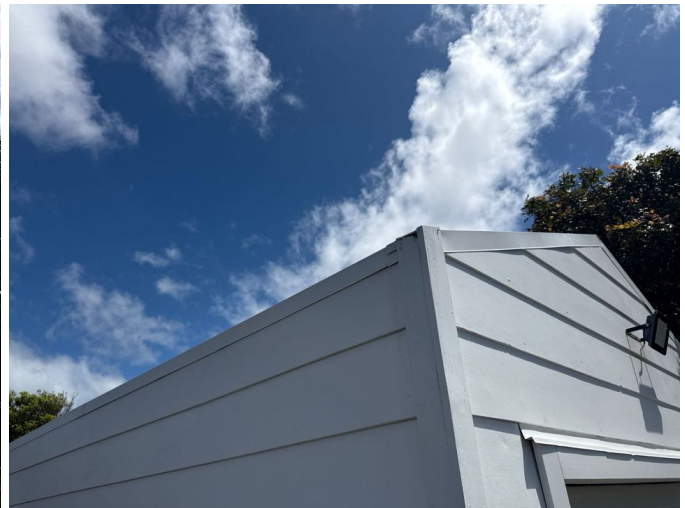
There are no barge boards or fascia under the barge flashings. This is a high weather tightness risk.

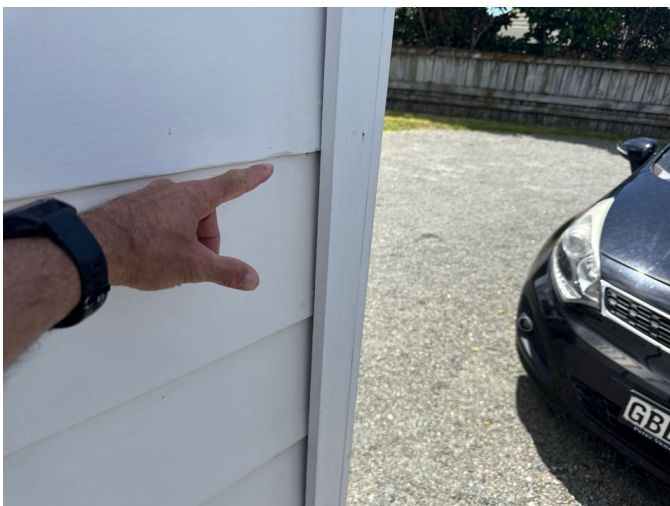
No scribes to the external corners

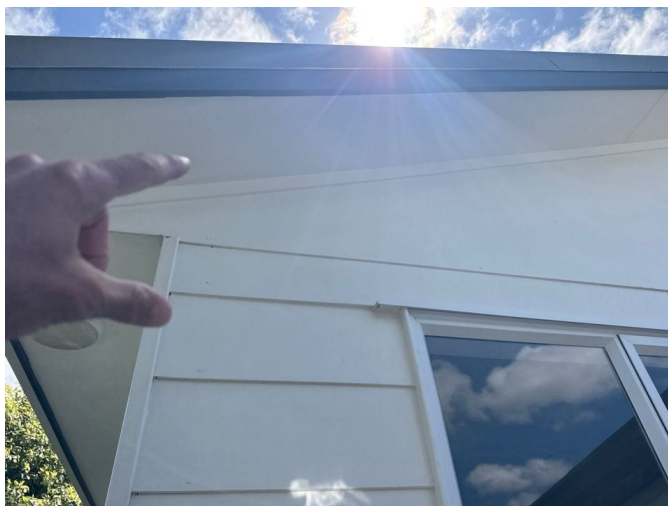
Due to the age of the home, some of the materials installed may contain elements of Asbestos. Please note this is safe in an inert state and must be kept well sealed. If any work is to be completed in areas that likely contain Asbestos then there are certain health and safety precautions that should be followed.

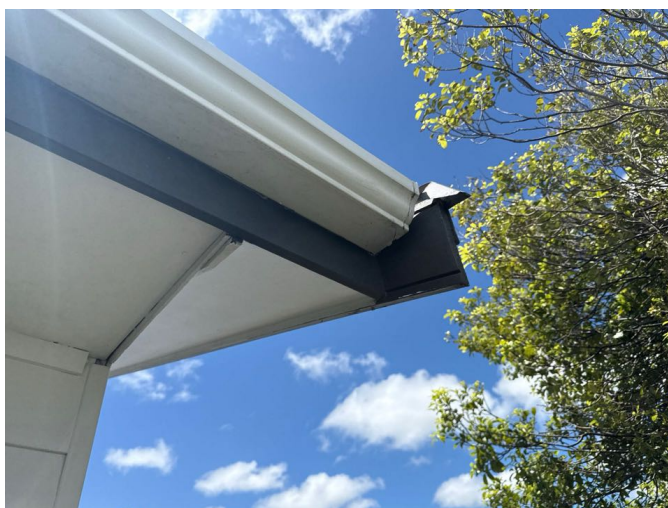
Good paint quality to the timber barge boards, fascia and fibre cement soffit linings

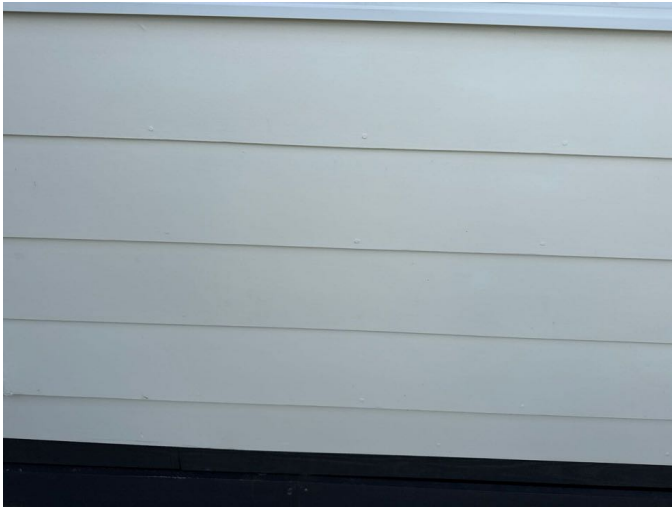
Good paint quality to the weatherboards

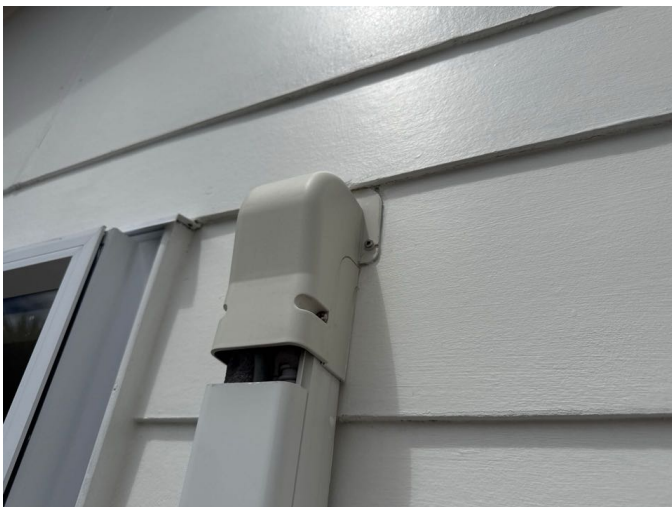
Cladding penetrations in general are a weather tightness risk area. Penetrations such as taps, screw fixings, gas or water pipes etc. A good seal must be maintained around all cladding penetrations over time to prevent issues.  
No evidence of failure could be found.

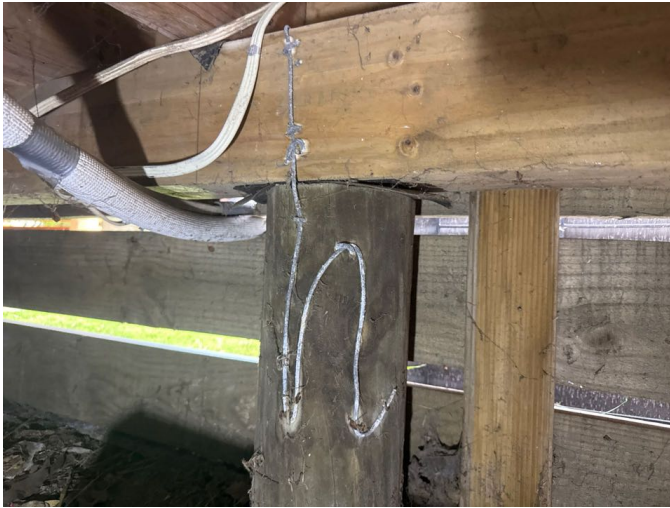
The timber piles are solid at the time of inspection. Galvanised wire and nail plates connect the bearers to the piles and anchors the structure to the ground.

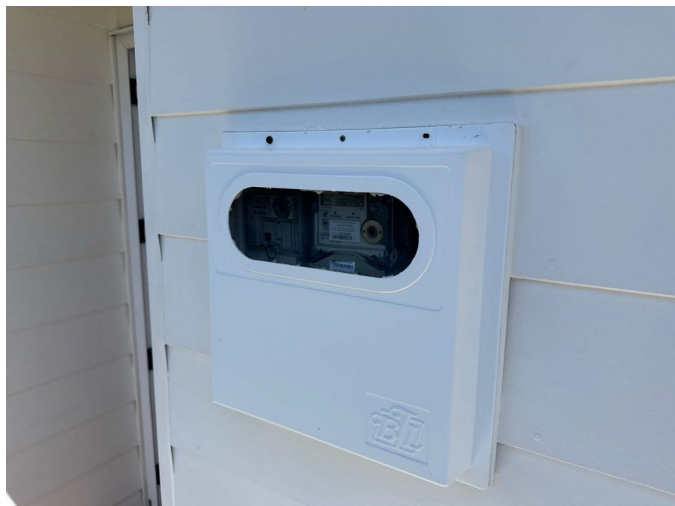
The meter board appears to be sufficiently sealed at the time of inspection. Smart meter installed, no obvious concerns sighted.

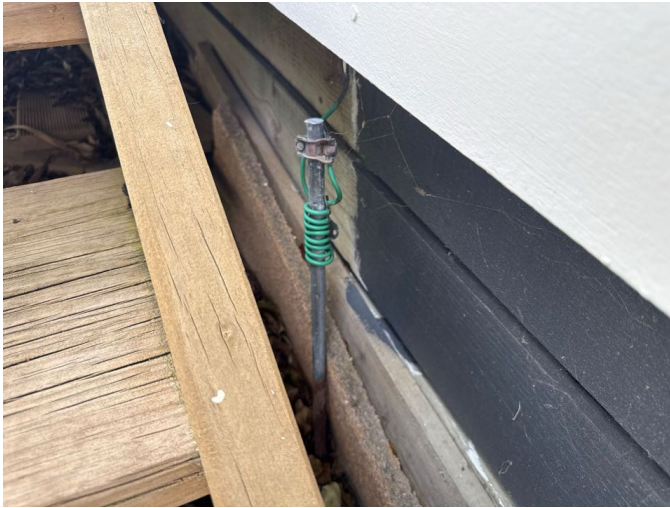
The electrical earth rod provides a safe path for fault currents to dissipate into the ground, helping protect people and equipment from electric shock and reducing the risk of damage during faults or lightning strikes.

An earth loop test should be considered to determine the earth's effectiveness.

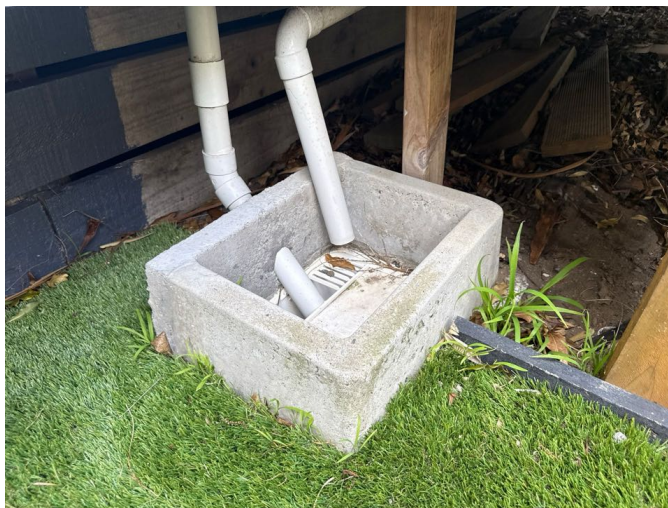
The overflow relief gully is an external outlet for waste in case of internal blockages. No sign of recent overflows. Good height noted.

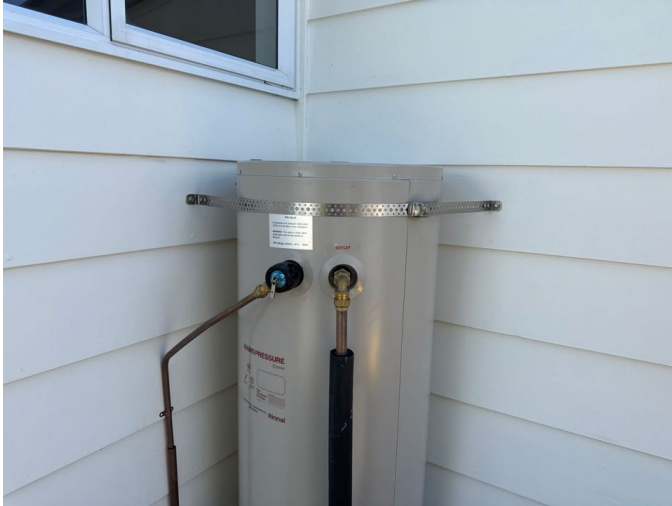
Back of garage.

Rinnai 180L Mains Pressure Electric Hot Water Cylinder. Seismic restraints installed.

The pressure-reducing valve that is located at the side of the mains pressure hot water cylinder should be tested every 6 months or in accordance with the manufacturer's instructions to make sure that it is in working order.

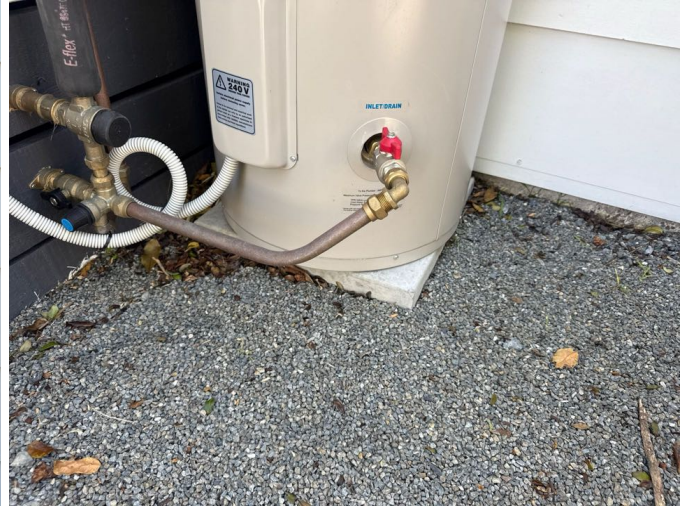
No sign of leaks at the base of the cylinder at the time of inspection

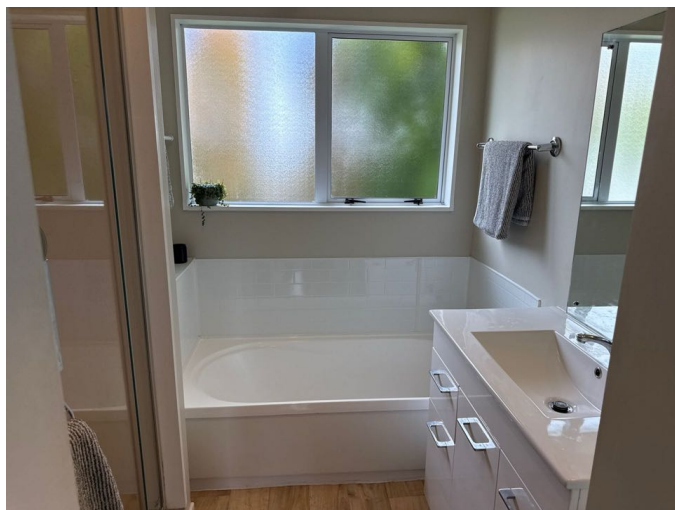
The rear edge of the vanity is well sealed. The taps are functioning well. No concerns with the water feeds or waste under the vanity

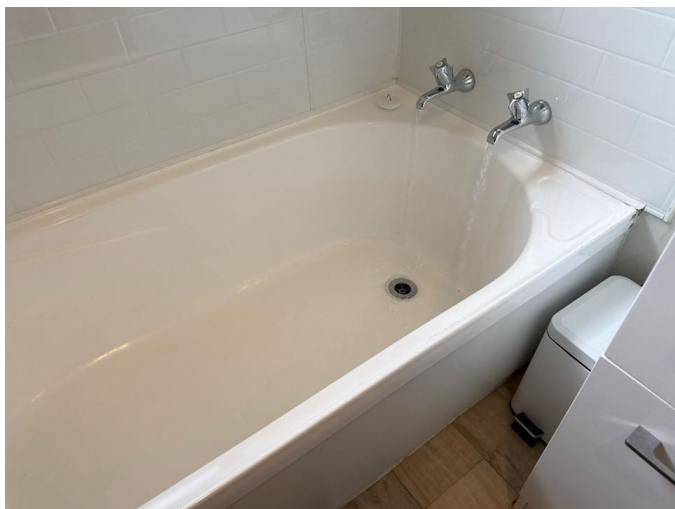
The perimeter of the bath is well sealed. The taps are functioning well.

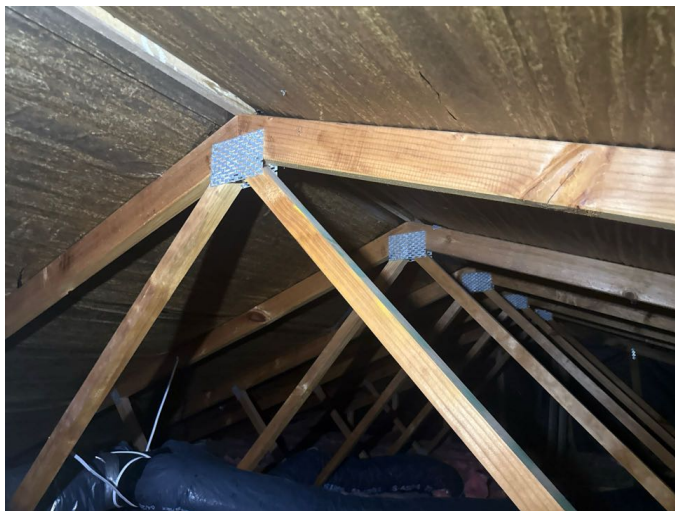
There was no evidence of current or past moisture ingress issues under the roof framing or linings (where accessible) at the time of inspection. The roof framing structure appears to be solid.

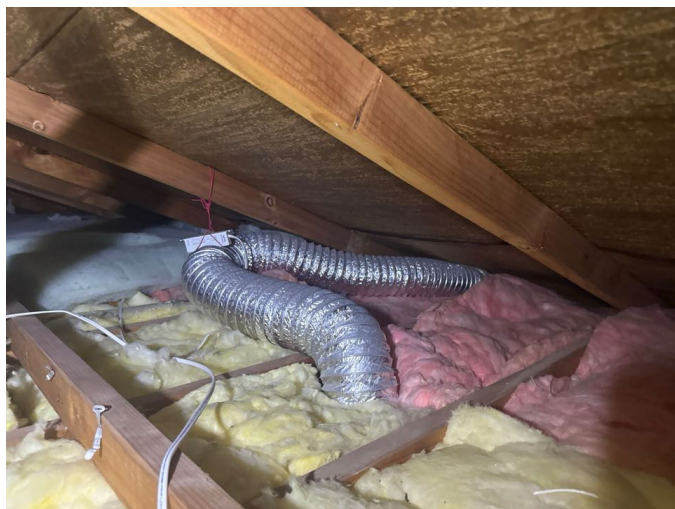
Extraction units vent to the exterior

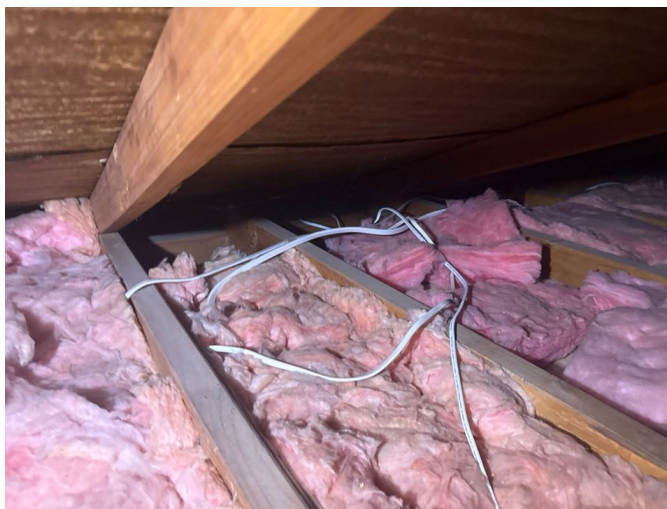
Only modern TPS wiring sighted during the inspection which is consistent for the age

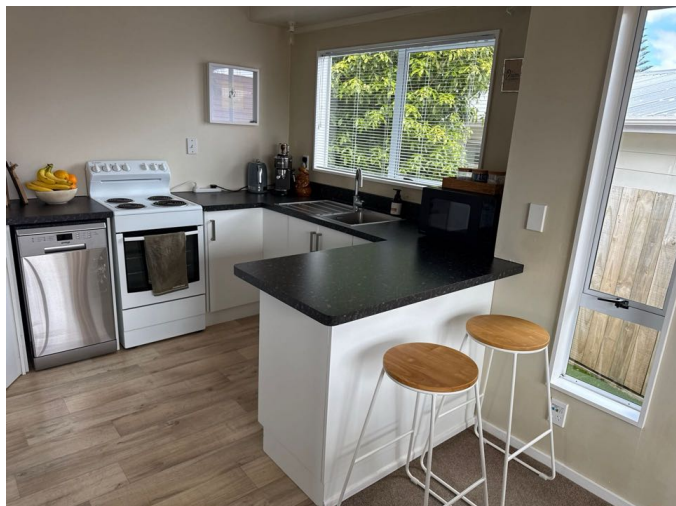
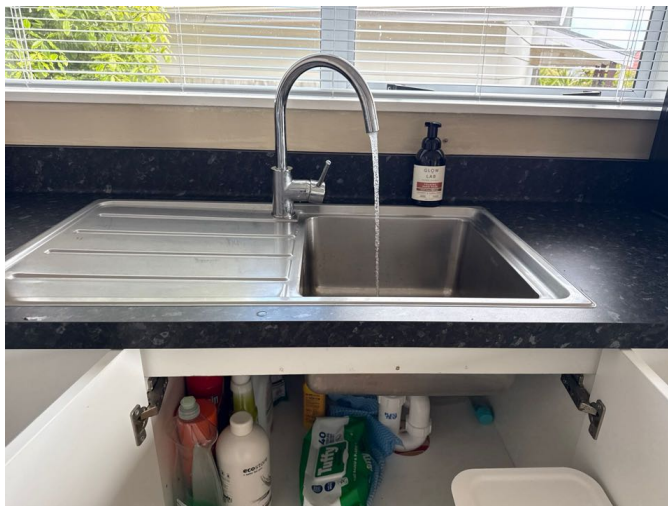
The rear edge of the bench top is well sealed. The tap is functioning well. No concerns with the water feeds or waste pipes under the sink.

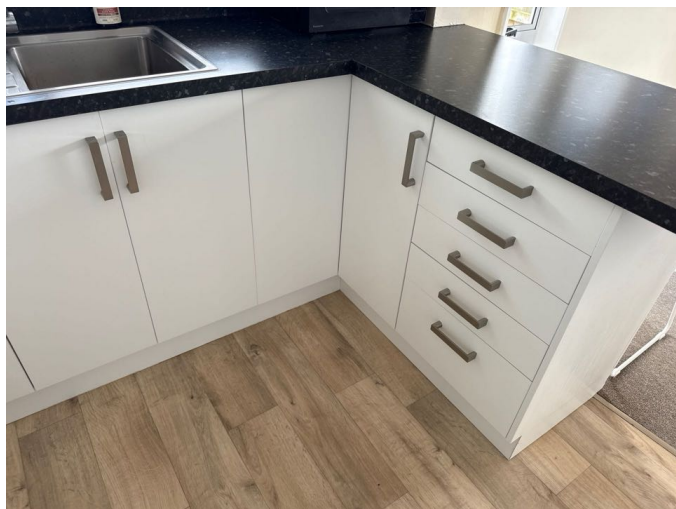
The kitchen cabinetry and vinyl floor are in good condition

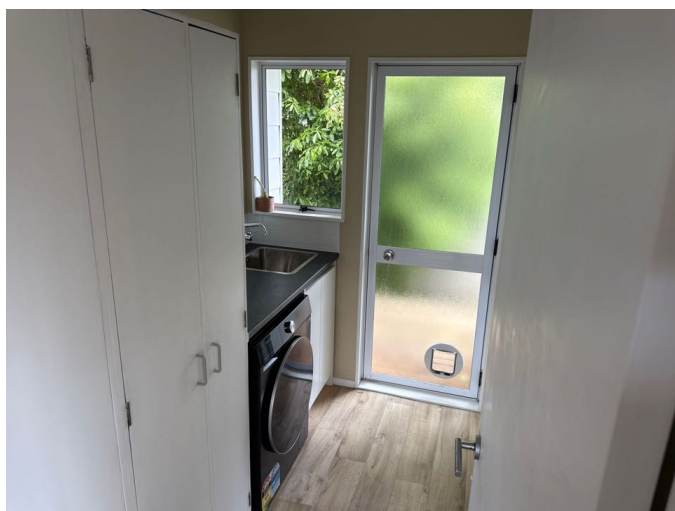
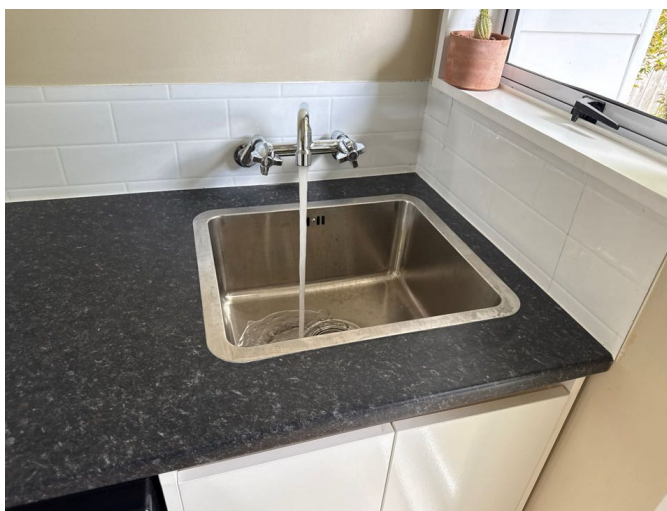
The tub is well sealed. The tap is functioning well.

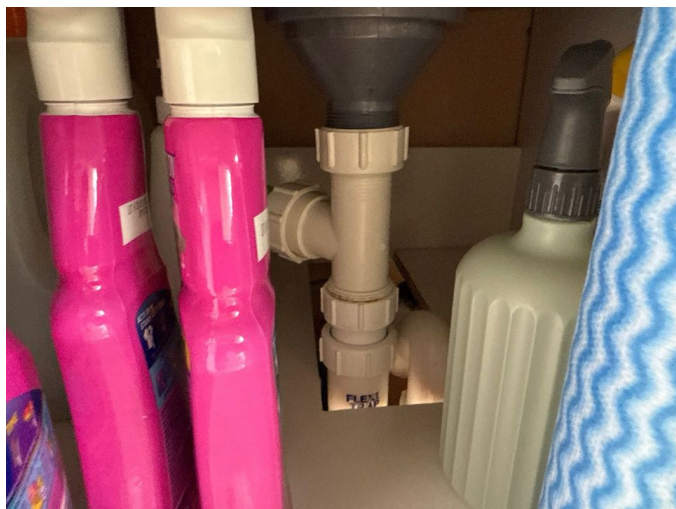
No concerns with the waste or water feeds beneath the tub

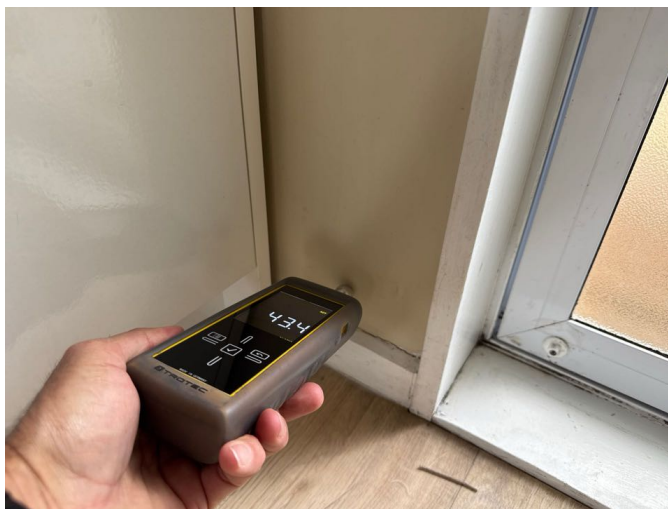
Moisture levels in the laundry were within the normal range at the time of inspection.

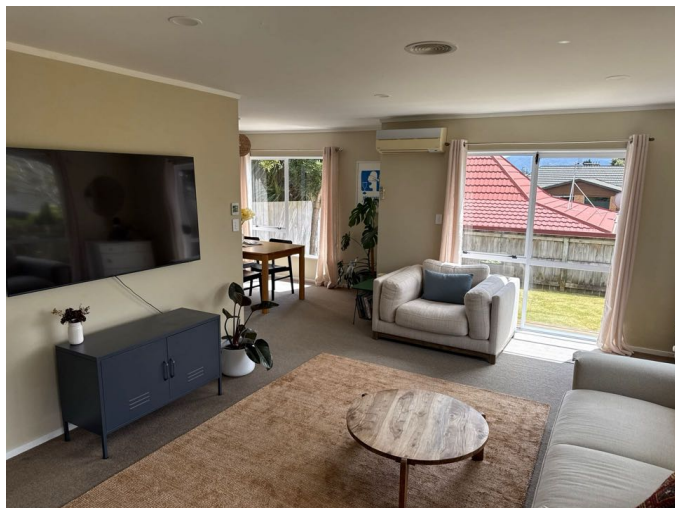
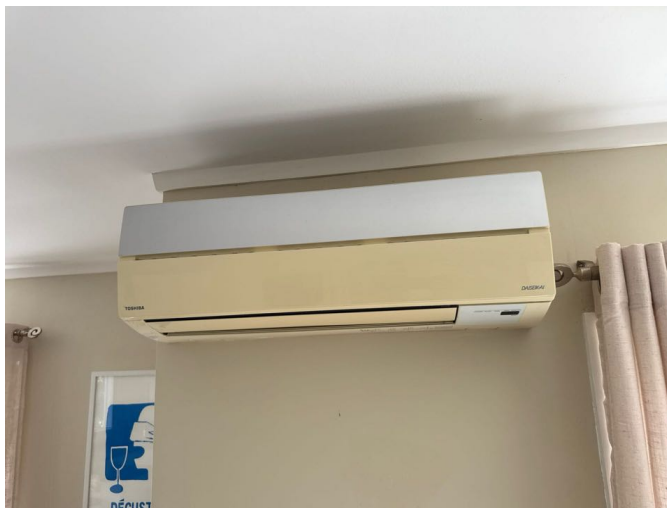
Heat pump installed,untested.

Heat pumps require regular servicing to be efficient. The manufacturers instructions should be checked and understood with regards to future servicing requirements.

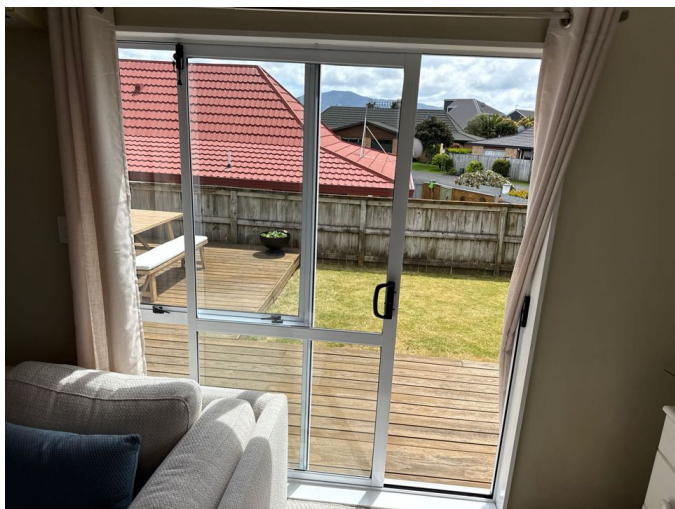
The sliding doors and windows are functional

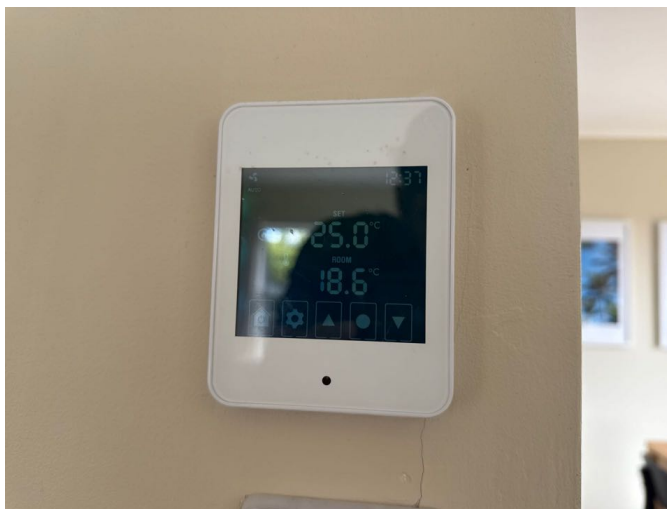
The control panel for the ventilation system is located in this room. Untested.

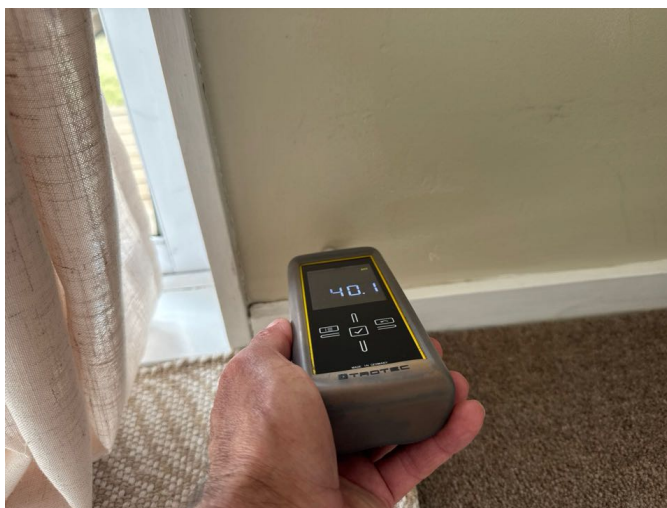
The moisture levels to the external walls were within the normal range

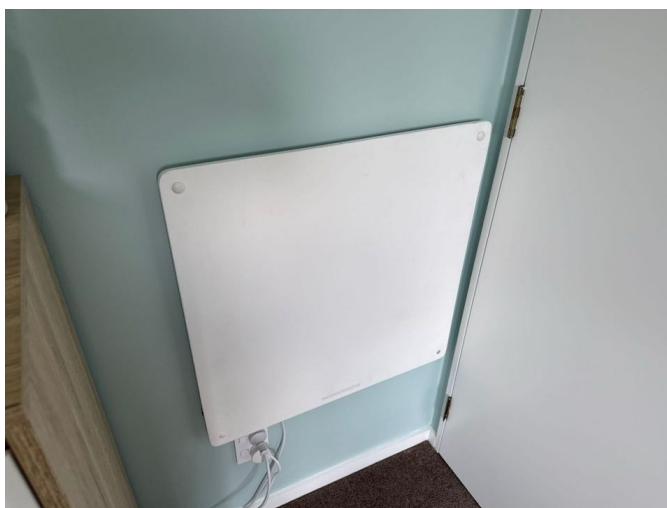
The heating appliances are not tested as part of the inspection process.

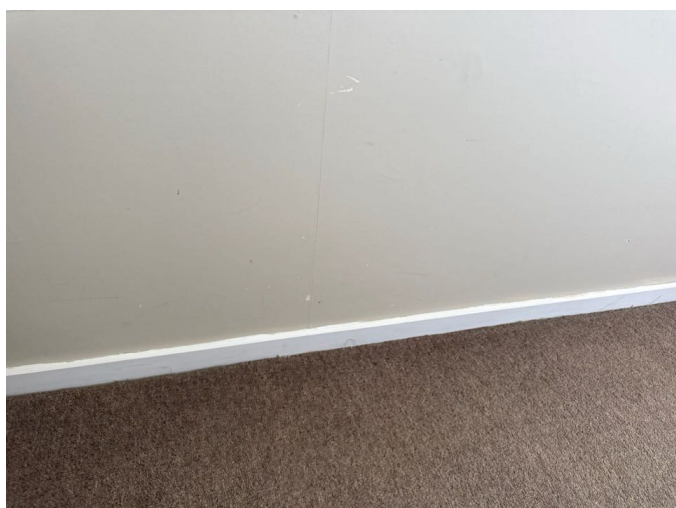
The wall and ceiling linings and carpet are in a tidy overall condition

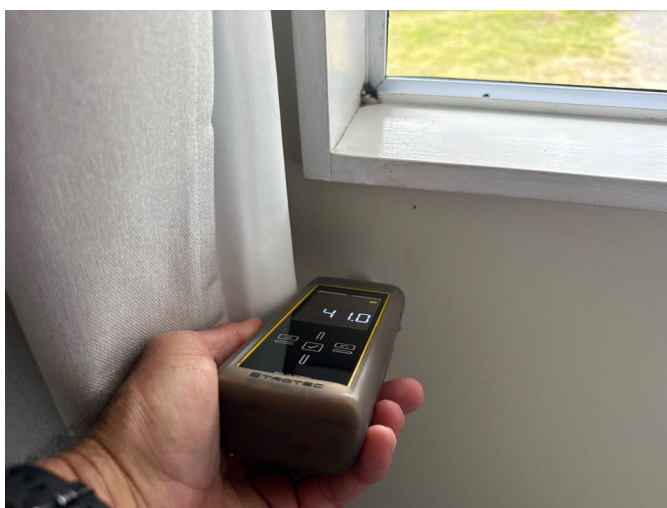
The moisture levels to the external walls were within the normal range

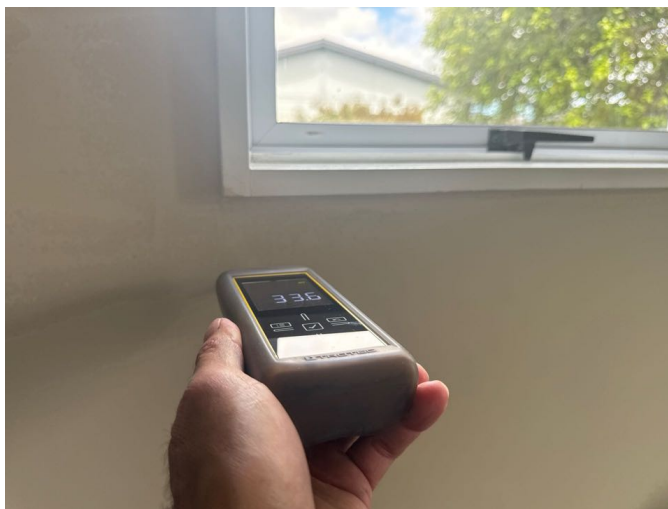
The moisture levels to the external walls were within the normal range

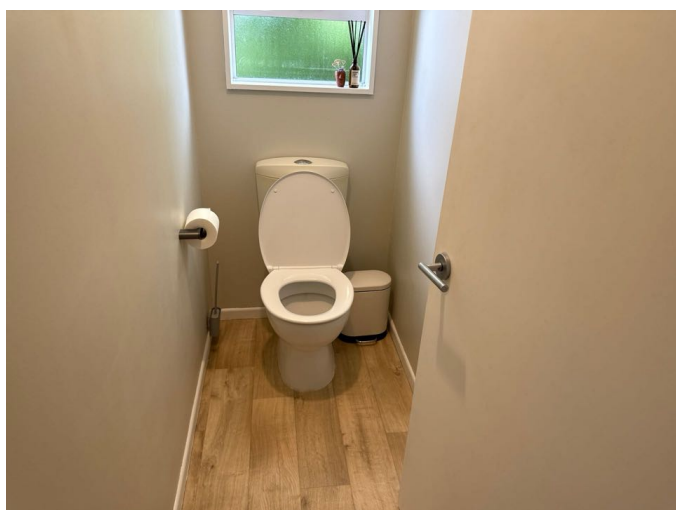
The base of the toilet is well sealed and is secure. The toilet is in a functioning condition.

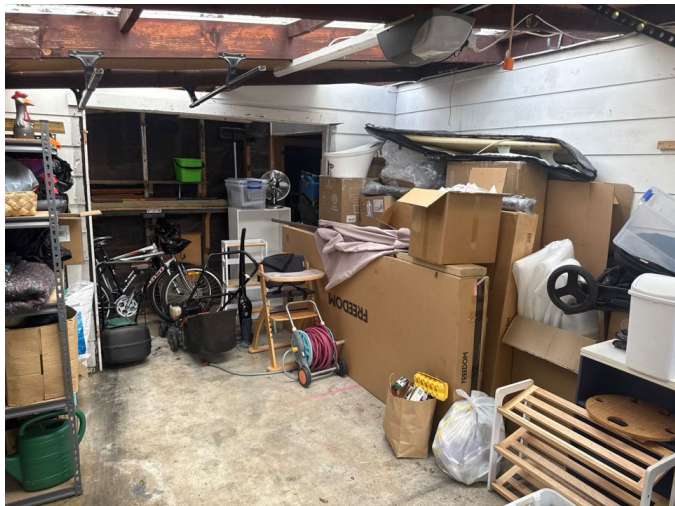
Not all areas of the garage could be fully inspected due to the presence of stored items. A full inspection is recommended once cleared. This applies to all concealed locations throughout the house.

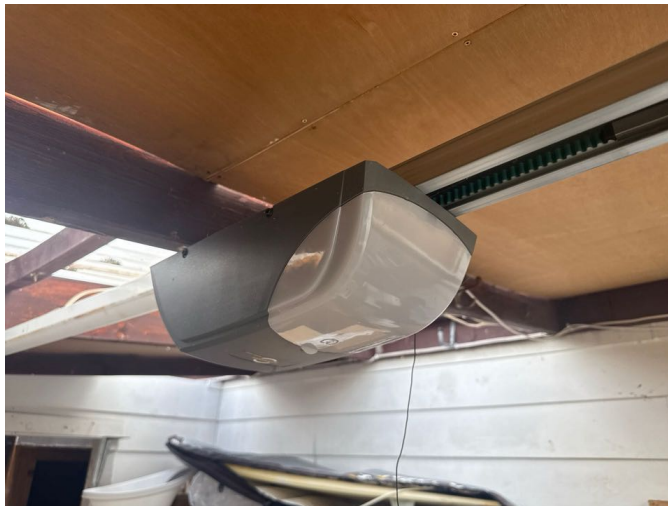
The electric garage door is functioning
