# BUILDING REPORT

## RED LBP PRE-PURCHASE REPORT

# PRE-PURCHASE

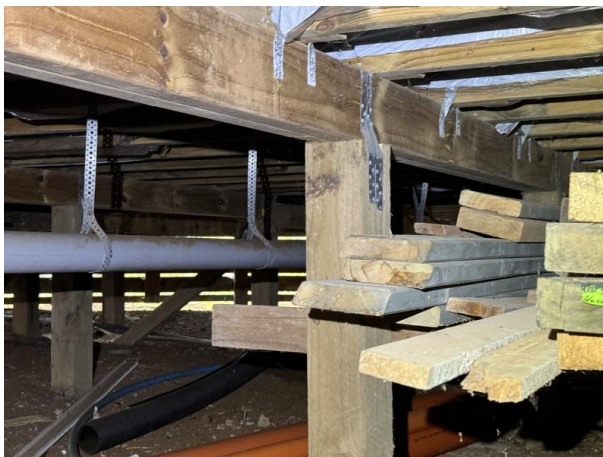
Photo 3

Subfloor showing timber bearers on timber piles.

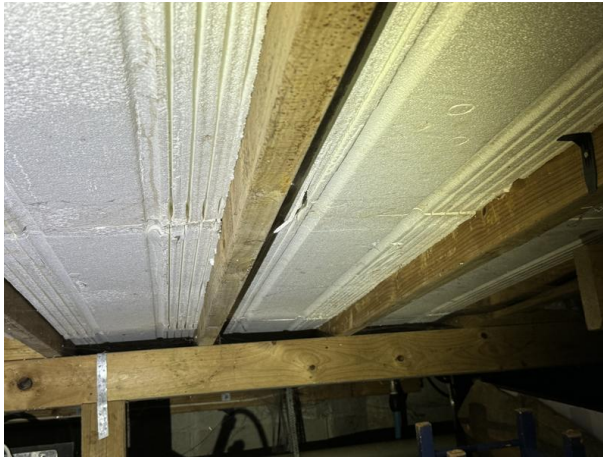
Photo 4

Polystyrene insulation.

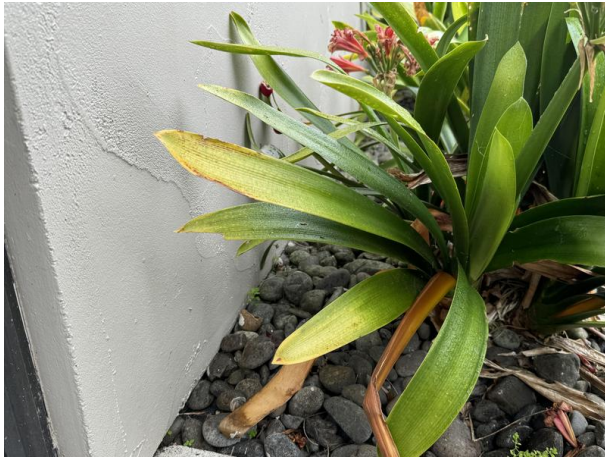
Photo 7

No ground clearance to the cladding on the southwest garage wall.

Recommend having a building contractor report on the remedial work required to the ground clearances.

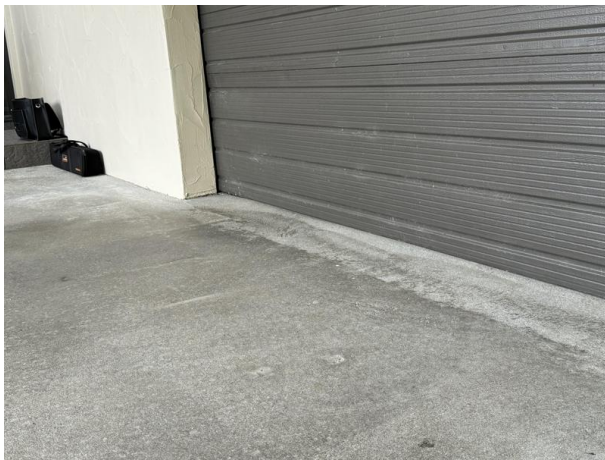
Photo 8

No ground clearances to the cladding on the northwest wall around the garage.

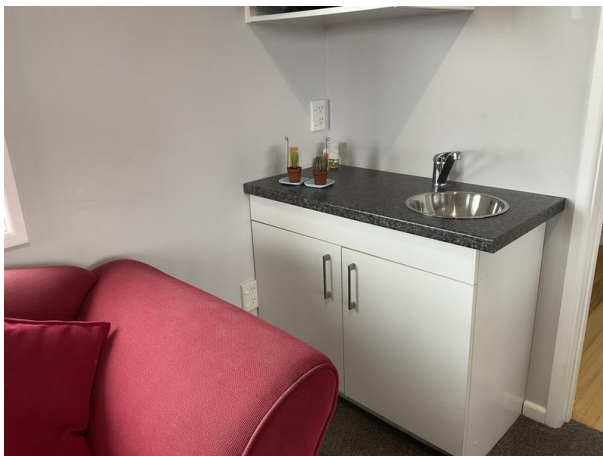
Photo 37

Hand basin. Bench to wall junctions sealed.

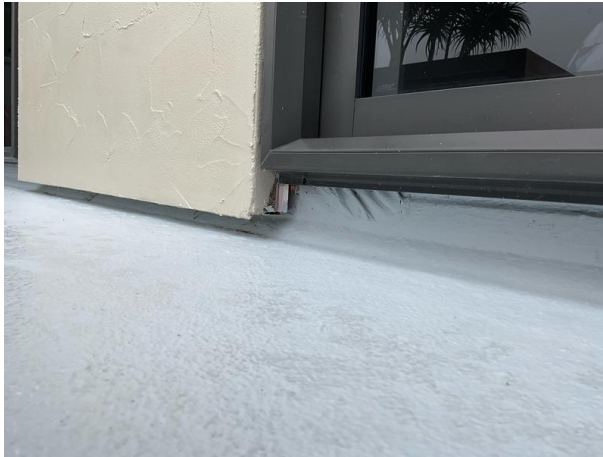
Photo 41

Membrane returns up the wall.  
Functional.

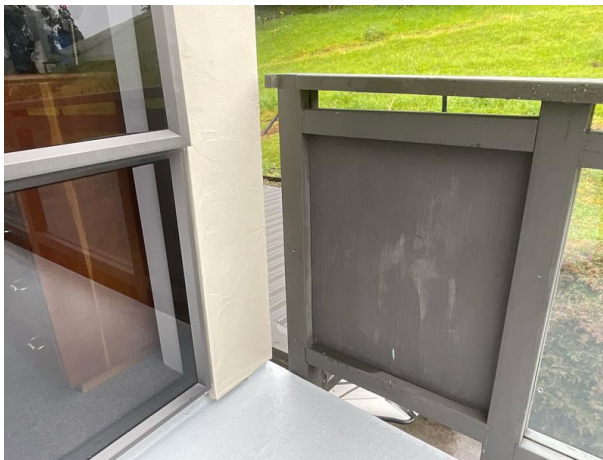
Photo 42

Balustrades are self supporting.

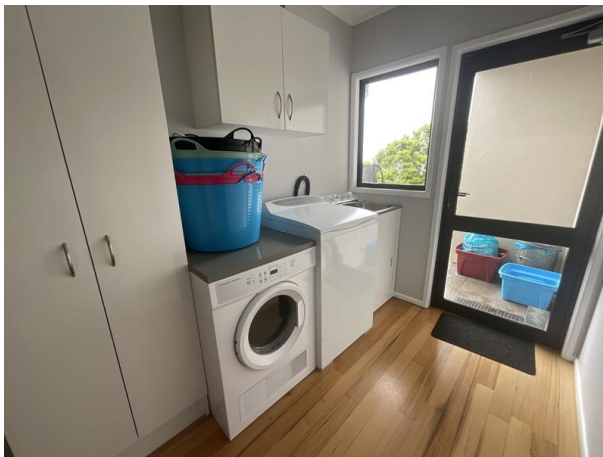
Photo 65

Laundry.

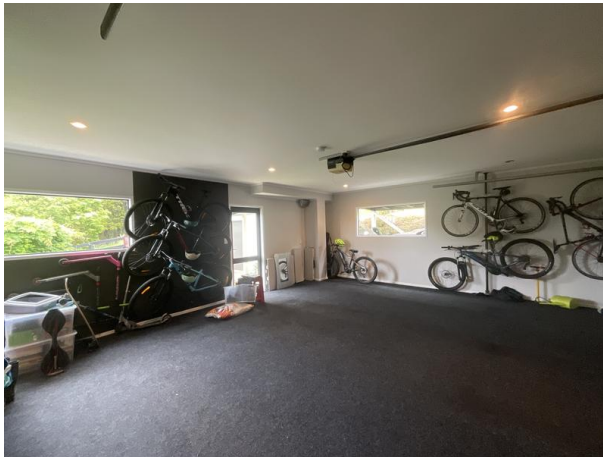
Photo 66

Garage.

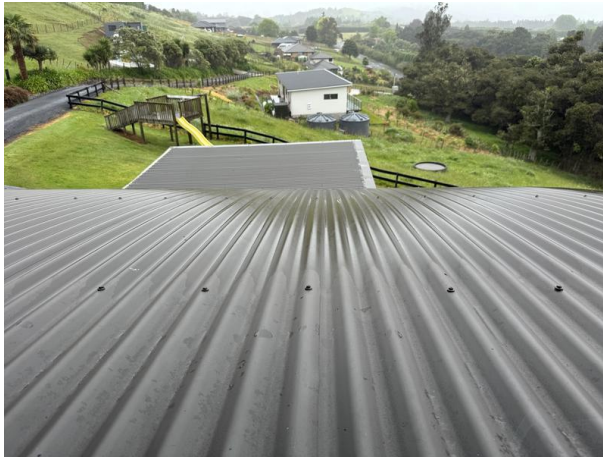
Photo 43

Profiled metal roof with screw fixings.

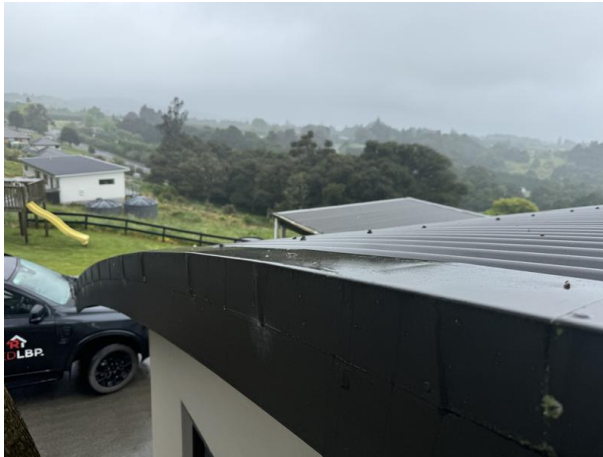
Photo 45

Example of a metal barge flashing. Functional.

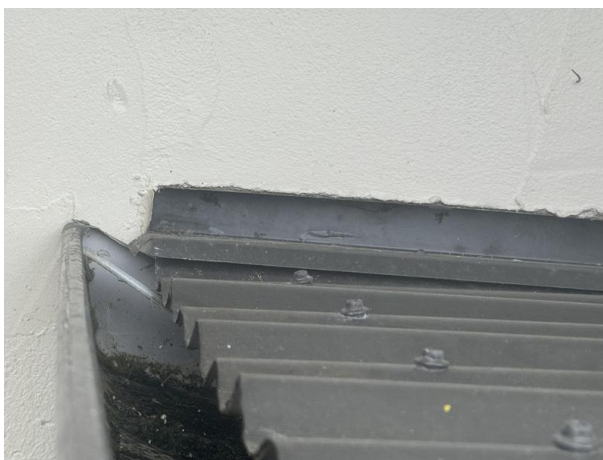
Photo 46

Example of a metal apron flashing with kick out.

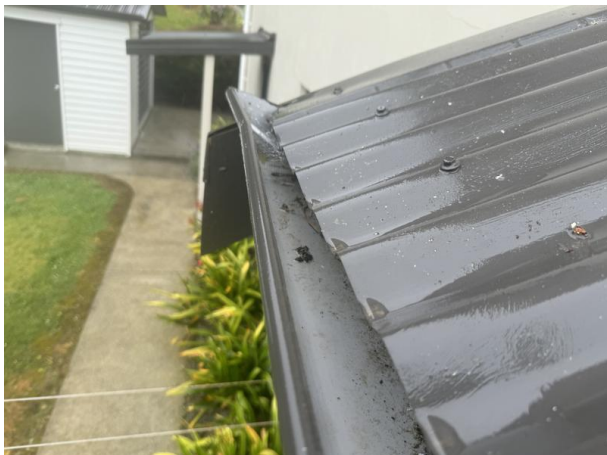
Photo 48

Example of profiled metal guttering. Clear at the time of inspection.

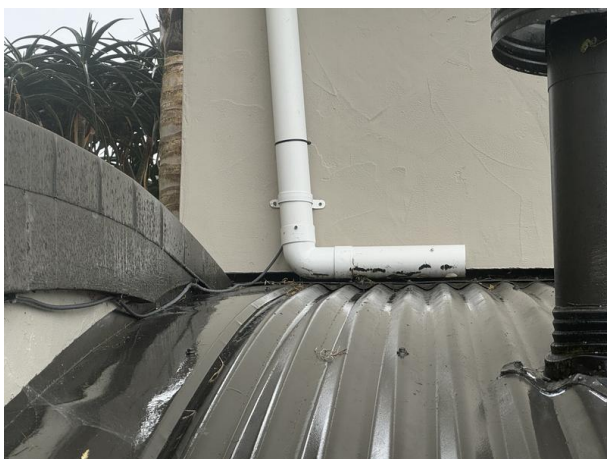
Photo 49

Example of PVC downpipe with spreader.

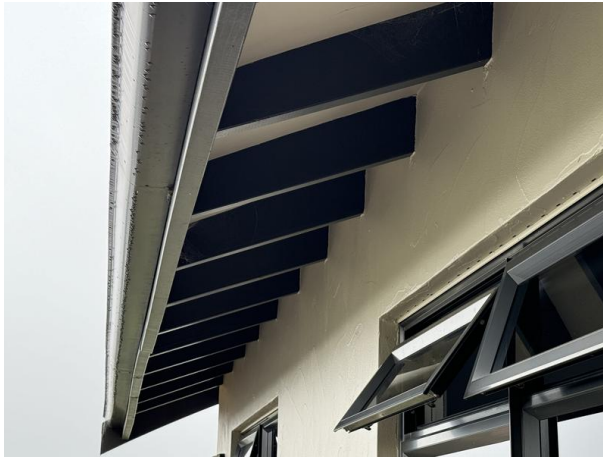
Photo 50

Fibrous cement soffits with exposed rafters.

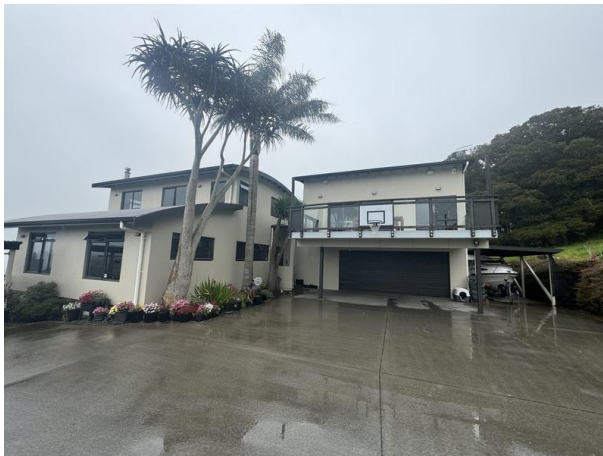
Photo 53

Northeast elevation.

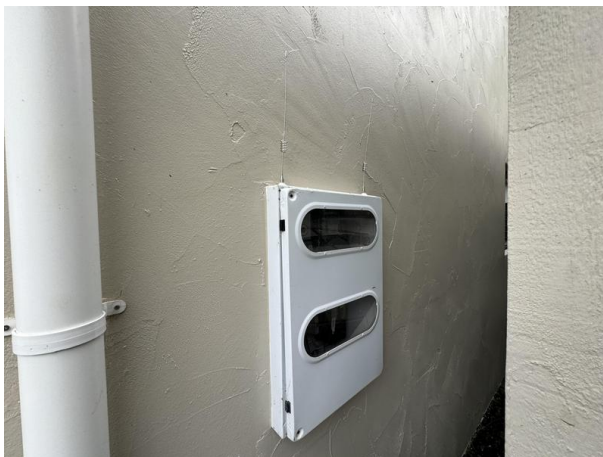
Photo 54

Metrebox penetration. No head flashing. Sealed on all sides.

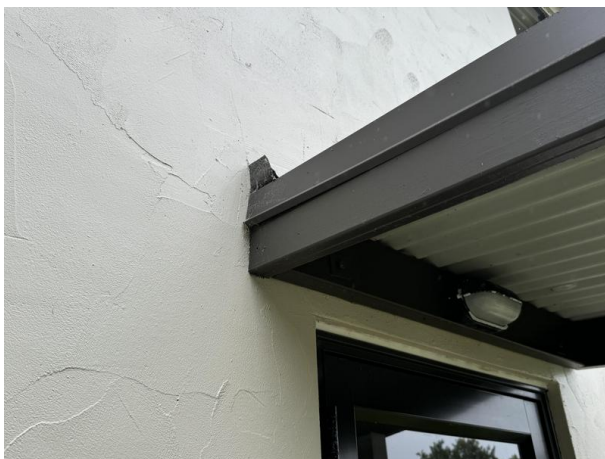
Photo 57

Garage door verandah is direct fixed with apron flashing and kick-outs installed.

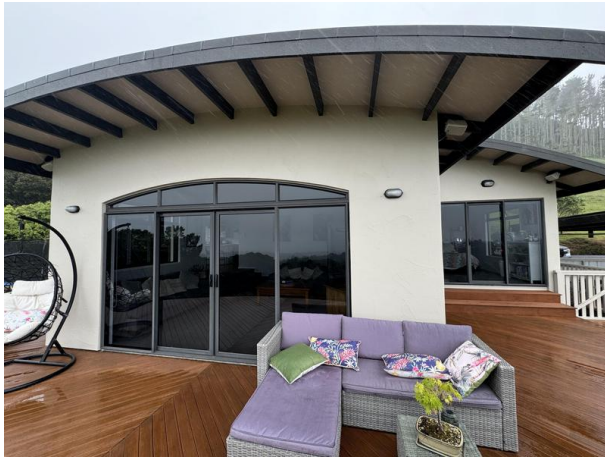
Photo 58

Southeast elevation.

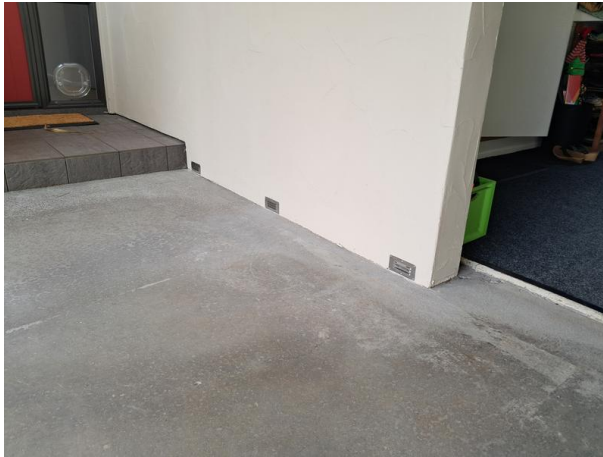
Photo 61

Update - 20/11/24 - Vendor has installed vents to the cladding at the front door to allow airflow to the cavity.

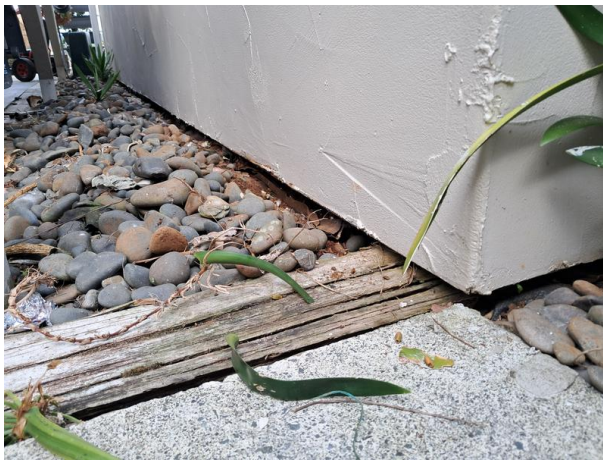
Photo 62

Update - 20/11/24 - Vendor has removed the stones from against the cladding.

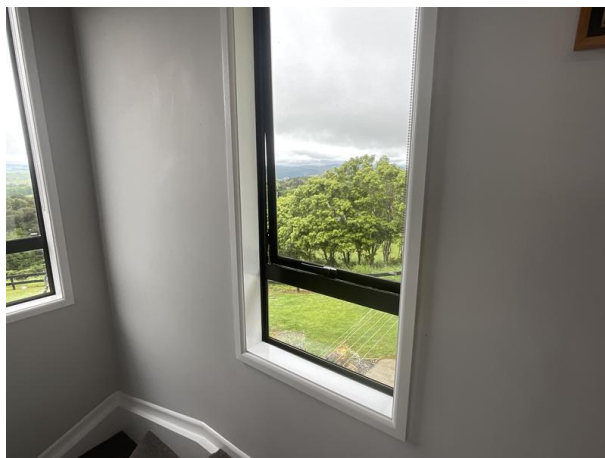
Photo 63

Example of aluminium joinery with timber reveals.

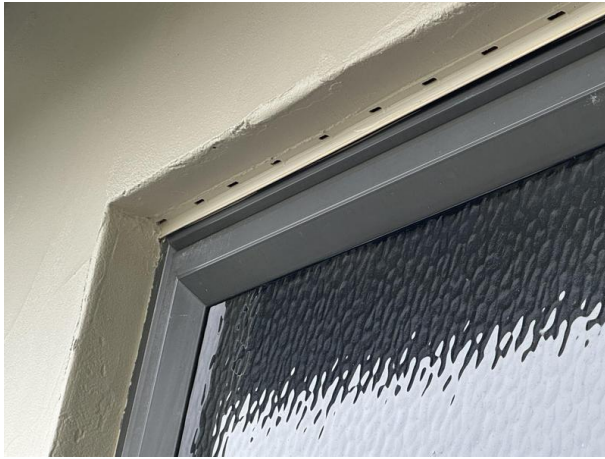
Photo 64

Example of typical joinery to cladding detail. Sealed around all sides. Vented cavity strip visible.

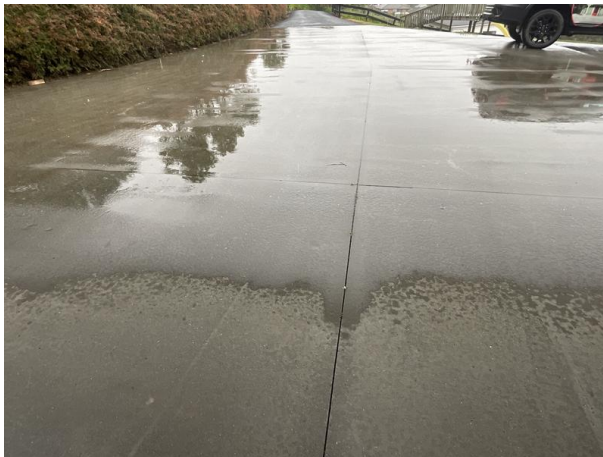
Photo 67

Asphalt and concrete driveway and parking area.

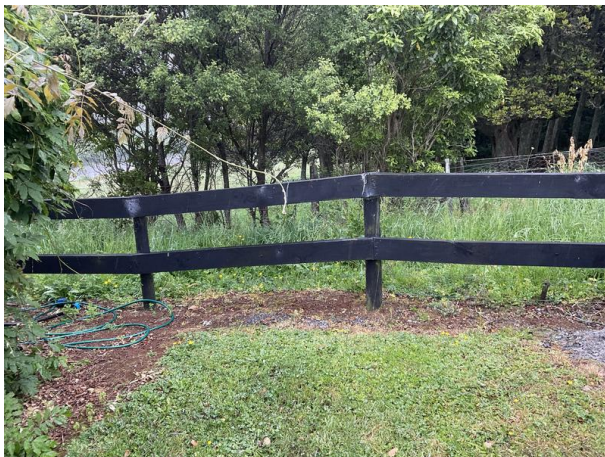
Photo 68

Timber post and rail fence located around the section.

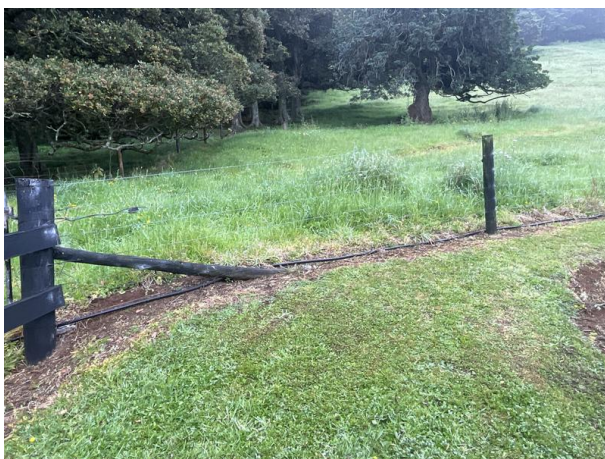
Photo 69

Timber post and seven wire fence located on the northwest side of the property.

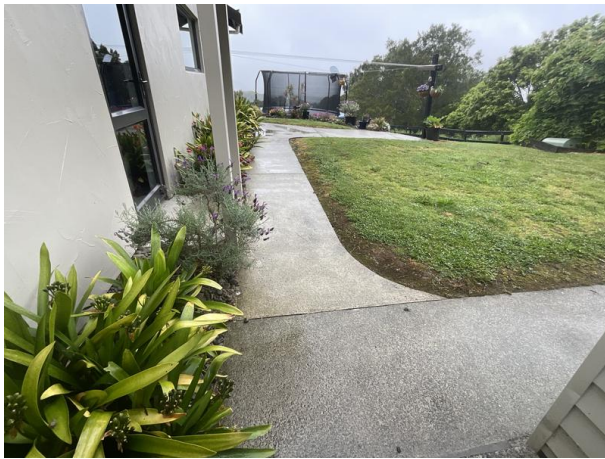
Photo 70

Concrete path running along the southwest side of the dwelling and garage.

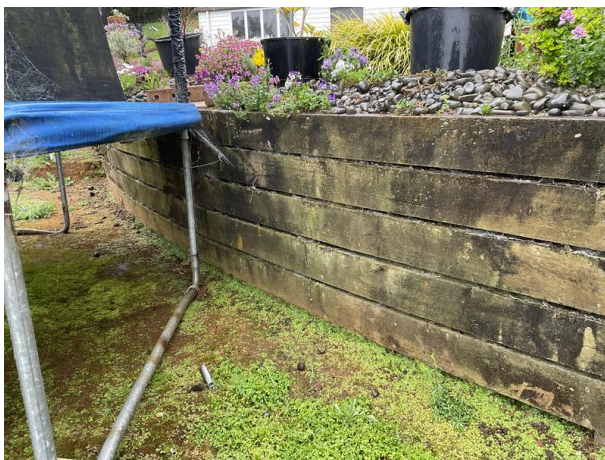
Photo 72

Timber retaining wall located on the southwest side of the property.

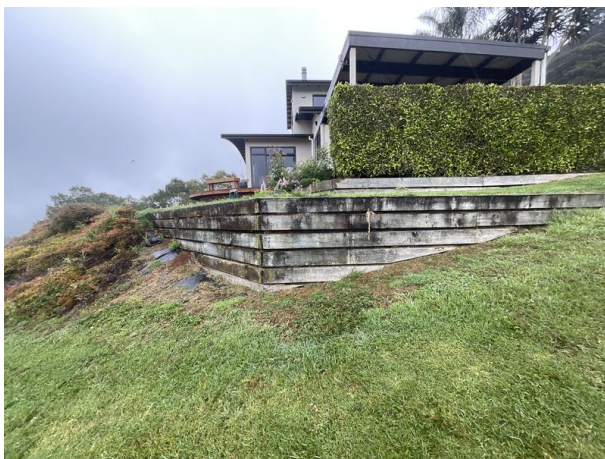
Photo 73

Timber retaining wall located on part of the southeast and part of the northeast side of the property.

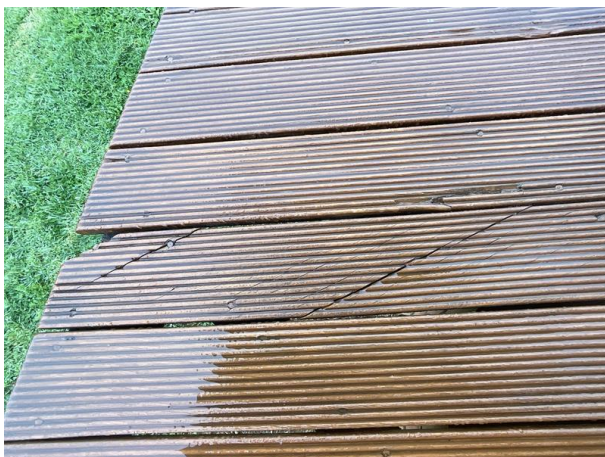
Photo 77

Large split/cut in one of the decking timbers outside the lounge.

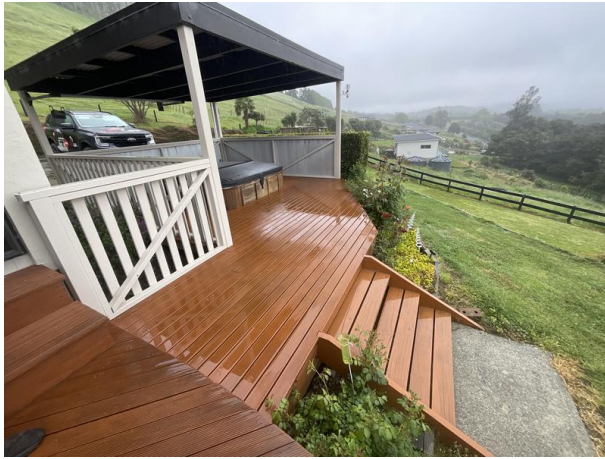
Photo 78

Partially covered deck and stairs on the northeast side of the dwelling.

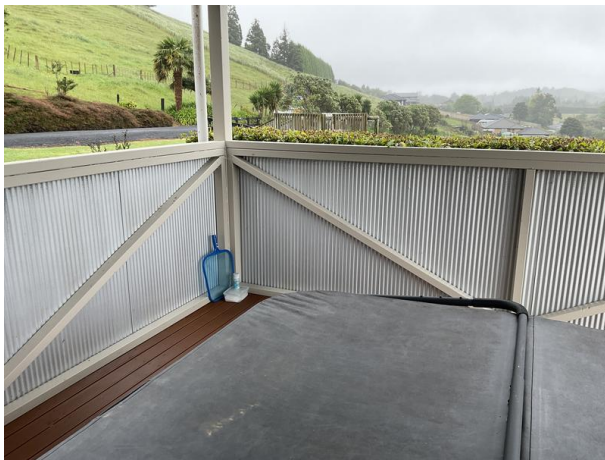
Photo 79

Timber and profiled metal privacy walls located on the northeast and northwest side of the deck.

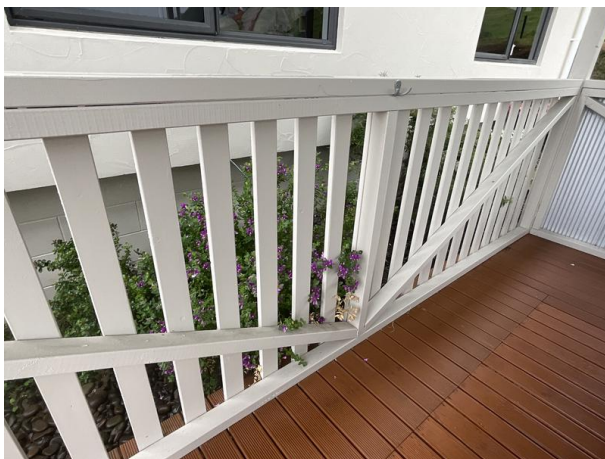
Photo 80

Timber balustrade located on the south side of the deck.

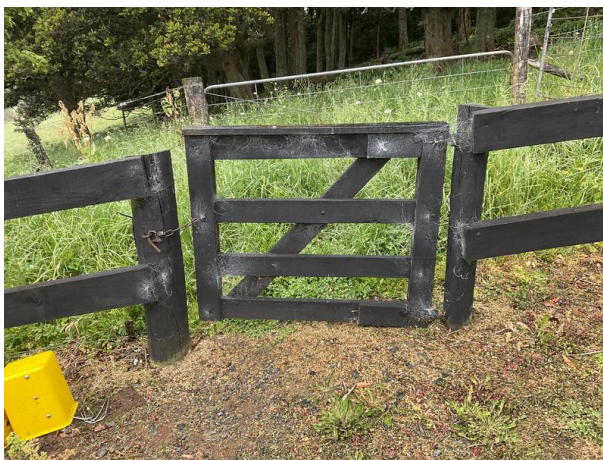
Photo 86

Timber gate located in the southwest fence.

Recommend regular lubrication of the hinges and latch to maintain full function.

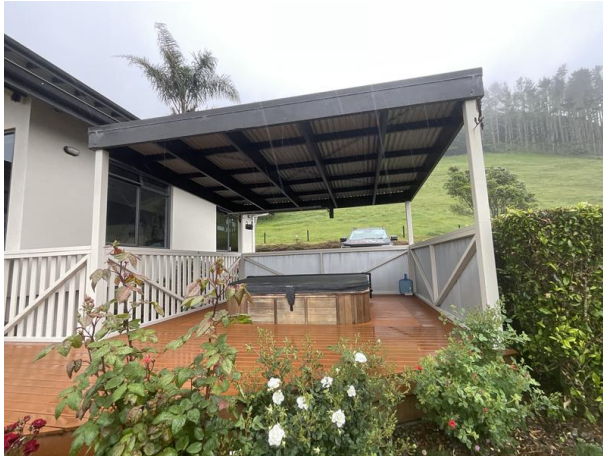
Photo 87

Timber and profiled metal self-supporting verandah over the northeast deck.

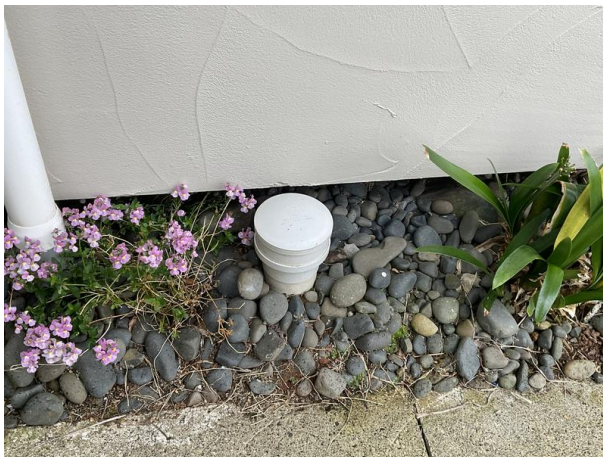
Photo 88

Gully relief located on the southwest side of the dwelling.

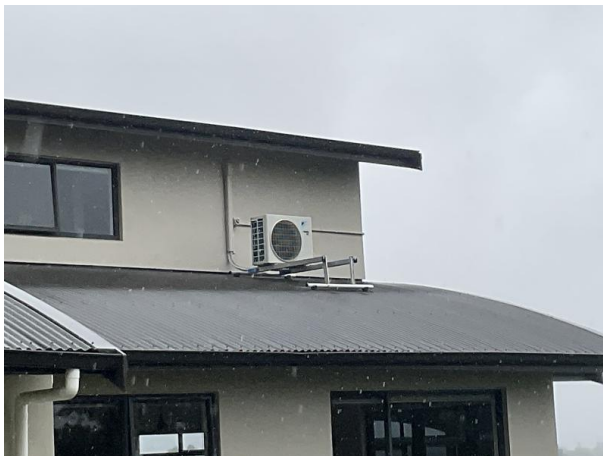
Photo 89

Heat pump units x 2 located on the roof.

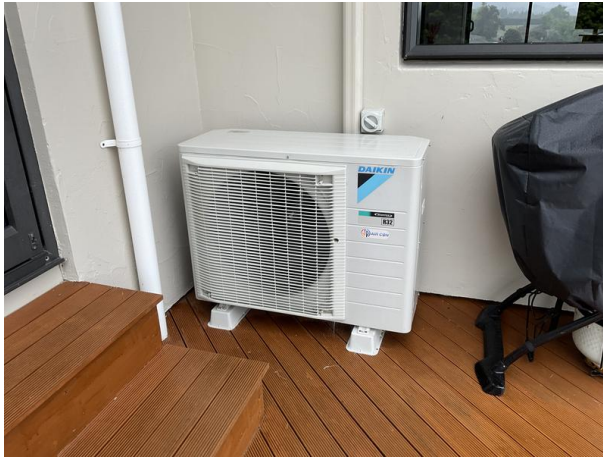
Photo 90

Exterior heat pump unit located on the southeast deck.

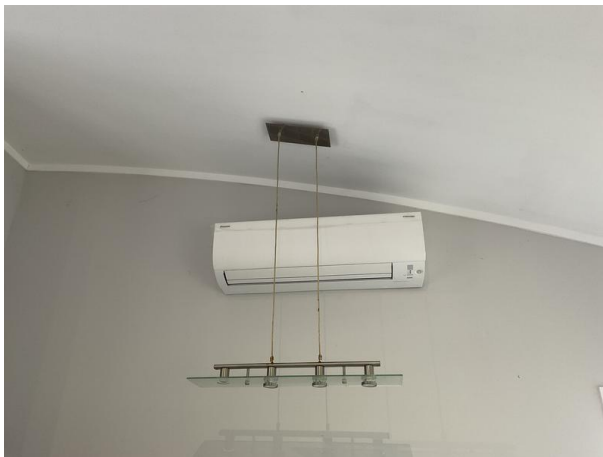
Photo 91

Daikin Inverter heat pump located in the living room.

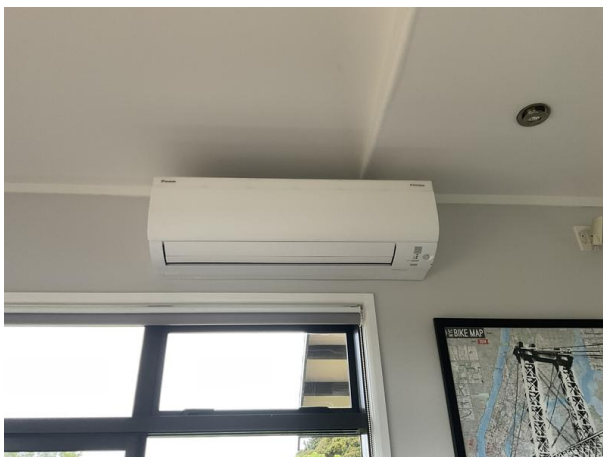
Photo 92

Daikin Inverter heat pump located in the lounge.

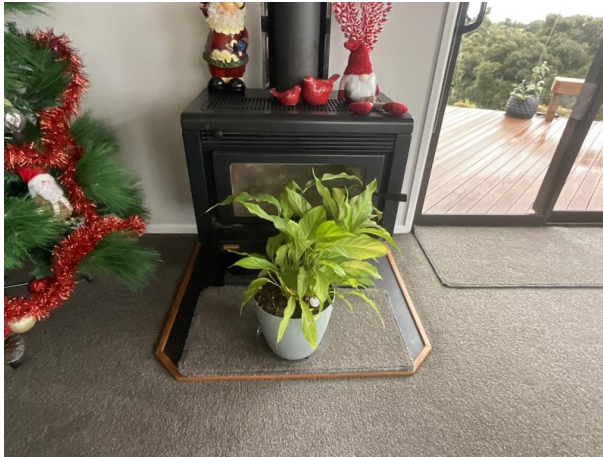
Photo 93

Kent Signature freestanding wood burner located in the lounge.

It is recommended to have the wood burner flue cleaned and checked annually.

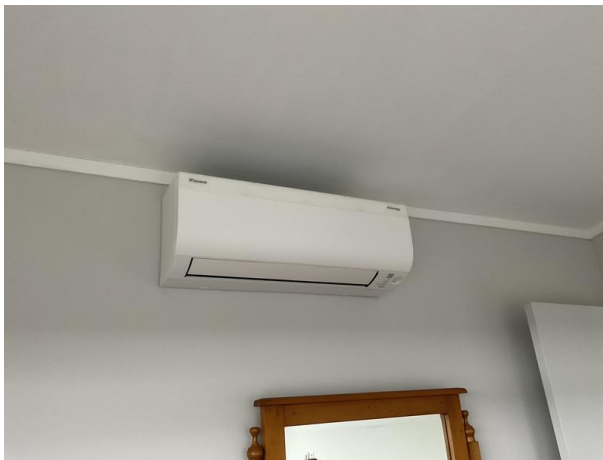
Photo 94

Daikin Inverter heat pump located in the bedroom three.

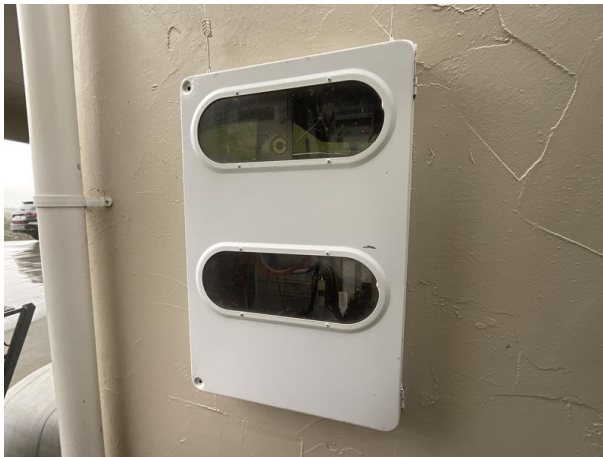
Photo 95

Metrebox located on the northwest side of the garage.

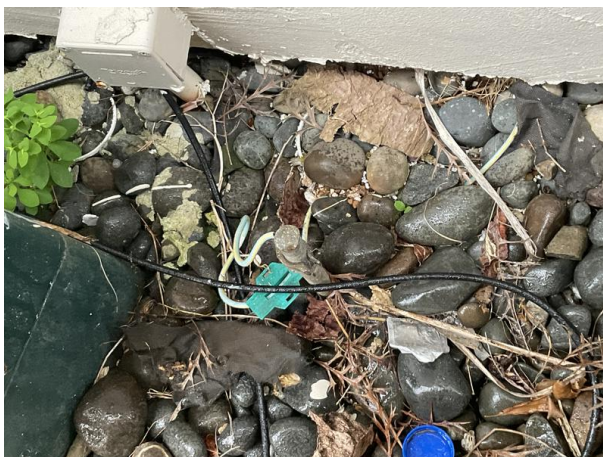
Photo 96

Earth peg located on the northwest side of the garage.

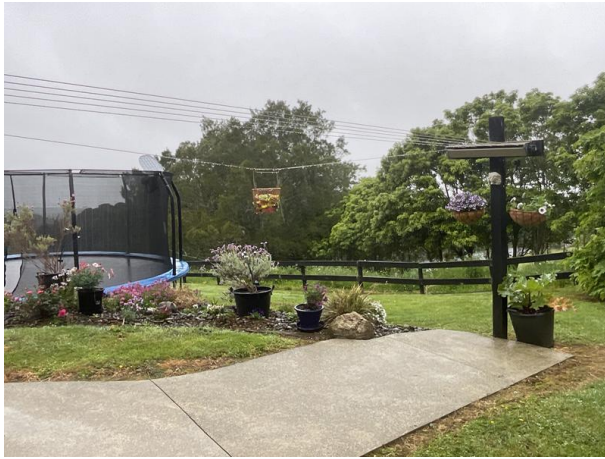
Photo 97

Clothesline located on the southwest side of the dwelling.

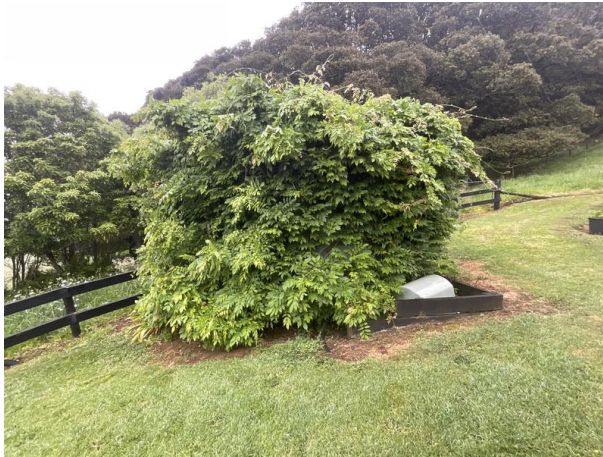
Photo 99

Septic tank breather located on the southwest side of the property.

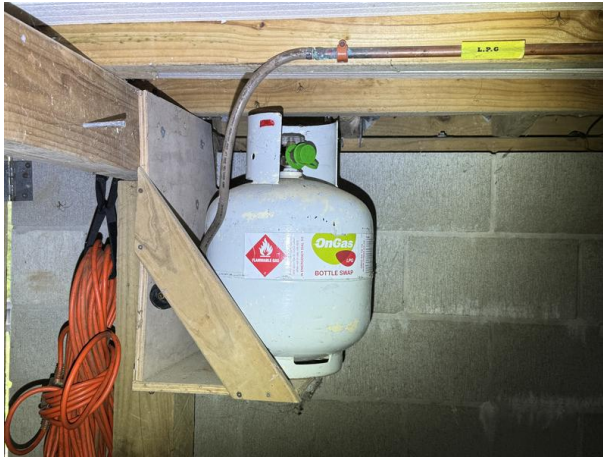
Photo 108

Example of a security sensor located through throughout the dwelling.
